**TECHNICAL REPORT 0-6804-3**  
TxDOT PROJECT NUMBER 0-6804

# Traffic Noise Barrier Analysis for SH 190 in Rowlett, Texas

August 2019; Published September 2020

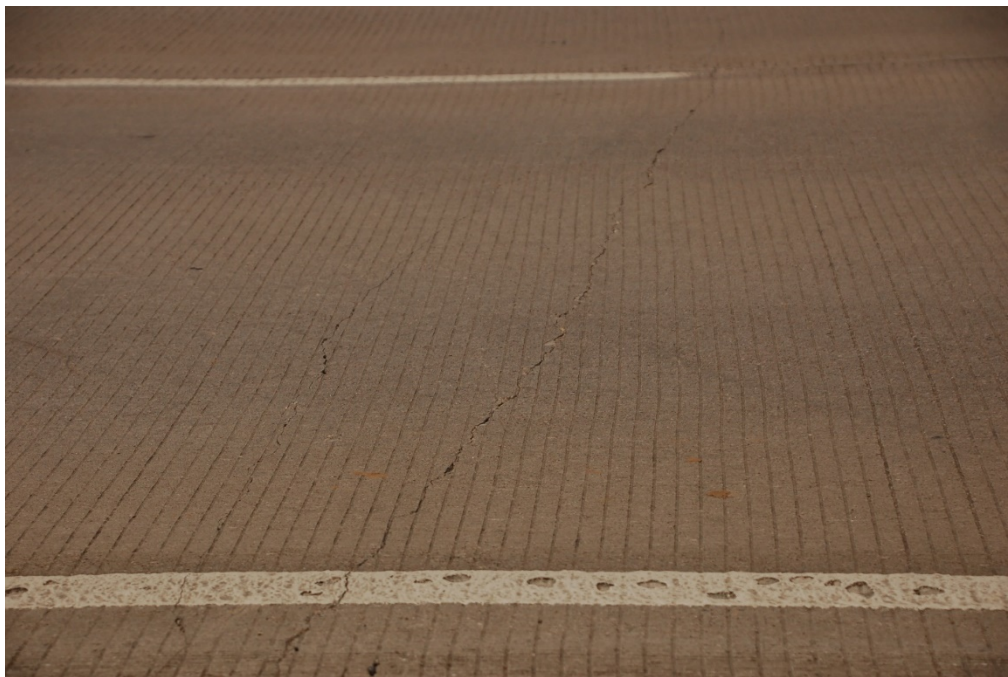
Transverse cracks are a normal occurrence on CRCP. Transverse cracking is defined as cracks that are mainly perpendicular to the pavement centerline. Crack spacing and crack widths are two parameters of importance on CRCPs. From the visual survey conducted on the pavements, crack spacing is adequate and the crack openings do not seem wide, so the cracks appear in good condition. There is very little spalling in a few of the cracks. Few longitudinal cracks were observed, but they appear to be very minor.

*Figure 3.11: Northbound frontage road. Transverse cracks*

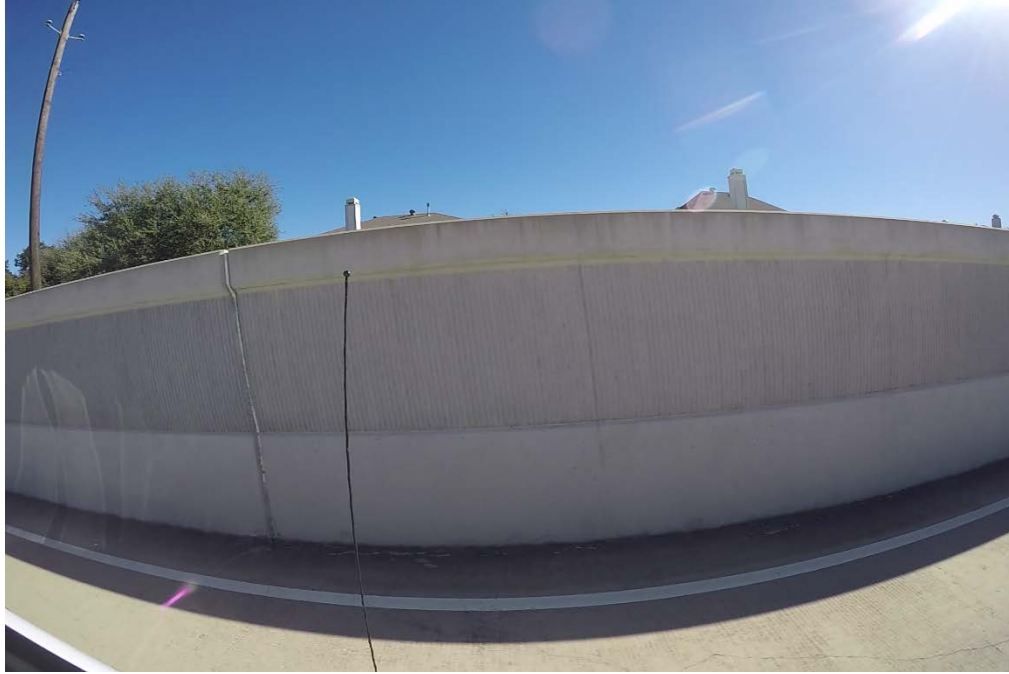
*Figure 3.12: Northbound frontage road. Longitudinal crack as recorded by video*

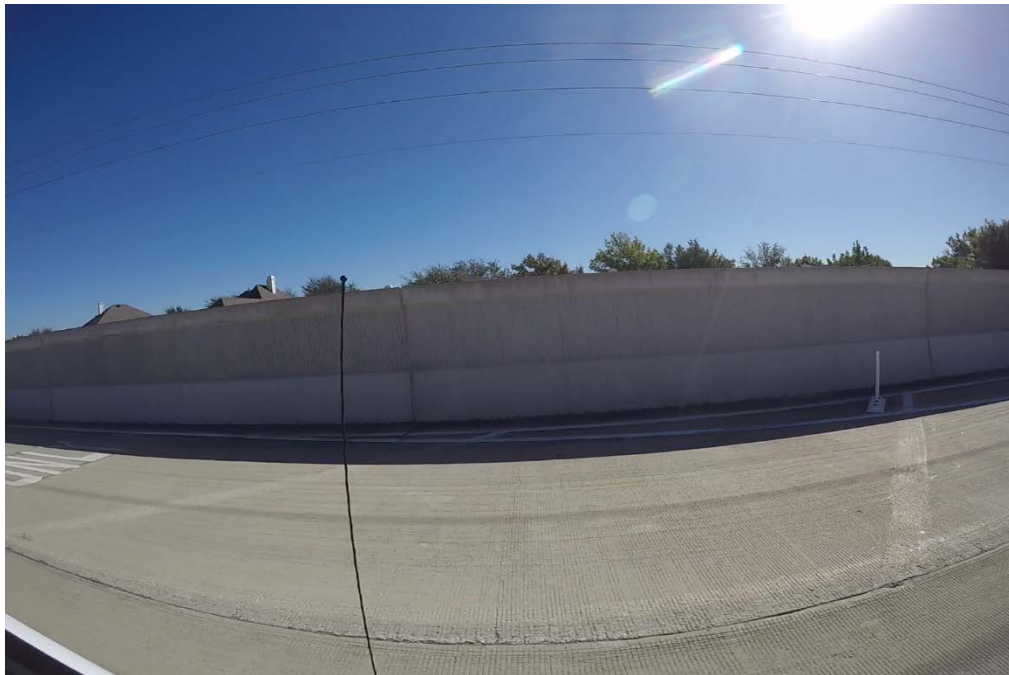
*Figure 3.13: Northbound frontage road. Minor spalling of the longitudinal joint as recorded by video*

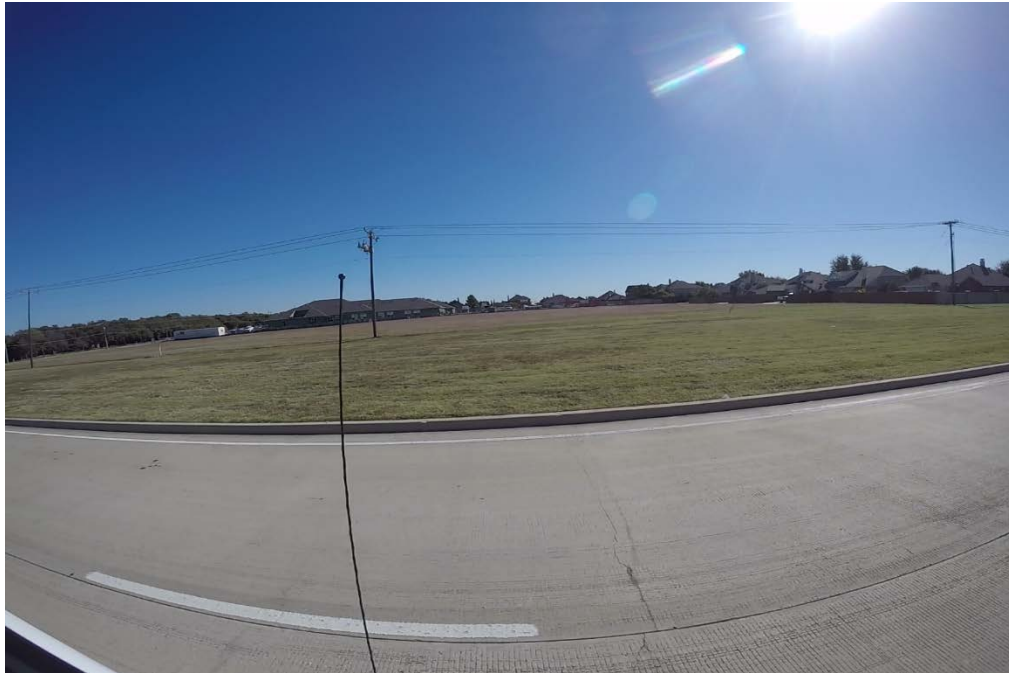
*Figure 3.14: Northbound frontage road. Minor spalling of the transverse crack as recorded by video*

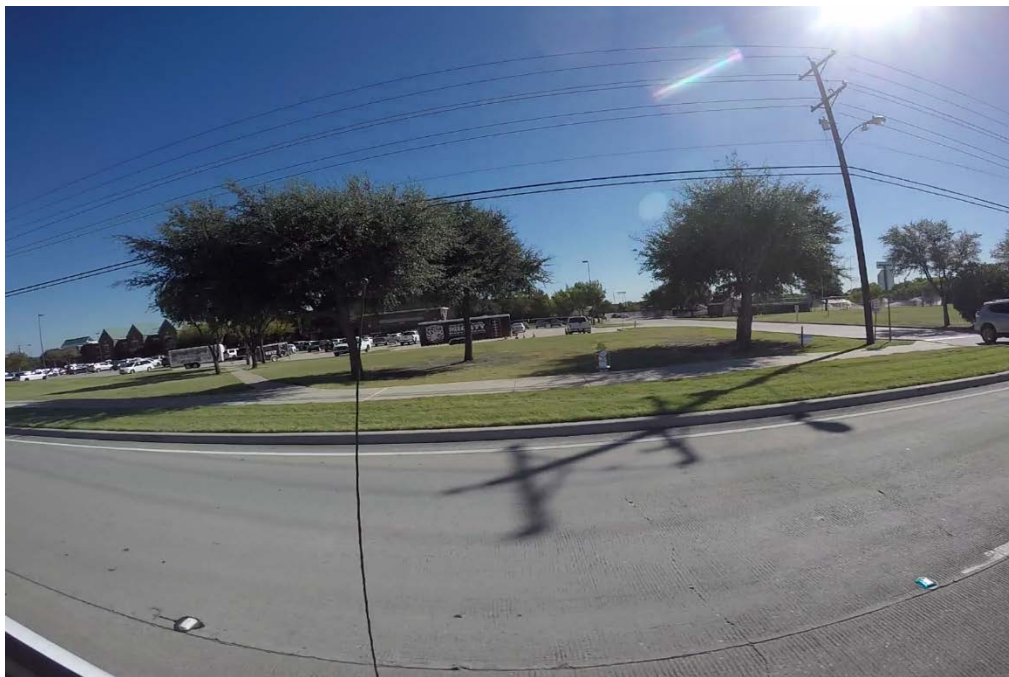
*Figure 3.15: Northbound frontage road. Transverse cracks as recorded by video*

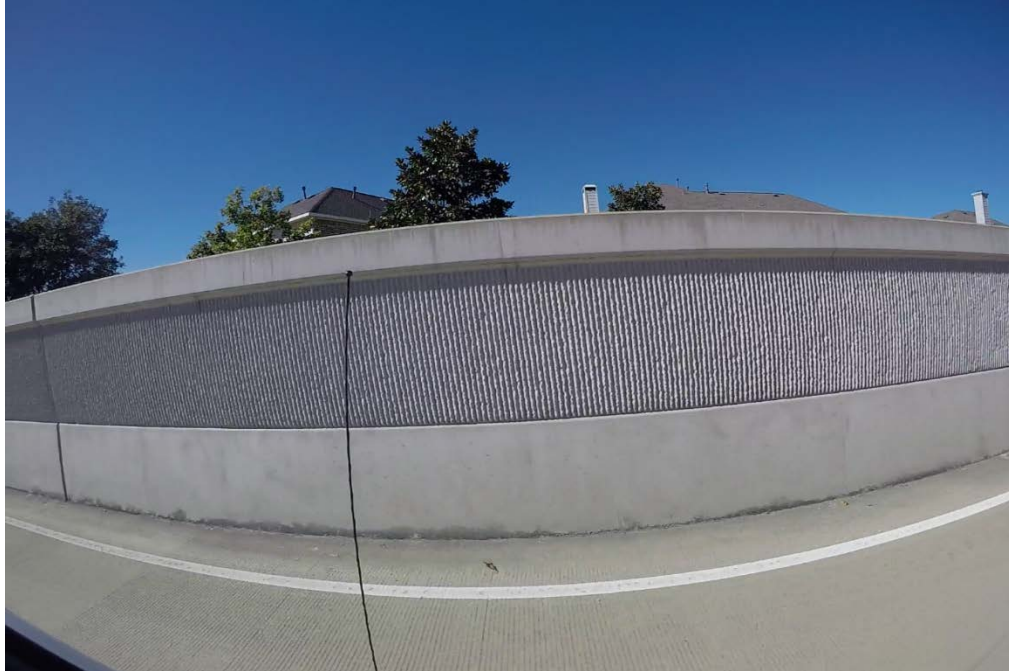
*Figure 3.16: Southbound frontage road. Pavement in excellent condition as recorded by video*

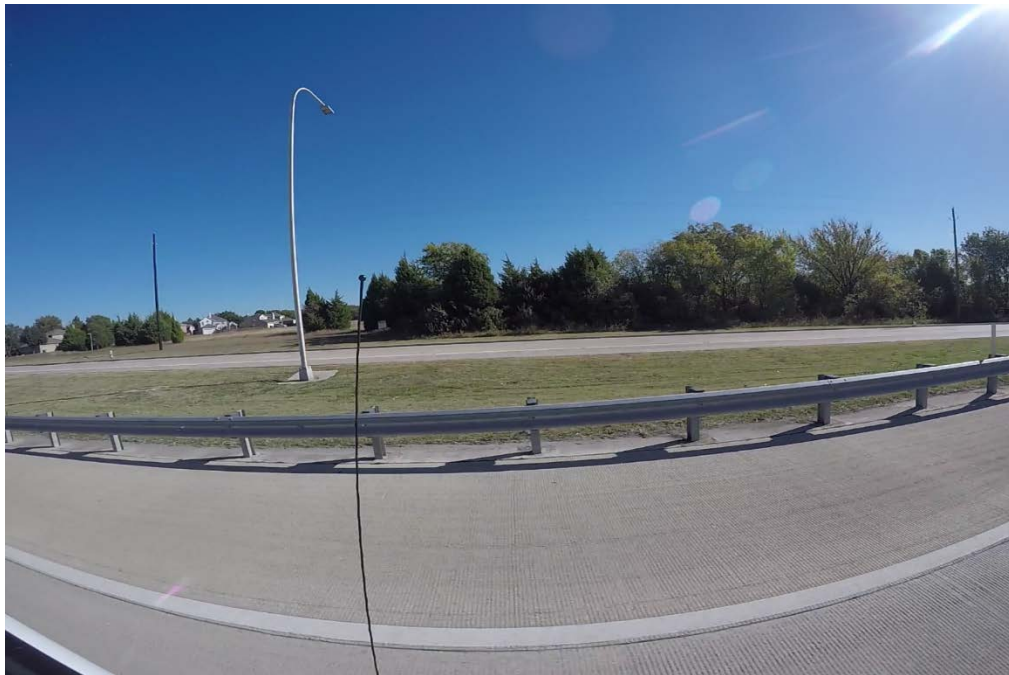
*Figure 3.17: Northbound main lane. Pavement in excellent condition as recorded by video*

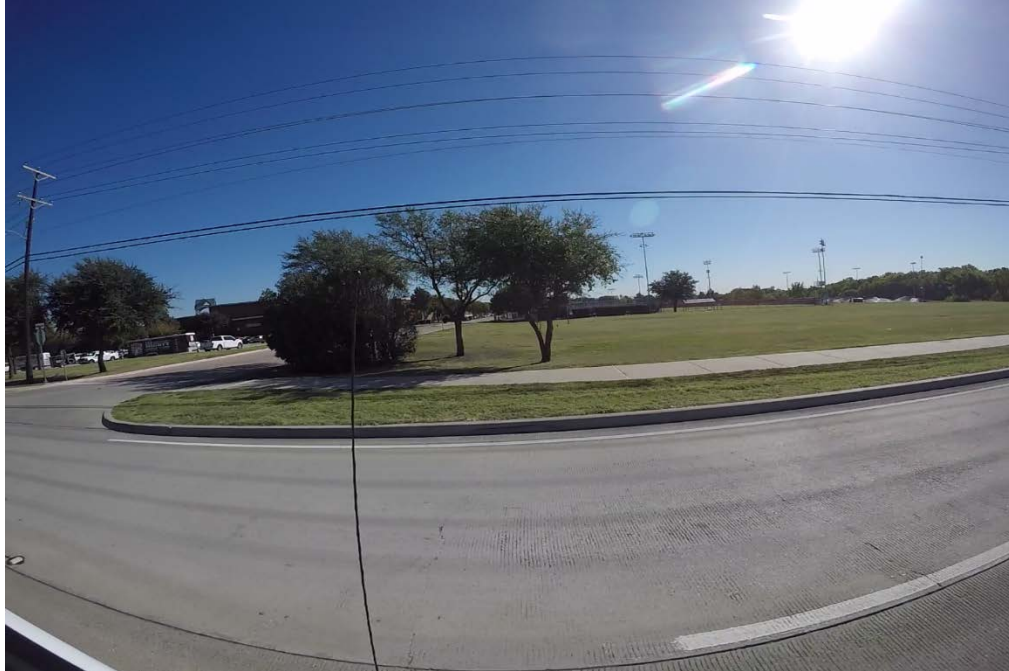
*Figure 3.18: Northbound frontage road. Pavement in excellent condition as recorded by video*

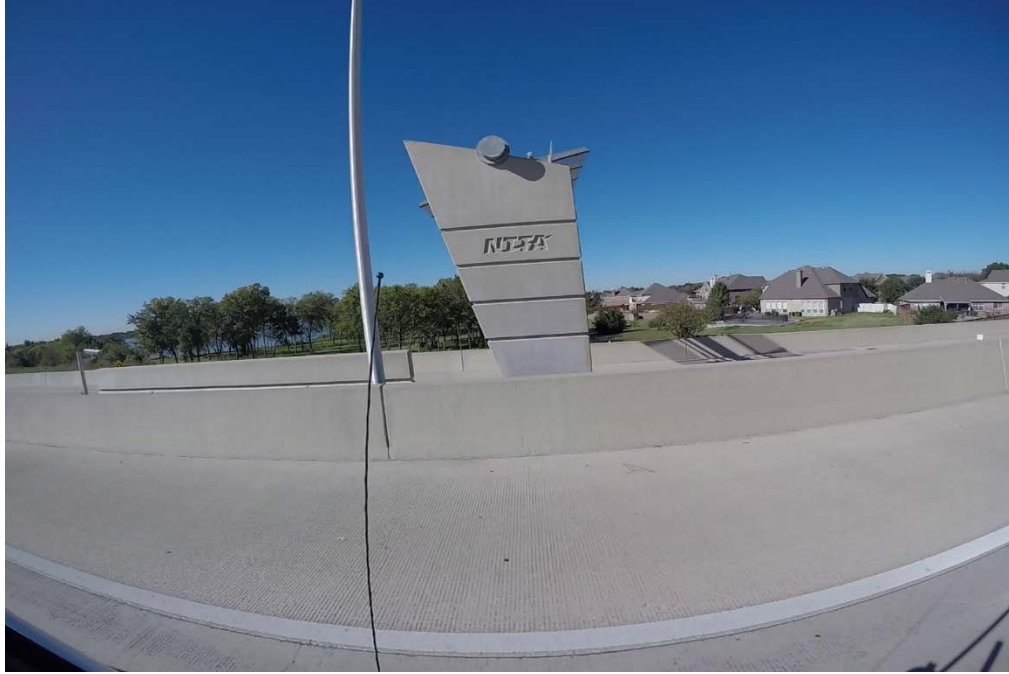
*Figure 3.20: Southbound main lane. Pavement in excellent condition as recorded by video*

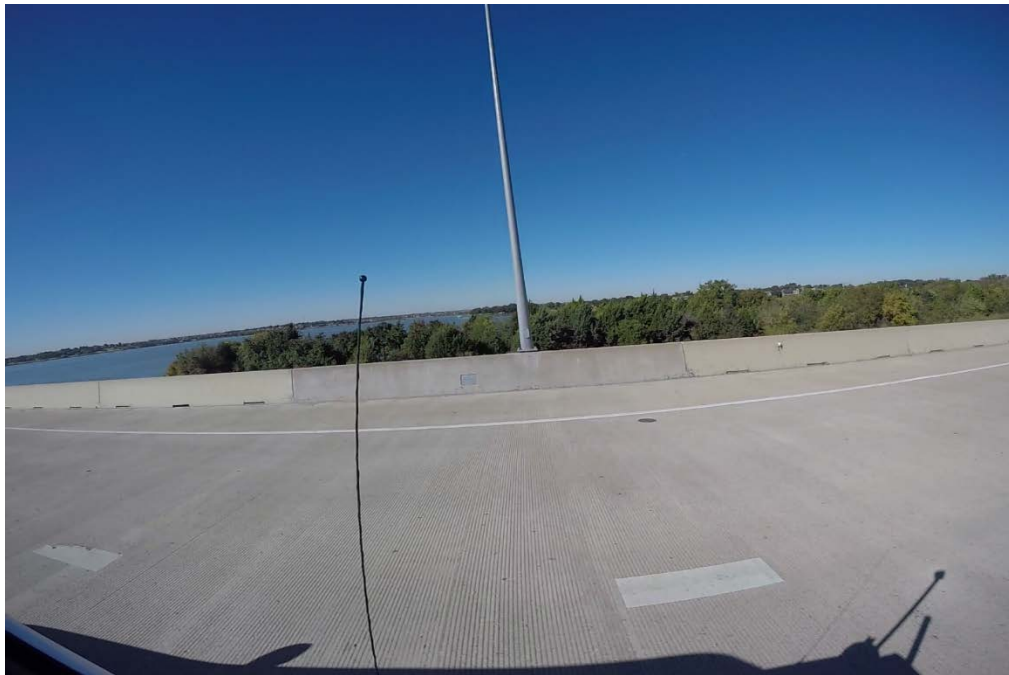
*Figure 3.21: Southbound main lane. Pavement in excellent condition as recorded by video*

It is estimated that the condition of the SH 190 pavements is excellent and does not contribute to the generation of additional tire/pavement noise.
