JOINT TRANSPORTATION RESEARCH PROGRAM

INDIANA DEPARTMENT OF TRANSPORTATION
AND PURDUE UNIVERSITY

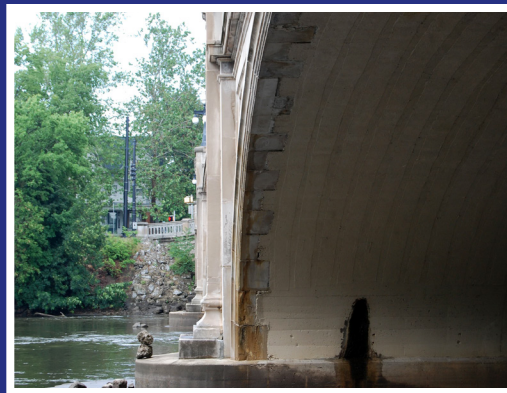
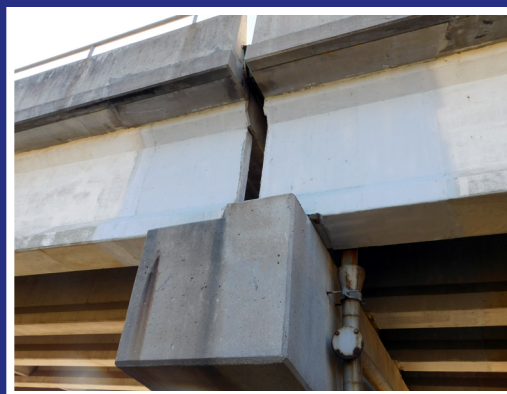
**Jon M. Pevey, William B. Rich,
Christopher S. Williams, Robert J. Frosch**

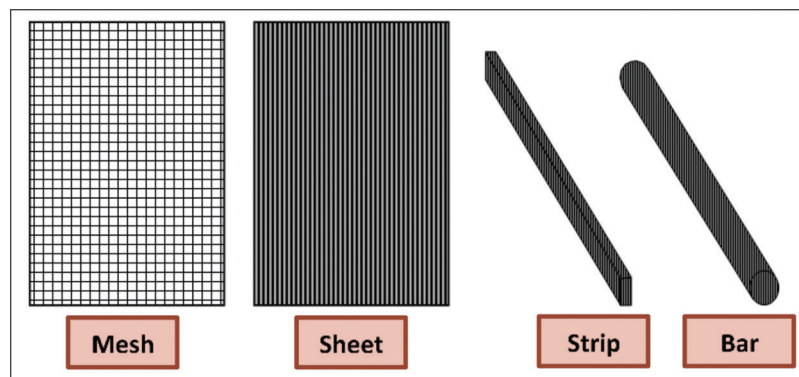
Figure 2.1 Common FRP product types.

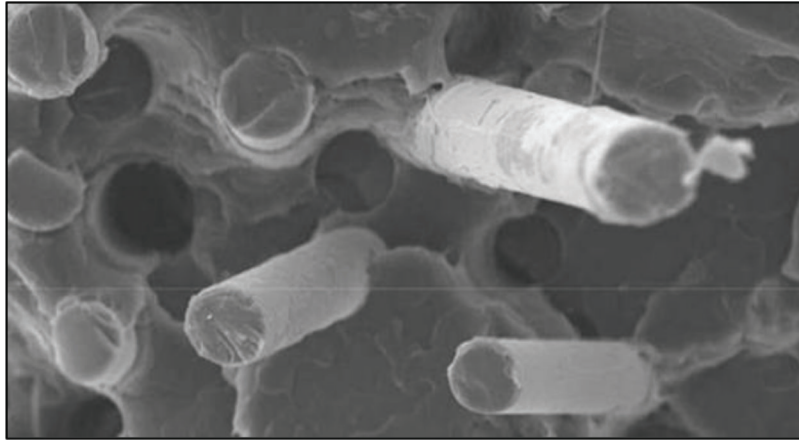
Figure 2.2 Fiber reinforced polymer microstructure (Czigány et al., 2013).

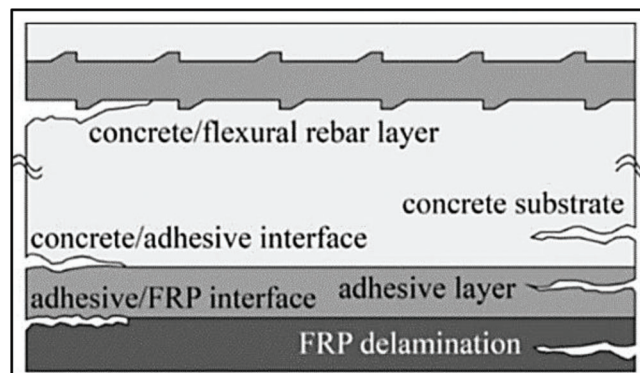
Figure 2.3 Possible paths for debonding (Kang et al., 2012a).

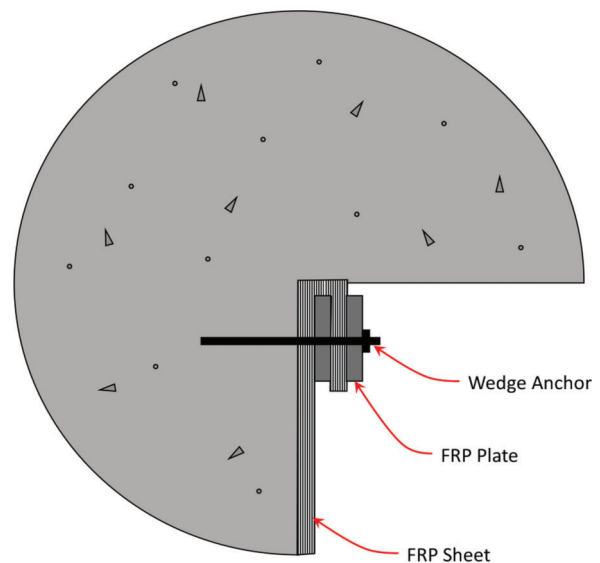
Figure 2.5 Modified anchor bolt system (adapted from Bae & Belarbi, 2013).

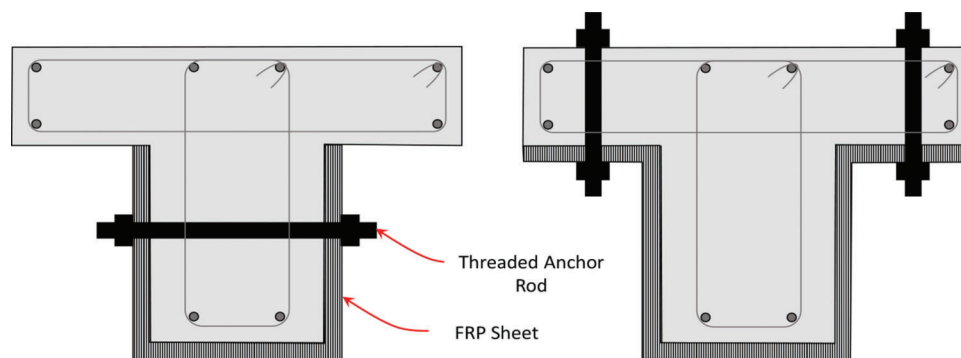
Figure 2.4 Threaded anchor rod system (adapted from Kim et al. 2012, originally from Deifalla & Ghobarah, 2006).

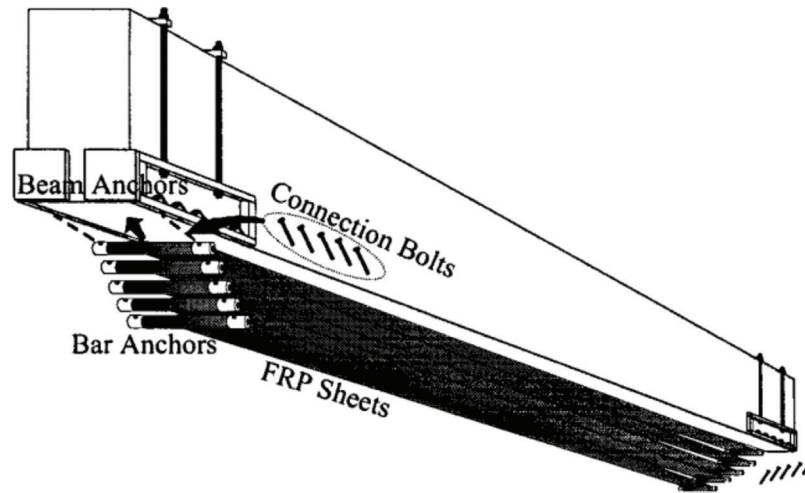
Figure 2.6 Externally-prestressed FRP system (Wight et al., 2001)

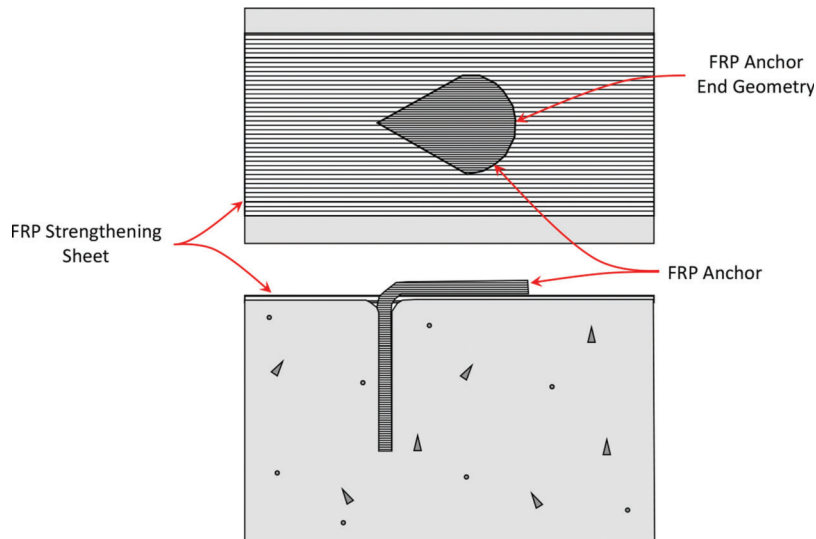
Figure 2.7 FRP fan anchorage system (adapted from Huaco Cárdenas, 2009).

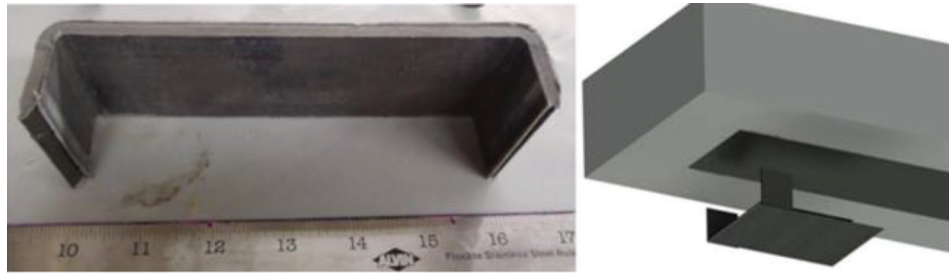
Figure 2.10 CFRP staple anchorage system (De Caso & Nanni, 2016).

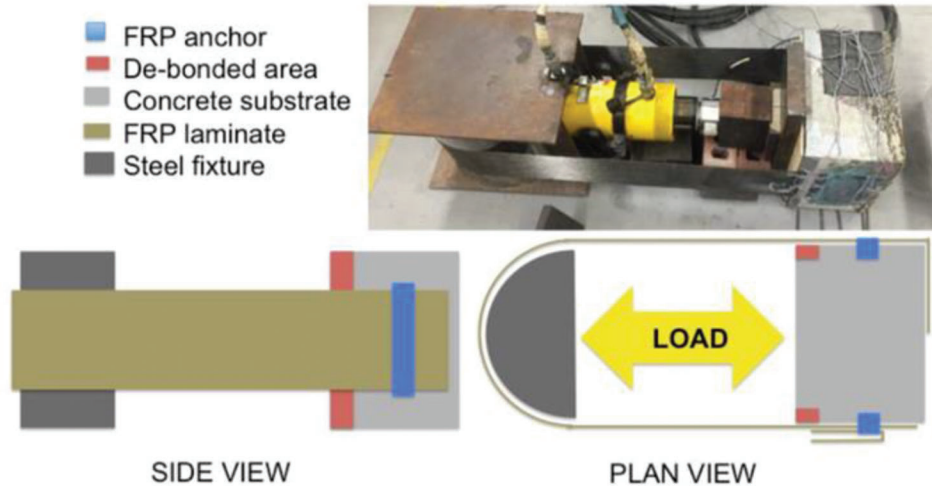
Figure 2.11 Double shear load test setup (De Caso & Nanni, 2016).

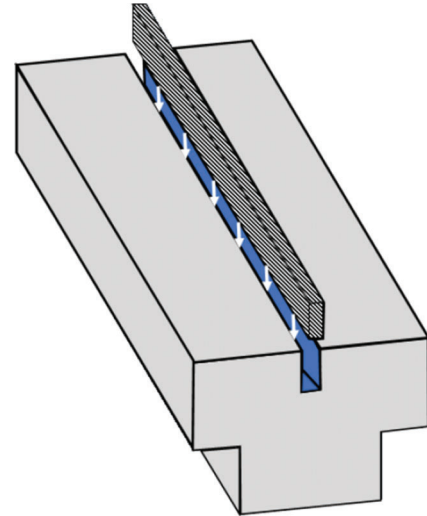
Figure 2.13 Near-surface-mounted system (adapted from Hughes Brothers, 2011).

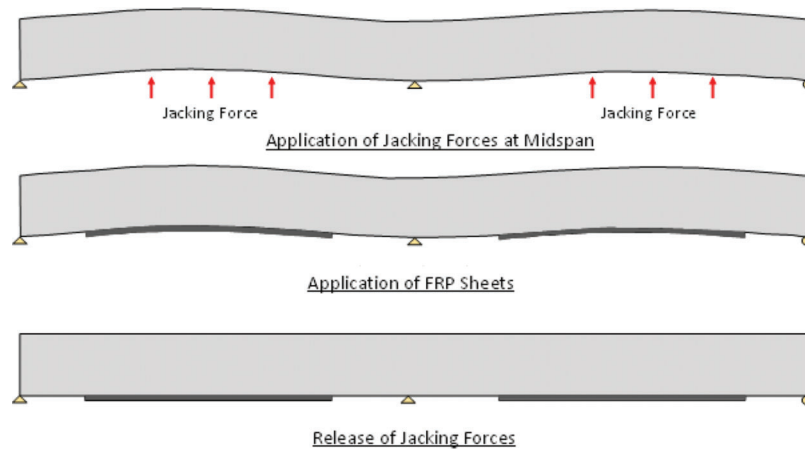
Figure 2.14 Cambered beam prestressing method (adapted from Saadatmanesh & Ehsani, 1991).

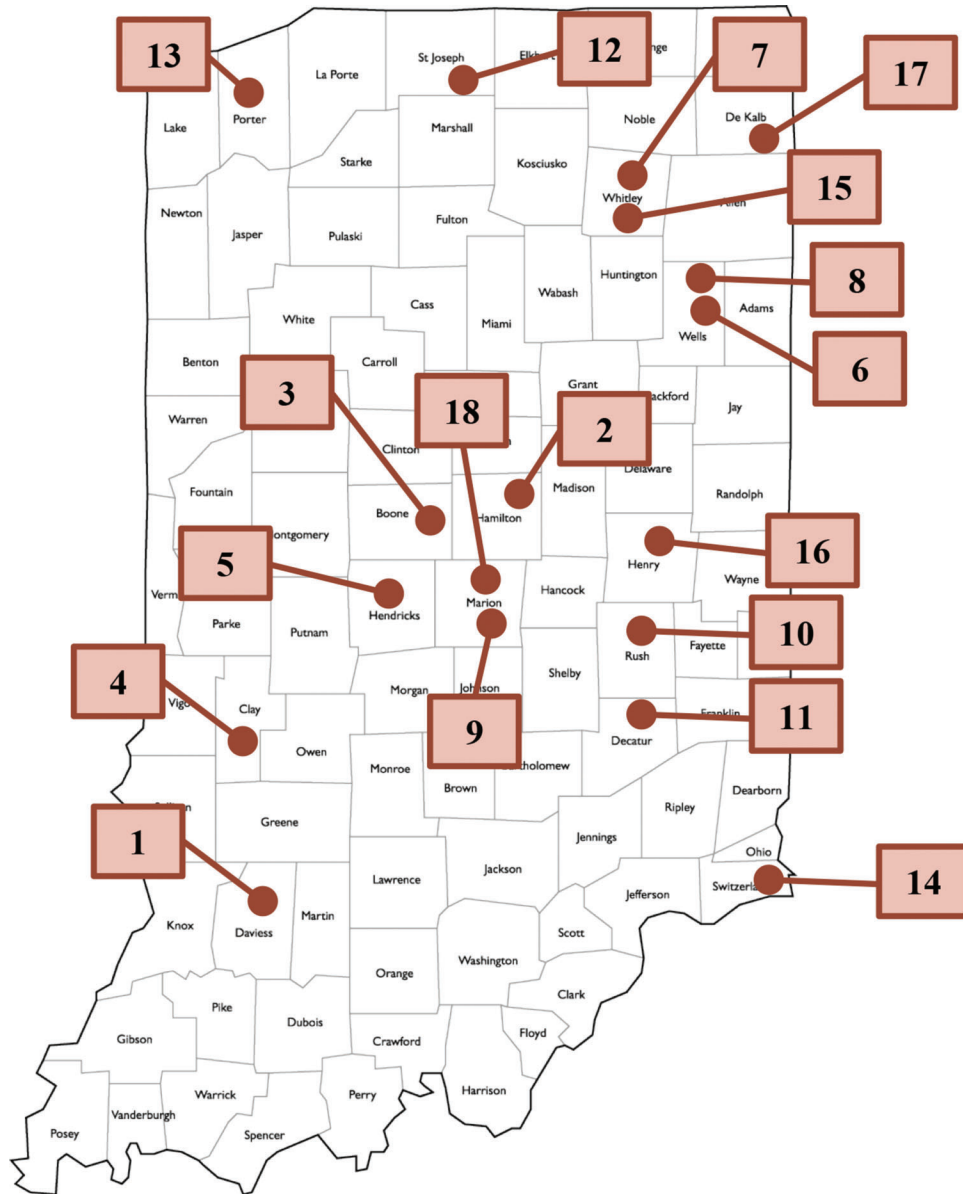
Figure 4.1 FRP-repaired bridges in Indiana (WorldAtlas, 2020).

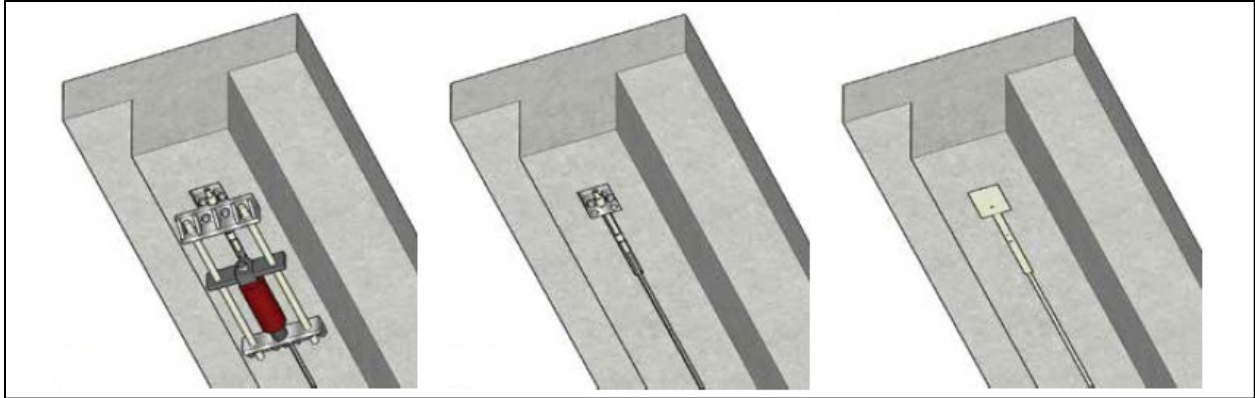
Figure B.1 Prestressed NSM strengthening system (from Jung et al., 2017).

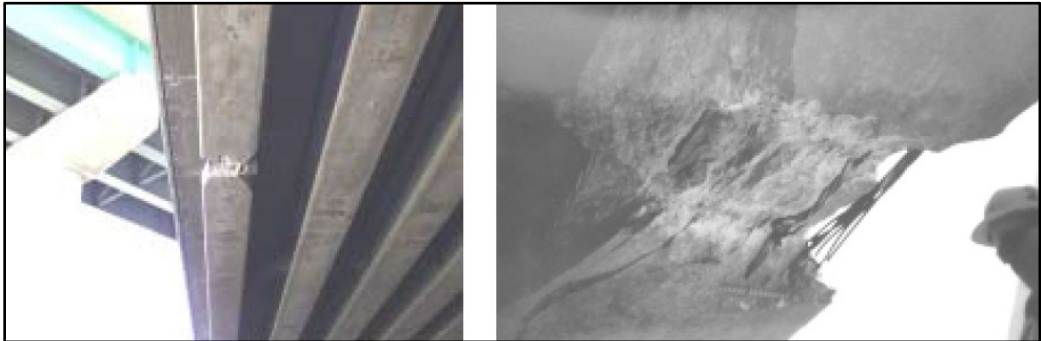
Figure B.2 Impact-damaged girder on Bridge A10062 (from Tumialan et al., 2001).

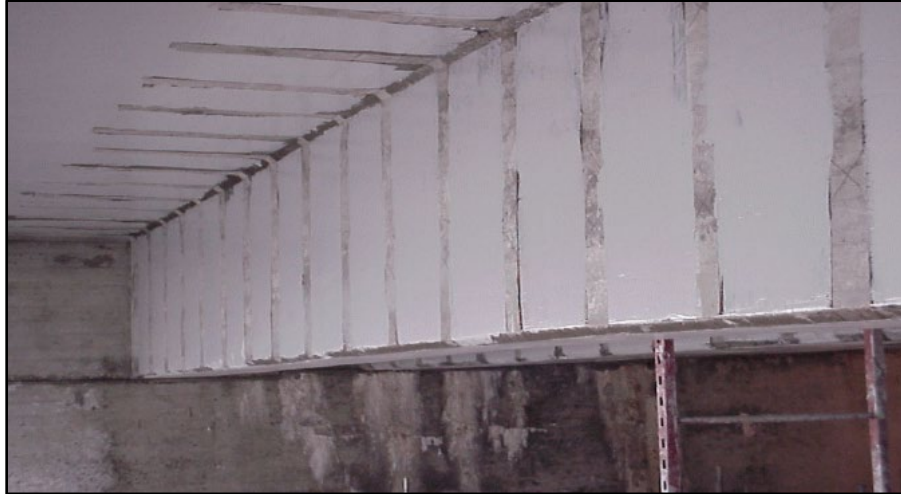
Figure B.3 Strengthening of a girder on the Wynantskill Bridge (Hag-Elsafi et al., 2003).

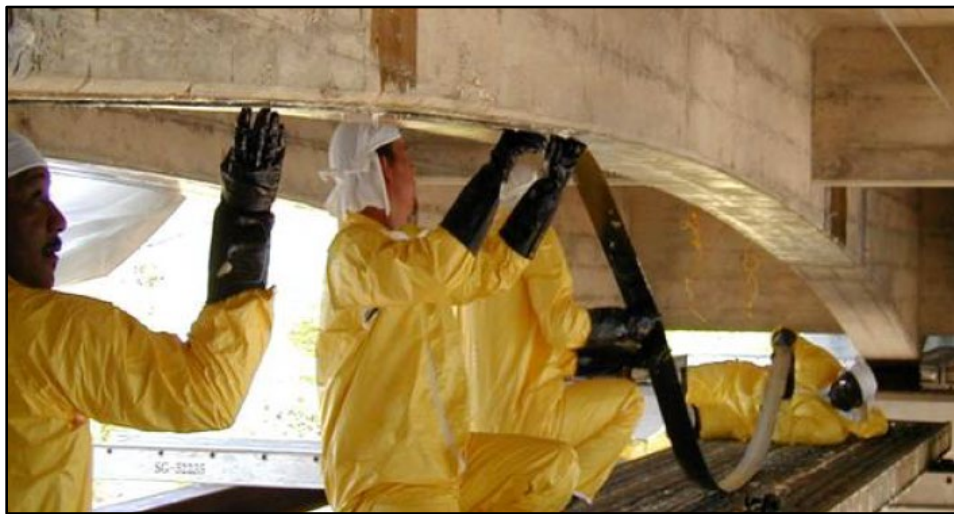
Figure B.4 FRP application to Uphapee Creek Bridge Girder (from Carmichael & Barnes, 2005).

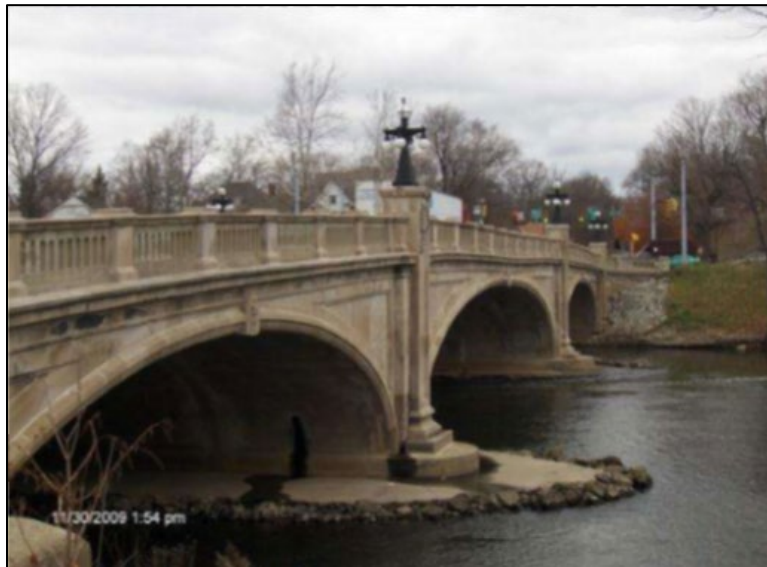
Figure B.6 East side of the bridge facing north (from Skinner (2011) inspection report).

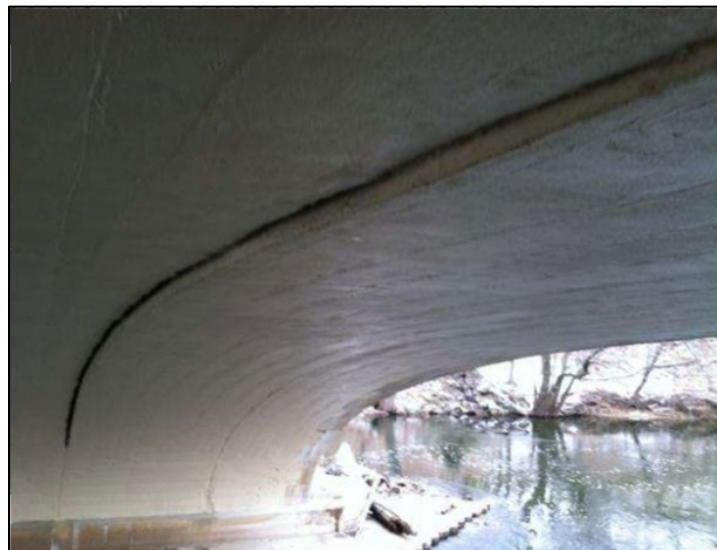
Figure B.8 Arch separation (from Dittrich et al. (2013) inspection report).

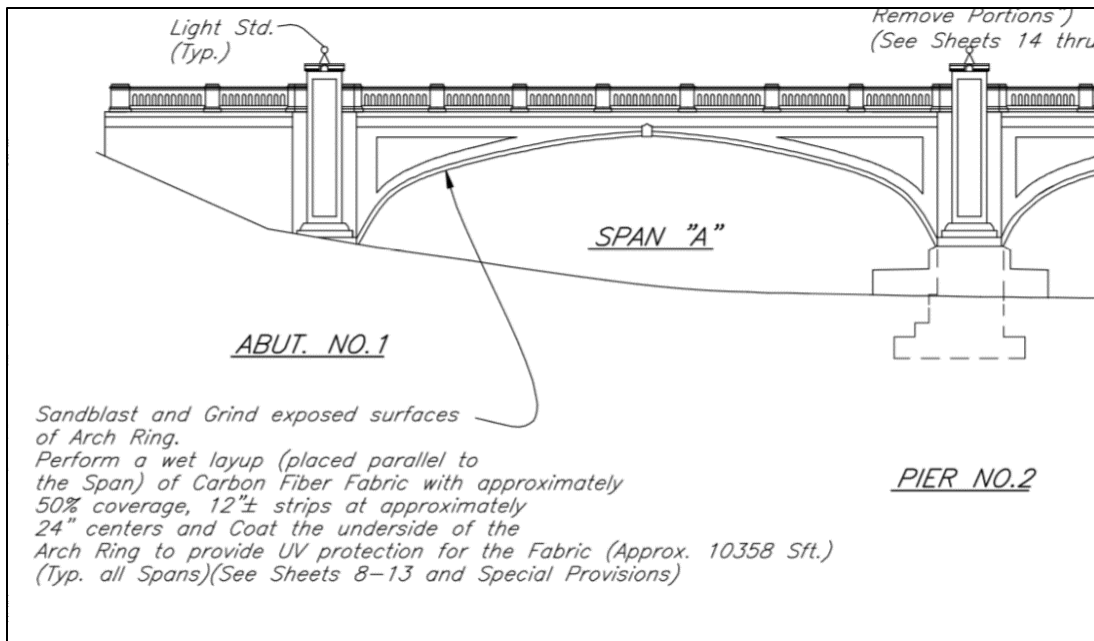
Figure B.9 FRP repair plans for arch rings (from INDO, 2012b).

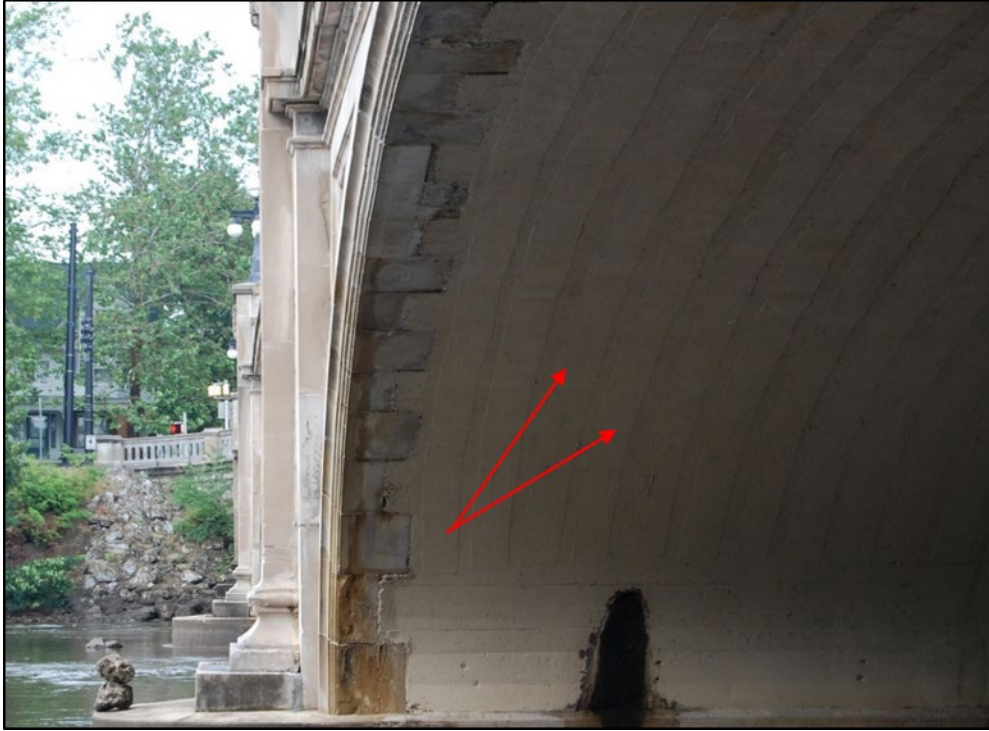
Figure B.10 CFRP strips on southern span.

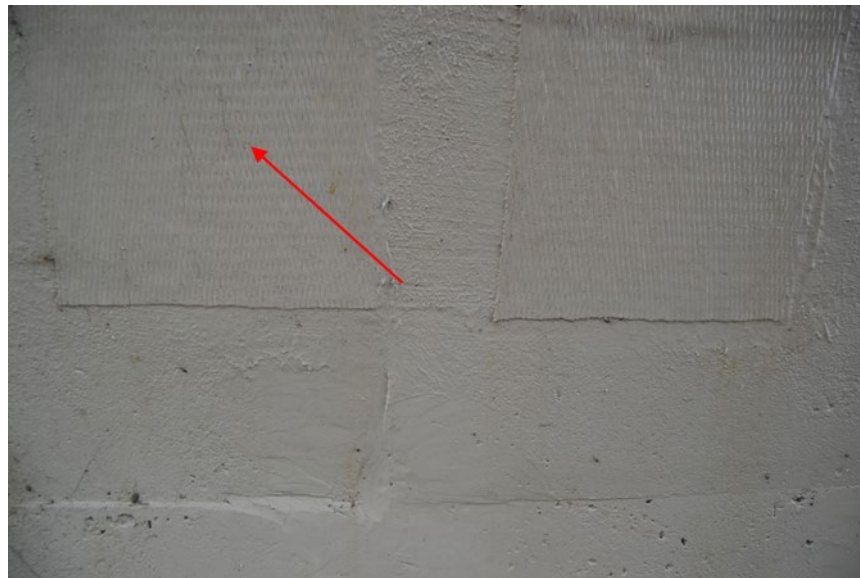
Figure B.15 Possible hairline cracks in CFRP sheet.

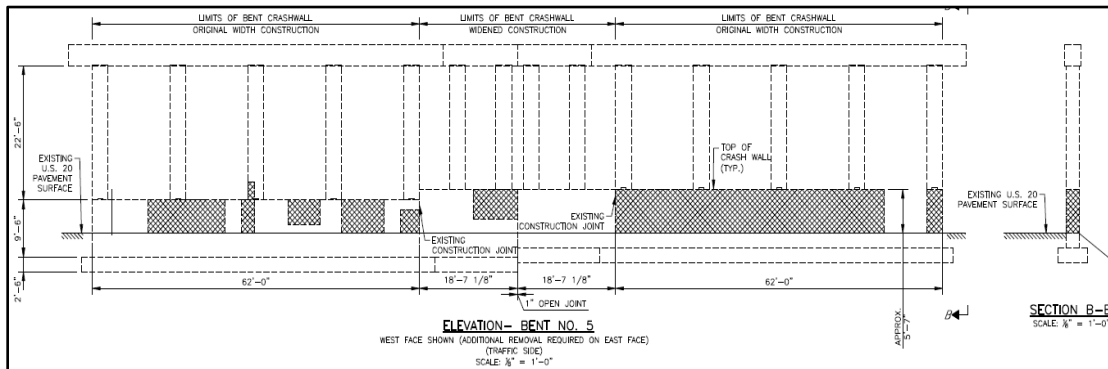
Figure B.17 Bridge rehabilitation plans: scheduled bent repairs (from INDOT, 2012a).

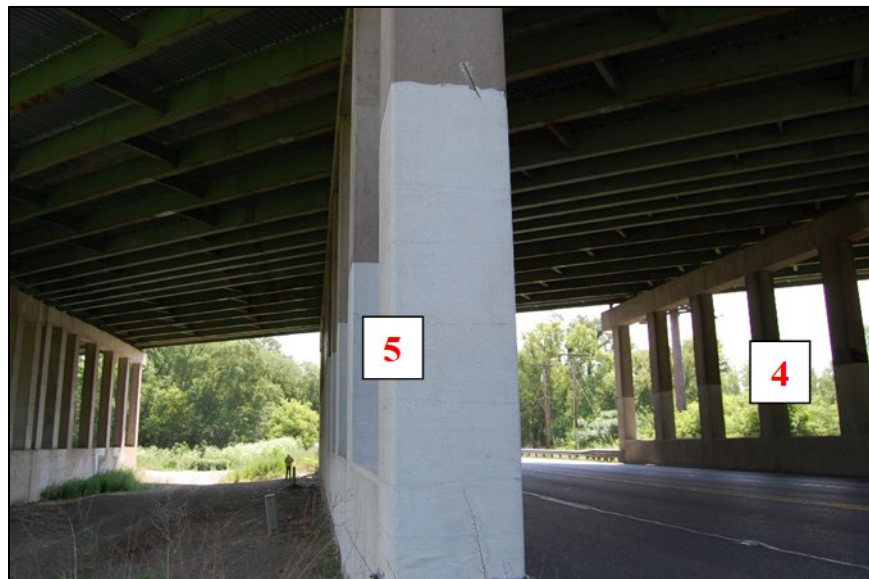
Figure B.18 View of both bents facing west.

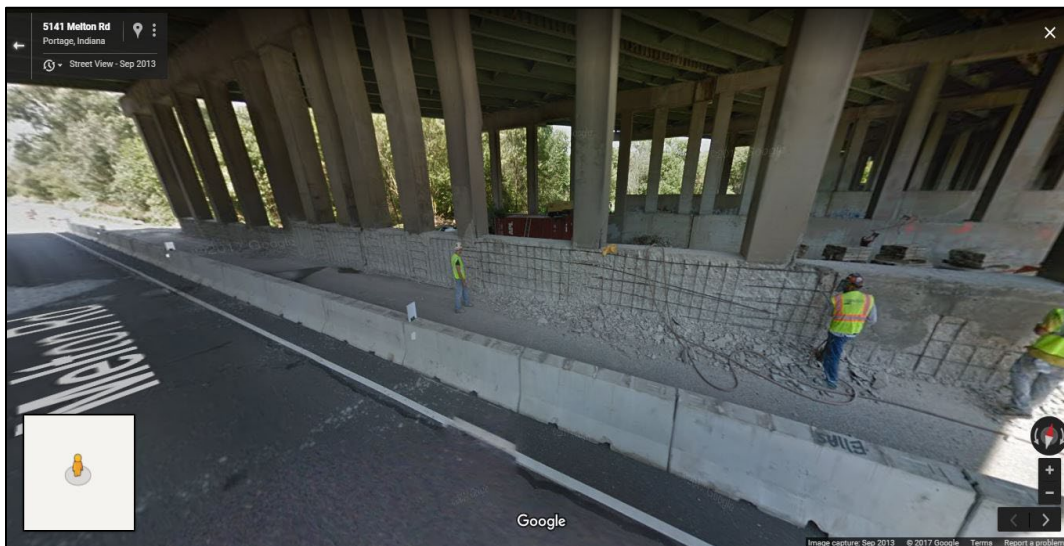
Figure B.19 Repair procedures on Bent 5, September 2013 (Google, 2013).

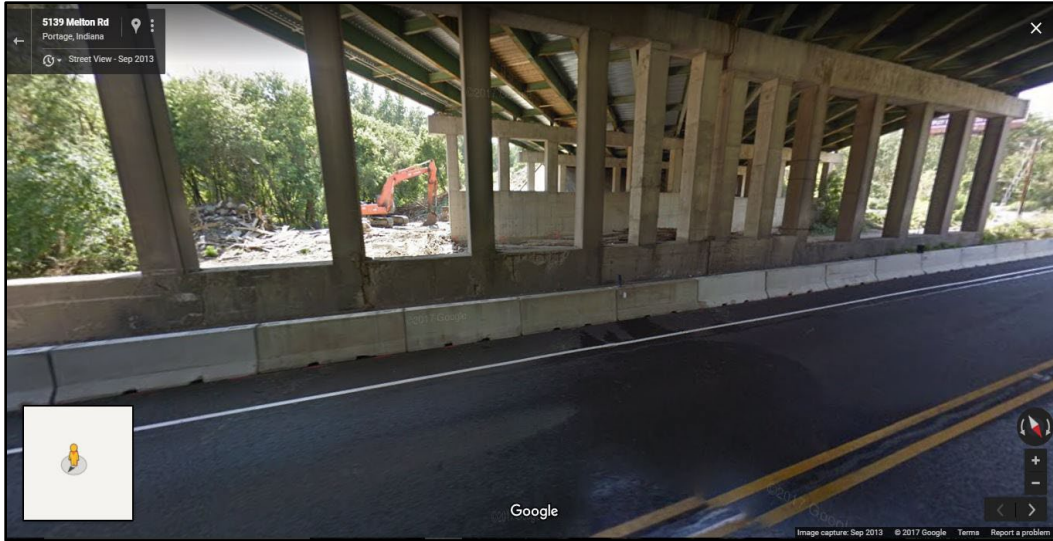
Figure B.20 Spalling and steel exposure of Bent 4 prior to FRP installation, September 2013 (Google, 2013).

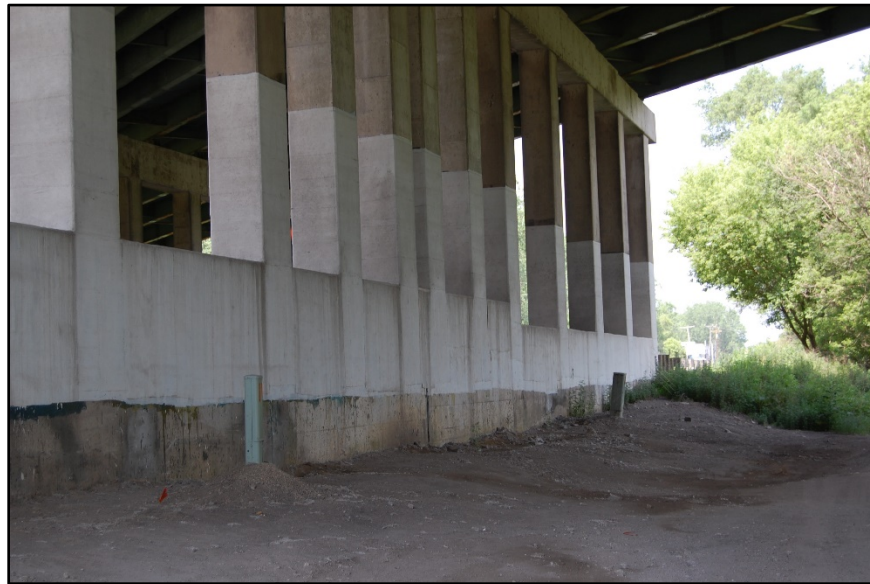
Figure B.21 Variable length of GFRP sheets on Bent 5 crashwall.

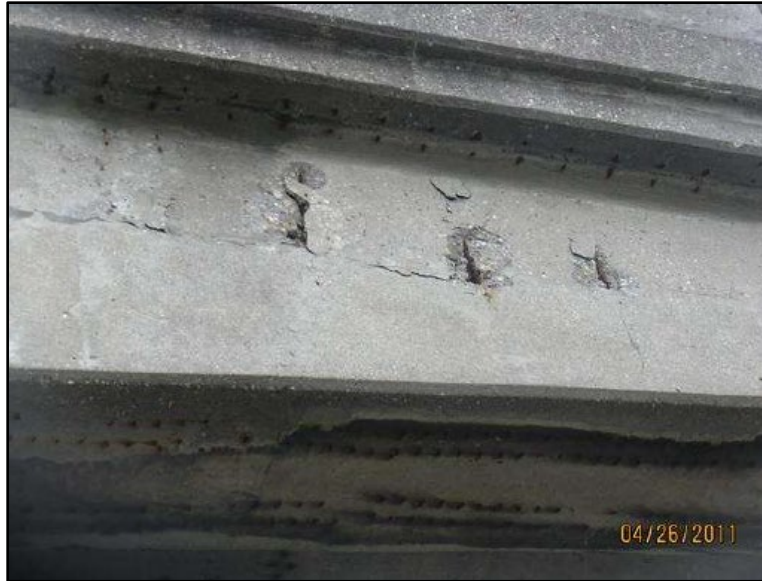
Figure B.28 Spalling and delamination with exposed rebar on girder (from Smith (2011) inspection report).

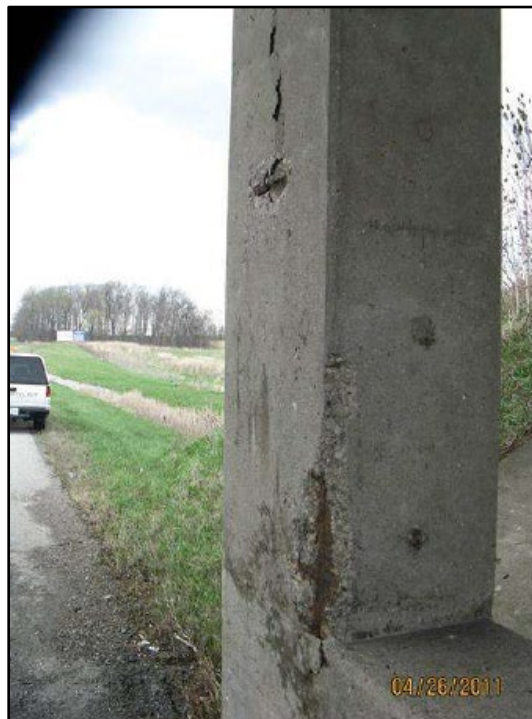
Figure B.29 Spalling and delamination at Pier 4, Span C (from Smith (2011) inspection report).

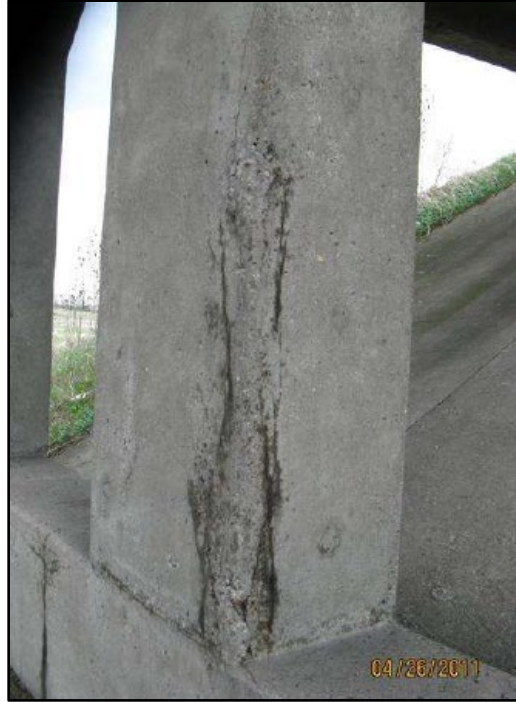
Figure B.30 Vertical delamination to the southwest corner of column at Pier 4, Span C (from Smith (2011) inspection report).

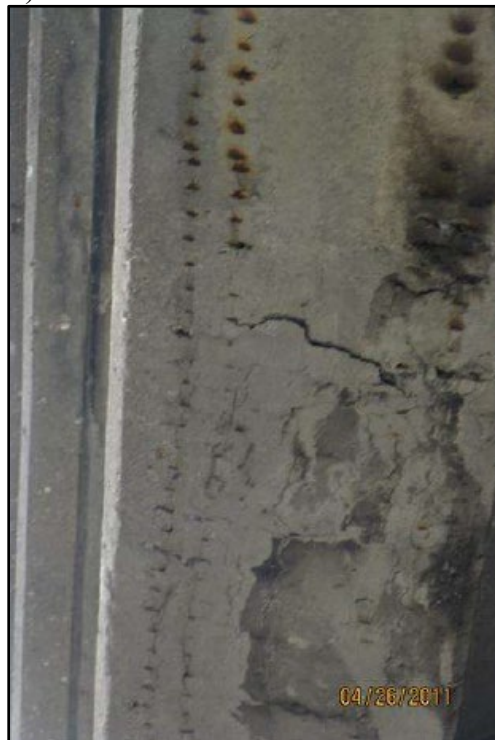
Figure B.31 Delamination at bottom of girder (from Smith (2011) inspection report).

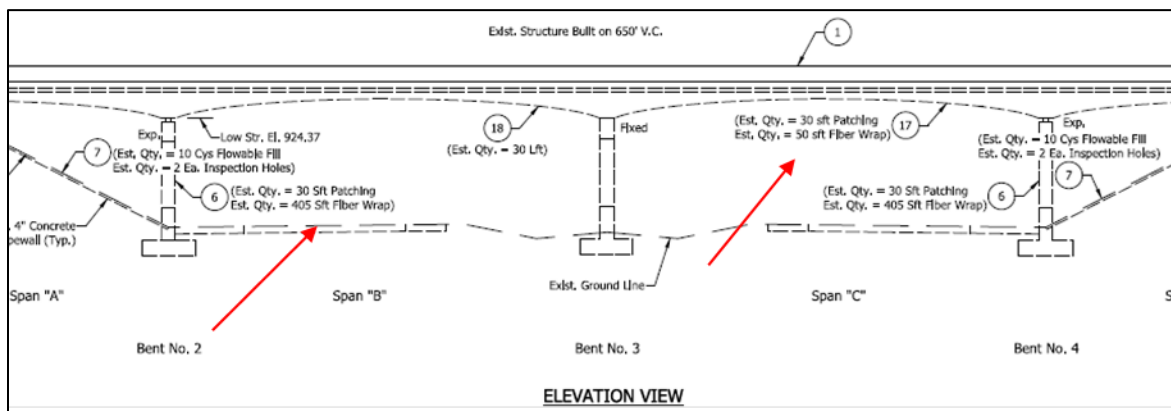
Figure B.32 Bridge rehabilitation plans: scheduled repairs (from INDOT, 2015).

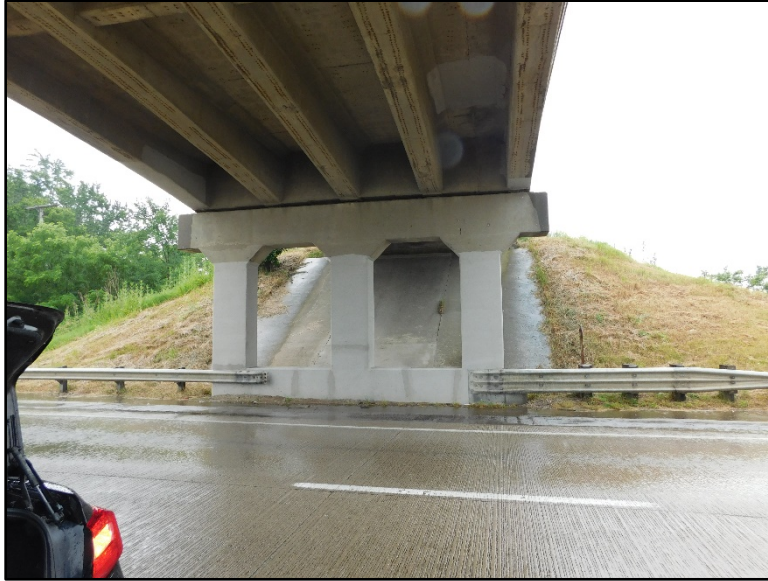
Figure B.33 View of the FRP-repaired western end pier.

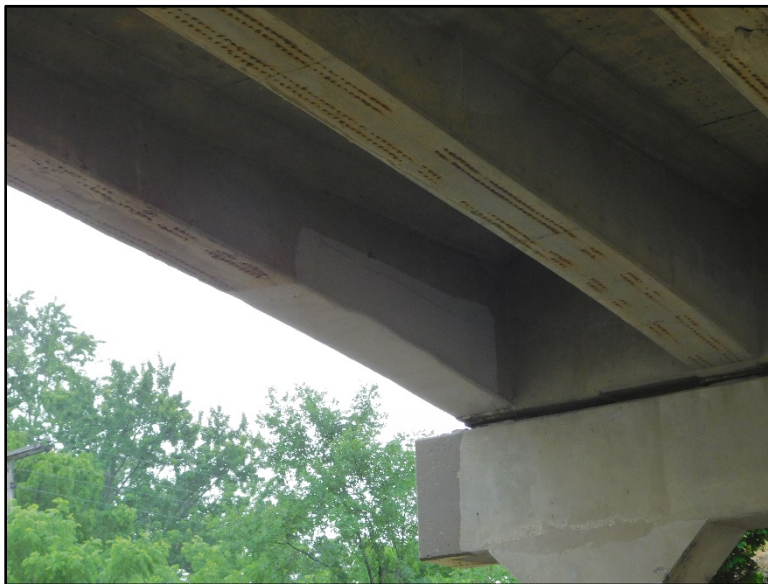
Figure B.34 Close-up of FRP-repaired beam end at western end pier.

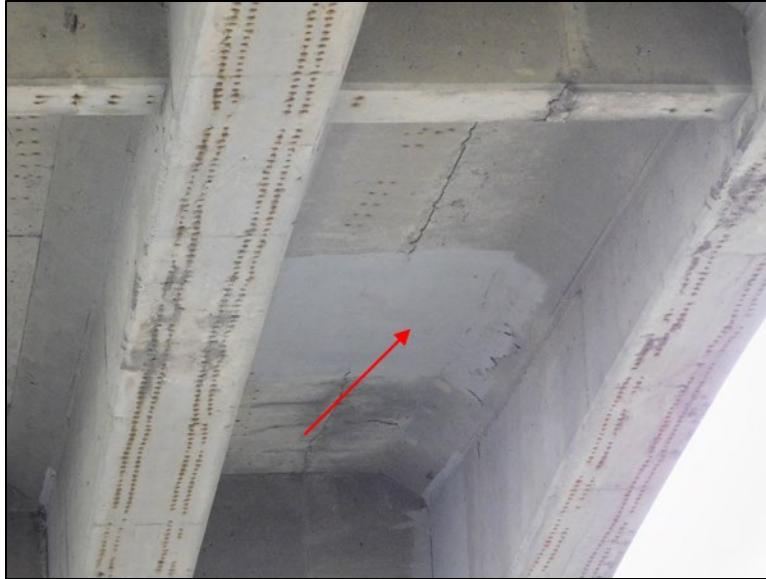
Figure B.35 Possible FRP repair to underside of deck over I-69 SB.

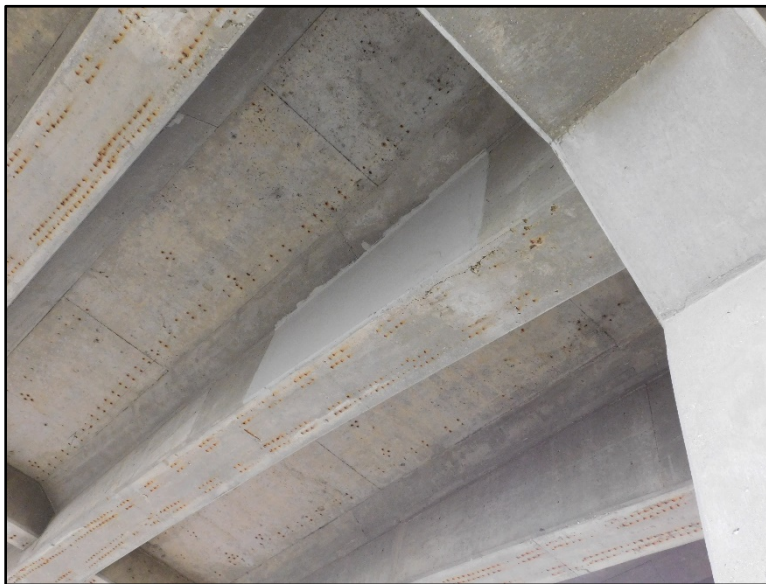
Figure B.36 One-sided repair of middle beam on eastern side of middle pier.

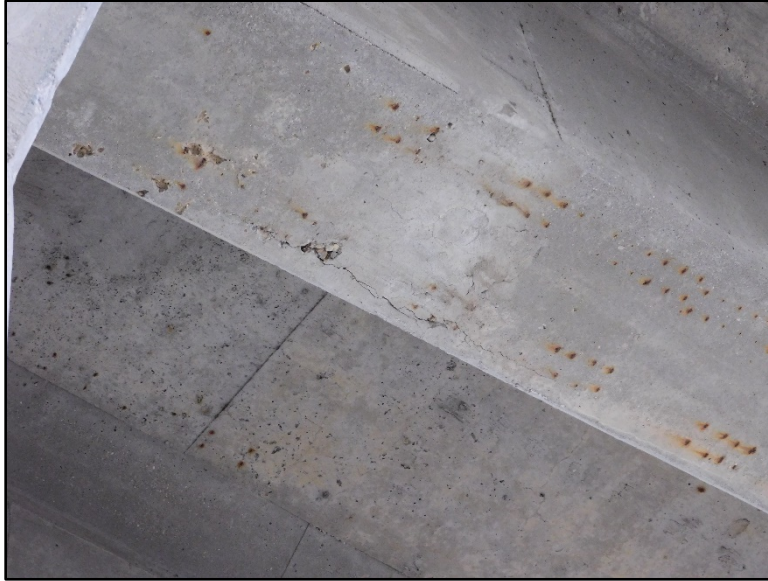
Figure B.37 Cracking along middle beam.

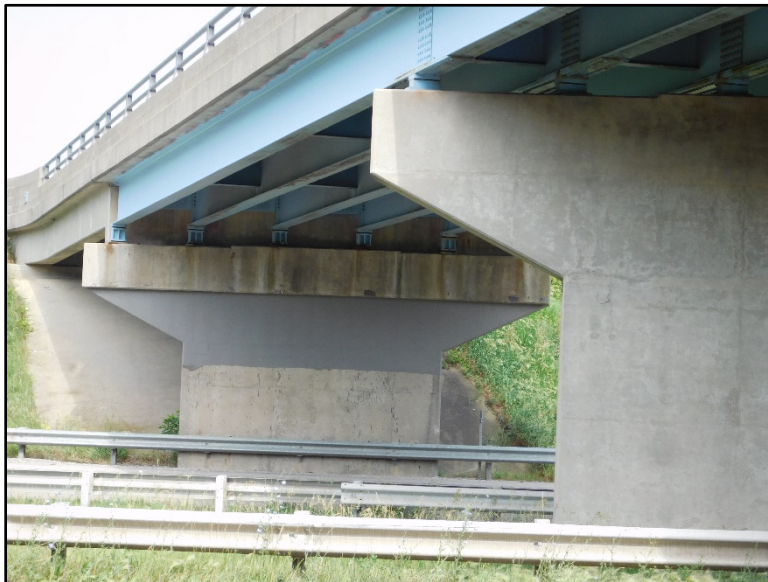
Figure B.38 View of bridge and FRP-repaired pier facing west.

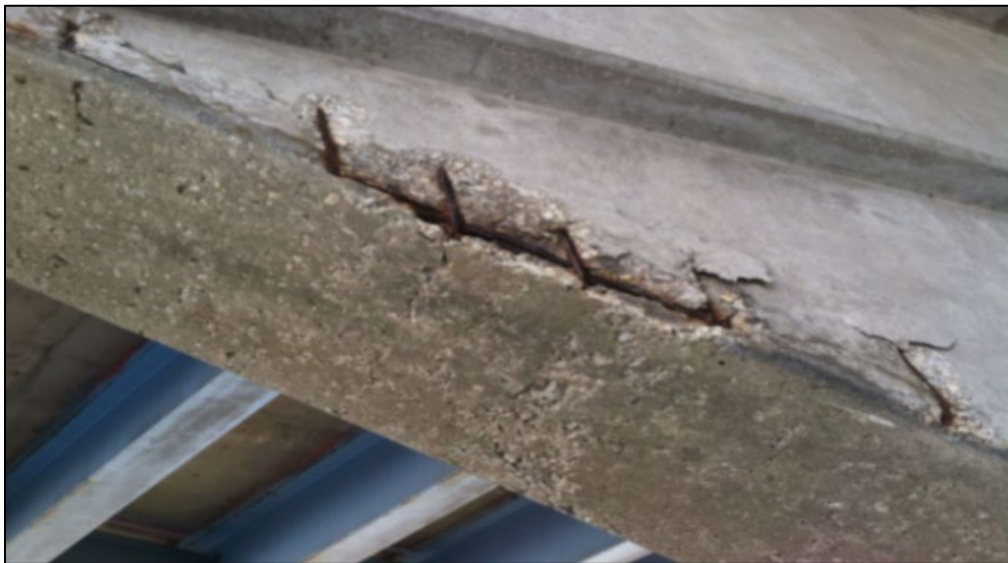
Figure B.39 Pier 2 north hammerhead spalling and exposed steel (from Biller (2015a) inspection report).

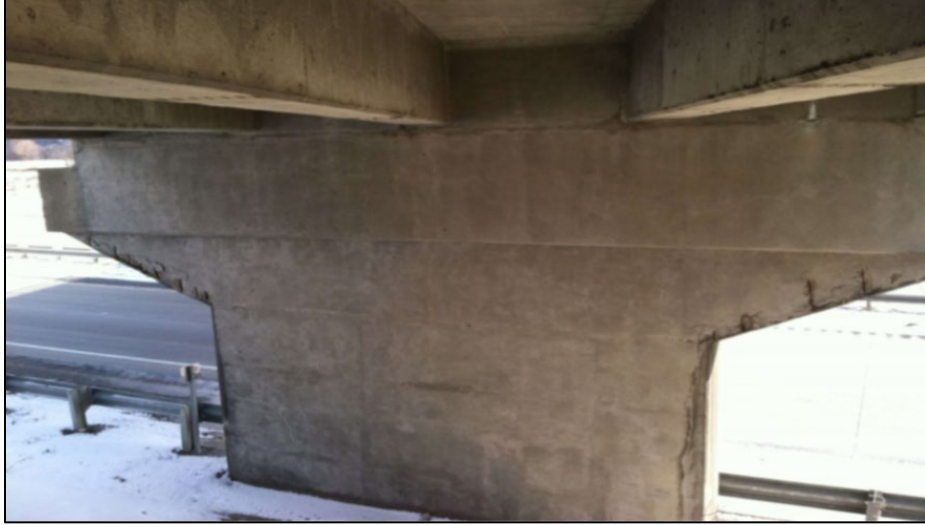
Figure B.40 Pier 2 Deterioration (from Biller (2015a) inspection report).

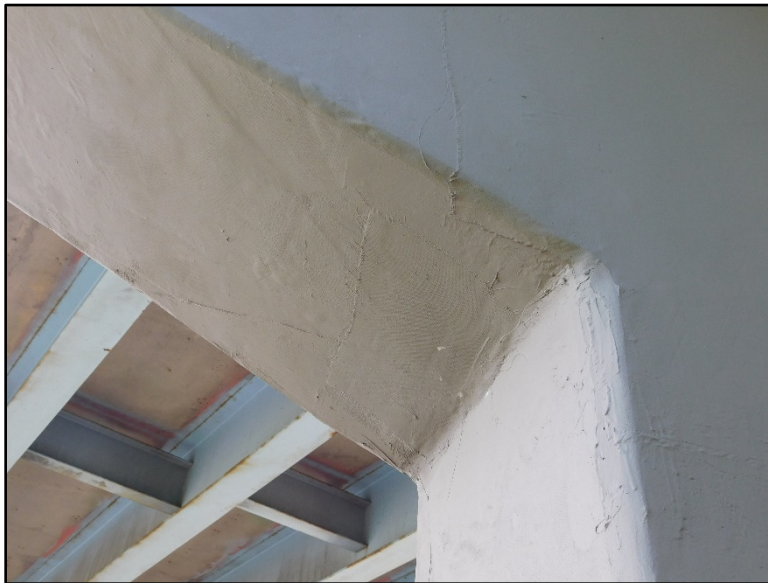
Figure B.41 Detailing of repair at tapered section of pier.

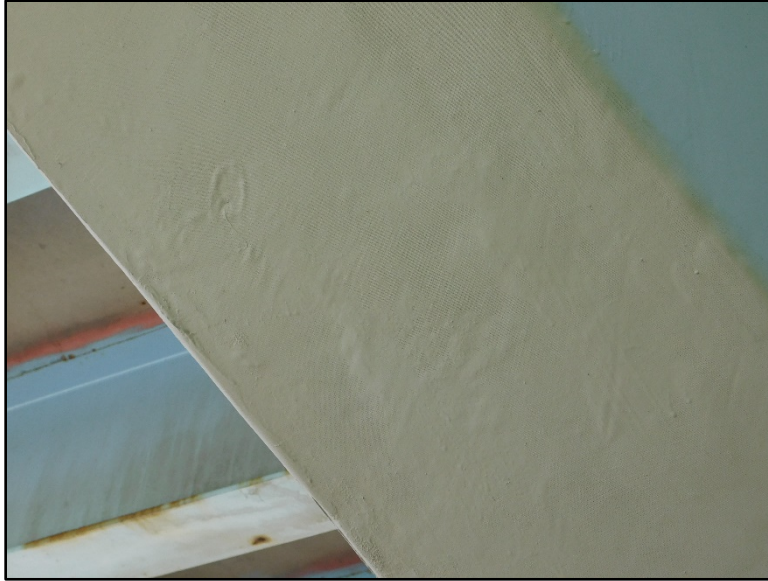
Figure B.42 Bubbling and depressions along tapered section of repaired pier.

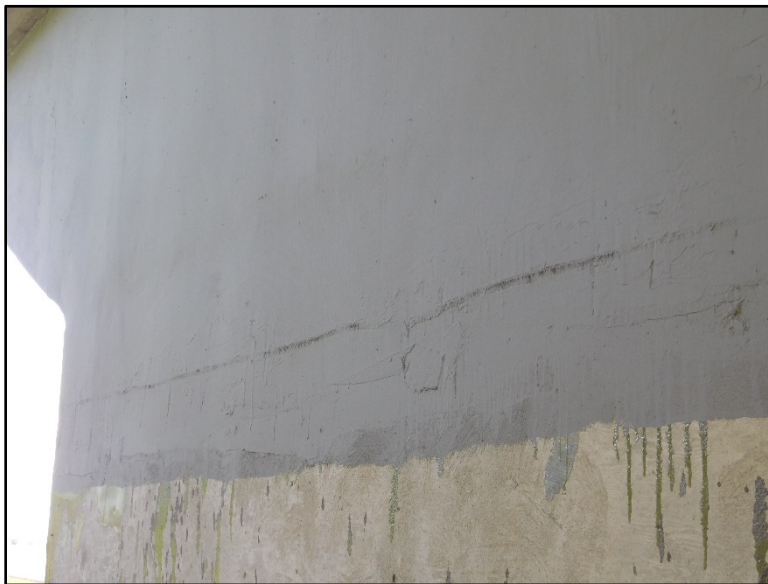
Figure B.43 Paint/epoxy runoff on sheets and onto concrete.

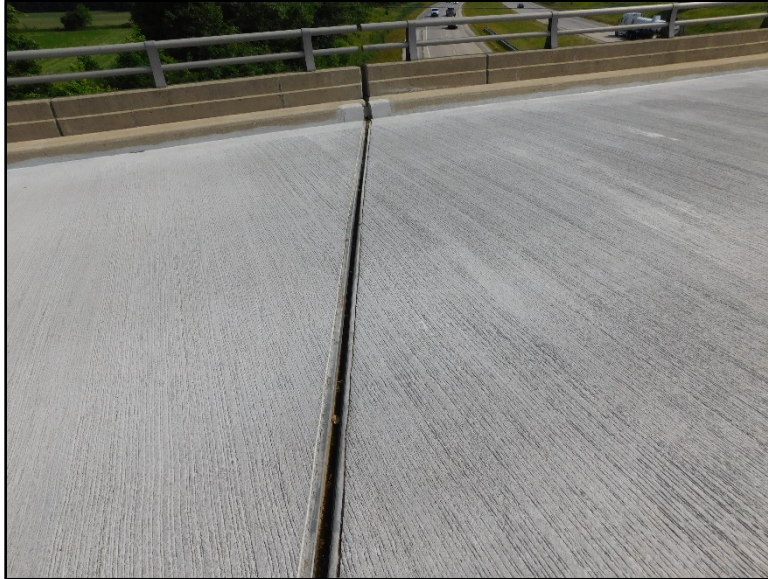
Figure B.44 Joint and deck surface directly above repaired pier.

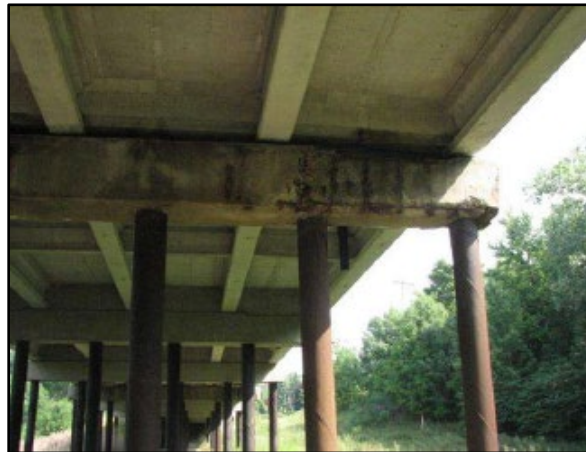
Figure B.46 Deterioration at Pier 4 (from Atkinson (2011) inspection report).

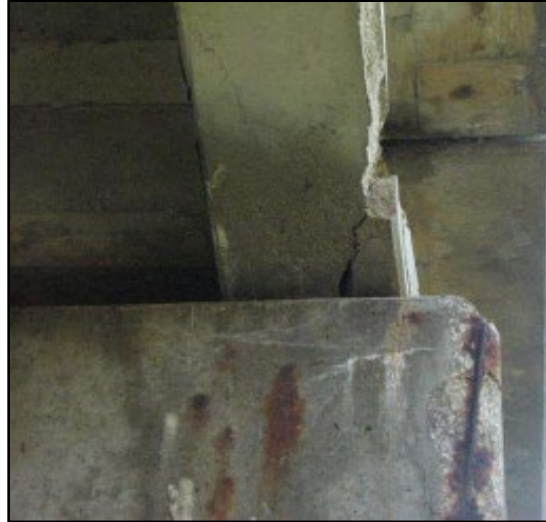
Figure B.47 Spalling of fascia beam and deep crack (from Atkinson (2011) inspection report).

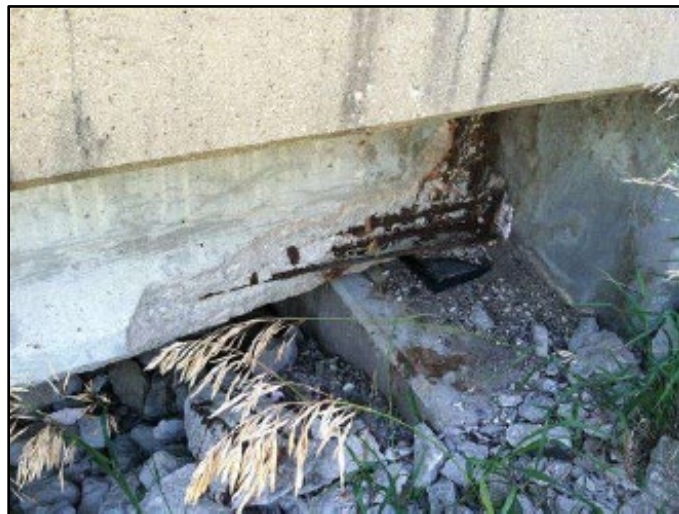
Figure B.48 Spalling and exposed strands at Beam 1 in Span A (from Biller (2013) inspection report).

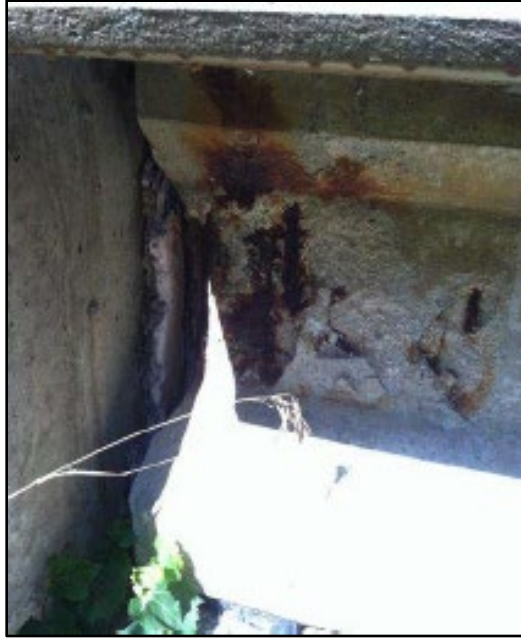
Figure B.49 Deterioration at Beam 5 in Span A (from Biller (2013) inspection report).

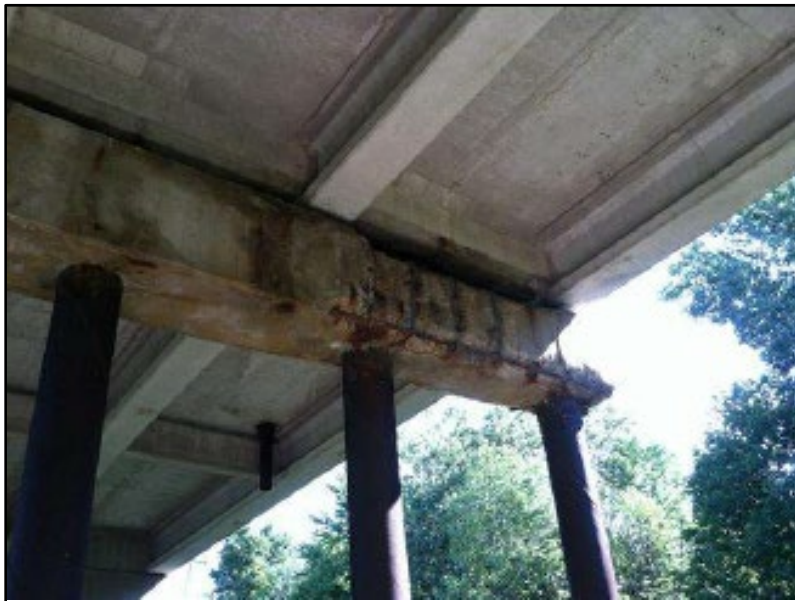
Figure B.50 Deterioration at Pier 4 bent cap (from Biller (2013) inspection report).

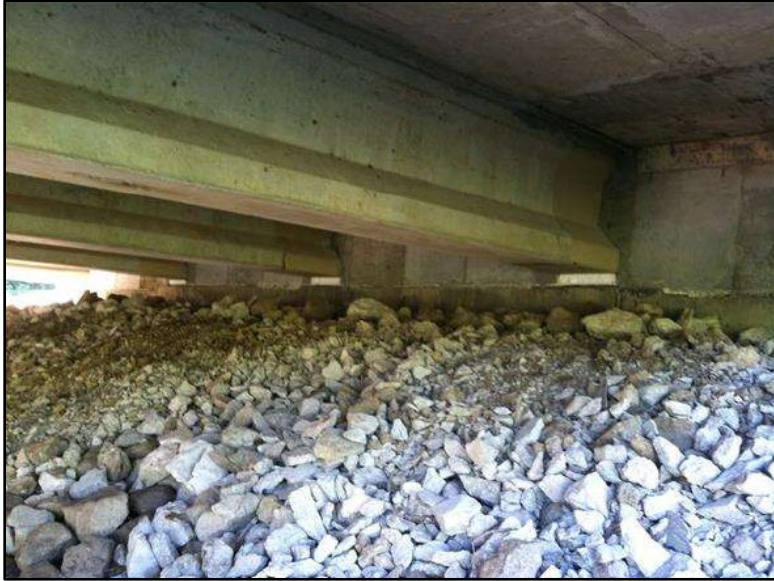
Figure B.51 Beam end region wrapping at Abutment 1 (from Biller & Gimbel (2014) inspection report).
