JOINT TRANSPORTATION RESEARCH PROGRAM

INDIANA DEPARTMENT OF TRANSPORTATION
AND PURDUE UNIVERSITY

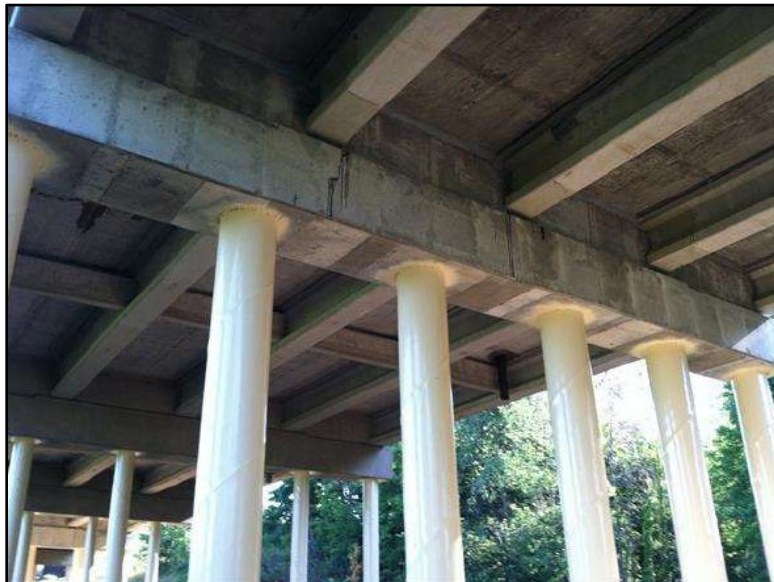
Figure B.52 Repaired beam ends, new bent cap, and encased piles at Bent 4 (from Biller & Gimbel (2014) inspection report).

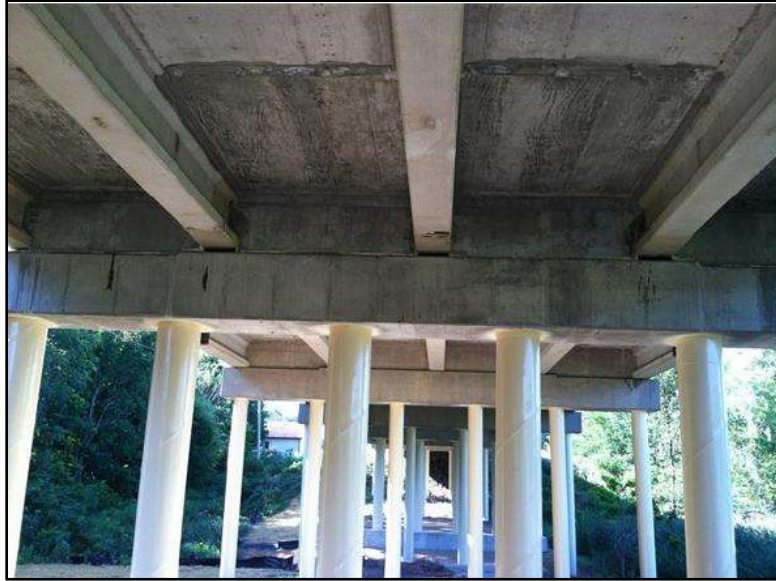
Figure B.53 Repaired beam ends, new bent cap, and encased piles at Bent 7 (from Biller & Gimbel (2014) inspection report).

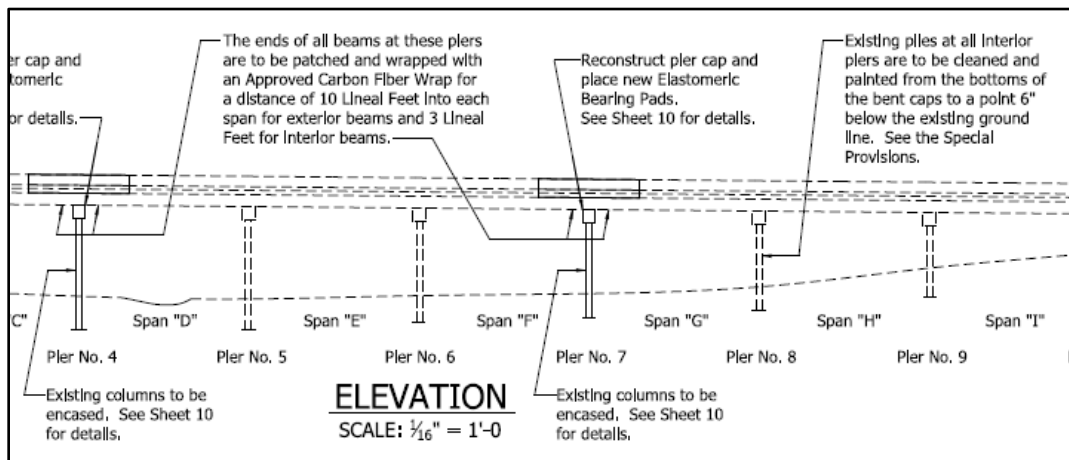
Figure B.54 Bridge rehabilitation plans (from INDOT, 2013).

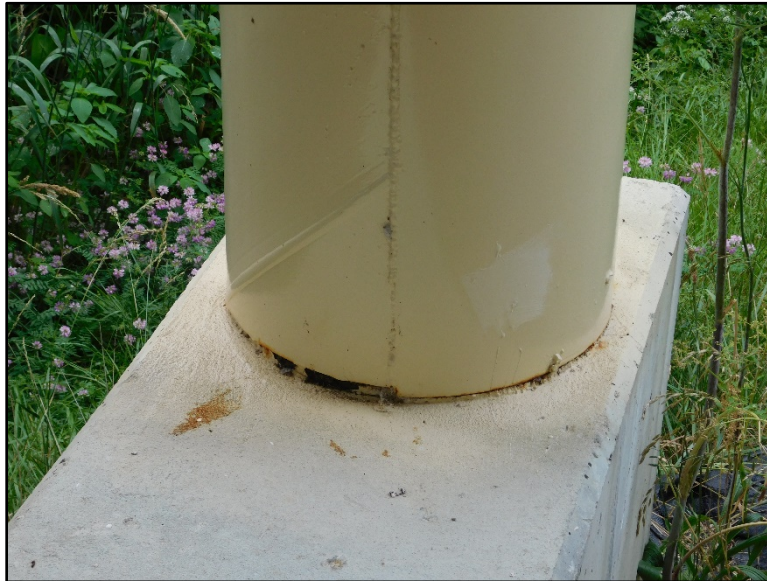
Figure B.55 Corrosion at base of steel jacket.

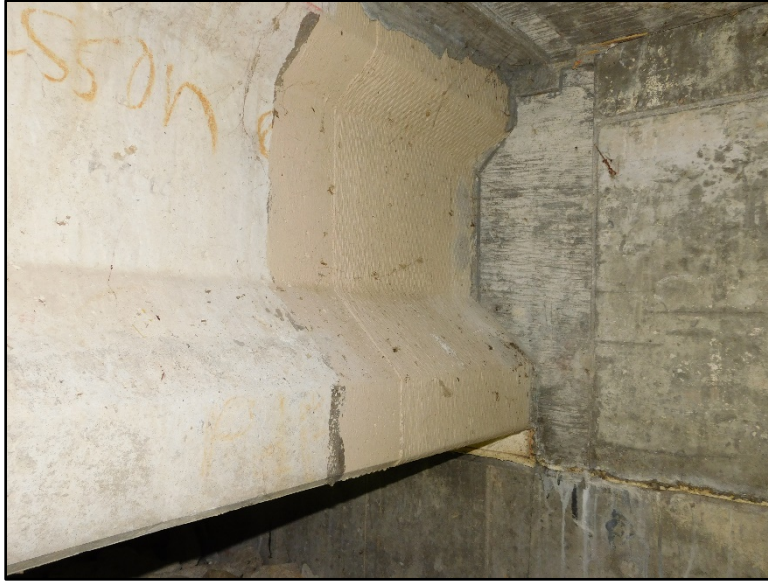
Figure B.56 Beam end repair at southern abutment.

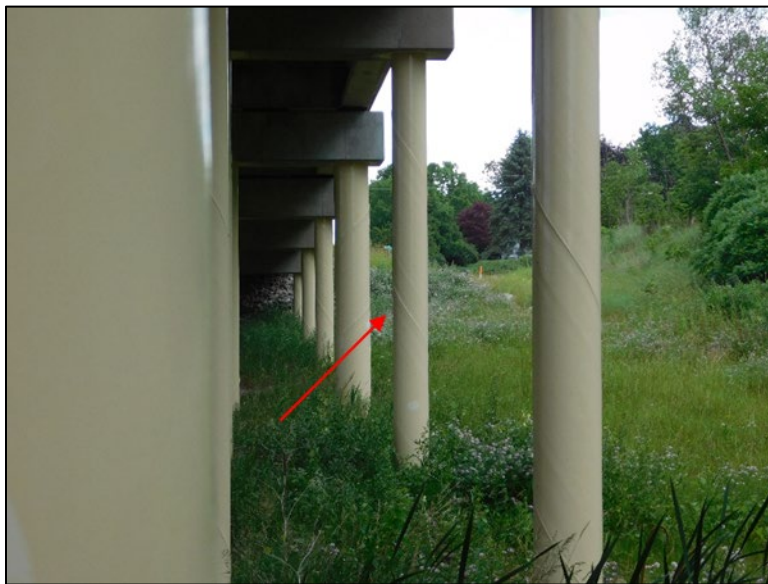
Figure B.57 Different column width from steel jacking.

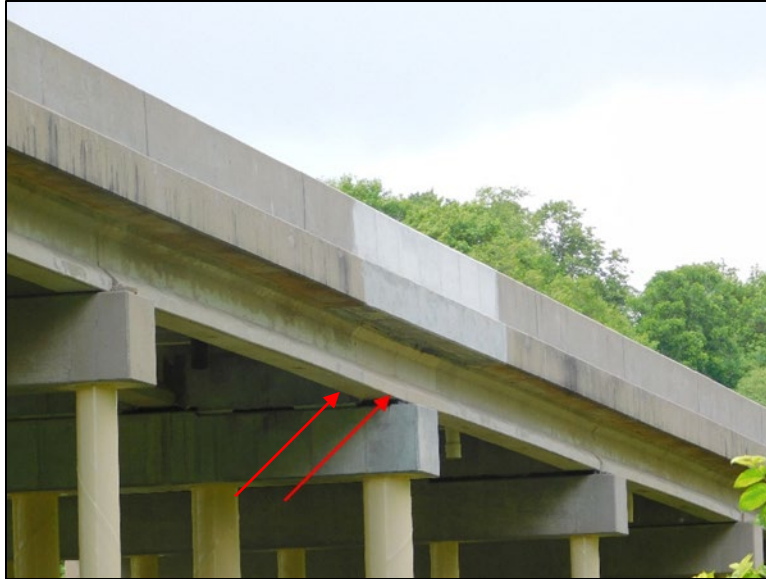
Figure B.58 Beam end repair at Pier 7 at expansion joint (from the southeast).

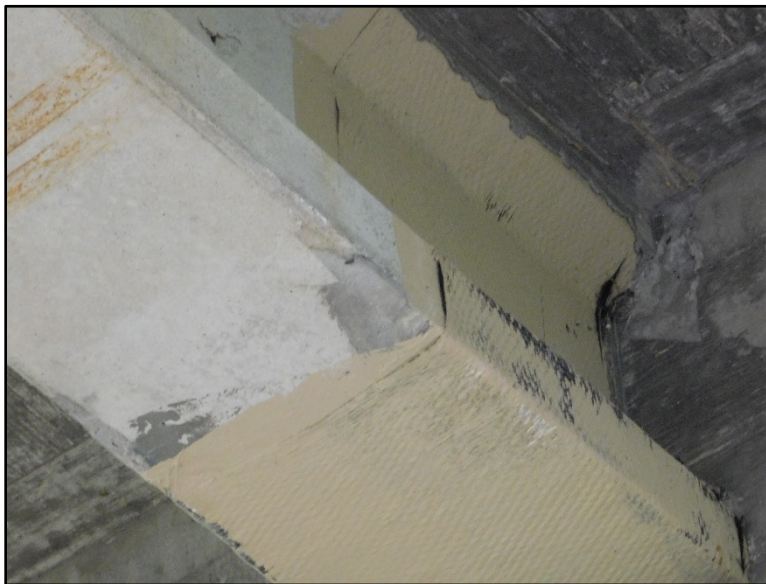
Figure B.59 Local debonding at beam ends at Pier 7.

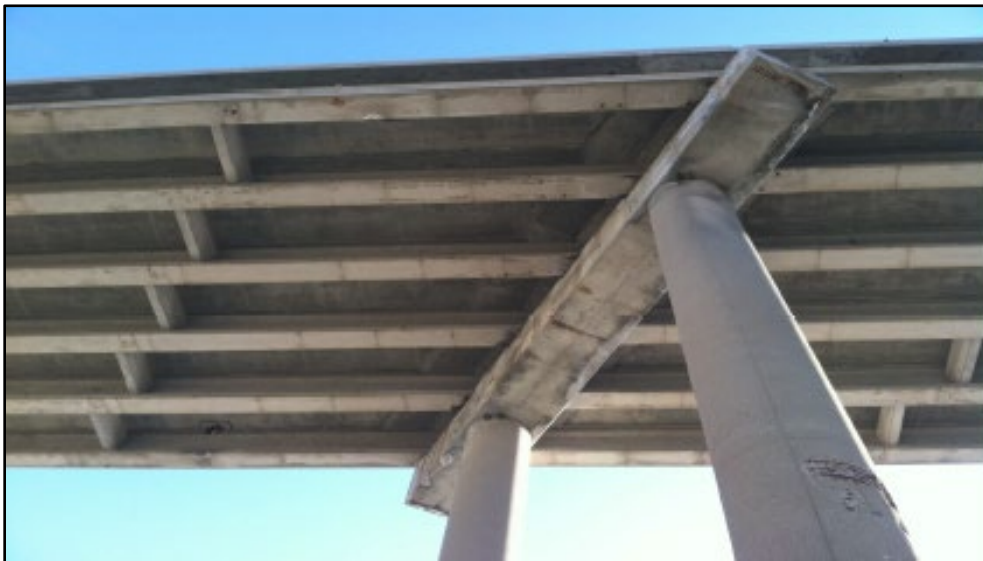
Figure B.62 Column spalling and cap deterioration at northbound Pier 4 (from Biller (2014a) inspection report).

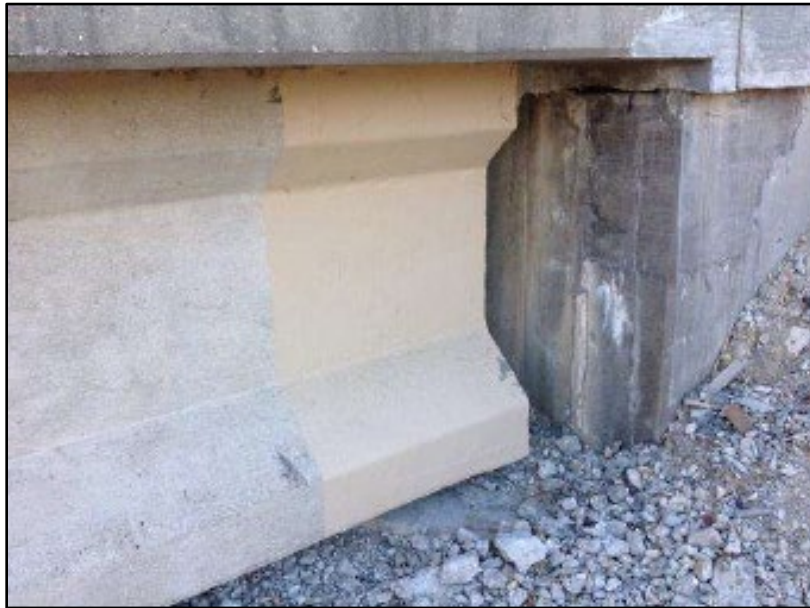
Figure B.63 Fiber Wrapped End of Beam 1 at Abutment 1 (from Schamberger (2016b) inspection report)

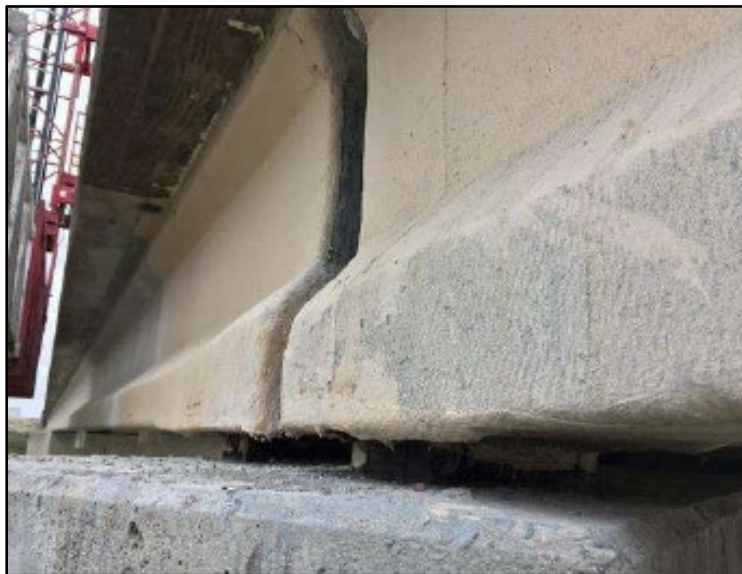
Figure B.64 Fiber wrapped beam ends at Pier 4 (from Schamberger (2016b) inspection report).

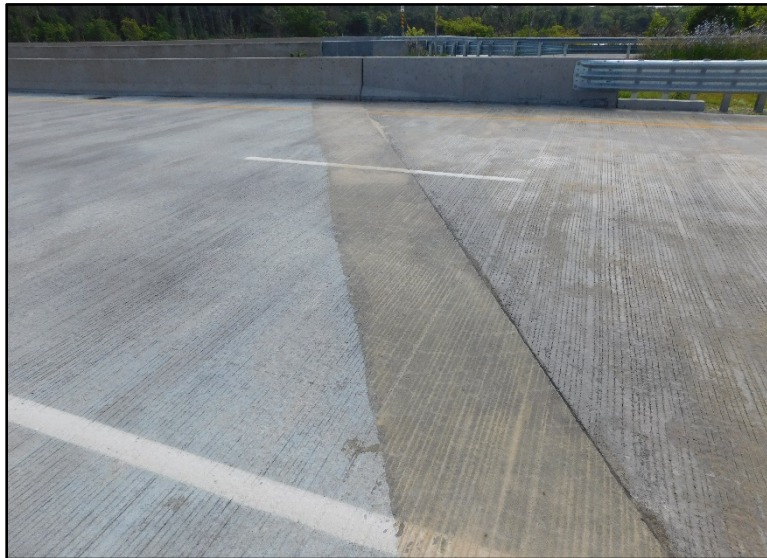
Figure B.65 Top of deck above the south end abutment of southbound bridge.

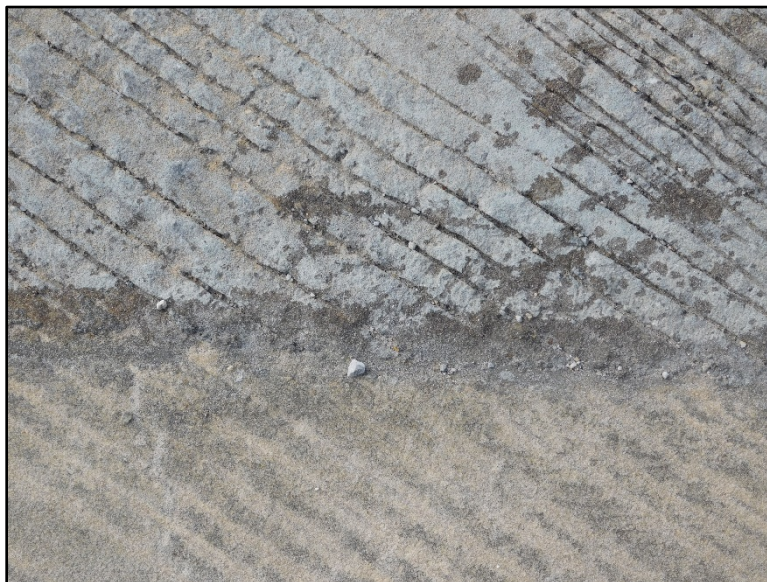
Figure B.66 Sand Layer on top of deck above the abutment diaphragm.

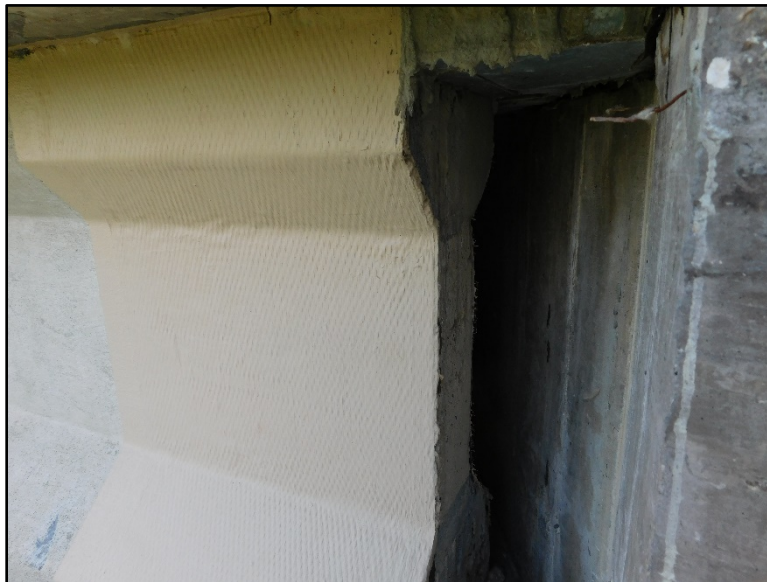
Figure B.67 Beam end repair at south end abutment of southbound bridge.

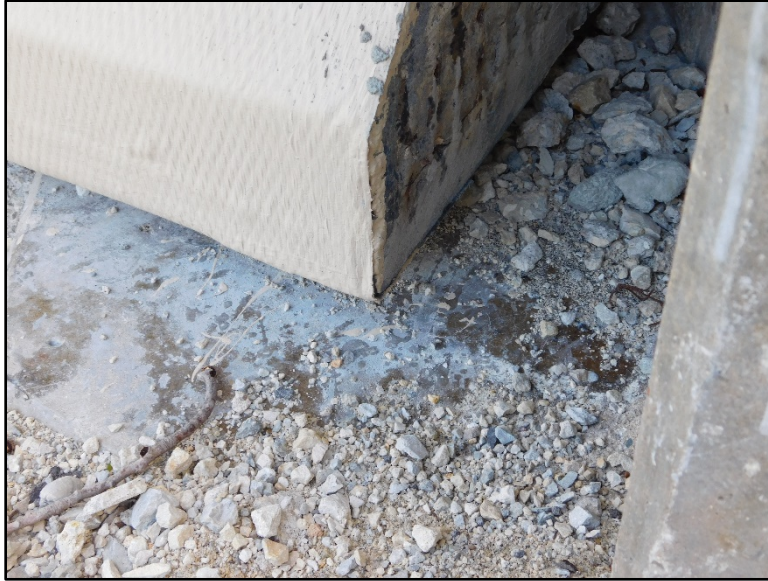
Figure B.68 Debonding of FRP at beam end.

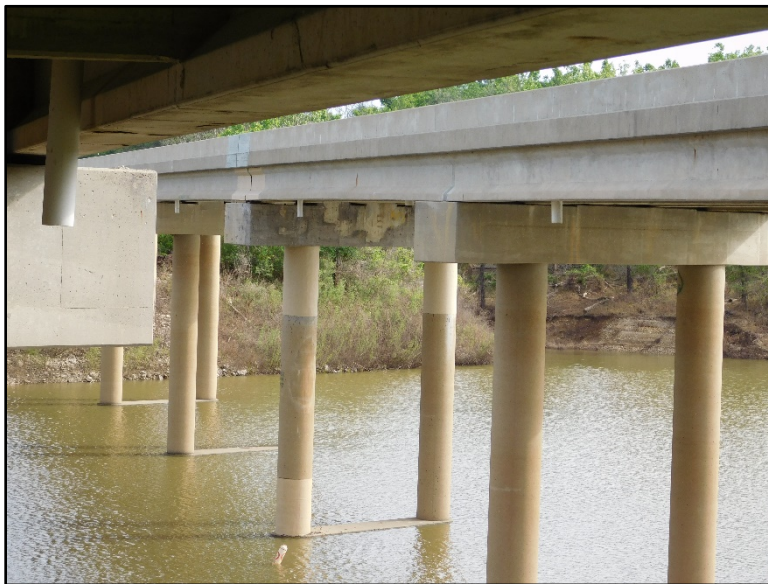
Figure B.71 Pier 4 Repairs on northbound bridge.

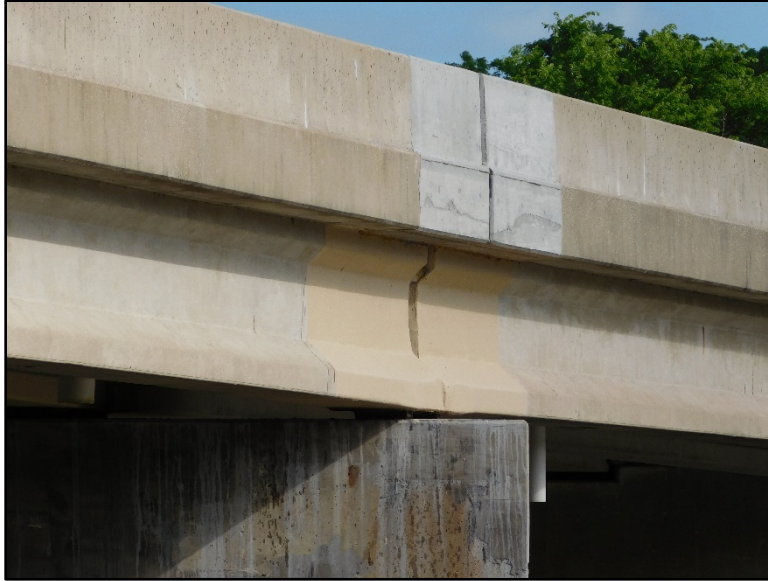
Figure B.72 Beam end repairs at southbound bridge Pier 4.

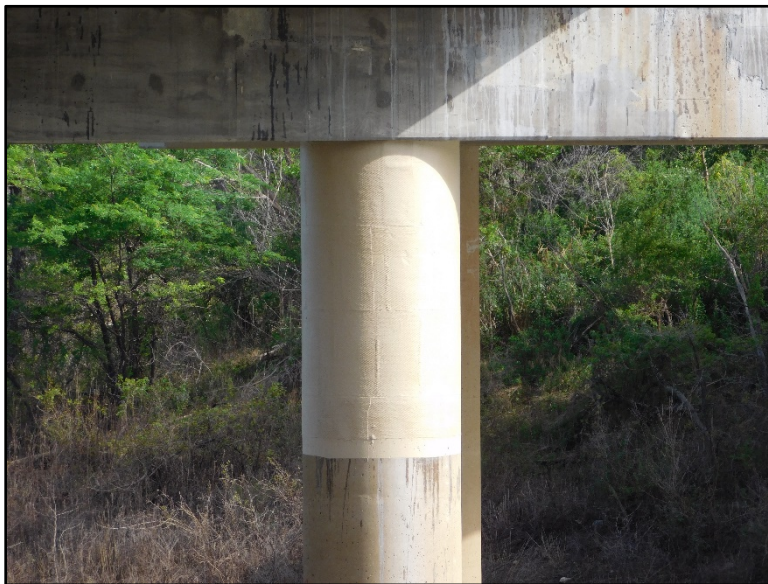
Figure B.73 Top of column repaired on southbound Pier 4.

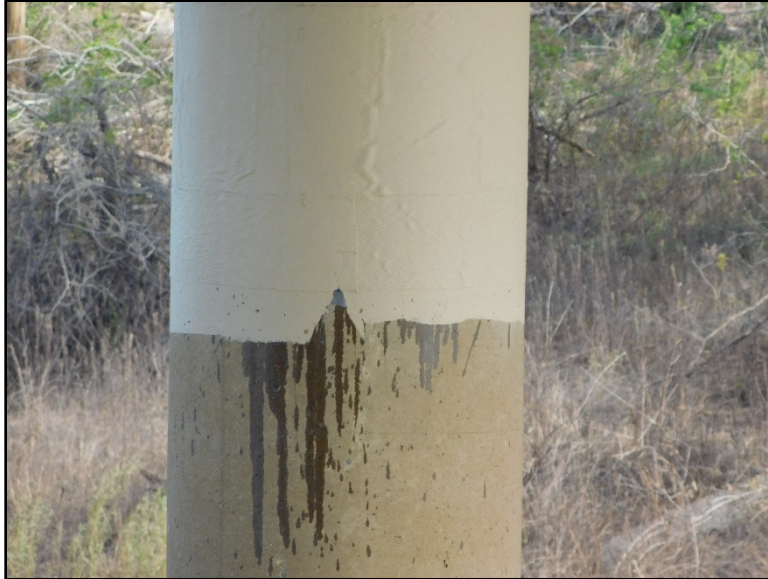
Figure B.74 Epoxy runoff and sheet bubbling.

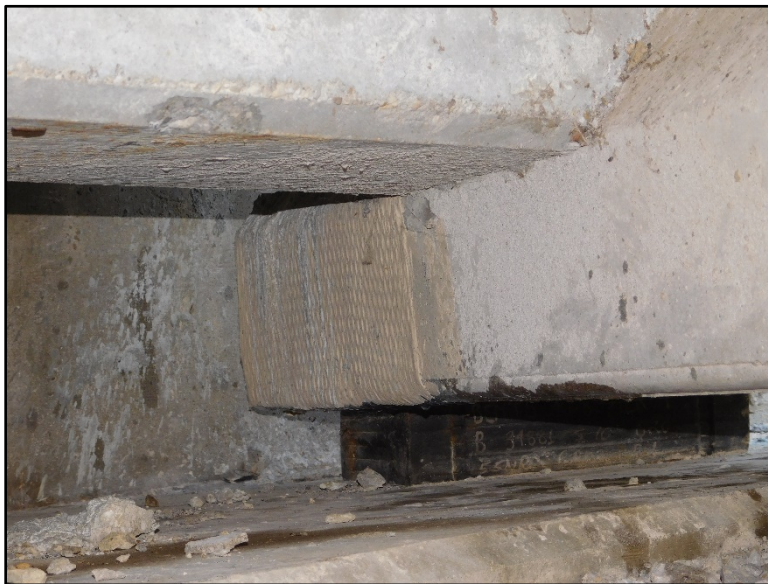
Figure B.75 Interior beam end repair (sheet termination at diaphragm).

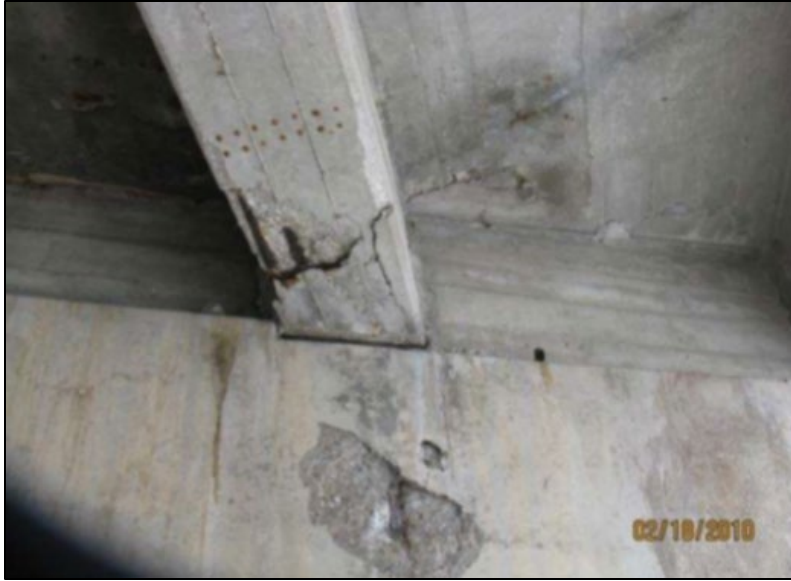
Figure B.77 Spalled beam end and exposed rebar at eastbound bridge (from Smith (2010a) inspection report).

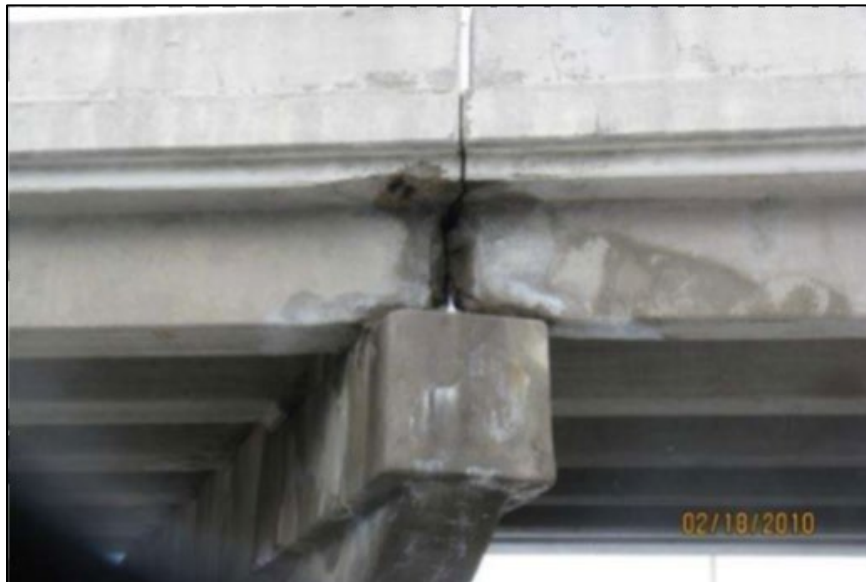
Figure B.78 Beam end deterioration at eastbound bridge (from Smith (2010a) inspection report).

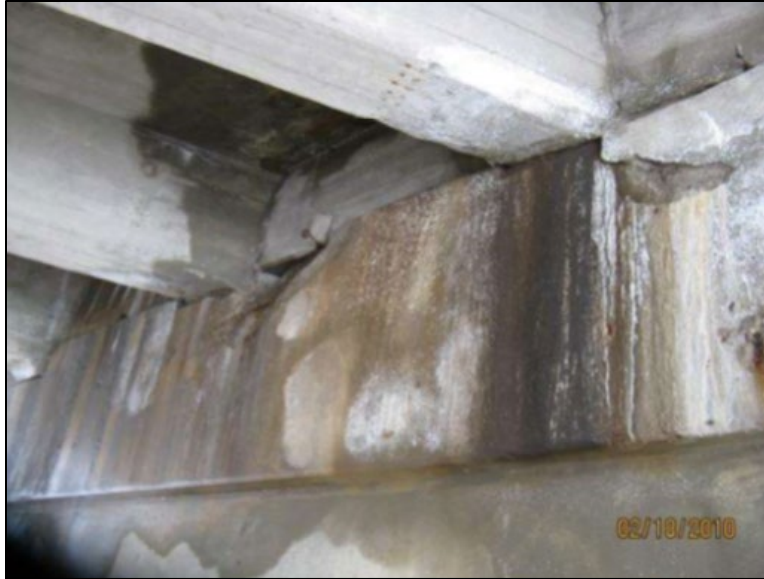
Figure B.79 Wet pier at leaking joint in eastbound bridge (from Smith (2010a) inspection report).

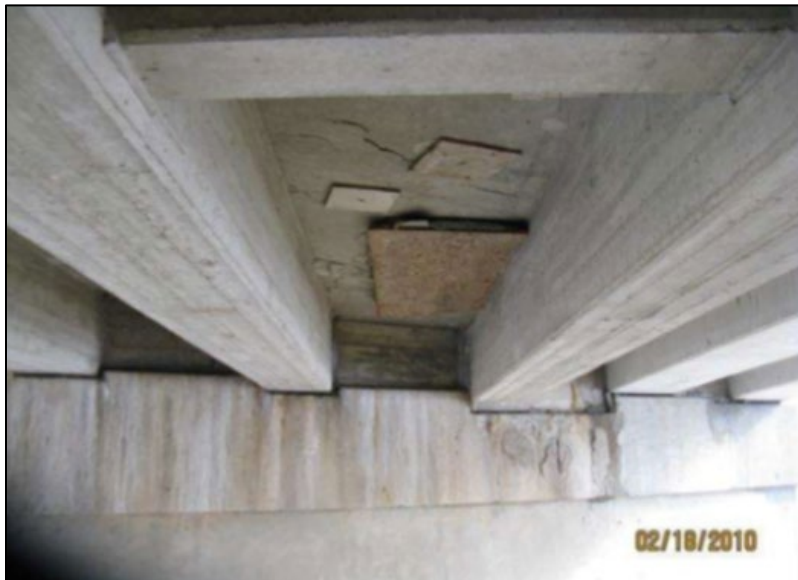
Figure B.80 Patching of deck underside of eastbound bridge (from Smith (2010a) inspection report).

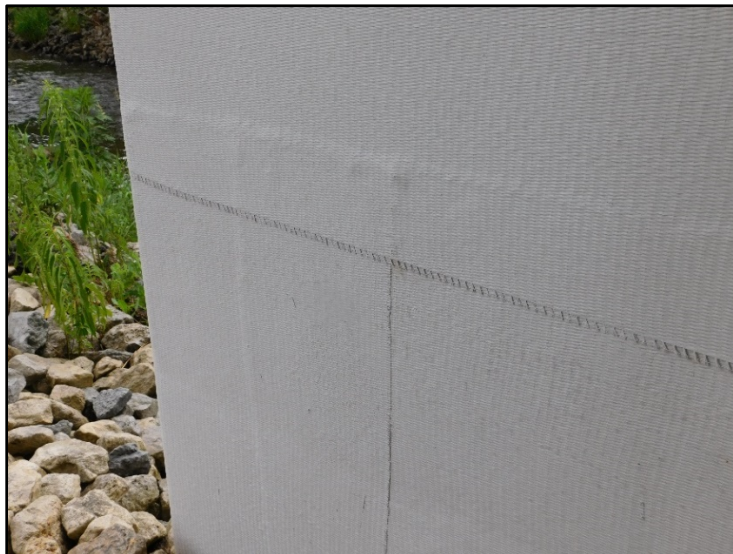
Figure B.81 Sheet overlapping of pier adjacent to Blue River.

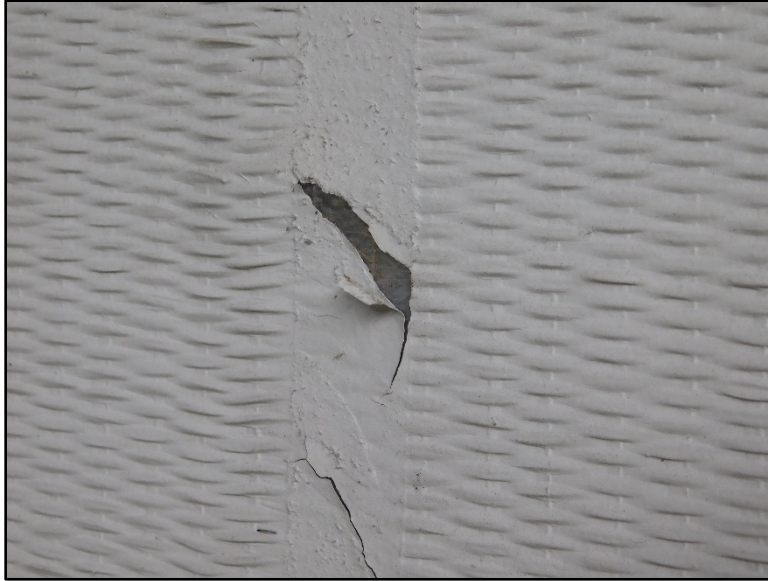
Figure B.84 Cracking and tearing of paint.

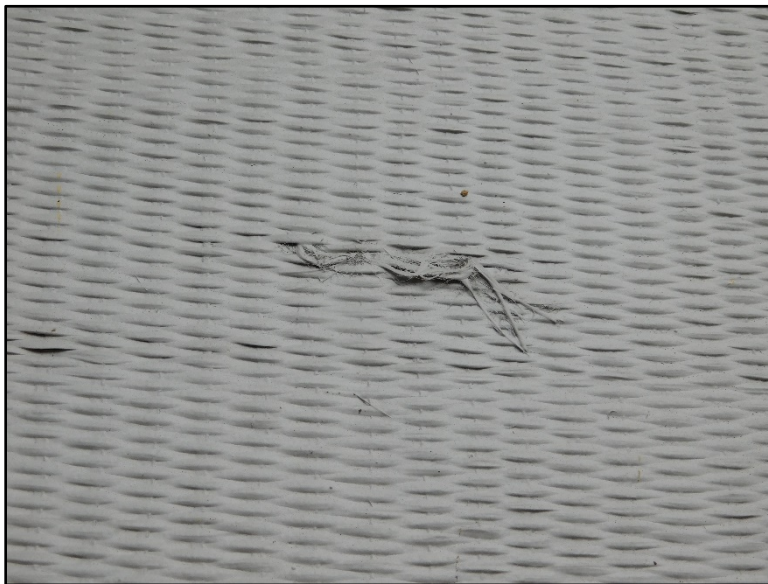
Figure B.85 Damaged and hanging fibers.

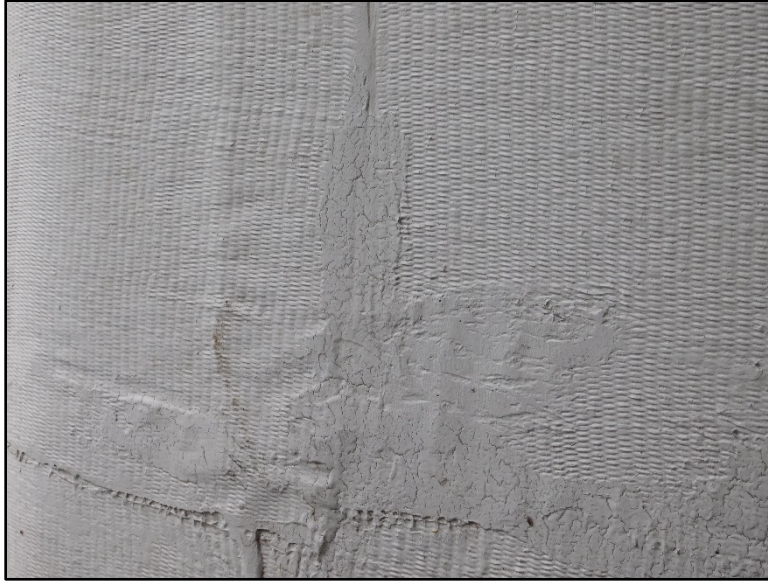
Figure B.86 Alligator-cracking.

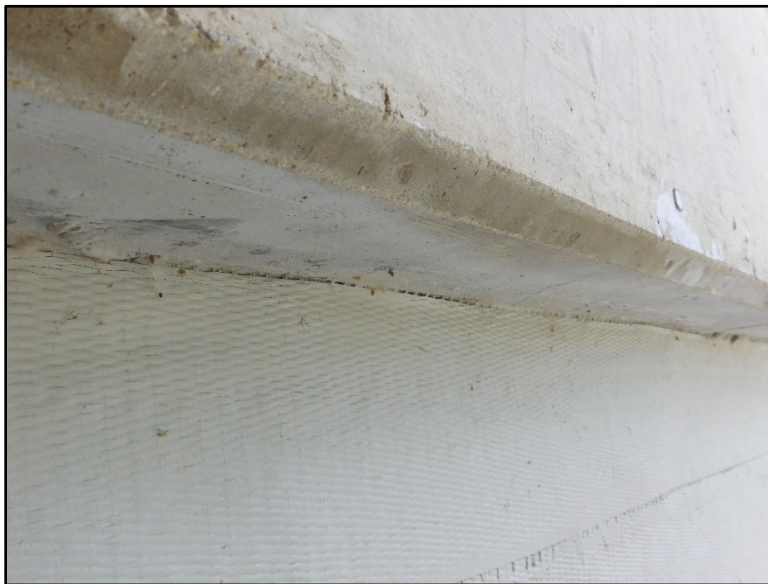
Figure B.87 Termination of wrap at pier cap.

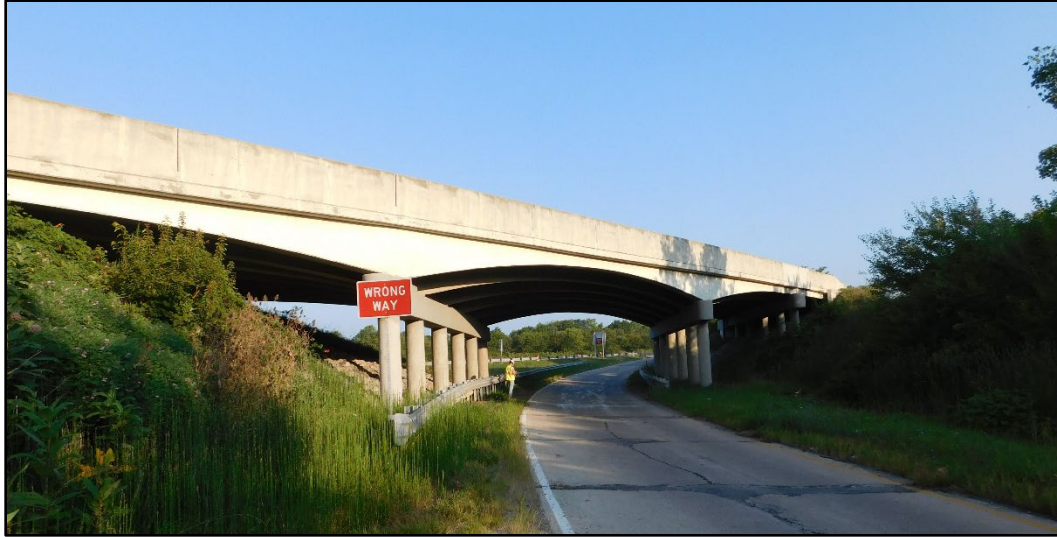
Figure B.88 Panoramic view of bridge facing west.

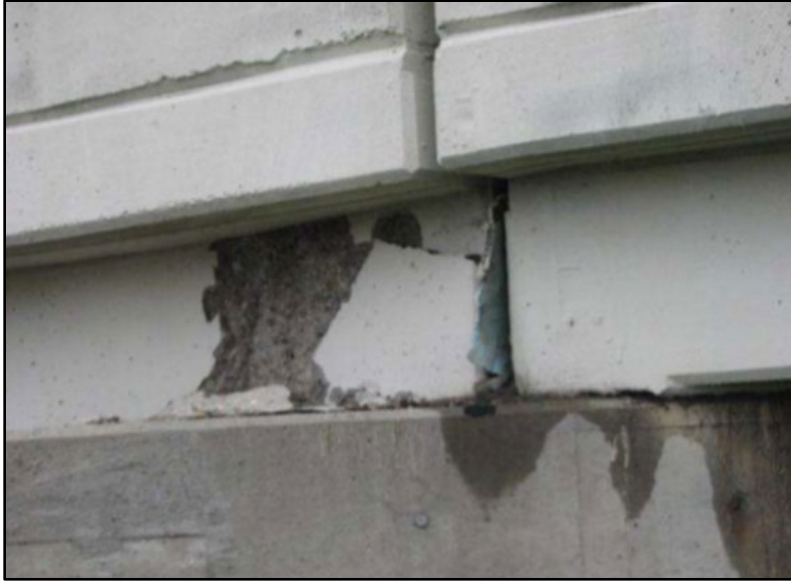
Figure B.89 Spalled east girder with exposed steel above Pier 2 (from Bewley (2011a) inspection report).

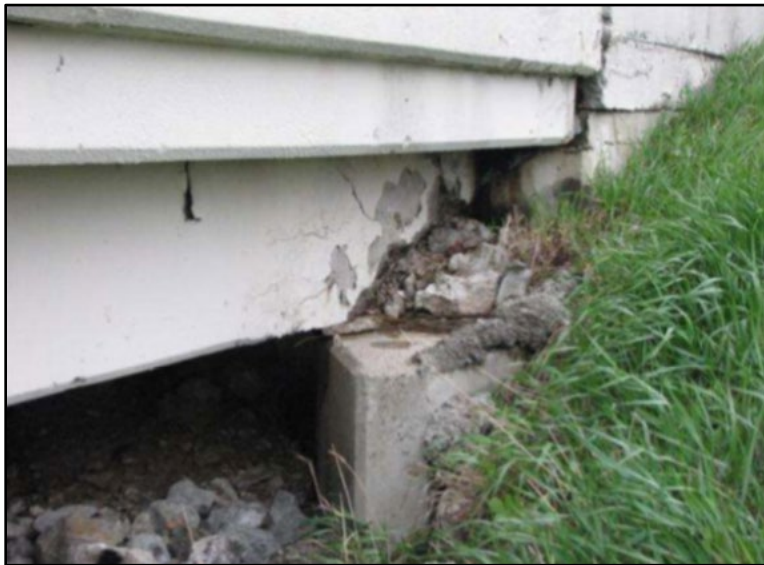
Figure B.90 Crumbling west girder at southwest corner of southern abutment (from Bewley (2011a) inspection report).

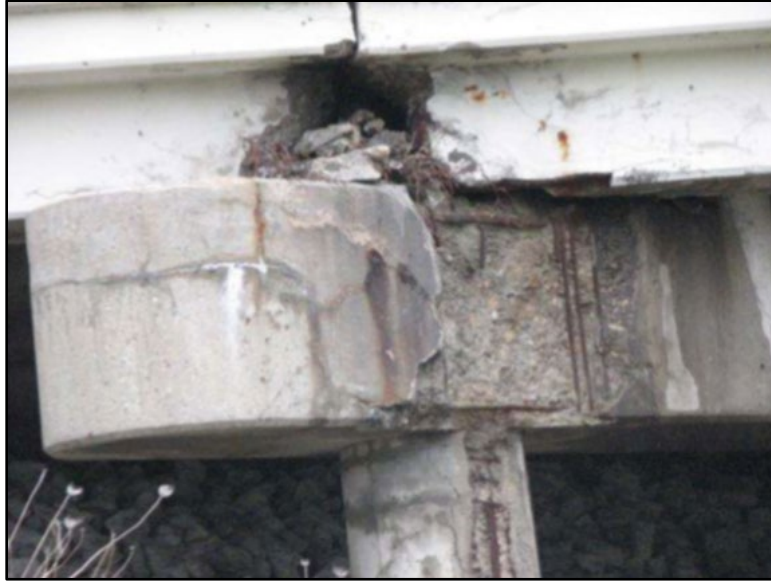
Figure B.91 Spalled west girder and deteriorated Pier 2 (from Bewley (2011a) inspection report).

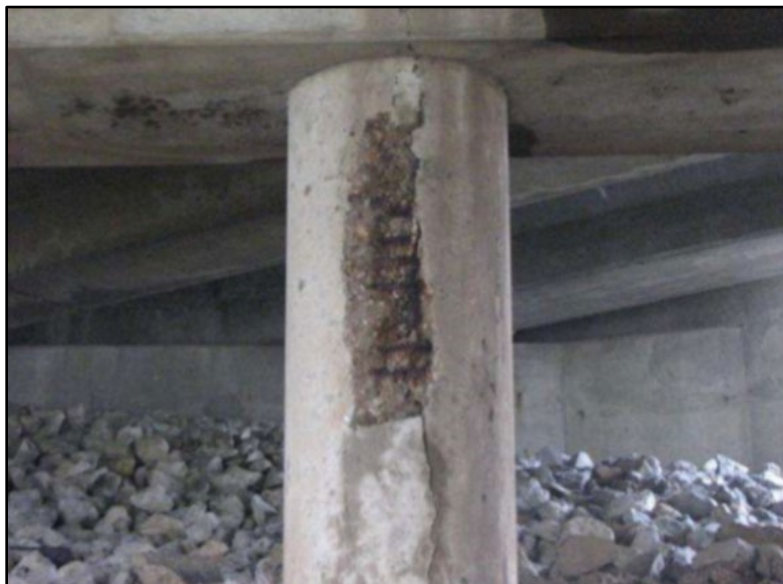
Figure B.92 Spalled column with exposed steel at Pier 2 (from Bewley (2011a) inspection report).

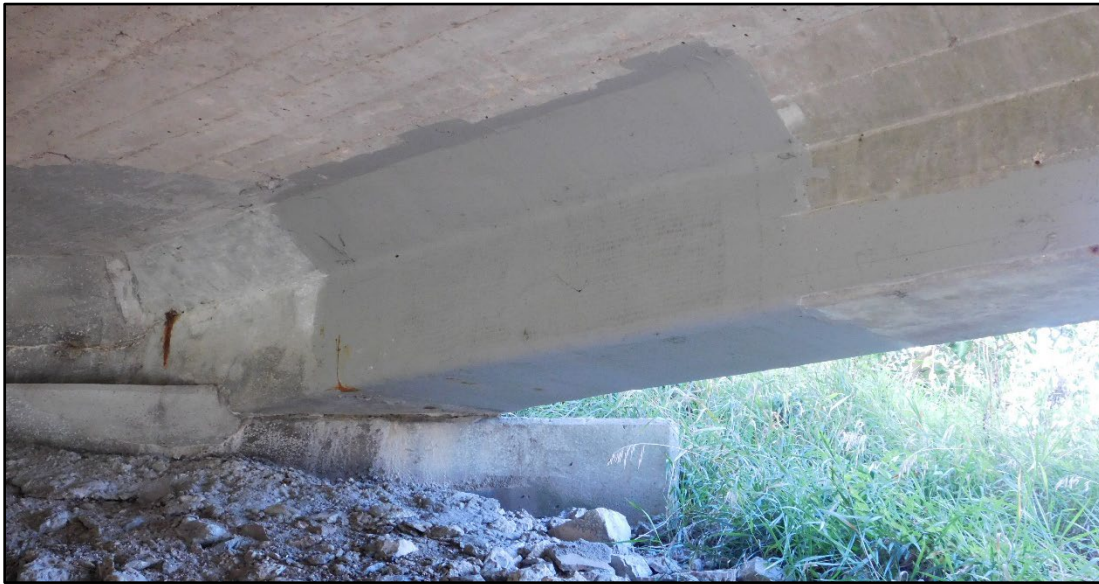
Figure B.93 Beam end repair of fascia girder at southern abutment.

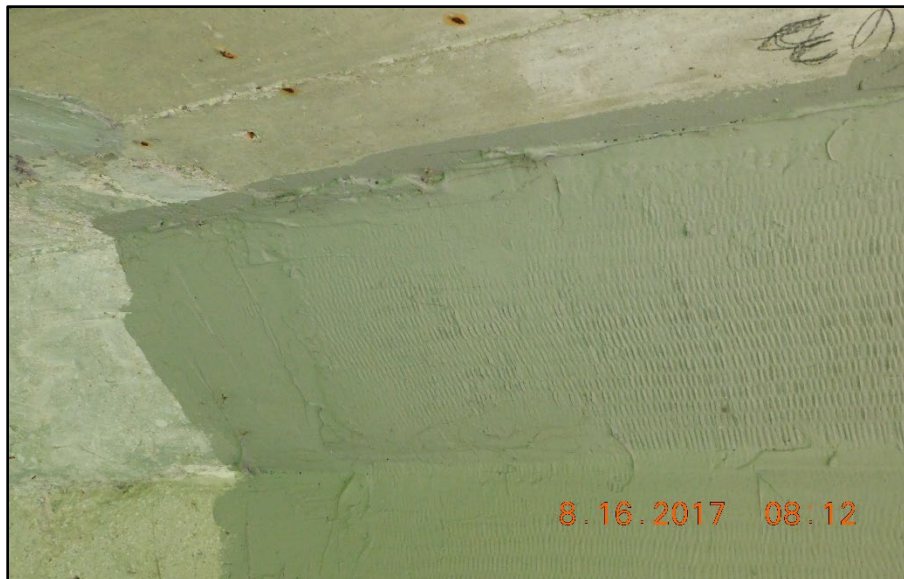
Figure B.94 Beam end wrapping up to deck.

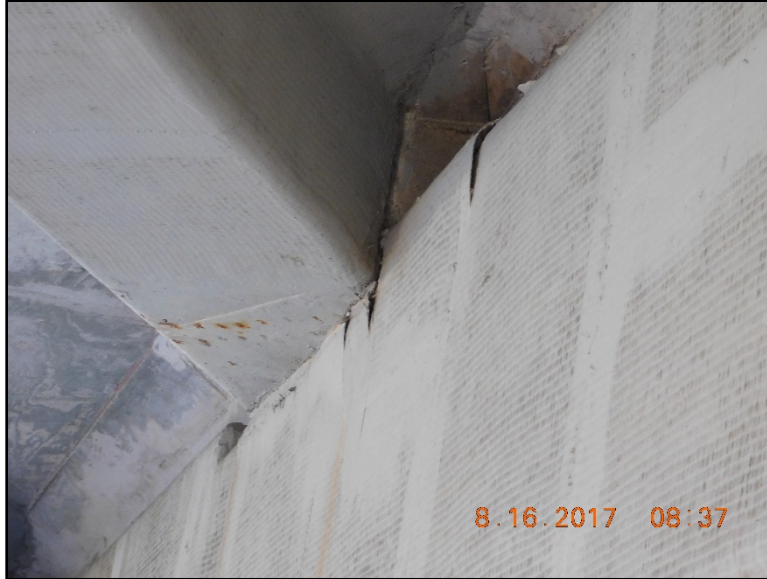
Figure B.101 Cracking and peeling of beam cap wrapping at beam end support.

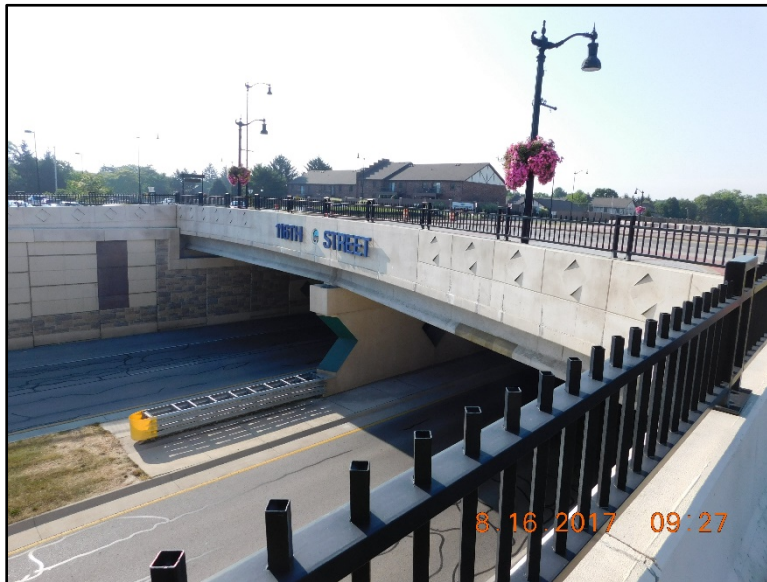
Figure B.102 Panoramic view of the bridge facing southeast.

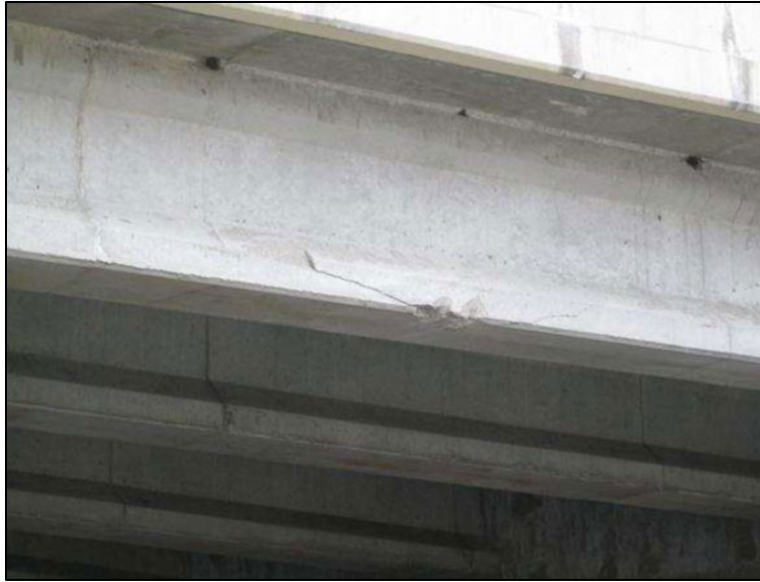
Figure B.103 Impact-damaged girder prior to FRP Repair (from Post (2013) inspection report).

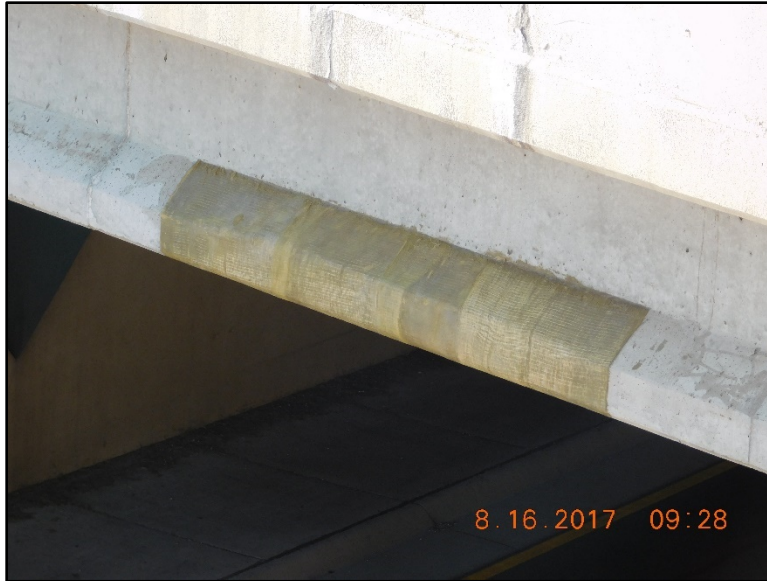
Figure B.104 Wrapping at impacted region.

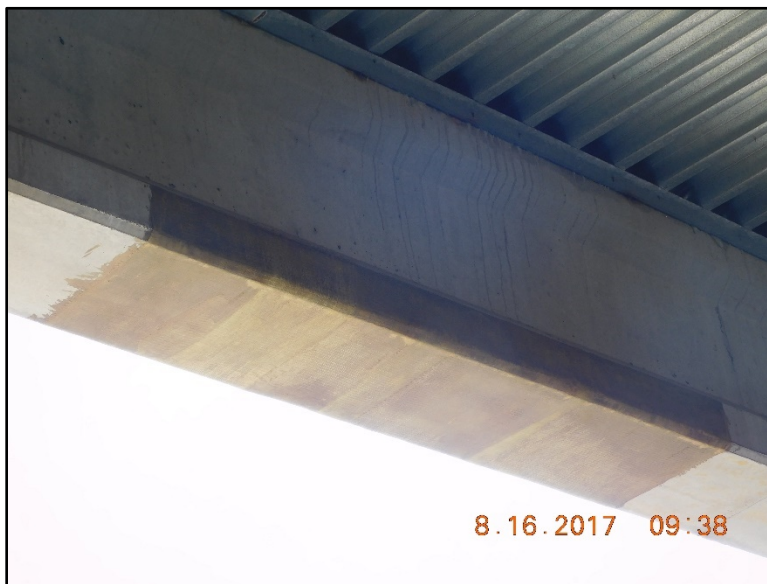
Figure B.107 Repair from underside of 116th Street Bridge.

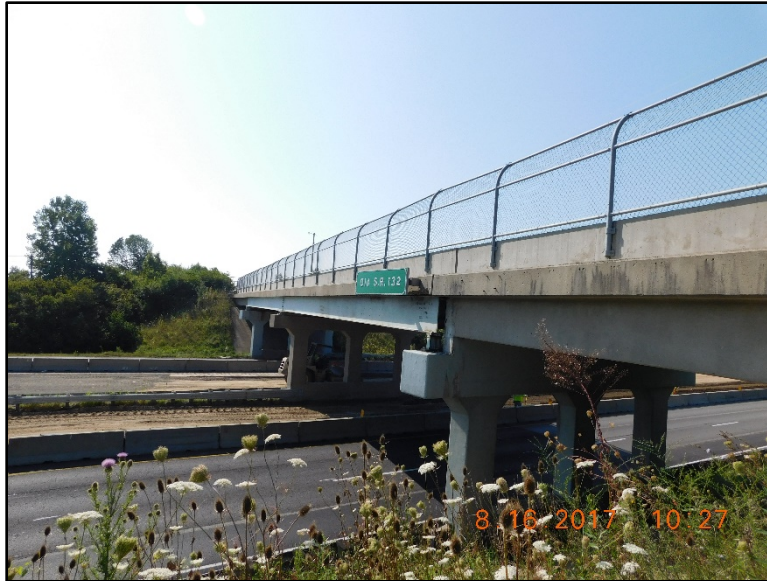
Figure B.108 Panoramic view of the bridge facing southeast.

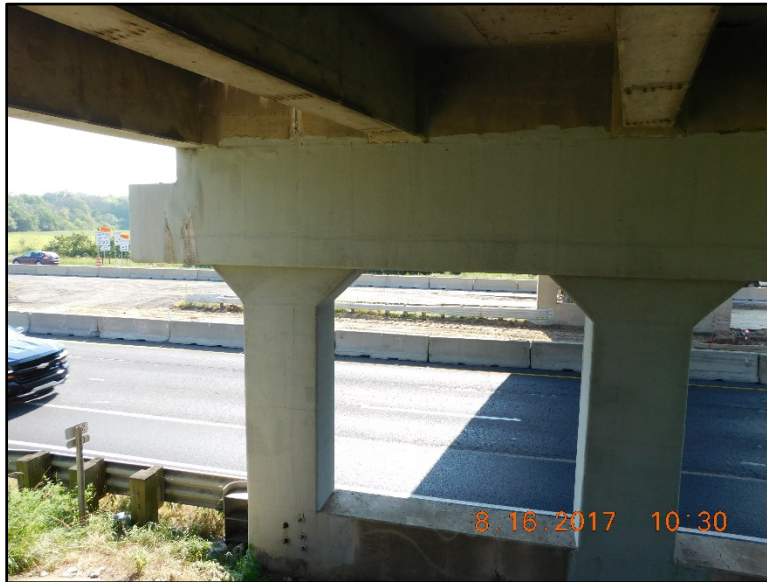
Figure B.109 Wrapped columns and pier cap at northwestern pier.

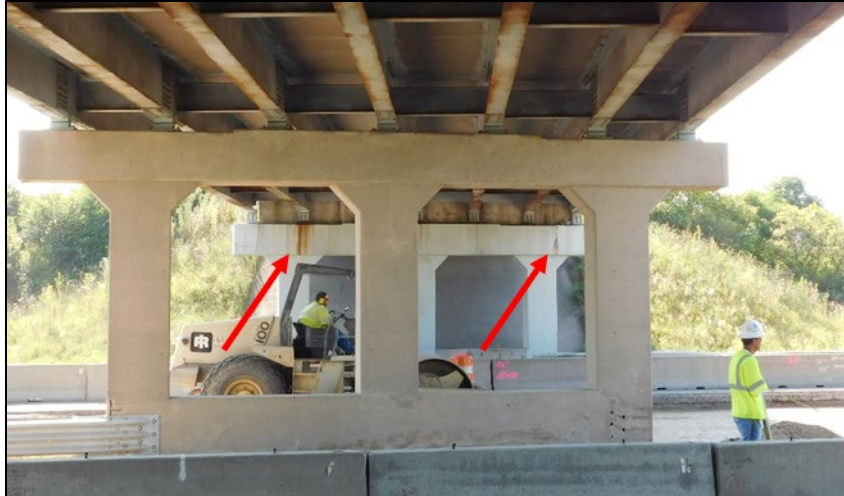
Figure B.113 Rust staining and other discoloration at southeastern pier.

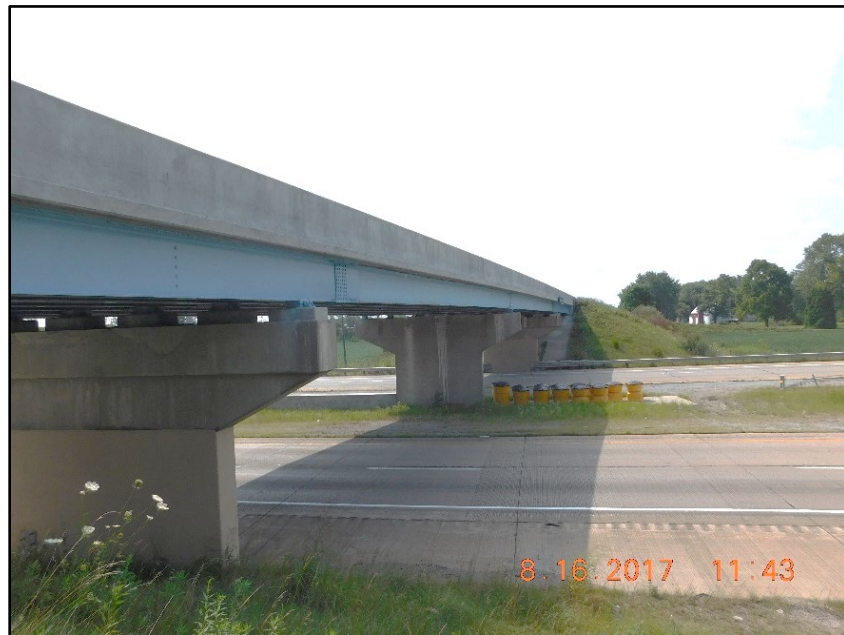
Figure B.114 Panoramic view of the bridge facing Southeast.

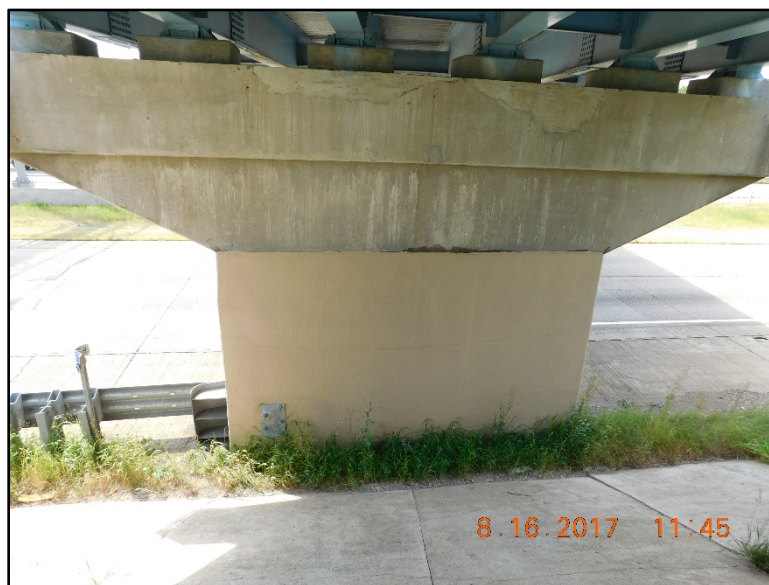
Figure B.115 Wrapped column at northern pier.

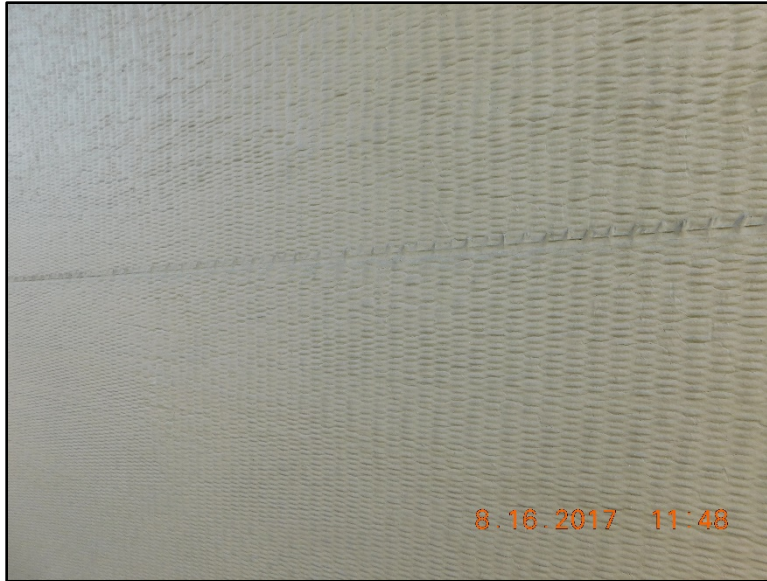
Figure B.118 Proper smooth surface of repair.

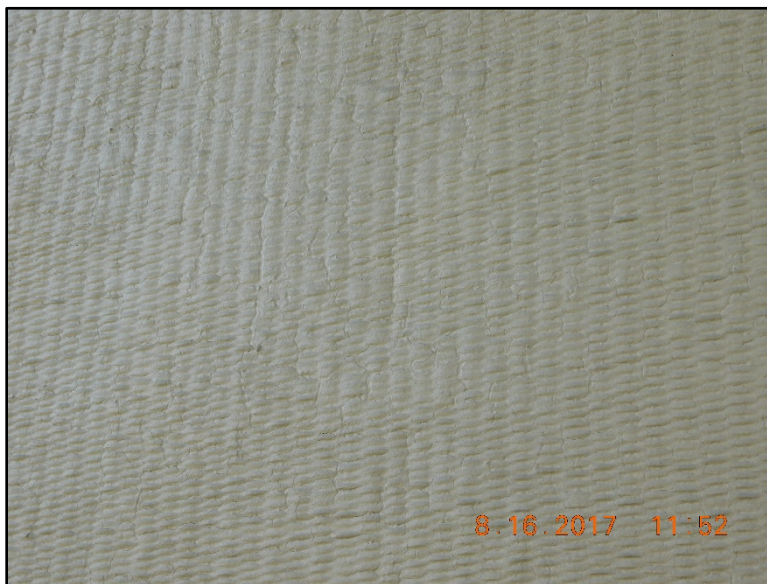
Figure B.119 Possible UV damage.
