JOINT TRANSPORTATION RESEARCH PROGRAM

INDIANA DEPARTMENT OF TRANSPORTATION
AND PURDUE UNIVERSITY

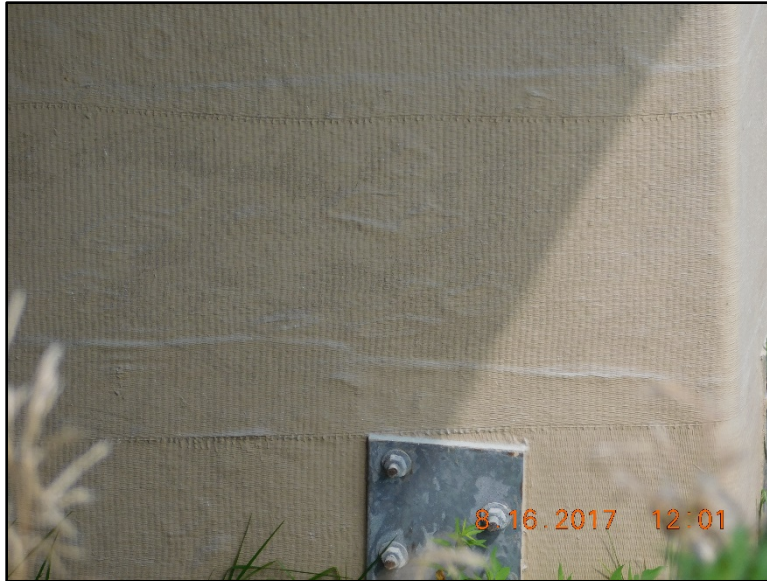
Figure B.120 Areas of voids on the repaired surface of the southern pier.

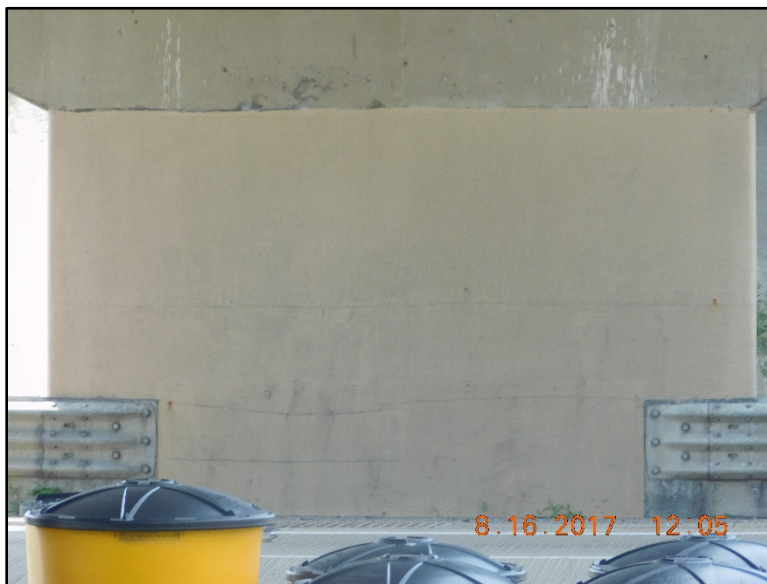
Figure B.121 Inconsistent layers and sagging of sheets.

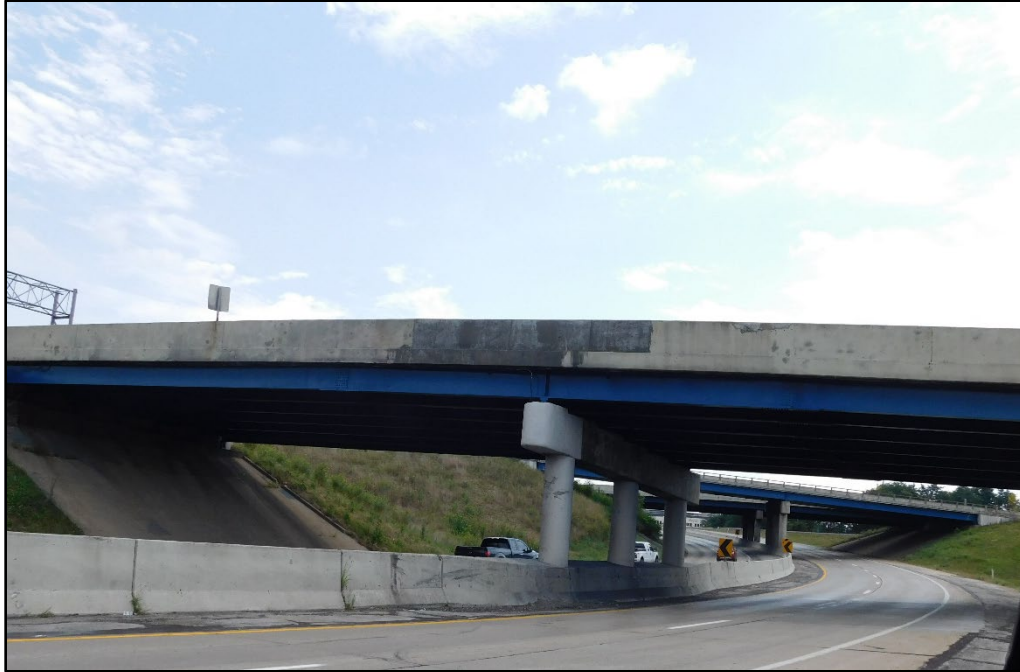
Figure B.122 Panoramic view of the bridge facing south.

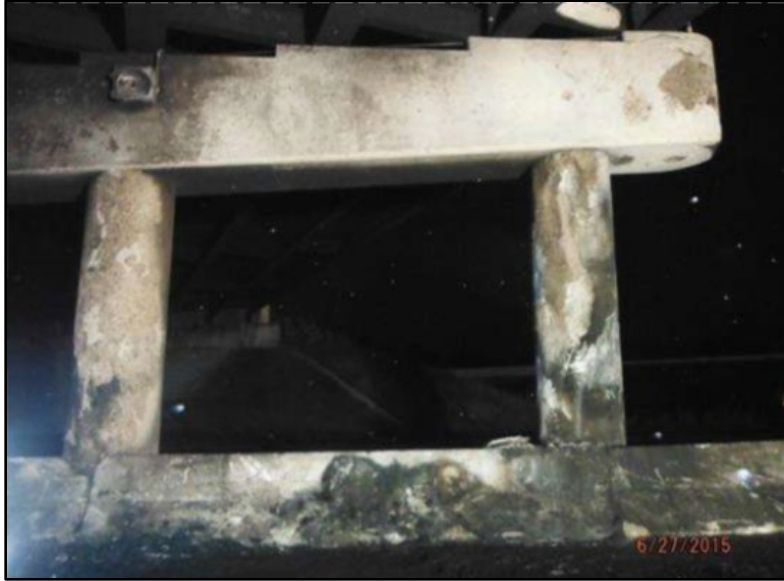
Figure B.123 Fire damage to Bent 2 (from Mickler (2015a) inspection report).

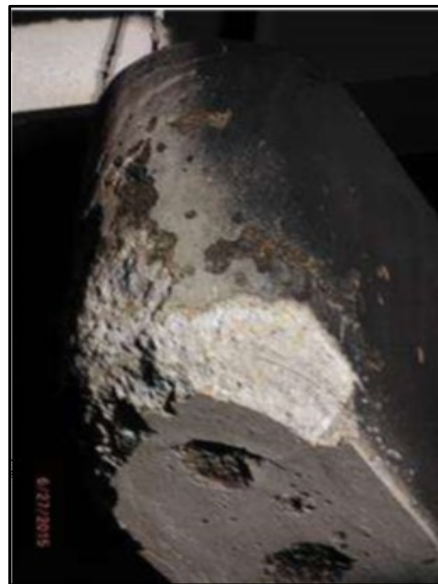
Figure B.124 Scaling of the north end of bent cap (from Mickler (2015a) inspection report).

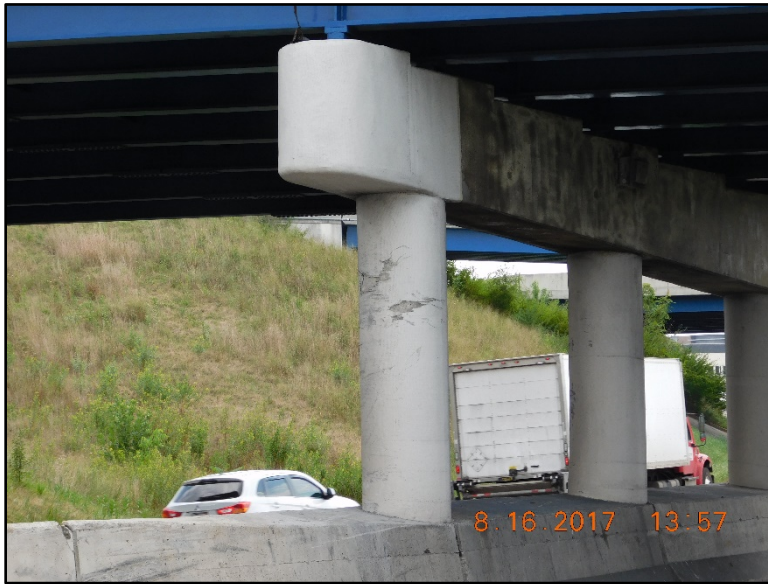
Figure B.125 Wrapped northernmost column and beam cap edge.

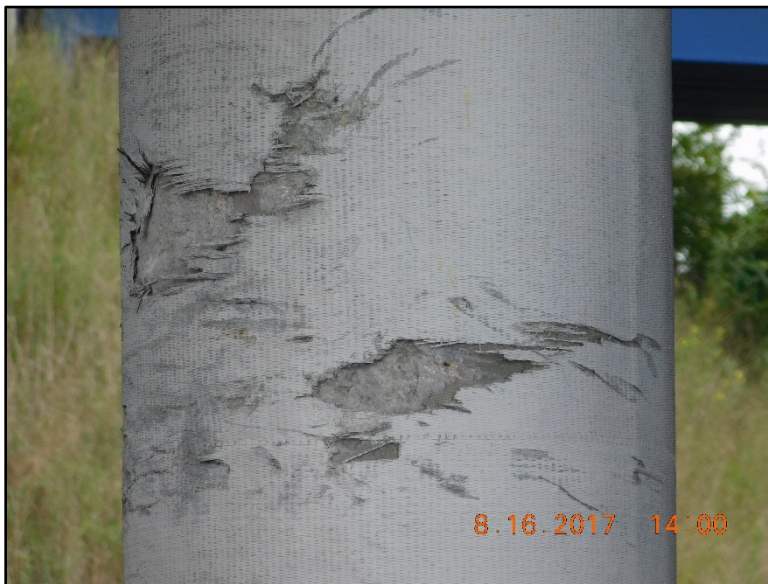
Figure B.126 Damage to northernmost column with exposed concrete.

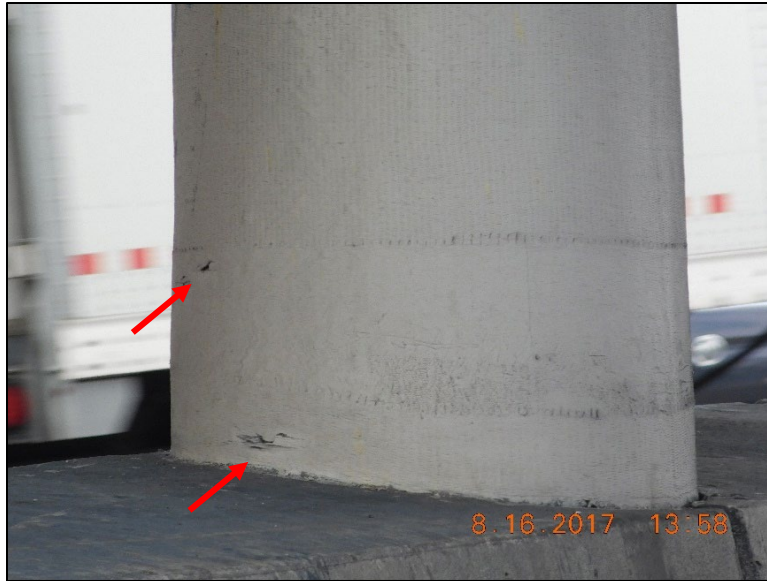
Figure B.127 Inconsistent layering of FRP sheets with signs of vehicle damages.

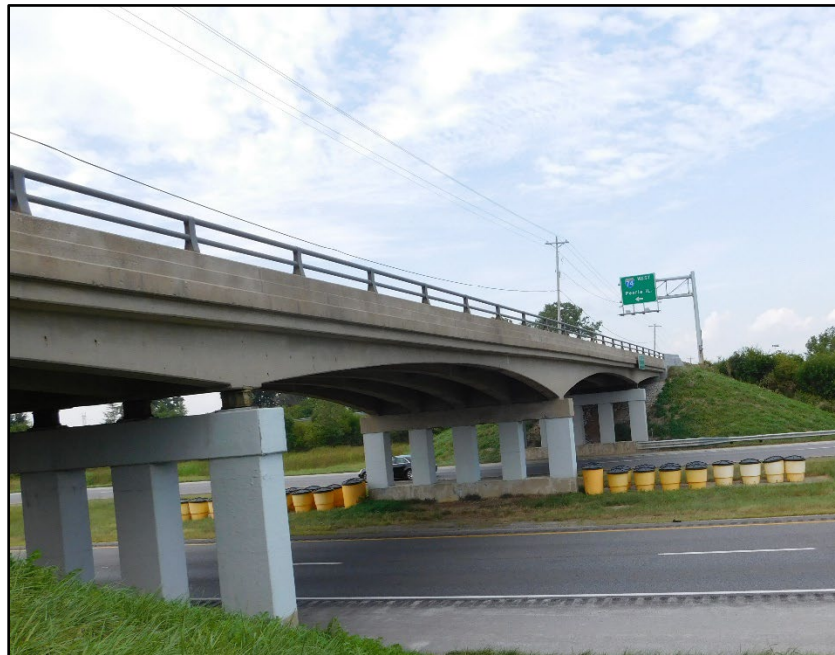
Figure B.128 Panoramic view of the bridge facing southeast.

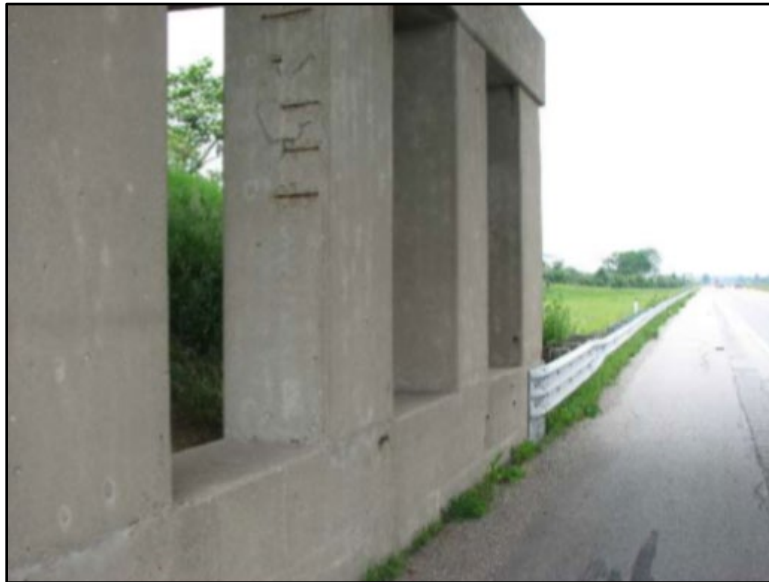
Figure B.129 Spalling and exposed rebar at Pier 2 (from Bewley (2009) inspection report).

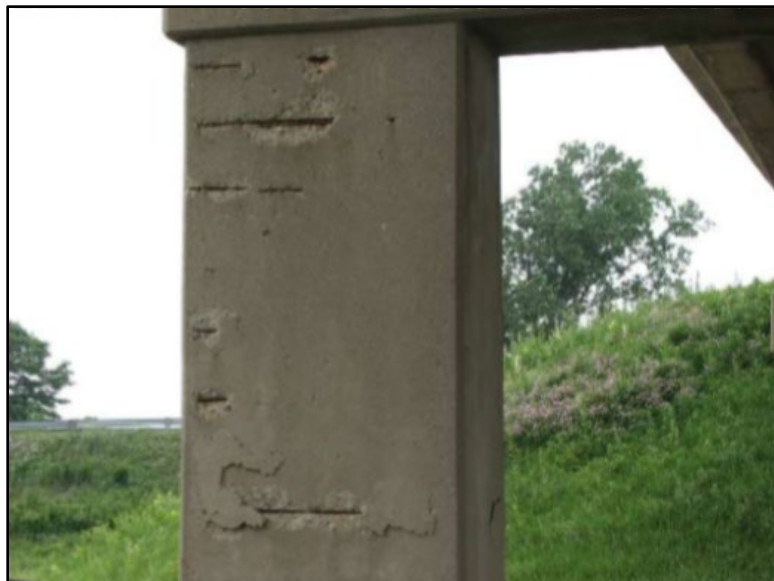
Figure B.130 Spalling and exposed rebar at Pier 3 (from Bewley (2009) inspection report).

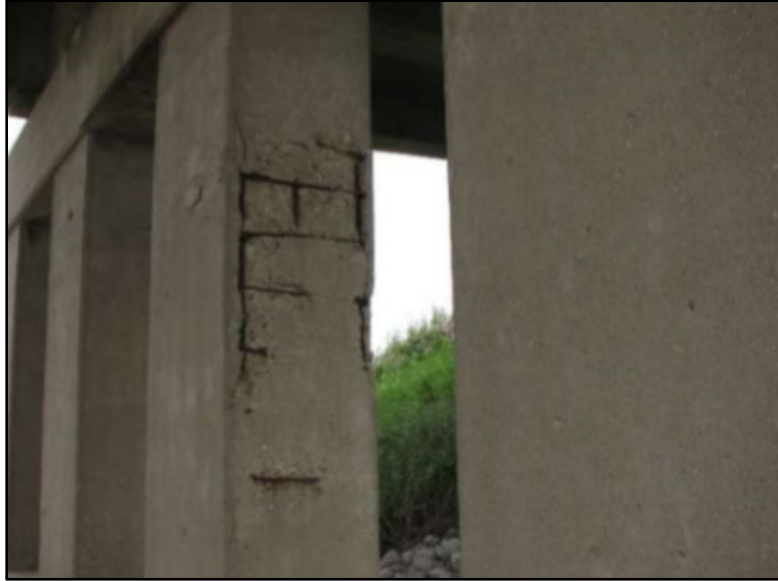
Figure B.131 Spalling and exposed rebar at Pier 4 (from Bewley (2009) inspection report).

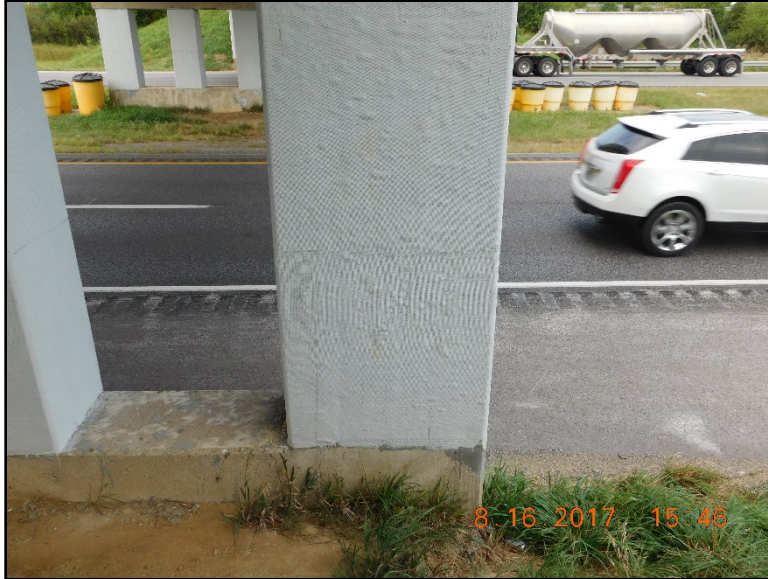
Figure B.132 Multiple voids in column wrap.

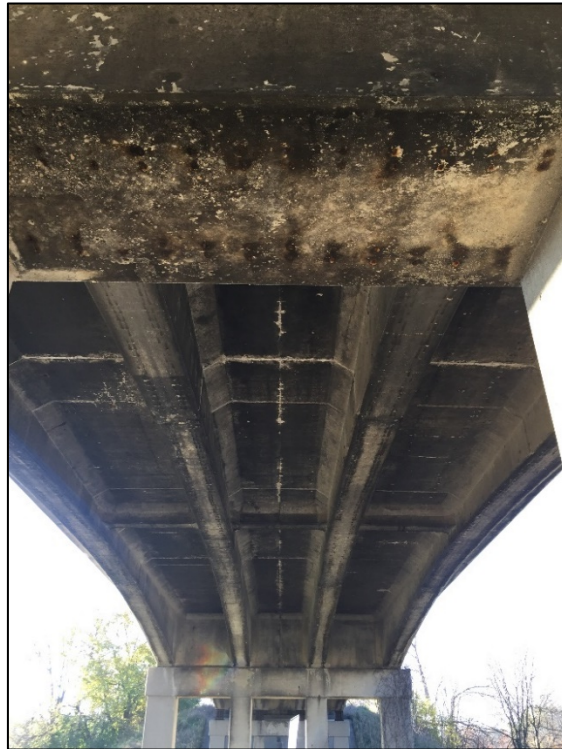
Figure B.139 Fire-damaged northern spans.

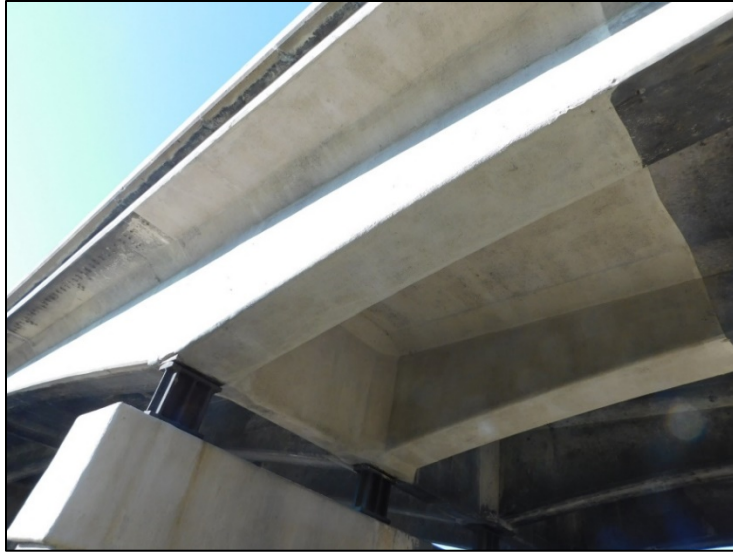
Figure B.140 Wrapped girders, diaphragm, and deck portion in northern span.

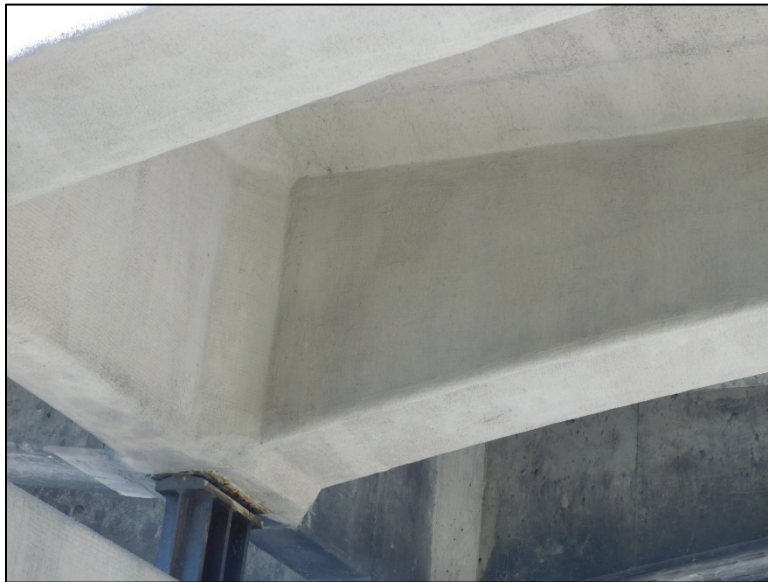
Figure B.141 Detailing of FRP repair at girder-diaphragm intersection.

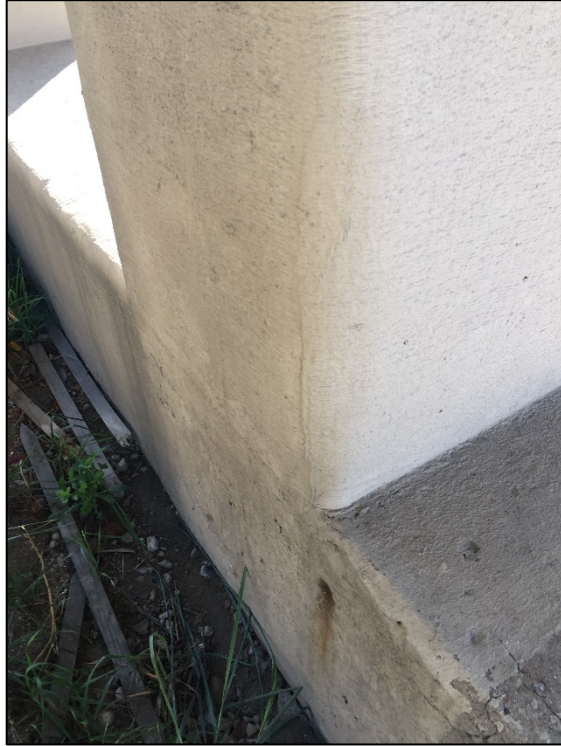
Figure B.142 Column wrap terminated at top of crashwall.

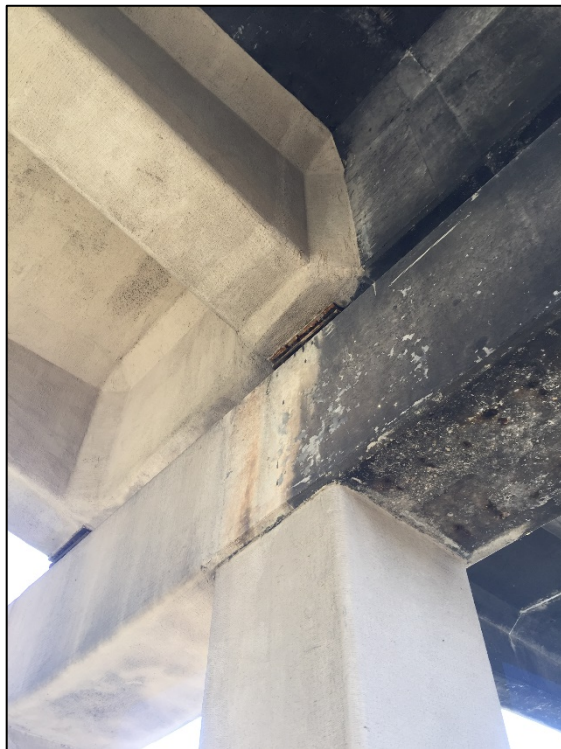
Figure B.143 FRP Repairs to column and portions of pier cap and superstructure.

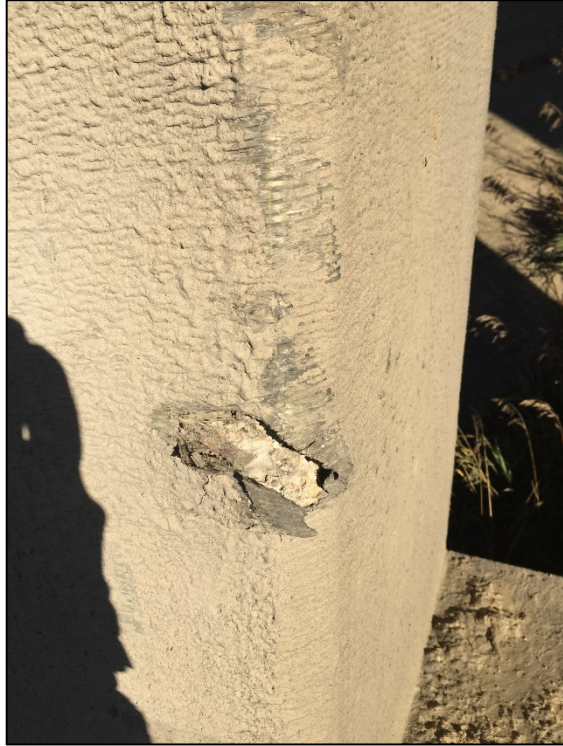
Figure B.144 Large tear in westernmost column wrap.

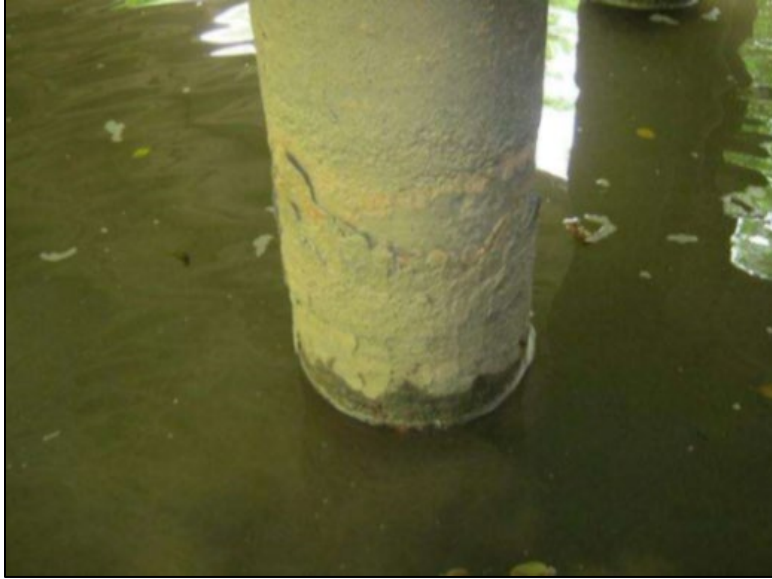
Figure B.147 Pile deterioration at eastern pier (from Conner (2011) inspection report).

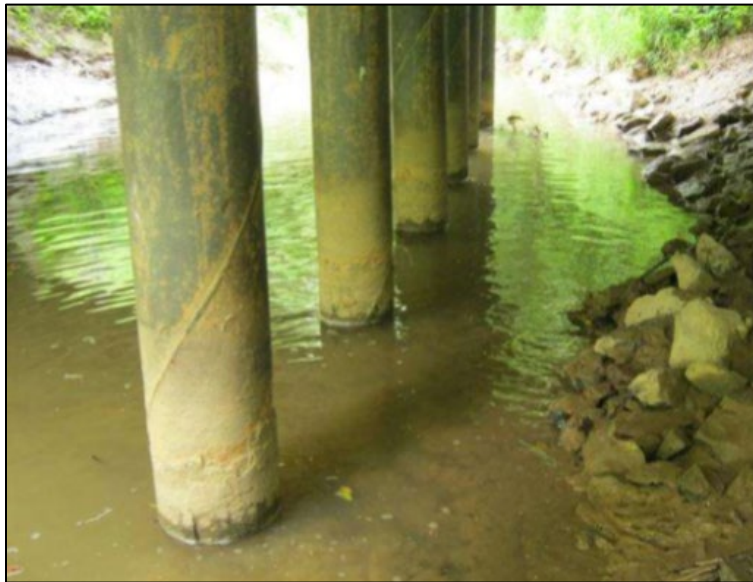
Figure B.148 Pile deterioration at eastern pier (from Conner (2011) inspection report).

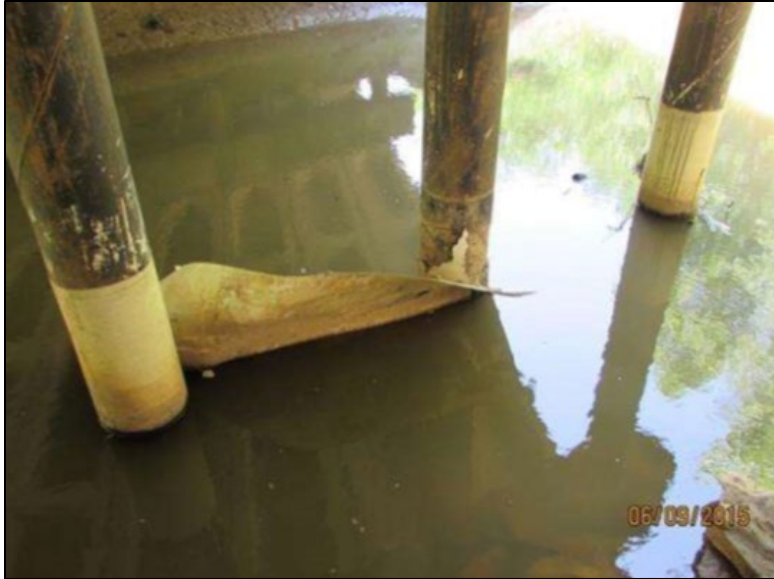
Figure B.149 Column wrap damage at eastern pier (from Olson (2015) inspection report).

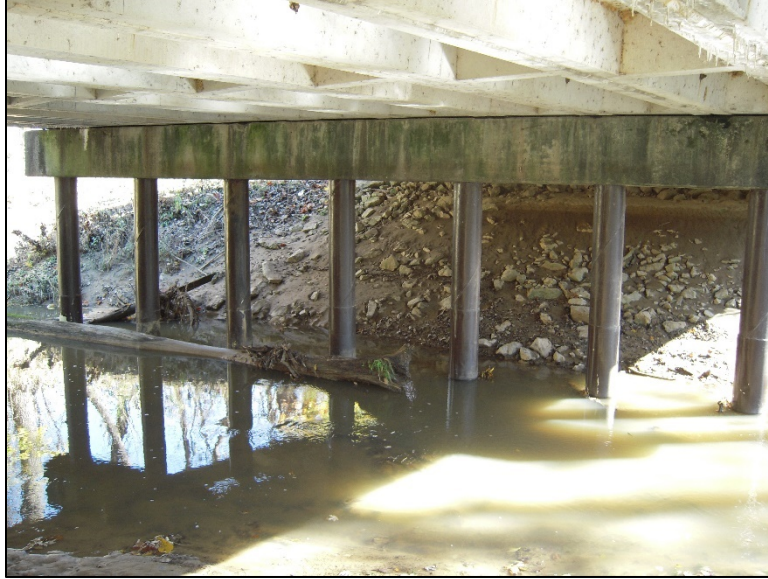
Figure B.150 FRP wraps on steel-encased columns of eastern pier.

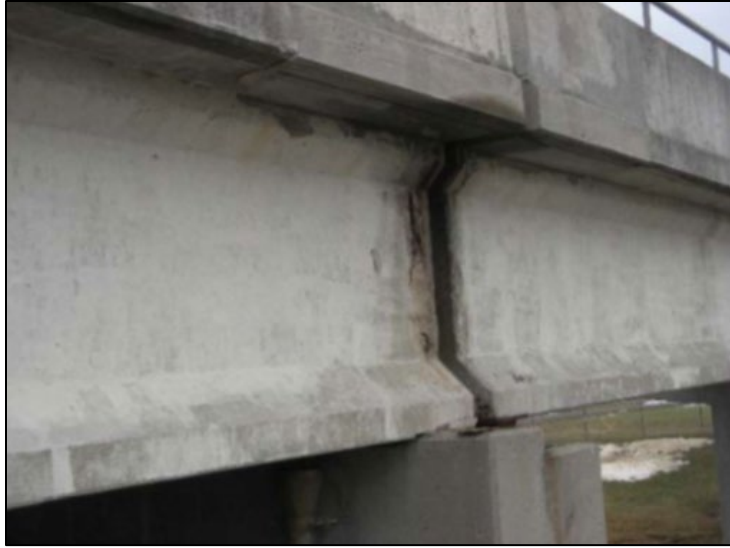
Figure B.157 Beam end deterioration at Pier 28 (from Everman (2010) inspection report).

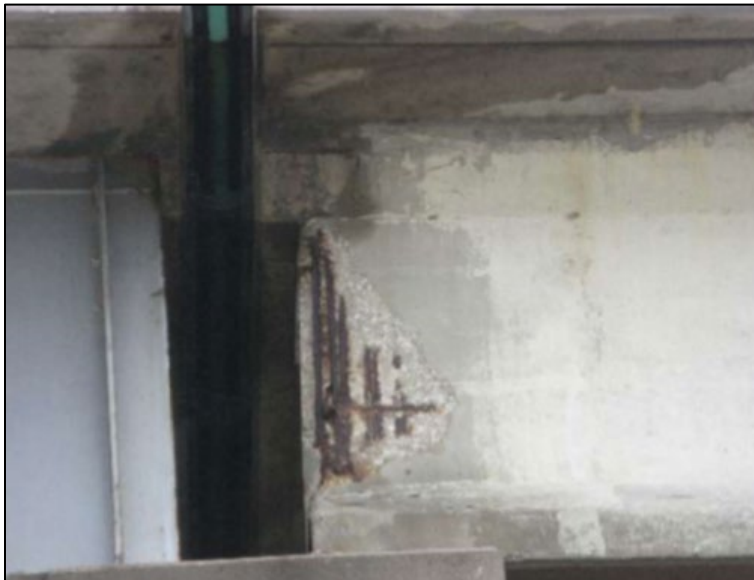
Figure B.158 Beam end deterioration at Pier 22 (from Everman (2010) inspection report).

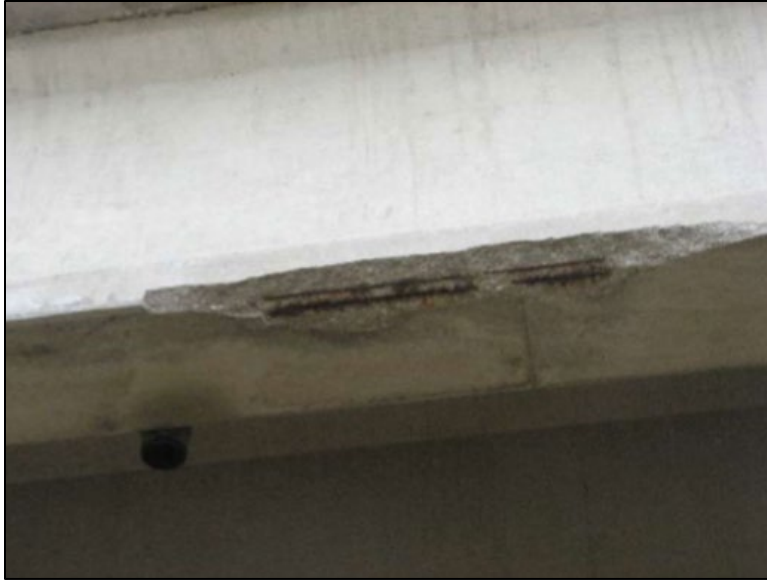
Figure B.159 Midspan spalling and exposed steel (from Everman (2010) inspection report).

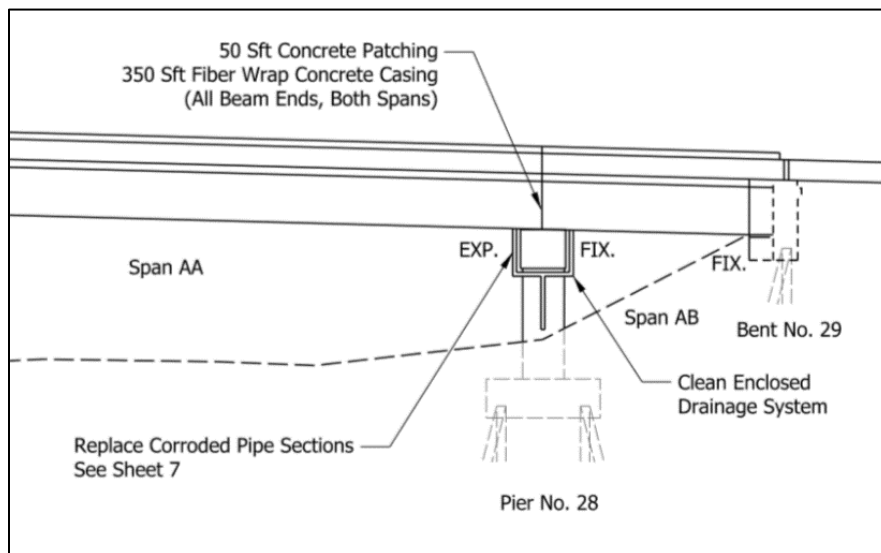
Figure B.160 Fiber wrap plans for beam ends at joint near IN-156 (from INDOT, 2014).

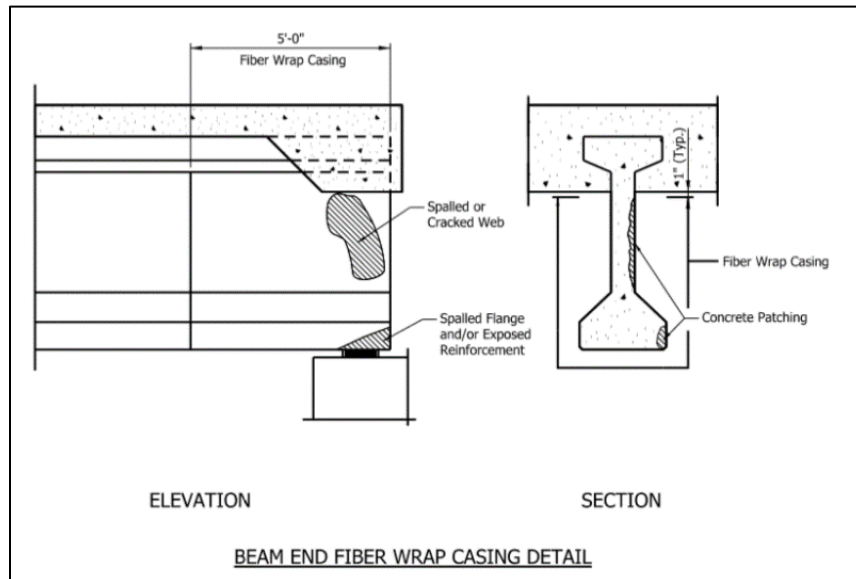
Figure B.162 Beam end repair details (from INDOT, 2014).

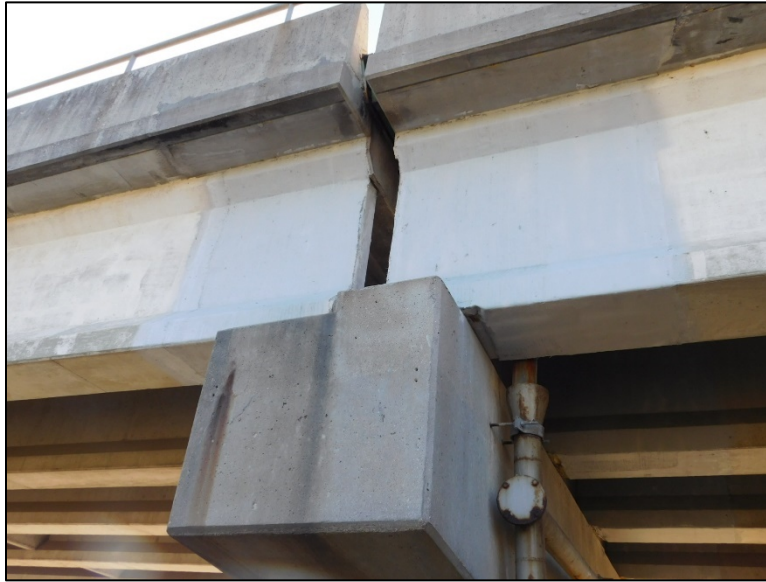
Figure B.163 Beam end repairs at joint near IN-156.

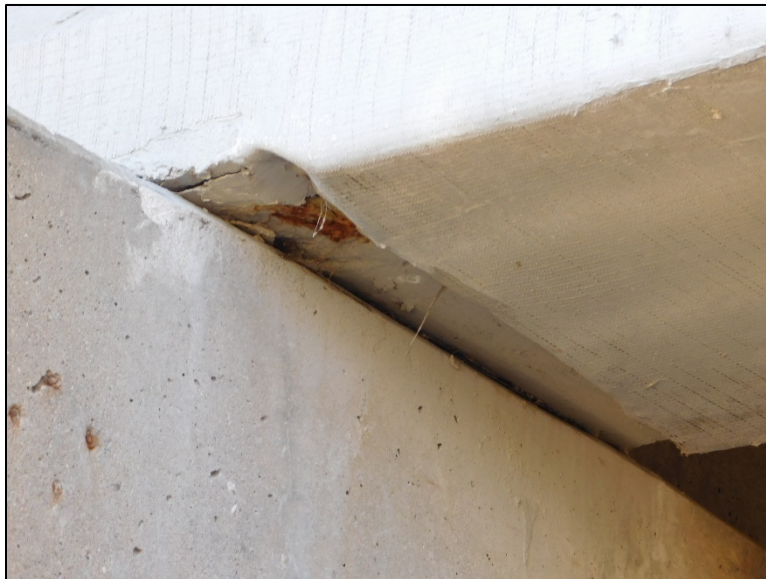
Figure B.164 Premature termination of FRP wrap at support location.

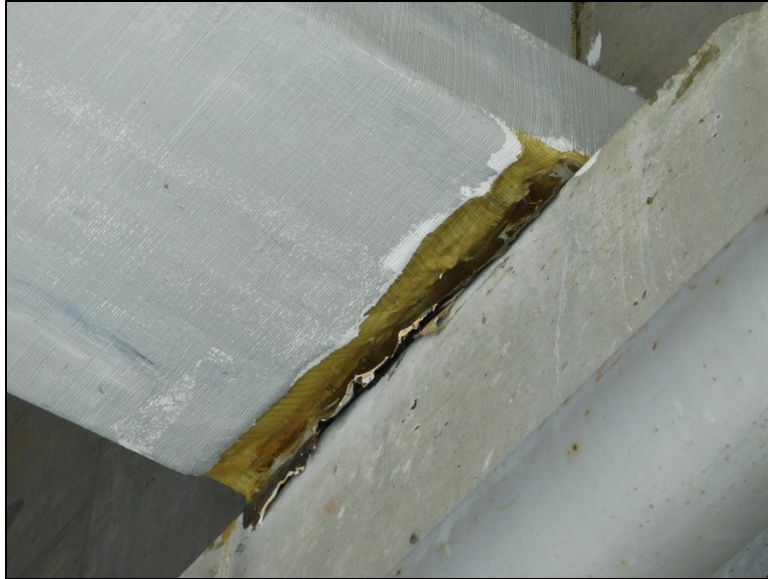
Figure B.165 Cracking/splitting of sheet at support location.

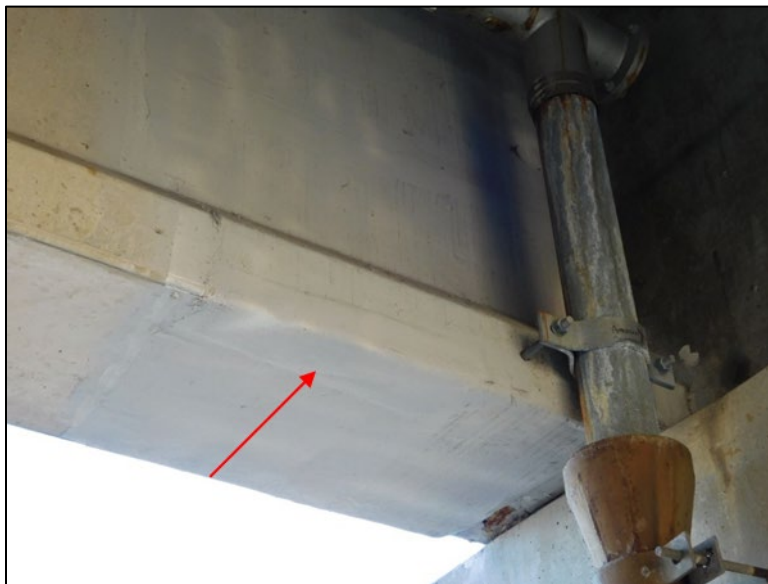
Figure B.166 Patching of FRP material.

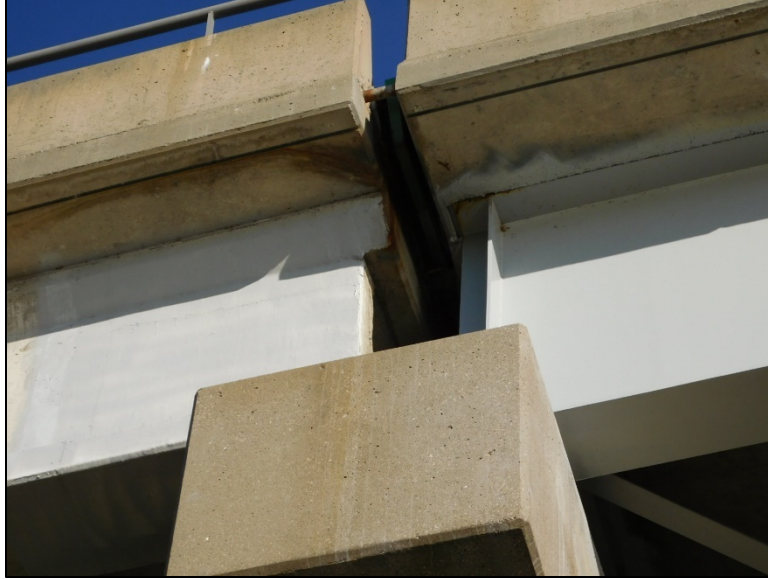
Figure B.167 Beam end repairs at Markland Dam joint.

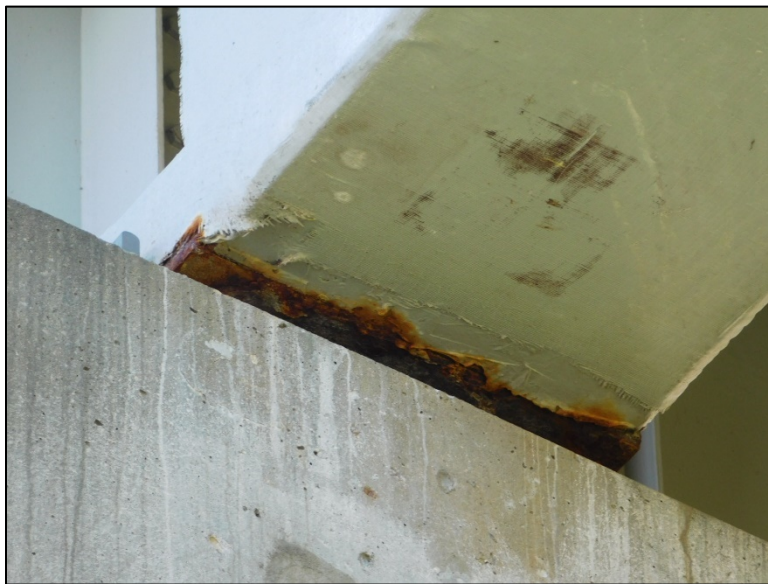
Figure B.168 Corrosion at beam end near support location.

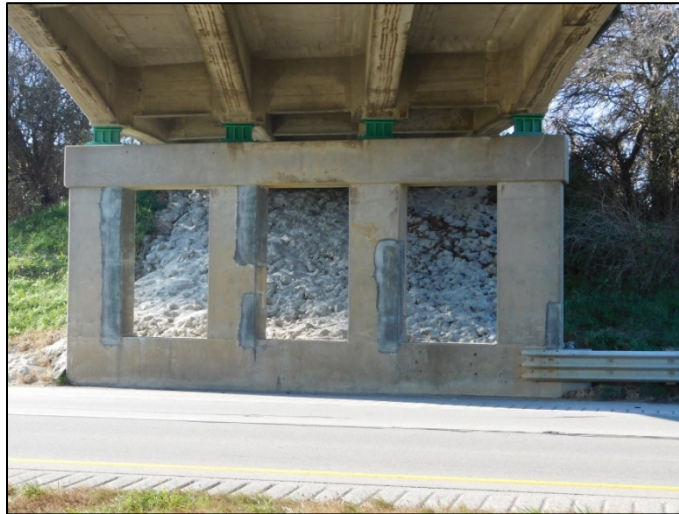
Figure B.170 Southern pier FRP patching.

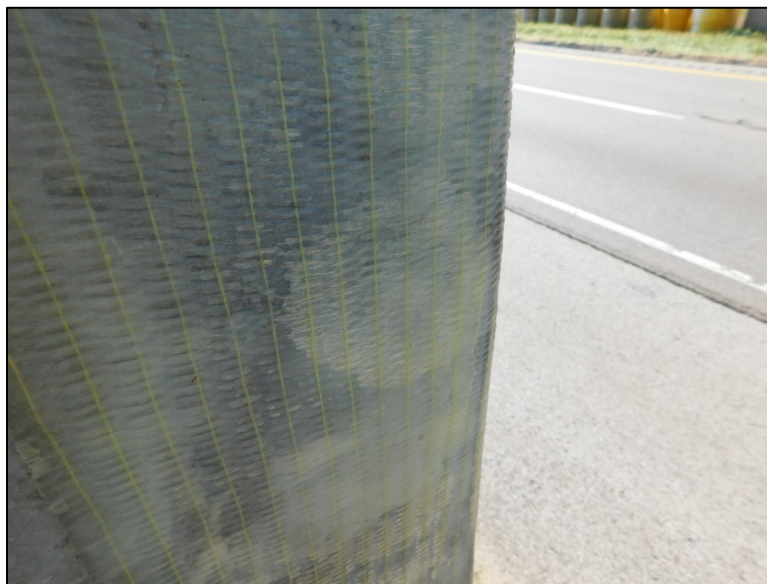
Figure B.171 Possible void or excess epoxy in repair region.

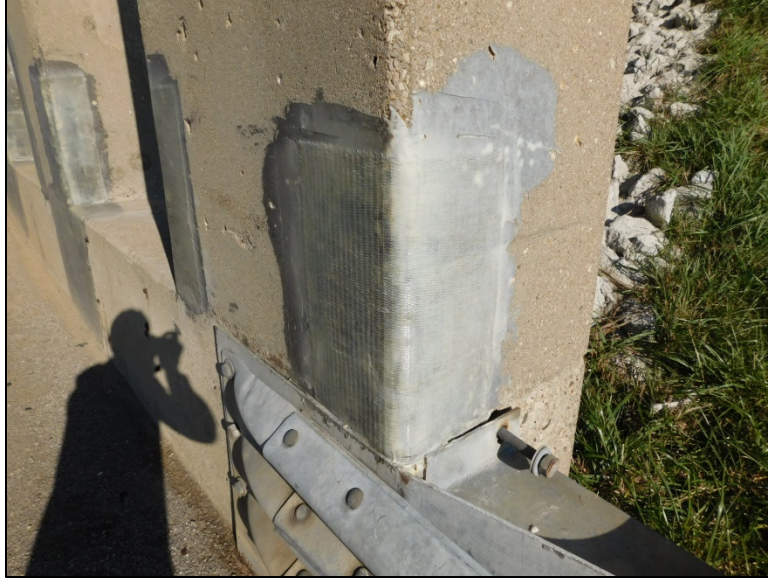
Figure B.172 Corner patching of columns at northern pier.

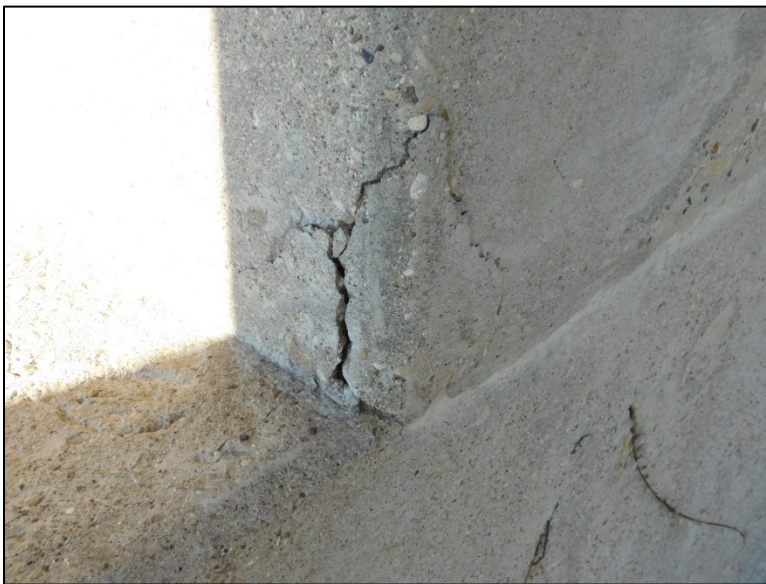
Figure B.175 Spalling of Pier 3.

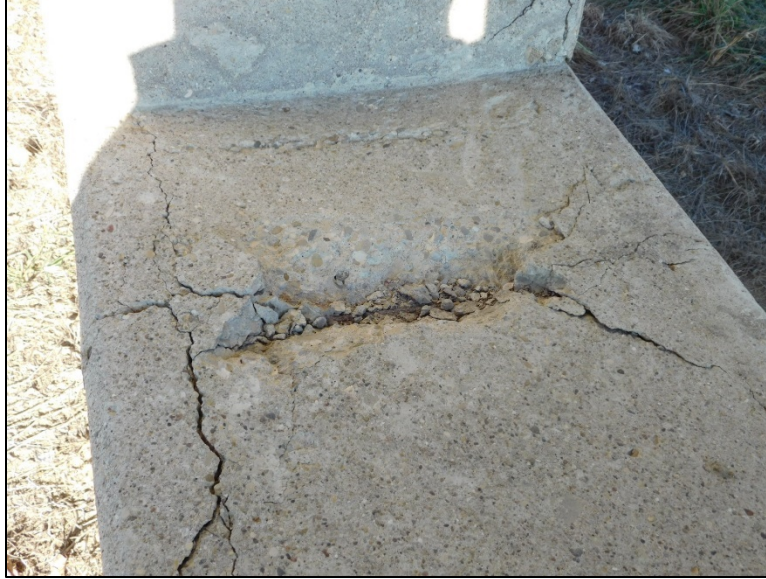
Figure B.176 Spalling of Pier 3.

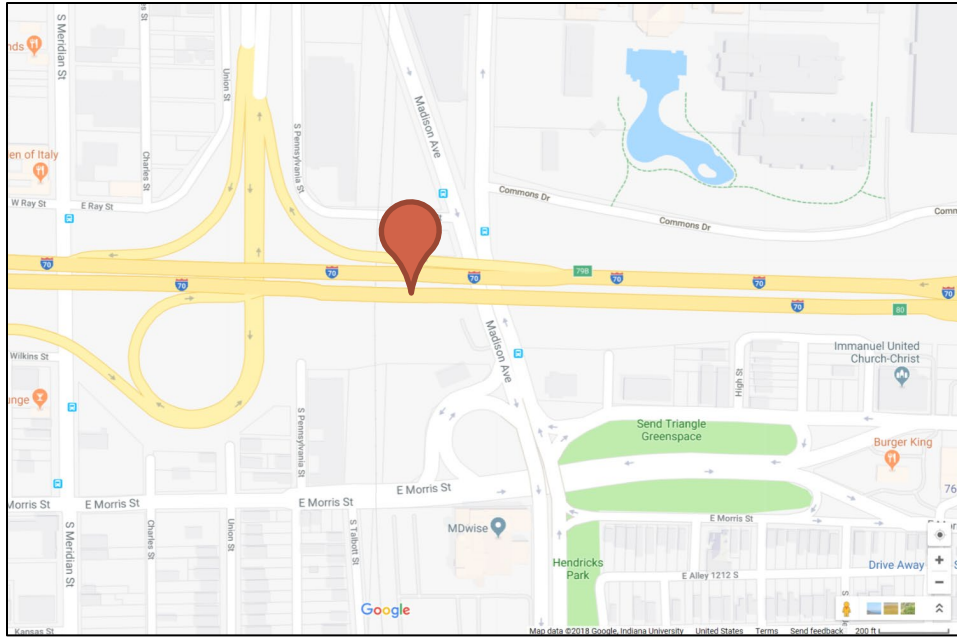
Figure B.177 I-70 bridge location (Google, 2018).

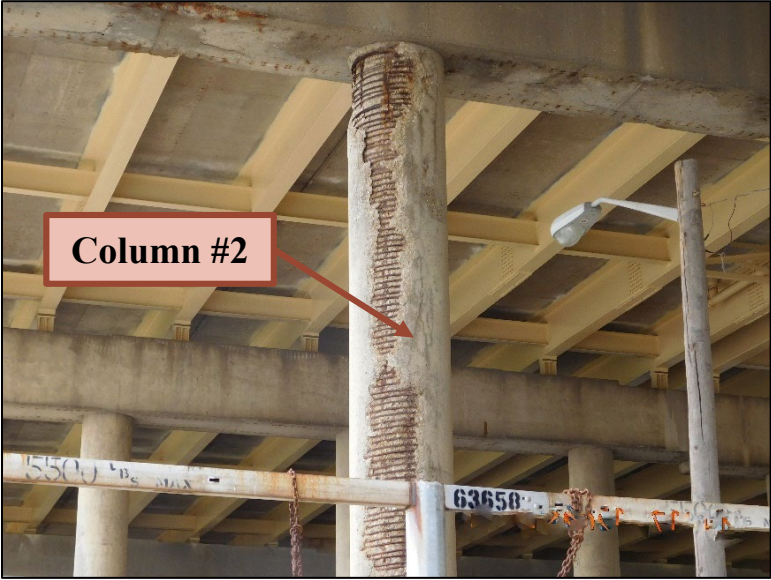
Figure B.179, contained the most severe deterioration of all columns. Concrete had spalled, and the steel reinforcing cage was exposed in areas that extended over a majority of the height of the column. In some areas, the concrete loss included all of the cover as well as some of the internal section (see Figure B.179(b)).

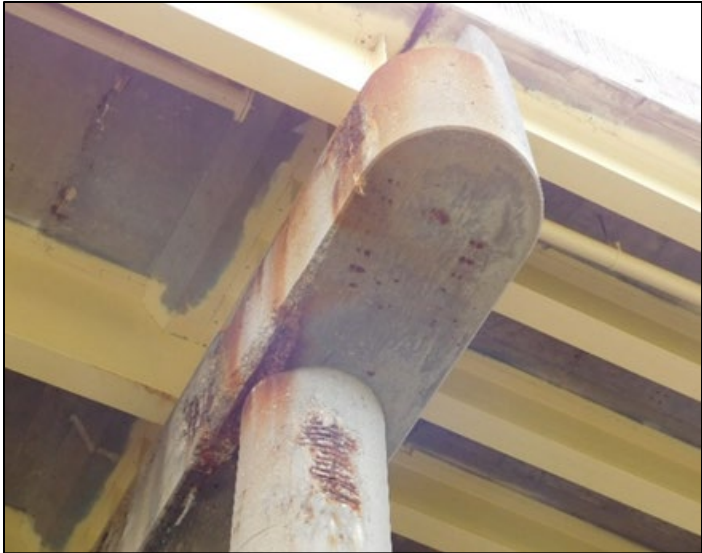
Figure B.180 Deterioration of fascia column at I-70 westbound pier.

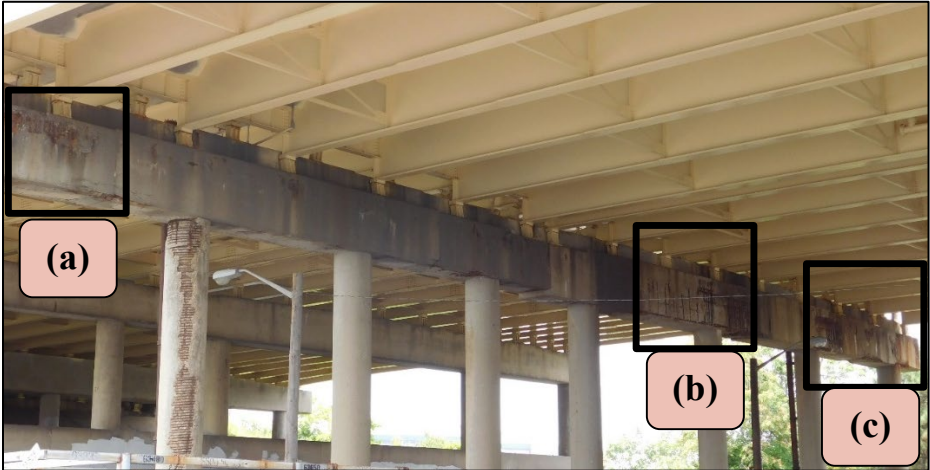
Figure B.181 Deterioration of pier caps.

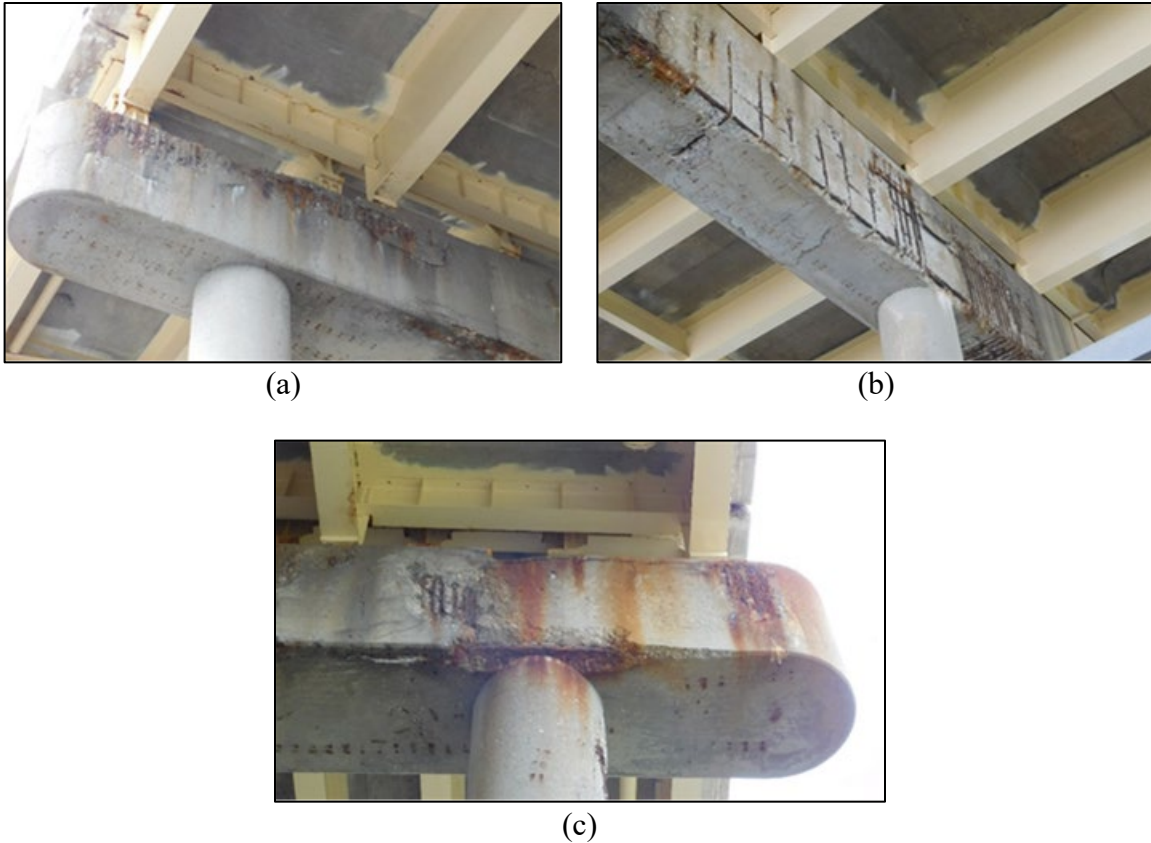
Figure B.181 (cont.) Deterioration of pier caps.

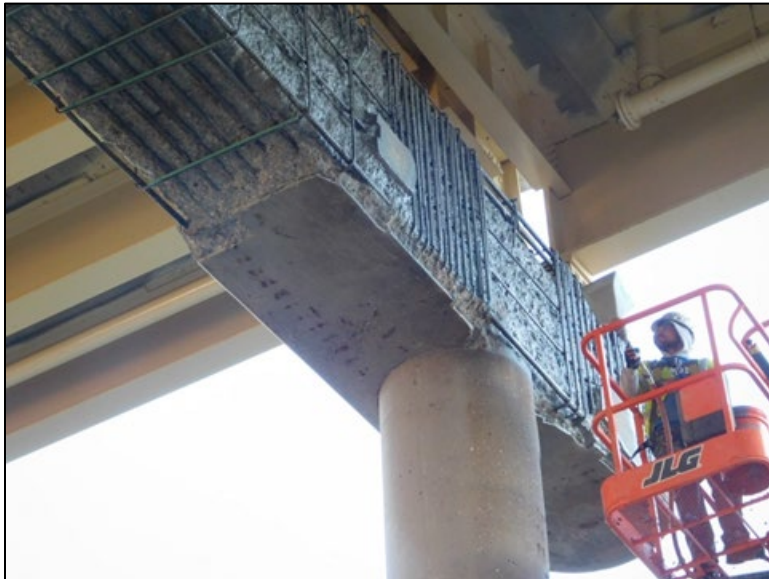
Figure B.182 Cleaned steel and removed concrete substrate prior to shotcrete application.

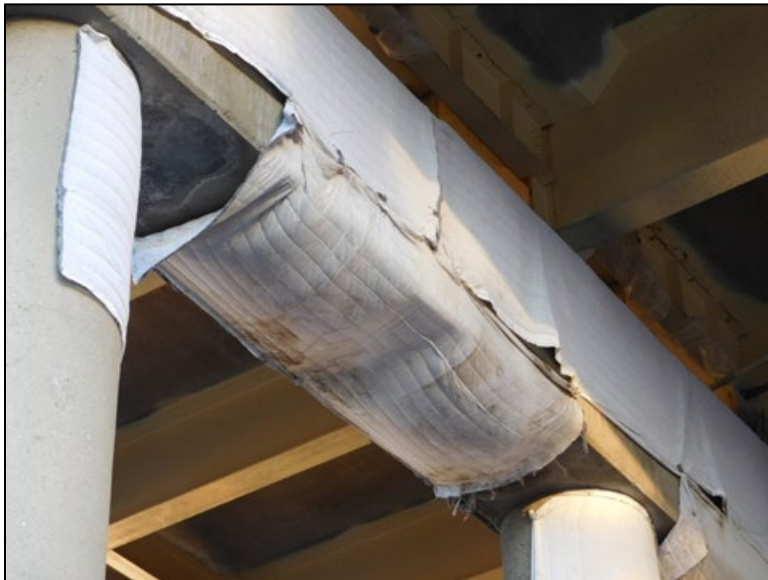
Figure B.185 Use of insulated curing blankets for temperature control after shotcrete application.

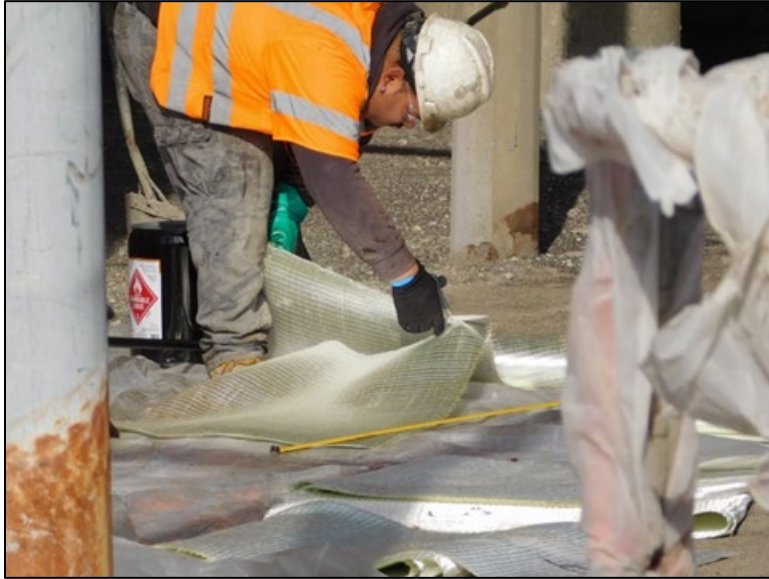
Figure B.186 Cutting the FRP sheets at ground level.

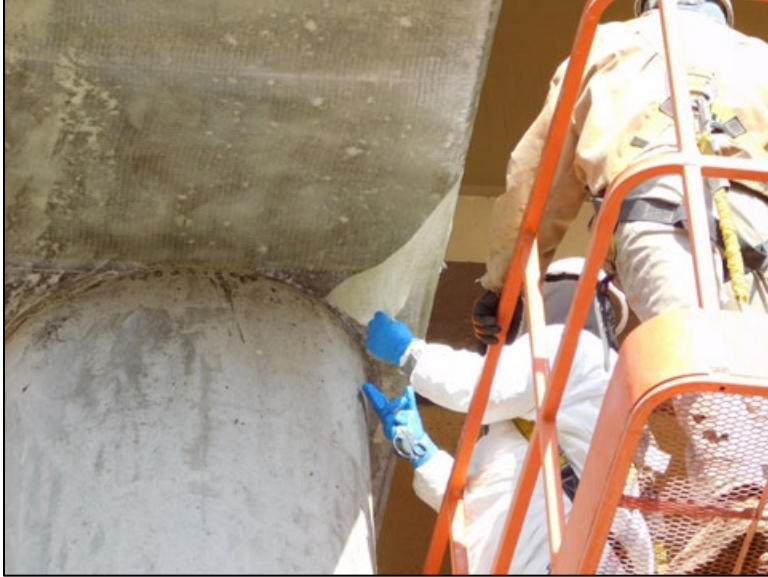
Figure B.190 Detailing of FRP sheets at column to pier cap intersection.
