JOINT TRANSPORTATION RESEARCH PROGRAM

INDIANA DEPARTMENT OF TRANSPORTATION
AND PURDUE UNIVERSITY

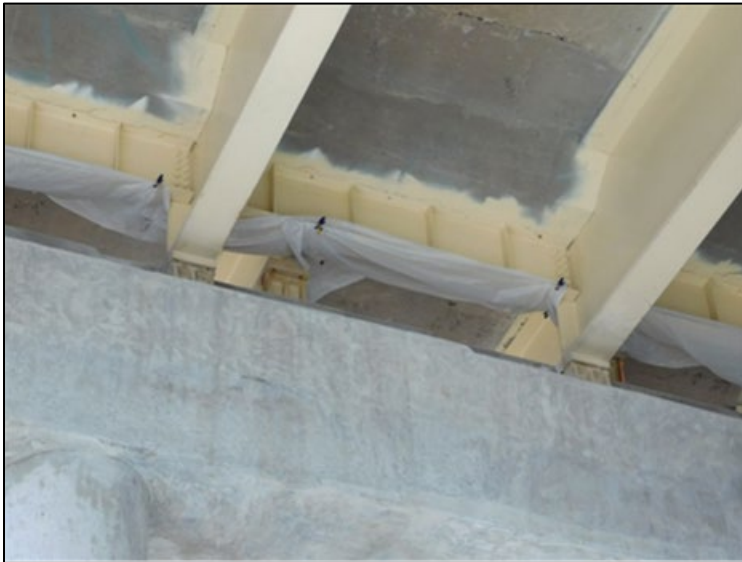
Figure B.191 Sealing of deck joint to prevent leaking onto pier.

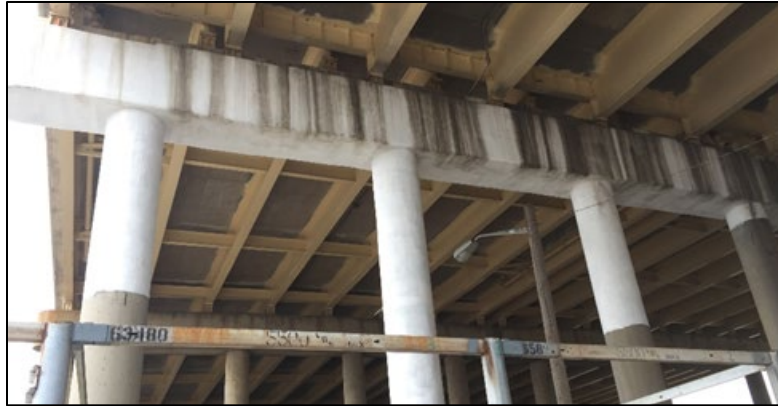
appeared to be in adequate condition. Close inspection for the presence of debonding, delaminations, or voids was not possible. Some of the painted areas of the repaired surface were noticeably chipping, as shown in Figure B.192(b). It was evident that the expansion joint was still leaking on the piers, and the repaired surfaces were significantly stained.

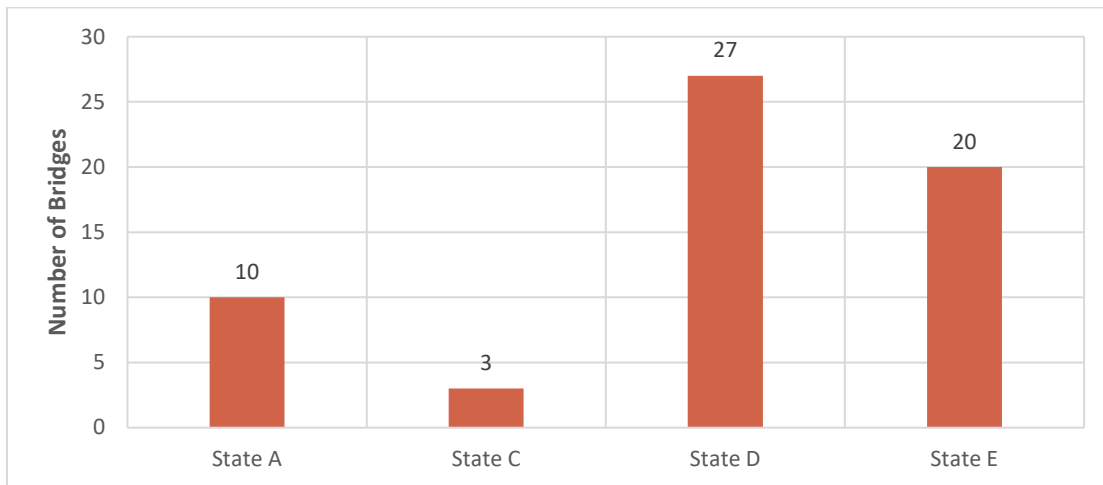
Figure C.1 Bridges to receive FRP systems by state according to survey responses.

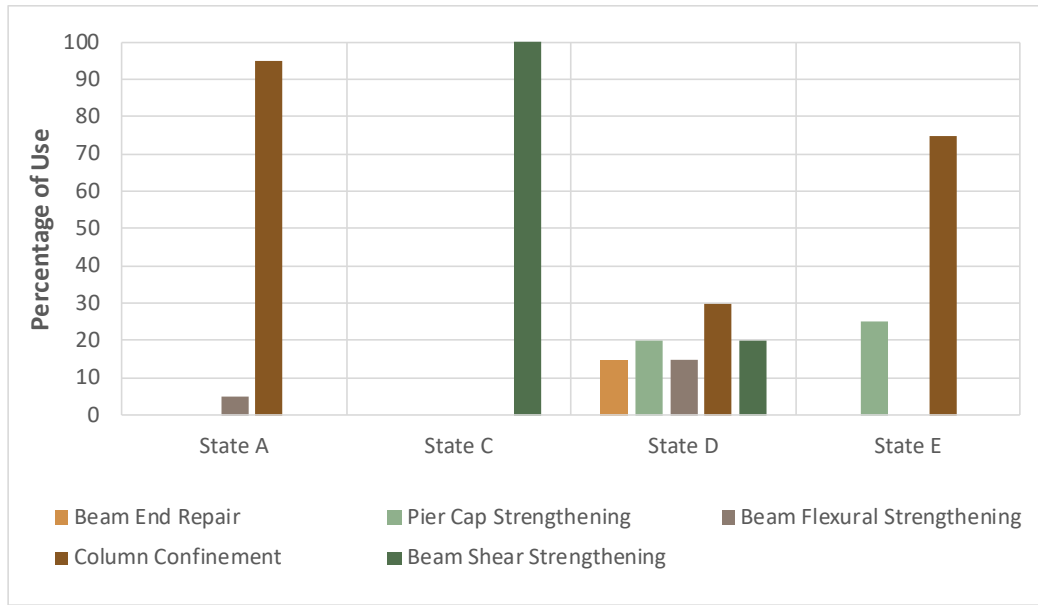
Figure C.2 FRP system types by state according to survey responses.

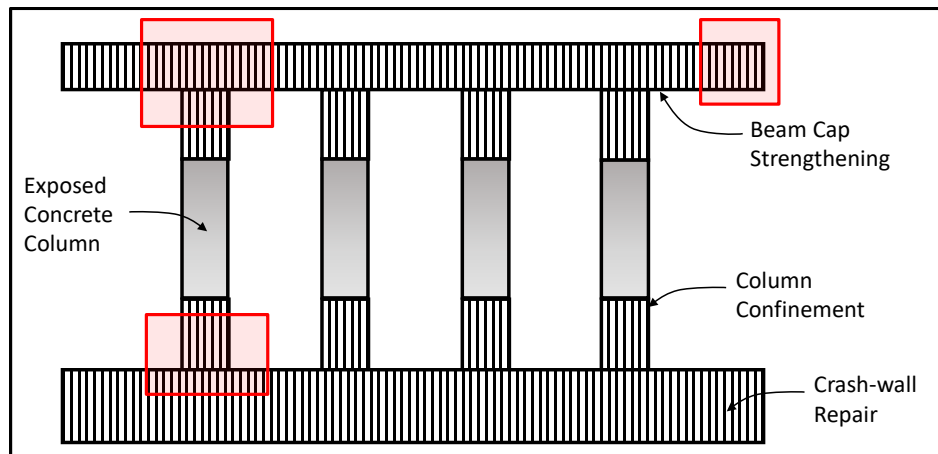
Figure C.3 Bridge element intersection points.

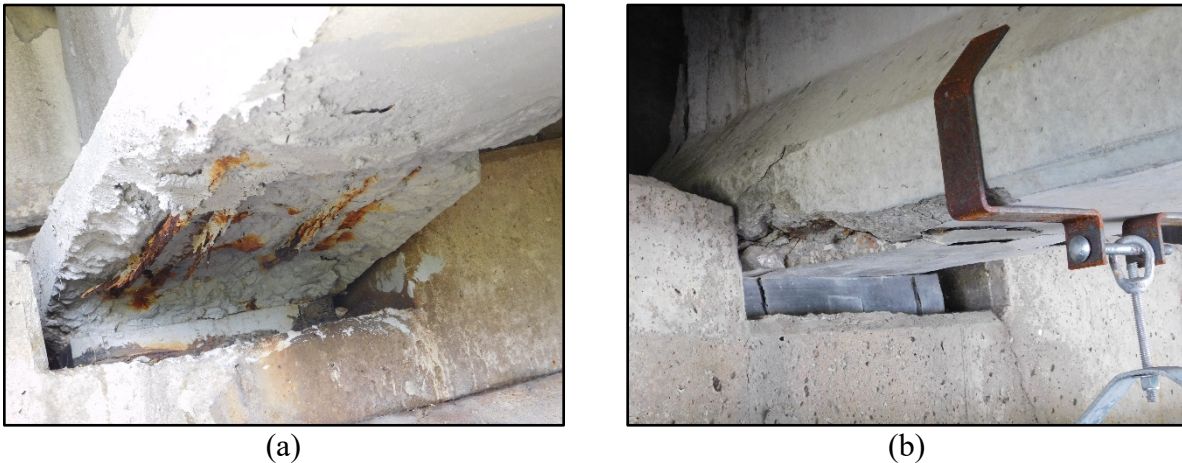
Figure C.4 Beam end region deterioration.

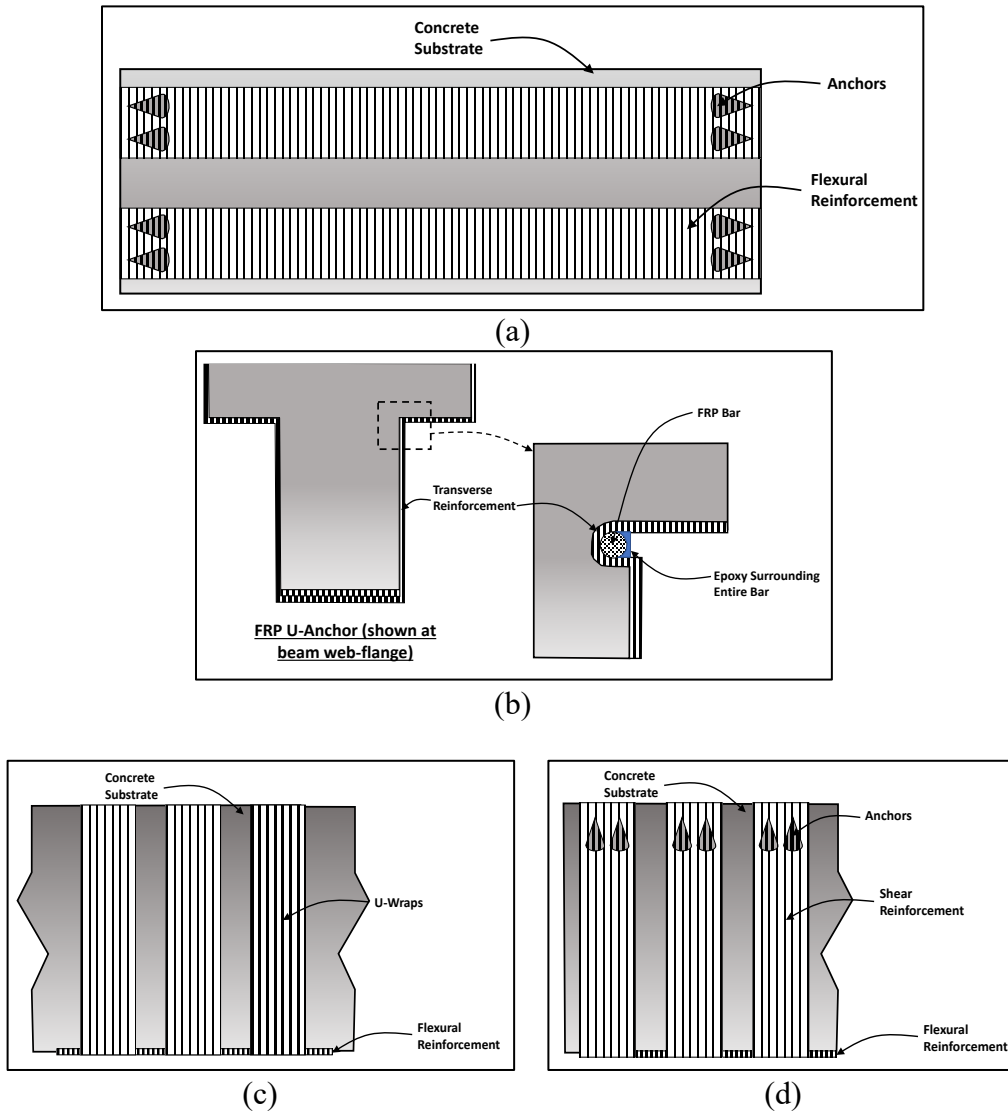
Figure C.5 Common anchorage techniques—(a) FRP spike anchors for flexural reinforcement; (b) FRP U-anchor; and (c) FRP U-wraps for flexural rein.
