RR08-12 July 2008

# Electrochemical Fatigue Sensor Demonstration on the Steel Bridge at the FAST

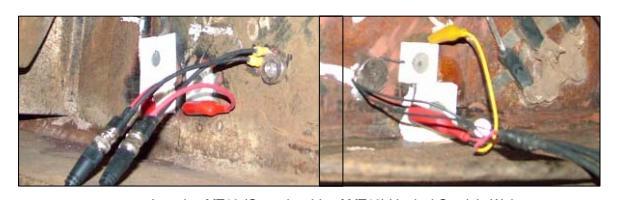
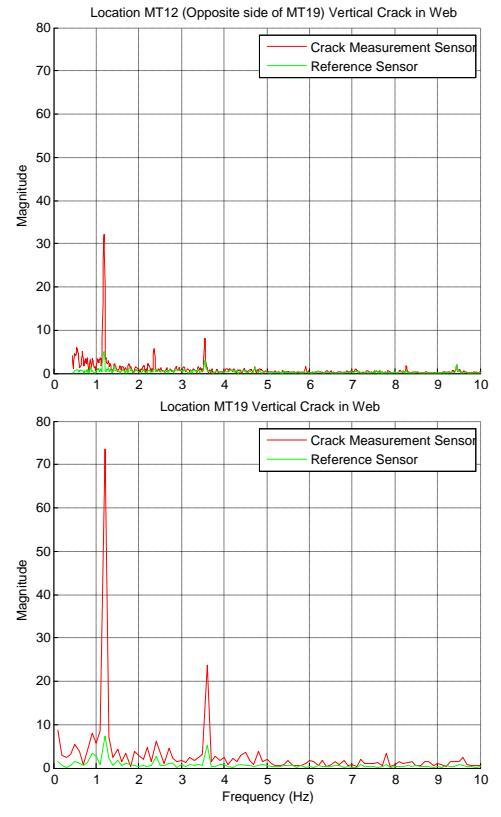
Figure 3. Locations MT 12 (left photo, top graph) and MT 19 (right photo, bottom graph).

The EFS data indicated that five of the 15 bridge locations have cracks that are growing (Table 1). Figure 3 shows the inspection locations for the MT 12 and MT 19 locations on the FAST steel bridge with growing cracks.

Cracks at locations MT 12 and MT 19 are back-toback sides of a through crack growing vertically from the bottom flange of girder 1 in the short span of the steel bridge near the center pier. The EFS data for these two locations indicate that both cracks are growing. One indication of growth is the presence of the higher order harmonics, as Figure 3 shows. The crack at location MT 19 appears to be more active (i.e., the crack at MT 19 is growing faster than the crack at MT 12), as shown by the relative magnitudes of the higher order harmonics.
