### Research Report KTC-20-30/SPR17-551-1F

### **Longer Service Life Bridge Coatings**

September 2020

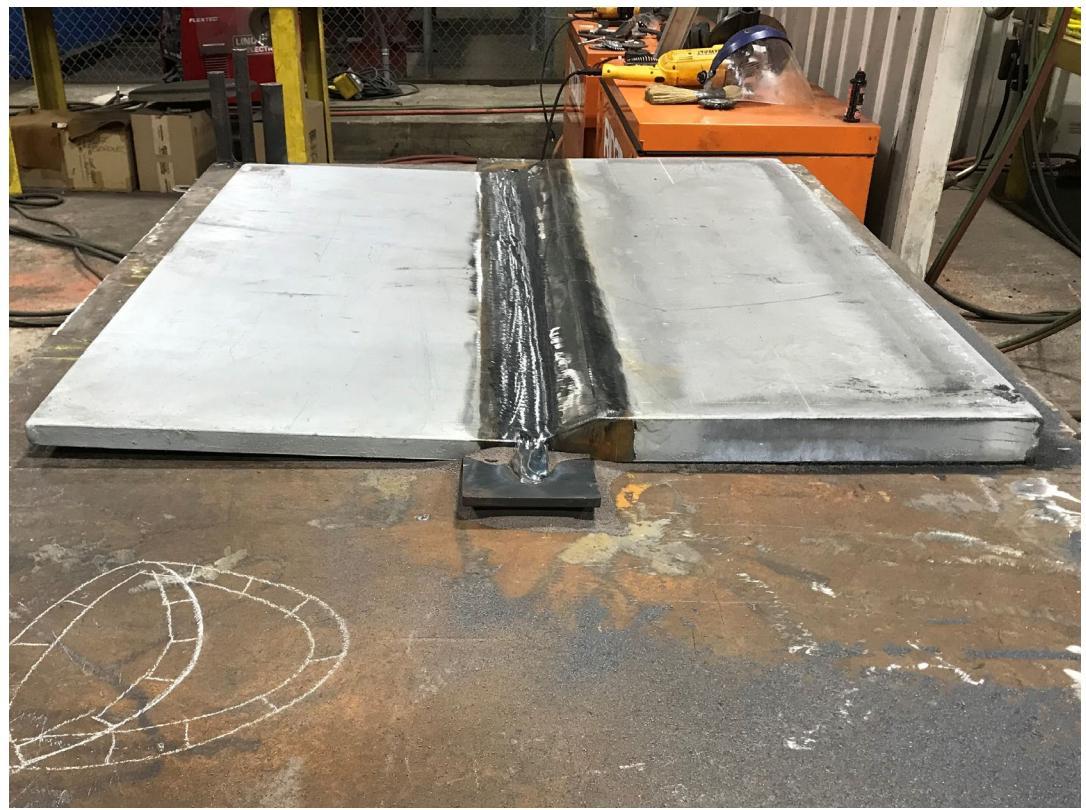
Using a Lincoln Electric IdealArc<sup>®</sup> TM-500 AC arc welder adjusted to approximately 200 amps, the plates were tack welded. After the tack welds were complete, sub-arc welding was performed using a Lincoln Electric Flextec<sup>®</sup> 650X welder and 74 HT Flex Feed<sup>™</sup> coupled with a Bug-O transport system (Figure 7). Filling the v-notch required seven passes. Slight distortion was noted after welding (Figure 8).

Figure 8 Distortion From Welding Process

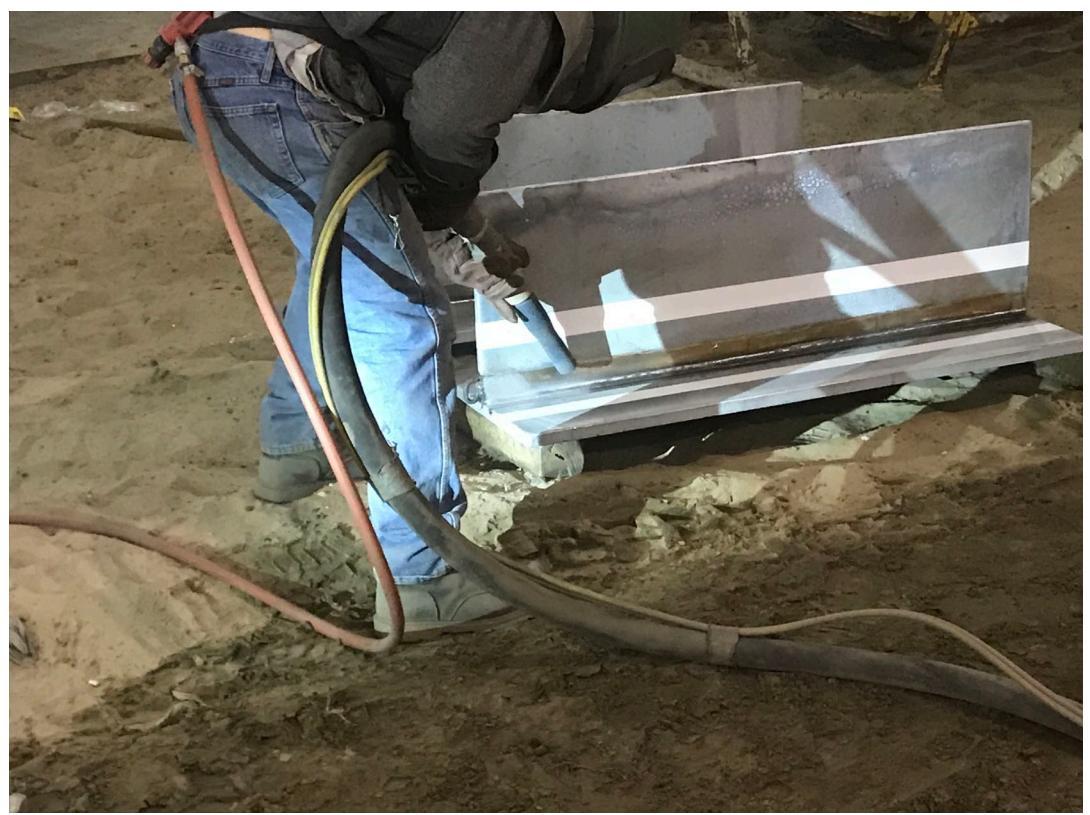
The blaster stated that he could control the blast so that no masking tape was necessary when feathering the edges of the HDG (Figure 15). Initially coarse coal slag was used for blasting, creating an anchor profile between 4.5 to 5.0 mils. ISC, Inc. personnel recommended using a higher profile for surfaces being metallized. The blast media was changed to #16 Aluminum Oxide which achieved a profile between 5.0 to 6.0 mils. ISC personnel stated a profile of 6.0 to 7.0 was typical when using aluminum oxide. Coal slag was used on the bevel side of the butt-welded plate and both sides of one of the T beams. The flat side of the butt-welded plate and the other T beam were blasted with the aluminum oxide. Air pressure was set at 120 psi and the blast nozzle was a #8 (1/2") for both types of media.

Figure 15 Abrasive Blasting Fillet Welds

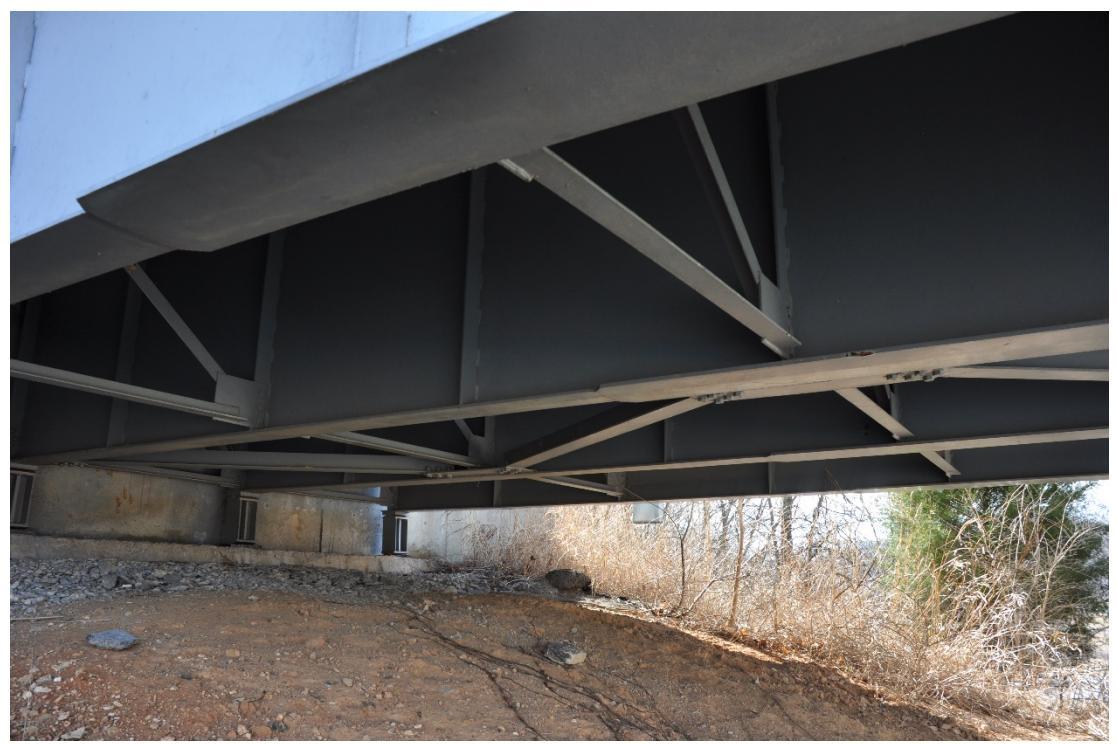
KY 98 over Barren River Bridge (Project CID 182951) in Allen County is a steel girder bridge with 4-Beams (5'6" x 14") that was overcoated in 1996. Our initial inspection in January 2018 identified the current paint system on the bridge as lead alkyd primer overcoated with a two-coat urethane system. The beams had very little corrosion (Figure 21) except in areas with excess bird droppings on the outer flanges.

Figure 21 Example of the Initial condition of 002 0098 B00025N

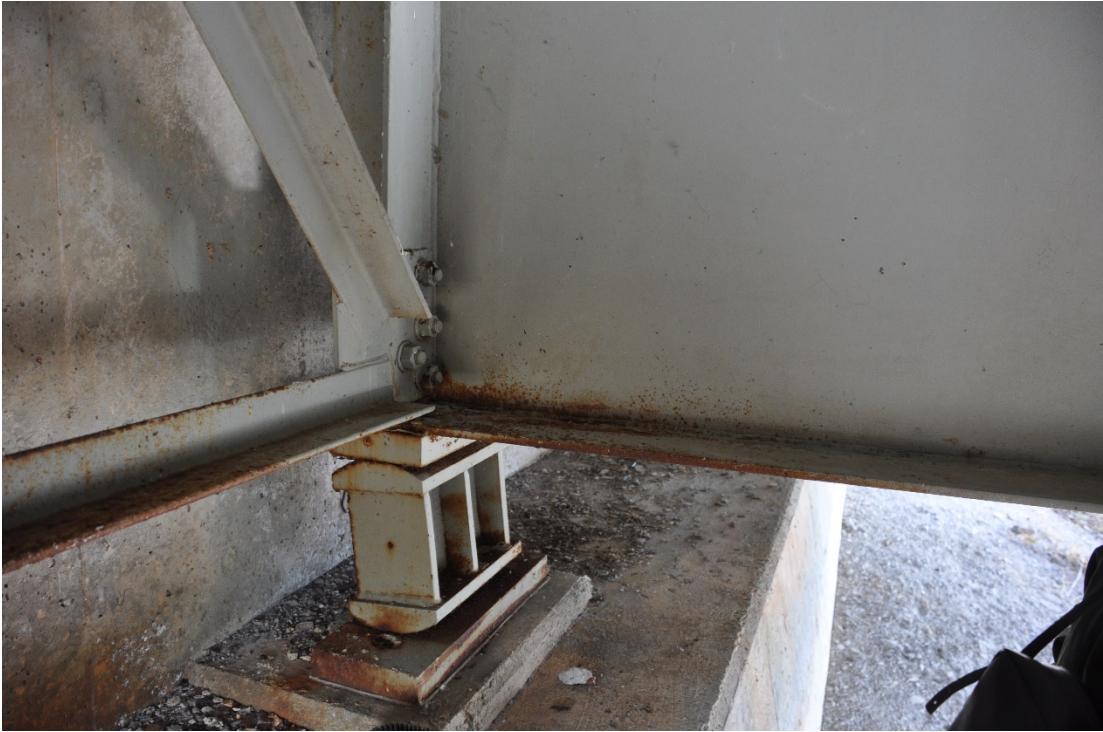
KY1855 over Walnut Creek (Project CID 182951) in Allen County is a steel-girder bridge with 4 beams (5' x 14"); it was last painted in 1986. Our January 2018 inspection identified its current paint systems as zinc primer with vinyl topcoat. The bridge steel was in good condition with some corrosion on the north end abutment (Figure 22) and very light rust in a few spots across the entire bridge. The bridge had expansion joints at 40-ft intervals and at 100 ft from each end. The joints had been patched at the deck and sealed at rail walls with bituminous material. Bresle Testing was performed on both bridges in accordance with SSPC Technology Guide 15 (*Field Methods for Extraction and Analysis of Soluble Salts on Steel and Other Nonporous Substrates*) Paragraph 4.2.2, "Adhesively Bonded Latex Patch or Cell/Probe Type Conductivity Meter Technique" (Figure 23). Conductivity measures were taken using a Horiba Model B-173 conductivity meter. Deionized water was used as extraction liquid with a conductivity measurement of 0 µS/cm.

Figure 22 Example of the Initial Condition of 002 1855 B00034N
