MASH 2016 Evaluation of a Non-Proprietary Type III Barricade

**Final Report – Revision-1
September 2018**

Sponsored by
Smart Work Zone Deployment Initiative
(TPF-5(295))
Federal Highway Administration
(InTrans Project 18-535)

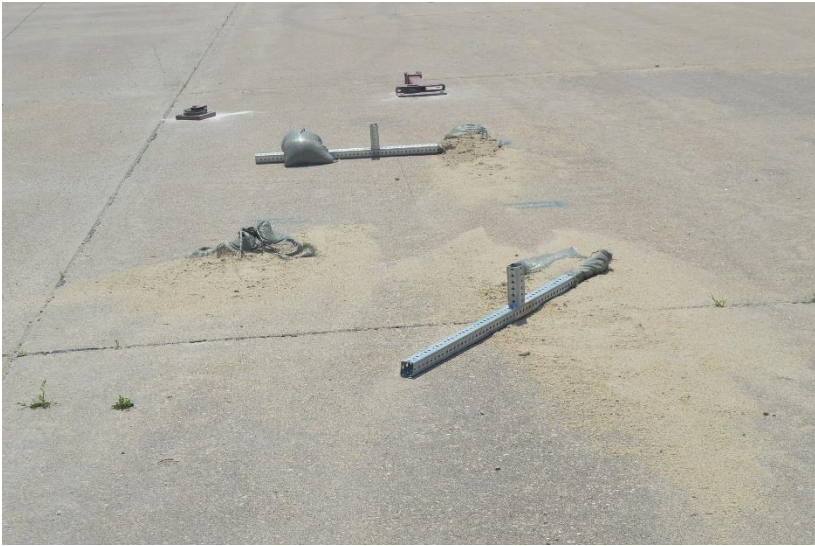
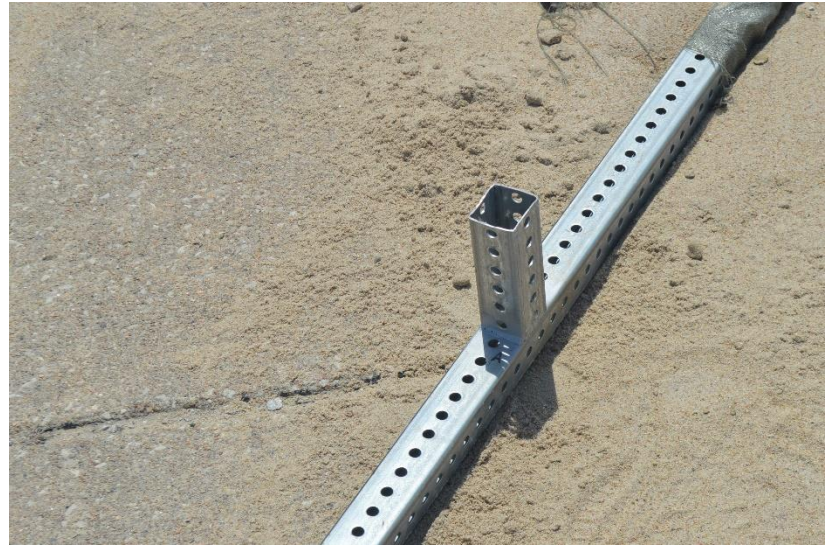
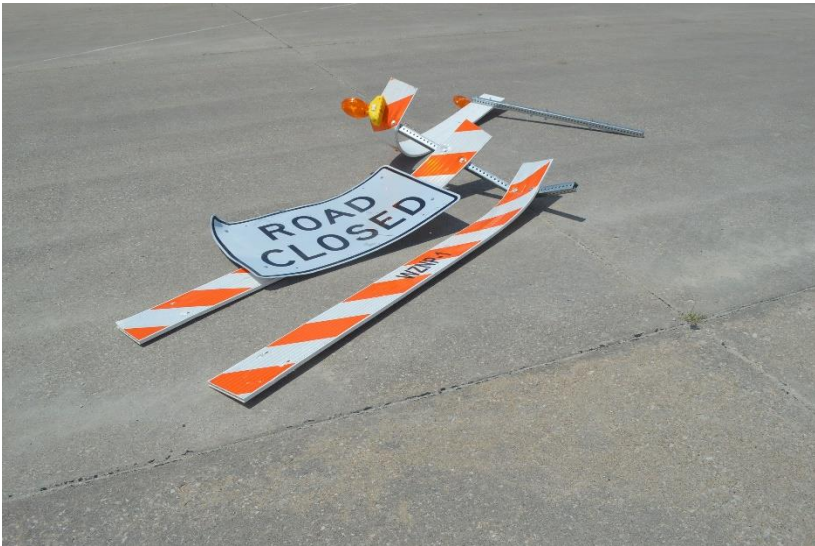
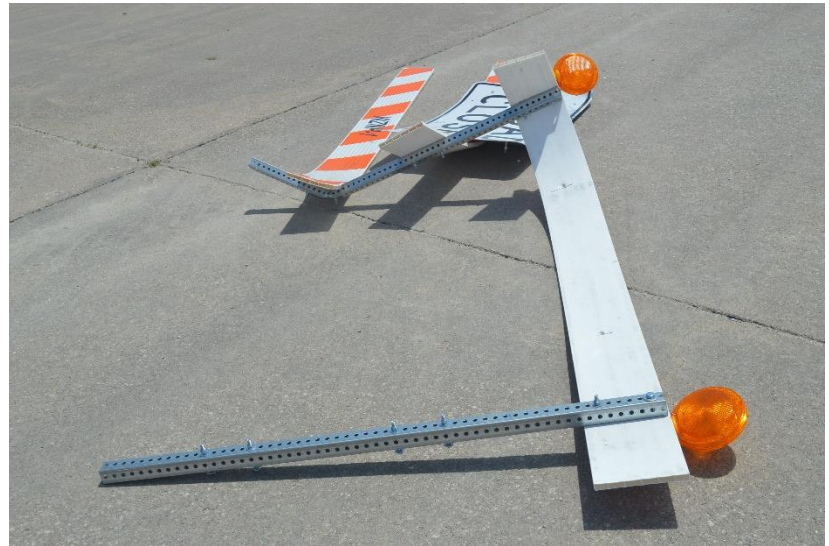
Figure 63. System Damage –Test No. WZNP-1, System A

Damage to the barricades was moderate, as shown in Figures 63 and 64. System damage consisted of bends and buckles in the uprights and panels, tears in the weighed sandbags, and bolt pullouts.

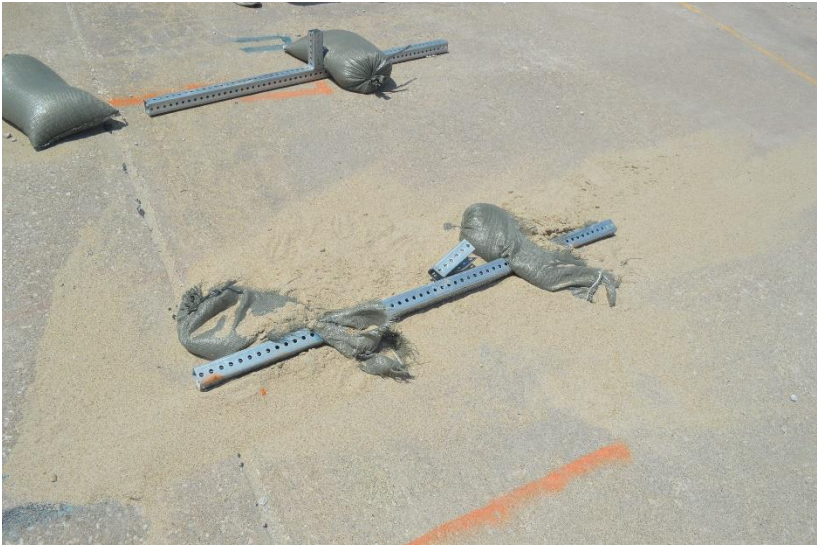
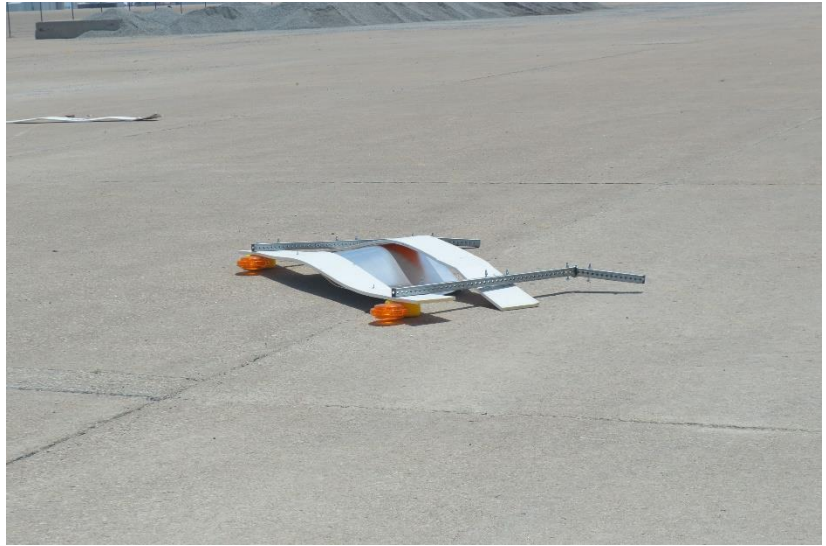
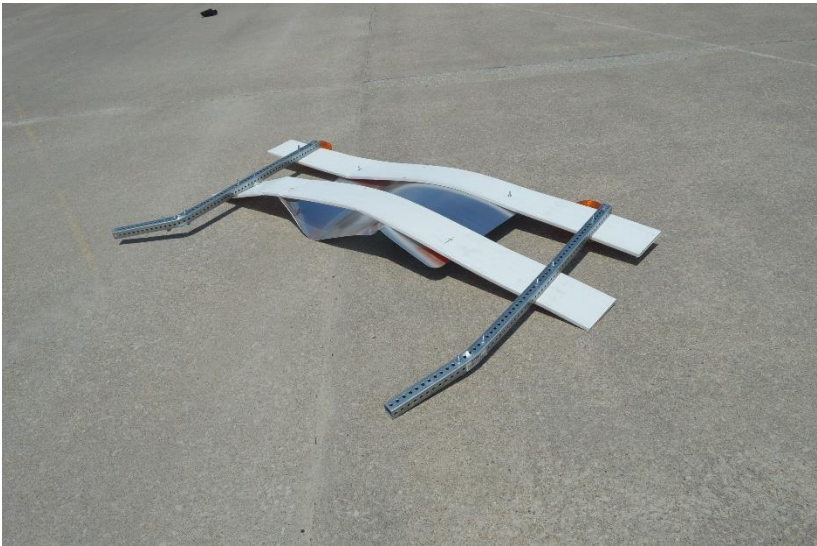
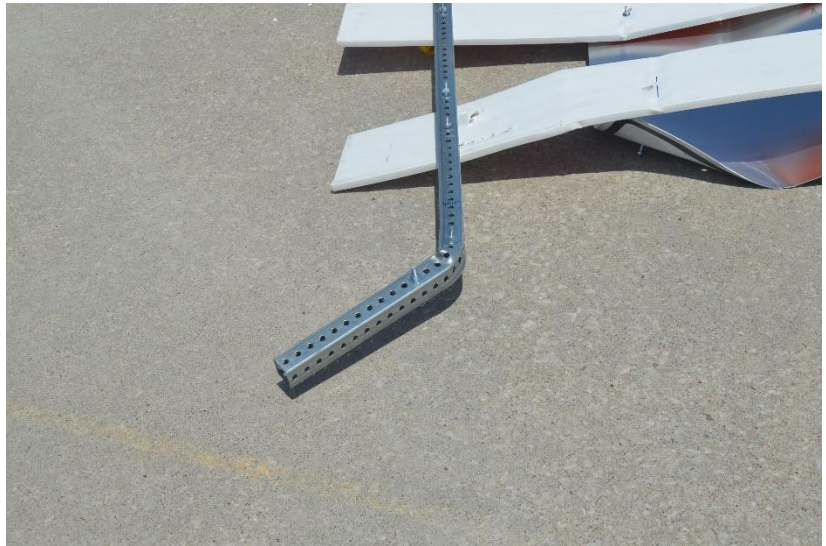
Figure 64. System Damage –Test No. WZNP-1, System B

System B also detached from both legs upon impact. The front side of the right upright buckled 16 in. (406 mm) from the bottom, where impact occurred. The vertical stub of the right leg had the front weld fractured, was bent downstream, and was fractured along the right-downstream corner along the length of the stub. The top barricade panel was bent 90 degrees about 11 in. (279 mm) from the right edge. Every bolt on the aluminum sign panel, except the bolt in the lower-left corner, was pulled out from the barricade panels and remained attached to the sign. The two sand bags on the right side were torn open.

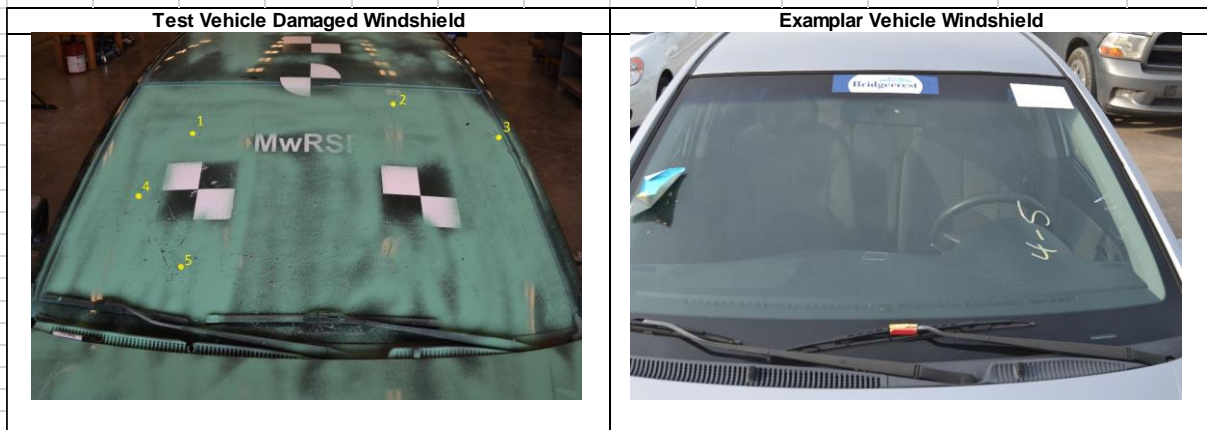
Figure C-10. Windshield Damage, Test No. WZNP-1

0.140	Vehicle's windshield cracked.
0.154	System A became airborne.
1.150	System A contacted ground.
