FINAL REPORT Catch Basin Inserts for Ohio Roadways

SEPTEMBER 2018

Ohio Department of Transportation Office of Statewide Planning and Research

www.greshamsmith.com GS&P Project No. 42299.00 ODOT PID 103684 State Job No. 135444 This Page Intentionally Left Blank.

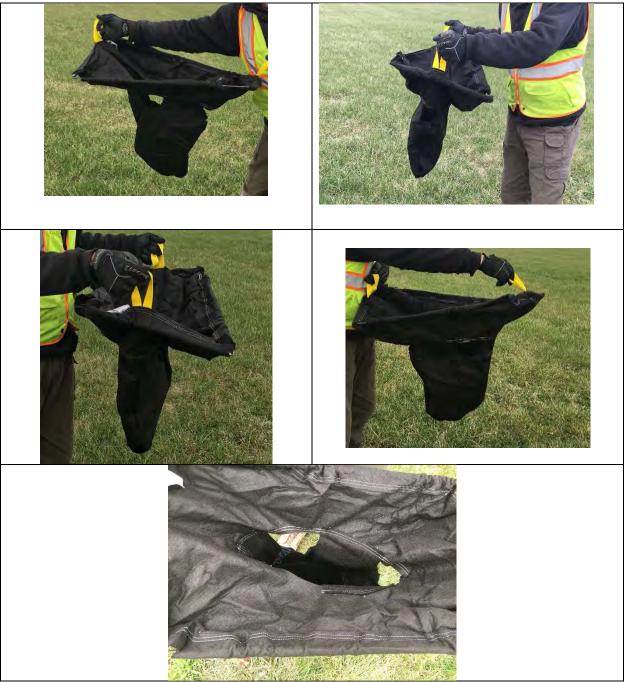
Maintena	nce Form		Weather Information
Date of Maintenance	8/23/17	Location ⊠ Site 1 □ Si	te 2	Weather at time of this inspection? □ Clear □ Rain □ Sleet □ Snowing
		101		□ Other:Sunny during maintenance
Inspector Name(s)	Kathryn Gruv	/er		Temperature:
CBI Name an		Time		Number of personnel
Vendor	Start	End		
Storm Sentinel	10:09	10:13	2	
Observations			Photos	
Describe conte basin insert: No standing wa	ter.			
Describe condi The block is wo impact flow

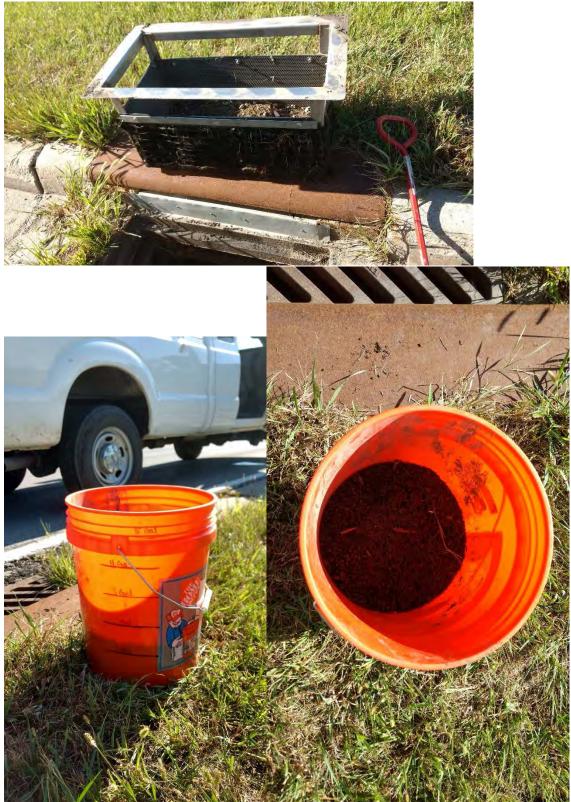
Maintenance Form		Form	Weather Information				
Date of Maintena nce	10/19 /17	$\begin{array}{c} \textbf{Location} \\ \boxtimes \text{ Site 1} \\ \square \\ \text{Site 2} \end{array}$	Weather at time of this inspection? □ Clear □ Rain □ Sleet □ Snowing □ Other:Summer during maintenance				
nee		104	□ Other:Sunny during maintenance Temperature:				
Inspector Name(s)	Kathry	n Gruver and A	riel Croasman				
CBI	1	Time	Number of personnel				
Name and Vendor	Start	End					
Drain Pac	10:47	10:54	2 – maintenance time was measured only at the garage. It does not include time to remove unit and travel to maintenance area				
Observat	ions		Photos				
of catch h No standir Debris is r mesh and debris car shop vac	basin insert: ng water. trapped betw outer fabric 't be remov	veen the wire bag, the ed with the					
Debris is mesh and	condition o trapped betw outer fabric 't be remov	veen the wire bag, the

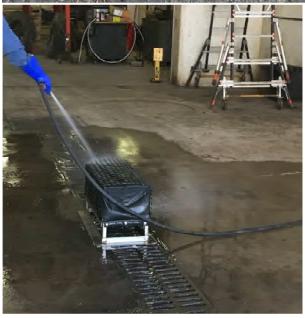
Remo	oval for	m	Weather Information
Date of Removal	3/9/18	Locat	ion e 1 □ Site 2	Weather at time of this inspection? ⊠ Clear □ Rain □ Sleet □ Snowing
Removar		104		\Box Other:
				Temperature:
Inspector Name(s)	Kathryn Gr	uver and	l Ariel Croasman	
CBI Name and	Removal	Time		
Vendor	Start	End		Number of personnel
DrainPac	8:54	8:59	2	
Observations Describe conter			Photos	
Describe conter	nts and condi	tion	A little less than one gallo	an of debris removed
of catch basin	its and condi	tion		d detached from the basket. The fabric mesh was loose
Special Equipm No special equip

Reason for removal End of study

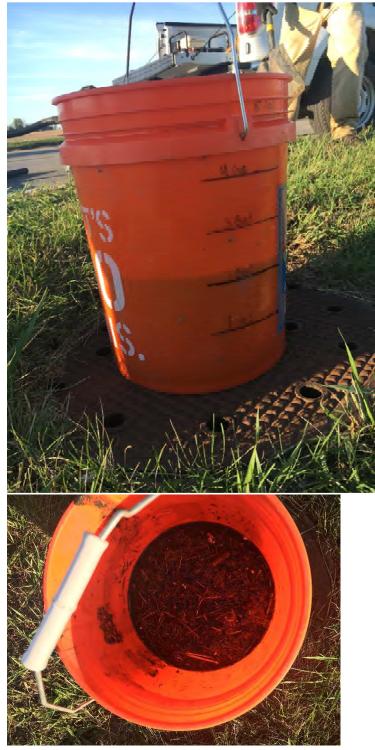
R	emoval for	m	Weather Information
Date of	12/14/17	Location		Weather at time of this inspection?
Removal		\boxtimes Site 1	\Box Site 2	\boxtimes Clear \square Rain \square Sleet \square Snowing
		113		□ Other:
T (K d C	1.4	:10	Temperature: 15
Inspector Name(s)	Kathryn G	ruver and A	riel Croasman	
			1	
CBI Name a		val Time	-	
Vendor	Start	End	2	Number of personnel
Triton	9:05	9:53	2	
Observation			Photos	
Describe com insert Very little de Standing wat	bris in CBI,	ch basin		
Describe com of catch basi Snow, grit an Special Equi	n d water.

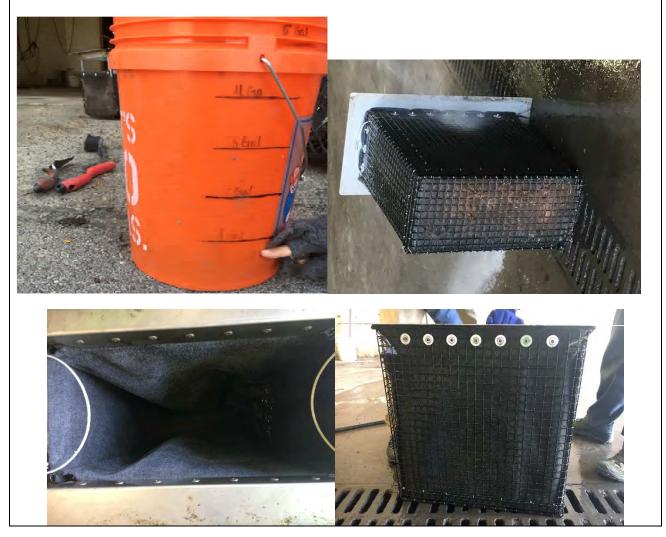
Re	emoval for	m	Weather Information
Date of	12/	/14/17	Location		Weather at time of this inspection?
Removal			Site 1	\Box Site 2	\boxtimes Clear \square Rain \square Sleet \square Snowing
			114		□ Other:
					Temperature: 15
Inspector	Ka	athryn Gr	uver and A	riel Croasman	
Name(s)					
CBI Name a	and		val Time		
Vendor		Start	End		Number of personnel
Absorb-it		8:59	9:03	2	
Observation	15	L	L	Photos	
Describe con	ntent	ts of catc	h basin	All Server	
insert				18 - 1- 18 VS	The second second second second
Very little de	ebris	in CBI			
Snow, grit ar	nd w	ater			
Show, gin ai	iu we				and the second sec
					A CARGONICIONAL DE LA CARGONIA
				a second	A REAL PROPERTY AND A REAL
					and the second sec
				A Providence of	
					States All States and All
Describe con	ntent	ts and co	ndition	The second se	
of catch bas					
				a specific	and the second se
Grit and deb	ris in	catch ba	sin.		
				2	
				the second

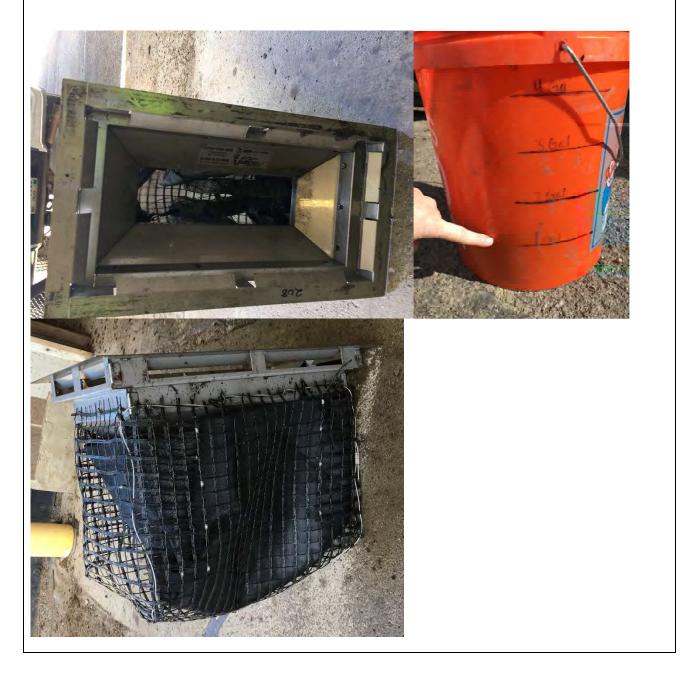
Date of Removal 3/9/18 Location □ Site 1 ⊠ Site 2 208 Weather at time of this inspection? ⊠ Clear Rain Sleet Snowing Inspector Name(s) Kathryn Gruver and Ariel Croasman Other: Temperature: Temperature: Temperature: Inspector Name(s) Kathryn Gruver and Ariel Croasman Number of personnel Flow Gard 9:36 9:48 2 Observations Photos Describe contents of catch basin insert Photos I gallon of debris removed. Standing water during last inspection Flow Flow Flow	ing
Inspector Kathryn Gruver and Ariel Croasman Name(s) Kathryn Gruver and Ariel Croasman CBI Name and Removal Time Vendor Start Start End Plus 9:36 9:36 9:48 2 Photos Observations Photos Describe contents of catch basin insert 1 gallon of debris removed. Standing water during last	ing
Inspector Name(s)Kathryn Gruver and Ariel CroasmanCBI Name and VendorRemoval Time EndNumber of personnelFlowGard Plus9:369:482ObservationsPhotosDescribe contents of catch basin insertPhotosI gallon of debris removed. Standing water during lastPhotos

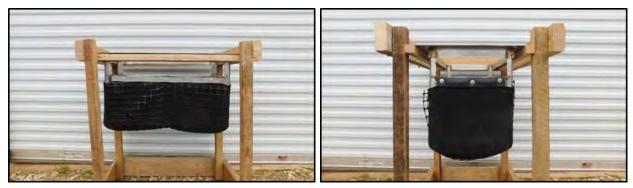
(a) front view (b) side view Figure C-24: Damage to DrainPac[™] after eight longevity tests.
