CRASH TESTING AND EVALUATION OF THE NETC 2-BAR CURB-MOUNTED BRIDGE RAIL

King K. Mak and Wanda L. Menges

February 1998

VOLUME IX: APPENDIX H -CRASH TESTING AND EVALUATION OF THE **NETC PL-2 BRIDGE RAIL DESIGN**

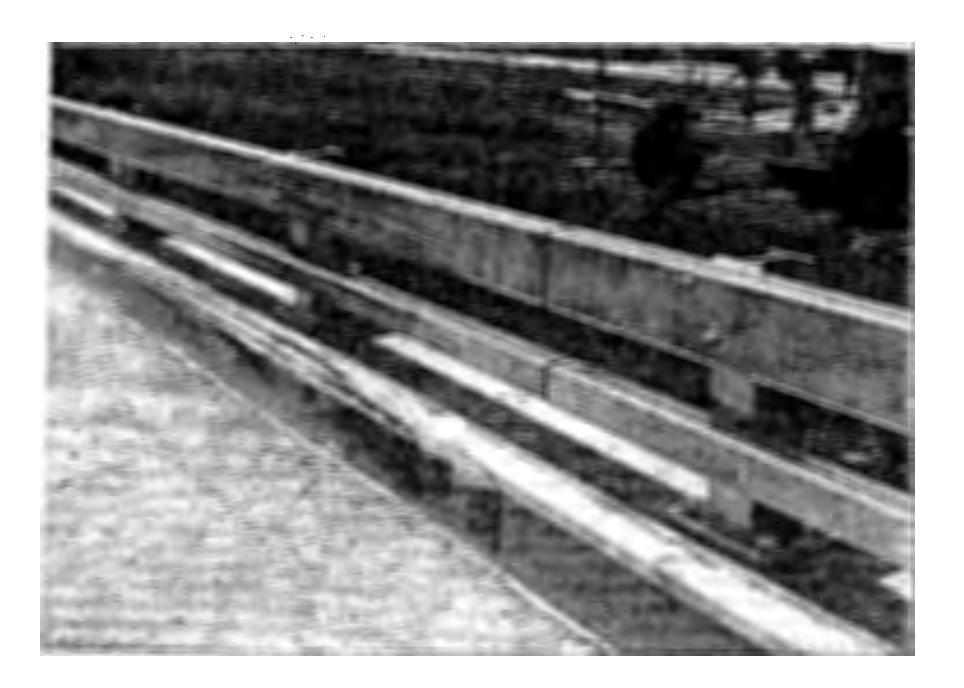
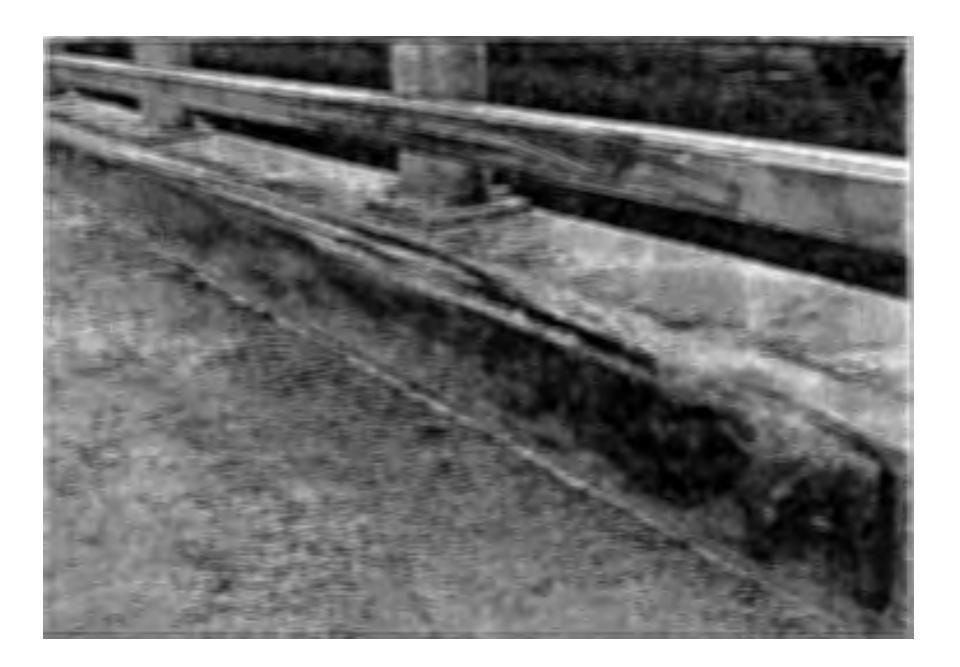
Figure 10. NETC bridge rail after test 471470-18.

As can be seen in figure 10, the bridge railing received minimal damage. The bridge railing and curb received only minor cosmetic damage. The vehicle was in contact with the

bridge railing for a total length of 4.0 m (13.2 ft). Shown in figure 11 are photographs of the post-test vehicle trajectory.

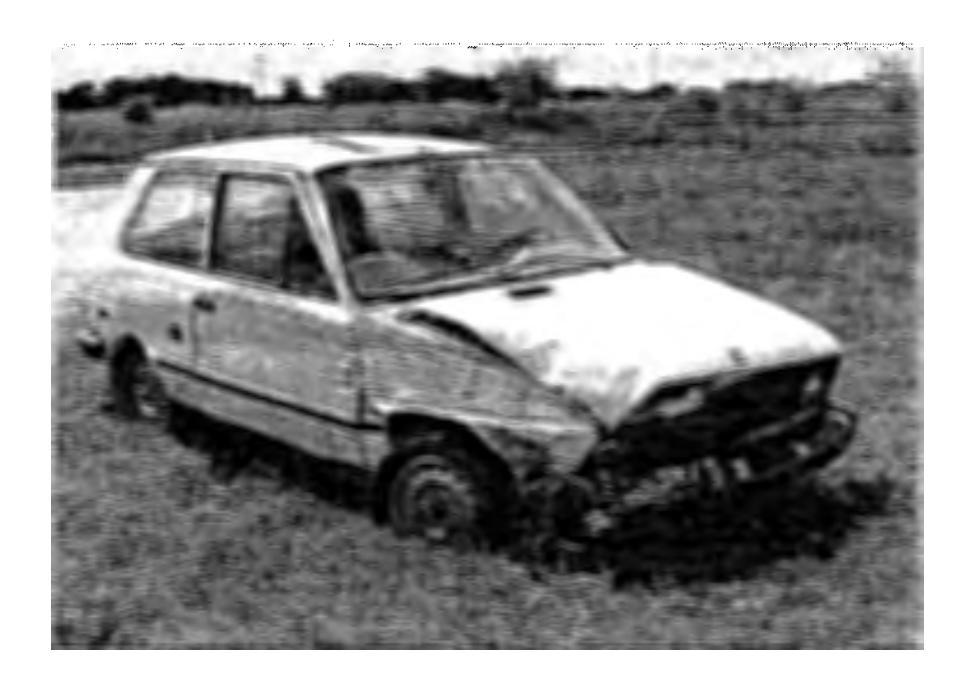
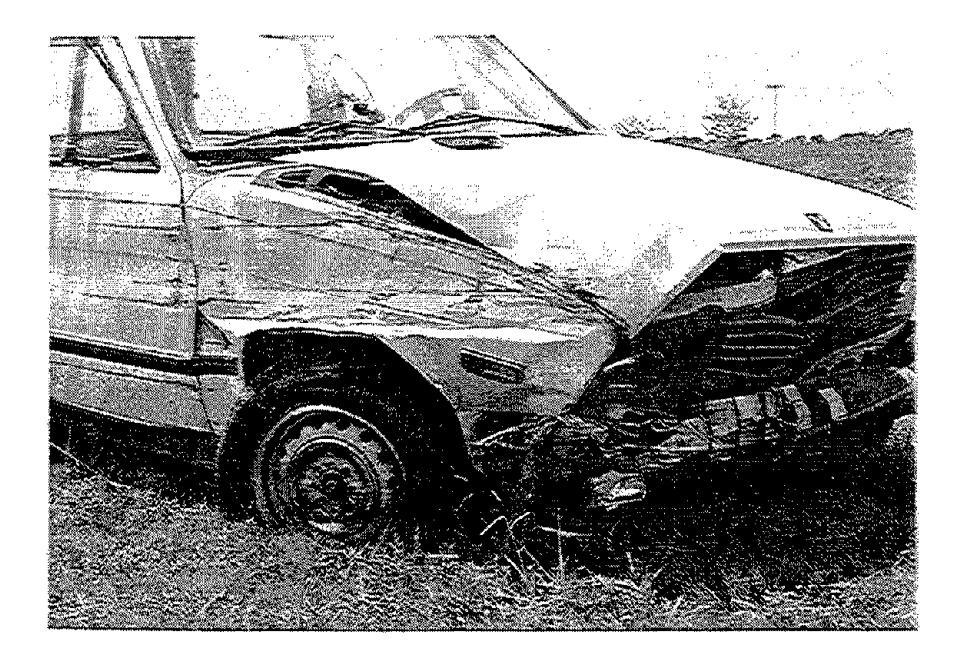
Figure 12. Vehicle after test 471470-18.

The vehicle sustained damage to the right side as shown in figure 12. Maximum crush at the right front corner at bumper height was 124 mm (4.9 in) and there was 20 mm (0.8 in) of crush at the right A-pillar. The wheelbase on the right side was shortened by 108 mm (4.3 in). The right front strut and sway bar were damaged. Also, damage was done to the front bumper, hood, grill, right front fender, right front rim, right door, right rear quarter panel, and right rear rim.

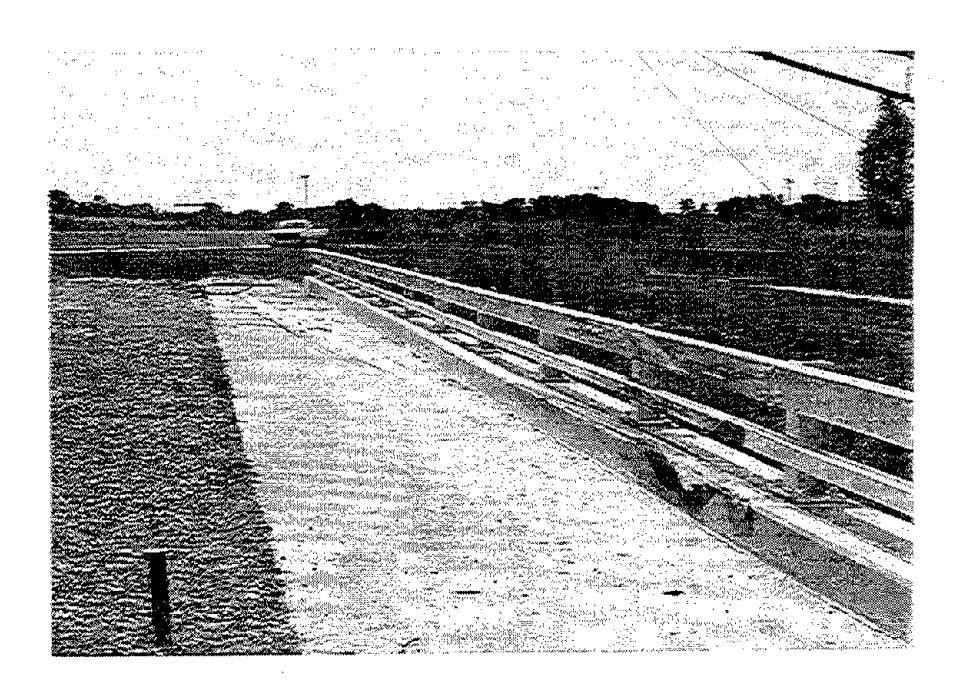
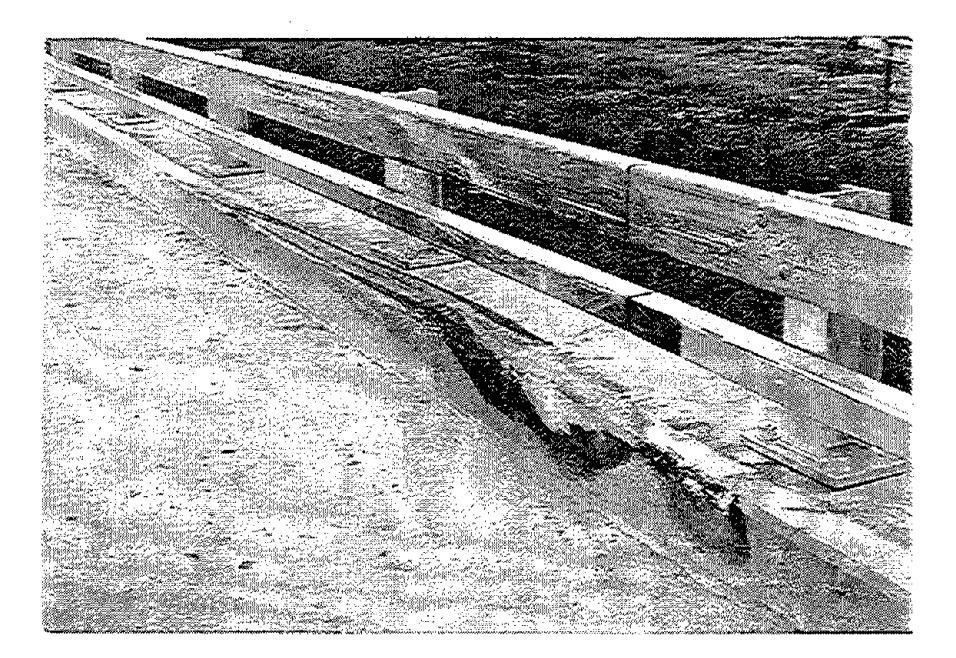
Figure 23. NETC bridge rail installation after test 471470-19.

As can be seen in figure 23, the bridge railing received only cosmetic damage. However, the curb section and bridge deck sustained structural damage at the two posts immediately upstream and downstream of the point of impact (posts 3 and 4). It appears from the damage patterns that the curb section and bridge deck failed under the combination of bending and shear forces (principally shear), as evidenced by the 45-degree cracks starting at the anchor bolts. This suggested that there might not be sufficient concrete cover and steel reinforcement around the anchorage bolts to resist the forces acting on the post and anchorage assembly during impact. Photographs showing the shear cracks are shown in figures 24 and 25. The vehicle was in contact with the bridge railing for a total length of 6.1 m (19.9 ft).

As discussed previously, the curb section and bridge deck sustained structural damage at the two posts immediately upstream and downstream of the point of impact in the pickup truck redirection test (test no. 471470-19). This resulted in some revisions to the design details for the bridge deck, curb section, and the steel reinforcement. The revisions included: increasing the thickness of the bridge deck; widening the width of the curb and deck to increase the cover on the anchor bolts; additional stirrups and distribution bar at the post anchors; and increasing the thickness of the spacer plate and the length of the anchor bolts. The redesigned bridge deck and curb section was constructed and evaluated in this crash test.

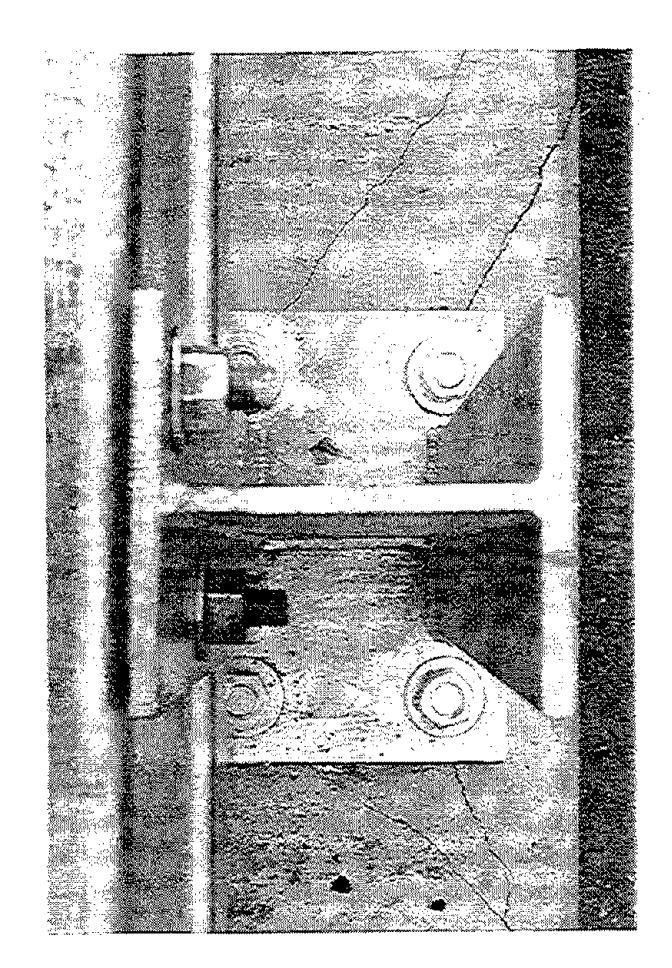
Figure 24. Cracks at post 4, test 471470-19.

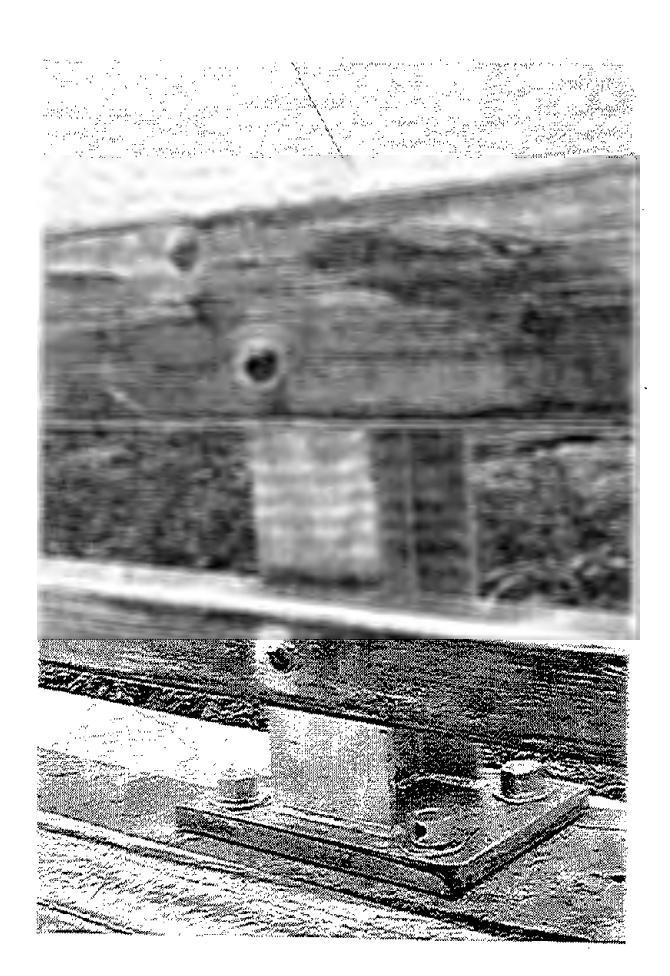
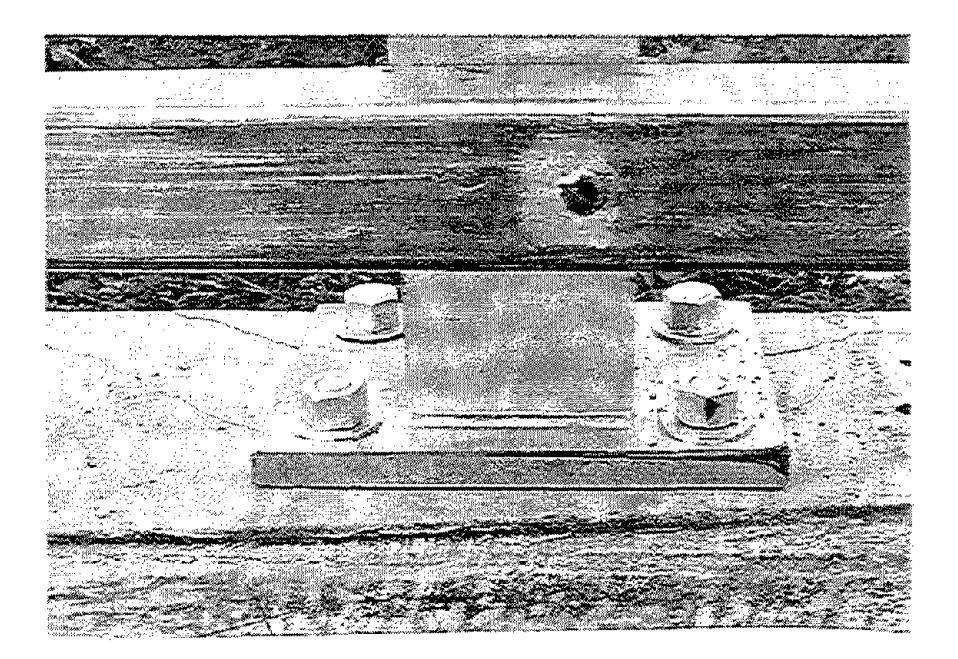
Figure 25. Damage to bridge rail at post 4, test 471470-19.

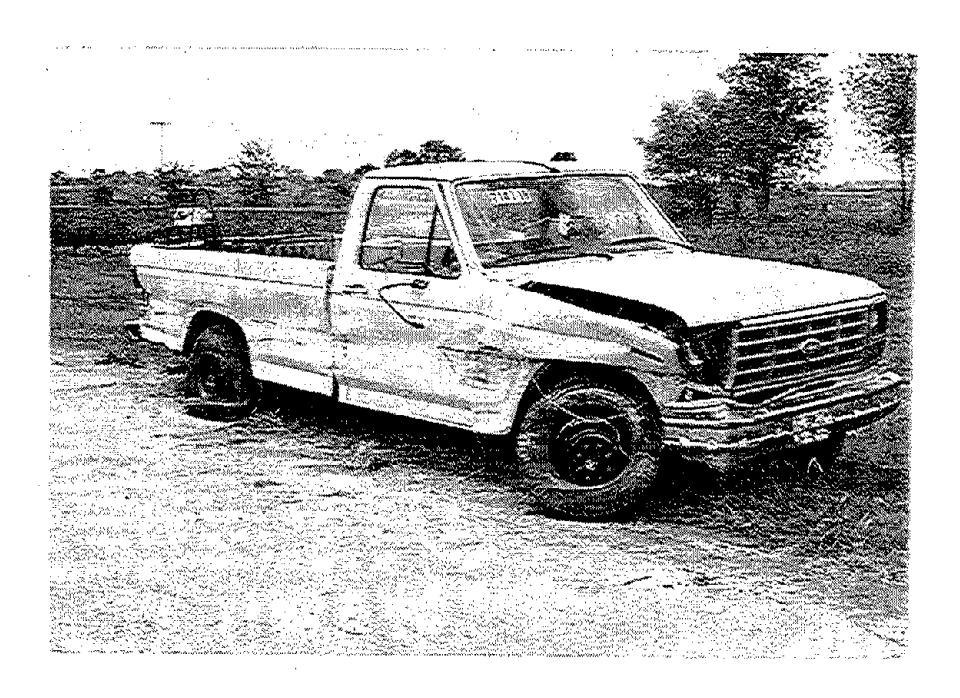
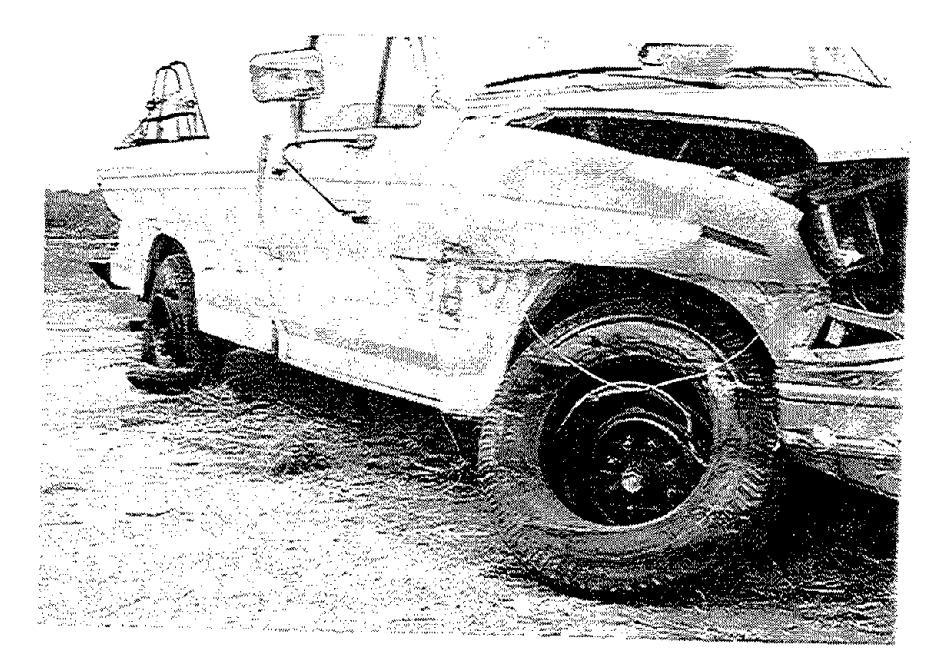
Figure 26. Vehicle after test for test 471470-19.

The vehicle sustained damage to the right side, as shown in figure 26. Maximum crush at the right front corner at bumper height was 254 mm (10.0 in) and there was 25 mm (1.0 in) of crush at the right A-pillar. The wheelbase on the right side was shortened by 32 mm (1.75 in). The tie rod and right radius arm were damaged. Also, damage was done to the front bumper, hood, grill, right front fender, right front rim, right door, right rear bumper, and right rear tire and rim.

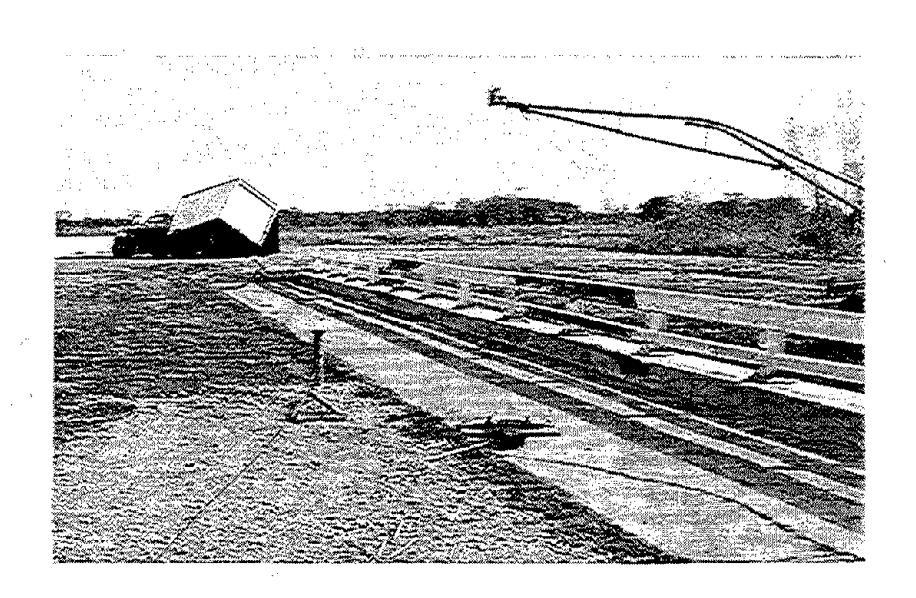
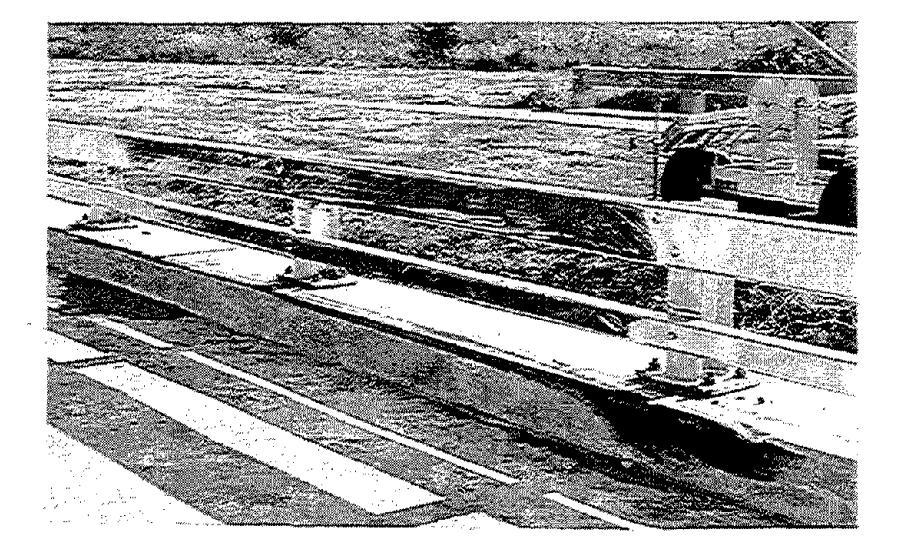
Figure 37. NETC bridge railing after test 471470-29.

As seen in figures 37 through 39, the bridge rail and deck test installation received moderate damage. There were tire marks and gouges on the face of the rail and curb. The length of contact with the curb was 5.5 m (18.0 ft), and length of the initial contact with the rail element was 4.3 m (14.0 ft). The box of the truck was in contact with the upper part of the rail from post 8 to the end of the test installation with tire marks on the face of the rail between posts 8 and 10. The bolts on the lower rail at posts 3, 4, and 5 were sheared off.

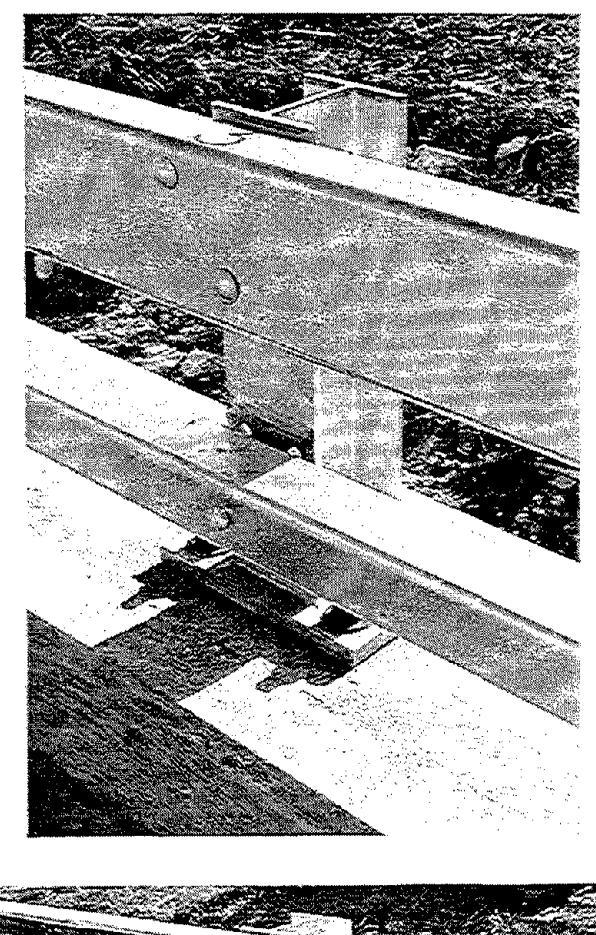
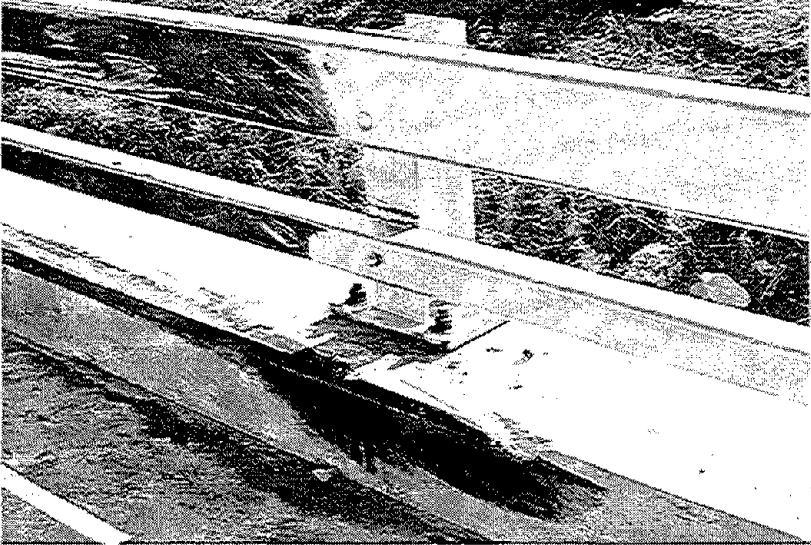
Figure 38. Damage at posts 3 and 4 after test 471470-29.

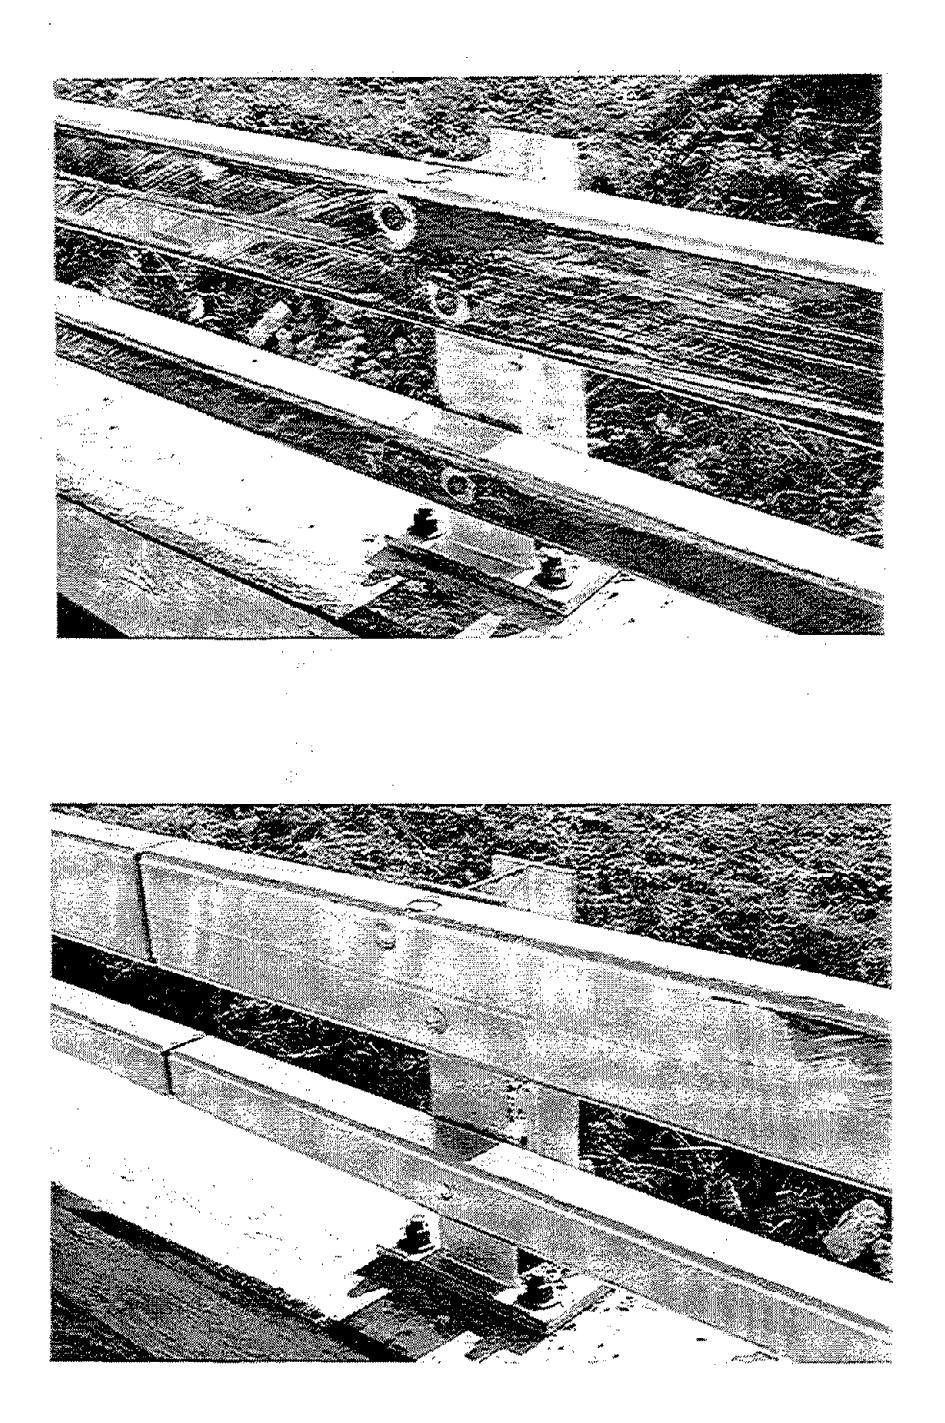
Figure 39. Damage at posts 5 and 6 after test 471470-29.

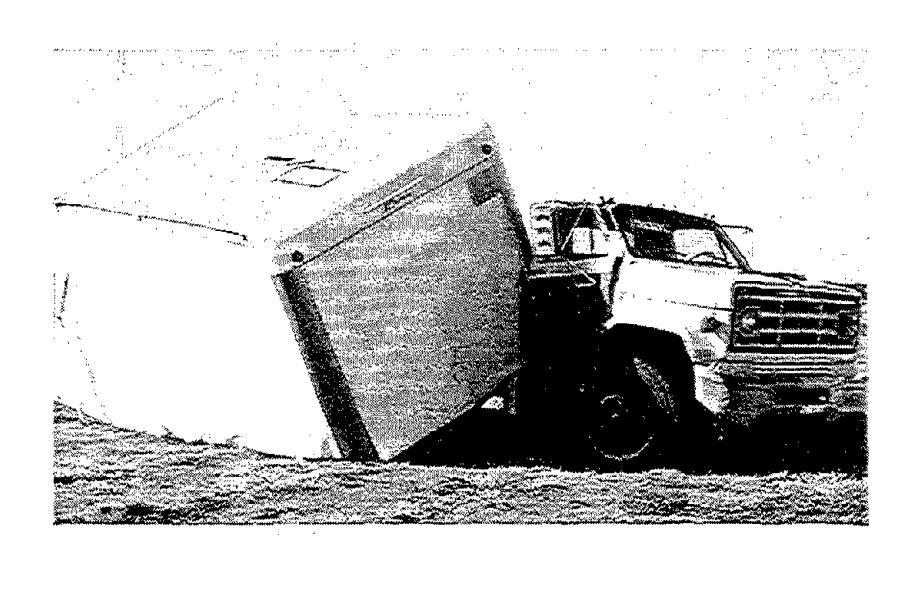
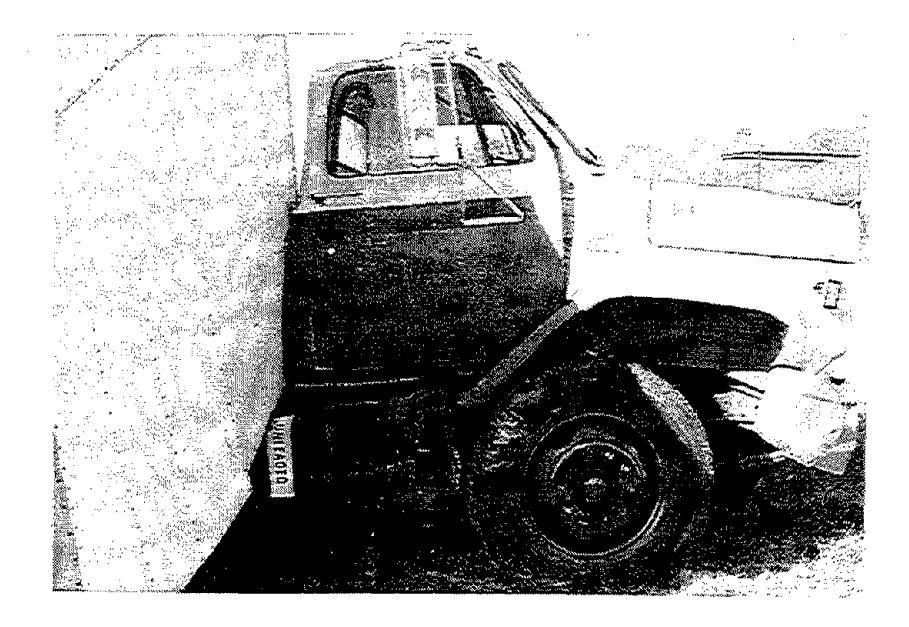
Figure 40. Vehicle after test 471470-29.

The vehicle sustained minimal damage, as shown in figures 40 and 41. Maximum exterior crush at the right front corner of the vehicle was 120 mm (4.7 in) and there was no deformation or intrusion into the occupant compartment. The right-side spring U-bolts were damaged and the right front tire and wheel were pushed rearward into the fuel tank. The box was partially separated from the frame and shifted to the right. The bumper, hood, right front quarter panel, and right door were also damaged.

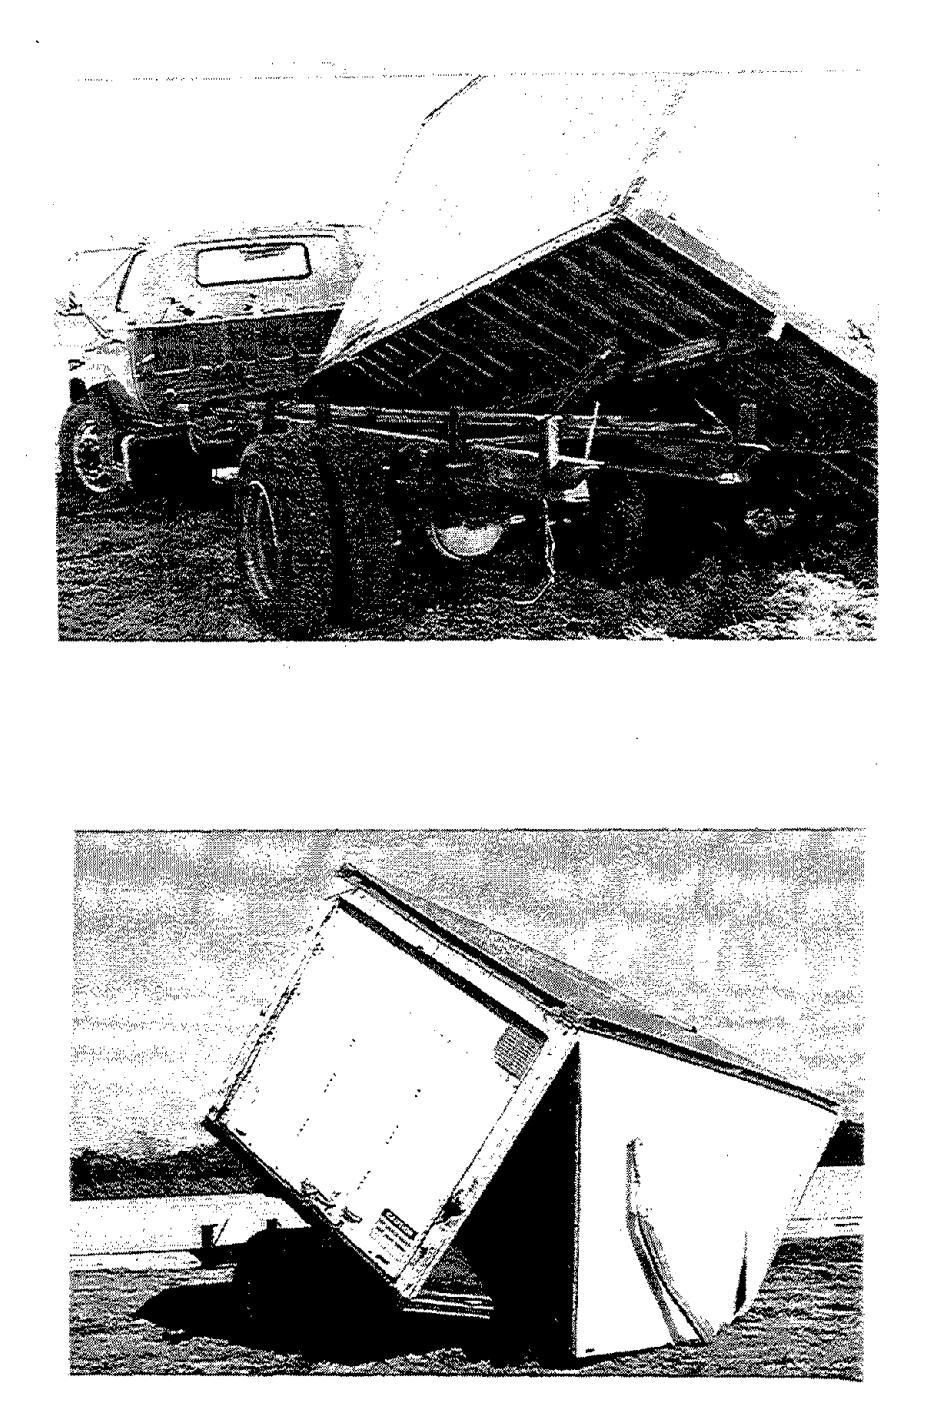
Figure 41. Damage to van-box after test 471470-29.
