Comparison of Laboratory Testing Methods for Bridge Coatings

Publication No. FHWA-RD-94-112

June 1995

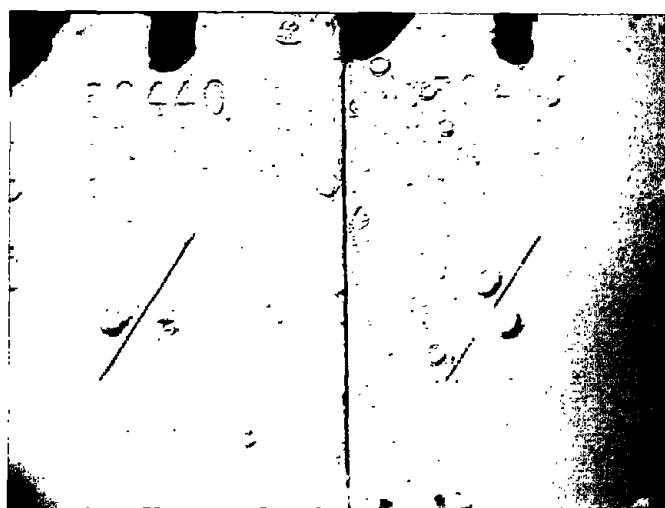
The water-based inorganic zinc potassium silicate/acrylic/acrylic system (code no. 10) exhibited severe blistering of the topcoats both on the panel surface and around the panel edges after only 500 h of the salt-fog test (figure 3), even though no rusting or undercutting of the inorganic zinc were observed on the surface and at the scribe. A large number of size 6 blisters were distributed over the panel surface and size 1 blisters (larger than size 2 blisters, 9 mm in diameter) developed 2 mm away from the scribe; this blister formation may be a result of relatively weak adhesion of the acrylic topcoat to the inorganic zinc primer (4.7 MPa) as determined by the pull-off adhesion test of the coating on an unexposed panel. The failure mechanism was intercoat adhesive failure between the inorganic zinc primer and the intermediate coat of acrylics. A similar topcoat failure (peeling) was also found for the high-ratio, water-based inorganic zinc potassium silicate system in our previous study, as well as in a similar FHWA study by Kogler and Mott.⁽⁶⁻⁷⁾ Topcoat blistering away from the scribe was also observed on the topcoated inorganic zinc potassium silicate system in a study by Szokolik.⁽⁸⁾ Topcoat delamination from water-based inorganic zinc has also been experienced on operational bridges. On the contrary, a generically similar, but differently formulated, topcoated, water-based inorganic zinc potassium silicate system performed excellently in the cyclic salt-fog/freeze test in our previous staff study.⁽⁶⁾ The delamination was possibly caused by the incompatibility of the topcoats with the relatively alkaline zinc primers that alkali carbonate formed together with zinc silicate polymer matrix after curing. In addition, both size and uniformity of the distribution of zinc particles can affect the rheological properties of the coating, which affect the application characteristics and the uniformity of the applied film.⁽⁹⁾ Extensive topcoat blistering (very fine, smaller than size 8, x40 magnification shown in figure 4) with limited undercutting (3.3 mm) occurred at the scribe of the solvent-based zinc-rich polyurethane/waterborne polyurethane/waterborne polyurethane (code no. 7). The higher-VOC, solvent-based polyurethane topcoats (code nos. 5 and 6) with the same primer, however, did not exhibit any blistering at the scribe. Another incident of blister clusters (6D, x40 magnification shown in figure 5) occurring at the scribe was found on the water-based zinc-rich epoxy/acrylic/acrylic (code no. 13). These very small, but dense, blisters were difficult to see because of the color of the coating; but they were visible with an optical microscope at x40 magnification. These topcoat

Figure 3. Condition of the water-based inorganic zinc potassium silicate/acrylic/acrylic system after 500 h of salt-fog exposure.

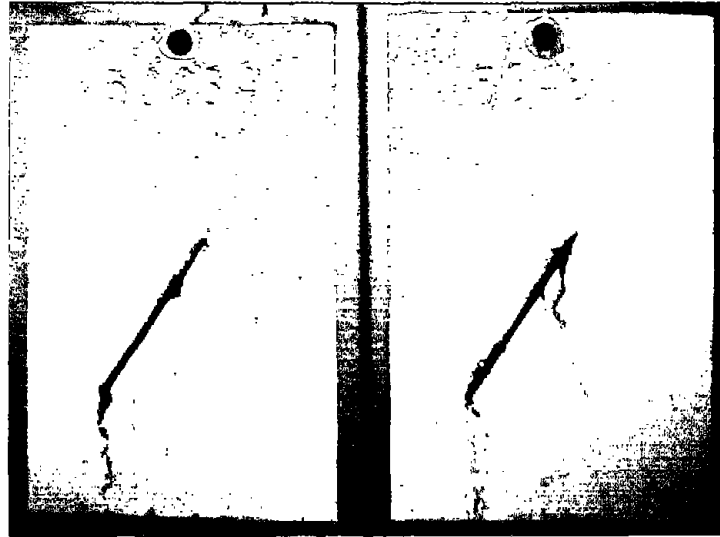
The waterborne vinyl coating system (code no. 12) exhibited pronounced blistering (6MD) over the entire panel plane surface and size 4 blisters at the scribe after only 500 h of the salt-fog exposure (figure 6). Again, the relatively weak adhesion found between the primer and the topcoat (3.9 MPa) for the unexposed coating system may be the precursor to the delamination. These blisters were filled with electrolytes (chloride and water) after the salt-fog exposure, but the apparent collapse of the majority of the blisters (figure 7) was noticed 2 d after being exposed to ambient laboratory environment (temperature = 25 °C, relative humidity = 50 percent), implying that drying for a reasonable timeframe has helped to heal the blistering. However, this pronounced blistering phenomenon was not found by Clement for the waterborne vinyl system evaluated after 1,500 h of his salt-fog exposure.⁽¹⁰⁾ This discrepancy may be attributed to different coating formulations or variations in panel preparations.

Figure 6. Condition of the waterborne vinyl system after 500 h of salt-fog exposure.

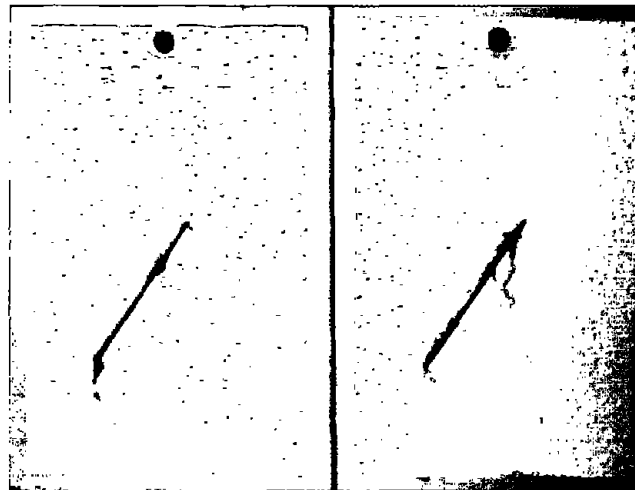
Figure 7. Condition of the waterborne vinyl system after 500 h of salt-fog exposure followed by standing in air for 48 h.

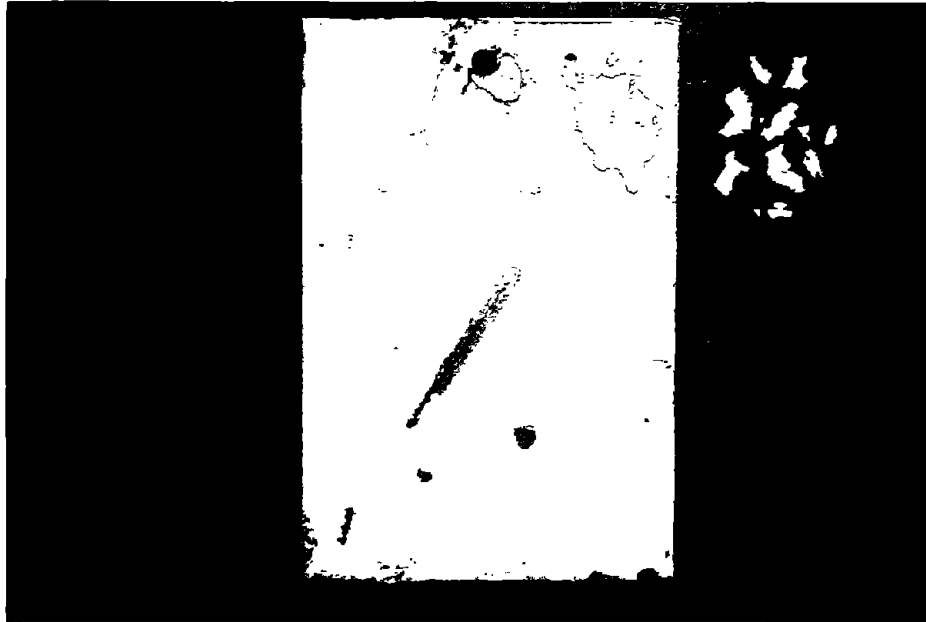
The calcium sulfonate/alkyd coating system is soft and vulnerable to abrasion and impact. Its pencil hardness is less than 1-6B. The topcoat peeled easily at the edges of scribes at the time of scoring, which demonstrates its fragility. Furthermore, in the adhesion test of this coating, the topcoat separated easily when roughed with sand paper prior to the bonding of a dolly, indicating that the adhesion of the topcoat to the primer is very weak. This suggests that the use of the calcium sulfonate/alkyd coating system on structures exposed to vehicle/personnel traffic and dirt conditions would not be advisable. The corrosion protection characteristics are acceptable. After 500 h of salt-fog exposure, the topcoat was easily separable and detachable from the primer coat and was easily lifted by a blade (figure 8). The failure mode demonstrates that the adhesion force between the primer and topcoat is extremely weak so that water accumulated at the primer-topcoat interface when it diffused through the porous topcoat. Improved topcoat adhesion is necessary for the coating system to perform well in an aggressively corrosive environment.

Figure 8. Condition of the calcium sulfonate/alkyd system after 500 h of salt-fog exposure. (The easily lifted topcoat is shown at right.)

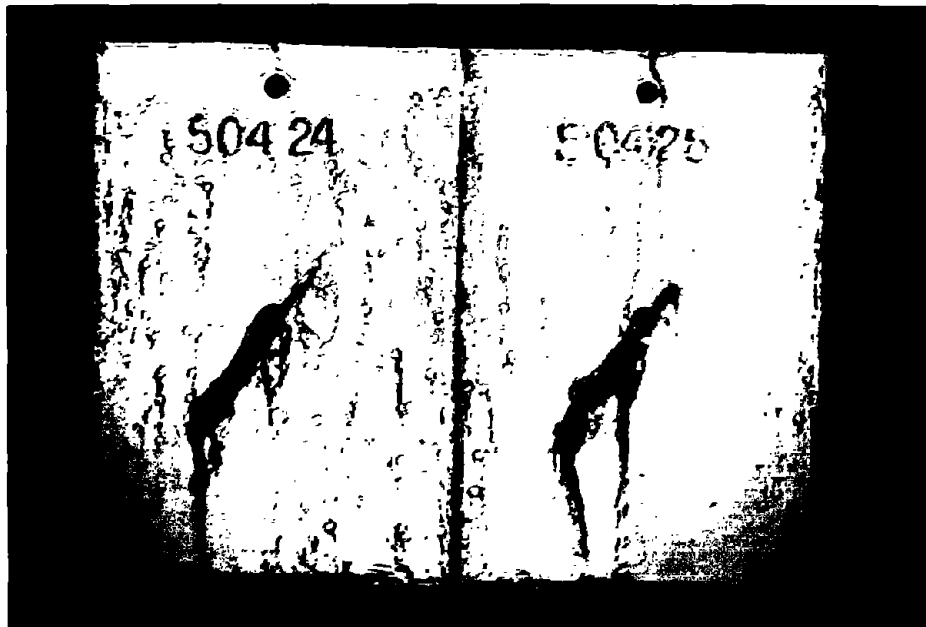
The epoxy mastic/polyurethane (code no. 8) developed a considerable number of rust-filled blisters on the plane surface and near the panel edges after 3,000 h of the salt-fog test (figure 9). The result is consistent with the underfilm corrosion observed in our earlier study of the low-VOC epoxy mastic/polyurethane system after 3,000 h of the salt-fog/freeze test.⁽⁶⁾ The susceptibility of the low-VOC epoxy mastic systems to underfilm corrosion demonstrated in this and other FHWA research makes the use of these materials to protect bridge steel in a salt-rich environment questionable, particularly since other systems have demonstrated superior performance in such applications.

Figure 9. Condition of the epoxy mastic/polyurethane after 3,000 h of salt-fog exposure.

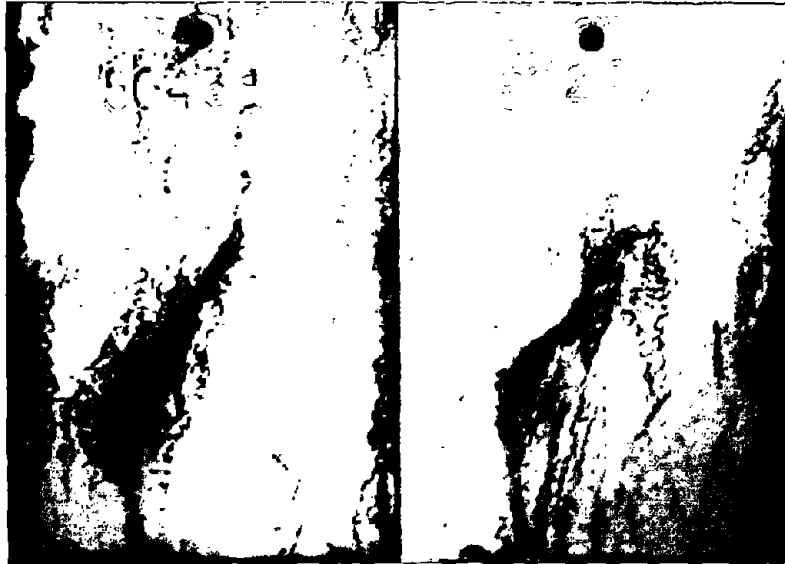
The epoxy urethane mastic/polyurethane (code no. 9) showed 9VD blisters (smaller than size 8 blisters) at the edges after 2,000 h of the salt-fog test (figure 10); these blisters extended about 15 mm from all four edges of the coated panels and underfilm corrosion was observed beneath the blisters.

Figure 10. Condition of the epoxy urethane mastic/polyurethane after 2,000 h of salt-fog exposure.

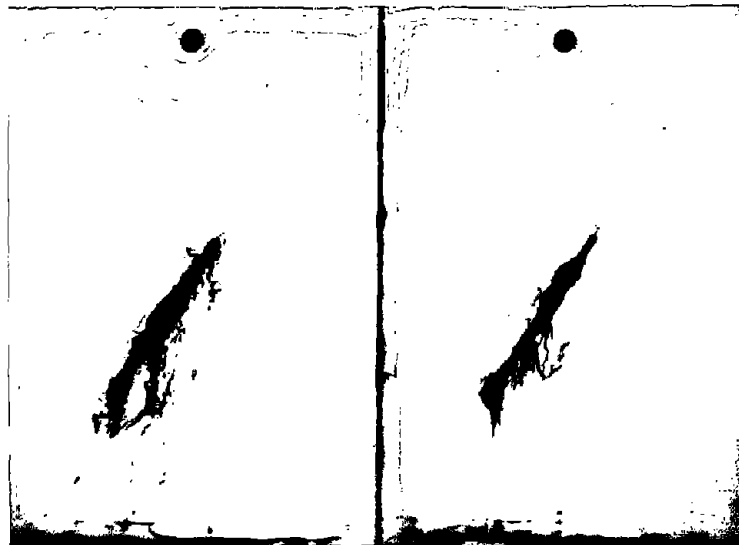
All of the coating systems developed creepage or cutback at the scribes. A majority of the coatings undercut to the same degrees of creepages, except for the solvent-based zinc-rich polyurethane/waterborne polyurethane/waterborne polyurethane (VOC of topcoat = 24 g/L, code no. 7) and the water-based zinc-rich epoxy/acrylic/acrylic (code no. 13), which had minute undercutting. No underfilm corrosion was found beneath the blisters at the scribe for these materials, illustrating the cathodic protection of steel afforded by zinc-metal primer. The waterborne acrylic system (code no. 3) exhibited severe blistering at the scribe with a creepage larger than 6.35 mm after 1,000 h of the salt-fog test (figure 11); this rapid failure makes its use in a high-salt environment questionable.

Figure 11. Condition of the waterborne acrylic system after 1,000 h of salt-fog exposure.

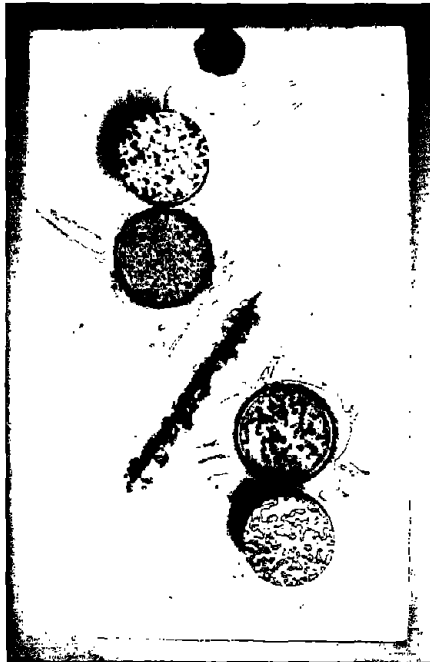
Figure 15. Topcoat delamination of the waterborne vinyl system after 3,000 h of Prohesion exposure.

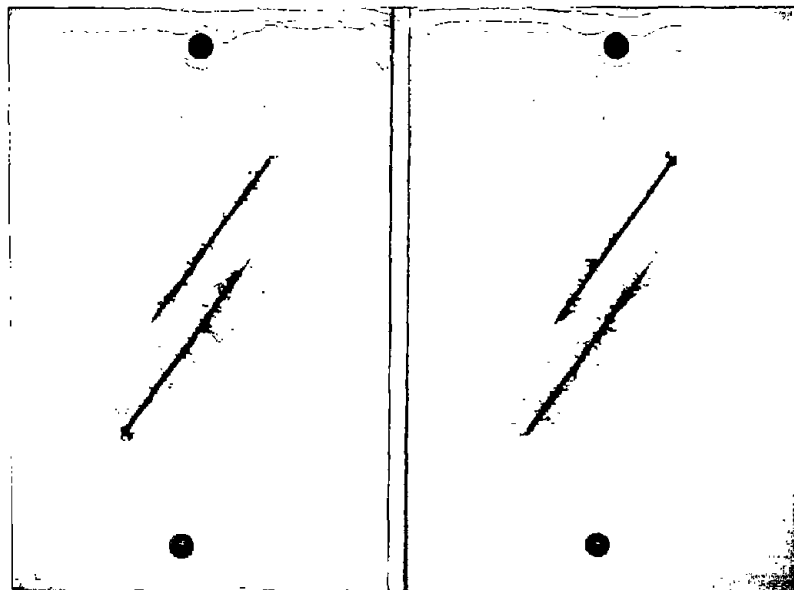
and 336 g/L, respectively). Among all the coating systems tested, the waterborne acrylic epoxy system failed most rapidly. It developed 8.5 mm of creepage (>6.35 mm) at the scribe after only 1,000 h of the Prohesion test as demonstrated by figure 16; on the contrary, this system showed a creepage of only 6.0 mm after 3,000 h of the salt-fog test. This difference in failure results implies that the waterborne acrylic epoxy may be prone to the attack of the weak acid (ammonium sulfate) used in the Prohesion test.

Figure 16. Condition of the waterborne acrylic epoxy system after 3,000 h of Prohesion exposure.

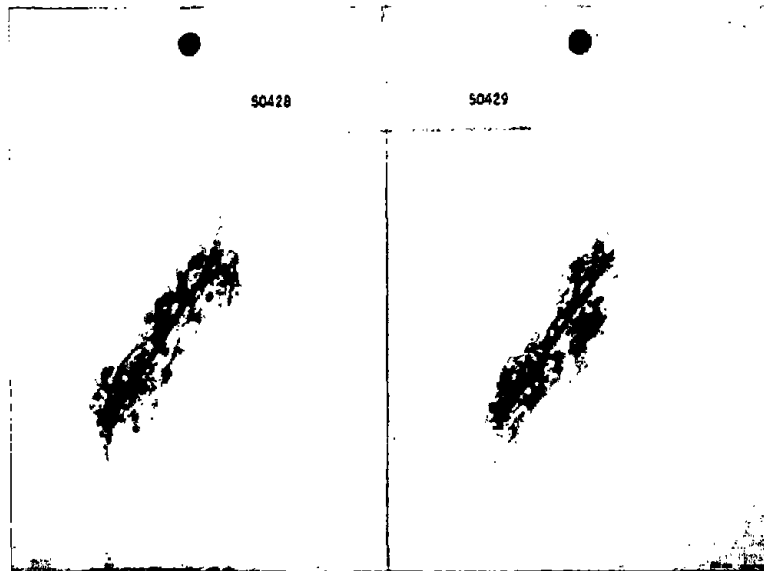
Figure 18. Condition of epoxy mastic/polyurethane system after 3,000 h of Prohesion exposure.

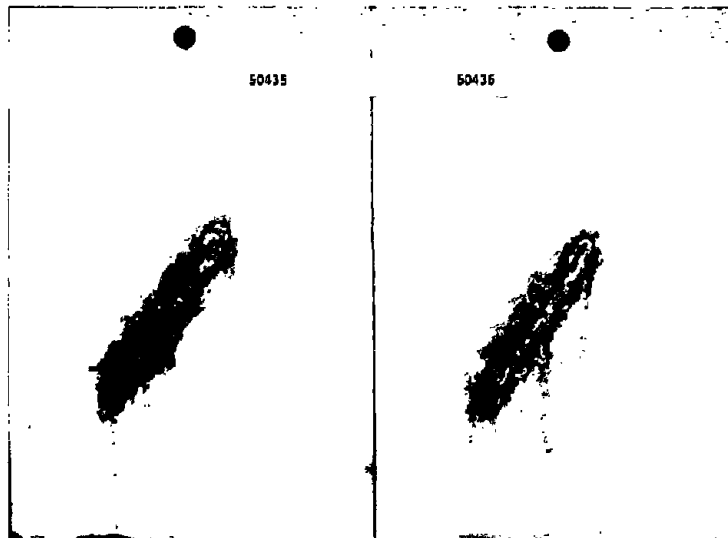
Figure 19. Condition of epoxy urethane mastic/polyurethane system after 3,000 h of Prohesion exposure.

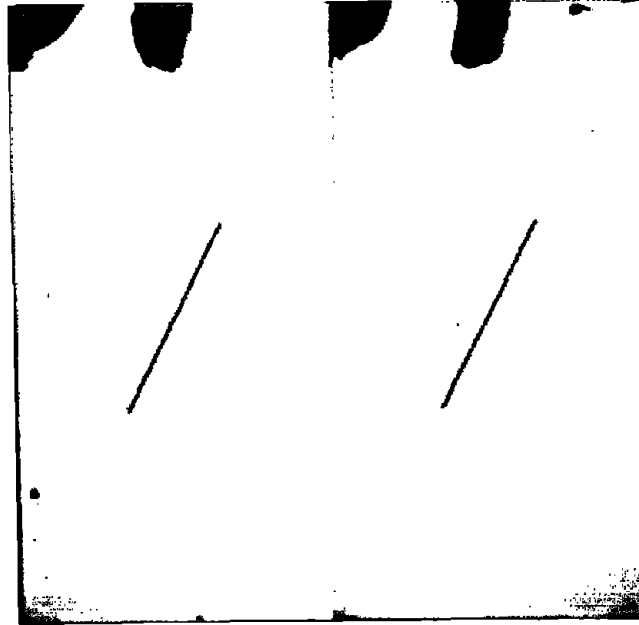
Figure 23. Condition of water-based inorganic zinc potassium silicate/acrylic/acrylic system after 3,000 h of cyclic freeze/QUV/Prohesion exposure.

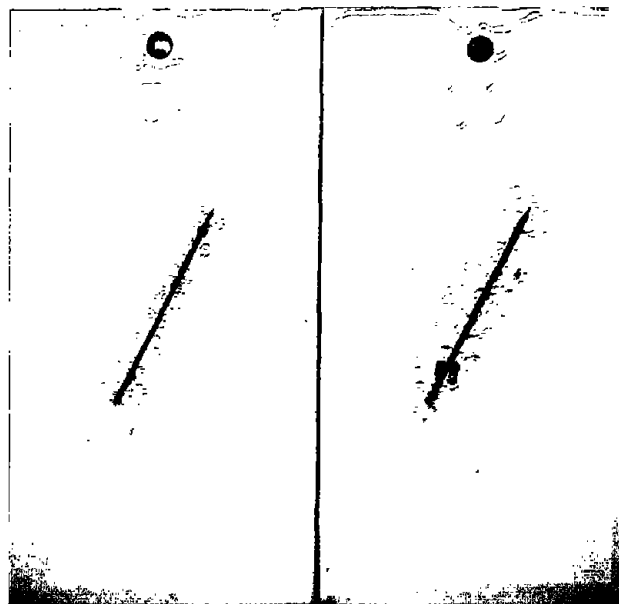
Figure 24. Condition of waterborne acrylic epoxy system after 3,000 h of cyclic freeze/QUV/Prohesion exposure.

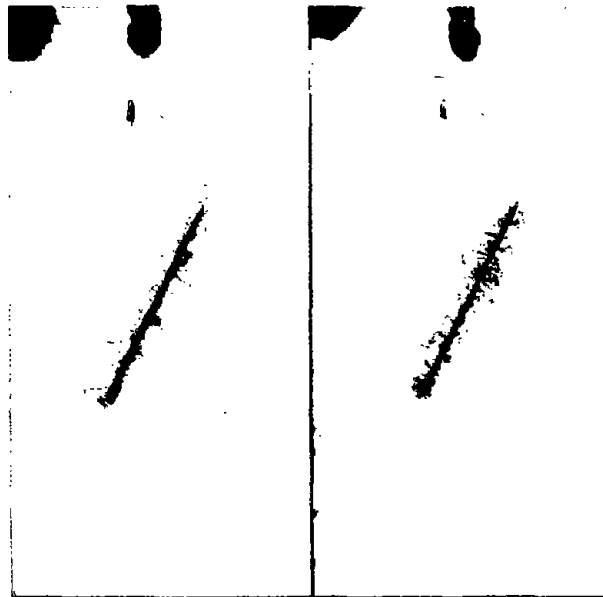
Figure 25. Condition of solvent-based low-VOC epoxy/acrylic modified epoxy system after 3,000 h of cyclic freeze/QUV/Prohesion exposure.

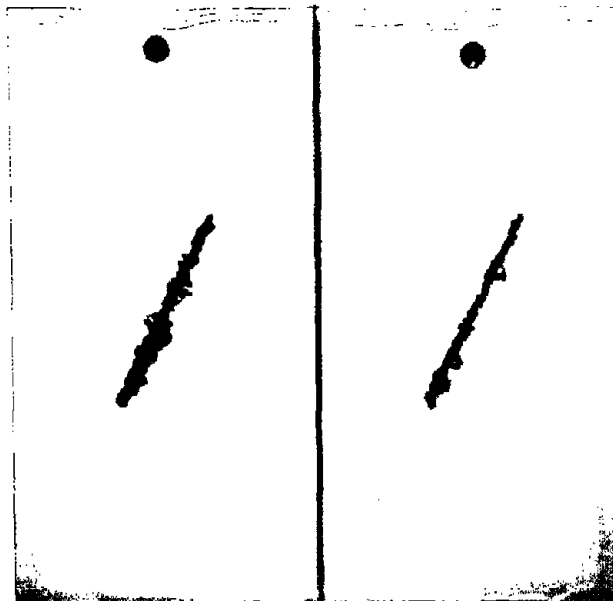
Figure 26. Condition of waterborne acrylic system after 3,000 h of cyclic freeze/QUV/Prohesion exposure.

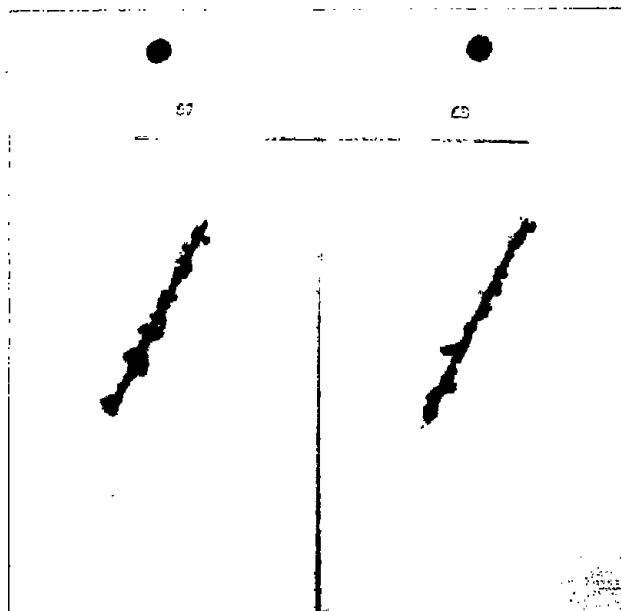
Figure 27. Condition of epoxy mastic/polyurethane system after 3,000 h of cyclic freeze/QUV/Prohesion exposure.

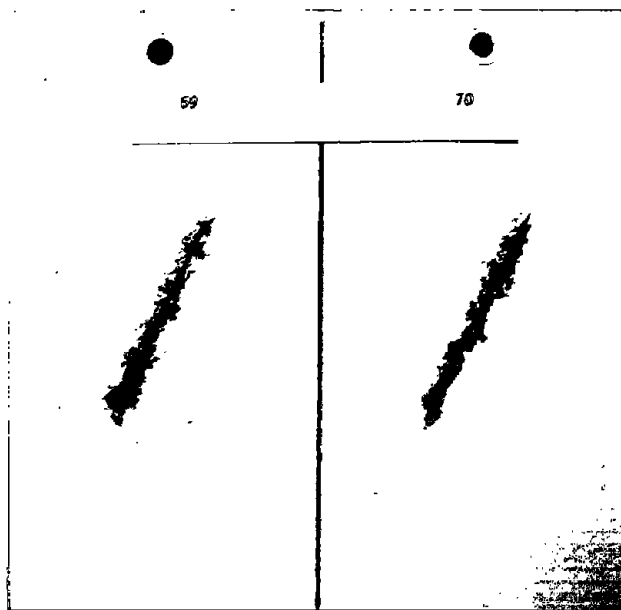
Figure 28. Condition of epoxy urethane mastic/polyurethane system after 3,000 h of cyclic freeze/QUV/Prohesion exposure.

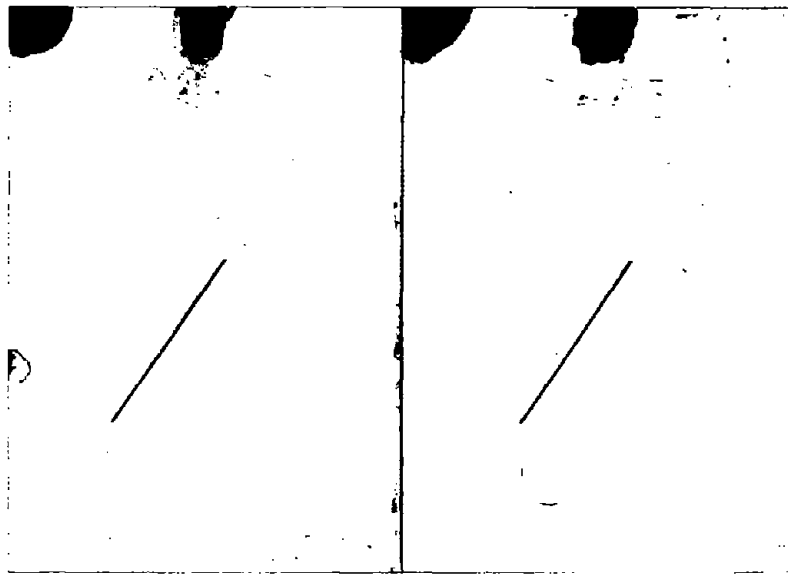
Only two of the coating systems showed plane surface failures after 28 months of outdoor exposure. The solvent-based calcium sulfonate/alkyd system exhibited topcoat peeling. The water-based inorganic zinc/acrylic/acrylic system developed topcoat delamination on edges and below scribe (figure 30).

Figure 30. Condition of water-based inorganic zinc potassium silicate/acrylic/acrylic system after 28-month outdoor exposure.

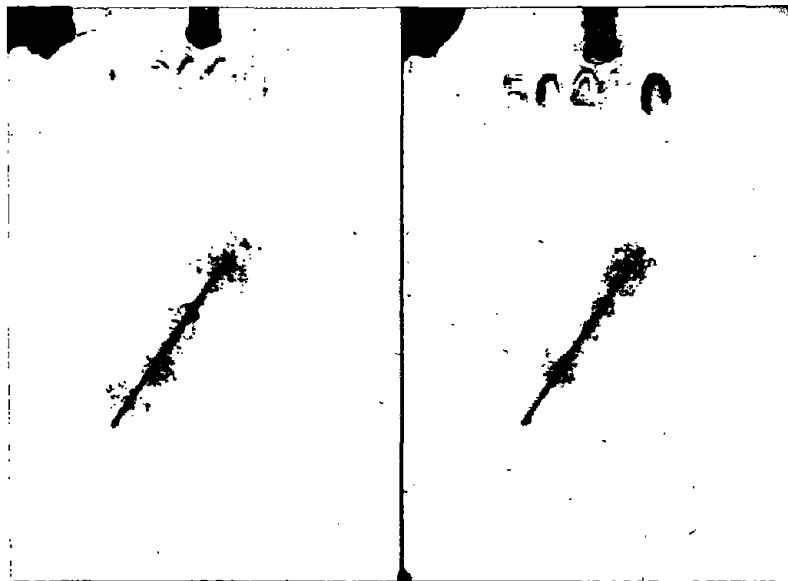
Figure 32. Condition of solvent-based low-VOC epoxy/acrylic modified epoxy system after 28-month outdoor exposure.

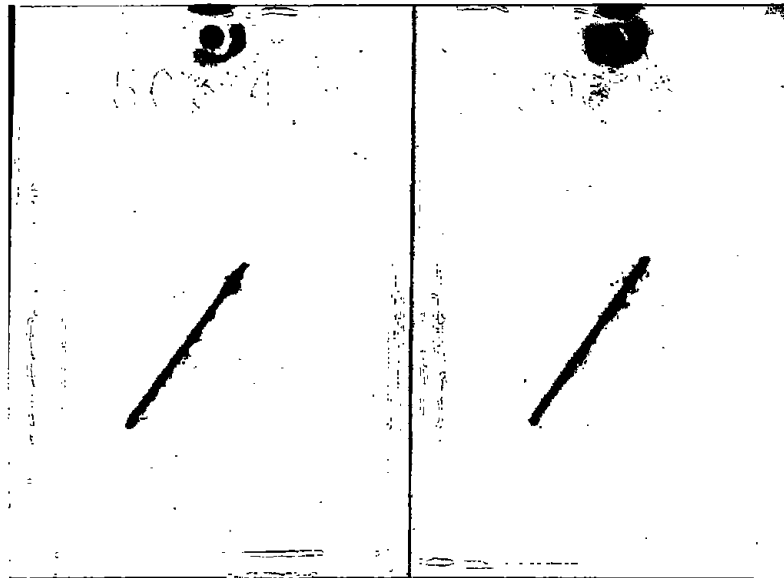
Figure 33. Condition of waterborne acrylic system after 28-month outdoor exposure.

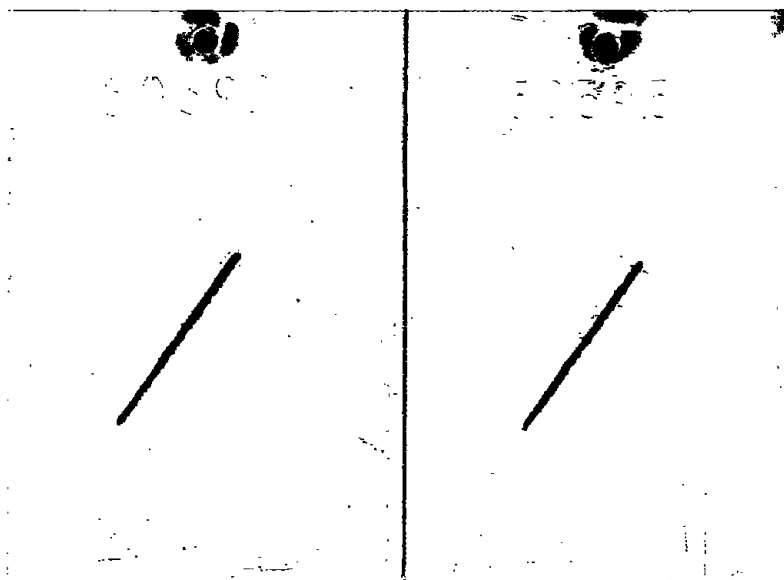
Figure 34. Condition of waterborne acrylic epoxy system after 28-month outdoor exposure.
