1. Report No. FHWA/RD-86/114		2. Government Accession No. PB86226065

4. Title and Subtitle PERFORMANCE OF FLEXIBLE DITCH LININGS		5. Report Date September 1985

16. Abstract A series of tests to determine the performance of ten flexible ditch lining materials were conducted at the U.S. Geological Survey Gulf Coast Hydrosience Center's Hydraulic Laboratory. The objectives of the tests were to determine the effect of the flexible liners on the germination and growth of grass and to determine the effectiveness of the liners to prevent erosion on highway channels until the establishment of vegetation. The vegetation establishment portion of the test was conducted on two types of soils, an erosion resistant soil and an erodible soil, while the erosion control portion of the test was conducted on an erodible soil only. The vegetation establishment test was conducted by planting grass on the test plots, installing the ten flexible liners and then checking for grass growth over a seven week period. Results include the seven week period as well as six months later. The erosion control portion of the test was conducted by installing the liner being tested in a 70 foot long trapizoidal chann

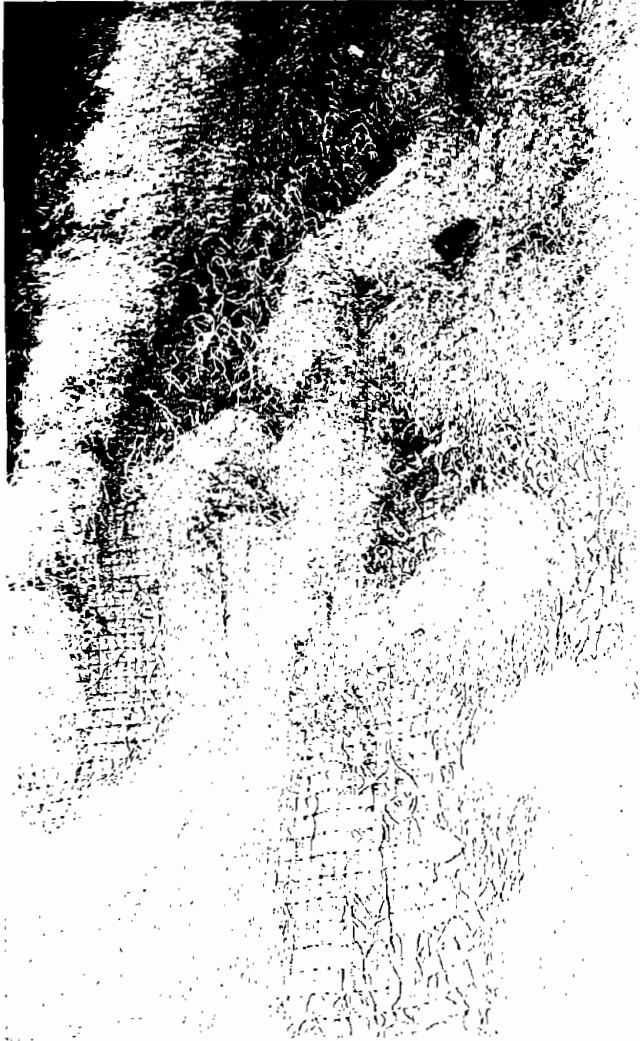
- 4) The wood excelsior tended to move further down the ditch when using stapling pattern no. 1.
- 5) A large portion of the liner damage occurred along the sides of the ditch as the depth of the flow increased (figures 48 and 49).

Figure 48.--Excelsior mat liner after a test run showing the liner damage along the side slopes. Photo taken at same location in test channel as figure 47.

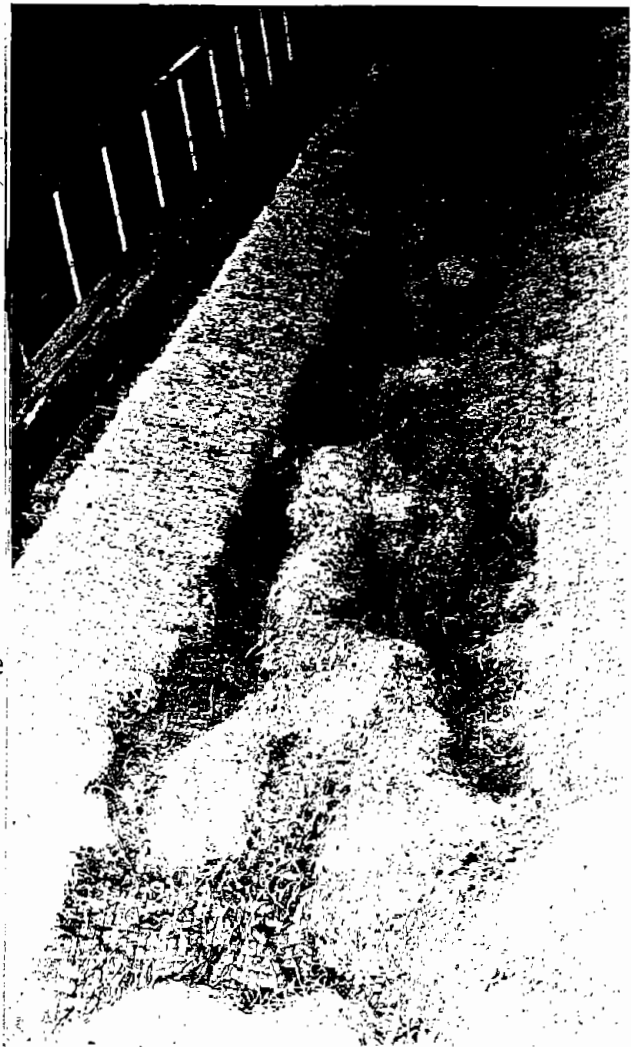
Figure 49.--Liner excelsior mat after test run showing damage to liner along the center 3/4 of the test channel.

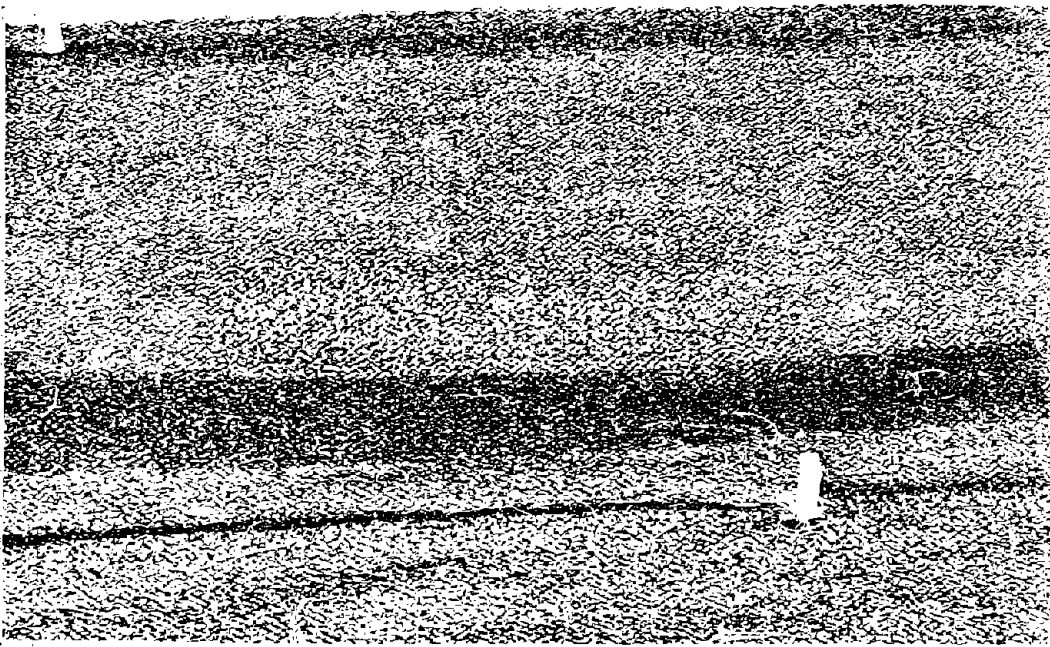
Figure 52.--Liner Enkamat after testing: Note the washout near the stake.

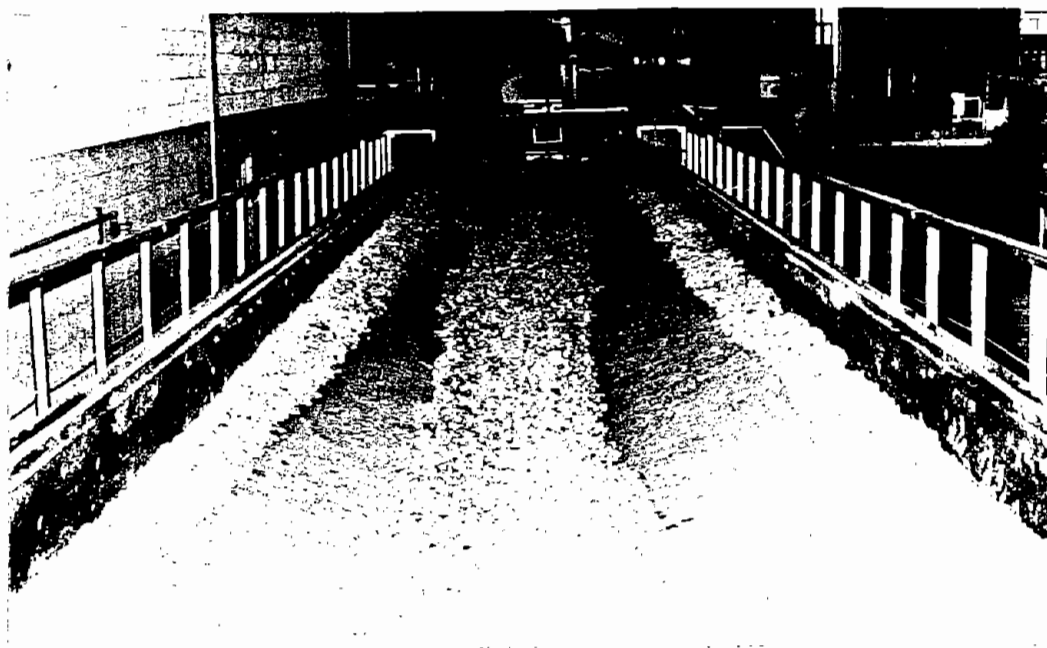
- 1) All failures were due to liner failures, not erosion failure.
- 2) The gravel appears to move down the ditch at a steady rate throughout the entire 30 minute test.
- 3) The failure at 1 percent slope had a moderate rate of failure with the gravel on the side slope of the ditch being deposited on the bottom of the ditch (figure 55).
- 4) The failure at 2 percent slope had a moderate rate of failure with the gravel at the upstream portions of the test ditch moving to the downstream portions of the ditch.
- 5) The liner failure at 3 percent slope was a rapid failure.
- 6) Erosion damage was minimal in all tests.

Figure 55.--Loose gravel after failure of liner showing the gravel on the side slopes washed out.

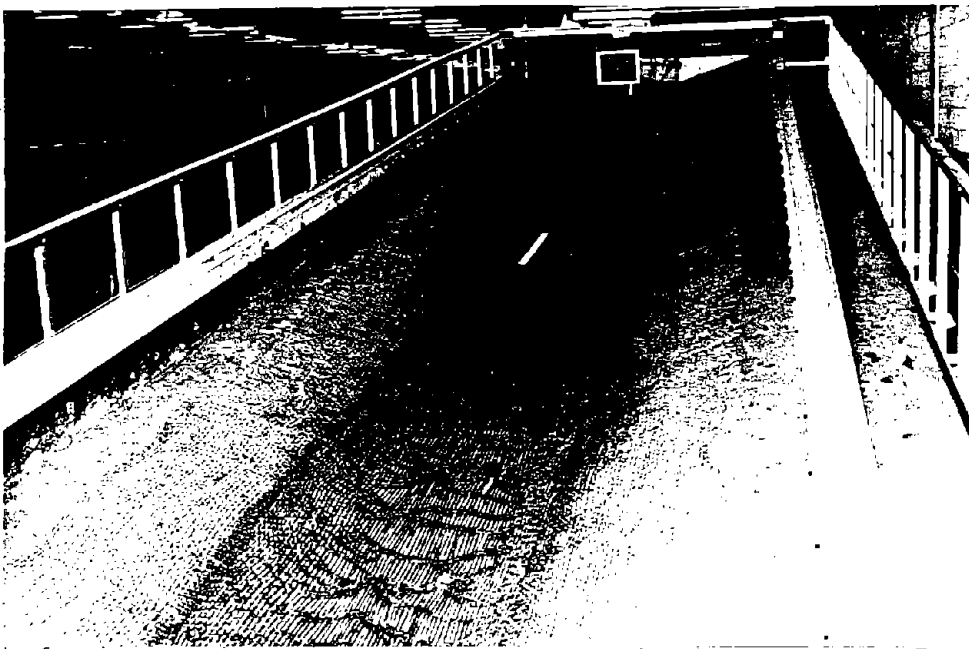
- 1) Erosion appeared to occur at a steady rate throughout the entire 30 minute test.
- 2) Erosion damage was minimal in all tests.
- 3) High water flows at high slopes appeared to unravel the jute netting between staples (figure 61).
- 4) The longitudinal jute strands appear to offer adequate protection in the areas where the liner was unraveled.

Figure 61.--Jute netting liner after testing showing the netting unraveling.

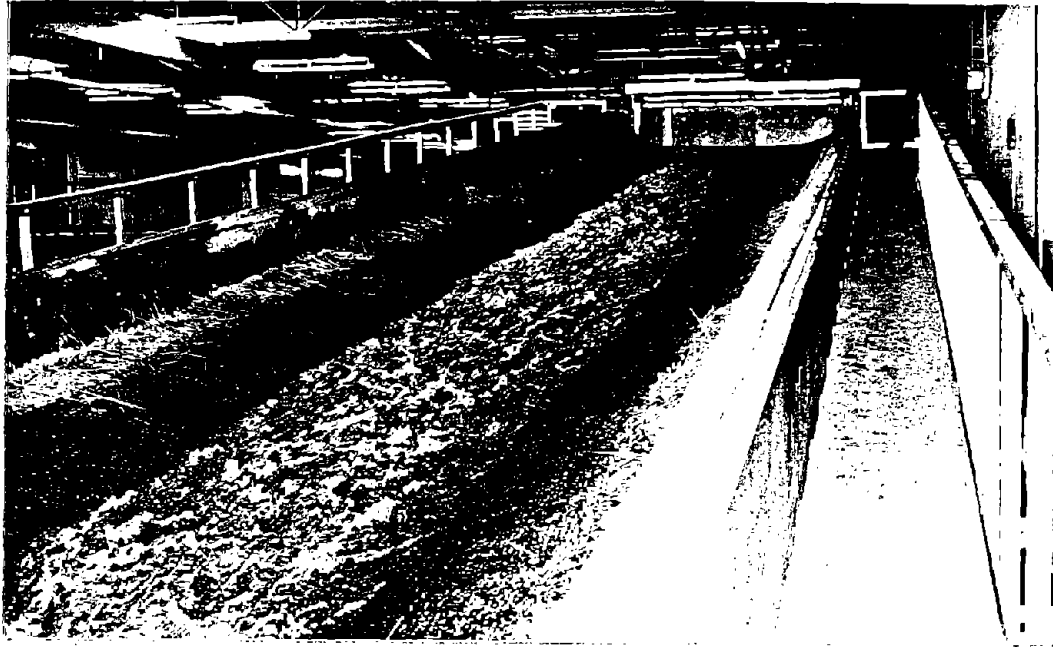
- 1) The liner had a tendency to float during all tests (figures 63 and 64).
- 2) All failures during the first set of testing were due to erosion failure.

Figure 64.--Jute netting over straw sprayed with asphalt liner during testing at high water flows also shows signs of floating along the water's edge.

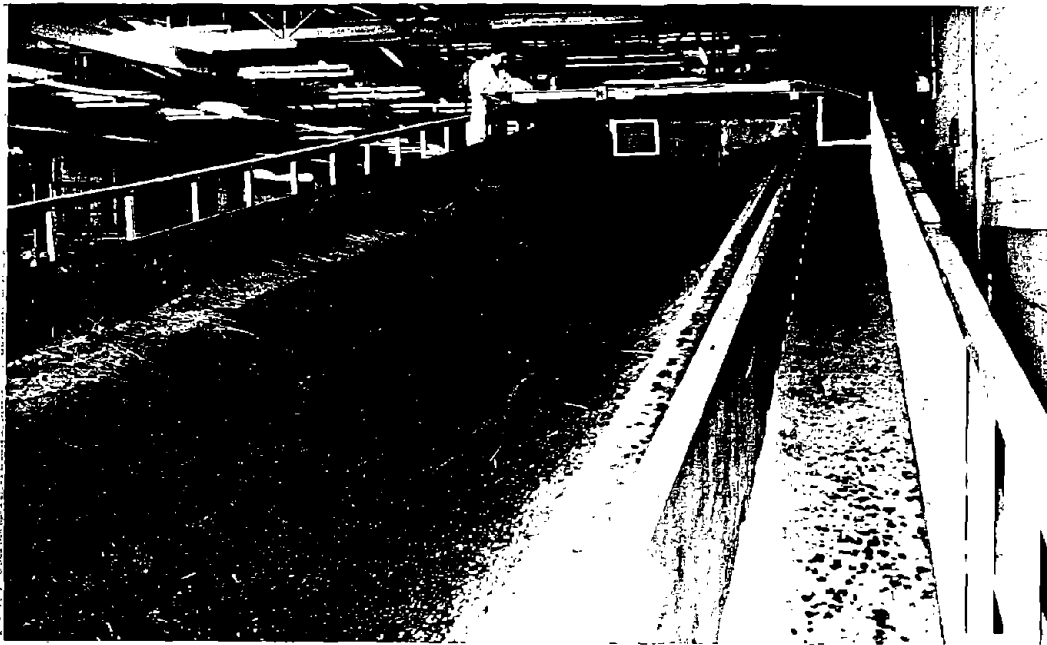
Figure 65.--Jute netting over straw sprayed with asphalt liner after testing shows areas where straw has washed out from under netting (lower left).

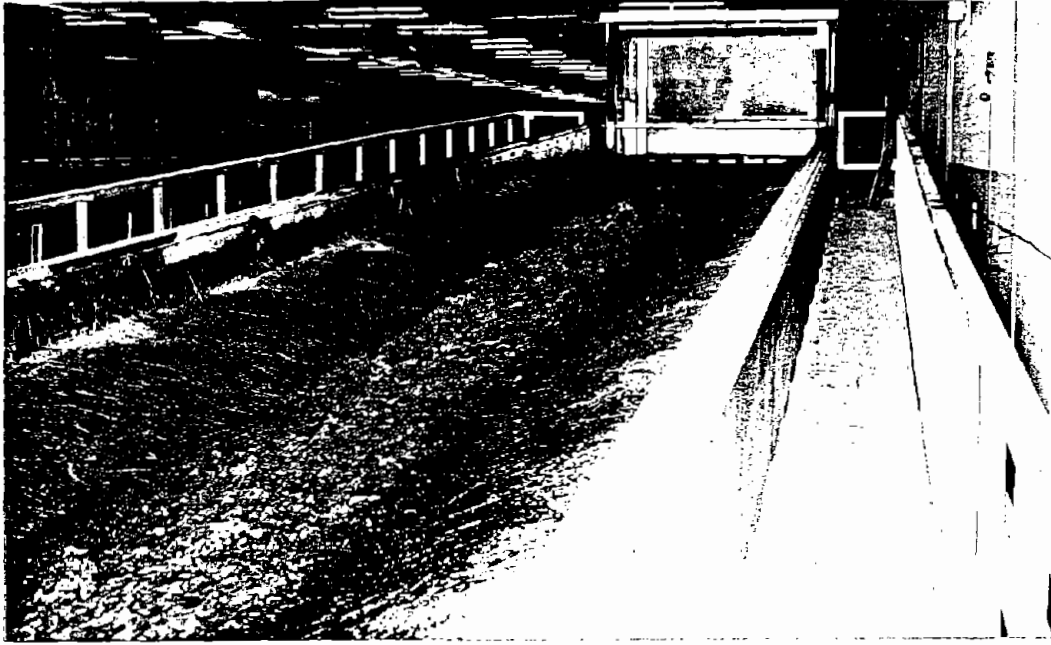
Figure 67.--Amxco netting over straw sprayed with asphalt liner during testing showing liner floating along the water's edge.

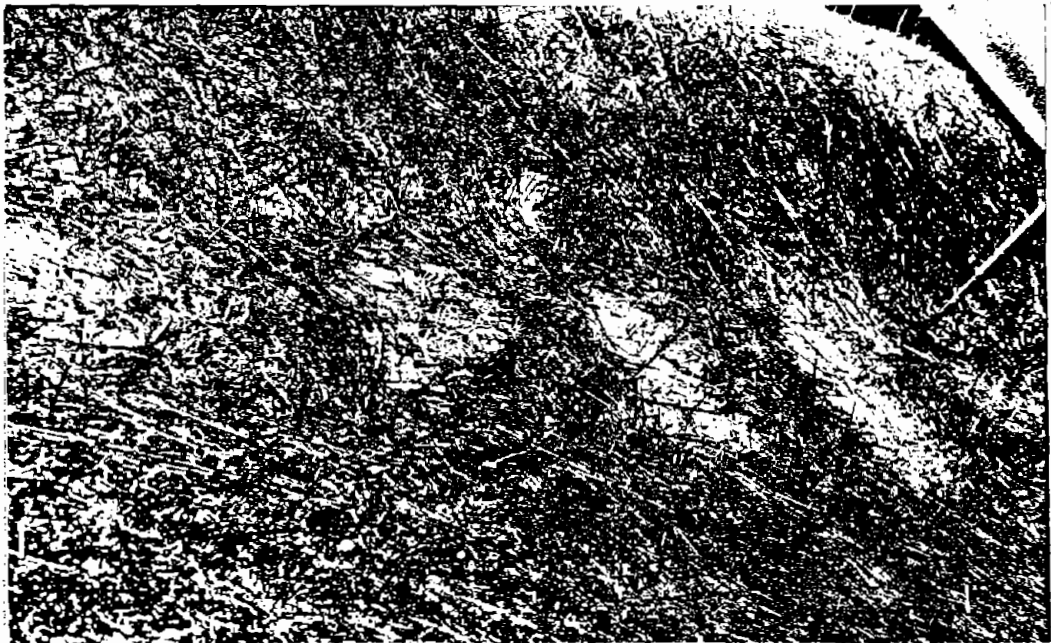
Figure 68.--Amxco netting over straw sprayed with asphalt after testing showing the bare spots between the staples.

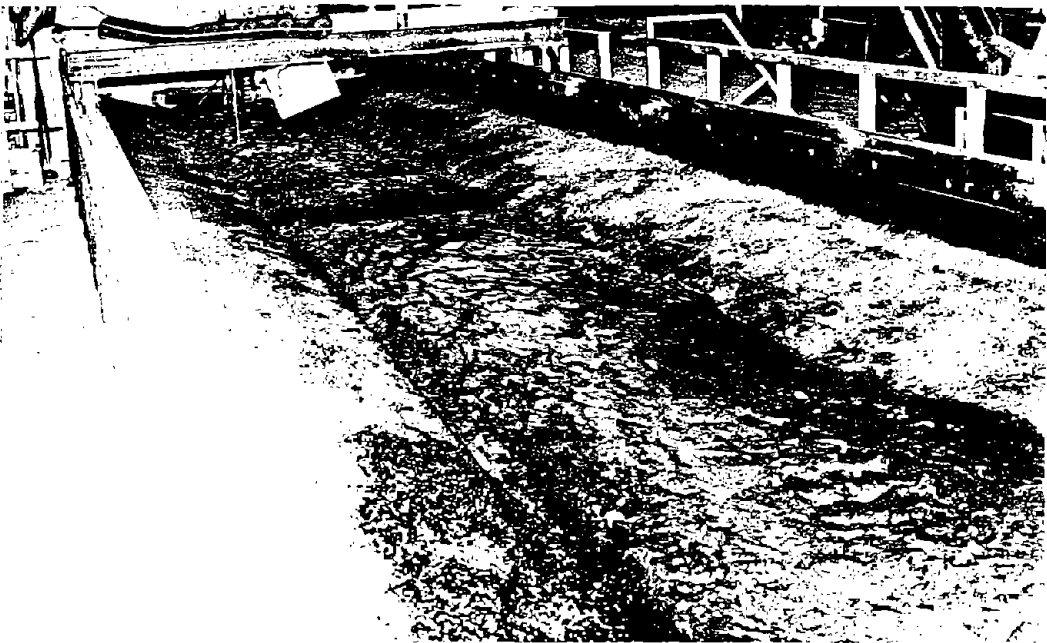
Figure 70.--Fiberglass roving, single layer, during testing 30 seconds after the lower 1/2 of the liner washed out.

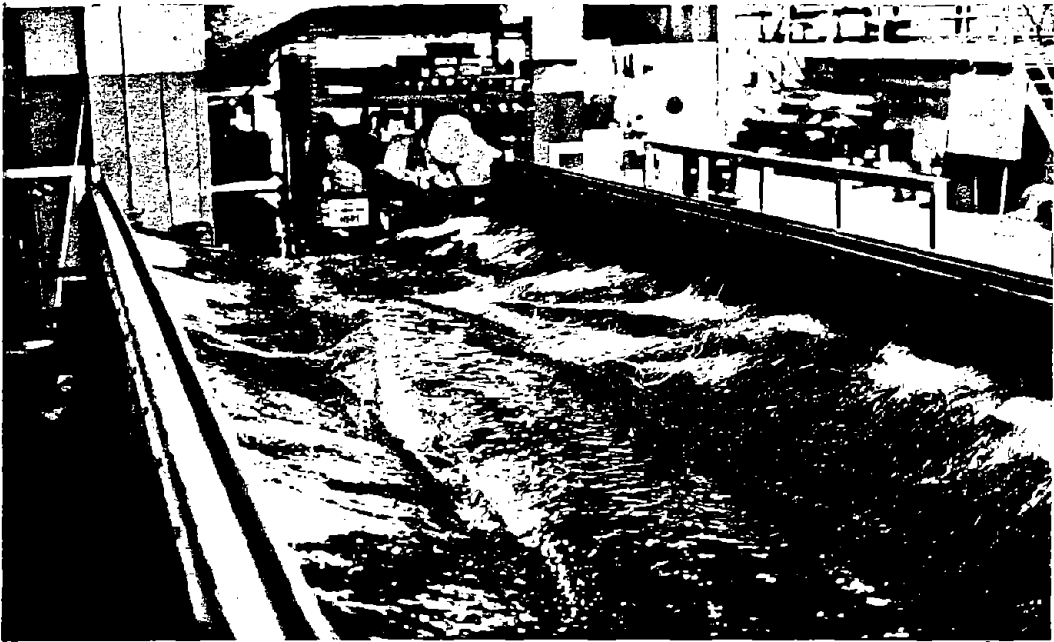
Figure 75.--Fiberglass roving, double layer, liner failing during test.
