# Flightcrew Response to Aircraft System Failures, Malfunctions, and Systems Not Functioning as Expected

## Final Report — October 2023

DOT-VNTSC-FAA-23-05

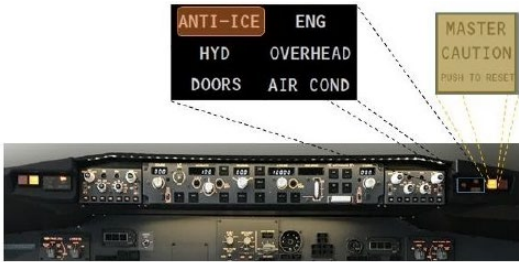
Source	Data (Quote or Summary)
p. 50/331 Volpe Summary	<p data-bbox="402 281 963 306">Master Caution Indicator and Probe Heat Panel</p> <p data-bbox="402 331 1414 499">Figure 9 shows the Master Caution and Anti-ICE warnings. There is a main MASTER CAUTION button that illuminates (yellow) on either side of the flight deck. On the FO side, there is a list of 6 possible systems to the left of the Master Caution light, one of which is the ANTI-ICE system. On the CA side, there is a similar box, but it lists different systems.</p>

<p data-bbox="565 779 764 793">FIGURE 9: MASTER CAUTION ANTI-ICE</p> <p data-bbox="1068 779 1187 793">FIGURE 10: PROBE HEAT PANEL</p>
	<p data-bbox="402 821 1357 919">Figure 10 shows the Probe Heat Panel. To further diagnose the ANTI-ICE system error, the pilot must look at the overhead panel, where there are additional (visual/light) indicators, one of these is for the (left/right) vane heating monitor.</p>
