**Report No. UT-24.06**

# **CULVERT/STORM DRAIN EVALUATION TECHNOLOGIES**

Utah Department of Transportation  
Research & Innovation Division

**Final Report  
April 2024**

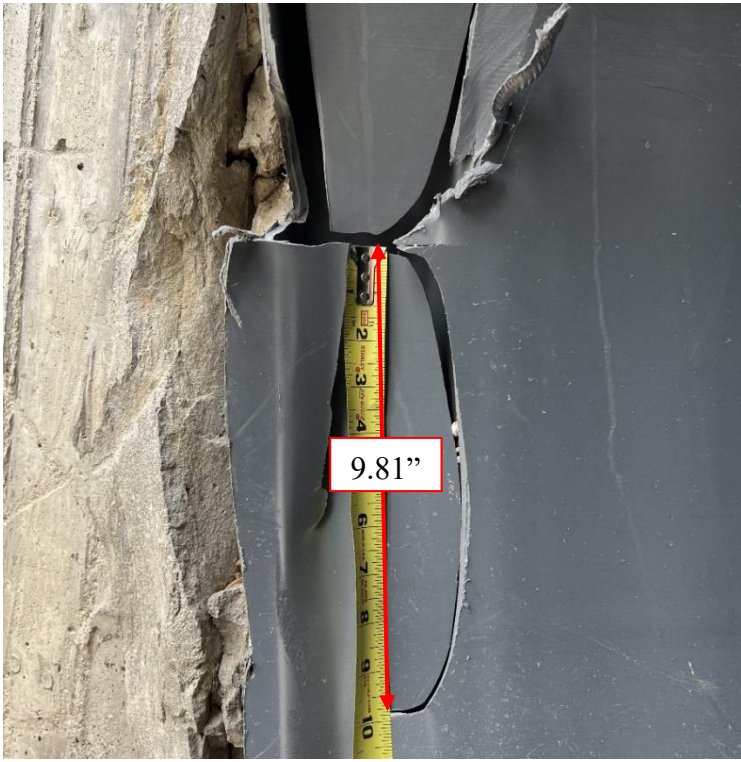
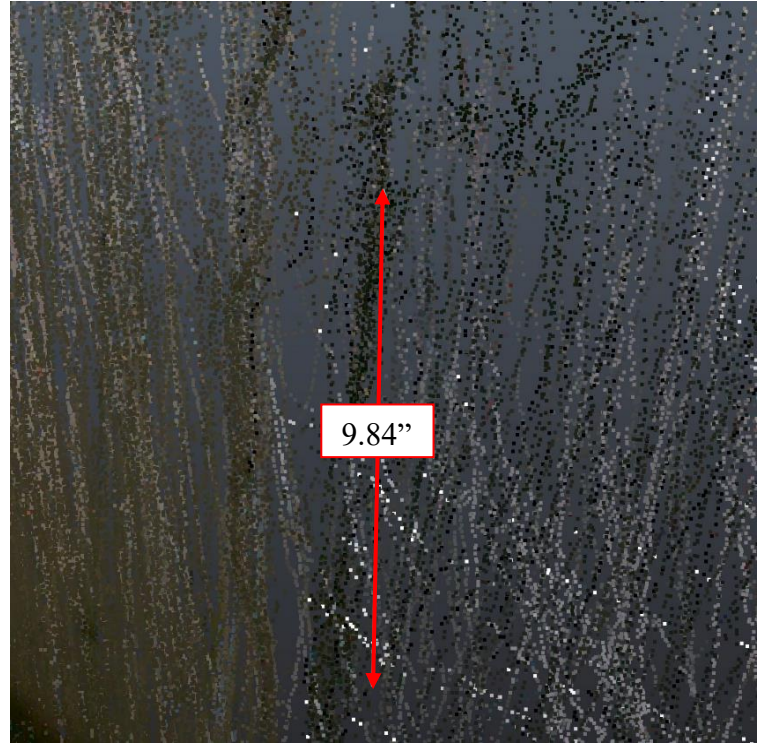
**Figure 4.2.1 – Cracking in Lisa Falls Polypropylene Pipe**

The research focused on what size of cracks could be evaluated with the aid of LiDAR-generated 3D models. Figure 4.2.1 shows an example of a crack in the Lisa Falls Polypropylene pipe. This pipe was chosen as it was found that smaller cracks were not identifiable with current mobile LiDAR technologies.

It needs to be noted that the minimum rating measurement for concrete culverts was a defect threshold of fractures greater than 0.05 inches. None of the point clouds were dense enough to be able to capture a fracture of this width. From the figures it can be seen how difficult it was to identify this extremely large crack through point clouds only. In fact, identifying the crack required changing the orientation of the point cloud for a specific area until the crack became somewhat visible. Without a photo and location as a base condition, this crack would not have been measurable through LiDAR. It can also be seen that very few points in the point cloud fall within cavity of the crack. This shows that if crack widths in the 0.5-inch range are not measurable, that the UDOT threshold of 0.05 inches is not currently measurable.

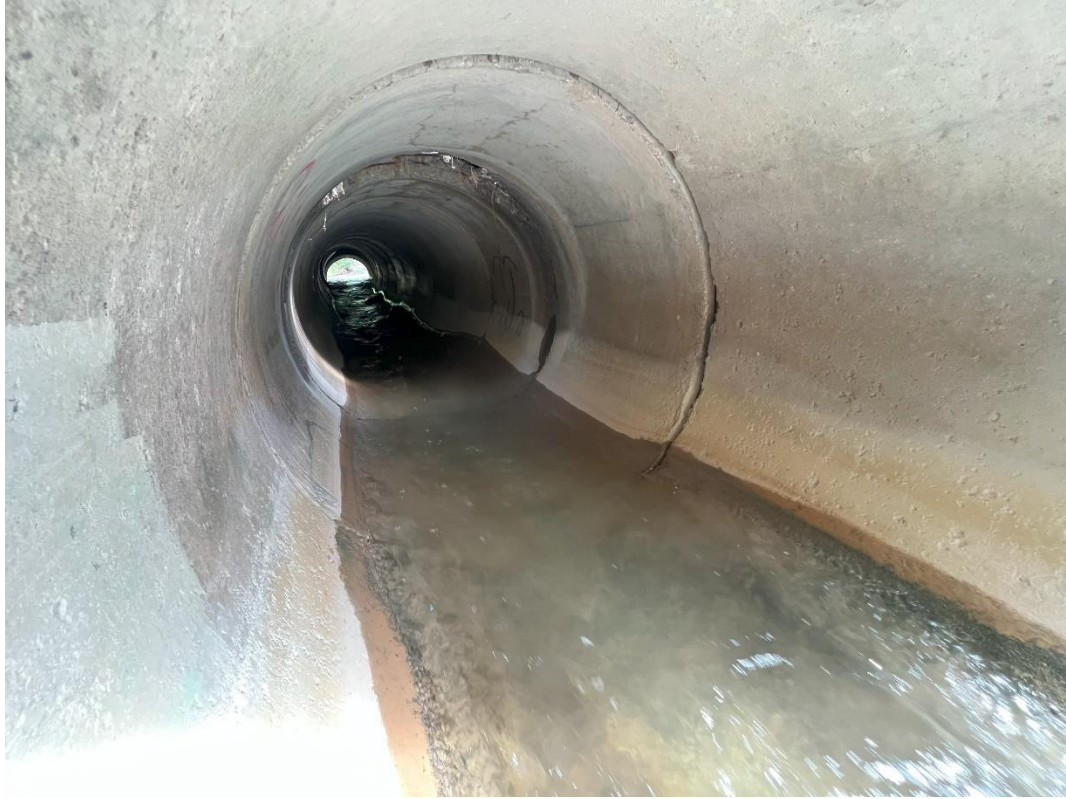
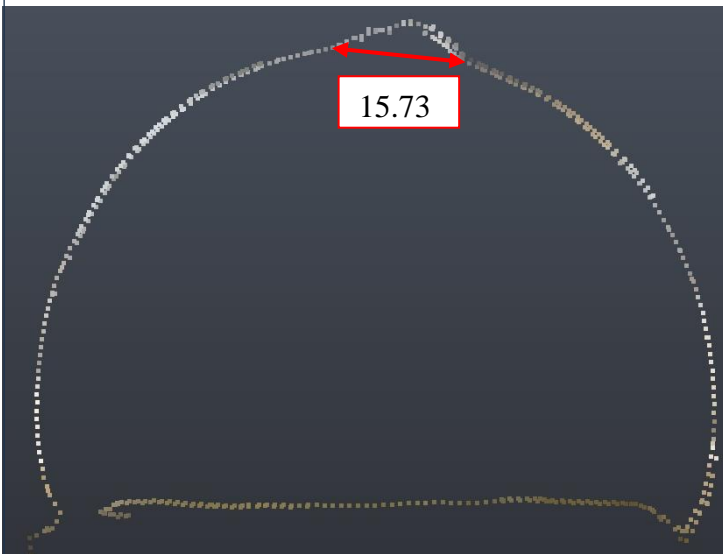
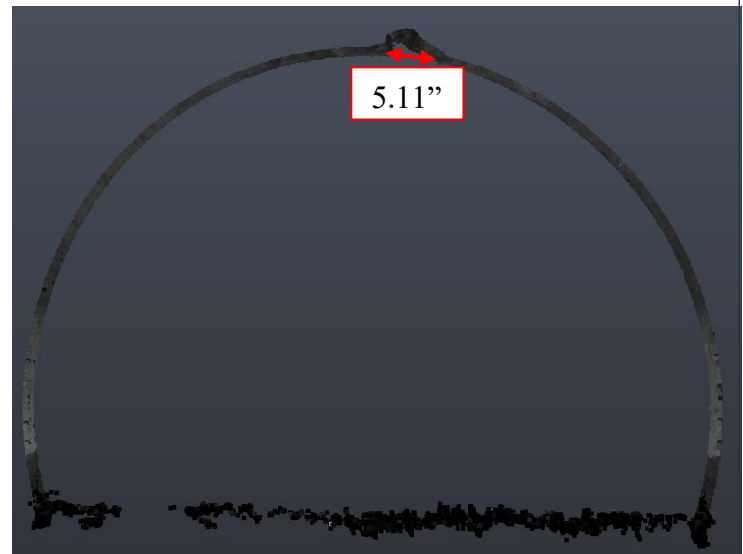
**Figure 4.3.1 – Spalling in Sugarhouse Park Reinforced Concrete Pipe**

Figure 4.3.1 shows the results of the analysis. It was not possible to get a photo of this section that illustrated the full shape of pipe and spall as is seen with LiDAR. This is one of the benefits of LiDAR or Photogrammetry over traditional pipe video inspections. The RTC360 was stationed immediately under the spall, so there is confidence that the RTC360 measurements are accurate. The BLK2GO scan was made, but the file was corrupted in processing and is not available. The testers would like to retest the pipe and amend the document to include the results of the BLK2GO at a later date.

**Photo of Sugarhouse Concrete pipe where the spall was measured.**

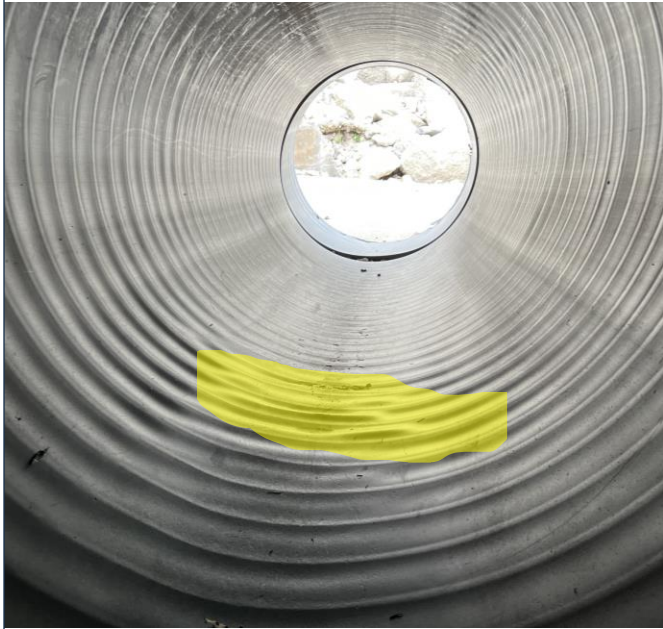
Localized Buckling or Rippling occurs when high stresses occur in plastic pipe walls. This section will review whether LiDAR can detect this small defect. Figure 4.5.1 shows a photo that illustrates the localized buckling and the sectioned point clouds for the different technologies at this location.

Photo with Localized Buckling Highlighted

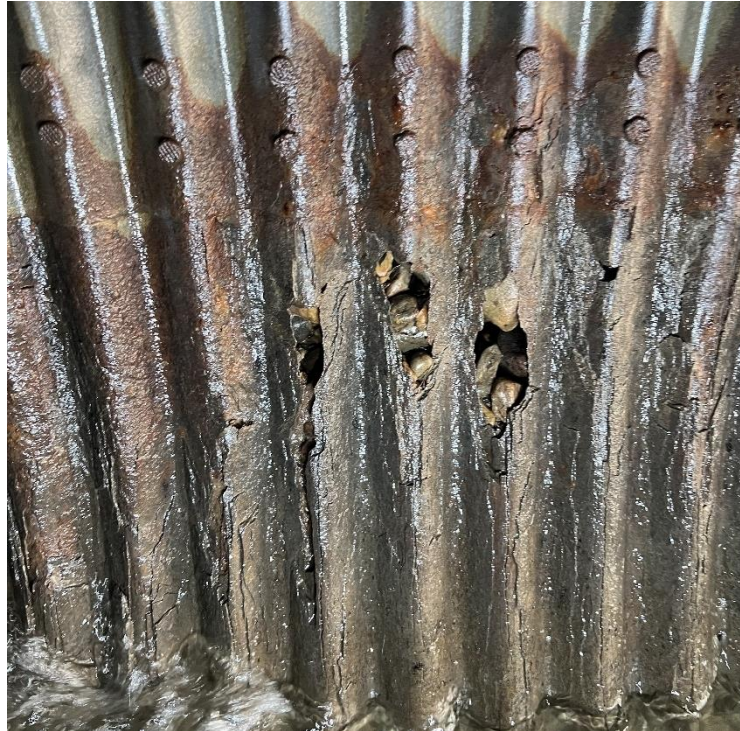
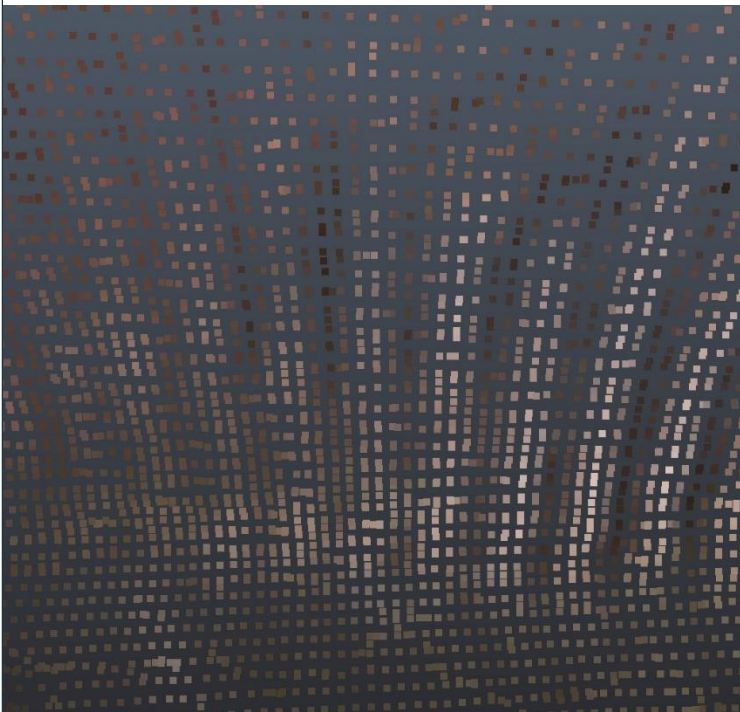
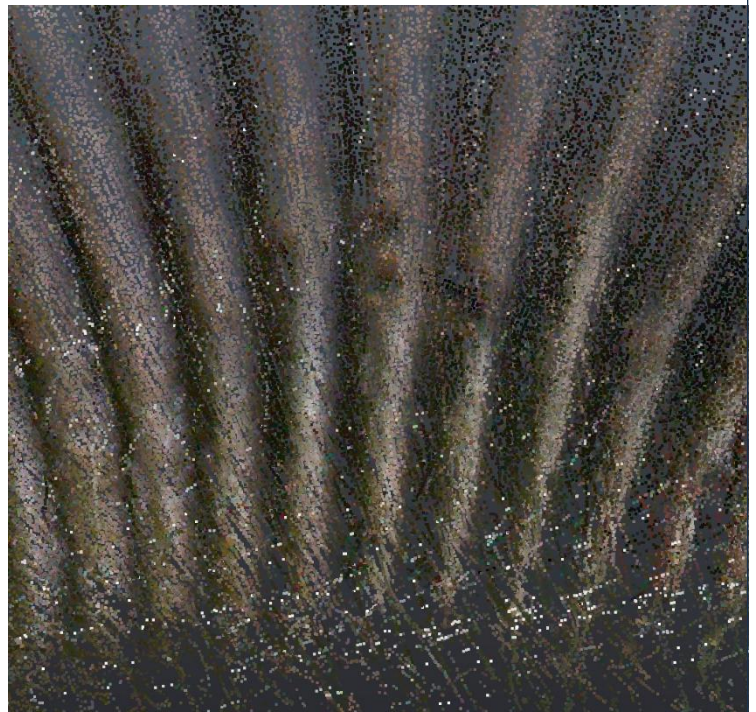
Surface damage was found in Test Pipe 5, the 84-inch Corrugated Metal Plate Arch, that goes under I-80 near the Mt. Aire Canyon exit. This section had corrosion fully through the pipe wall in multiple locations near the low flow line. This area was chosen as it was near the entrance and had the best lighting. Figure 4.6.1 shows the photo of the area with the Pocket LiDAR and BLK2GO scans. The RTC360 was not used as control for this pipe due to the steep conditions to access the inlet.

**Photo of Corrosion Damage**

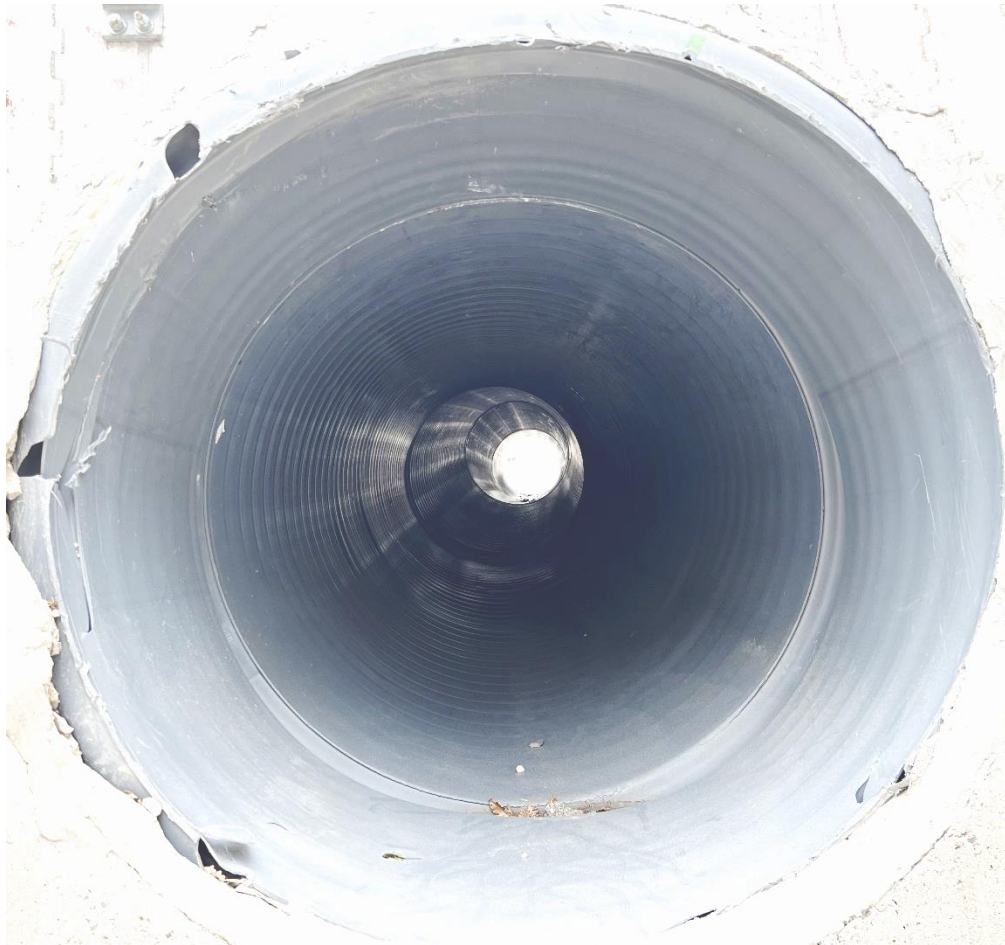
**Figure 4.7.1 – Photo of Interior Grade Change, Lisa Falls 60”  
Polypropylene Pipe**

Figure 4.7.1 shows the Lisa Falls pipe from the downstream outlet. This photo shows how the first sections of pipe, in the background, are at a different slope than the rest of the pipe. Figure 4.7.2 shows the Lisa Falls pipe with lines indicating a straight grade from inlet to outlet. Slope measurements to the broken back point of inflection are shown.
