Final Report

Crime Prevention through Environmental Design (CPTED) for Public Transit Stations

Jennie Perey Saxe, Ph.D.

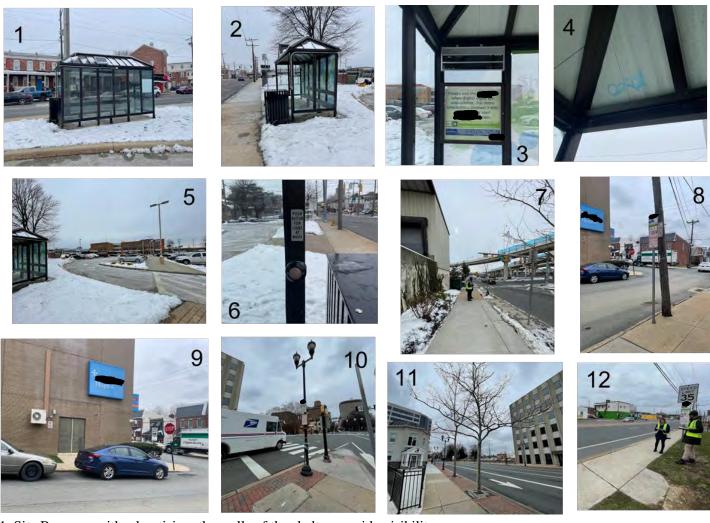
- 1. Site B even with advertising, the walls of the shelter provide visibility.
- 2. Site B waste receptacle, signage, set-back and sidewalk, advertising visible on back wall of shelter.

3. Site B – signage could also encourage safety or maintenance needs to be reported via app; scratch in paint to right of sign.

12. Site F – unobstructed signage, proximity to road (posted limit generally not observed by traffic), and lack of shelter (though concrete is present indicating infrastructure may have been present previously).

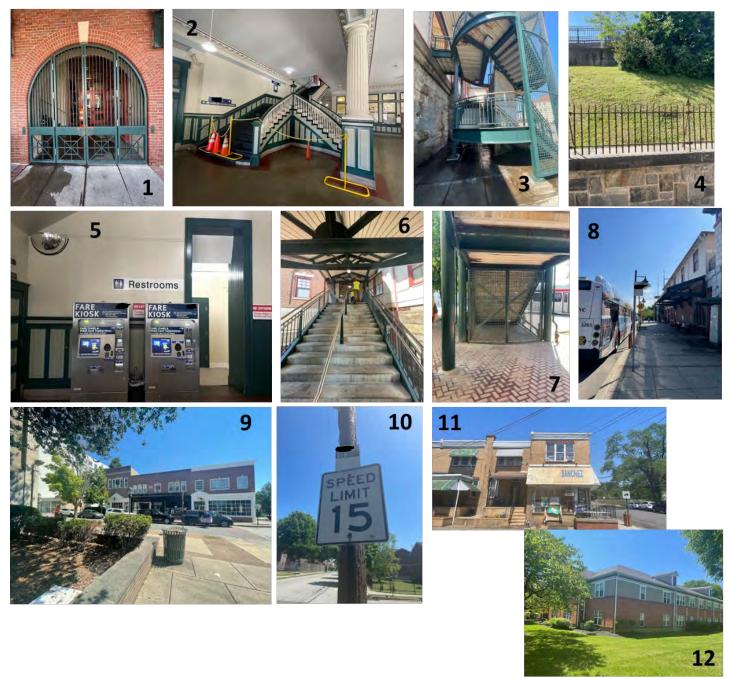
1. Site G gated tunnel to prevent unauthorized access.

2. Site G interior; this side of the stairway and column are not visible directly from the operator booth (background); an installed mirror provides some visibility; also visible is bright paint and lighting.

6 and 7. Site G exterior stairway to northbound platform has open railings and lighting (noted, not assessed); underneath of stairway is partially blocked, reducing opportunities to hide.

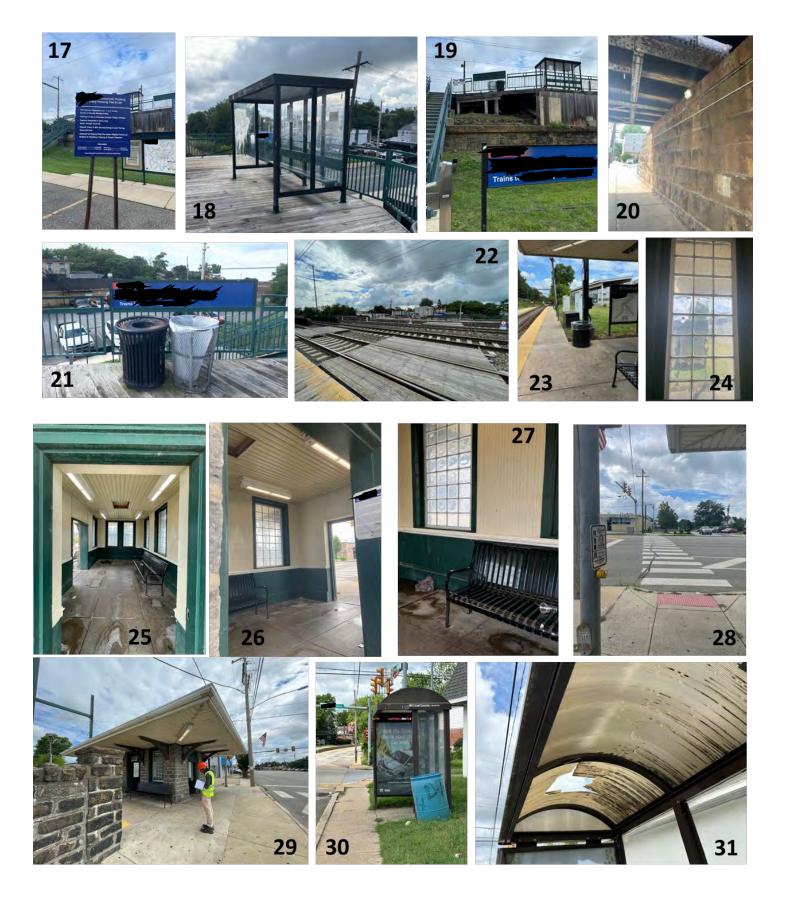
13. Site J: visible are shelter with poor visibility, peeling paint, and rusting roof located in a large parking lot; bollards present but may not be sufficient to prevent vehicle ramming.

14. Site J interior with litter; not shown: rusting roof.

20. Site K sight line beneath track; lighting noted (not assessed); no graffiti present.
