TECHNICAL DEVELOPMENT REPORT NO. 135

FIRE TEST OF R-4360 ENGINE NACELLE AS USED  
IN AN INSTALLATION SIMILAR TO THE B-50

By  
Lyle E Tarbell

Aircraft Division  
Technical Development  
January 1951

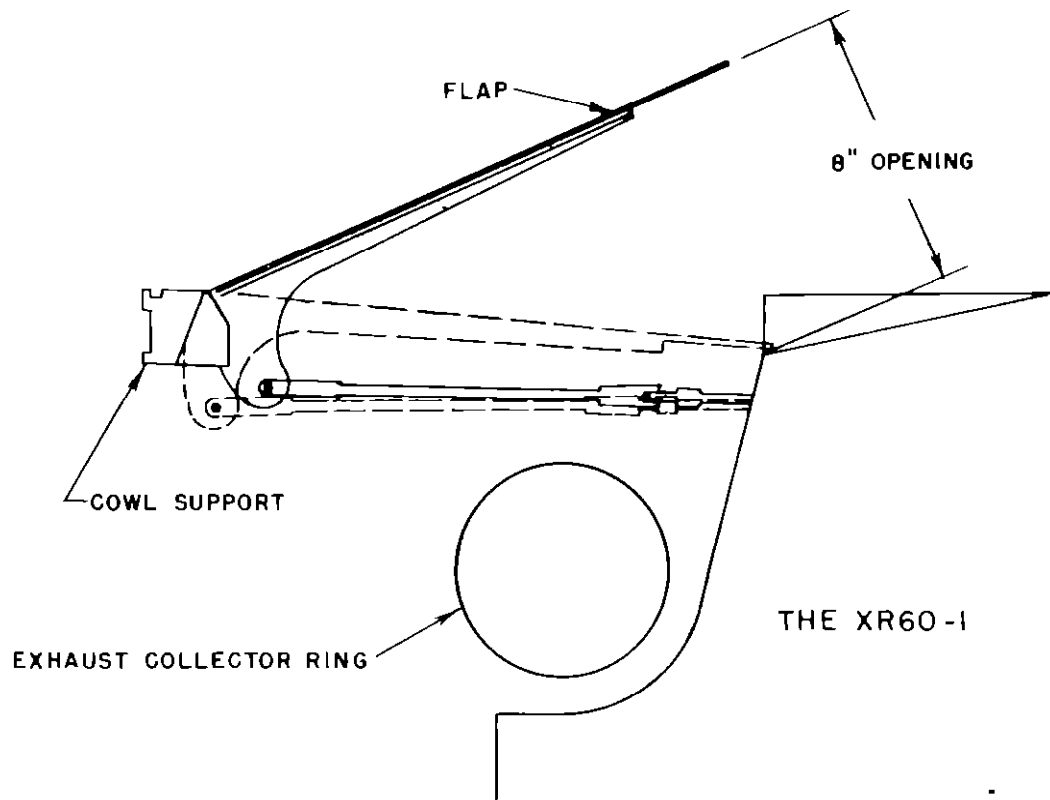
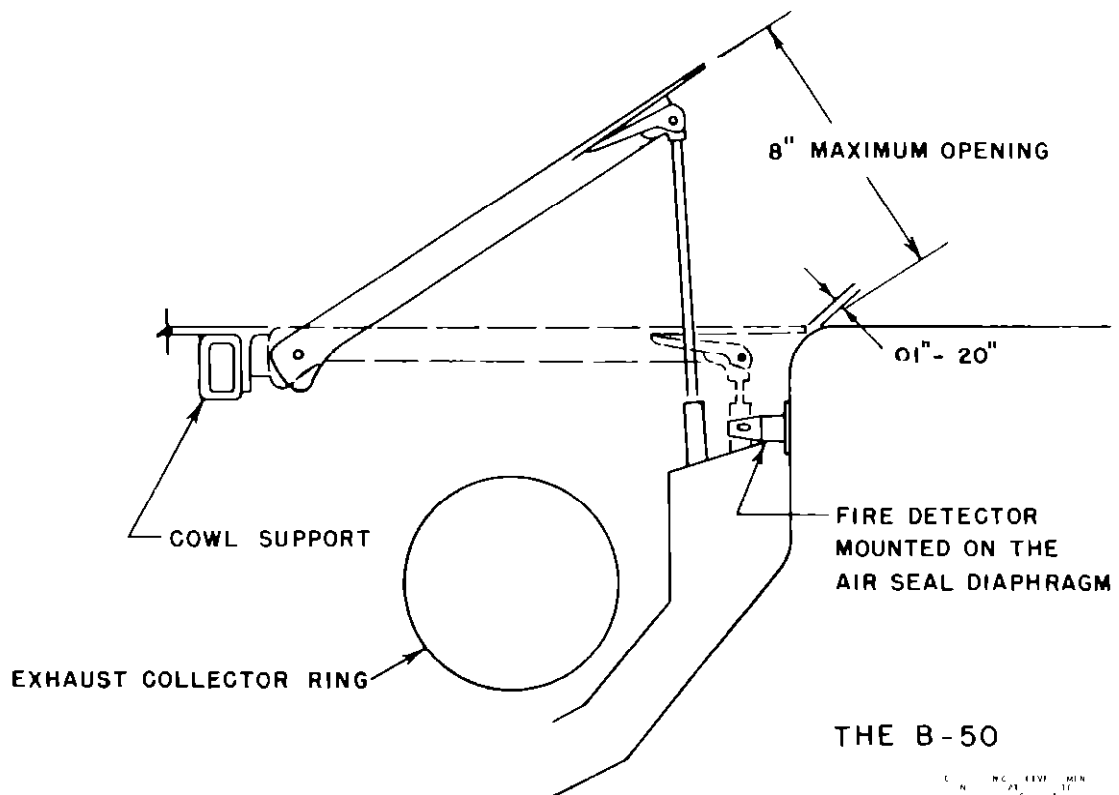
FIG 1 SKETCH SHOWING THE COWL FLAPS OF THE TWO TYPES OF AIRCRAFT IN EXTREME POSITIONS

A large part of the investigation was devoted to the study of fire detectors and fire-detector systems in the power section. The study centered particularly around the cowl-flap region through which power-section fires tend to pass. Fig. 1 shows the comparable views of this region in the two installations. The conclusions based on this study indicate that the present practice of locating the fire-detector system on the air-seal diaphragm of the B-50 has merit. Other locations were found which were as good or better for a wider range of conditions, but, considering the problems of installation and maintenance, as well as the efficiency during the most critical period of aircraft operation, i.e., in flight, a detector system located on the diaphragm constitutes a practical solution to the detector problem in the power zone for this airplane.

1. The present practice of mounting heat-actuated fire detectors on the air-seal diaphragm be continued for practical reasons. Spacing of unit detectors should not exceed eight inches, center to center.

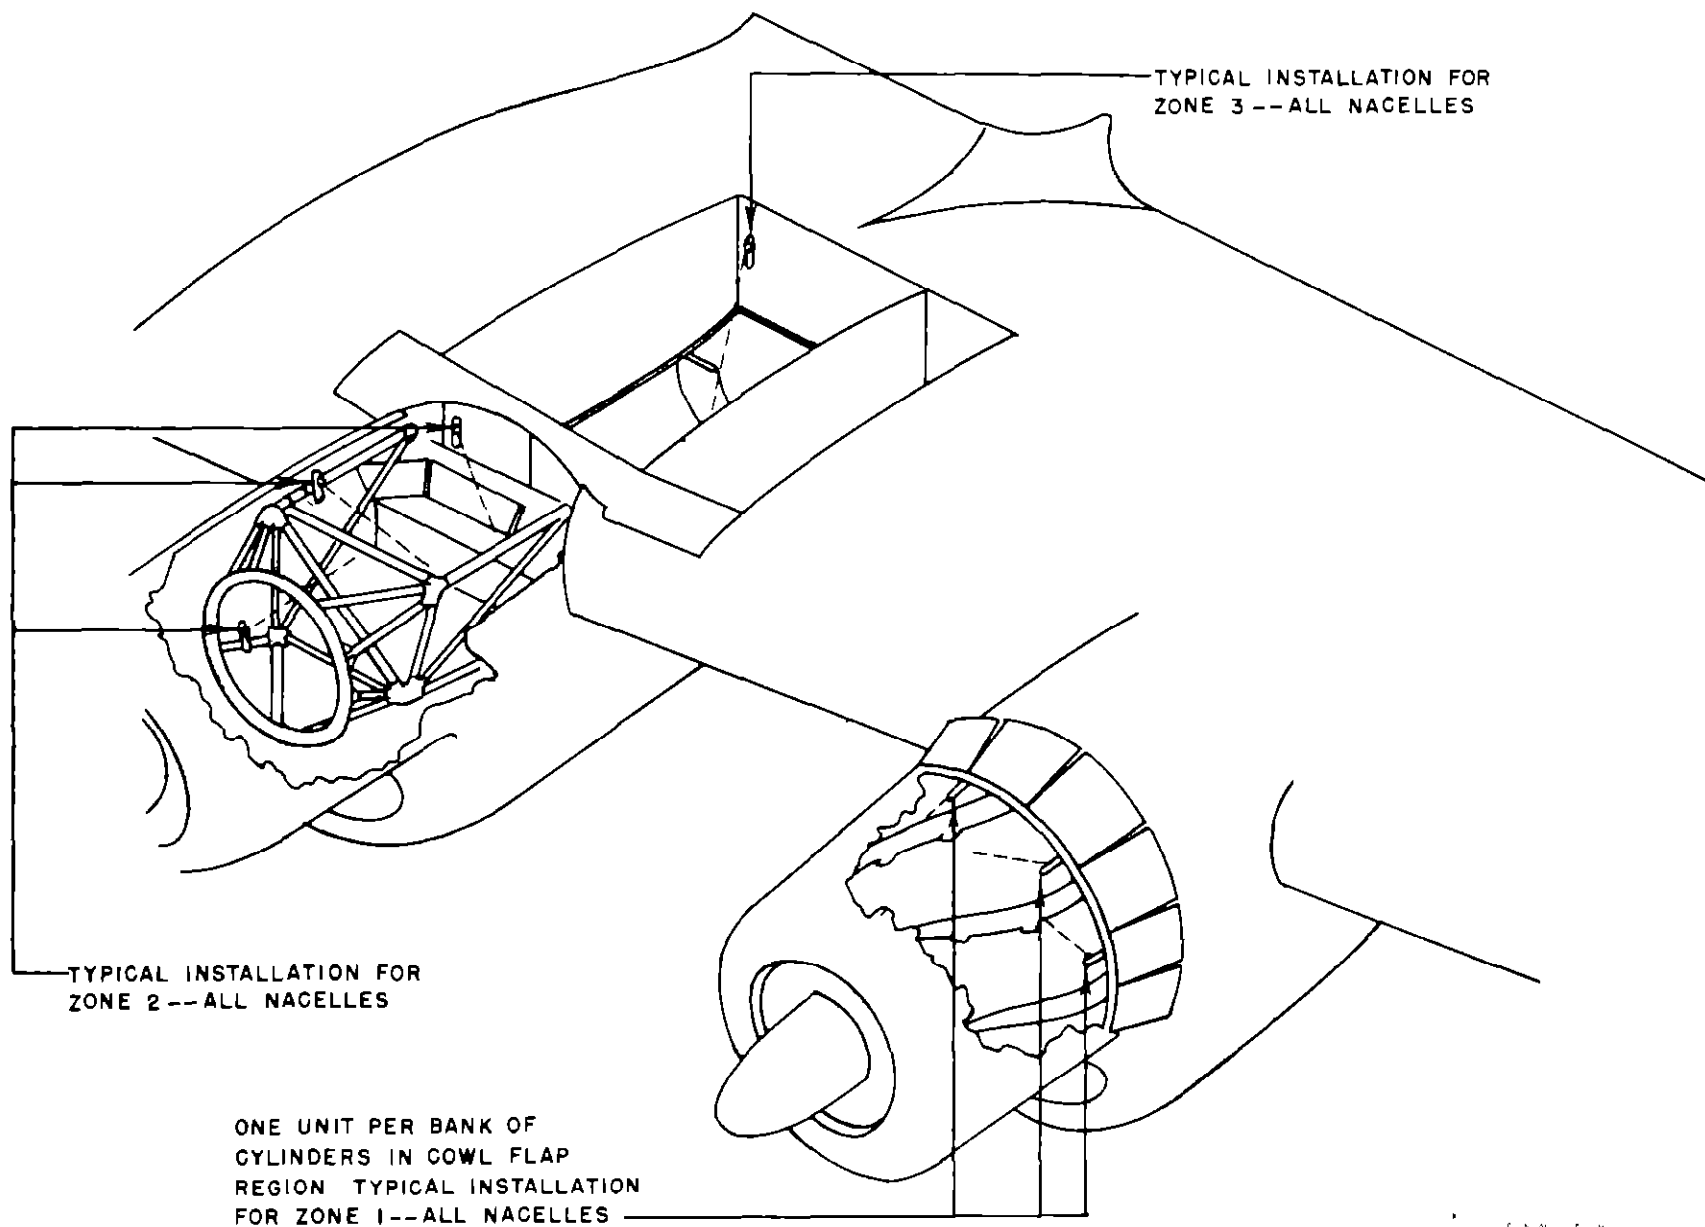
FIG 2 SUGGESTED LOCATIONS FOR FD-2 FIREYE UNITS

A suitable arrangement of Fireye units in the power section involved the use of only five units mounted on the cowl-support ring so that each eye was offset slightly from a direct radial line through an exhaust manifold by moving it around the ring toward the next manifold (approximately one fourth to one third of the distance). The scheme followed was for each eye to be slightly removed from the proximity of an exhaust stack to minimize radiant heating effects and at the same time to maintain a considerable distance between the eye and the next stack to minimize the strength of the infrared radiation. The eyes were directed to view 45 degrees away from the radial line directly into the engine.

lower cylinders. The reason for this was that fires originating near the bottom of the engine tend to emerge through the lower cowl-flap openings on either side of the nacelle and, in doing so, come under the surveillance of other units. Five units located in the general region encompassed by the cowl flaps were considered sufficient. Naturally, no harm is done by the addition of units under the engine if the added protection is felt to be desirable. Fig. 2 illustrates the arrangement in the power section and also suggests other possible locations for the remaining units to complete a system for one nacelle.

3. Fireye flame detectors, if contemplated for use in the power section of the B-50, be located on the cowl-support ring and spaced circumferentially between banks of cylinders. The units should be twisted to view approximately 45 degrees away from a line toward the engine and to avoid a direct view of the hot exhaust stacks. See Fig 2.

4. Fireye units, if contemplated for use in Zone 2 or Zone 3 of the B-50, be installed to observe as much open space as possible within the zones and, also, the areas where flames may tend to enter or leave the zones. See Fig. 2.

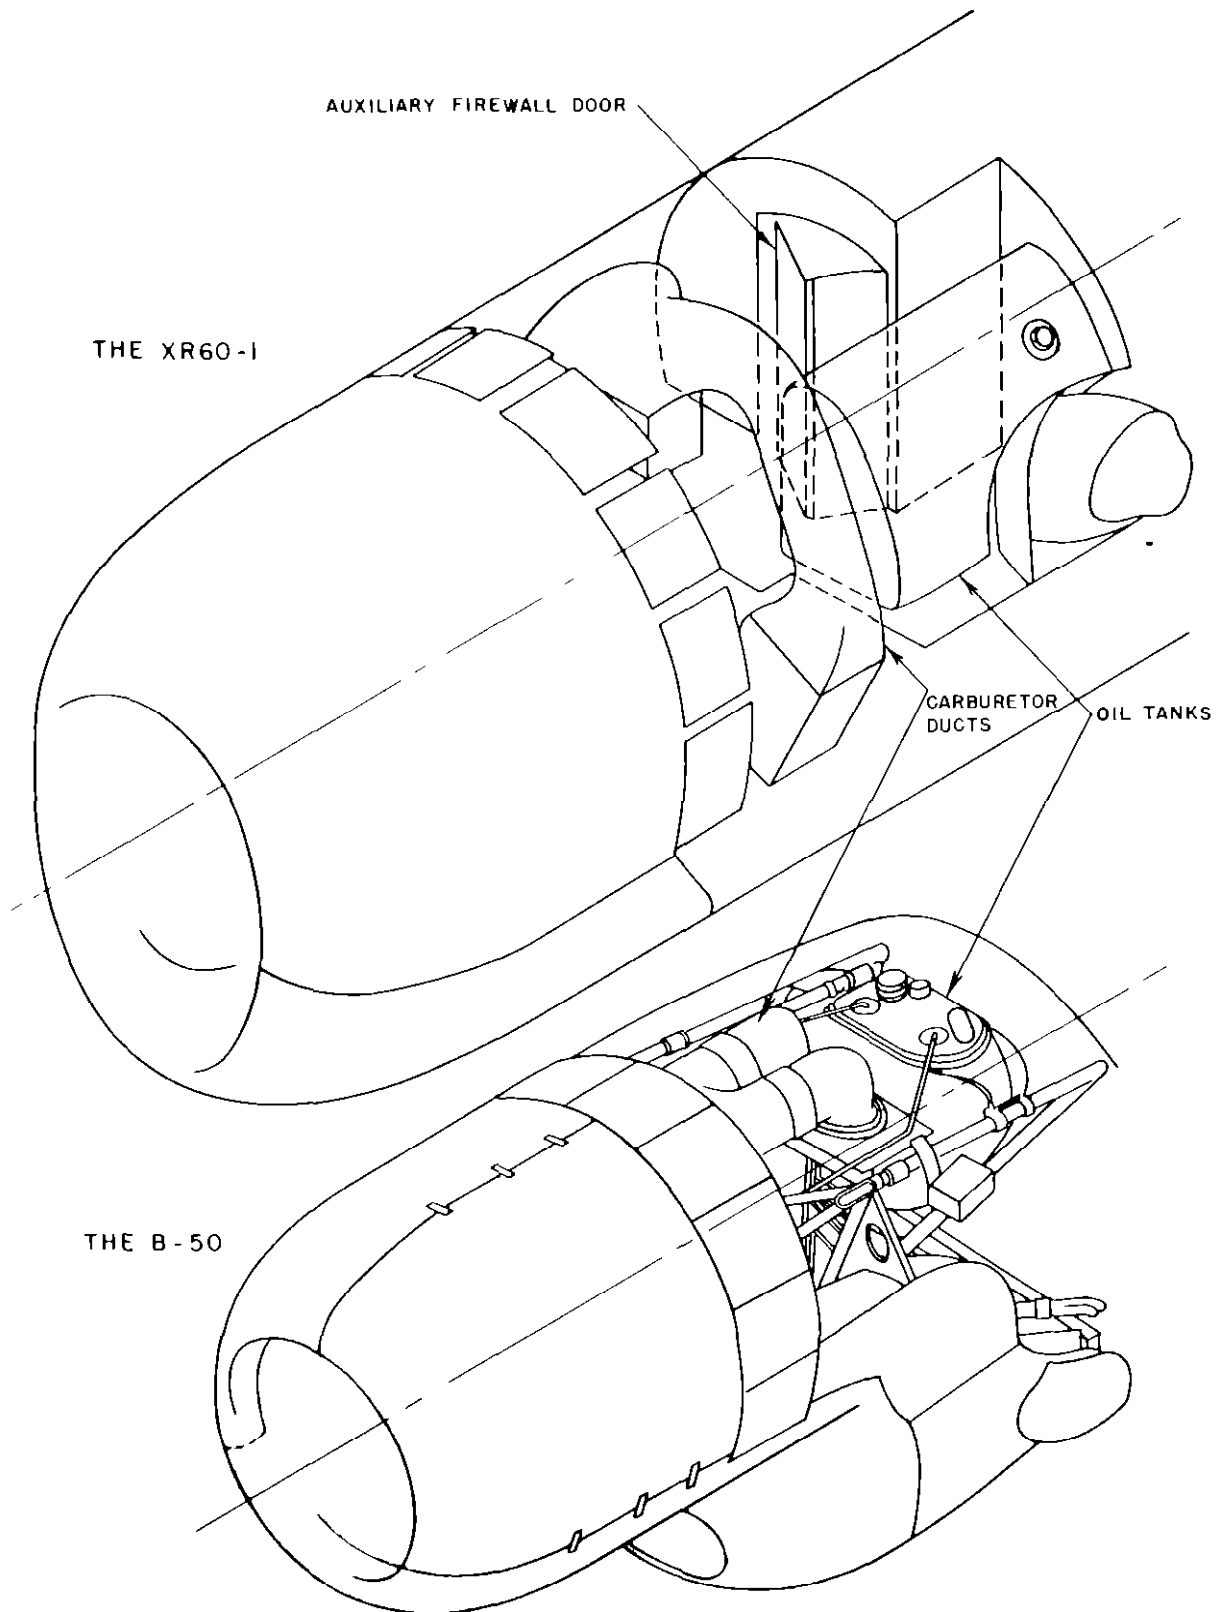
FIG 3 SKETCH SHOWING ARRANGEMENT OF DUCTS AND OIL TANKS IN THE ACCESSORY SECTIONS

The accessory section in the test installation differed considerably from that in the B-50. In the latter installation, the space aft of the air-seal diaphragm is filled to a large extent with ducts, the engine lubricating oil tank and other equipment. In the test installation, however, considerable open space has been provided, as in the flying counterpart, into which a mechanic can crawl via the wing during flight if necessary. This space is divided into two parts by an auxiliary fire wall through which passage is afforded by a folding door. The space forward of this fire wall would correspond roughly to the accessory section of the B-50 in purpose, but there is no space in the B-50 comparable to the space aft of the auxiliary fire wall

It is evident from the sketch that the accessory section is much more congested in the B-50 than in the Constitution. The results of the tests conducted in this region, therefore, may not be directly applicable, but may be used as a general guide to detector installation where specific information is lacking.
