# Riprap Filters and Stability of Riprap-Covered Slopes: Technical Report

Technical Report 0-7091-R1

TEXAS A&M TRANSPORTATION INSTITUTE  
COLLEGE STATION, TEXAS

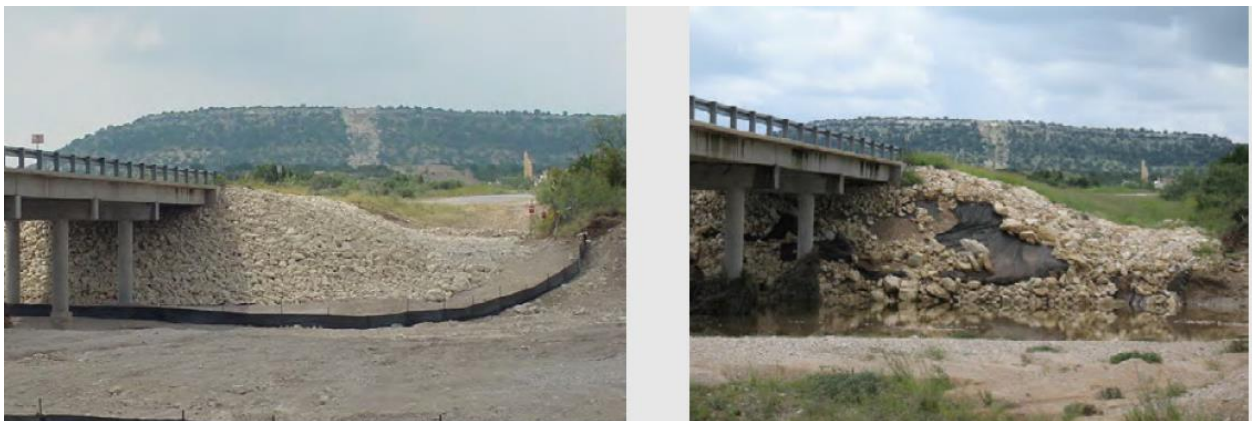
**Particle erosion** is considered the most common type of riprap-covered slope failure. Erosion (displacement) of the riprap stones at the toe of the slope will eventually lead to a failure of the riprap along the slope until the stream velocity is not high enough to move the remaining riprap stones lying near the channel (Figure 10). Figure 11 shows a riprap-covered slope failure due to toe erosion in Texas.

**Figure 11. Toe Erosion Slope Failure (Delphia, 2018).**

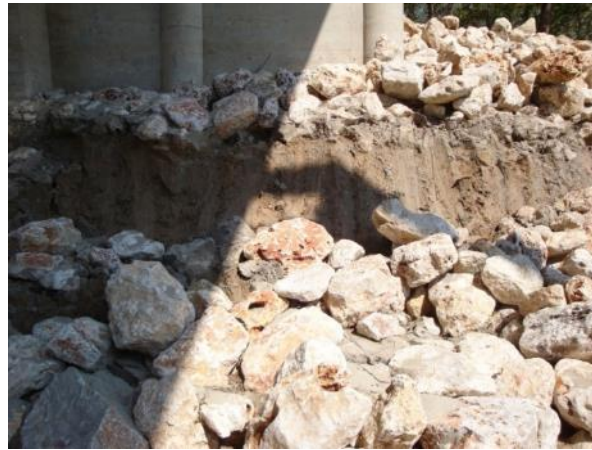
**Figure 67. Riprap-Covered Slope Failure (Briaud et al., 2010).**

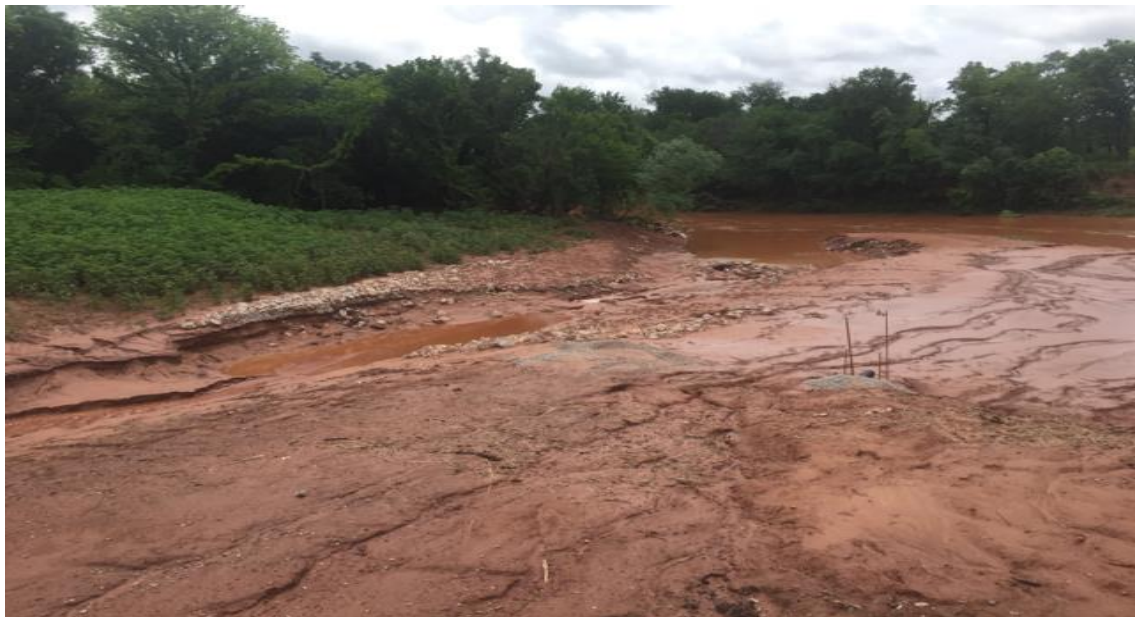
**Figure 85. Riprap-Covered Slope Failure (Courtesy of Oklahoma DOT).**

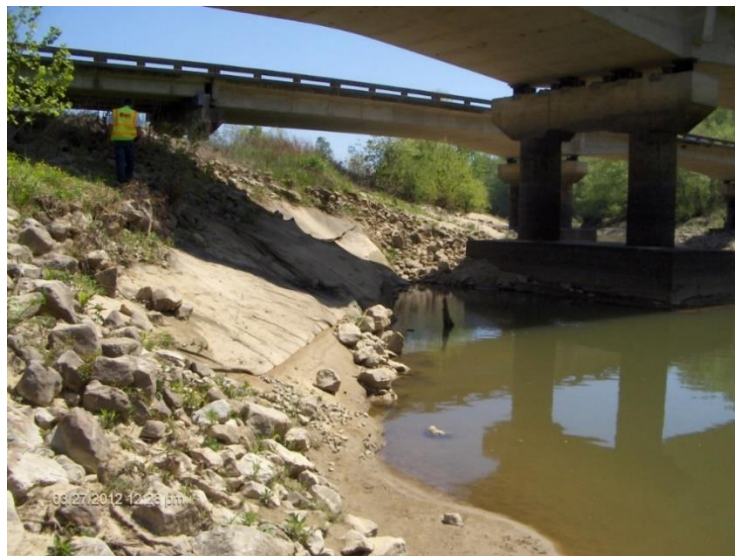
**Figure 87. Riprap Slope Failure (Courtesy of Mississippi DOT).**

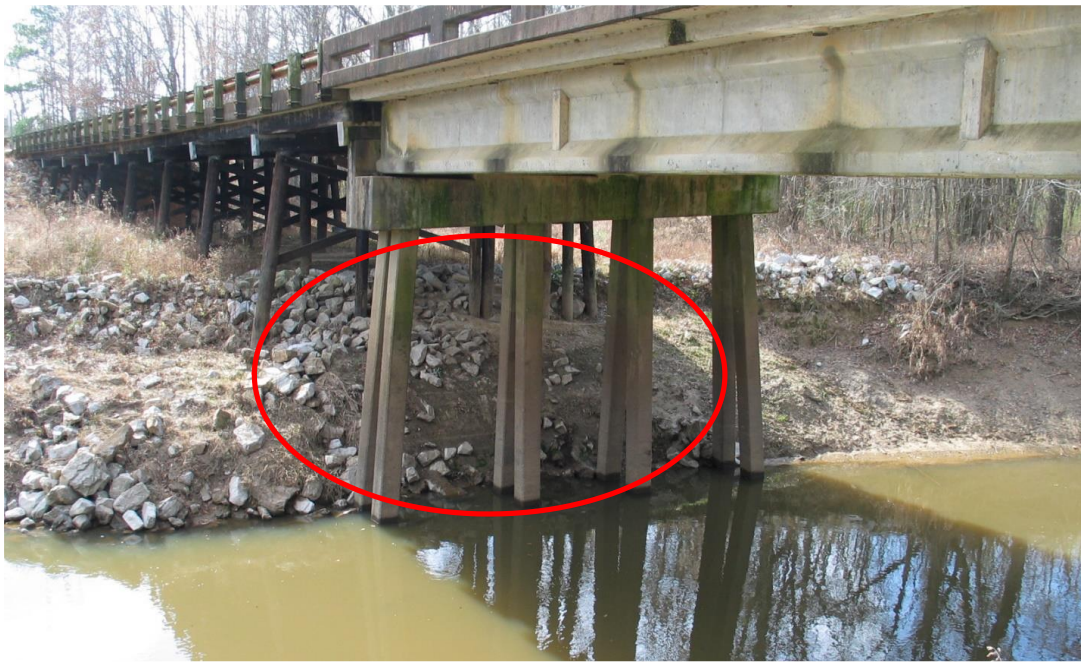
**Figure 88. Riprap Slope Failure (Courtesy of Mississippi DOT).**

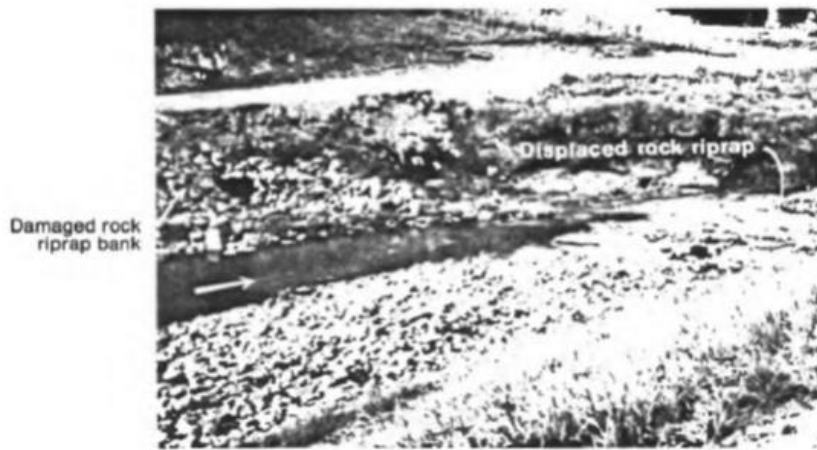
**Figure 89. Pinole Creek Riprap Failure (Blodget & McConaughy, 1986).**

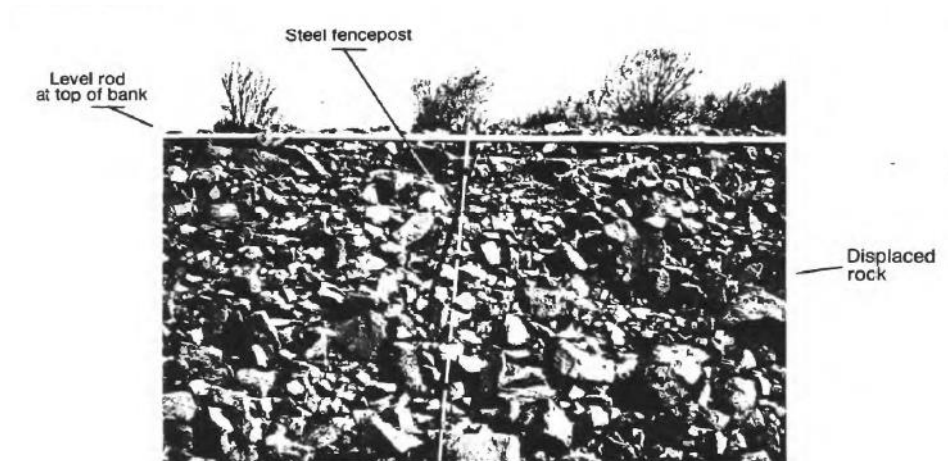
**Figure 90. Site E-10 over Sacramento River Riprap Failure (Blodget & McConaughy, 1986).**

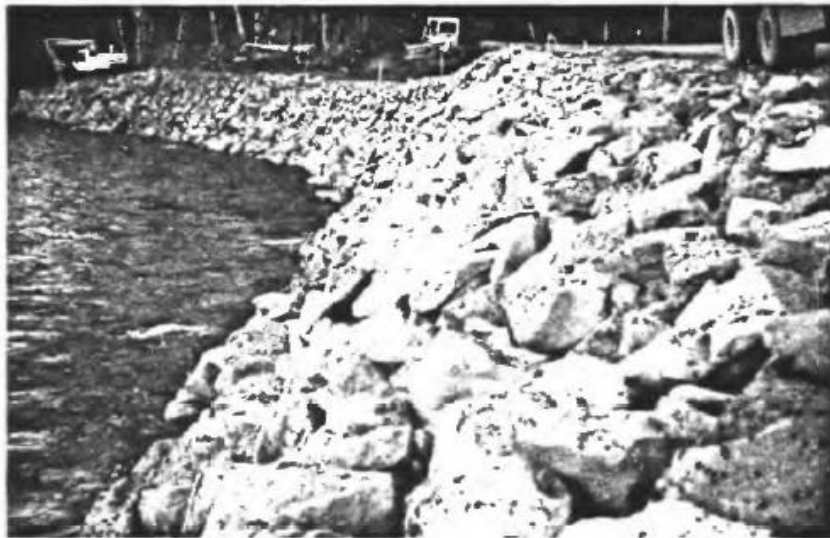
**Figure 91. Hoh River at Site 1 Forks Riprap Failure (Blodget & McConaughy, 1986).**

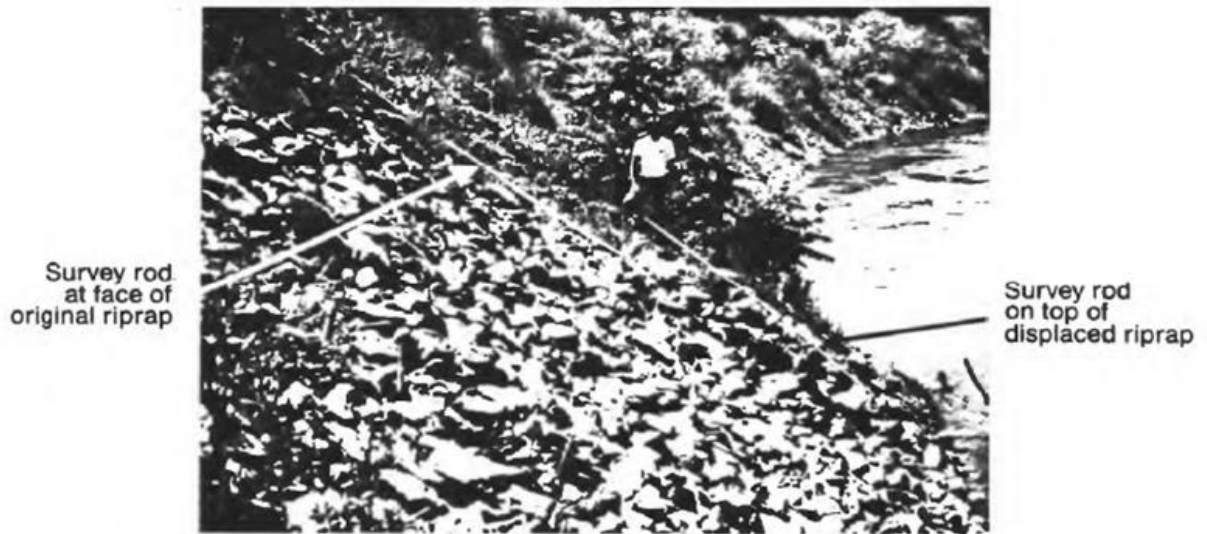
**Figure 92. Cosumnes River at Site 3 Riprap Failure (Blodget & McConaughy, 1986).**

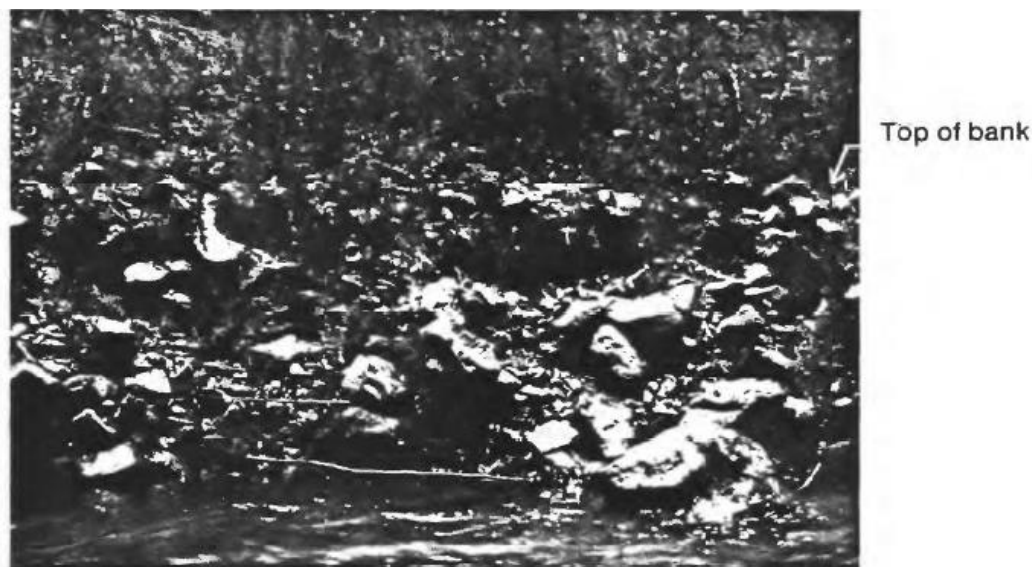
**Figure 93. Truckee River at Sparks Riprap Failure (Blodget & McConaughy, 1986).**

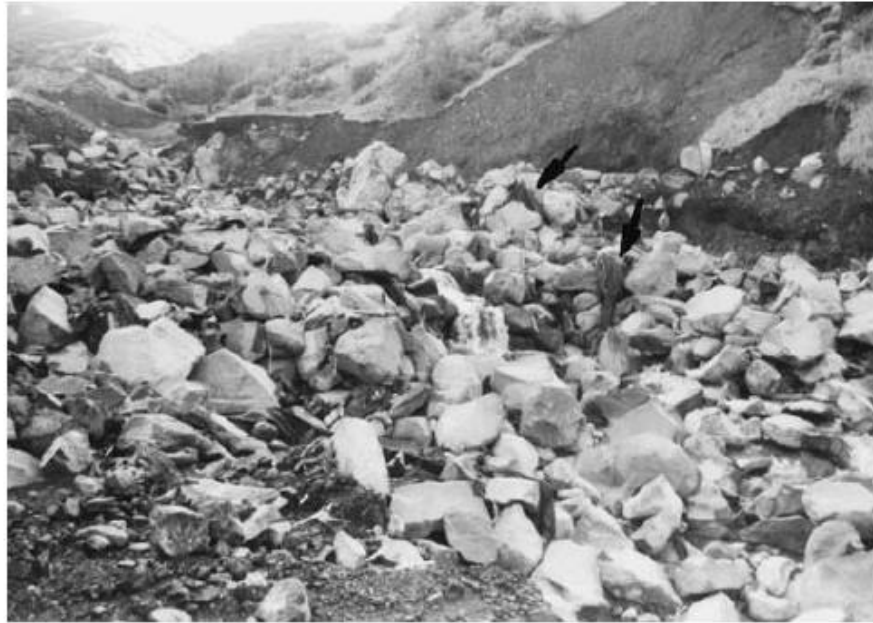
View is looking upstream. Woven-tape geotextile (slit-film) marked with arrows is inappropriate as RSP-fabric on banks (photographed May 1995)

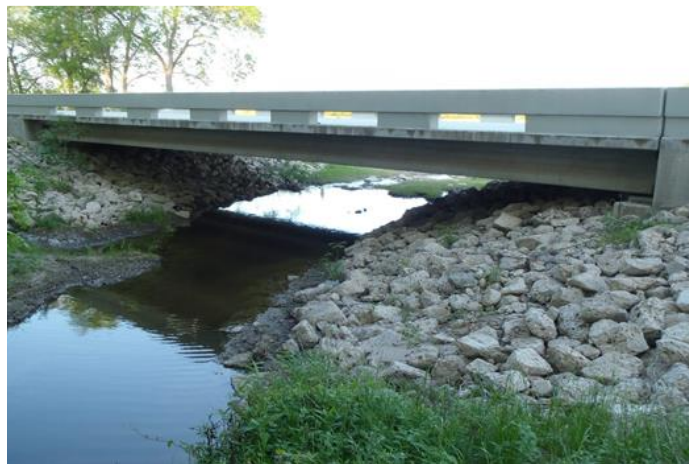
**Figure 97. FM 1155 Little Sandy Creek Riprap Failure (Courtesy of TxDOT).**

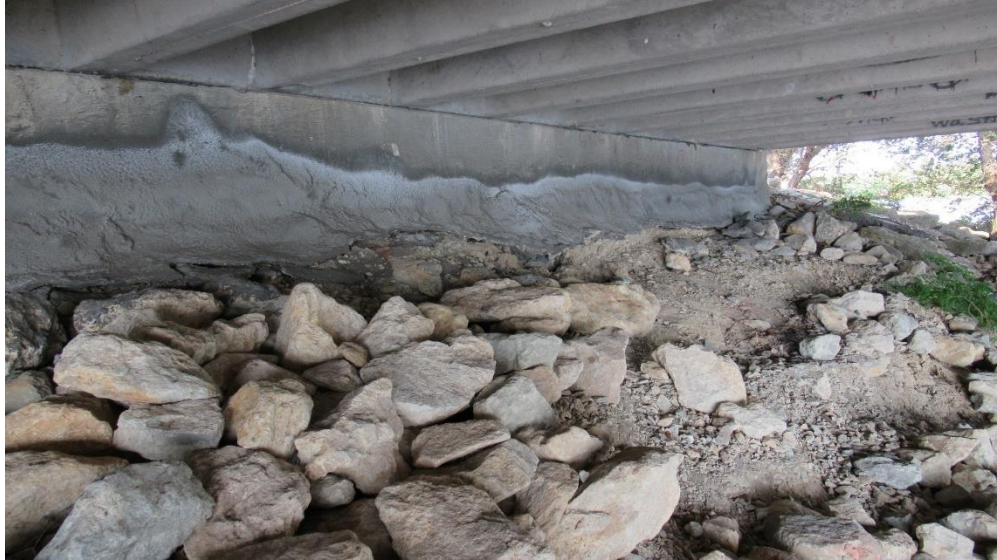
**Figure 100. SH 78 over Price Creek Riprap Slope Failure (Courtesy of TxDOT).**

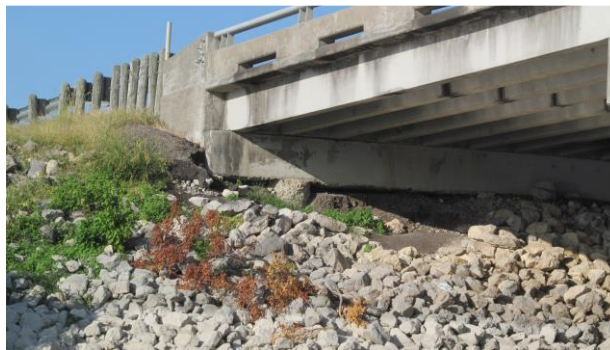
**Figure 101. FM 982 over Tickey Creek Riprap Slope Failure (Courtesy of TxDOT).**

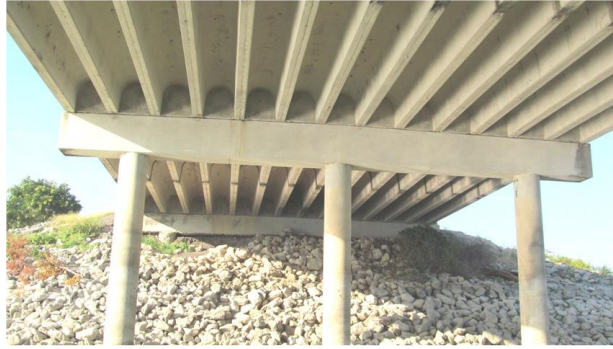
**Figure 102. FM 982 over Tickey Creek Riprap Slope Failure (Courtesy of TxDOT).**

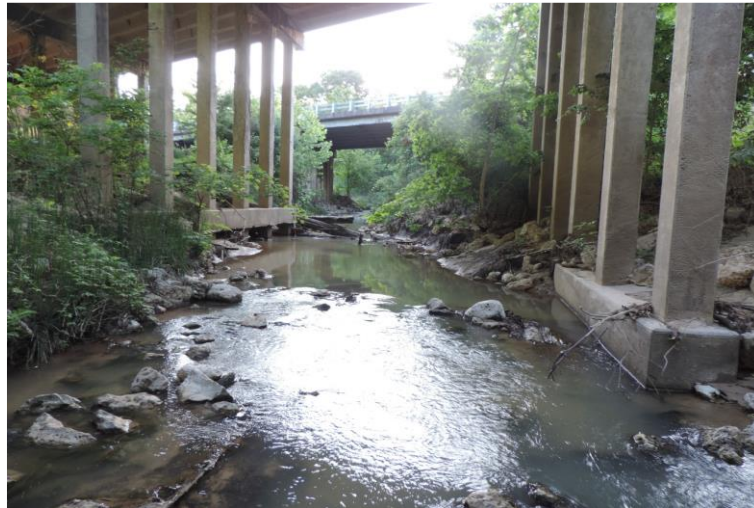
**Figure 103. US 59 over Morgan Creek Riprap-Covered Slope Failure (Courtesy of TxDOT).**

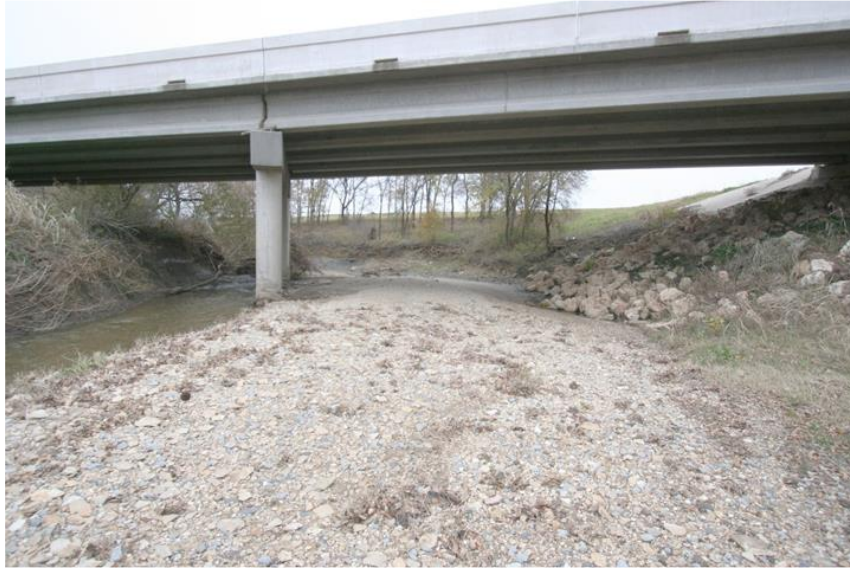
**Figure 104. IH 35 NBFR over Cobb Creek Riprap Slope Failure (Courtesy of TxDOT).**

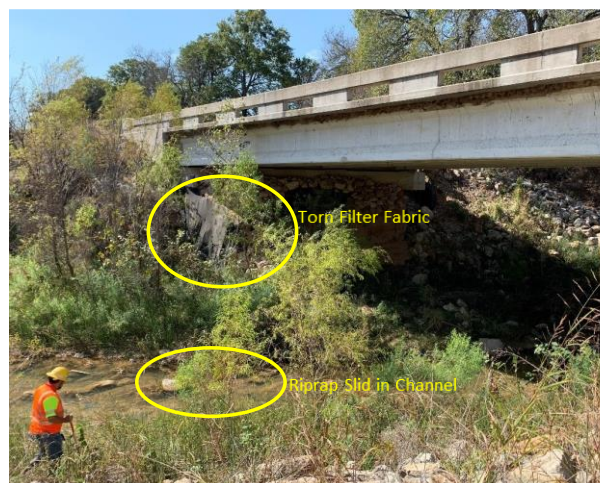
**Figure 106. FM 667 Cobb Hollow Riprap Slope Failure (Courtesy of TxDOT).**

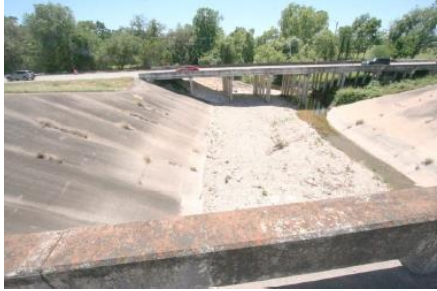
42	TxDOT	SH 71 EB over Rocky Creek - Yoakum	Concrete riprap being repaired by re-installing concrete riprap, but failed again. Rock riprap will be installed instead.

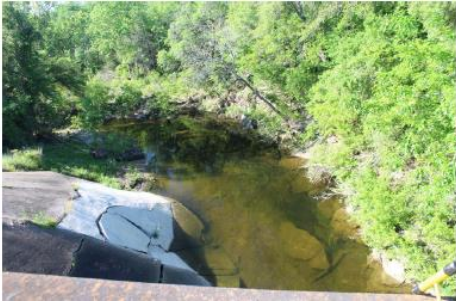
43	TxDOT	FM 667 Cobb Hollow - Wichita Falls	Riprap Washed away
