Project 3.16: CT Bridge Girder Sections with Precast Decks and FRP Girder-Deck Shear Connectors

Final Report April 2024

Department of Civil and Environmental Engineering
University of Maine

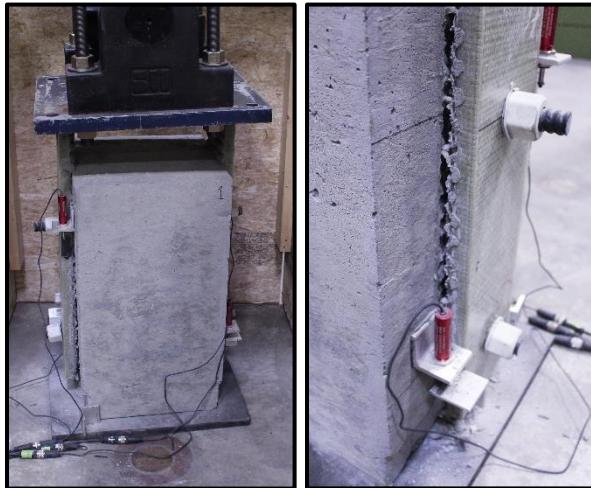
Shear Block 1 completed 368,000 cycles before prematurely failing due to a loss of composite action between the shear-plate and concrete block. This is shown by the visible gap in the connection in Figure 2-6. An inspection of the failed side with the shear-plate removed is shown in Figure 2-7. This inspection revealed that the concrete ridges had sheared off, the top shear connector had splintered apart, and the bottom nut had cracked, further showing the effects of a failure.

Figure 2-6: Shear Block 1 Failure

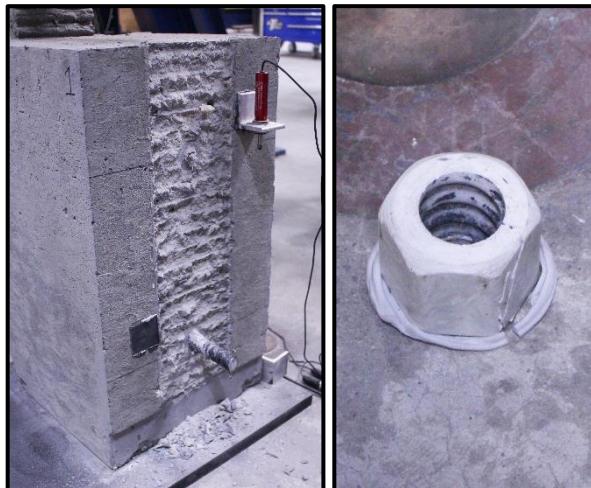
Figure 2-7: Shear Block 1 Failure Inspection

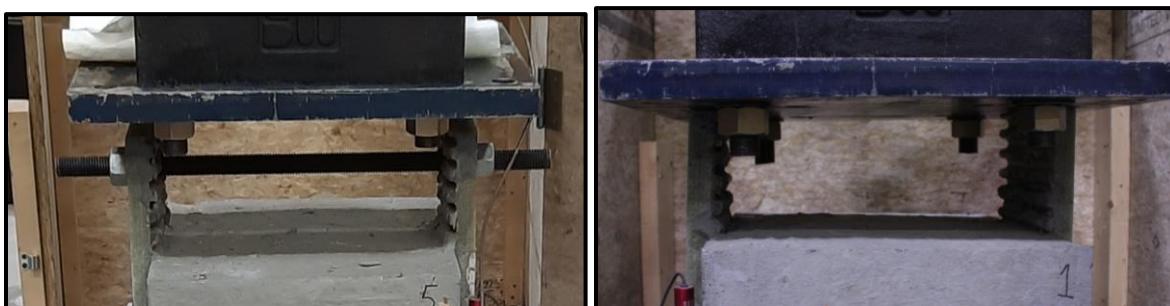
A probable root cause for the premature failure is a missing cross brace between the shear-plates of shear block 1. The cross brace is a steel threaded rod that is intended to prevent unintended eccentric loads from horizontally loading the shear-plates, causing the shear-plates to pry on the other shear connection elements. This prying could fatigue load these components in a way they were not designed for. Figure 2-9 shows a shear block with a cross brace and shear block 1 without its cross brace. Lastly, the low ridge quality of shear block 1, given in Appendix A, may have contributed to the premature failure by further reducing the contact of the ridges.

Figure 2-9: Shear Block with a Cross-Brace (Left); Shear Block 1 Without a Cross-Brace (Right)

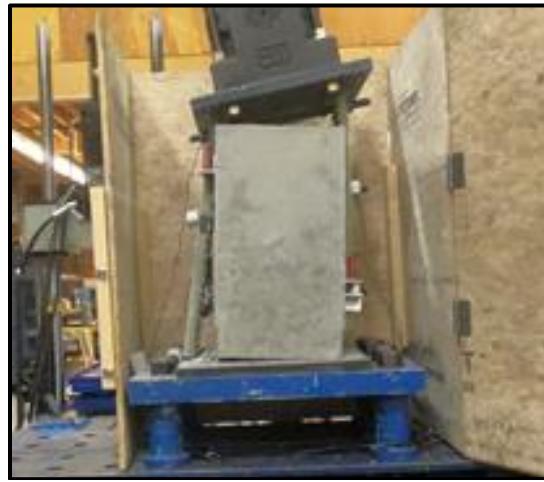
Shear block 3 completed 1.4 million cycles before it prematurely failed, likely due to an unexpected load spike from the actuator. Failure occurred on the side of shear-plate B as shown in Figure 2-12. Figure 2-13 shows shear-plate B’s failed shear connectors, concrete ridges, and a bend in shear-plate A. Unlike in other failures, the bottom FRP nut also was found on the ground apart from the shear block.

Figure 2-12: Shear Block 3 Premature Failure

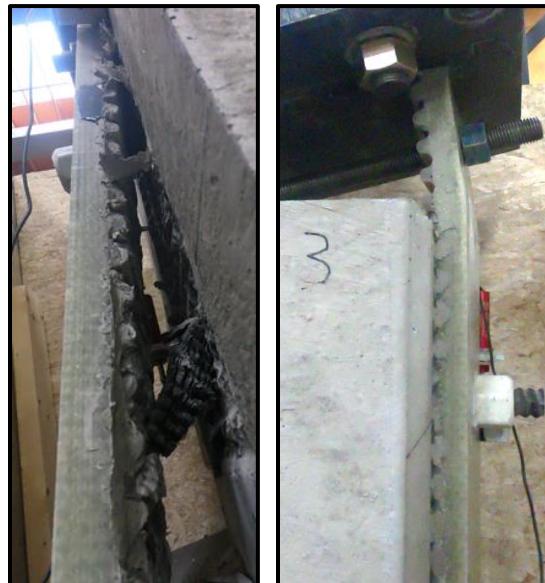
Figure 2-13: Failed Side (Left); Cracked Nut (Center); Bent Shear-Plate A (Right)

Shear block 3 likely failed due to a load spike caused by a malfunction of the Instron controller. Despite the premature failure however, it is possible that the shear block would have failed prematurely during fatigue testing. Both the accumulated slip and stiffness of shear block 3 exceeded those of the specimens that completed 6 million fatigue cycles. Figure 2-114 shows the accumulated slip in shear-plate B near failure reached 0.015 in., three time that of shear block 2. Additionally, the stiffness of shear block 3 was already half that of shear blocks 2 and 4 at one million fatigue cycles as shown in Figure 2-5. Notably, a bend occurred in shear-plate A, which is unique to this shear block. This may be a result of combined bending and buckling in the plate. As plate B failed, the cross braced was pulled with it, applying a lateral bending force on plate A. Additionally, as the plate bent it was compressed as well, increasing the moment, and potentially buckling the plate as well.

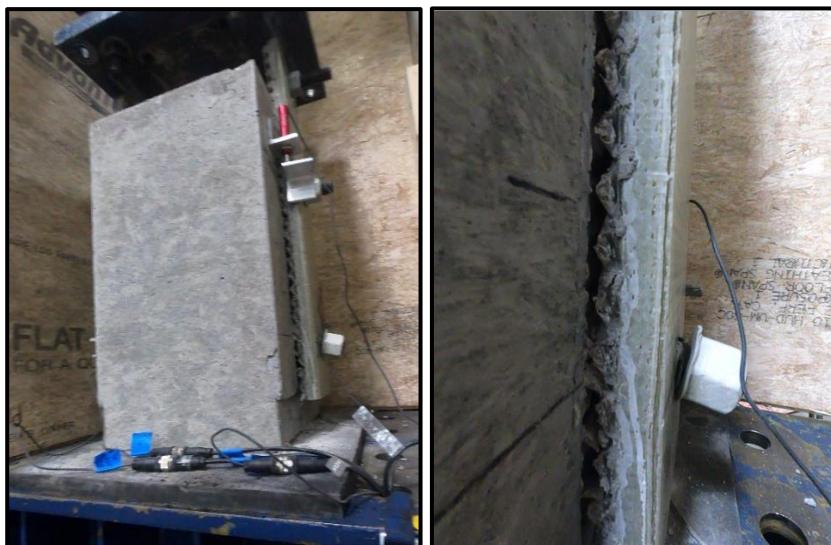
Shear block 5 completed 4.5 million cycles before the side of plate B unexpectedly failed as shown in Figure 2-17. Like shear blocks 1 and 3, the concrete ridges, bottom FRP nut, and Gbar shear connector had failed. Figure 2-18 shows the accumulated slips between the shear-plate and concrete block of the shear block over the test duration. These accumulated slips remained relatively constant for the first three million load cycles. After this, the slip in plate B began to increase rapidly, failing with 0.1 in. of accumulated slip. Figure 2-19 shows the average slip-load response of the shear block at 1,000 cycles and at 4.5 million complete cycles. Since the horizontal displacement between the curves is the difference in accumulated slip between the two cycles, the X-axis scale is relatively large for showing the slips within each load cycle. Additionally, the distance between these two curves is about 0.055 in. and not 0.1 in. since these curves average the slips of both sides of the shear block together.

Figure 2-17: Failed Shear Block 5

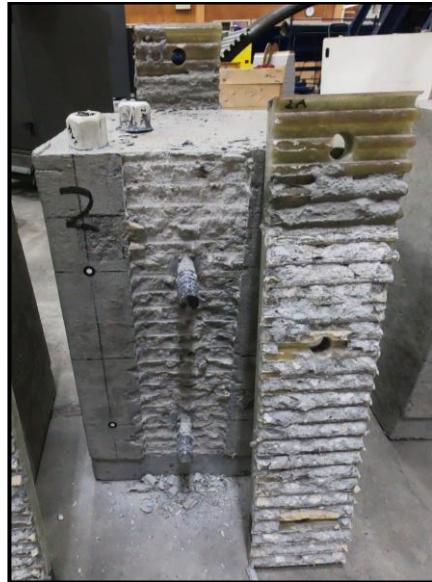
During the failure of shear block 2, there was a large and a small load peak, followed by a plateau proceeding failure in Figure 2-2. To determine the corresponding failure sequence of the shear connection, the protos presented in Figures 2-26 and 2-27 were taken. Figure 2-26 shows the shear block post failure. Plate A was removed to examine the extent of the damage, revealing the concrete ridges had sheared off the specimen, and both FRP nuts had cracked. The Gbar however, had not failed in shear. Meanwhile, Figure 2-27 shows crack propagation through the bottom FRP nut as it split apart. These images correspond to the transition between the plateau in Figure 2-22, and the rapid load drop afterwards. From these images it is most likely that failure started with the concrete ridges at peak load. Then, the shear connectors began to bend as they carried more of the shear load. This caused the shear-plates to push against the FRP nuts, which then cracked under the loading. This allowed the shear-plate to then slide along the shear connector, unloading it.

Figure 2-26: Shear Block 2 Failure

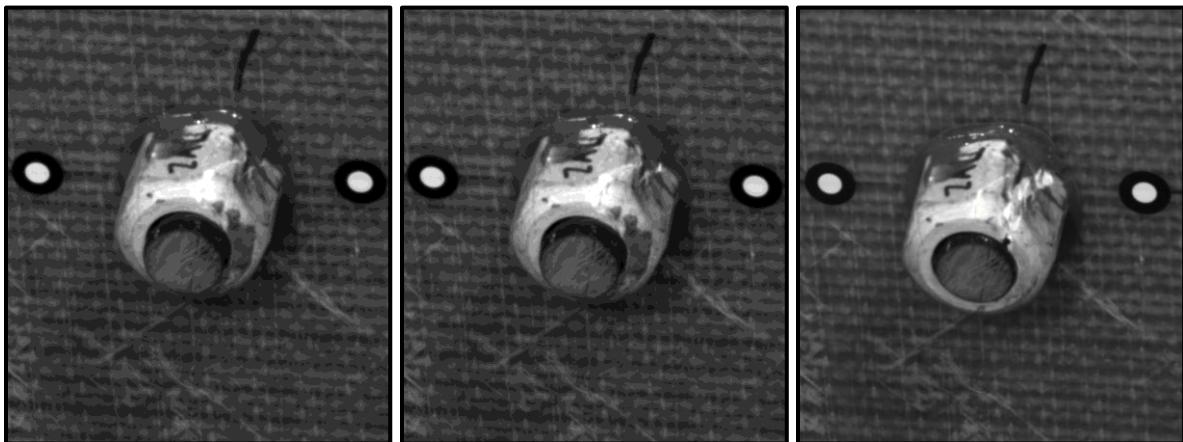
Figure 2-27: Shear Block 2 DIC Progressive Nut Failure

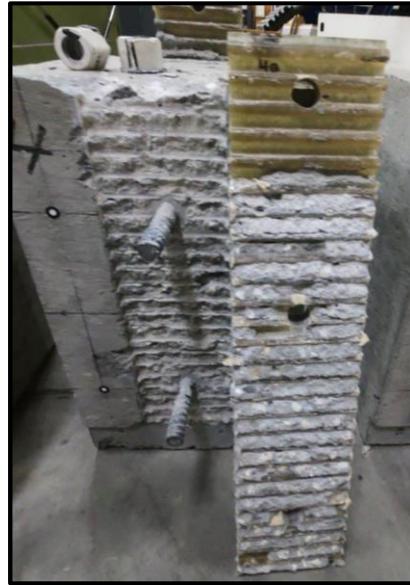
The effects of failure on shear block 4 are like those observed in shear block 2. Figure 2-30 shows the concrete ridges failed, and the G-bar shear connectors did not. The FRP nuts are cracked as well. Figure 2-3 shows the DIC frames corresponding to before and after the first load-displacement peak seen in Figure 2-2. In Figure 2-31 a crack forms in the concrete to the right of the shear-plate along its bottom edge, and a crack to the left expands, spalling concrete off. Figure 2-32 shows the DIC frames corresponding to the second load-displacement peak. In these frames the previous cracks expand and release from the stud, and the FRP nuts crack apart.

Figure 2-30: Shear Block 4 Inspection

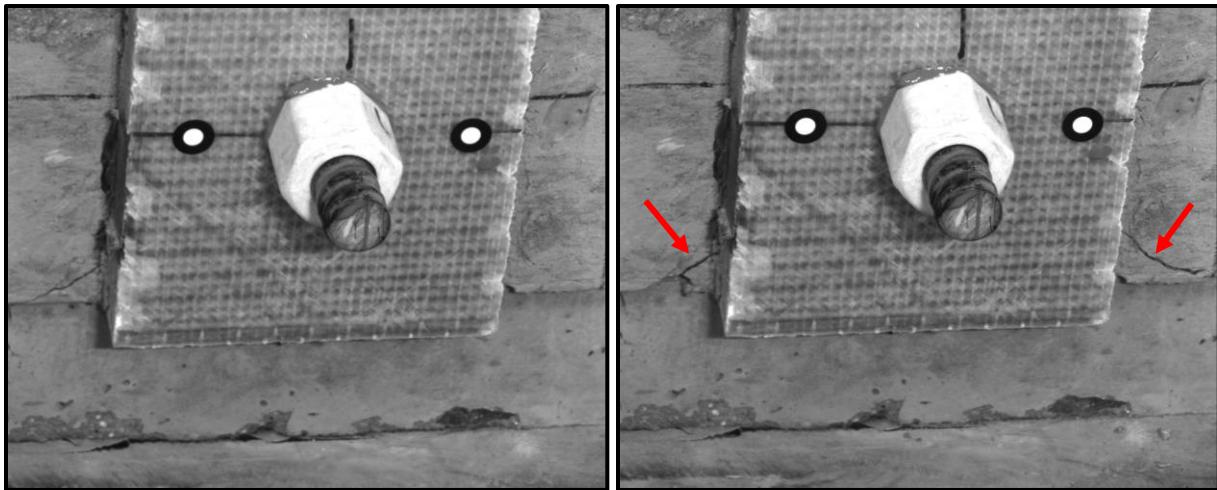
Both sets of DIC frame suggest the concrete ridges initially failed or started failing during the first load peak, leaving the shear connectors to carry the load until the FRP nuts failed during the second and final load peak.

Figure 2-31: Shear Block 4 DIC Frames Before and After the First Load-Displacement Peak

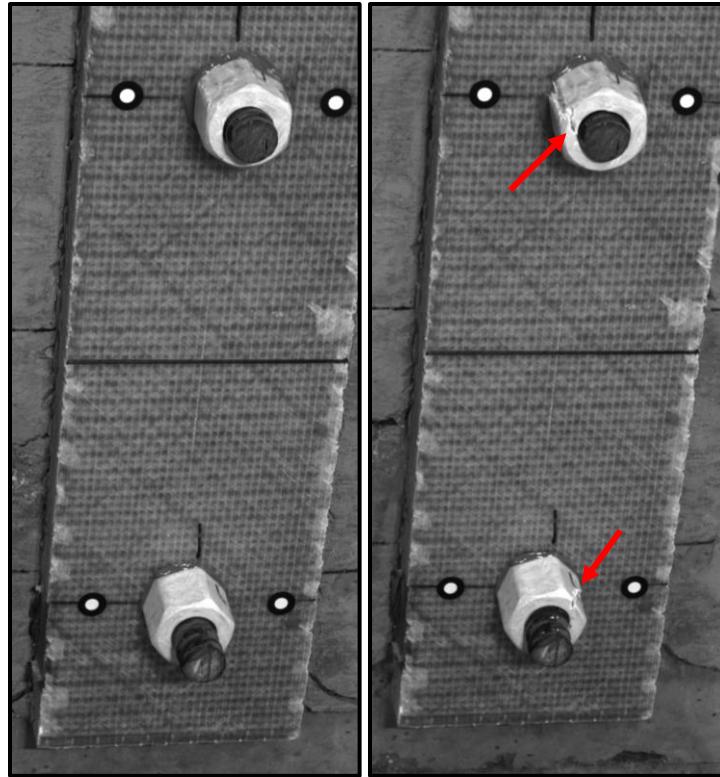
Figure 2-32: Shear Block 4 DIC Frames Before and After the Second Load-Displacement Peak

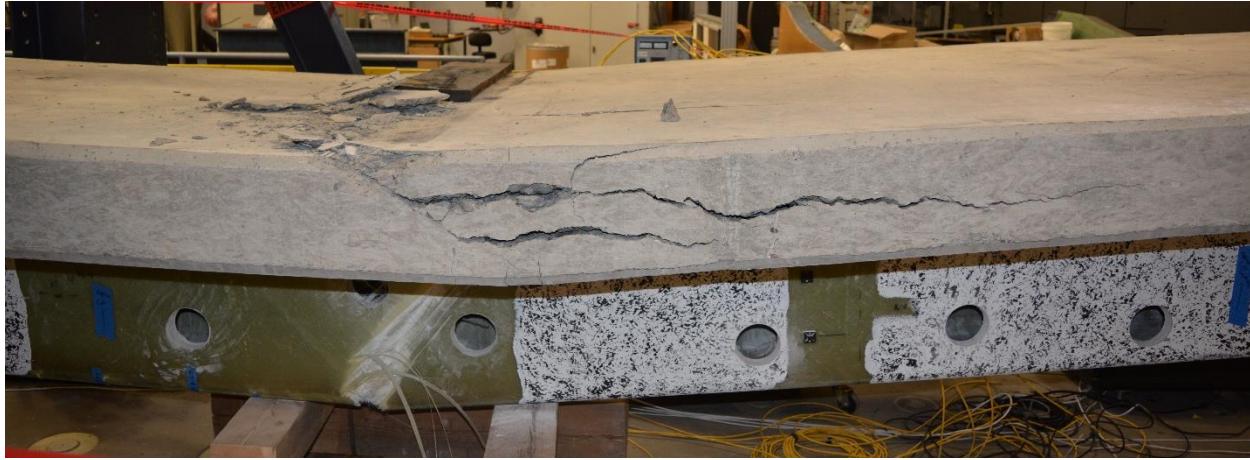
Figure 4-13: Image UTC-4 of Failure Location and Damage
