Flammability of Automotive Child Restraint Seats for Use in Aircraft

November 2001

DOT/FAA/AR-TN01/42

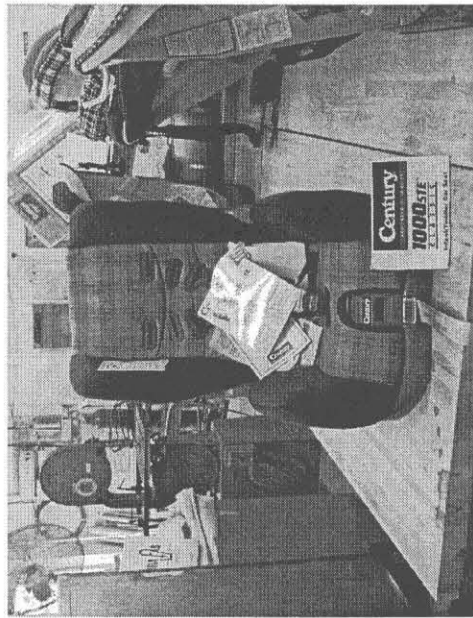
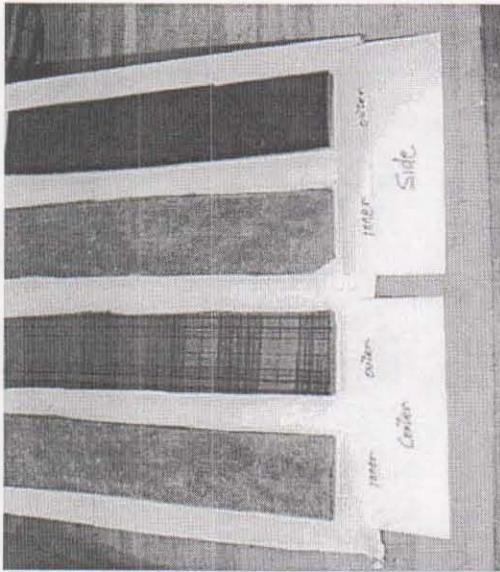
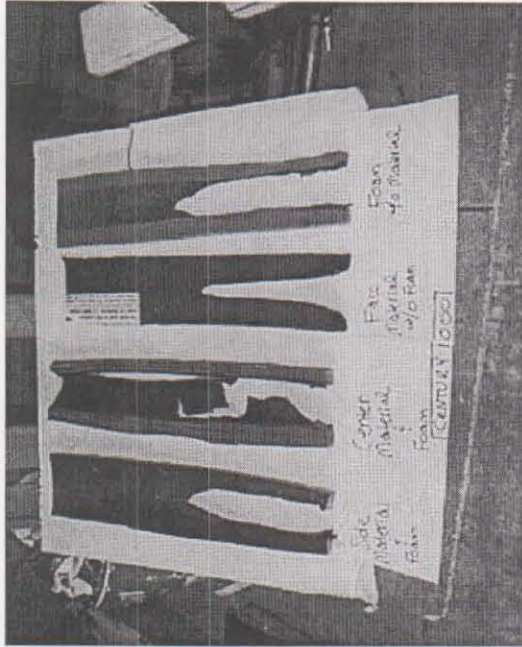
FIGURE 1. CENTURY 1000 STE: \$49.00

- Century 1000 STE. Four of the six seat materials failed the vertical test criteria (figure 1). The center (checked) material was the most flammable, failing both flame time and burn length criteria (entire sample length was burned). Even those materials that passed had relatively long burn lengths (>5 inches).

Material Name	Time to Ignition (min:sec)	Flame Time (min:sec)	Burn Length (inches)	Drip Flame Time (min:sec)	Comments
Sides (blue)	0:01	0:14	Face: 7.0 Back: 7.8	0:00	Fail
Sides (blue)	0:01	0:30	Face: 7.4 Back: 10.0	0:00	Fail
Sides (blue)	0:01	0:02	Face: 5.6 Back: 6.5	0:00	Fail
Center (checked)	0:01	1:23	12.0+	0:00	Fail
Center (checked)	0:01	1:21	12.0+	0:00	Fail
Cloth Face (no foam)	0:01	0:00	Withdrew 5.8	0:00	Pass
Foam Alone (w/o cloth face)	0:01	0:12	10.0	0:00	Fail
Plastic Structure	0:01	2:18	7.5	0:30	Fail
Foam Backing	0:01	0:04	5.75	0:00	Pass

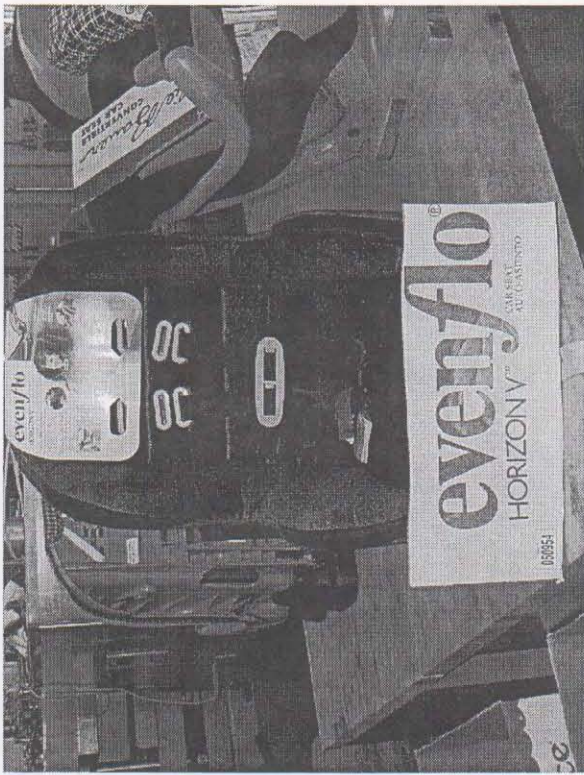
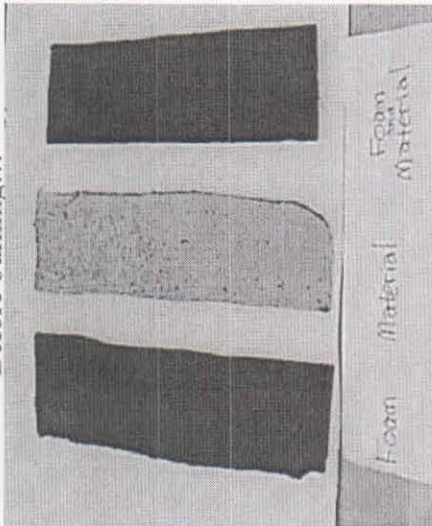
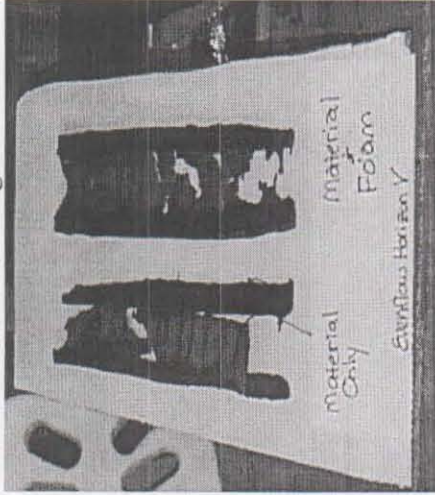
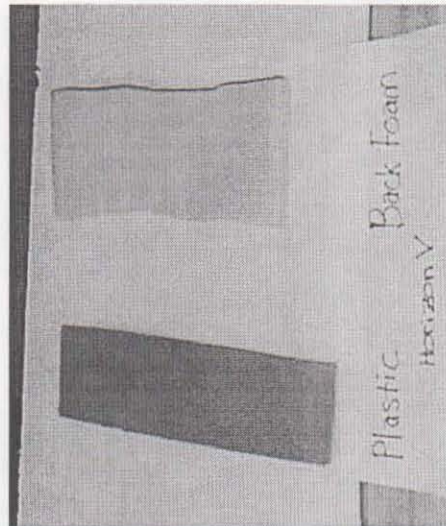
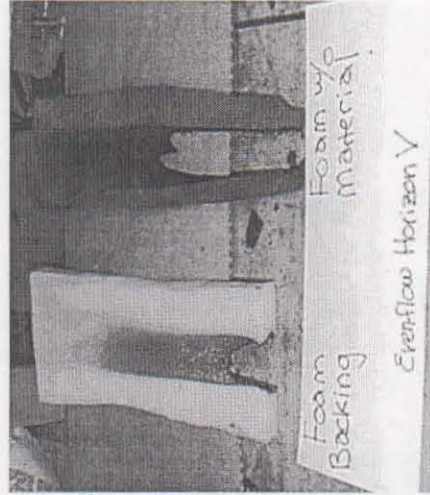
FIGURE 2. EVENFLO HORIZON V: \$79.99

- Evenflo Horizon V. Four of the five seat materials failed the vertical test criteria (figure 2). Three of the failed materials exceeded both the allowable flame time and burn length (entire sample length was burned).

Material Name	Time to Ignition (min:sec)	Flame Time (min:sec)	Burn Length (inches)	Drip Flame Time (min:sec)	Comments
Outer Material (entire seat)	0:01	1:10	12.0+	0:00	Fail
Outer Material (entire seat)	0:01	1:16	12.0+	0:00	Fail
Outer Material (entire seat)	0:01	1:12	12.0+	0:00	Fail
Cloth Face	0:01	0:53	12.0+	0:00	Fail
Plastic Structure	0:01	7:10	12.0	0:00	Fail
Foam Alone (w/o face)	0:01	0:00	9.0	0:00	Fail
Foam Backing	0:01	0:00	6.0+	0:00	Pass

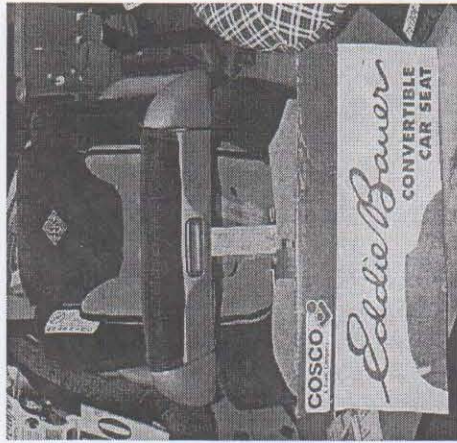
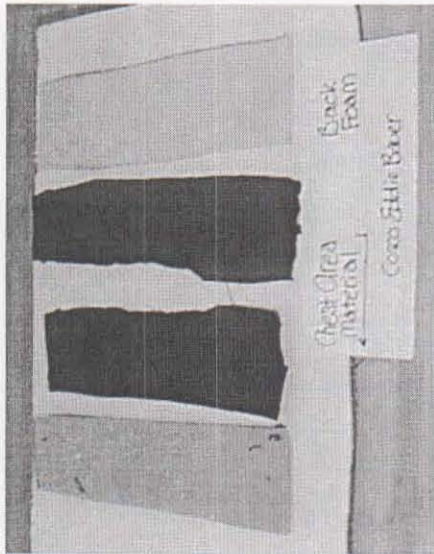
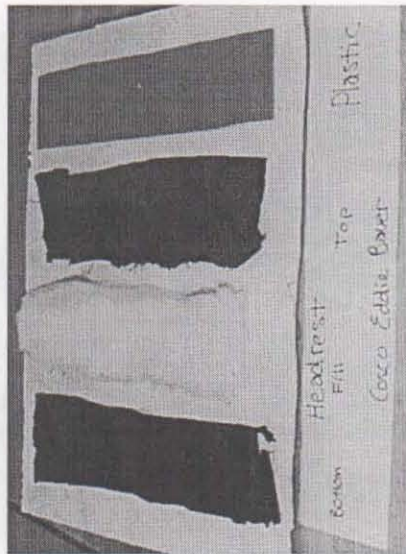
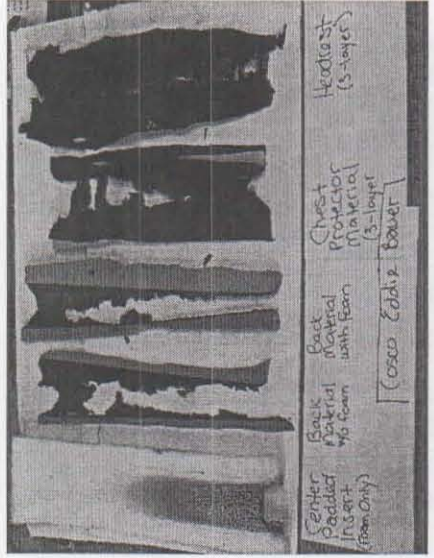
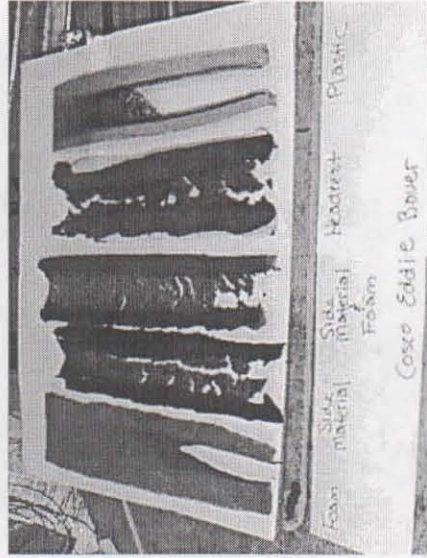
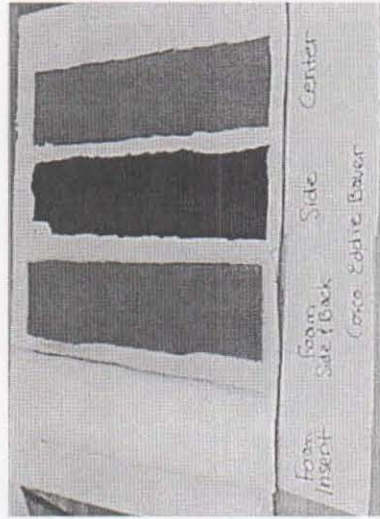
FIGURE 3. COSCO EDDIE BAUER: \$99.99

- Cosco Eddie Bauer. Seven of the eight materials failed the vertical test criteria (figure 3). All of the samples that failed exhibited very high flames. The center-padded insert foam, which passed, was the only material that did not exhibit high flames. One specimen of fabric material was tested in accordance with the FMVSS test procedure (horizontal orientation). A burn rate of 3.8 inches/minute was measured, just slightly less than the allowable 4.0-inches/minute value.

Material Name	Time to Ignition (min:sec)	Flame Time (min:sec)	Burn Length (inches)	Drip Flame Time (min:sec)	Comments
Foam with Green Material	0:01	1:15	12.0+	0:00	Very High Flames (10-12 in), Fail
Green Material Only	0:01	0:57	12.0+	0:00	Very High Flames, Fail
Foam w/o Green Material	0:01	0:00	Front: 6.0, Back: 6.5	0:00	Pass
Headrest (3-layer)	0:01	1:16	12.0+	0:00	Very High Flames, Fail
Headrest (3-layer)	0:01	1:13	12.0+	0:00	Very High Flames, Fail
Plastic Structure	0:04-0:05	2:18	9.0	1:00	Fail
Center Padded Insert Material (brown)	0:01	0:58	12.0	0:00	Very High Flames, Fail
Center Padded Insert Material (brown)	0:01	0:57	12.0+	0:00	Very High Flames, Fail
Back Material and Foam	0:01	1:50	12.0+	0:00	Very High Flames, Fail
Center Padded Insert Foam Only	0:01	0:01	Front: 5.5, Back: 4.5	0:00	Pass
Chest Protector	0:01	1:08	12.0+	0:00	Very High Flames, Fail

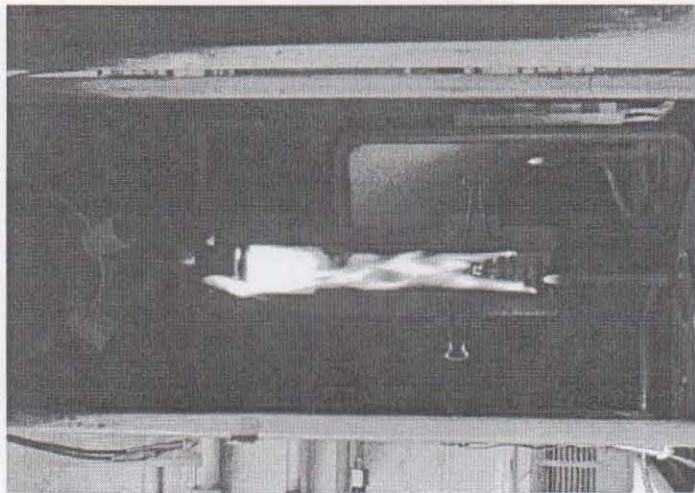
Green Outer Seat Material

NOTE: The Eddie Bauer seat materials had substantially higher flames than the other seven seats in the test. To show the magnitude of these flames, here are pictures of the Eddie Bauer seat during actual testing.

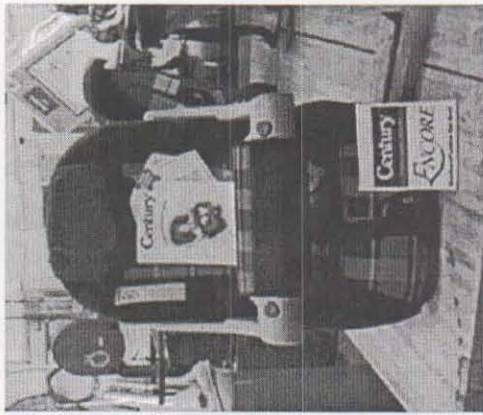
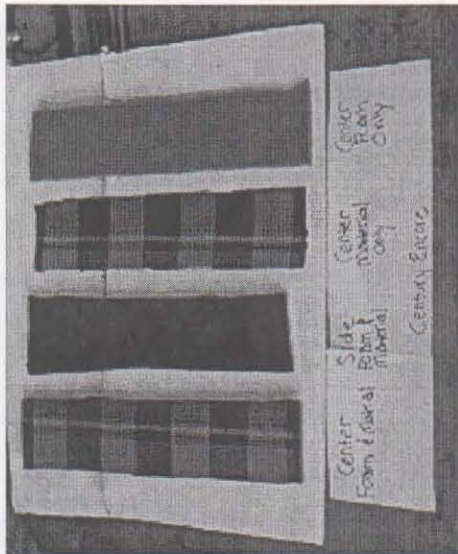
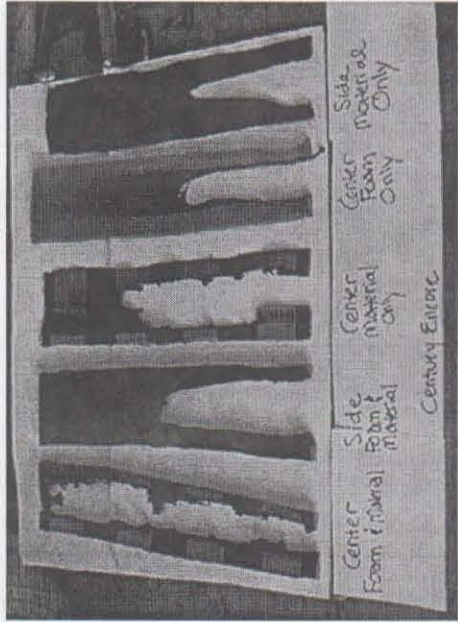
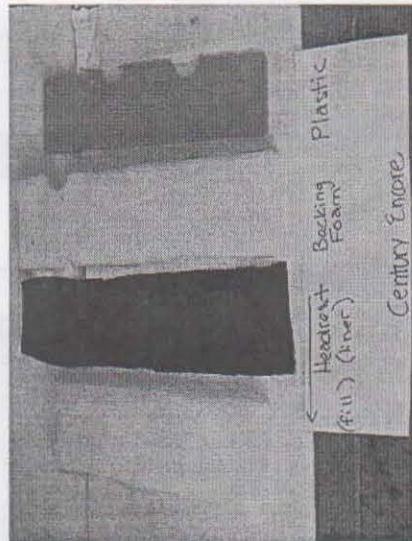
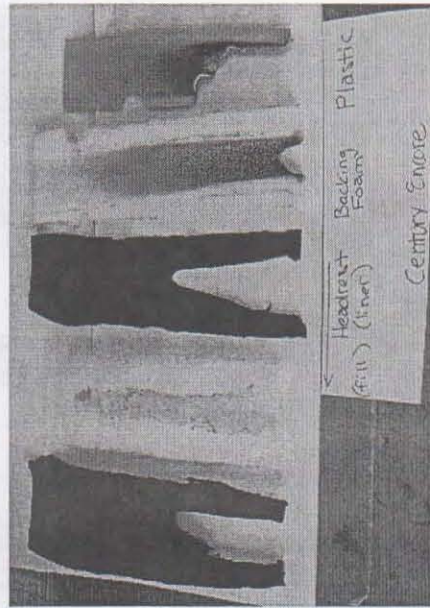
FIGURE 4. CENTURY ENCORE: \$89.00

- Century Encore. Four of the nine seat materials failed the vertical test criteria (figure 4). Some of the materials generated heavy smoke, including two of the samples that passed the test criteria. Again, even those samples that passed had relatively long burn lengths (>5 inches).

Material Name	Time to Ignition (min:sec)	Flame Time (min:sec)	Burn Length (inches)	Drip Flame Time (min:sec)	Comments
Center Foam and Material (plaid)	0:01	1:23	12.0+	0:21	Heavy Smoke, Fail
Side Foam and Material (blue)	0:01	0:05	Front: 7.0 Back: 6.8	0:00	Heavy Smoke, Fail
Side Foam and Material (blue)	0:01	0:12	Front: 8.2 Back: 10.5	0:00	Heavy Smoke, Fail
Center Material Only (plaid)	0:01	1:06	8.5	0:00	Heavy Smoke, Fail
Side Material Only (blue)	0:01	0:05	Withdrew 5.6	0:00	Pass
Center Foam Only	0:01	0:06	8.0	0:00	Pass
Center Foam Only	0:01	0:03	Front: 7.0 Back: 8.0	0:00	Pass
Foam Backing	0:01	0:00	6.5	0:00	Pass
Headrest (3-layer)	0:01	0:08	Front: 4.75 Back: 5.2	0:00	Heavy Smoke, Pass
Headrest Liner	0:01	0:05	Withdrew 5.8	0:00	Heavy Smoke, Pass
Headrest Fill	0:01	0:00	Withdrew 9.0	0:00	Withdrew w/no flame, Fail
Plastic Structure	0:01	1:58	5.0	1:30	Fail

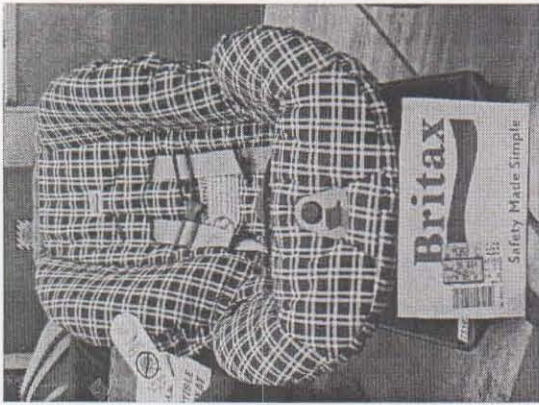
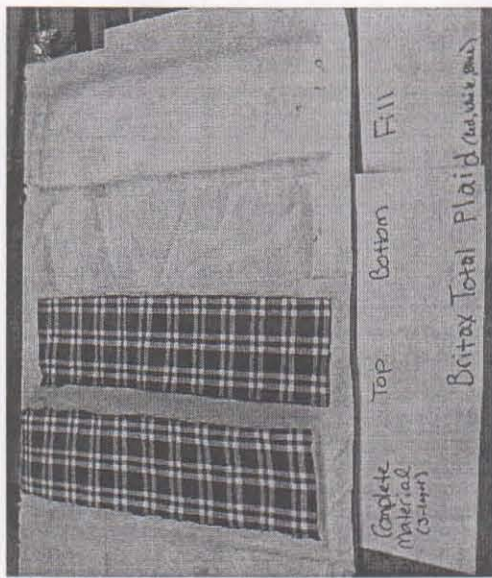
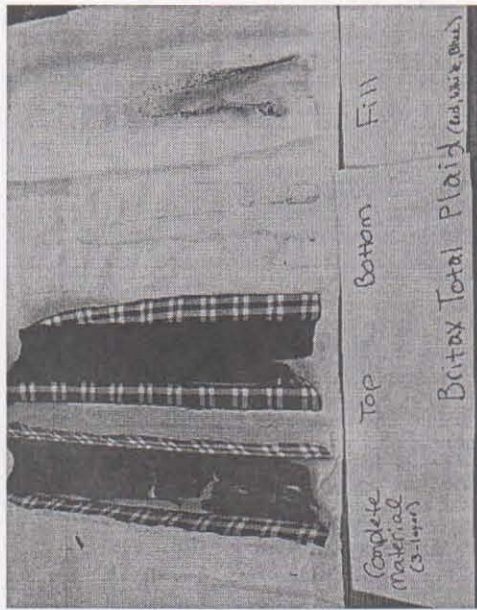
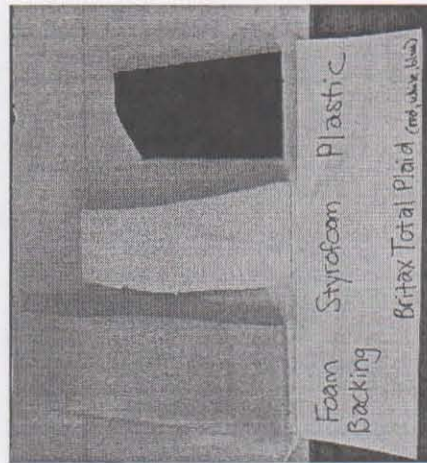
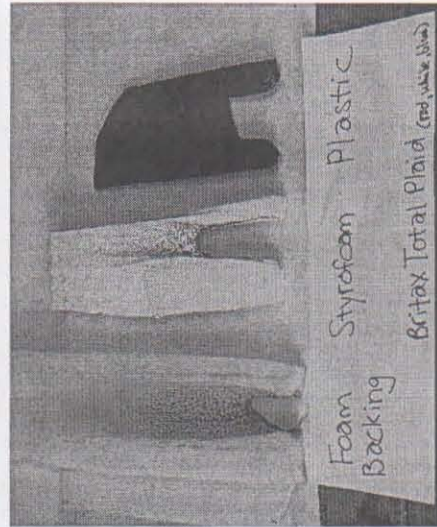
FIGURE 5. BRITAX TOTAL PLAID: \$199.99

- Britax (Total Plaid). Four of the seven seat materials failed the vertical test criteria (figure 5). Some of the materials, including a sample that passed, exhibited heavy smoke and, in one case, fast burning. The two materials that passed had relatively long burn lengths (>5 inches).

Material Name	Time to Ignition (min:sec)	Flame Time (min:sec)	Burn Length (inches)	Drip Flame Time (min:sec)	Comments
Complete Material (3-layer)	0:01	0:55	12.0+	0:00	Heavy Smoke, Fail
Top Material	0:01	0:14	12.0+	0:00	Fast Burning, Fail
Bottom Material	0:01	0:00	Withdrew 9.0	0:00	Heavy Smoke, Fail
Fill Material	0:01	0:00	Withdrew 5.5	0:00	Heavy Smoke, Pass
Foam Backing	0:01	0:00	6.9	0:00	Pass
Styrofoam	0:01	0:00	Withdrew 8.0	0:00	Pass
Plastic Structure	0:01	2:31	4.7	1:37	Fail

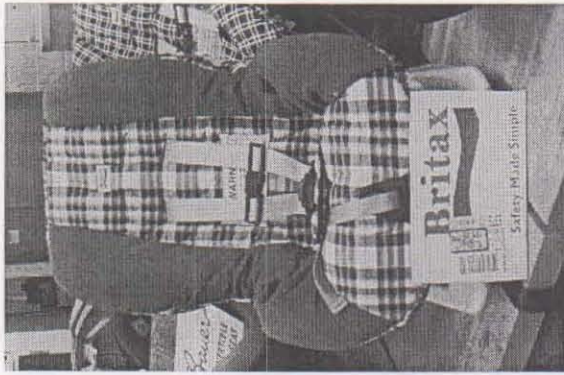
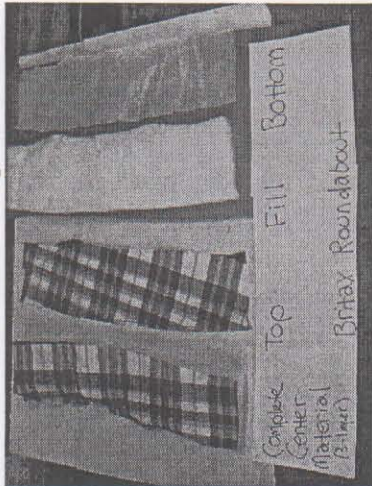
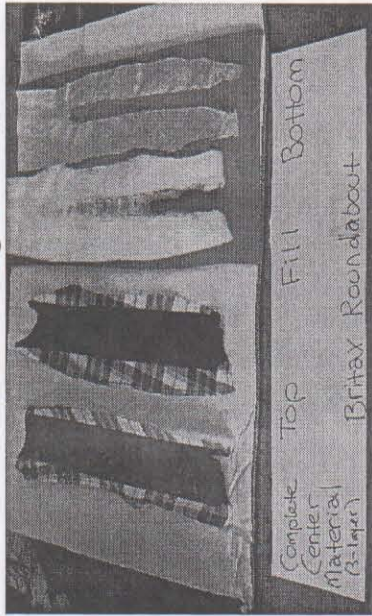
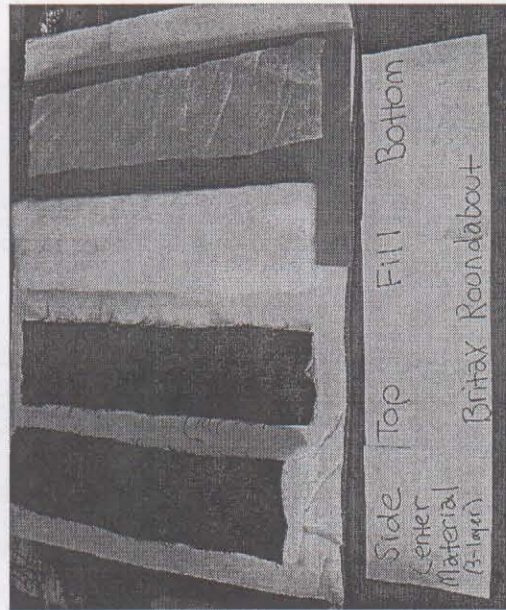
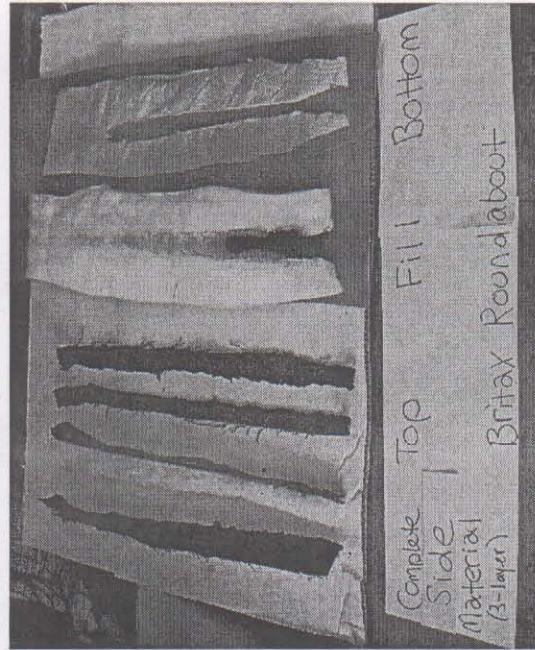
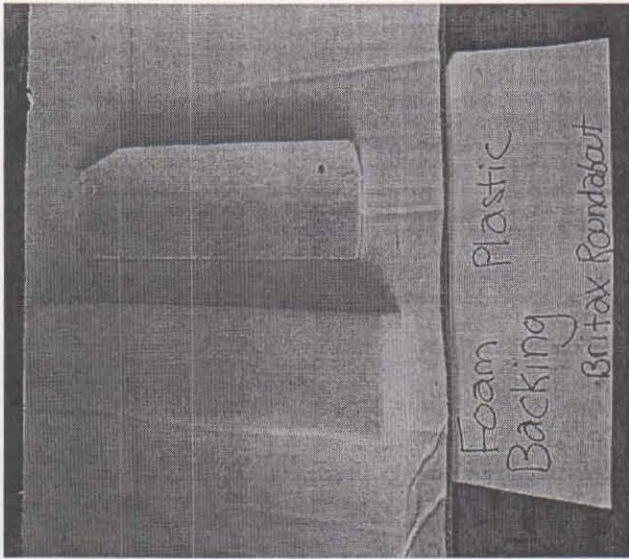
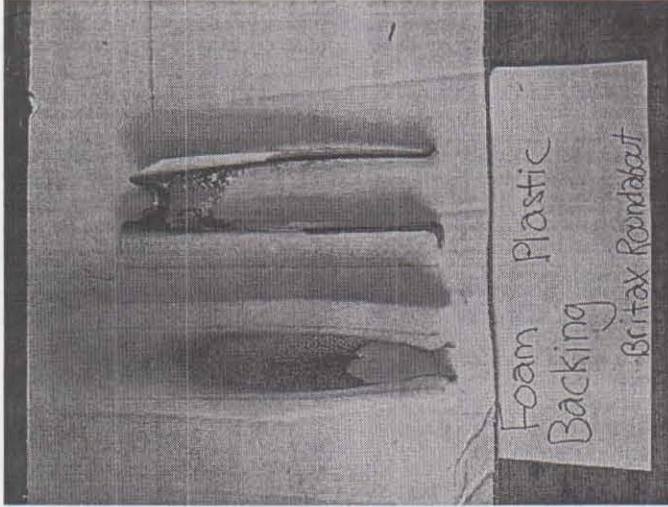
FIGURE 6. BRITAX ROUNDABOUT: \$199.00

- Britax Roundabout. Six of the eight seat materials failed the vertical test criteria (figure 6). Those materials that passed had relatively long burn lengths (7 and 8 inches). Four of the materials burned along the entire sample length.

Material Name	Time to Ignition (min:sec)	Flame Time (min:sec)	Burn Length (inches)	Drip Flame Time (min:sec)	Comments
Complete Center Material	0:01	0:48	12.0+	0:00	Fail
Top Material (plaid)	0:01	0:37	12.0+	0:00	Fail
Fill Material	0:01	0:00	8.0	0:00	Pass
Bottom Material	0:01	0:00	9.3	0:00	Fail
Complete Side Material	0:01	1:20	12.0+	0:00	Fail
Top Material (denim)	0:01	1:01	12.0+	0:00	After flame out, material continued to glow - only occurrence of this throughout the test. Fail
Fill Material	Same material as 4 lines above—same material should produce similar results				
Bottom Material	Same material as 5 lines above—same material should produce similar results				
Backing Foam	0:01	0:01	7.0	0:00	Pass
Plastic Structure	0:01	2:35	8.5	0:25	Fail

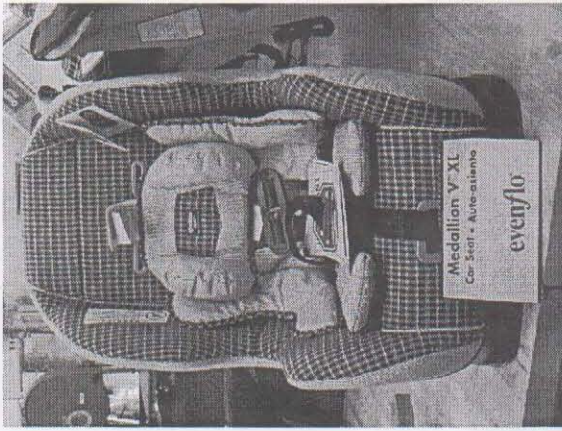
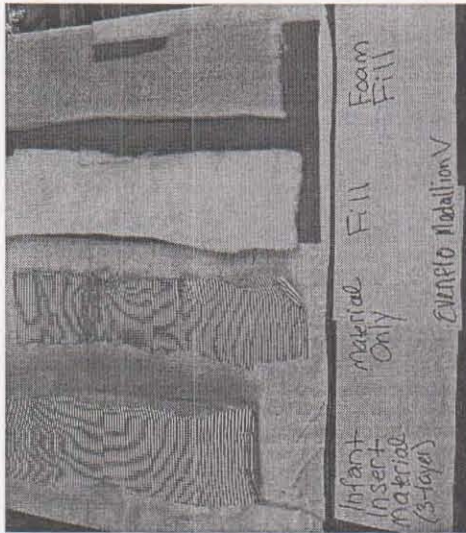
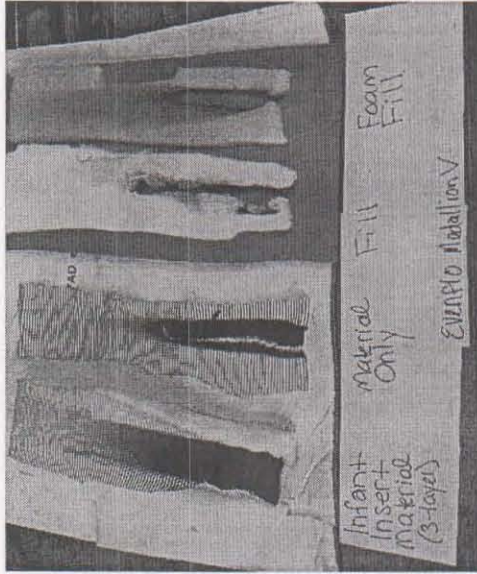
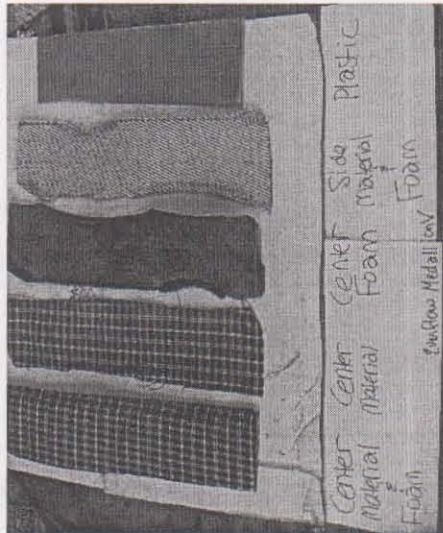
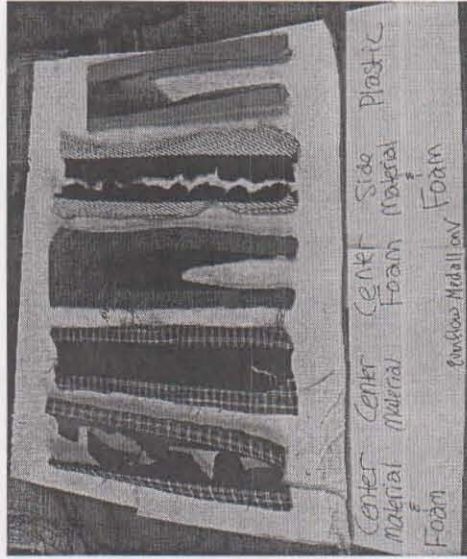
FIGURE 7. EVENFLO MEDALLION V: \$139.99

- Evenflow Medallion. Six of the nine seat materials failed the vertical test criteria (figure 7). The center material and foam produced the heaviest smoke of all seat materials in the

test series. It appeared that the dense smoke inside the test chamber was the cause of flame extinguishment. When it appeared that the flame was out and the door of the test cabinet was slightly opened to evacuate the smoke, the flame reignited apparently due to oxygen entering the cabinet.

Material Name	Time to Ignition (min:sec)	Flame Time (min:sec)	Burn Length (inches)	Drip Flame Time (min:sec)	Comments
Infant Insert Material (3-layer)	0:01	1:06	4.8	0:00	Fail
Infant Insert Material (3-layer)	0:01	0:01	3.5	0:00	Fail
Top Material	0:01	0:00	6.25	0:00	Pass
Fill Material	0:01	0:14	6.0	0:00	Pass
Foam Fill	0:01	0:00	7.8	0:00	Pass
Center Material and Foam	0:01	1:00	12.0+	0:00	Heaviest Smoke, Fail
Center Material and Foam	0:01	1:04	12.0+	0:00	Heaviest Smoke, Fail
Center Material	0:01	0:11	12.0+	0:00	Fail
Center Foam	0:01	0:17	7.1	0:00	Fail
Side Material and Foam	0:01	0:21	12.0+	0:00	Heaviest Smoke, Fail
Plastic Structure	0:05	3:56	8.5	2:00	Fail
Backing Foam	Same material as Evenflo Horizon V Backing Foam—should produce similar results

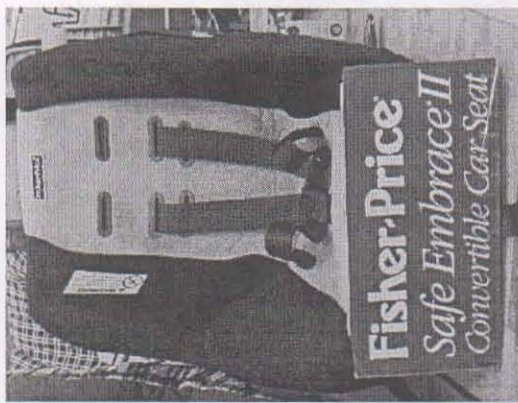
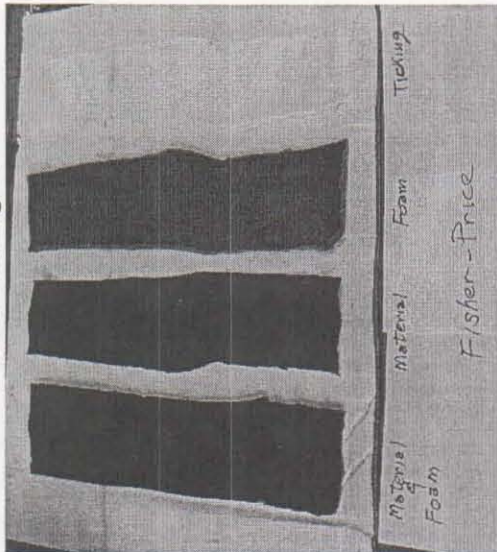
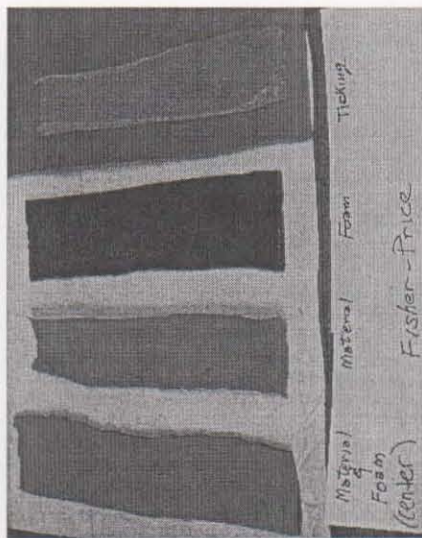
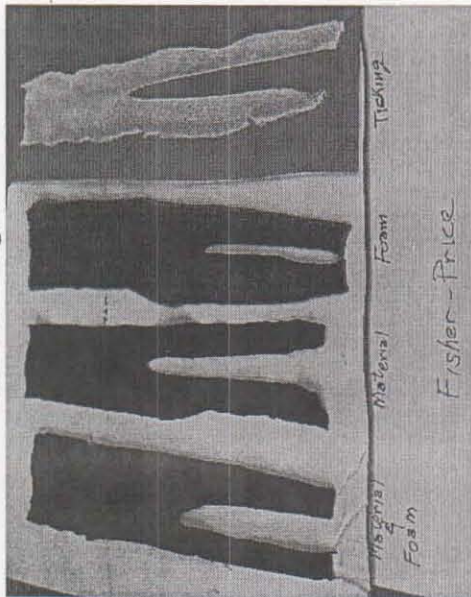
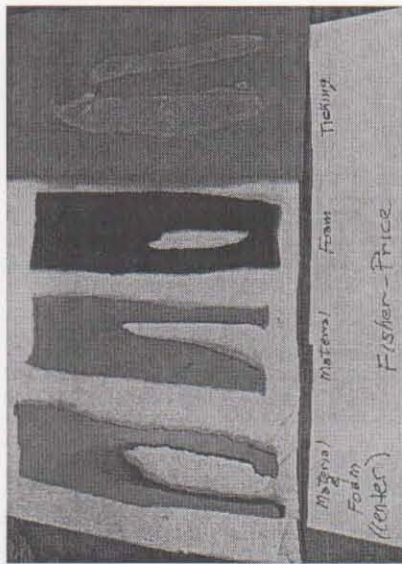
FIGURE 8. FISHER PRICE SAFE EMBRACE II: \$149.99

- Fisher Price Safe Embrace II. Three of the nine seat materials failed the vertical test criteria (figure 8). The materials that passed had relatively long burn lengths (≥ 5 inches).

Material Name	Time to Ignition (min:sec)	Flame Time (min:sec)	Burn Length (inches)	Drip Flame Time (min:sec)	Comments
Side Material and Foam	0:01	0:04	6.3	0:00	Pass
Side Material	0:01	0:00	Withdrew 7.0	0:00	Withdrew w/no flame, Pass
Side Foam	0:01	0:00	5.0	0:00	Pass
Bottom Material	0:01	0:00	Withdrew 8.0	0:00	Pass
Center Material and Foam	0:01	0:16	Front: 7.0 Back: 9.0	0:00	Fail
Center Material	0:01	0:00	Withdrew 6.5	0:00	Pass
Center Foam	0:01	0:00	Front: 6.5 Back: 8.0	0:00	Pass
Bottom Material	0:01	0:00	Withdrew 11.0	0:00	Fail
Backing Foam	Same material as Britax Total Plaid Backing Foam—should produce similar results				
Plastic	0:05	2:43	9.0	0:22	Fail
