# Identification Techniques to Reduce Confusion Between Taxiways and Adjacent Runways

September 2007

DOT/FAA/AR-TN07/54

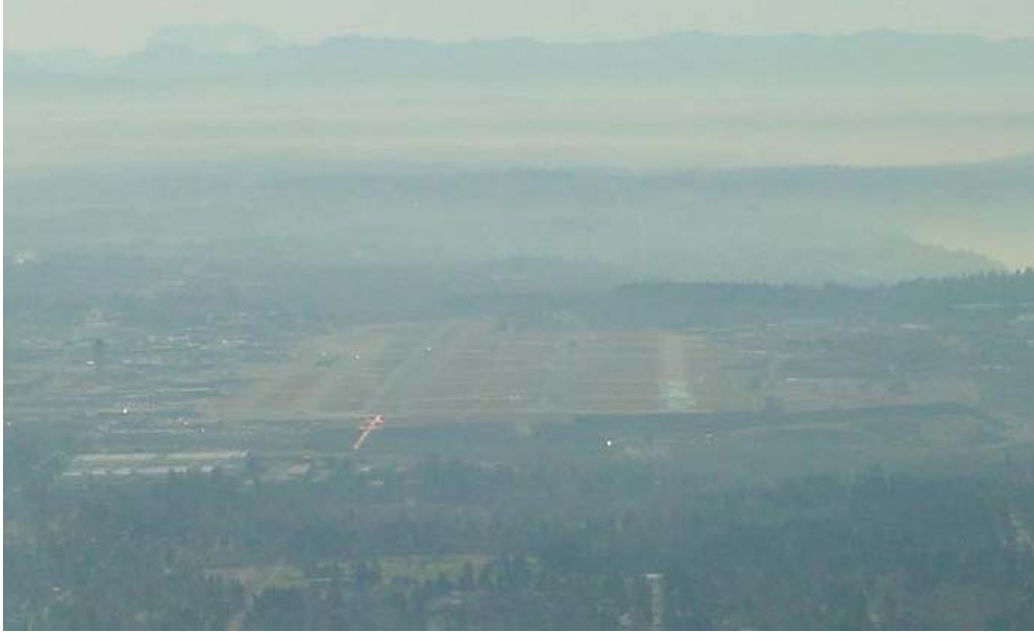
Since December 1999, SEA-TAC has experienced multiple incidences of commercial airline pilots performing approaches to, and actual landings on, taxiway Tango mistakenly identifying it as the parallel runway 16R. These incidents have occurred during the day in visual flight rule (VFR) weather conditions, during the period of mid-November to March, when low sun angle and frequent rain showers prevailed. Upon approach to the airport from the north, taxiway Tango is the most visible of all the airport's surfaces (figure A-1 in appendix A).

Figure A-1. View of SEA-TAC on Approach to Taxiway Tango (on the Right) and the MALSR System Illuminated on Runway 16L (on the Left)

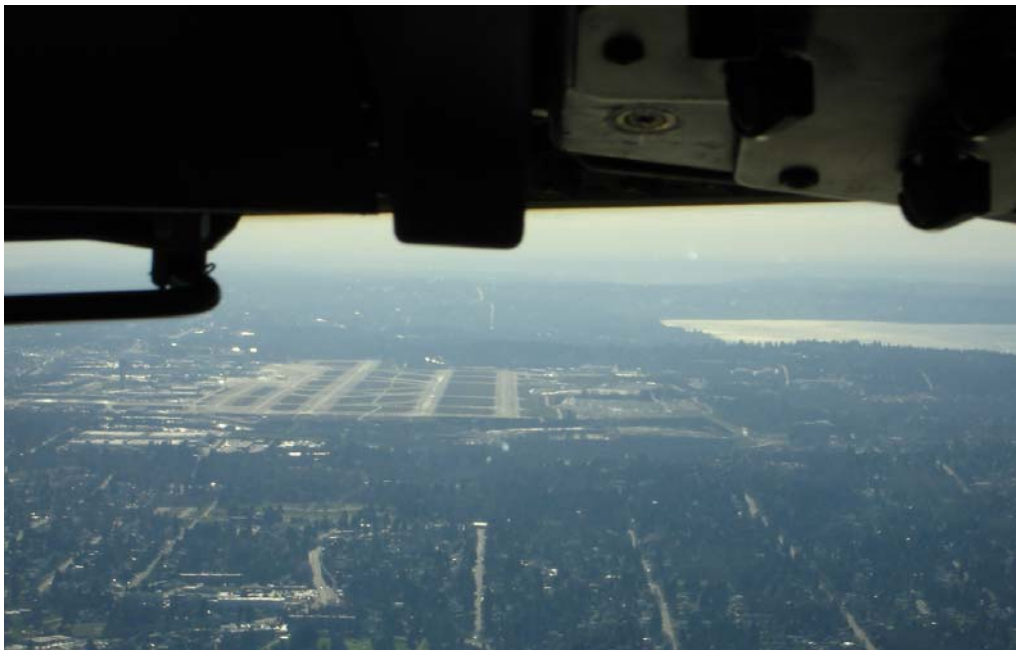
Taxiway Tango was constructed in October 1999 in preparation for future expansion of a third parallel runway to the west of the airport. Approximately 2 months after completion of taxiway Tango, one pilot made an approach to the taxiway thinking it was runway 16R. The pilot stated that, because of intense sun glare, he lined up to the taxiway since it was clearly more visible than the other landing surfaces. Similar instances have happened where pilots were cleared to land on runway 16R, but because of the glare from the sun, made approaches or landed on taxiway Tango. In another incident, which resulted in a landing, the pilots had been actively tracking the Instrument Landing System localizer for runway 16R until breaking out of the overcast. However, once visual acquisition of the airport was in sight, taxiway Tango was a more appealing landing surface than the surrounding pavements. Taxiway Tango faces north/south, which leads to problems when the sun, during the winter months, is very low on the horizon. This causes paint markings on the pavement surface to wash out, making it difficult to differentiate between surfaces (figures A-2 and A-3 in appendix A).

Figure A-2. Distant View of SEA-TAC Showing Aircraft Aligned With Taxiway Tango on the Right

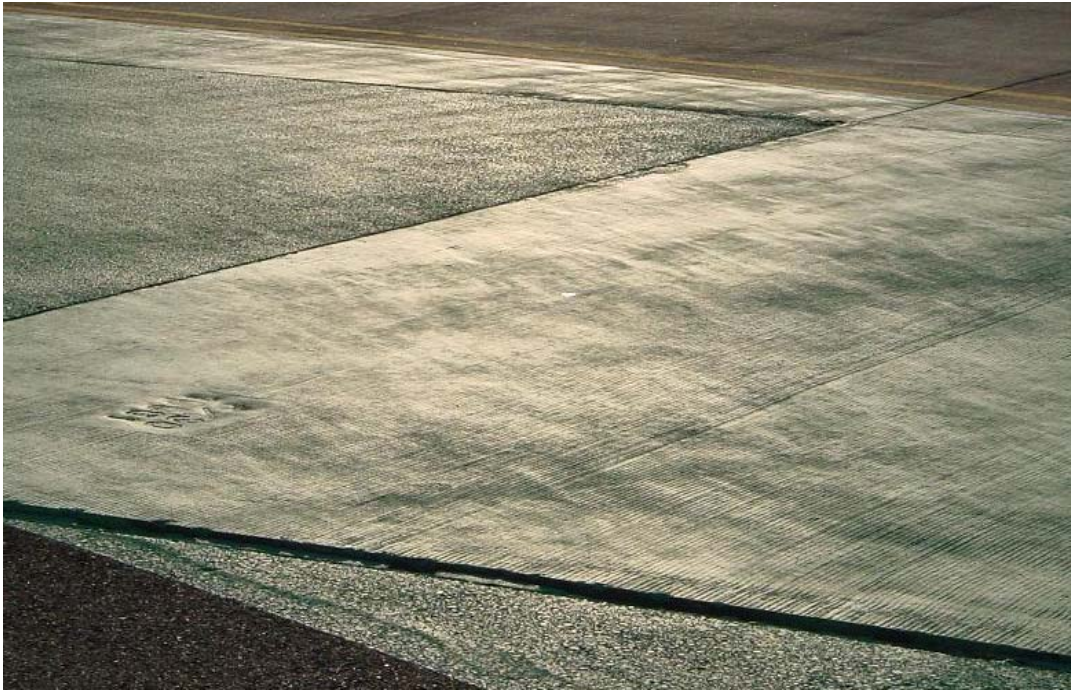
Figure A-3. Sun Glare on Black Surface Treatment (SEA-TAC)

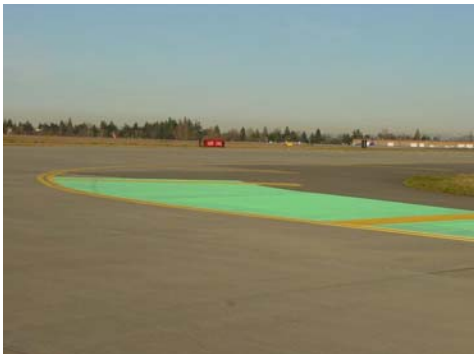
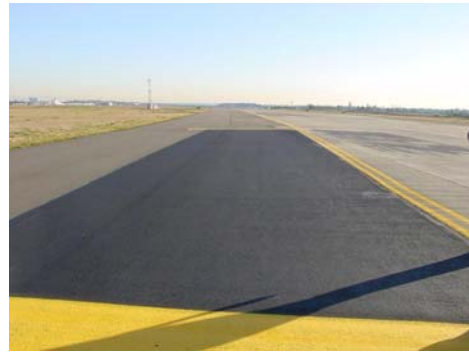
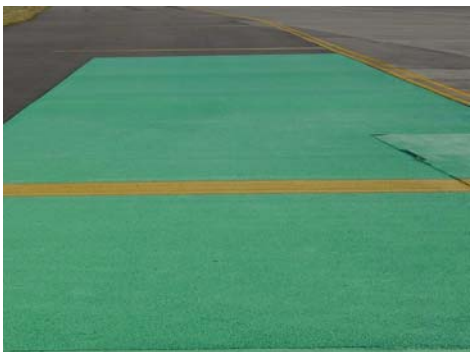
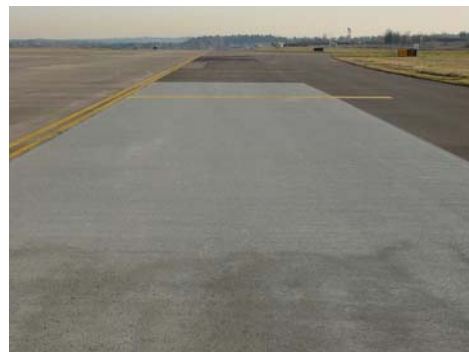
Mitre Corporation was tasked to research various surface treatments, which are thicker than paint that can be used in an effort to overcome the sun's glare so that the pilot can see the marking material from the air. The surface treatments are thicker than paint, much like pavement seal-coating material. The goal was to create a zig-zag pattern on the taxiway using the surface treatments, in an effort to deter the pilot from landing on the taxiway. These surface treatments were evaluated in February 2005 at SEA-TAC, where various types of material were placed on the shoulder of taxiway Tango, as shown in figure A-4 in appendix A. The results of that research showed that some type of unique surface treatment was required to enhance the color and/or shape of the taxiway, which would in turn make the taxiway less visible to approaching pilots. Unfortunately, using these surface treatments did not overcome the sun's glare, as shown in figures A-1 and A-2 in appendix A, and were just as invisible as normal airport paint.

Figure A-4. Mitre's Surface Treatment Solutions (SEA-TAC)

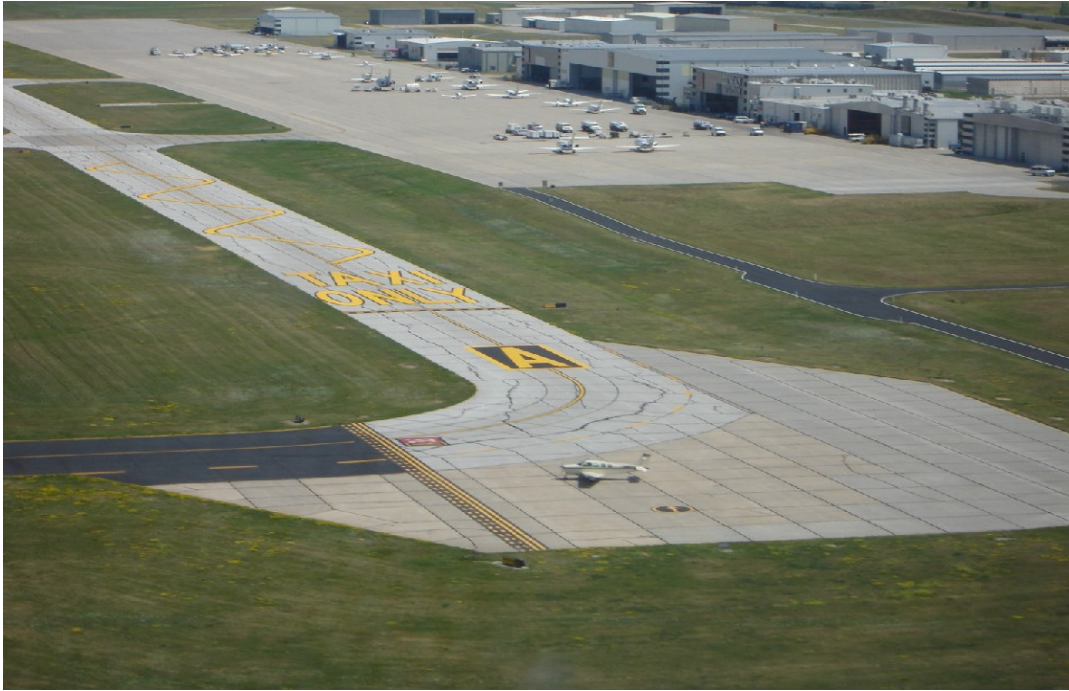
Figure A-13. Nonstandard Paint Markings on Taxiway Alpha at Lincoln Airport (LNK)

- Removal of the boxed A painted designation is recommended, since it looks too much like a displaced threshold chevron. This paint marking may be making the situation worse, since the character A with its arrow-like resemblance, potentially draws the pilot's attention to the hold line that is just beyond it on the taxiway, creating a visual illusion that it is a runway.

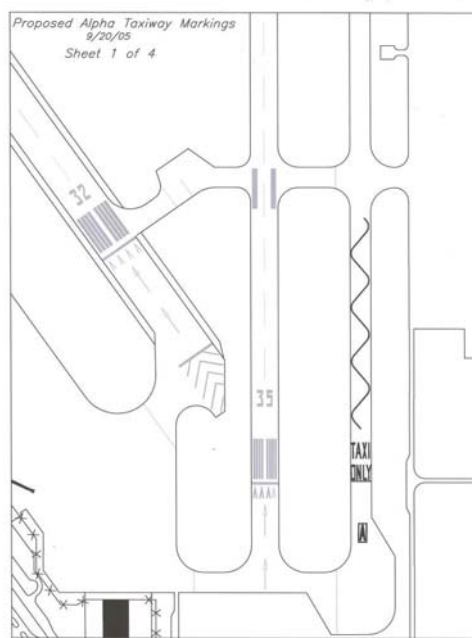
Figure A-14. Taxiway Alpha and Runway 35 With Nonstandard Taxiway Markings (LNK)

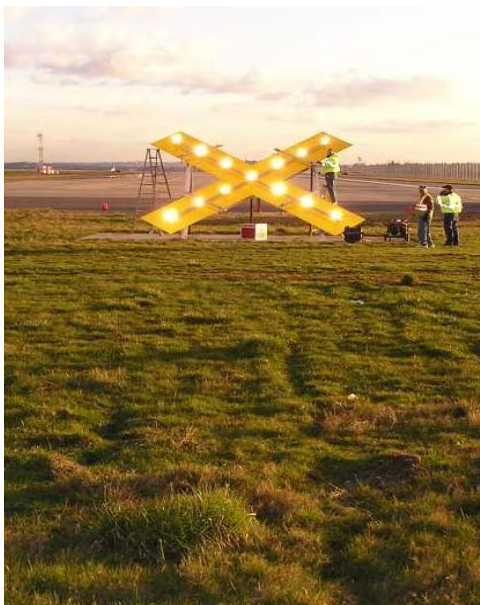
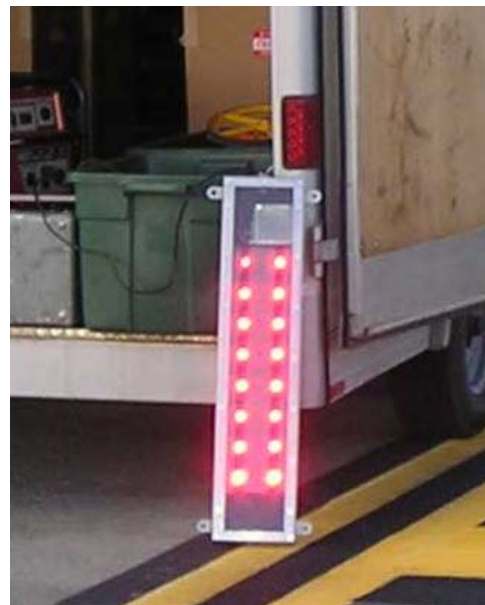
One of the visual aid devices brought to SEA-TAC was a temporary elevated lighted X intended to be set up at the end of taxiway Tango on the approach end of runway 16R. The elevated lighted X was attached to the already existing metal X that the airport had installed. In addition, a prototype in-pavement red LED fixture was placed next to the elevated lighted X during the evaluation (figure A-17 in appendix A).

Figure A-17. (a) Elevated Lighted X on Ground and (b) High-Intensity Light-Emitting Diode Sample (LNK)

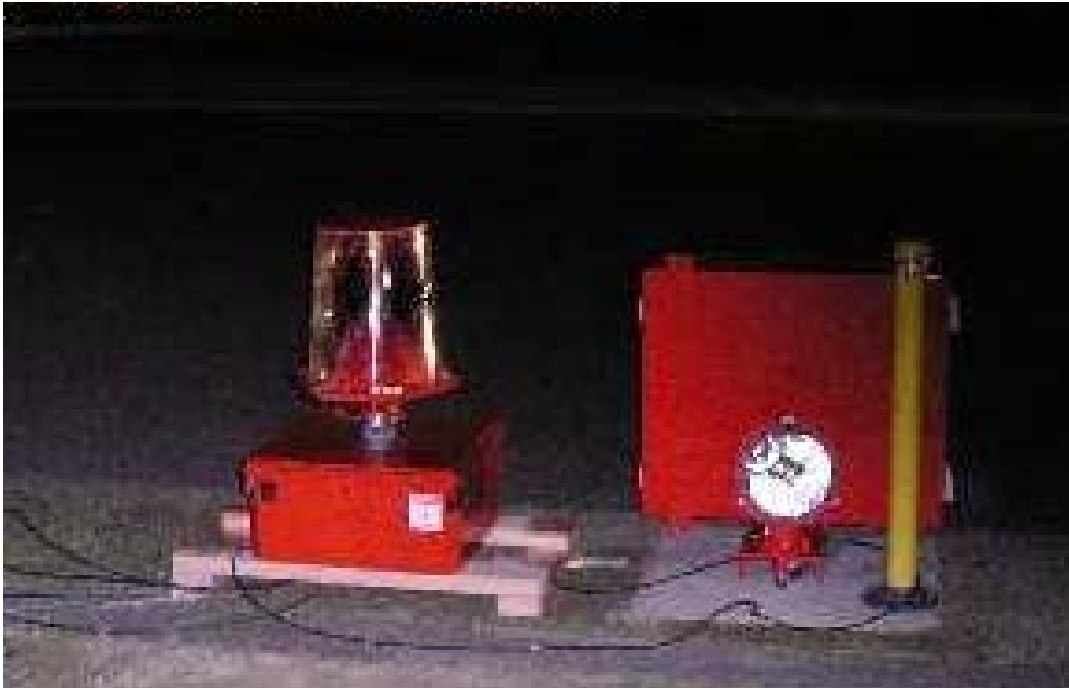
Other equipment that was set up were two sets of FAA-approved omnidirectional REILs. The omnidirectional REILs were installed at the end of runways 16R and 16L, next to the airport's existing unidirectional REILs (figure A-18 in appendix A).

The omnidirectional REILs were found to be more visible than the unidirectional REILs during the approaches. This was because only one unidirectional REIL fixture was visible to the pilot approaching taxiway Tango due to its canted alignment in the opposite direction. The omnidirectional fixtures, however, were always visible during the approach from about 4.5 nm out. Some participants reported that the omnidirectional REILs caught the eye better than the unidirectional REILs, while others stated they did not notice them unless they were looking for them. This was attributed to the large space between the two parallel runways and the parallel

Figure A-18. Omnidirectional REIL and Unidirectional REIL (LNK)

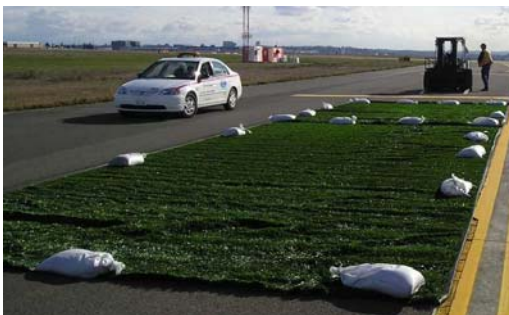
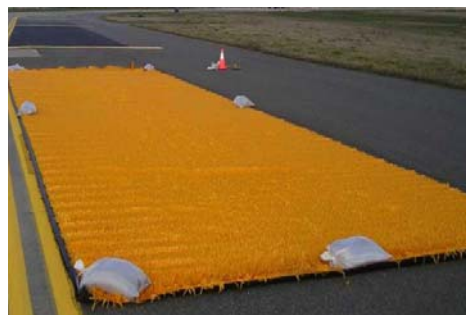
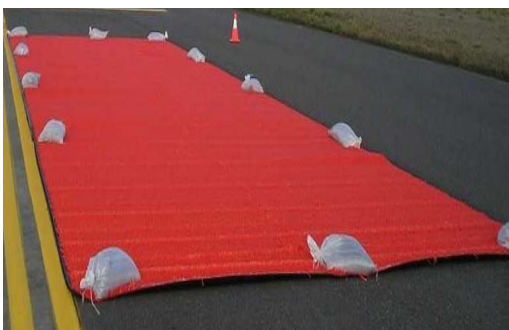
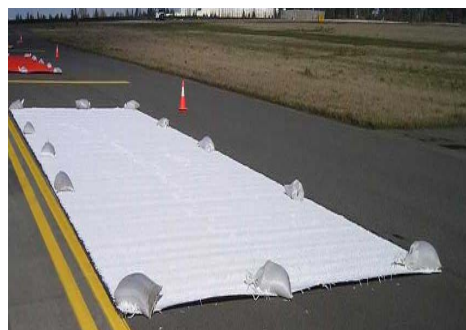
Another visual aid that was installed on the shoulder of the taxiway included four strips of artificial turf in yellow, green, orange, and white. The purpose of the brighter colors was to determine which color was most conspicuous from the air. It was discussed that the creation of a large X or other shape with the bright artificial turf could be used in the prethreshold area of a taxiway or a runway. Each artificial turf strip measured 15 ft wide by 50 ft long and was held in place using sand bags (figure A-19 in appendix A).

Figure A-19. Details of Artificial Turf Installation (LNK)

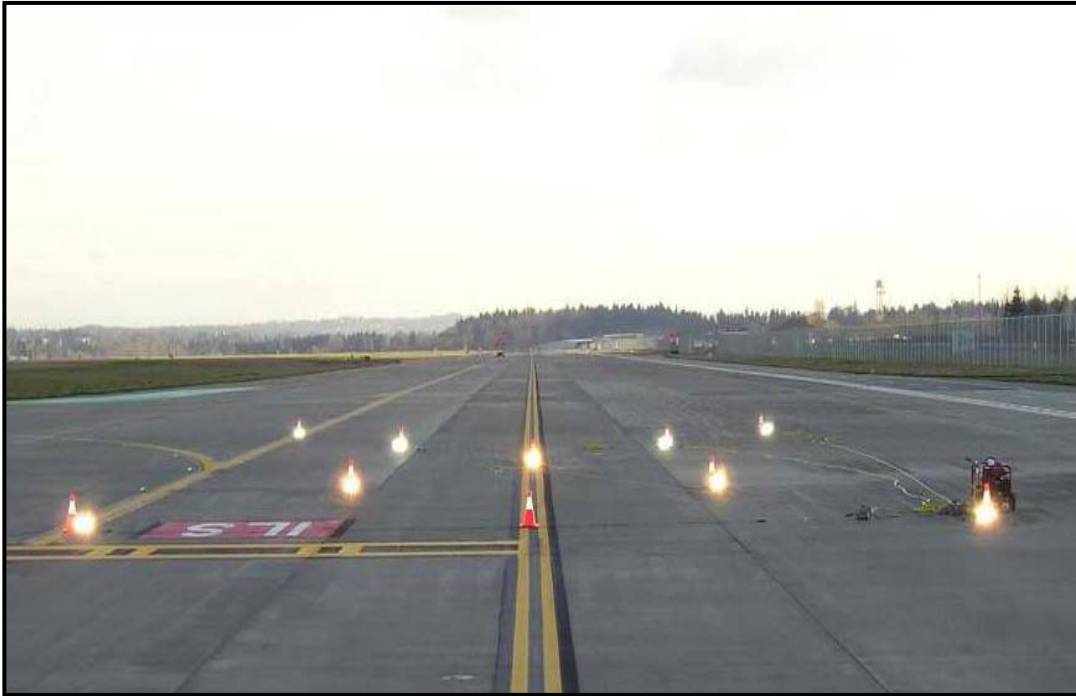
The final visual aid to be evaluated was the in-pavement lighted X. The in-pavement lighted X was located on the taxiway centerline of taxiway Tango, parallel to the touchdown zone markings on runway 16R, facing the approach of runway 16R (figure A-20 in appendix A).

Figure A-20. In-Pavement Lighted X on Taxiway Tango (SEA-TAC)

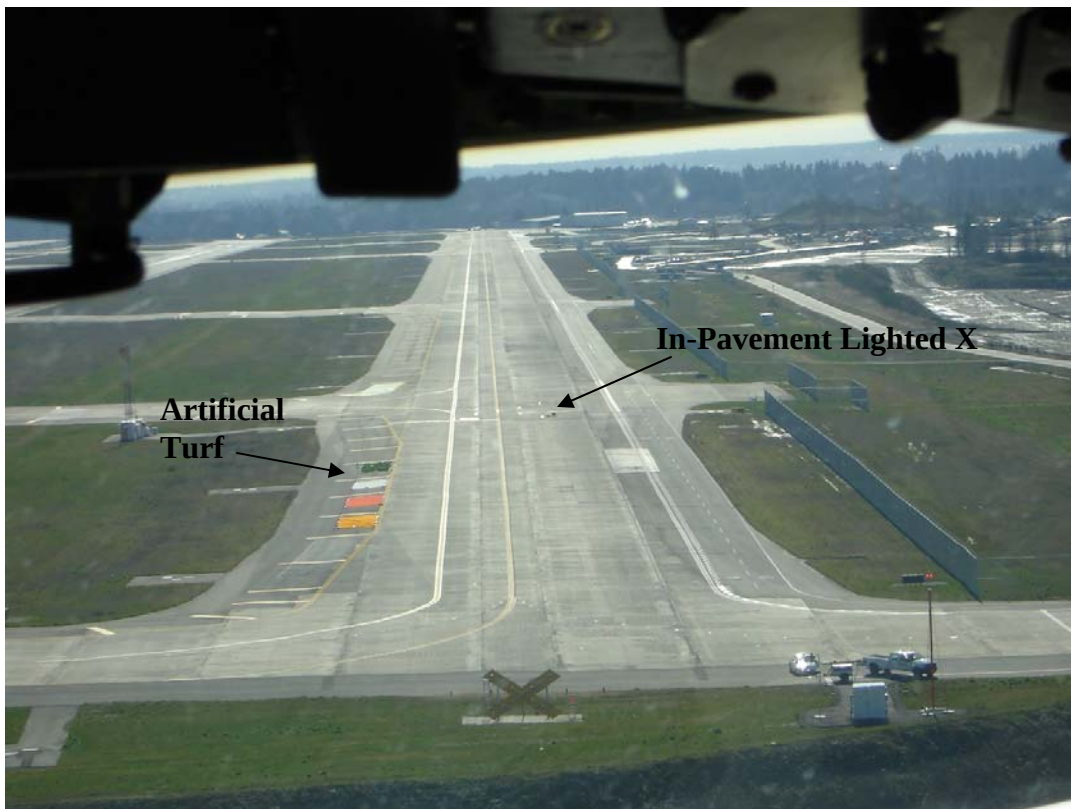
SEATTLE-TACOMA INTERNATIONAL AIRPORT RESULTS. During the evaluation, it was noted that the in-pavement lighted X looked more like a line of white lights than an X (figure A-21 in appendix A). It was determined that placing the LED and incandescent fixtures together caused this visual appearance, and because the incandescent fixtures were brighter than the LED fixtures, the X looked off balance or like a line. Although the X configuration could not be interpreted by many of those onboard, the pilots reported that they liked having lights flashing on the taxiway pavement, because it made them think twice before landing there. Because the sun glare is so prominent at SEA-TAC; there was concern that the white light could disappear into the pavement during this condition. The possibility of using a different color, such as yellow, was discussed but was not tested. The in-pavement lighted X was visible at approximately 4.5 nautical miles (nm) from the end of the taxiway.

Figure A-21. In-Pavement Lighted X in Operation With Artificial Turf on the Left Shoulder of Taxiway Tango (SEA-TAC)

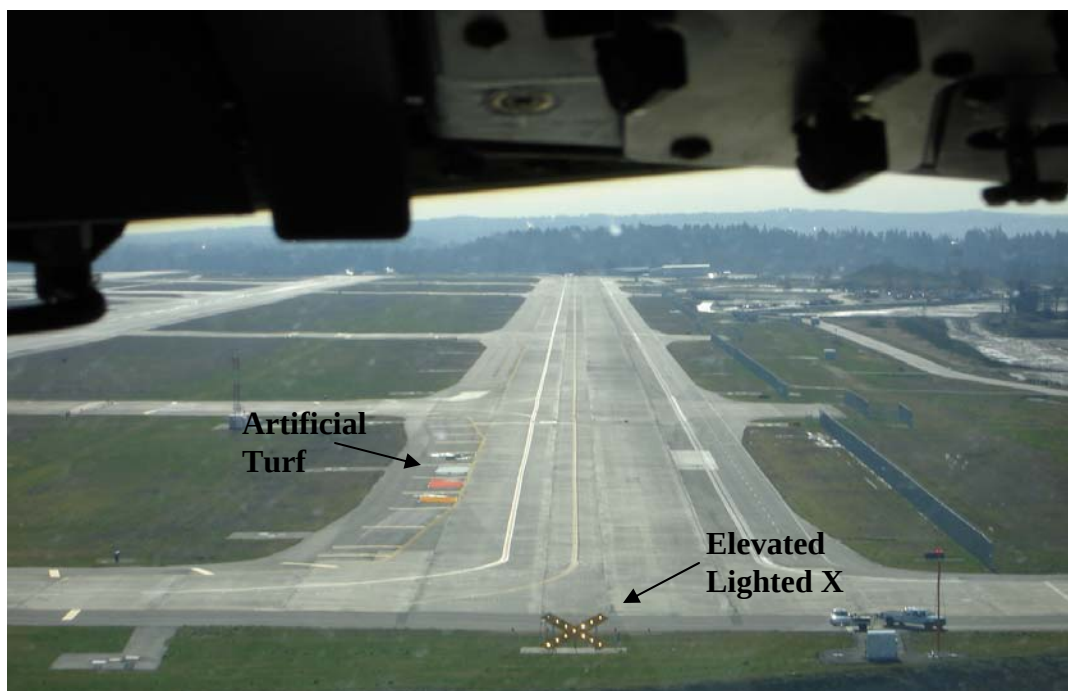
The elevated lighted X performed well, although a few of the incandescent fixtures were not aimed properly towards the final approach path (figure A-22 in appendix A). Consequently, this caused the X to lose some of its configuration. In addition, the prototype in-pavement red LED fixture that was positioned near the X was not visible at all during any of the approaches. This is likely due to its small size. Even though some of the incandescent fixtures on the X were not aimed properly, it was still one of the first visual aid devices to be seen on approach. The possibility of using a faster and crisper flash rate was discussed to enhance the X. The elevated lighted X was visible at 4.5 nm from the threshold.

Figure A-22. Elevated Lighted X and Artificial Turf Material (SEA-TAC)
