**GEORGIA DOT RESEARCH PROJECT 22-20**

Final Report

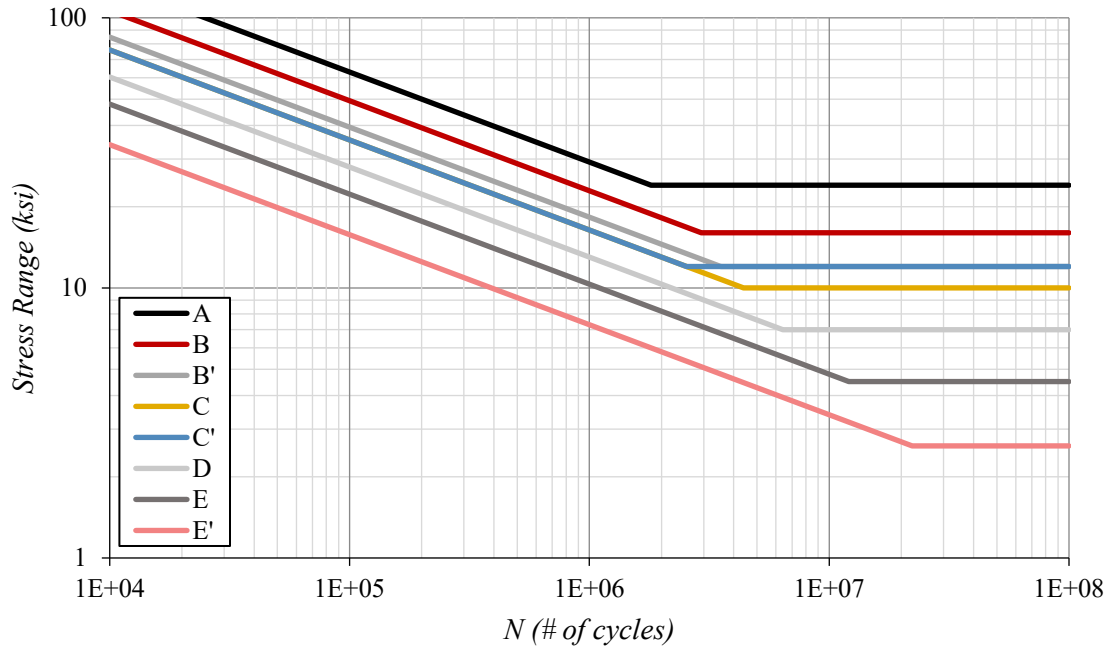
**Figure 2-2. Graph. AASHTO S–N fatigue resistance design curves.**

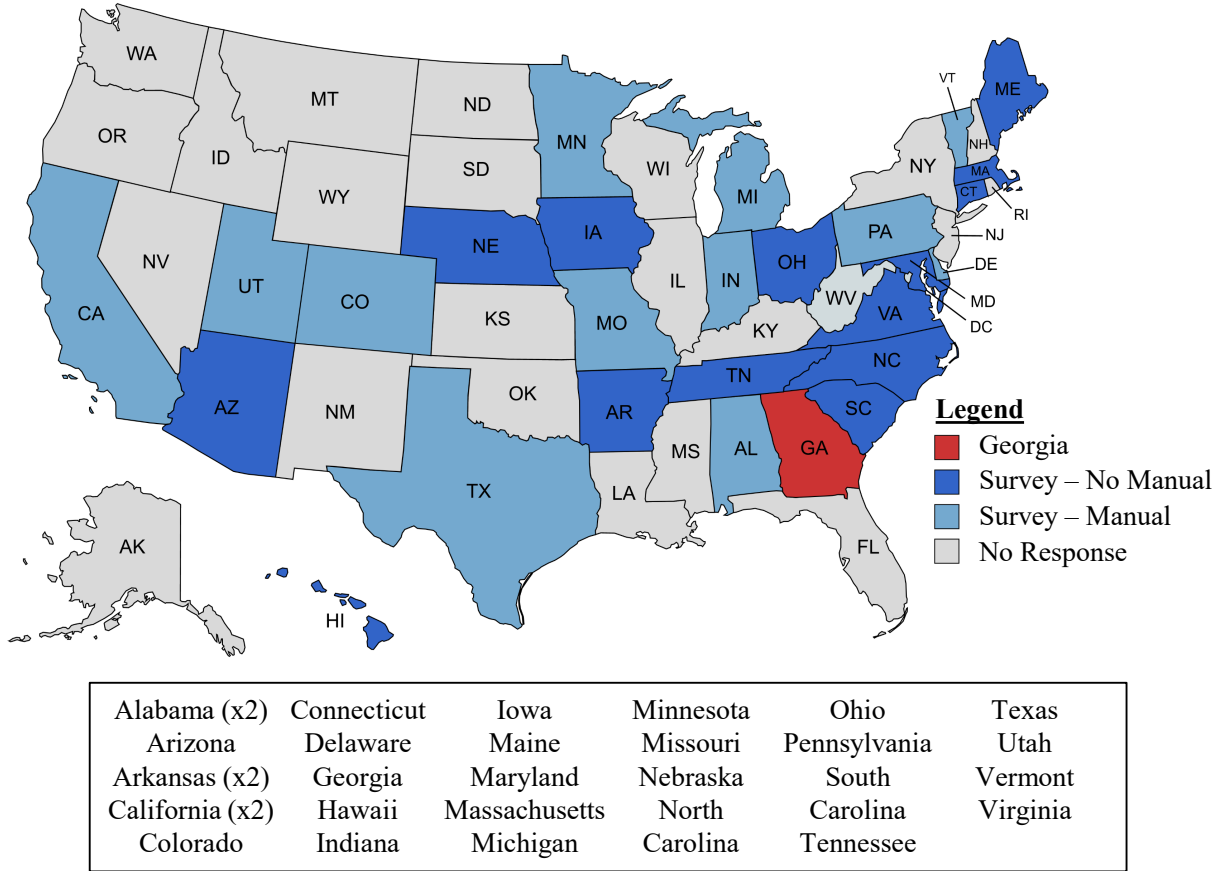
**Figure 3-1. Illustration. Map and list of survey responses per state.**

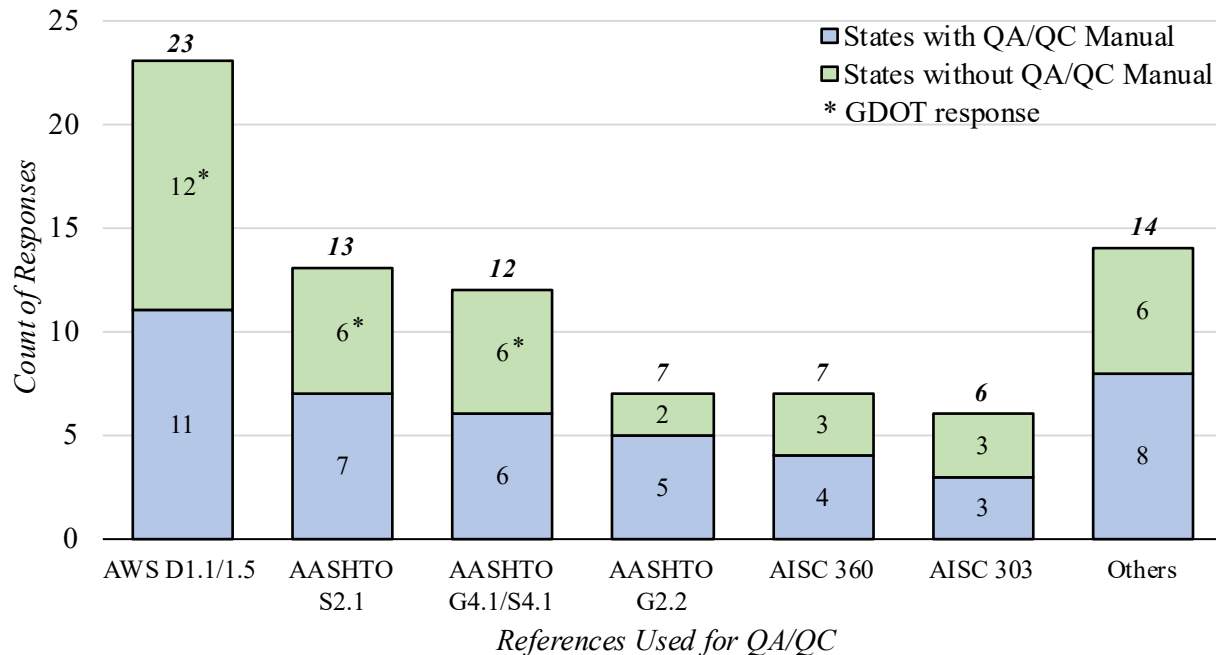
**Figure 3-2. Graph. References used for QA/QC standards or to create QA/QC manual.**

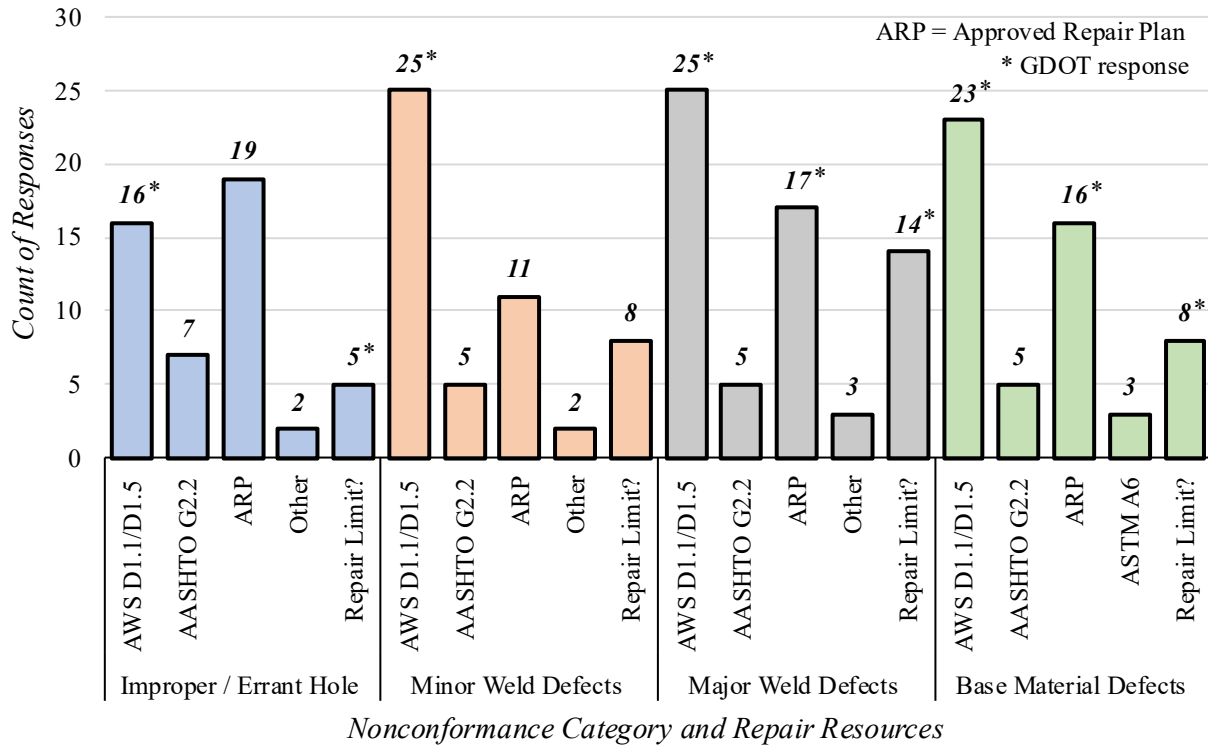
**Figure 3-3. Graph. Resources and restrictions for nonconformance repairs.**

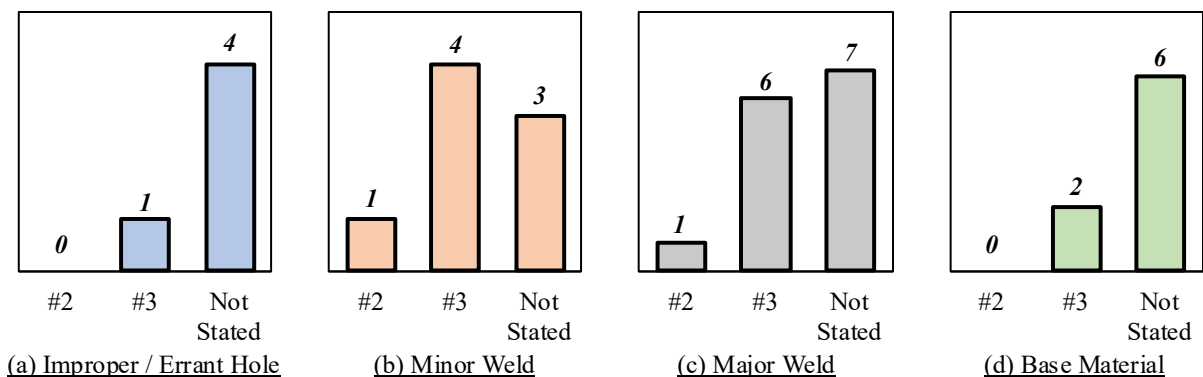
Repair Limit for Each Nonconformance Category

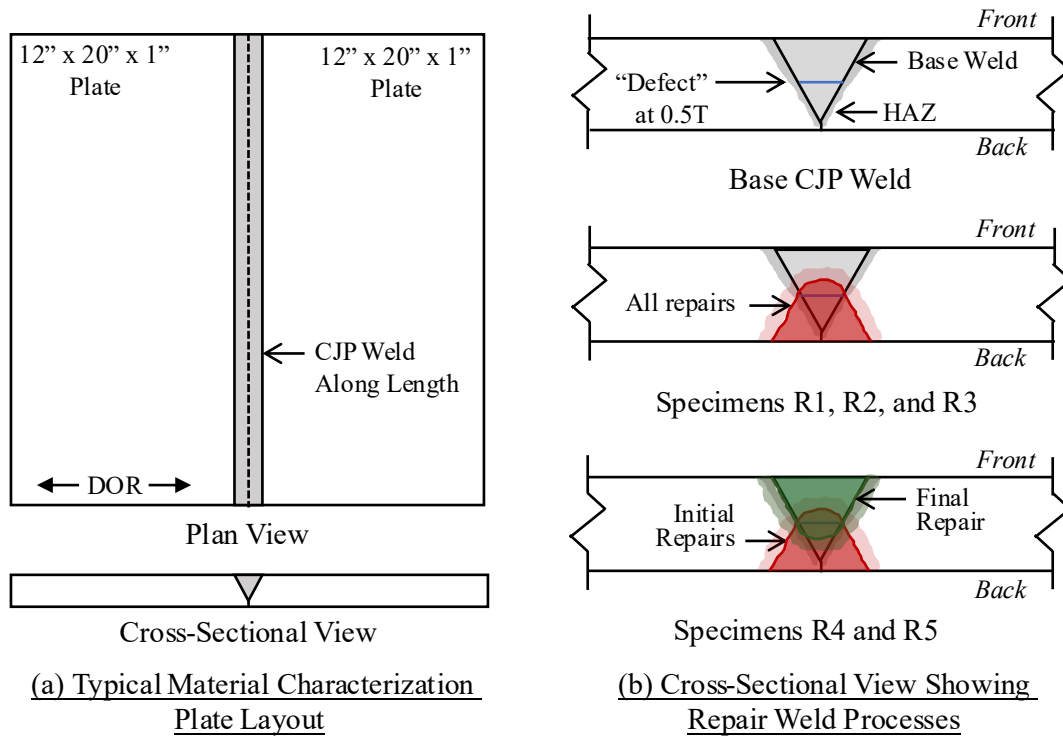
**Figure 4-1. Multiple Illustrations. Layout of material characterization plates and illustration of different repair processes. (a) Typical material characterization plate layout and (b) Cross-sectional view showing repair weld processes**

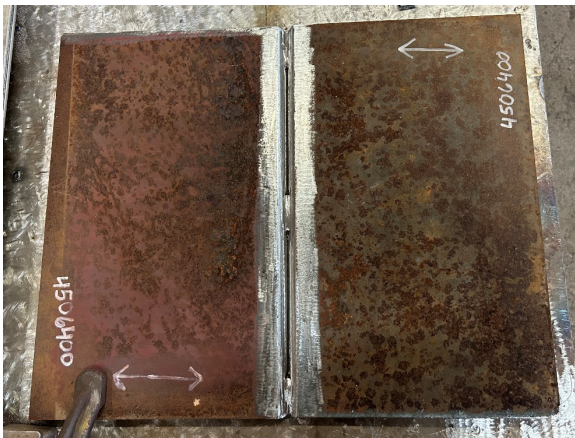
Step 1: Prep and align plates.

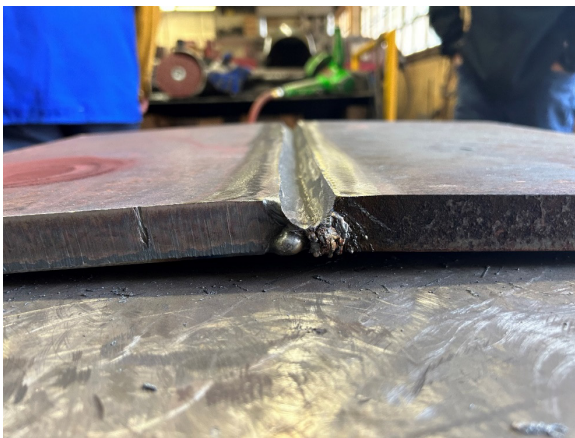
Step 3: Excavate “defect” by arc gouging and grinding.

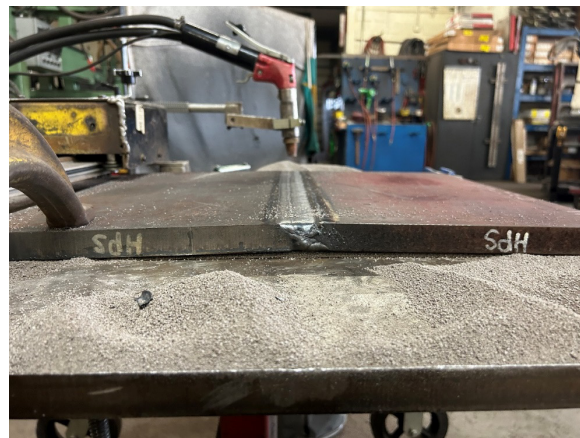
Step 4: Perform repair weld using SAW.

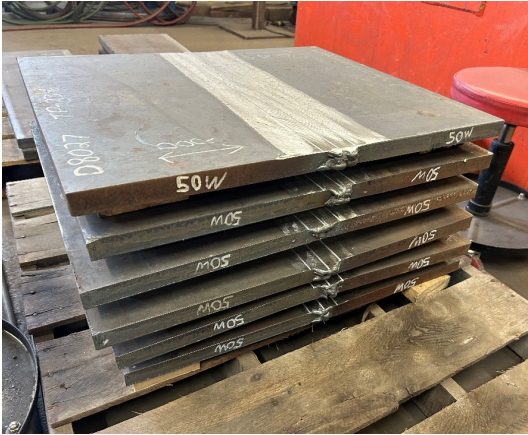
All 50W Plates After Fabrication

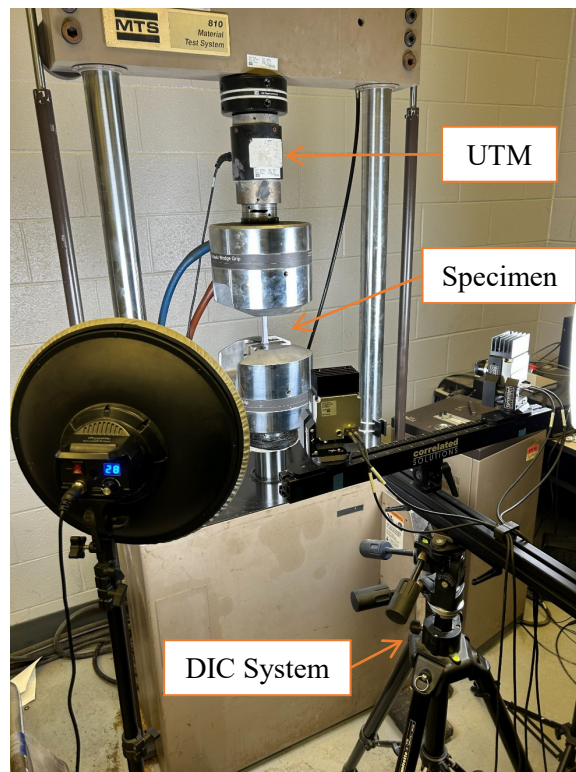
**Figure 5-2. Photo. Overview of tension testing setup.**

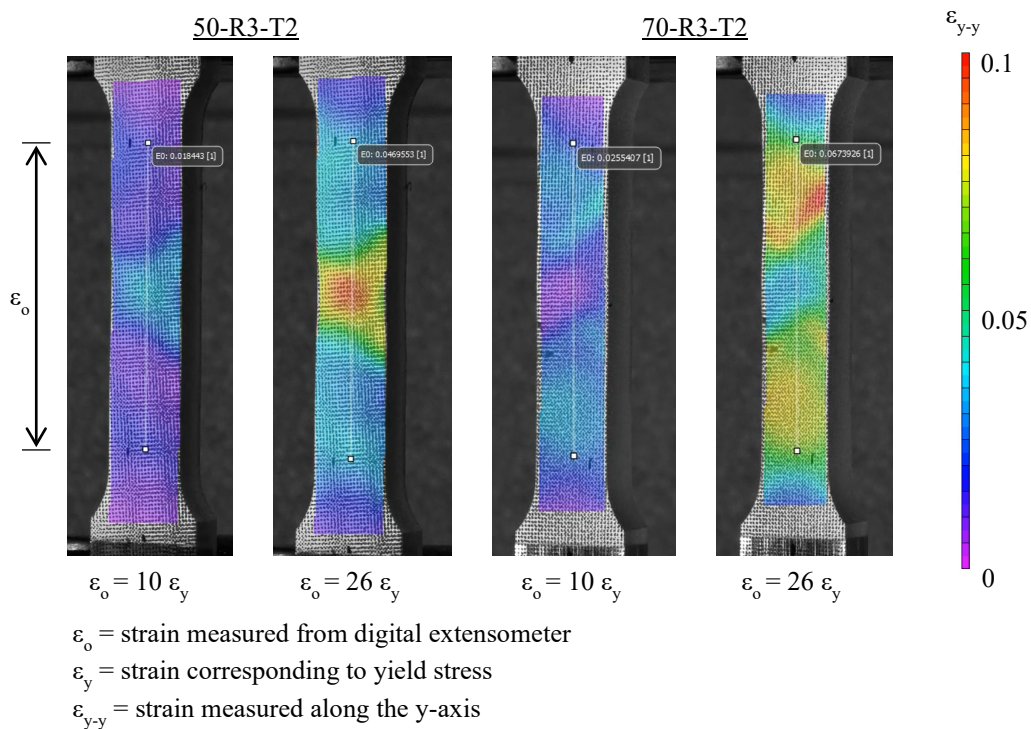
**Figure 5-4. Multiple Photos. DIC data showing strain fields of 50-R3-T2 and 70-R3-T2 at various loading stages.**

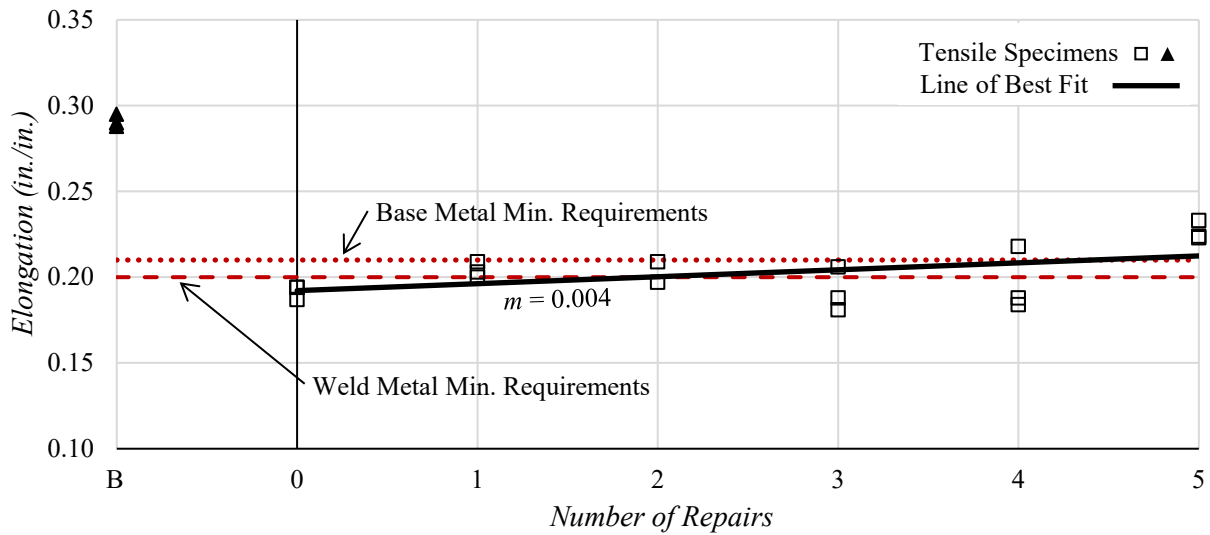
**Figure 5-19. Graph. Comparison of measured elongations for 50-grade tensile specimens.**

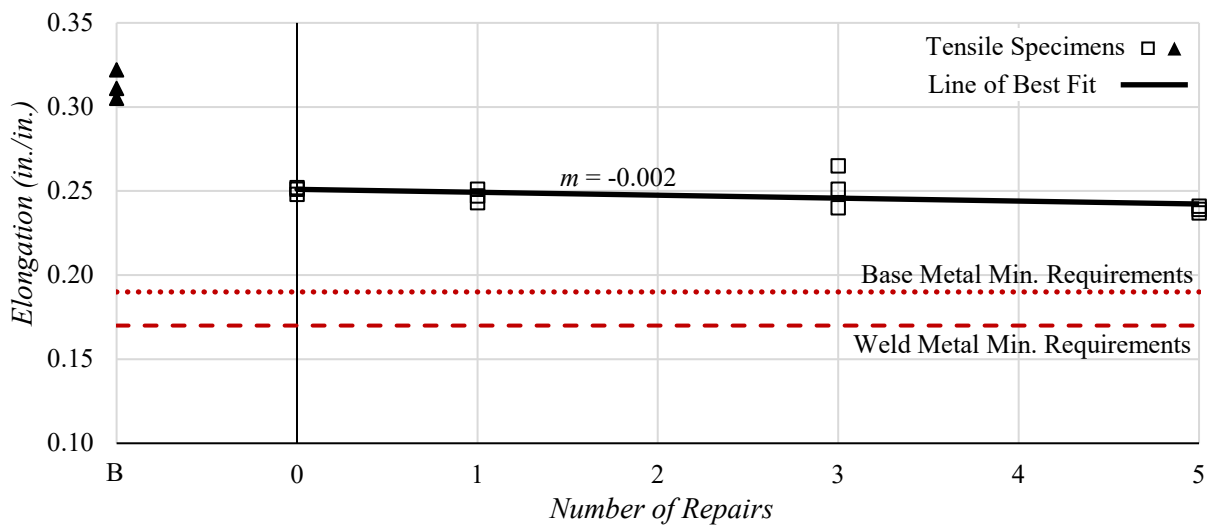
**Figure 5-20. Graph. Comparison of measured elongations for 70-grade tensile specimens.**

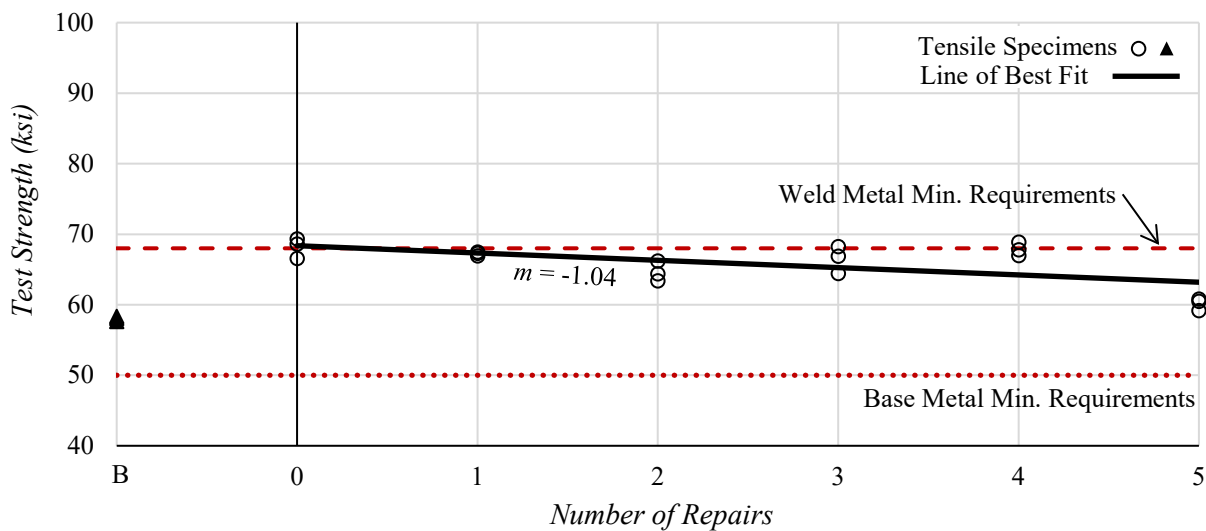
Figure 5-21. Graph. Comparison of yield stresses for 50-grade tensile specimens.

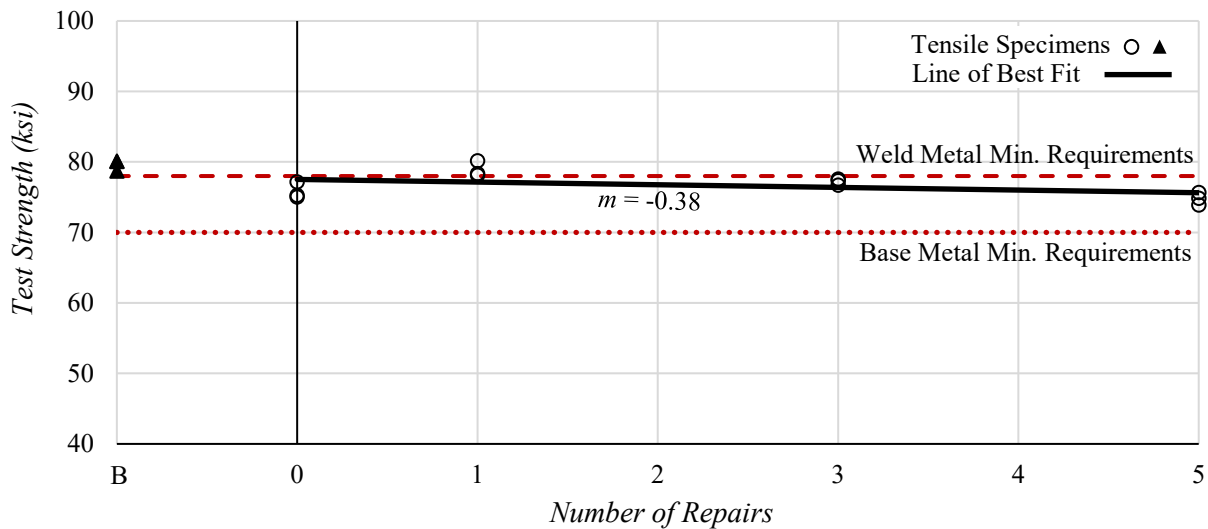
**Figure 5-22. Graph. Comparison of yield stresses for 70-grade tensile specimens.**

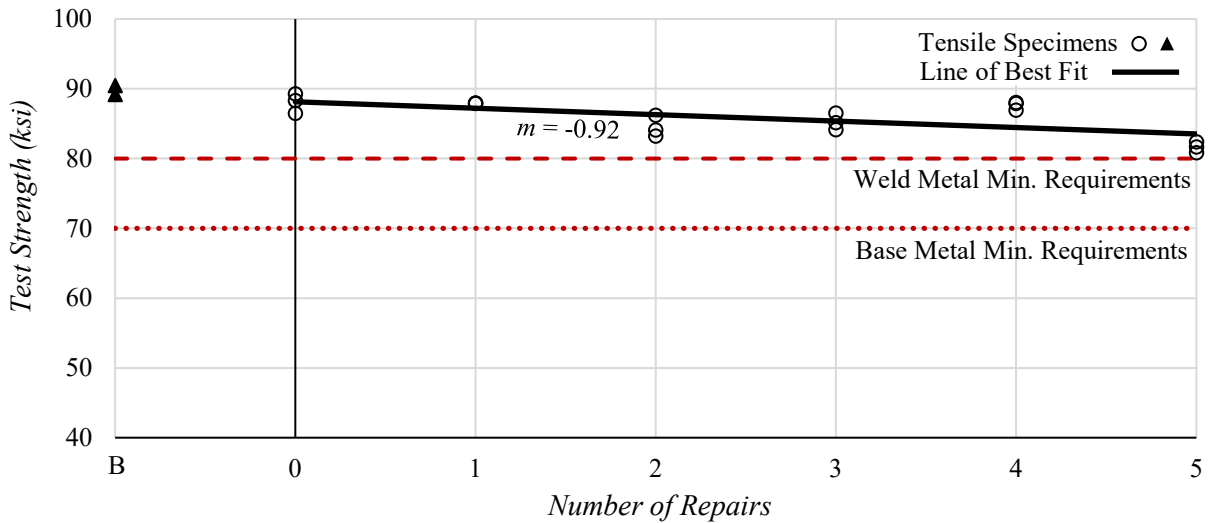
Figure 5-23. Graph. Comparison of tensile stresses for 50-grade tensile specimens.

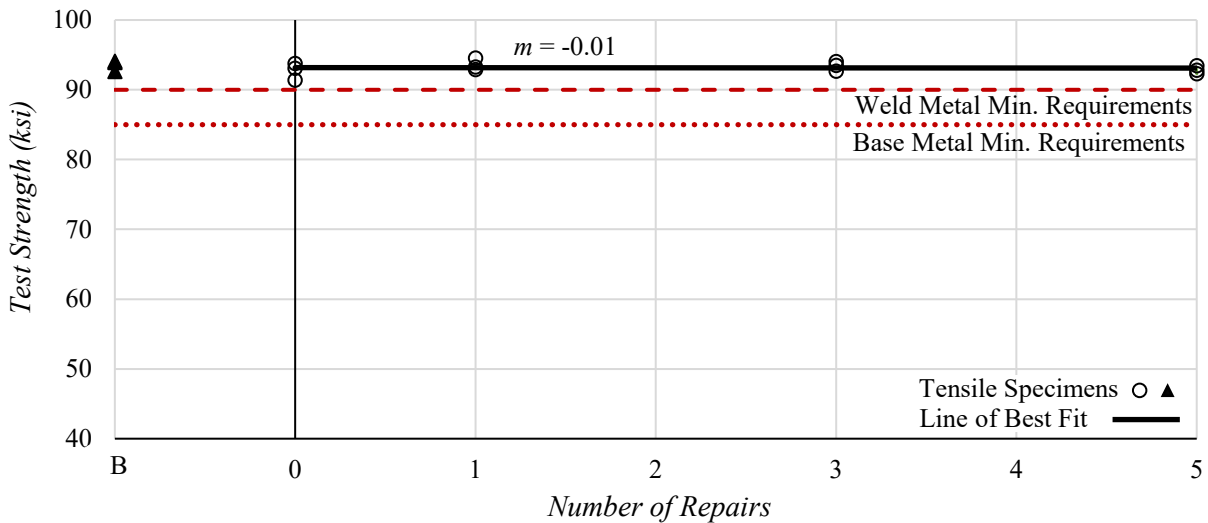
Figure 5-24. Graph. Comparison of tensile stresses for 70-grade tensile specimens.

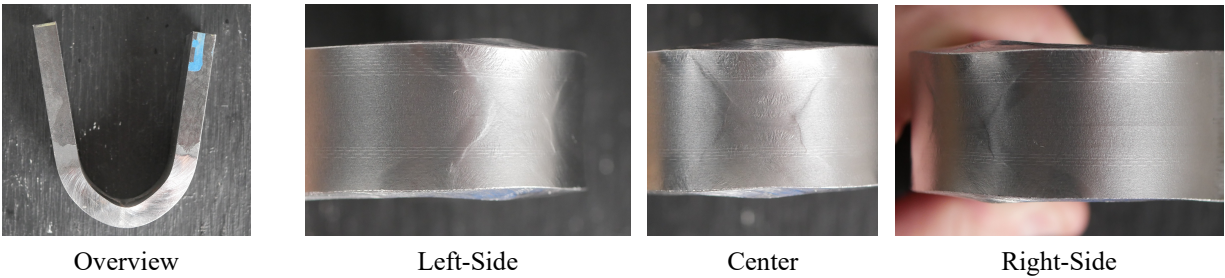
(a) Photos of 50-R1-B1 side-bend test (Pass)

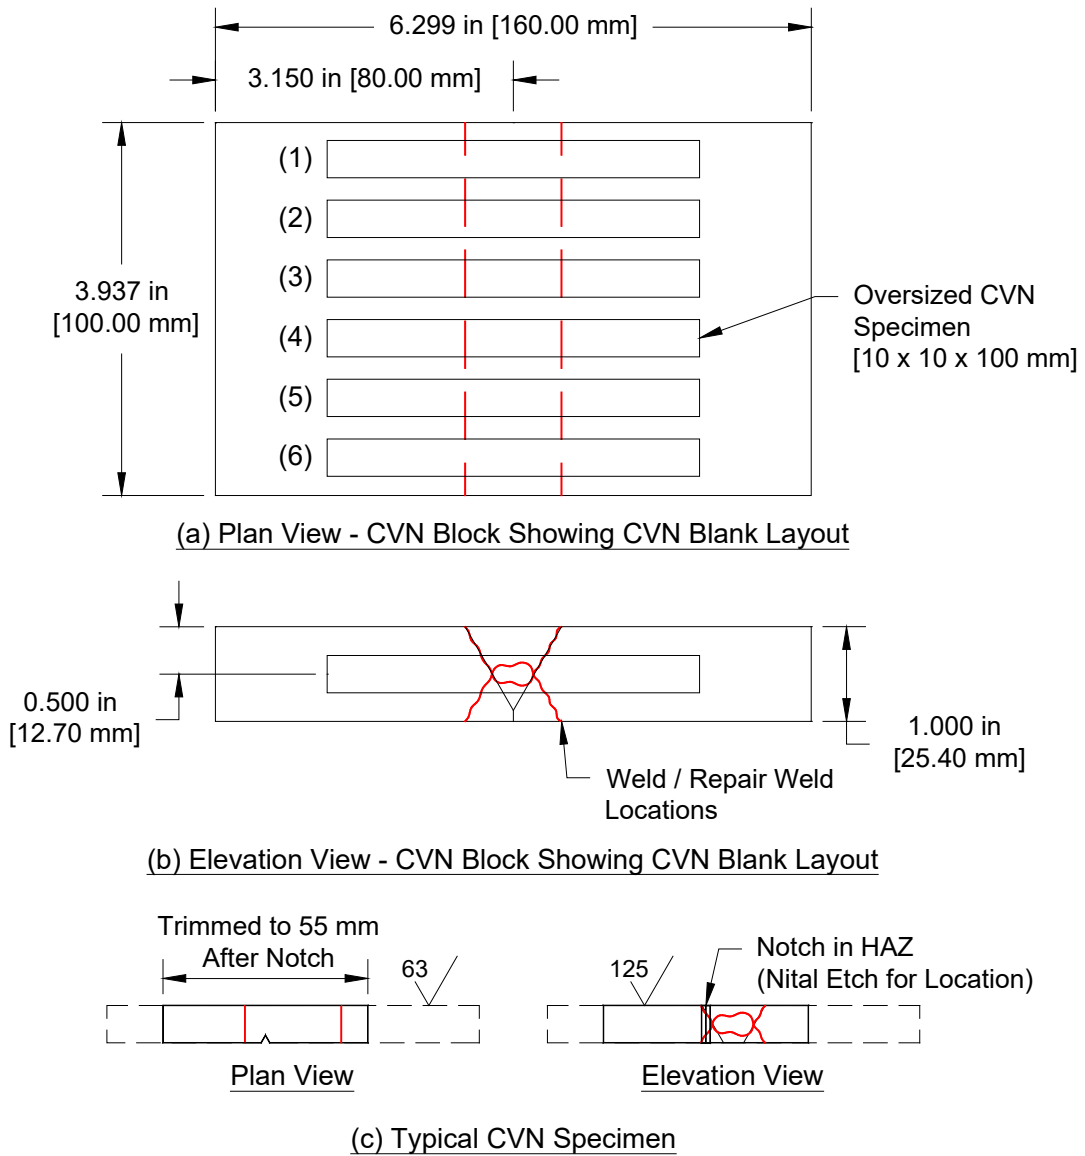
**Figure 5-29. Illustration. Typical CVN impact specimen. (a) Plan View – CVN block showing CVN blank layout, (b) Elevation View – CVN block showing CVN blank layout, and (c) Typical CVN specimen**

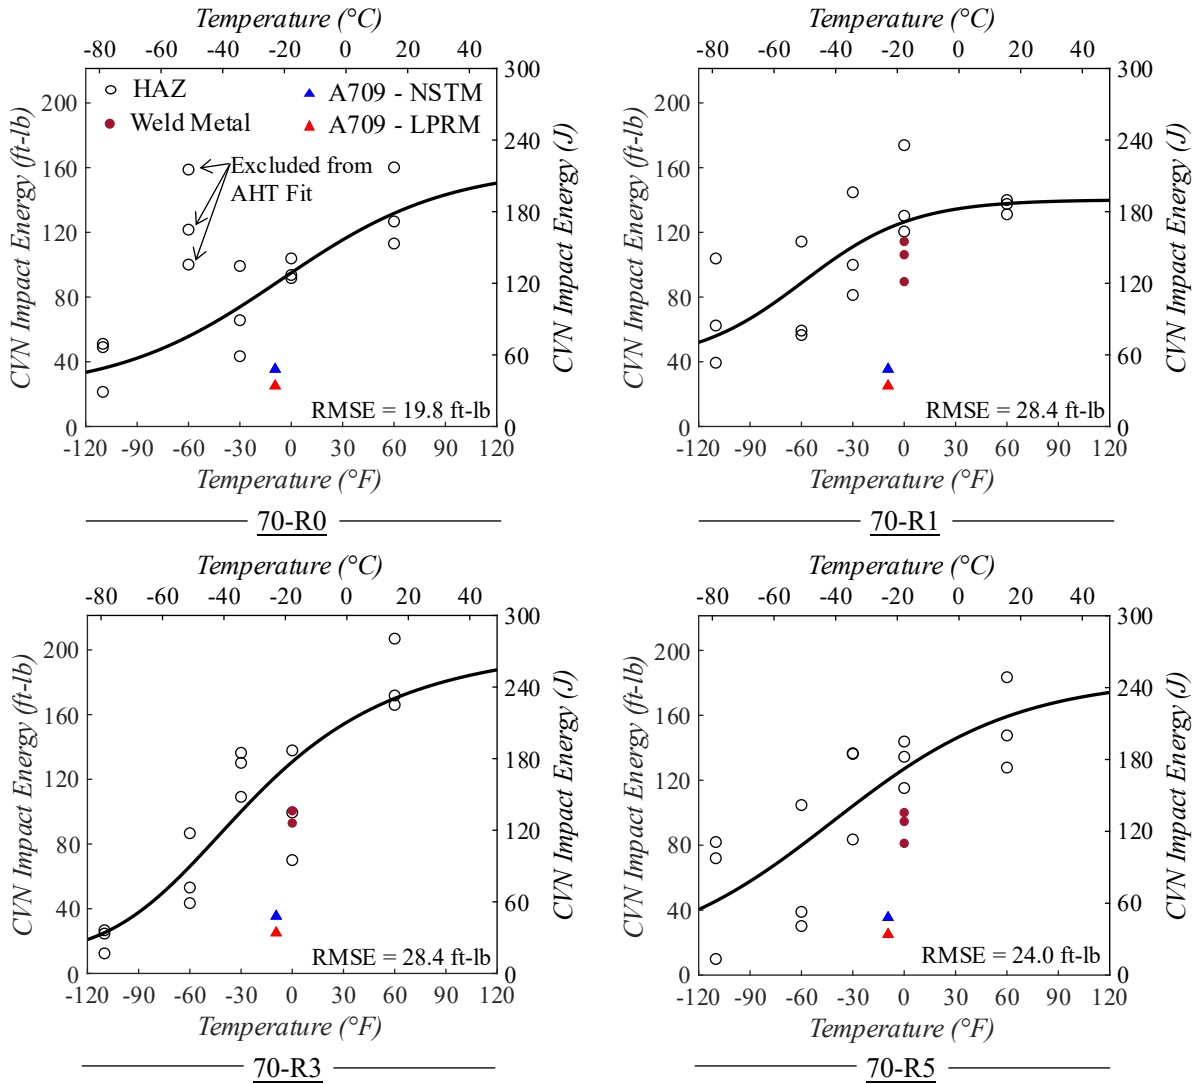
**Figure 5-34. Multiple Graphs. CVN impact test results for 70-grade welded sample groups.**

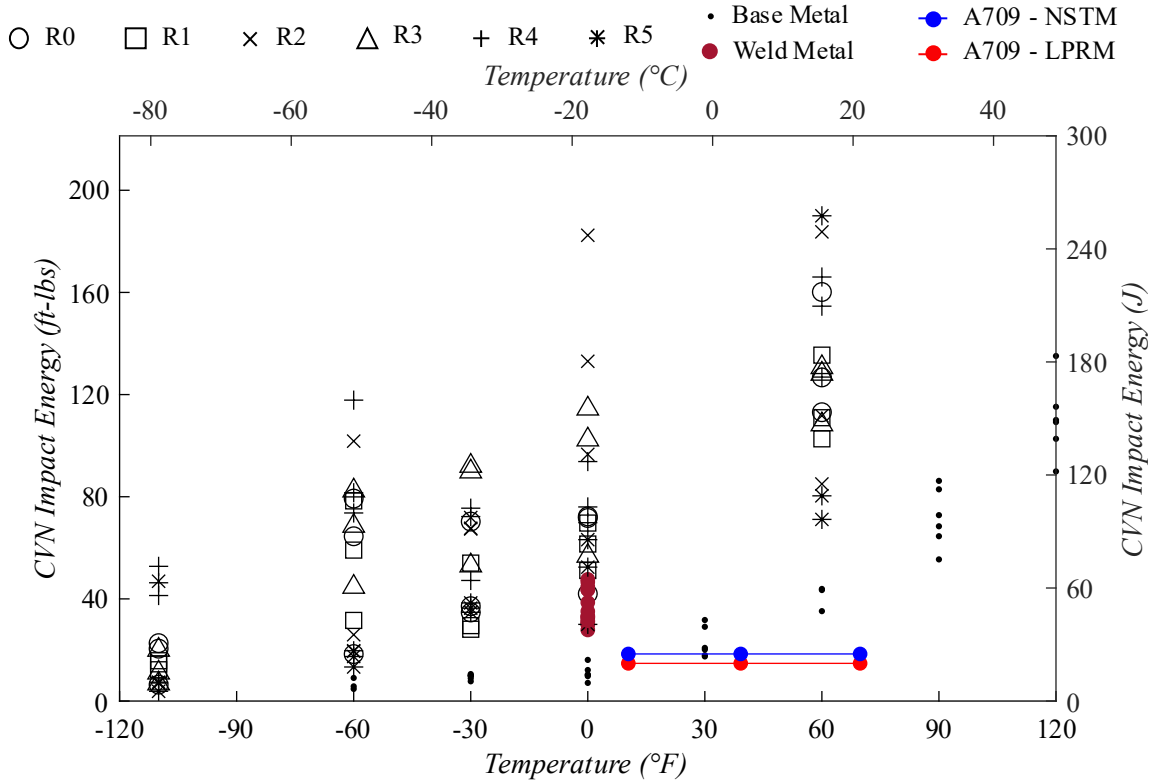
Figure 5-35. Graph. CVN impact test results for all 50-grade specimens.

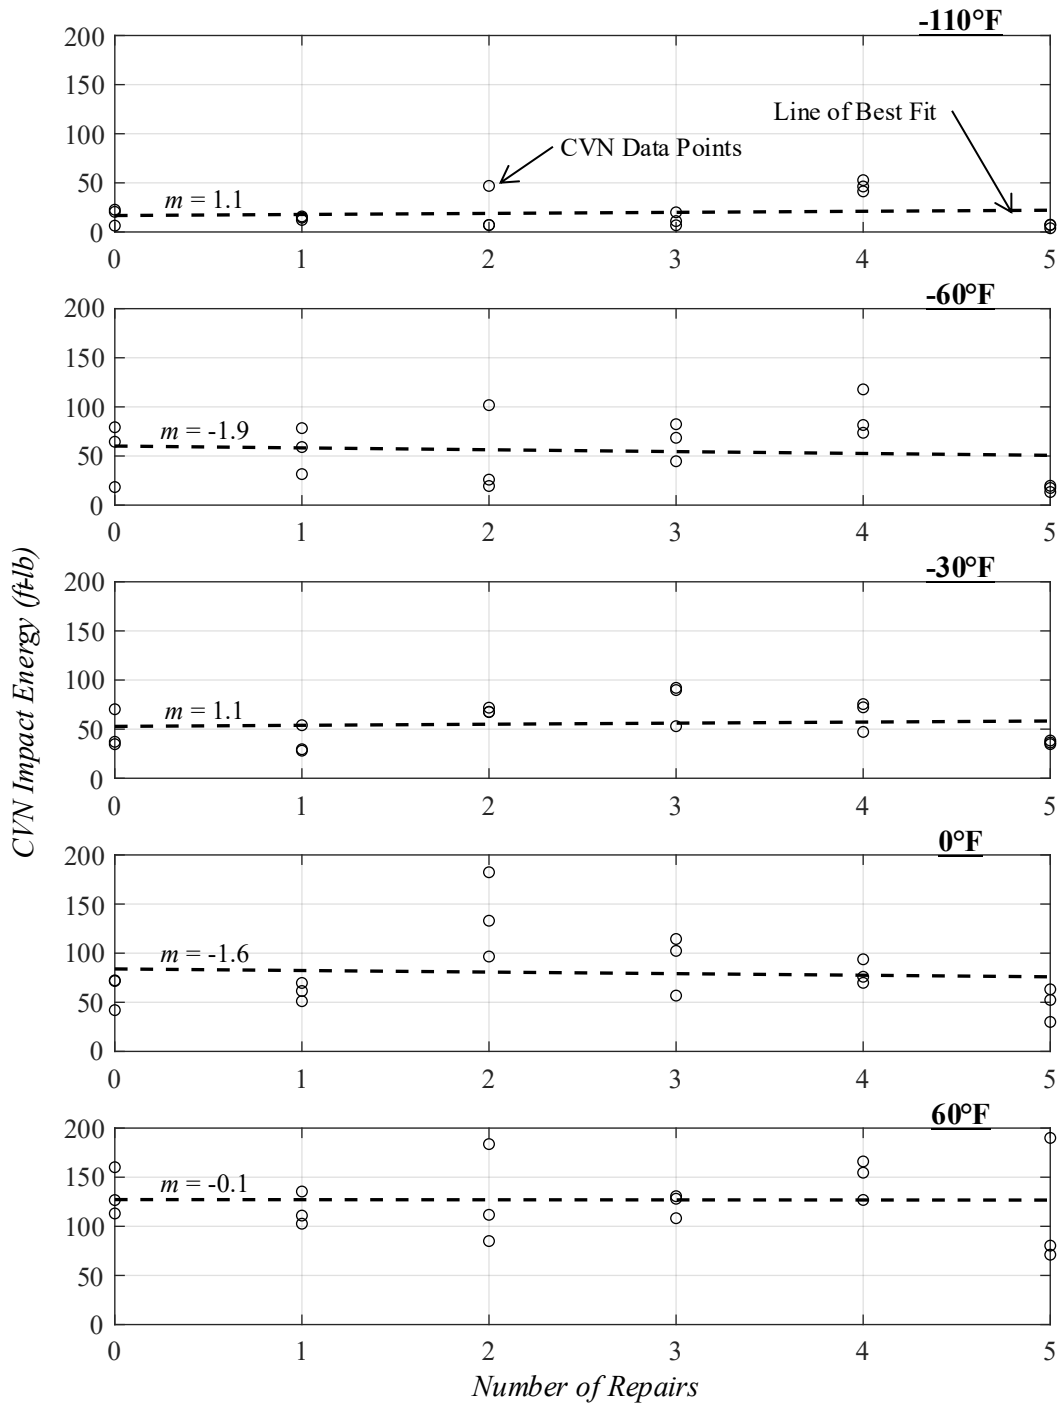
**Figure 5-37. Multiple Graphs. Comparison plots showing the 50-grade CVN impact energies versus the number of weld repairs for each test temperature.**

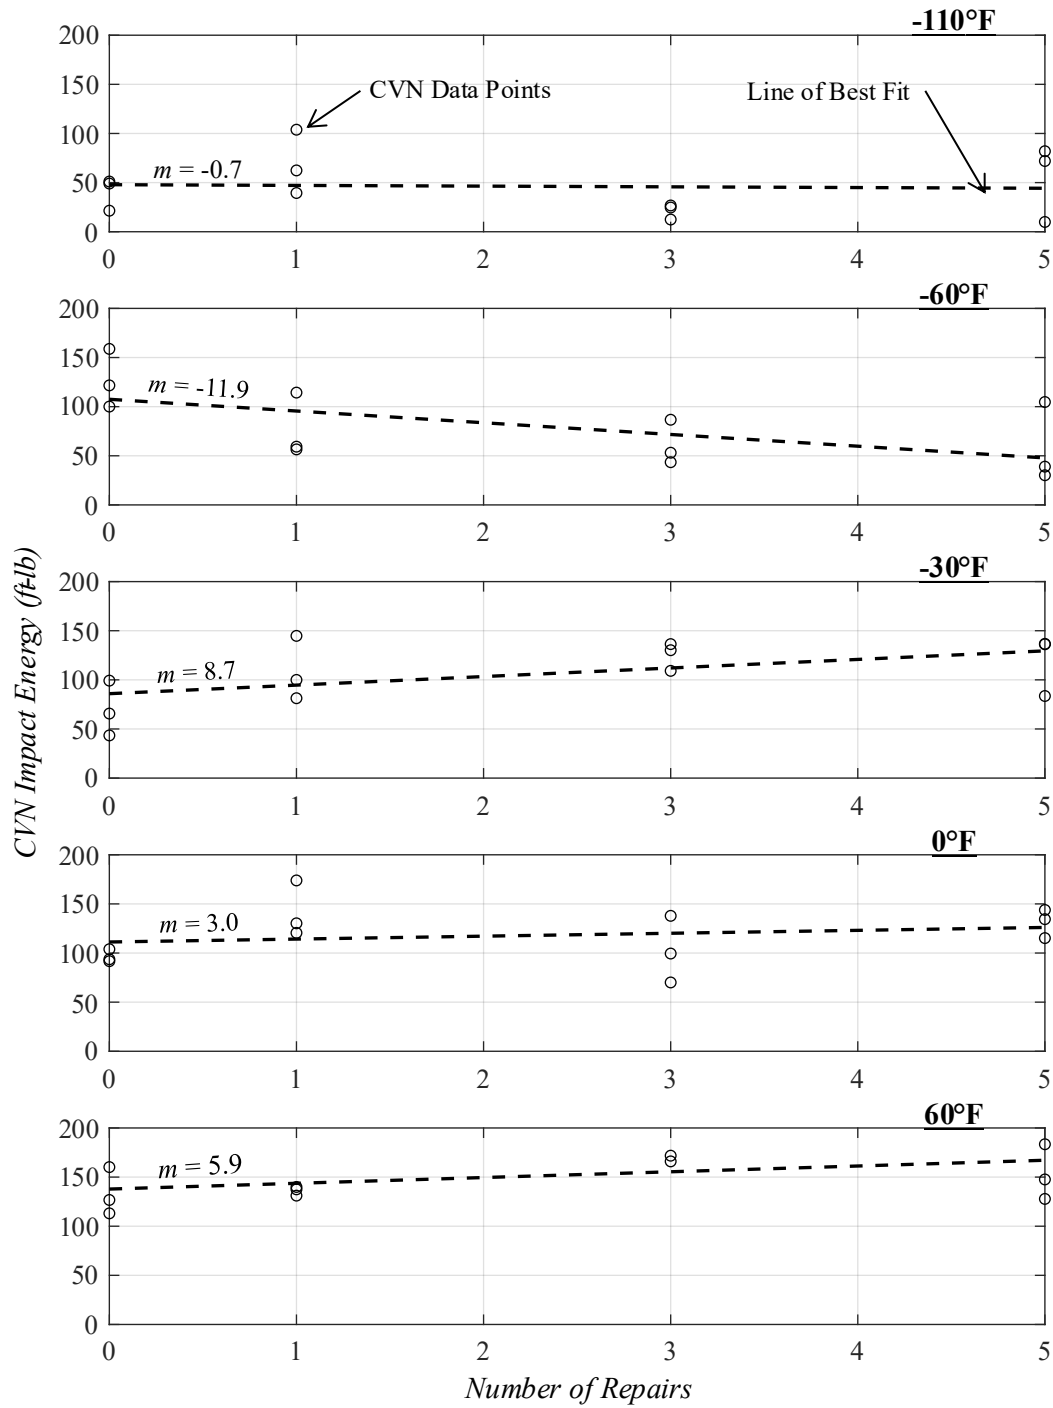
**Figure 5-38. Multiple Graphs. Comparison plots showing the 70-grade CVN impact energies versus the number of weld repairs for each test temperature.**

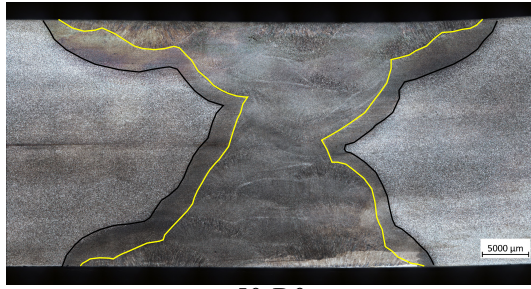
As the figures show, all the welded specimens had similar double V-groove geometrical weld profiles, and the weld profiles were well maintained through all the repairs except sample group 50-R5, which is much larger than the other profiles. Based on the alignment, the final repair for 50-R5 was slightly off-center, resulting in an expanded weld profile compared to the other specimens. Table 5-4 shows that all specimens of each material had comparable weld widths and HAZs, except for 50-R5. For the 50-grade materials (excluding 50-R5), weld widths ranged from 9 to 11 millimeters, and HAZ widths ranged from 1.2 to 3.2 millimeters. For the 70-grade materials, weld widths ranged from 11.1 to 12.9 millimeters, and HAZ widths ranged from 1.8 to 4.4 millimeters.

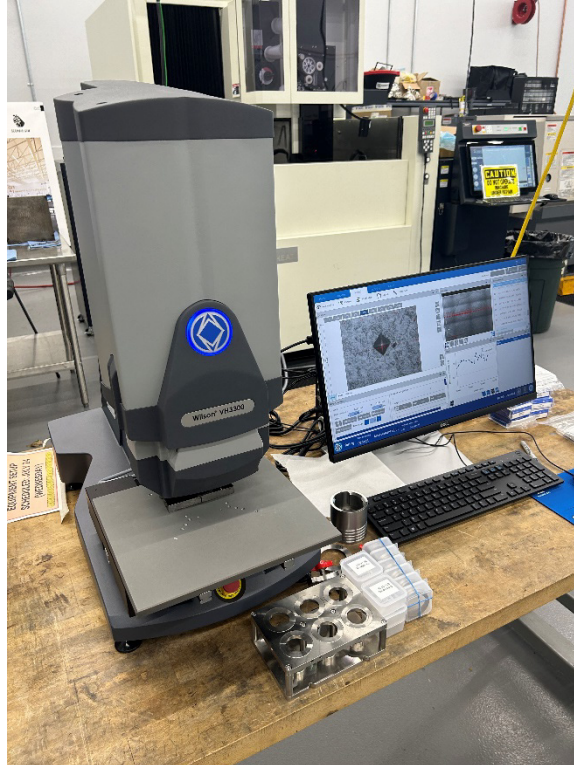
**Figure 5-42. Photo. Overview of microhardness test setup.**

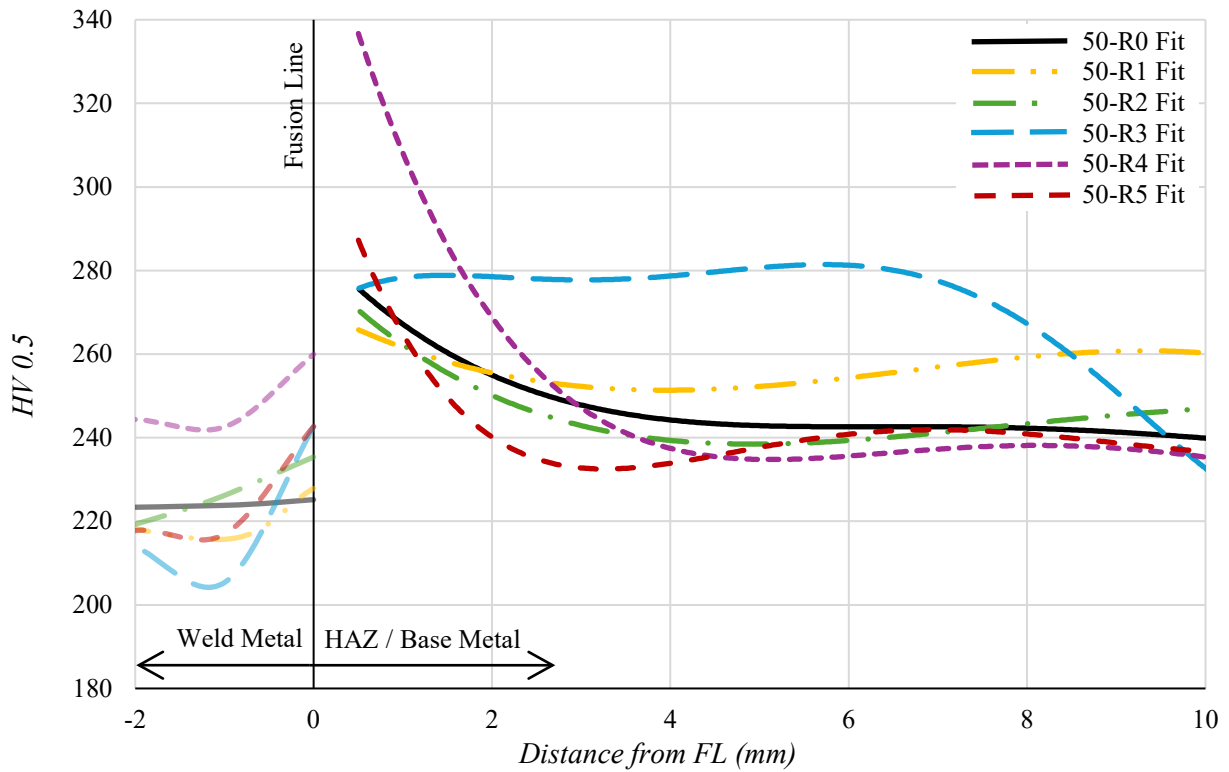
**Figure 5-54. Graph. Comparison of 50-grade hardness values within the HAZ.**

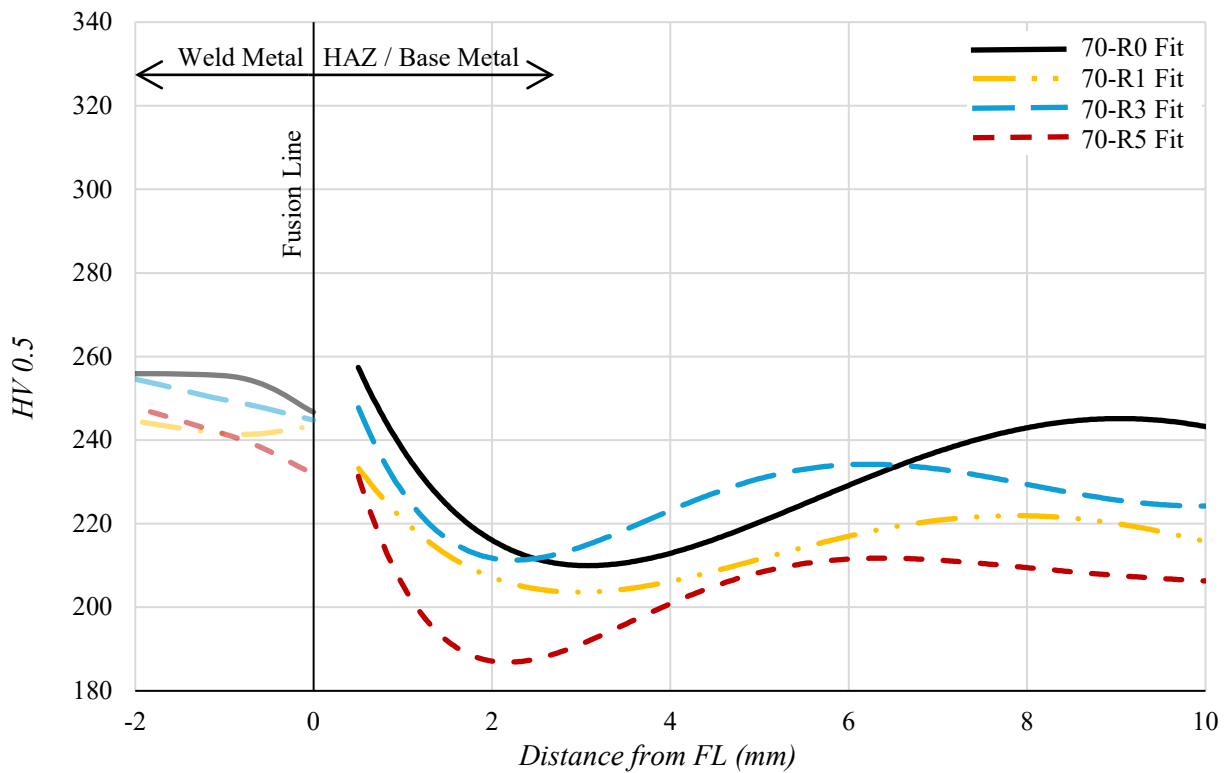
**Figure 5-55. Graph. Comparison of 70-grade hardness values within the HAZ.**

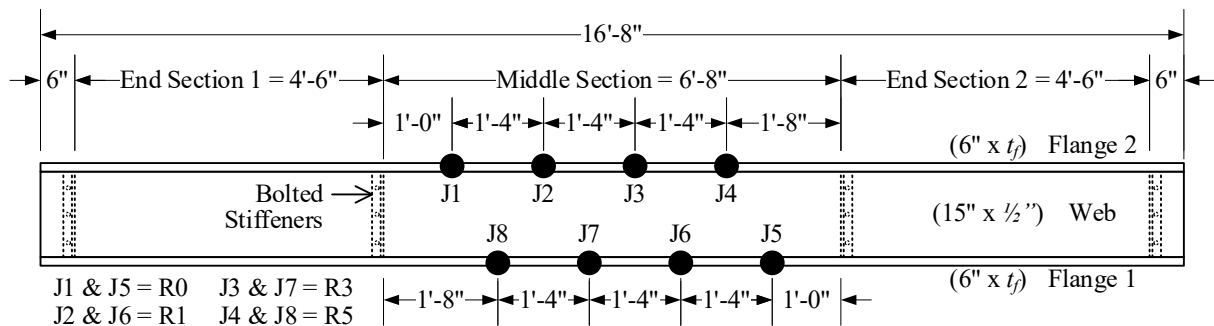
Figure 6-1. Illustration. Layout of fatigue testing girders.

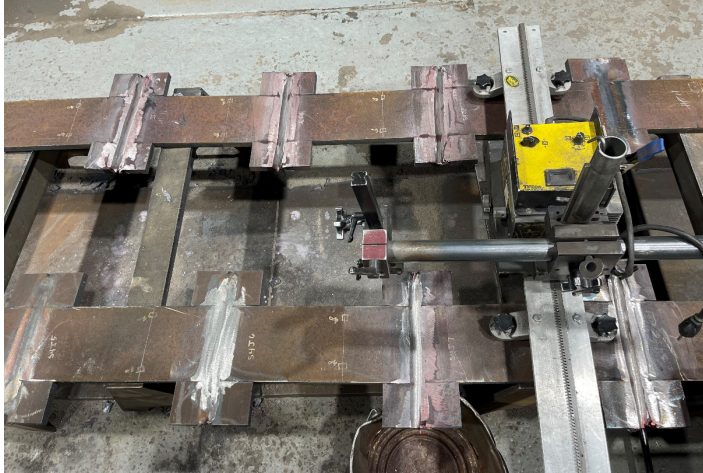
(a) Photo showing CJP joints being welded  
(G4 Shown)

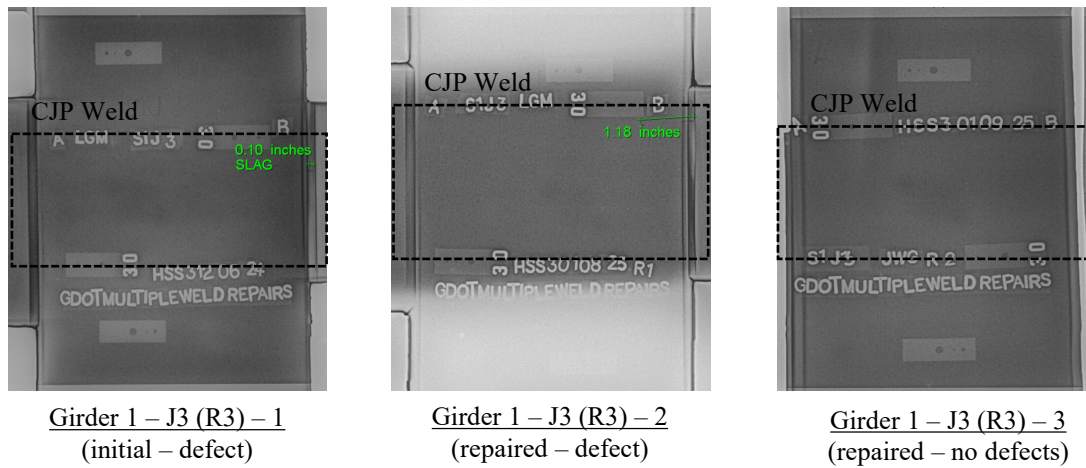
**Figure 6-4. Radiographic testing (RT) NDT results from G1-J3 showing a detected defect and the final RT with no defects.**

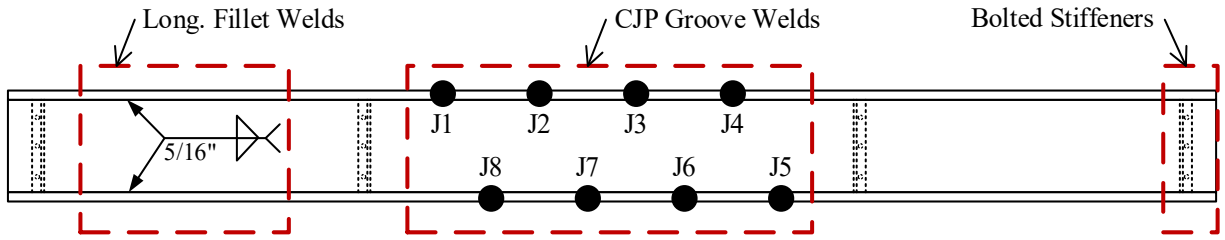
Figure 6-5. Illustration. AASHTO fatigue details on the test girder.

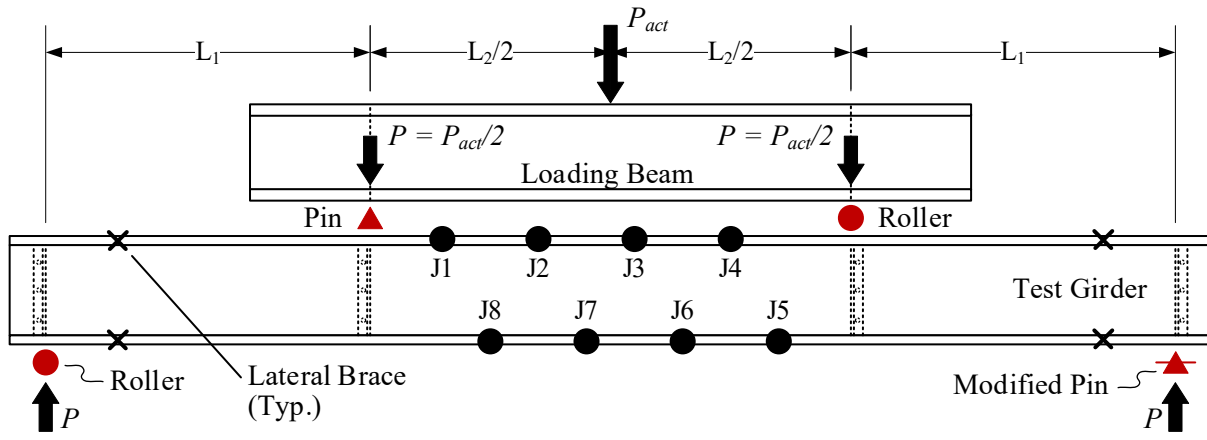
(a) Four-Point Bending Loading Configuration
