**GEORGIA DOT RESEARCH PROJECT 22-20**

Final Report

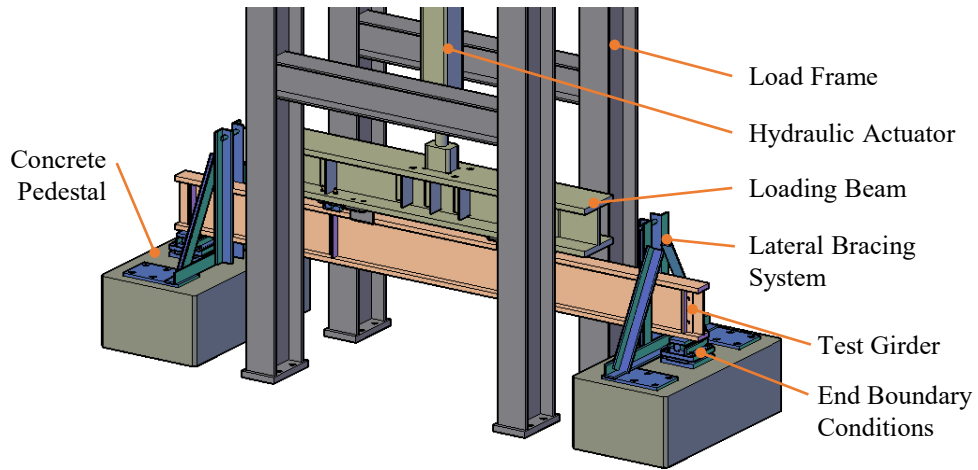
Figure 6-7. Illustration. Schematic overview of the large-scale fatigue testing setup.

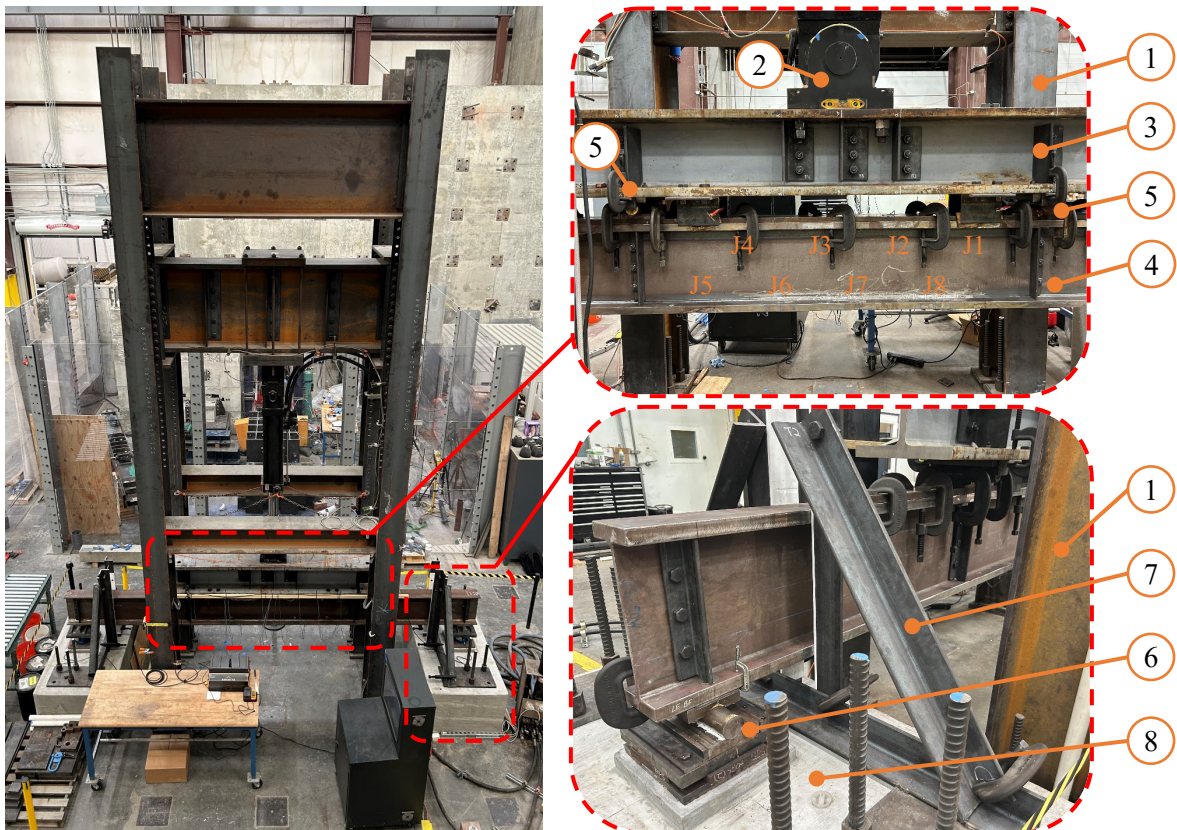
Figure 6-8. Multiple Photos. Photos of the large-scale fatigue testing setup. (1) load frame, (2) hydraulic actuator, (3) loading beam, (4) test girder, (5) internal boundary condition, (6) exterior boundary condition, (7) end lateral bracing system, (8) concrete pedestal

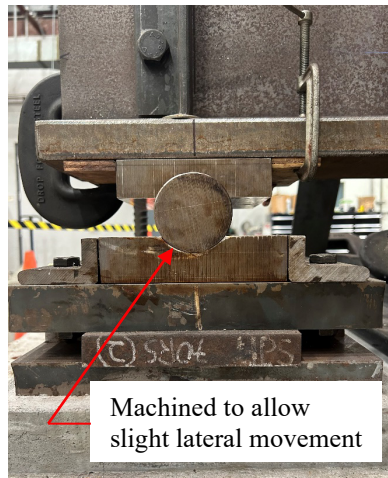
(a) End B.C. – Modified Pin

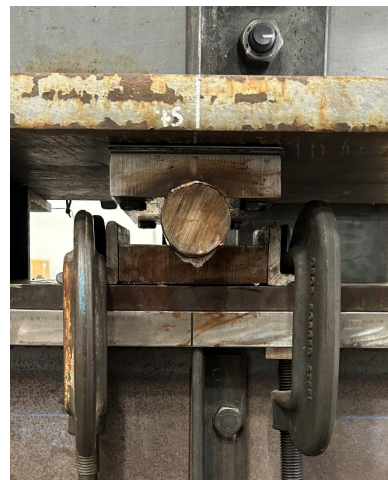
(d) Internal B.C. - Pin

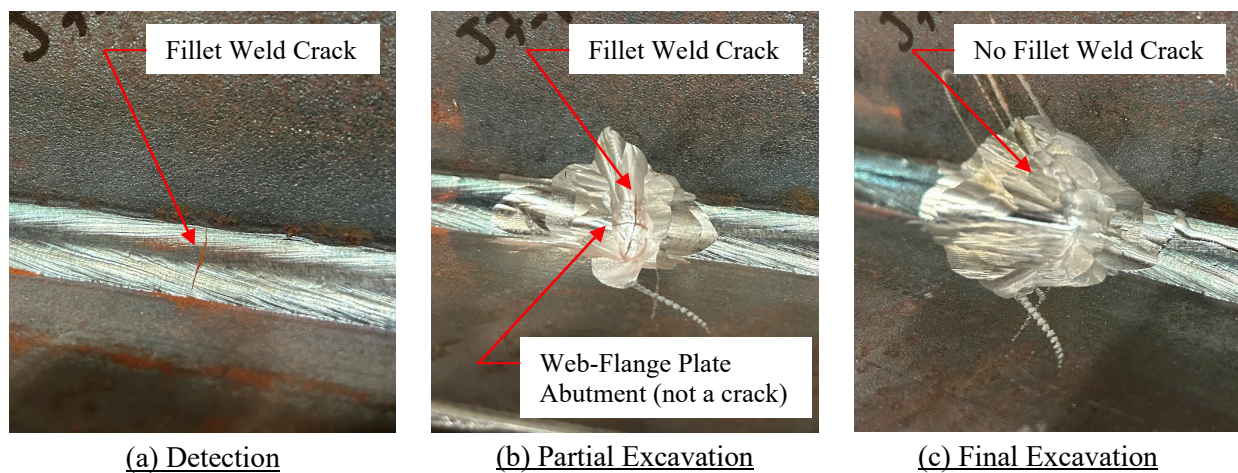
**Figure 6-10. Multiple Photos. Photos showing the mechanical grinding repair process. (a) Detection, (b) Partial excavation, and (c) Final excavation.**

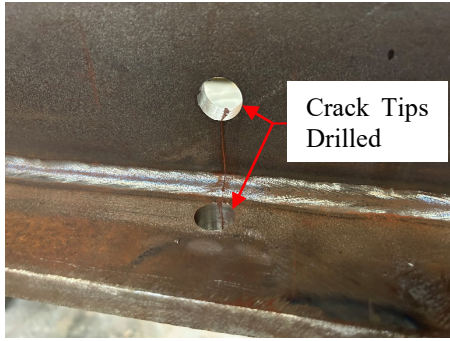
(a) Crack Tip(s) Arrested

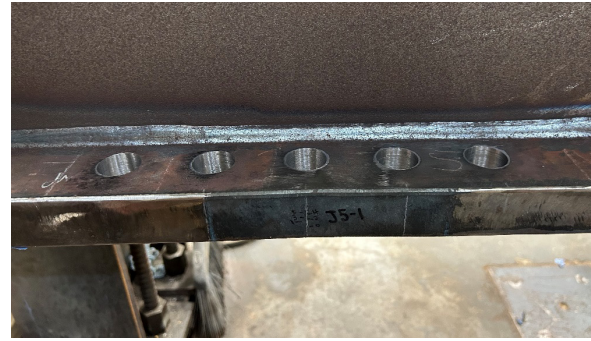
(b) Bolt Holes Drilled in Flange

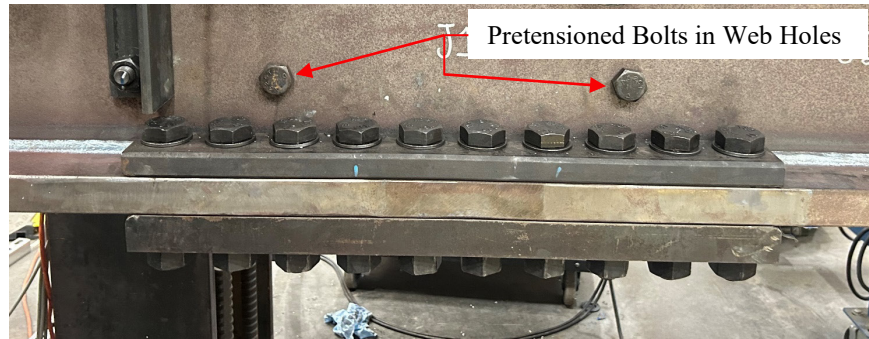
(c) Cover Plates Installed with Pretensioned Bolts

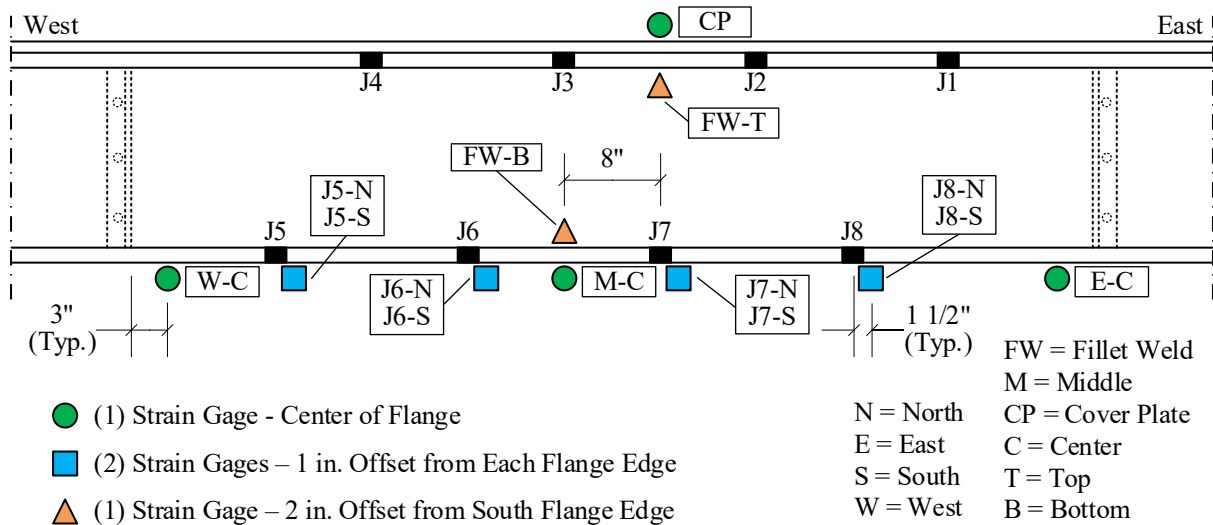
**Figure 7-1. Illustration. Instrumentation layout for Girder 1 - Flange 1 (looking north).**

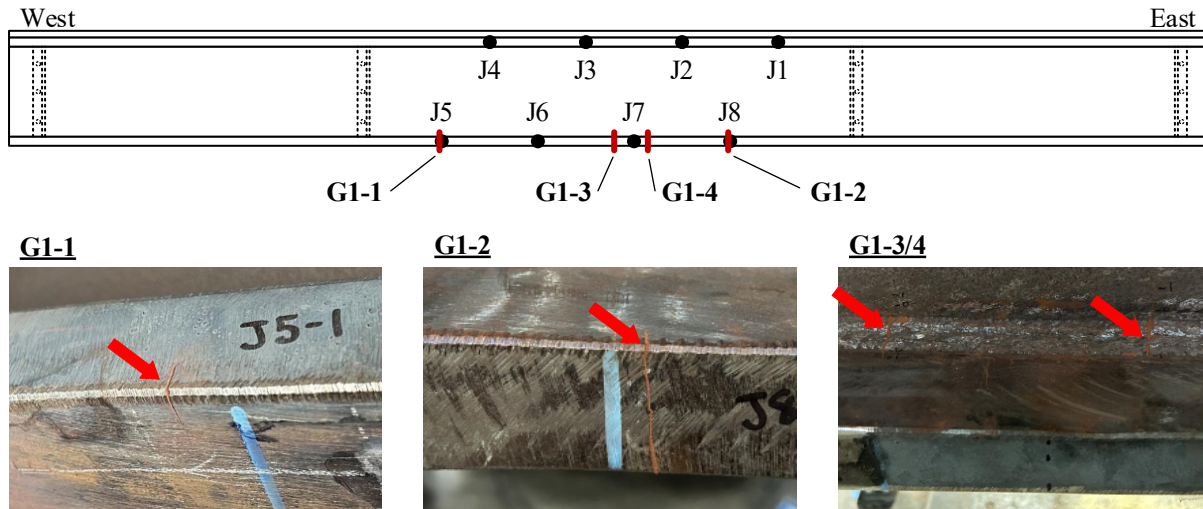
**Figure 7-2. Illustration. Overview showing the different fatigue cracks for Girder 1 – Flange 1.**

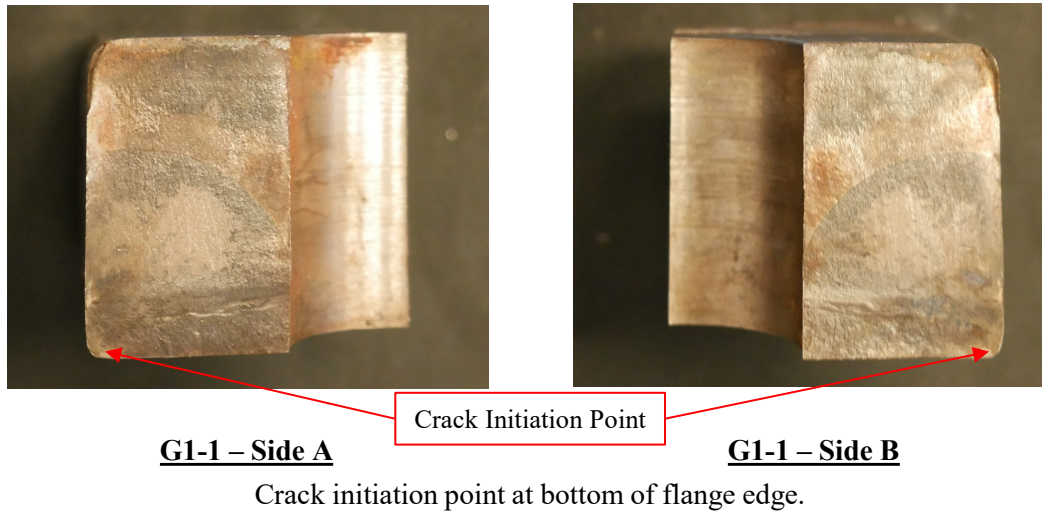
**Figure 7-3. Photo. Destructive evaluation of Crack G1-1, which led to the failure of G1-J5.**

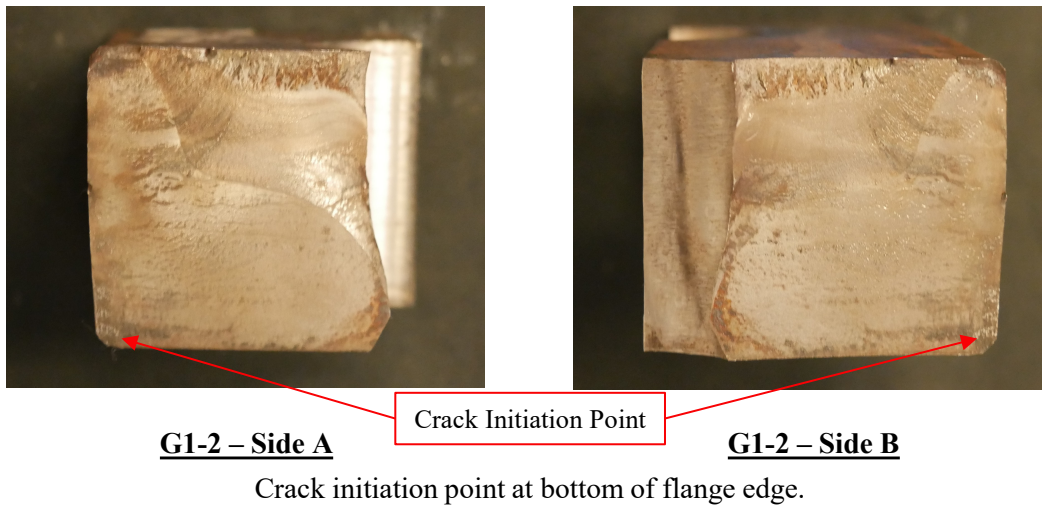
**Figure 7-4. Photo. Destructive evaluation of Crack G1-2, which led to the failure of G1-J8.**

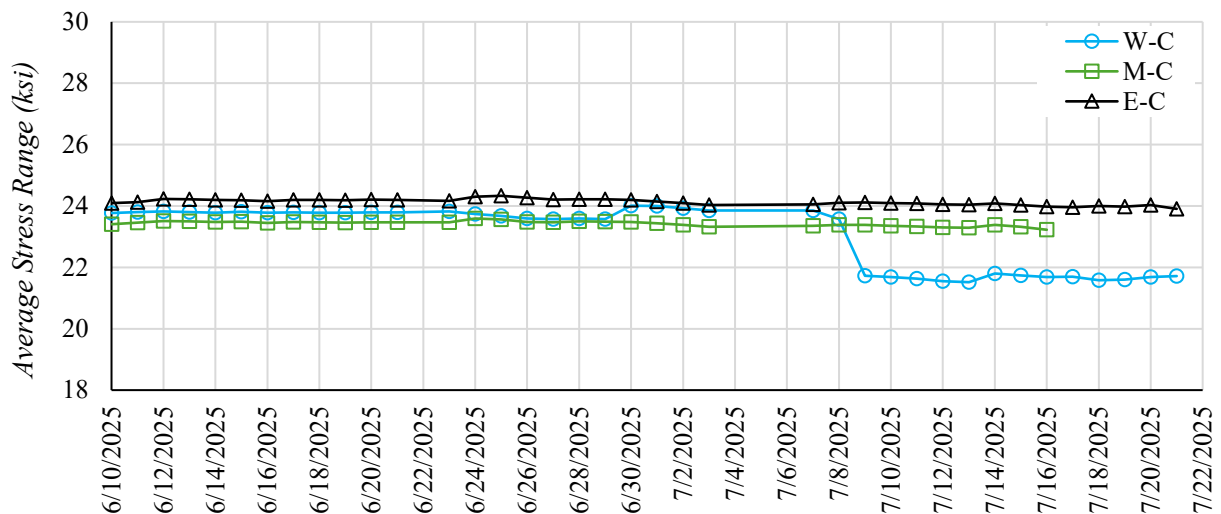
**Figure 7-5. Graph. Average daily stress range for Girder 1 – Flange 1 measured with strain gages along the bottom flange centerline.**

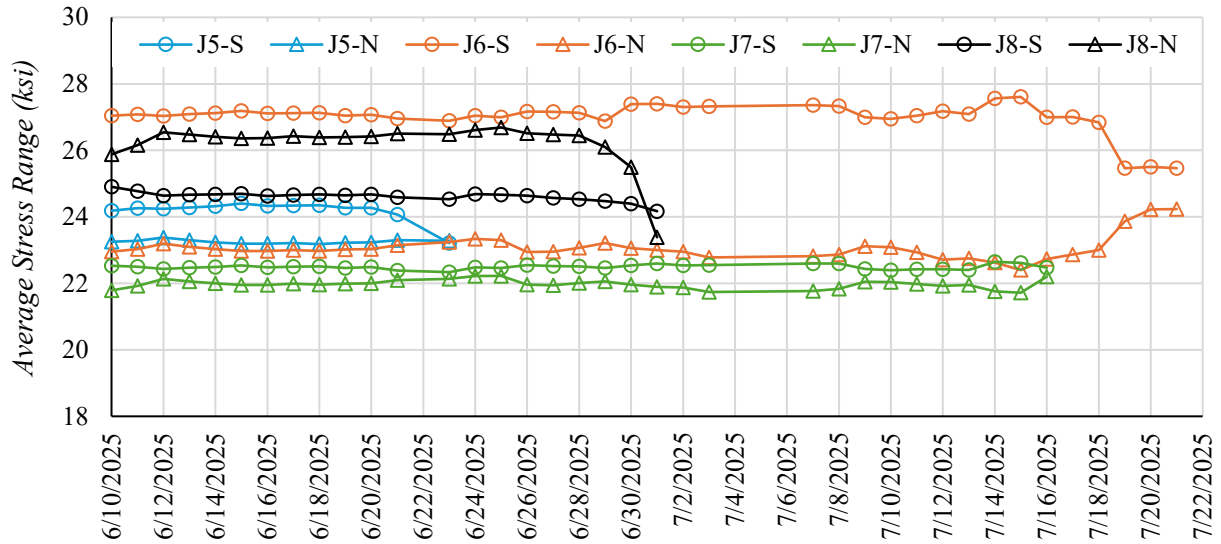
**Figure 7-6. Graph. Average daily stress range for Girder 1 – Flange 1 measured with strain gages at CJP butt-splice joints.**

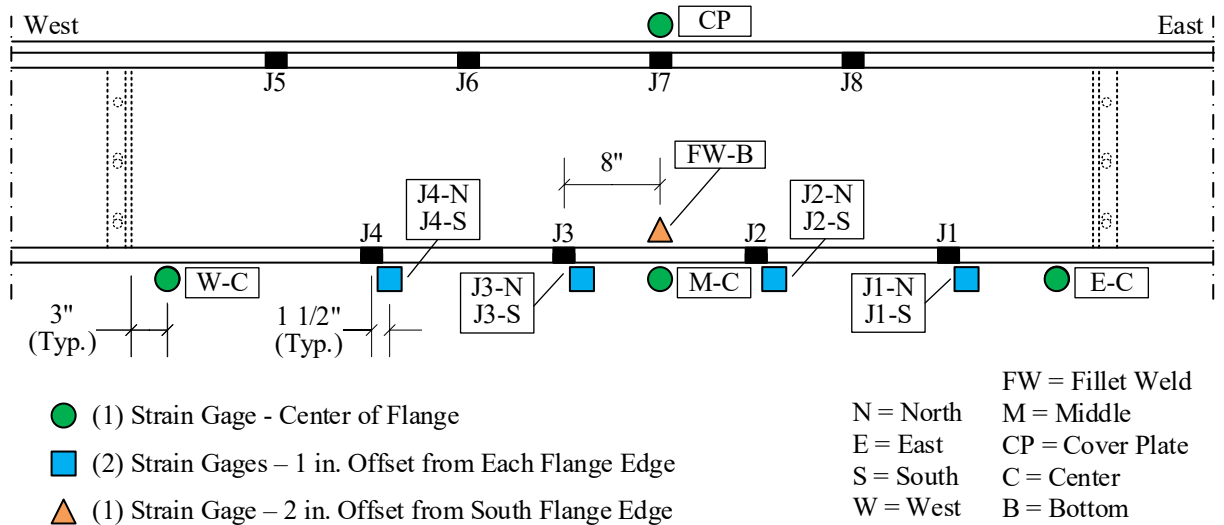
**Figure 7-7. Illustration. Instrumentation layout for Girder 1 - Flange 2 (looking north).**

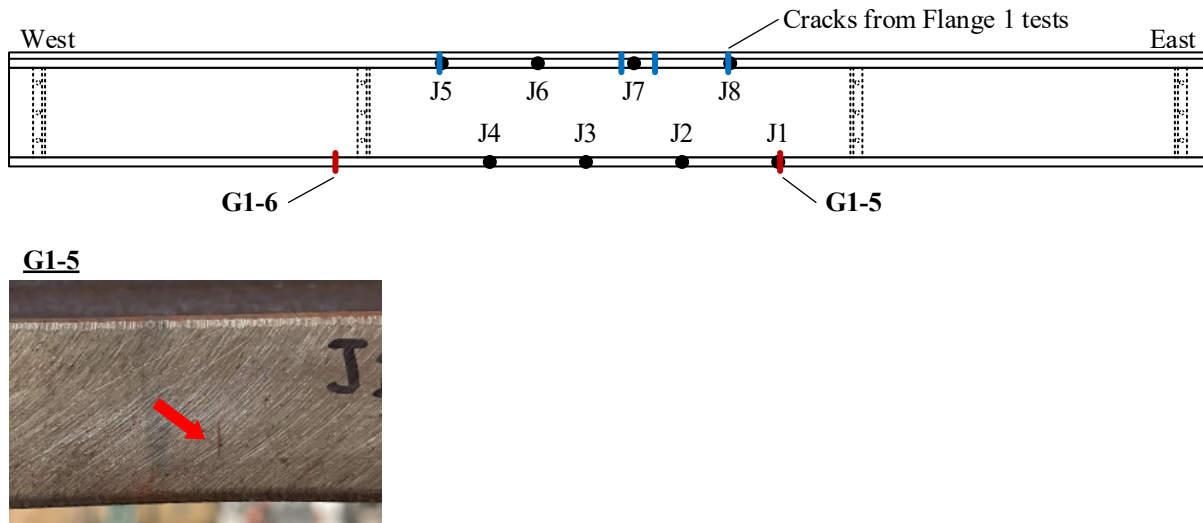
**Figure 7-8. Illustration. Overview showing the different fatigue cracks for Girder 1 – Flange 2.**

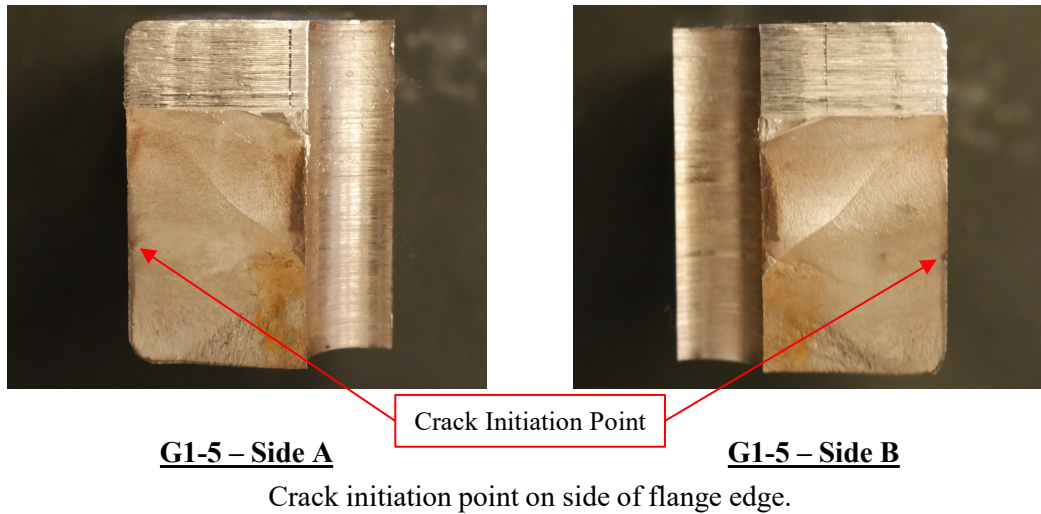
**Figure 7-9. Photo. Destructive evaluation of Crack G1-5, which led to the failure of G1-J1.**

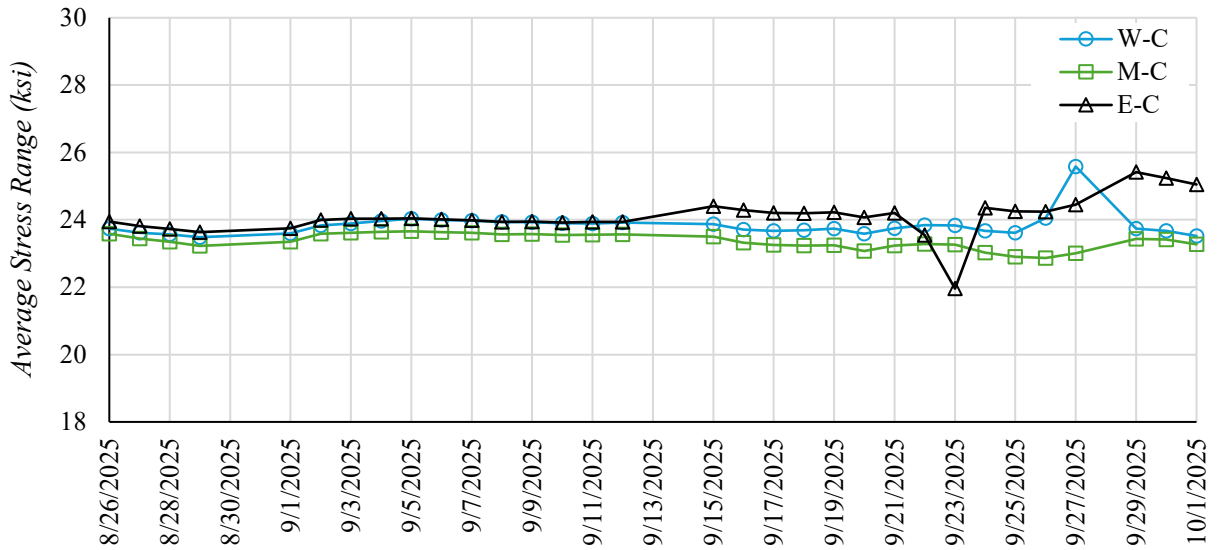
**Figure 7-10. Graph. Average daily stress range for Girder 1 – Flange 2 measured with strain gages along the bottom flange centerline.**

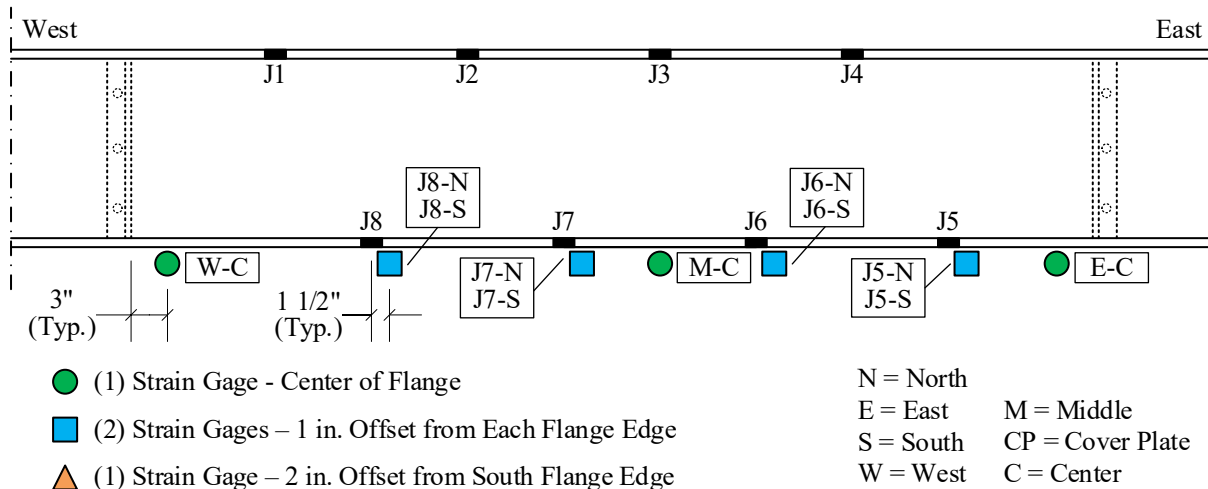
**Figure 7-12. Illustration. Instrumentation layout for Girder 2 - Flange 1 (looking north).**

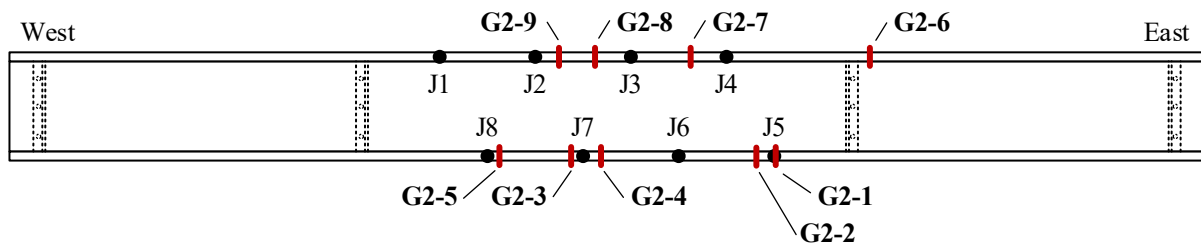
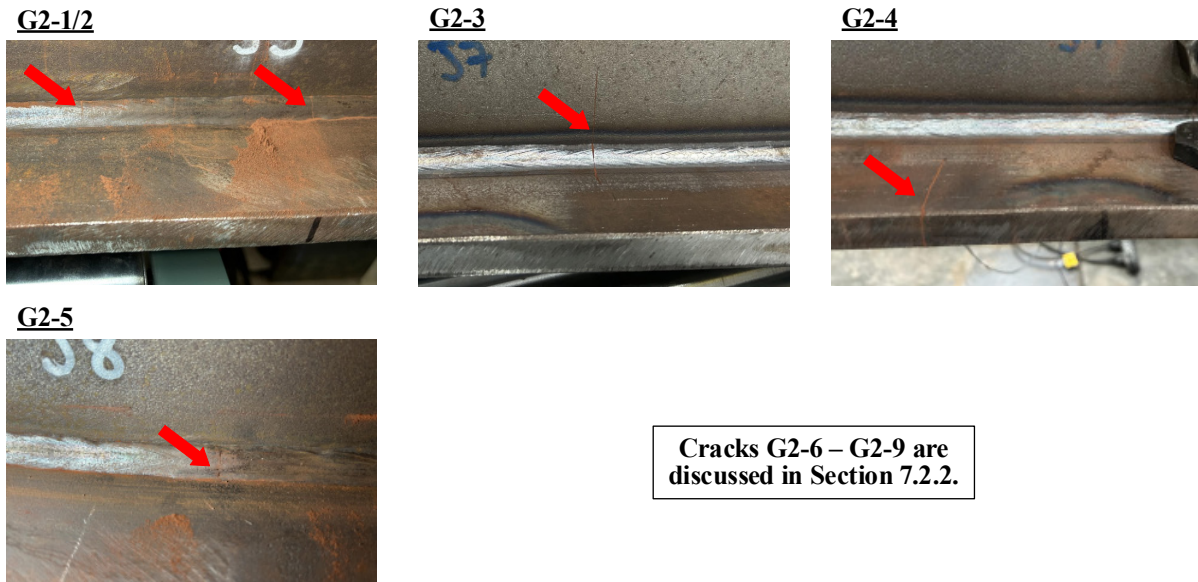
**Figure 7-13. Illustration. Overview showing the different fatigue cracks for Girder 2 – Flange 1.**

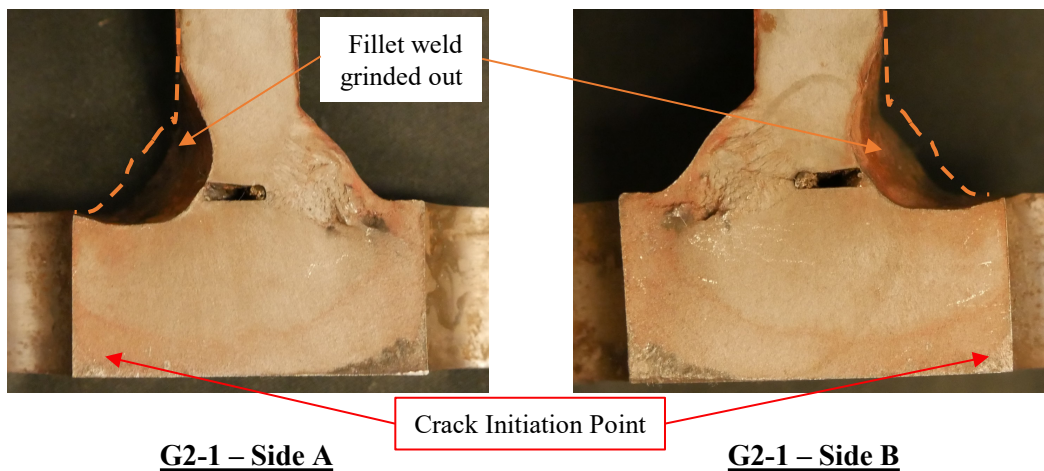
Crack initiation point at root of fillet weld at flange-web juncture.  
Note: Area partially excavated from mechanical grinding repair attempt.

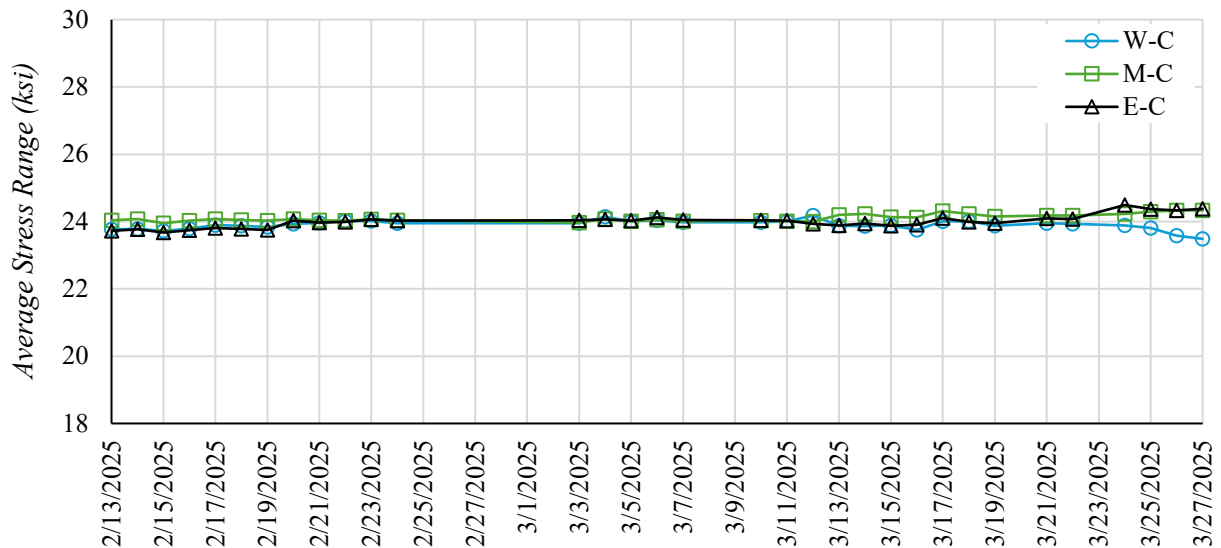
**Figure 7-15. Graph. Average daily stress range for Girder 2 – Flange 1 measured with strain gages along the bottom flange centerline.**

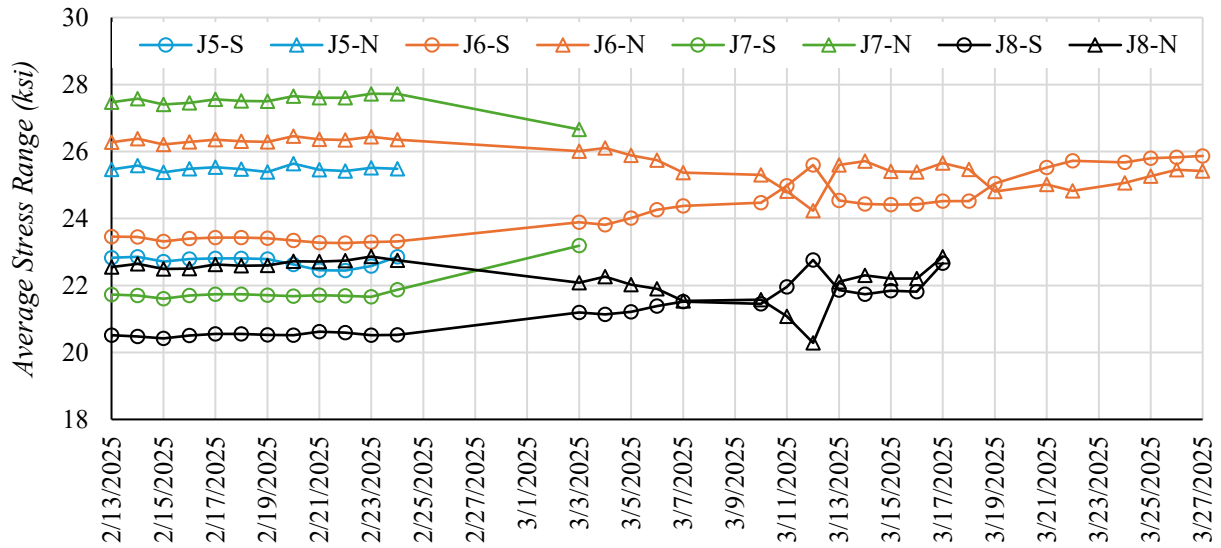
**Figure 7-16. Graph. Average daily stress range for Girder 2 – Flange 1 measured with strain gages at CJP butt-splice joints.**

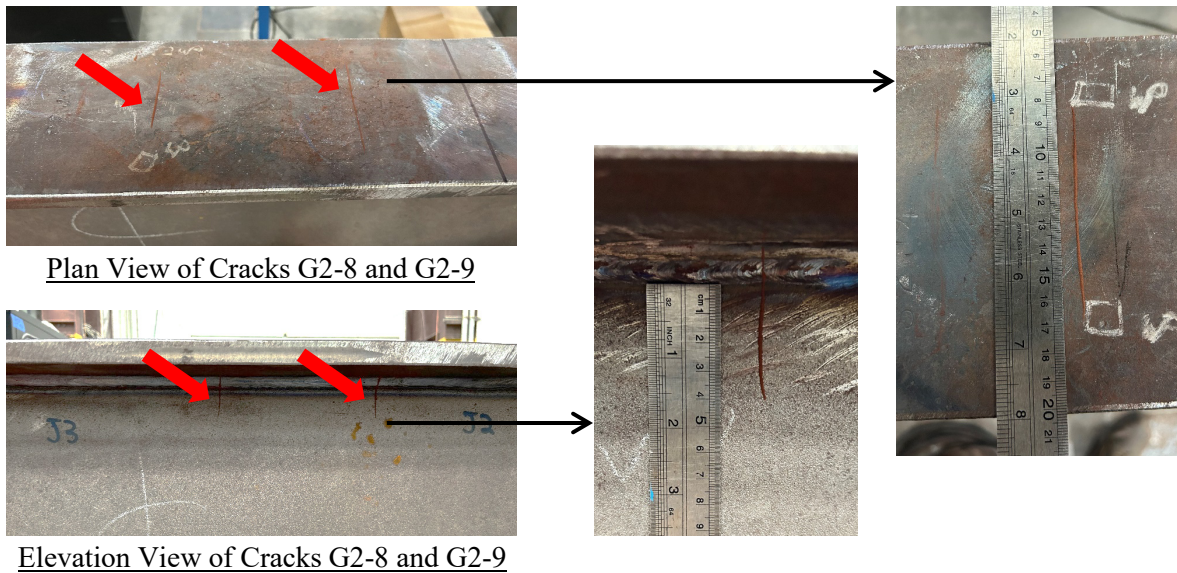
**Figure 7-17. Multiple Photos. Photos showing cracks G2-8 and G2-9 developed in Girder 2 - Flange 2 during testing of Flange 1.**

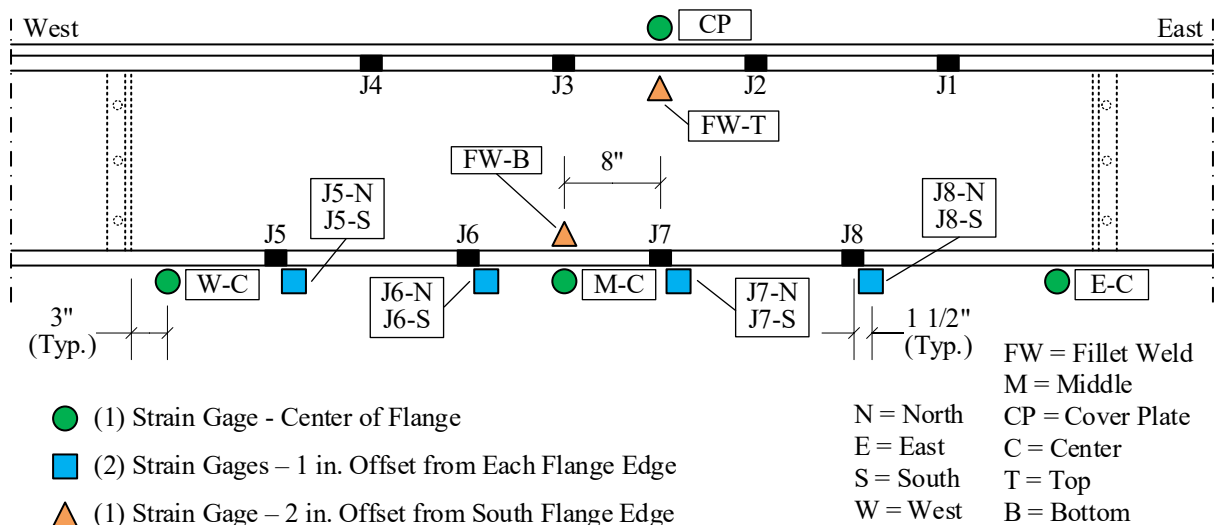
**Figure 7-18. Illustration. Instrumentation layout for Girder 3 - Flange 1 (looking north).**

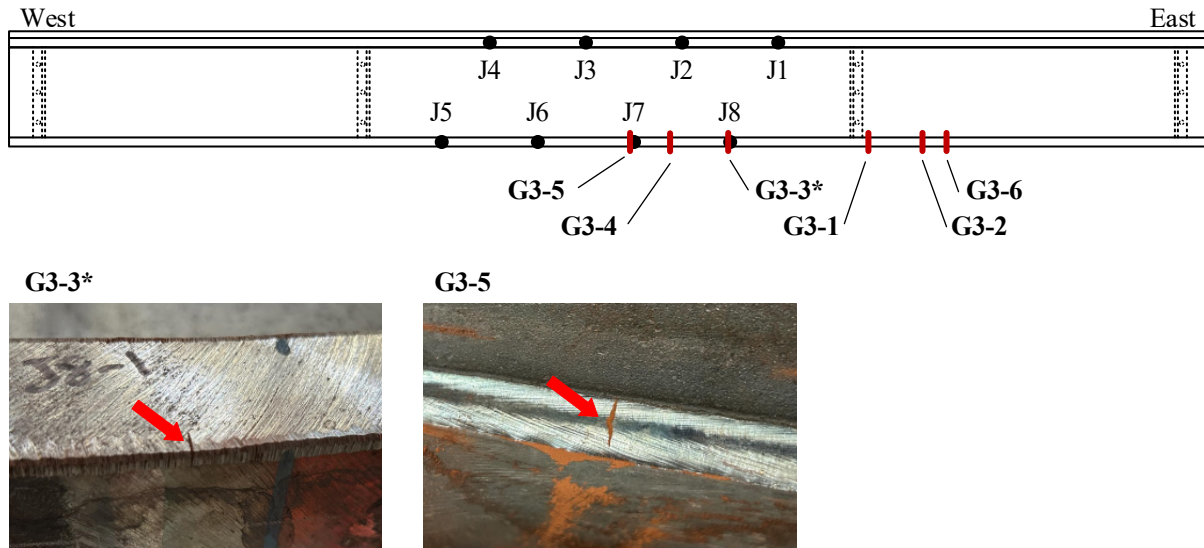
**Figure 7-19. Illustration. Overview showing the different fatigue cracks for Girder 3 – Flange 1.**

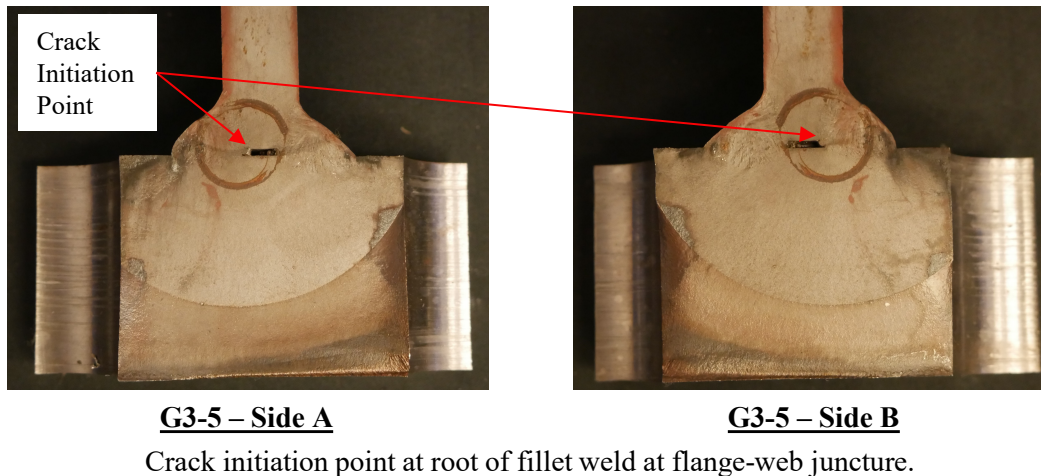
**Figure 7-20. Photo. Destructive evaluation of Crack G3-5, which led to the failure of G3-J7.**

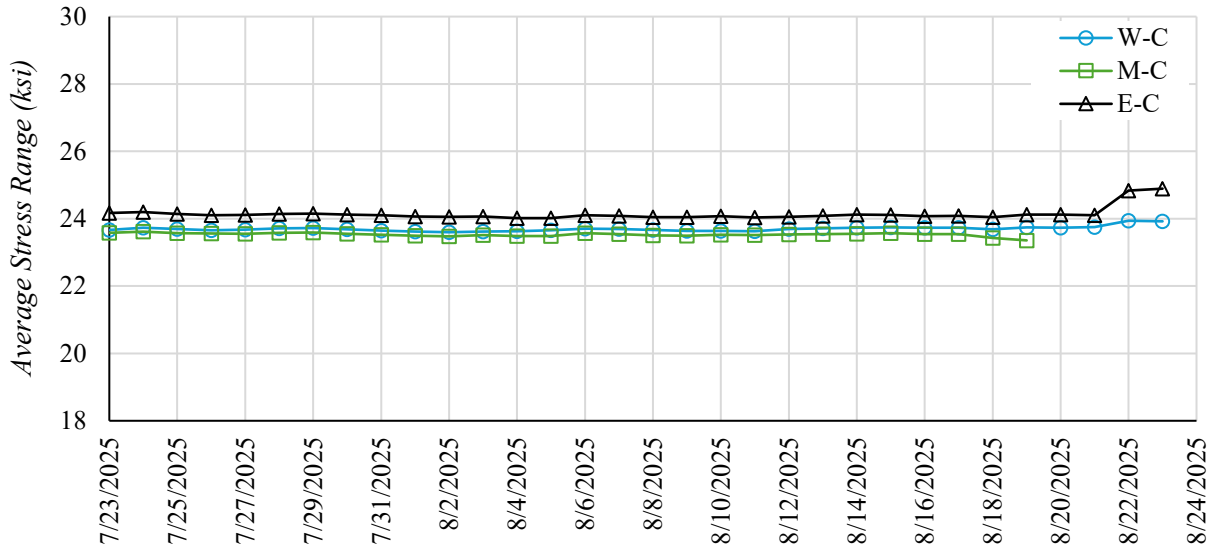
**Figure 7-21. Graph. Average daily stress range for Girder 3 – Flange 1 measured with strain gages along the bottom flange centerline.**

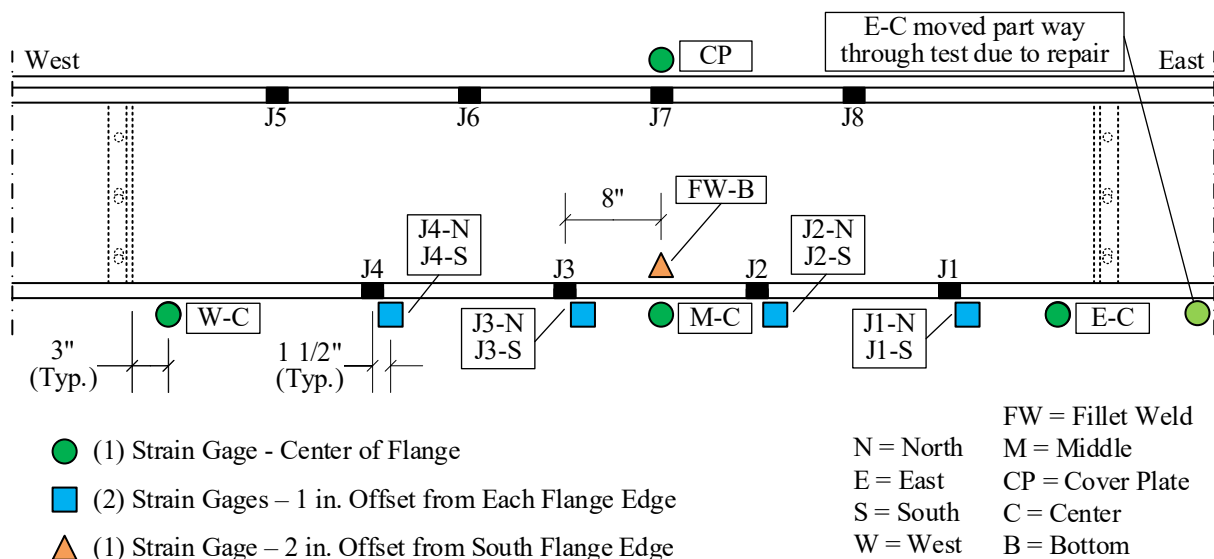
**Figure 7-23. Illustration. Instrumentation layout for Girder 3 - Flange 2 (looking north).**

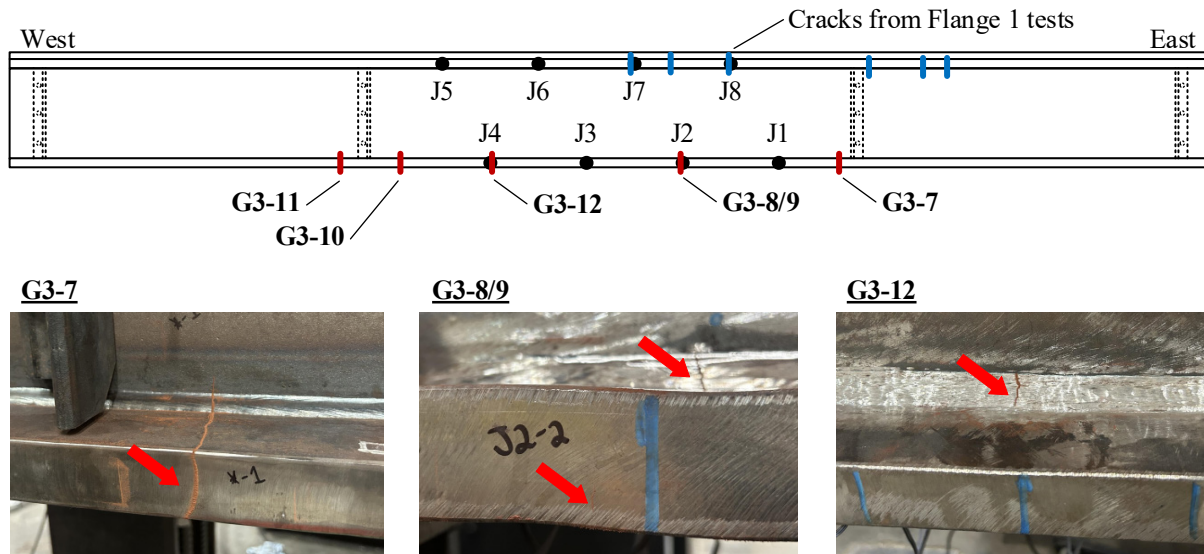
**Figure 7-24. Illustration. Overview showing the different fatigue cracks for Girder 3 – Flange 2.**

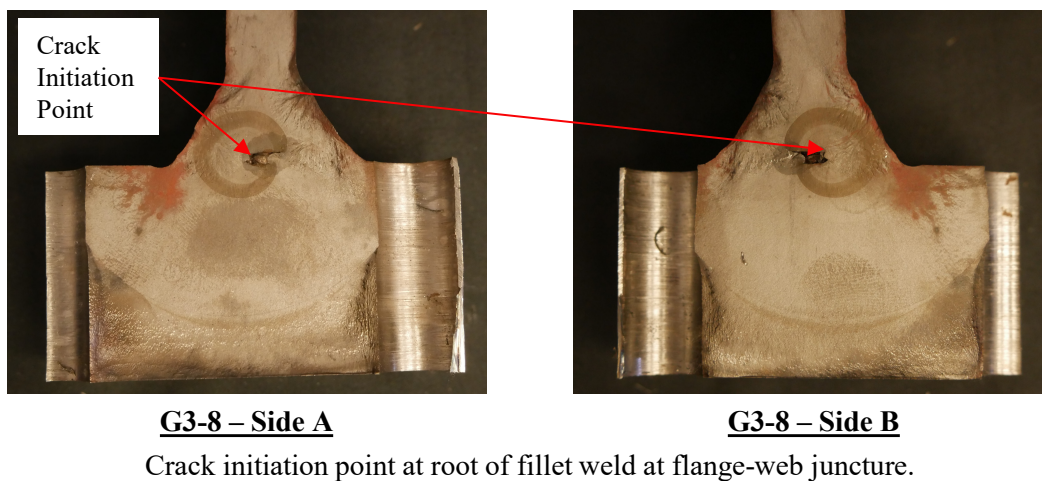
**Figure 7-25. Photo. Destructive evaluation of Crack G3-8, which led to the failure of G3-J2.**

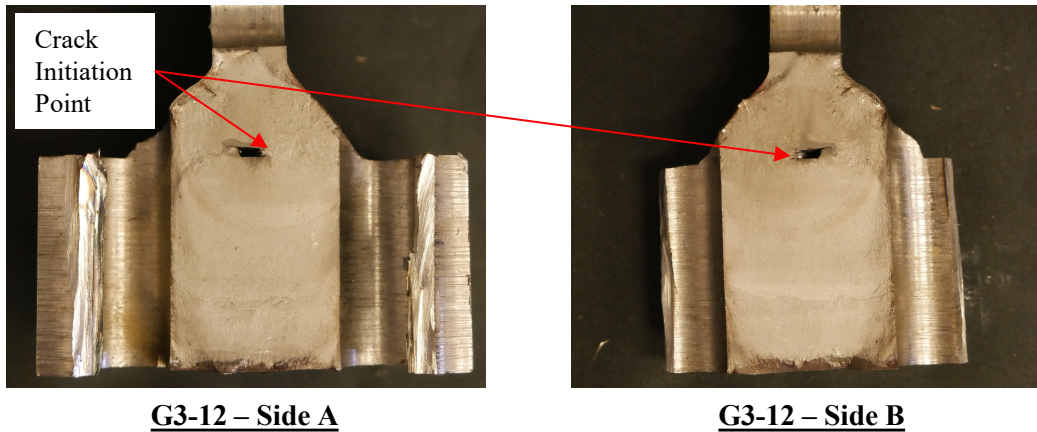
**G3-12 – Side A** **G3-12 – Side B**  
 Crack initiation point at root of fillet weld at flange-web juncture.

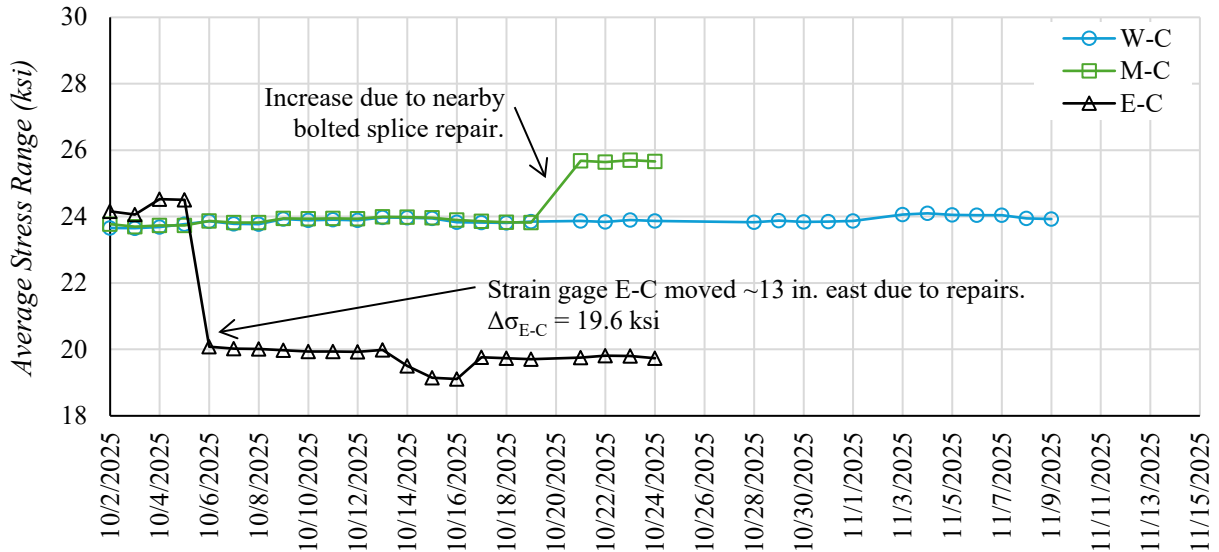
**Figure 7-27. Graph. Average daily stress range for Girder 3 – Flange 2 measured with strain gages along the bottom flange centerline.**

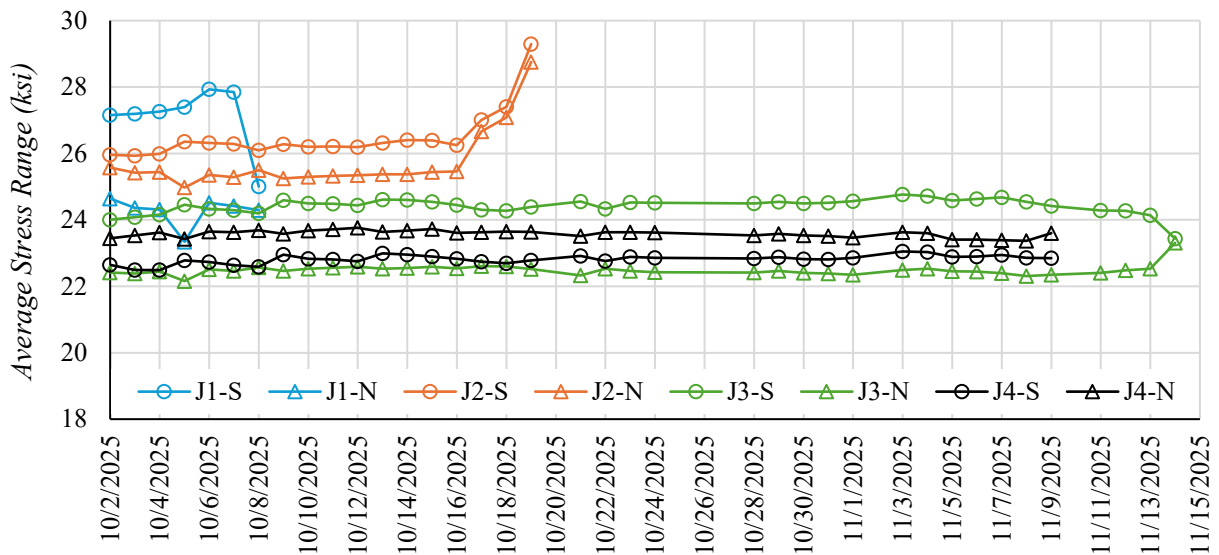
**Figure 7-28. Graph. Average daily stress range for Girder 3 – Flange 2 measured with strain gages at CJP butt-splice joints.**

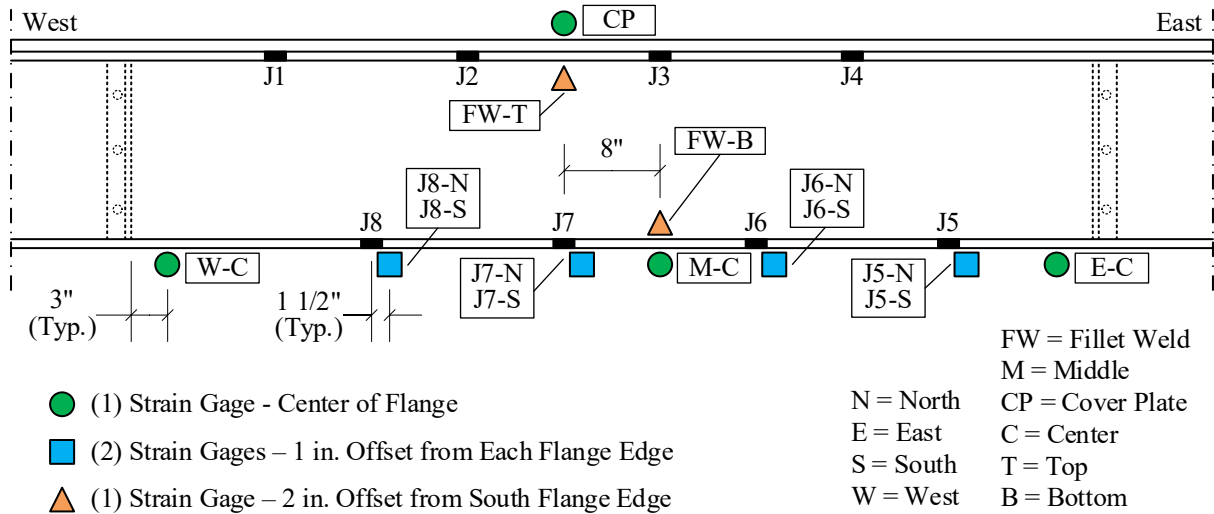
**Figure 7-29. Illustration. Instrumentation layout for Girder 4 - Flange 1 (looking north).**

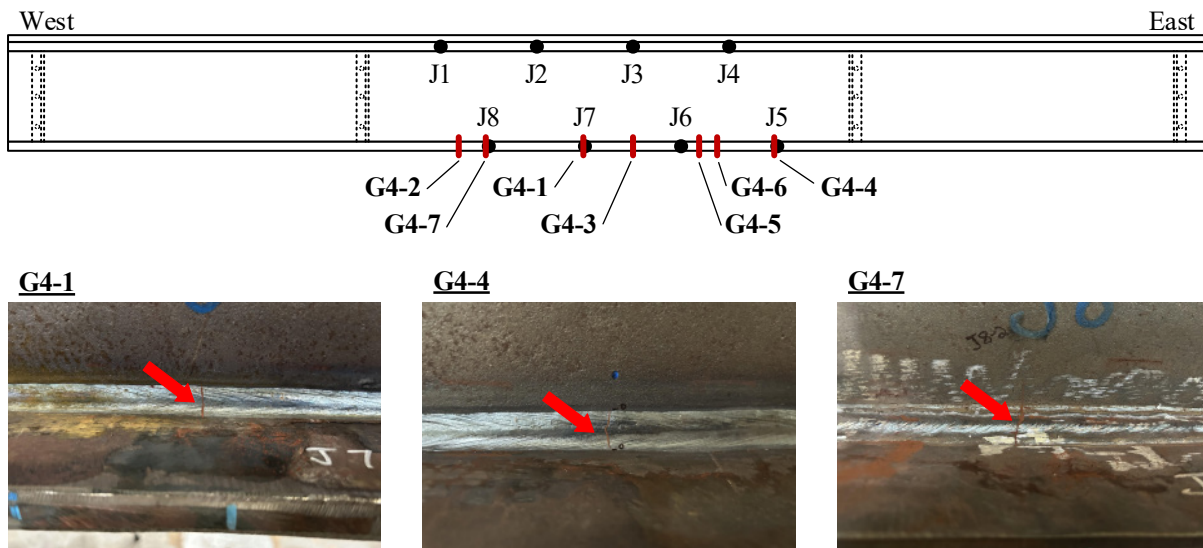
**Figure 7-30. Illustration. Overview showing the different fatigue cracks for Girder 4 – Flange 1.**

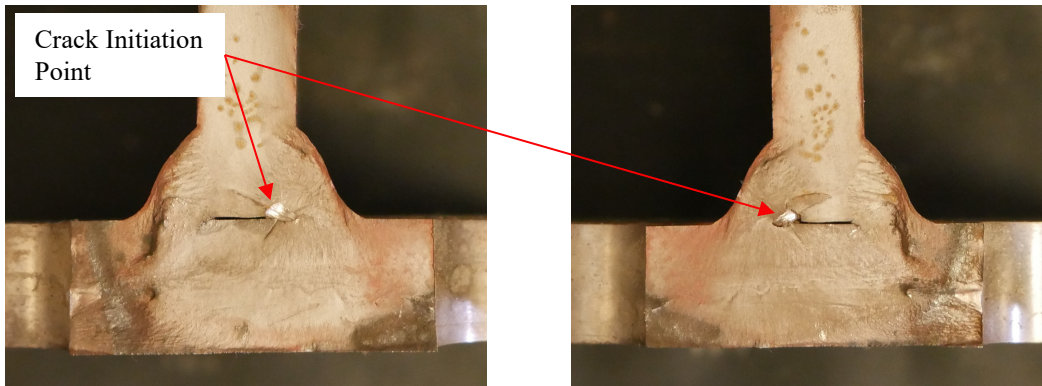
After testing was completed for Girder 4, Cracks G4-1, G4-4, and G4-7 were isolated and cut open using a vertical band saw to expose the internal crack planes and crack initiation points. Figures 7-31 to 7-33 show the crack initiation point and general crack growth behavior of Cracks G4-1, G4-4, and G4-7, respectively. These figures confirm that Cracks G4-1, G4-4, and G4-7 started at the root of the fillet weld at the flange-web juncture. As such, joints J7 (R3), J5 (R0), and J8 (R5) are classified as early stoppages since the joints failed due to fillet welds rather than the CJP welds. A summary of the fatigue-life test results for the four CJP joints tested is shown in Table 7-13, including the joint and fatigue life corresponding to joint failure, early stoppage, or runout life. Note that all CJP joints tested exceeded the minimum AASHTO design life.

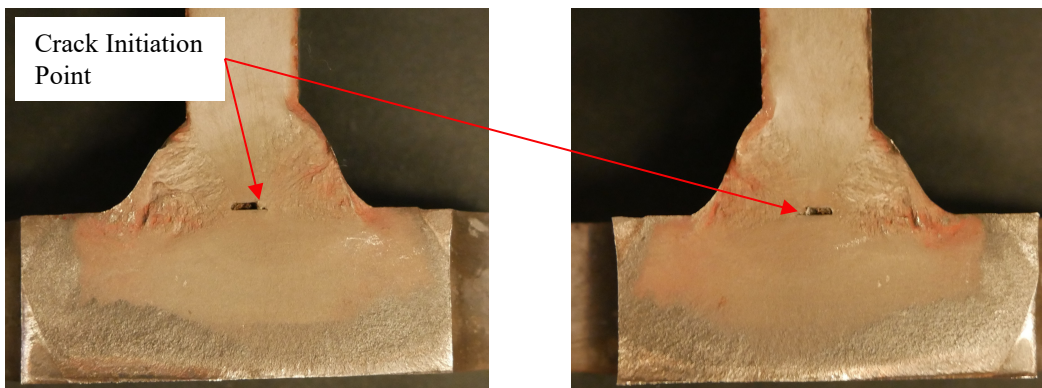
**Figure 7-31. Photo. Destructive evaluation of Crack G4-1, which led to the failure of G4-J7.**

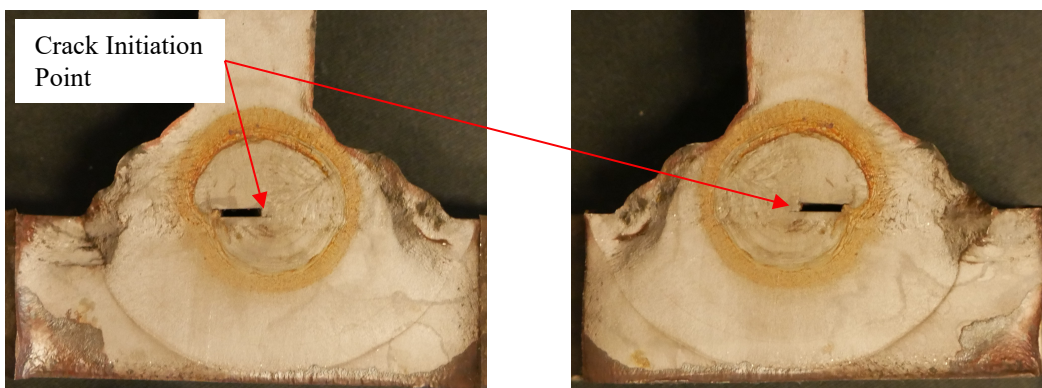
**Figure 7-32. Photo. Destructive evaluation of Crack G4-4, which led to the failure of G4-J5.**
