**GEORGIA DOT RESEARCH PROJECT 22-20**

Final Report

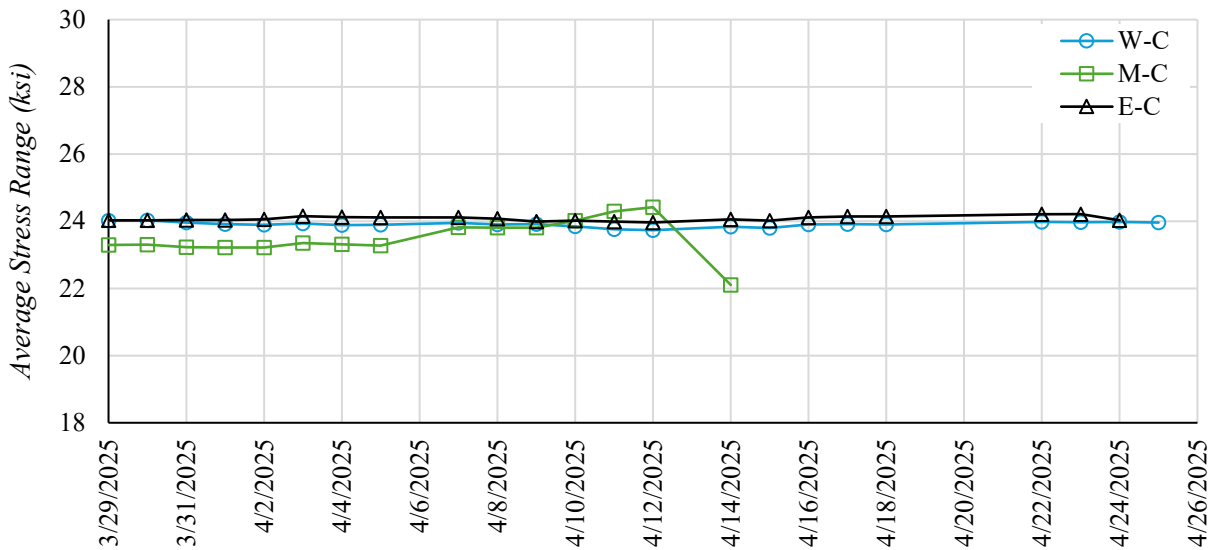
**Figure 7-34. Graph. Average daily stress range for Girder 4 – Flange 1 measured with strain gages along the bottom flange centerline.**

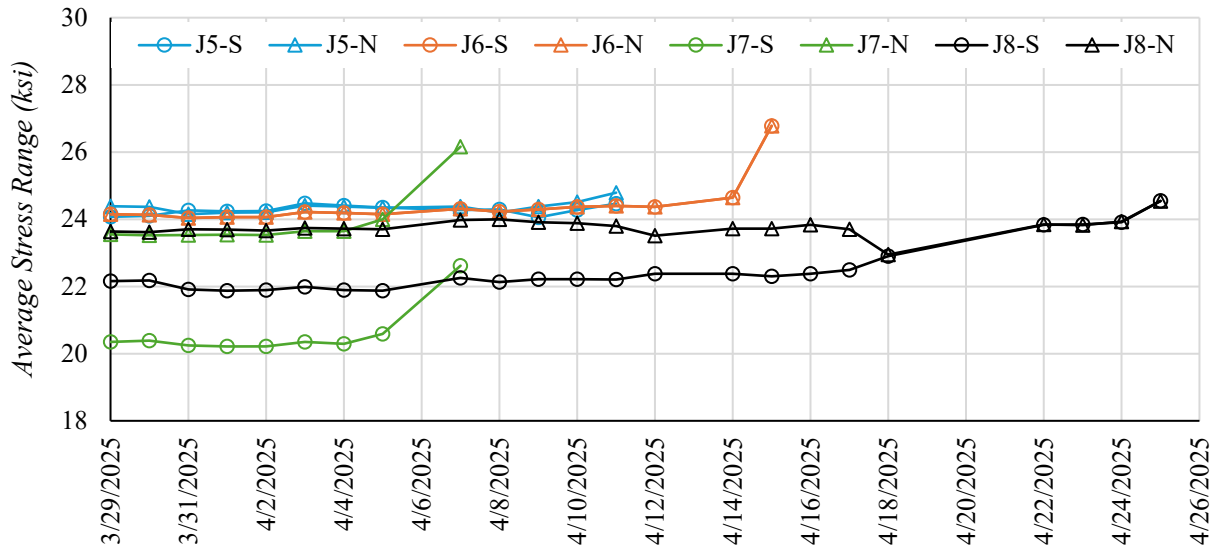
**Figure 7-35. Graph. Average daily stress range for Girder 4 – Flange 1 measured with strain gages at CJP butt-splice joints.**

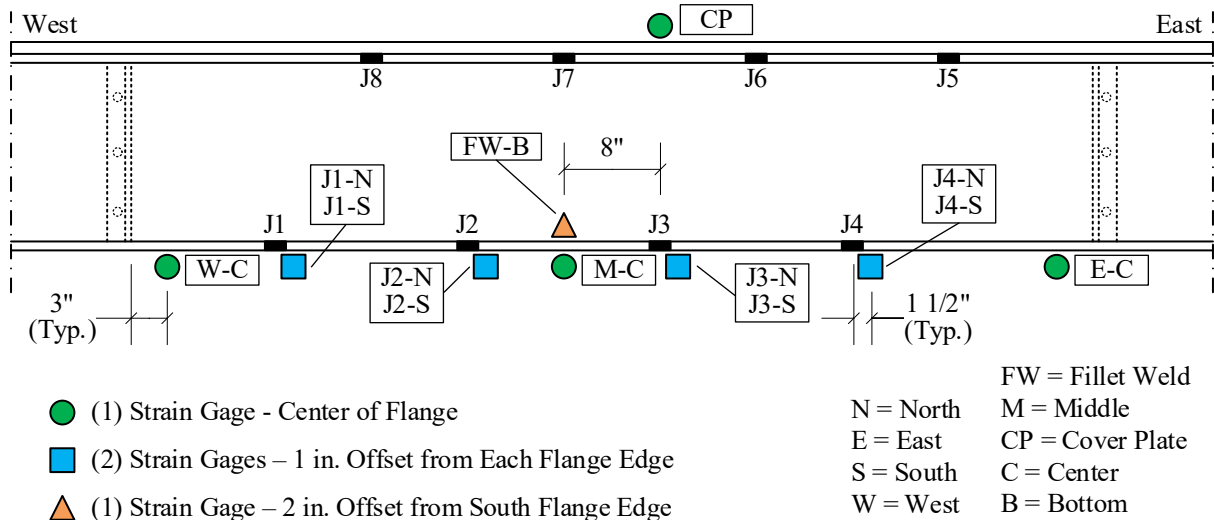
**Figure 7-36. Illustration. Instrumentation layout for Girder 4 - Flange 2 (looking north).**

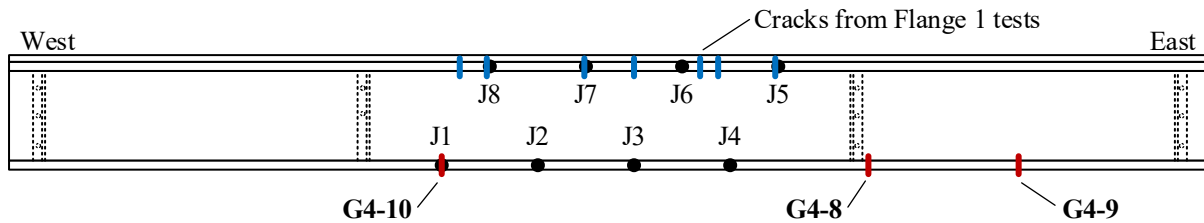
<i>Crack</i>	<i>Crack Type</i>	<i>Crack Location</i>	<i>Detection Date</i>	<i>Cycle Count @ Detection</i>	<i>Cycle Count @ Failure</i>	<i>Crack Repair</i>
G4-8	Flange Edge	48 in. East of J4	5/9/2025	1,231,300	1,231,300	Bolted Splice
G4-9	Fillet Weld	23 in. East of J4	5/17/2025	2,250,000	2,274,110	Bolted Splice
G4-10	Fillet Weld	J1	5/17/2025	2,250,000	2,339,200	Bolted Splice

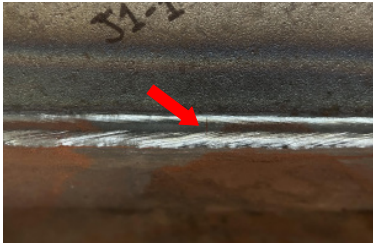
**Figure 7-37. Illustration. Overview showing the different fatigue cracks for Girder 4 – Flange 2.**

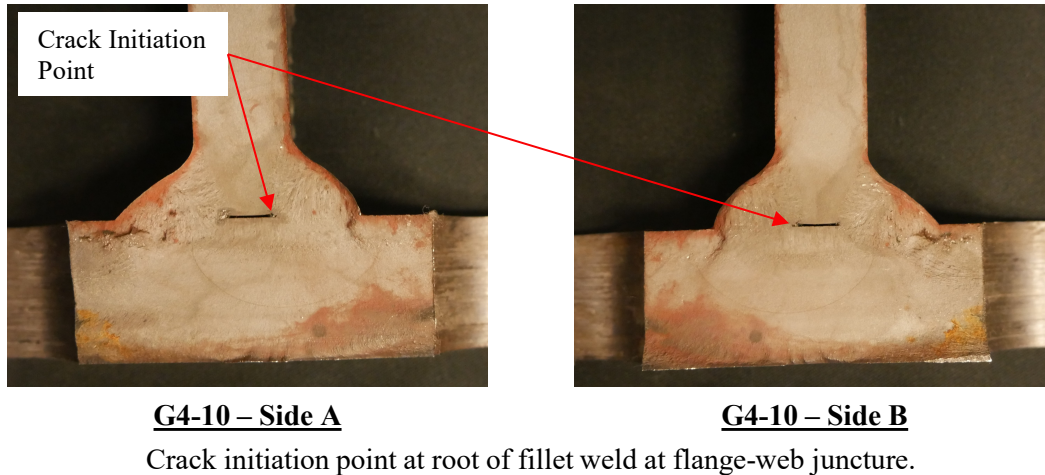
**Figure 7-38. Photo. Destructive evaluation of Crack G4-10, which led to the failure of G4-J1.**

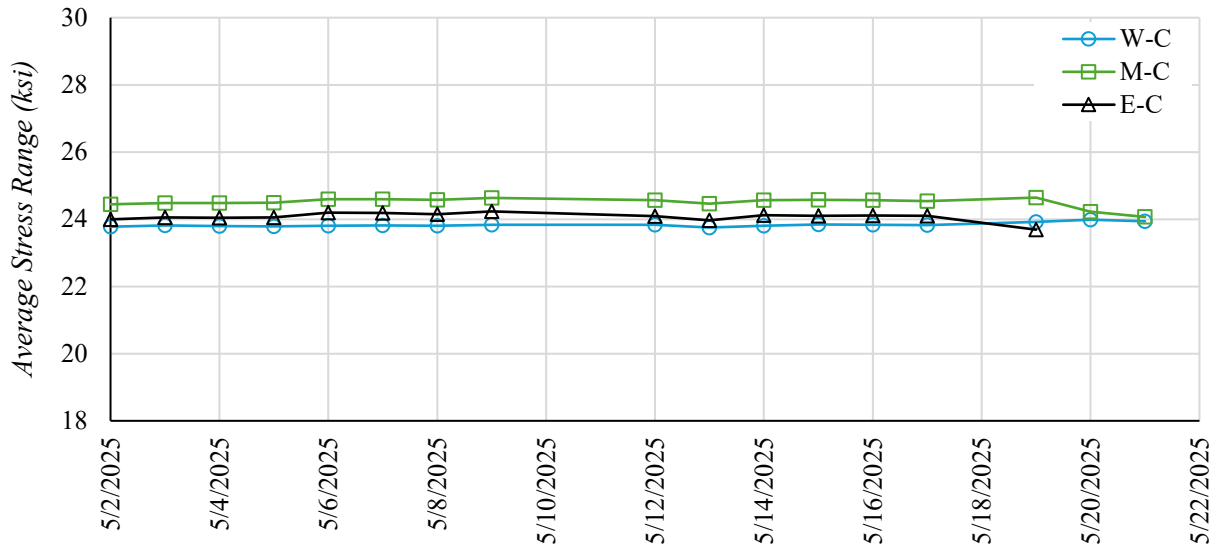
**Figure 7-39. Graph. Average daily stress range for Girder 4 – Flange 2 measured with strain gages along the bottom flange centerline.**

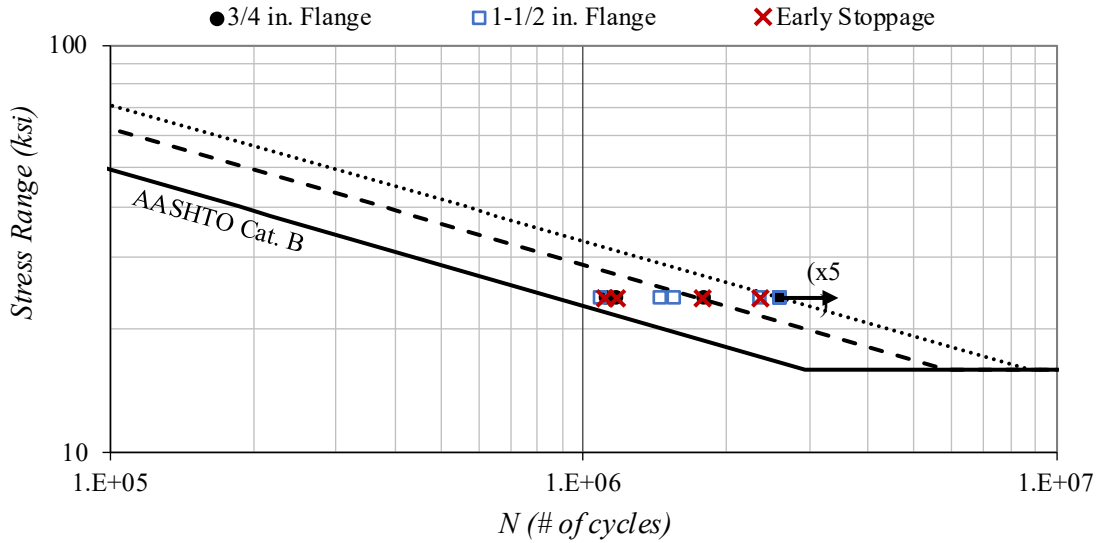
(a) S-N Plot Showing Fatigue Test Results

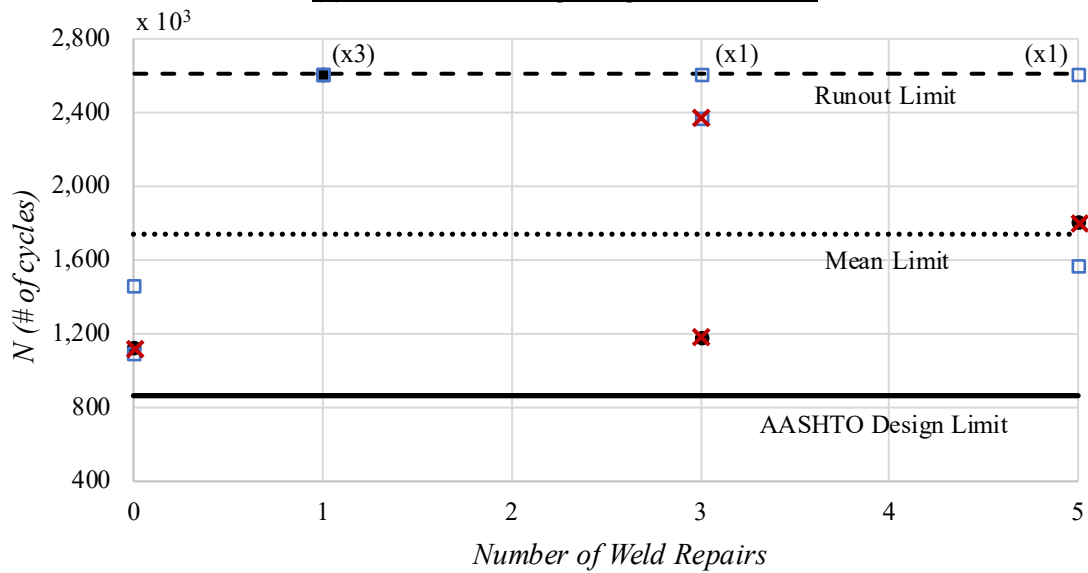
(b) Comparative Plot Showing Number of Weld Repairs

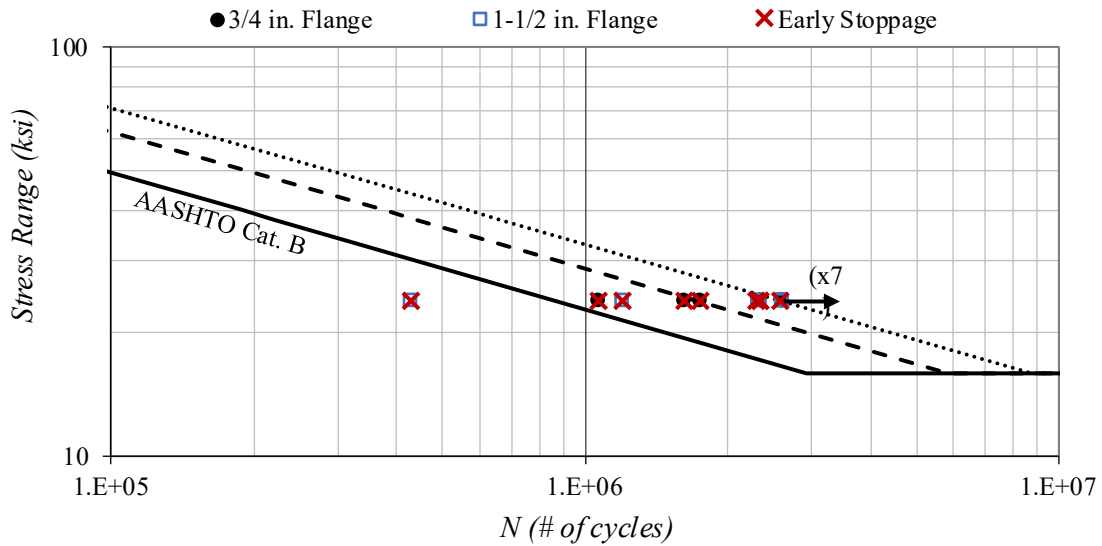
(a) S-N Plot Showing Fatigue Test Results

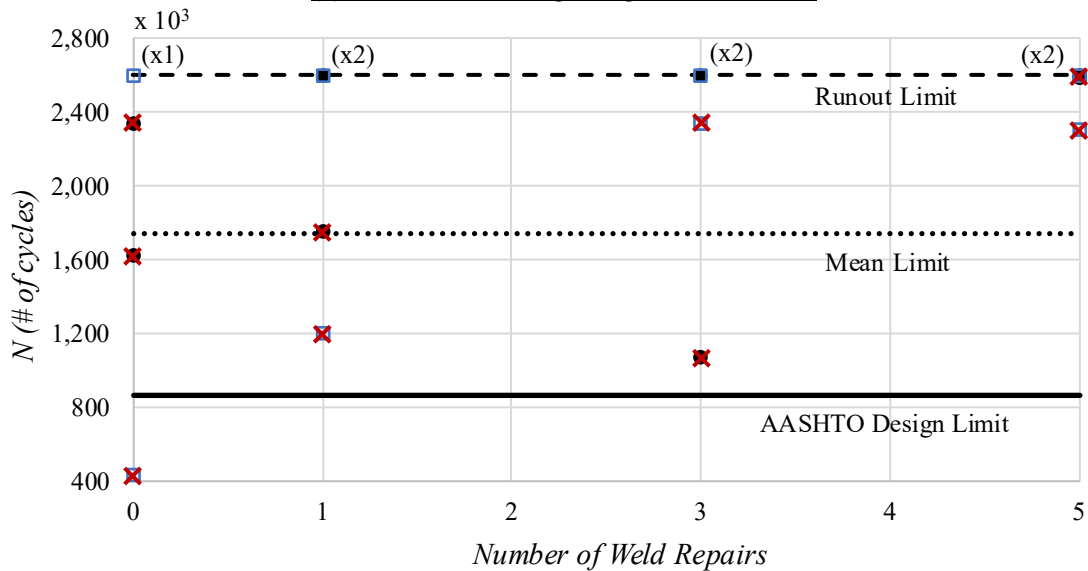
(b) Comparative Plot Showing Number of Weld Repairs

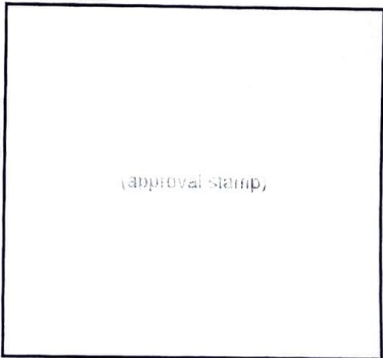
Authorized for use by Chris Lausch, CWI/ WPC HSS.

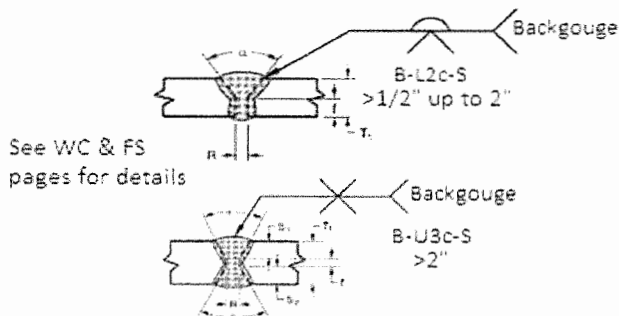
**Minimum Preheat Requirements.**

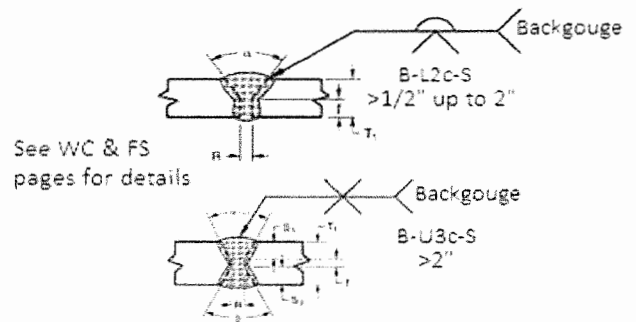
**Minimum Preheat Requirements.**
