DOT/FAA/CT-83/10

# Evaluation of an Improved Flame Resistant Aircraft Window System

Final Report  
May 1984

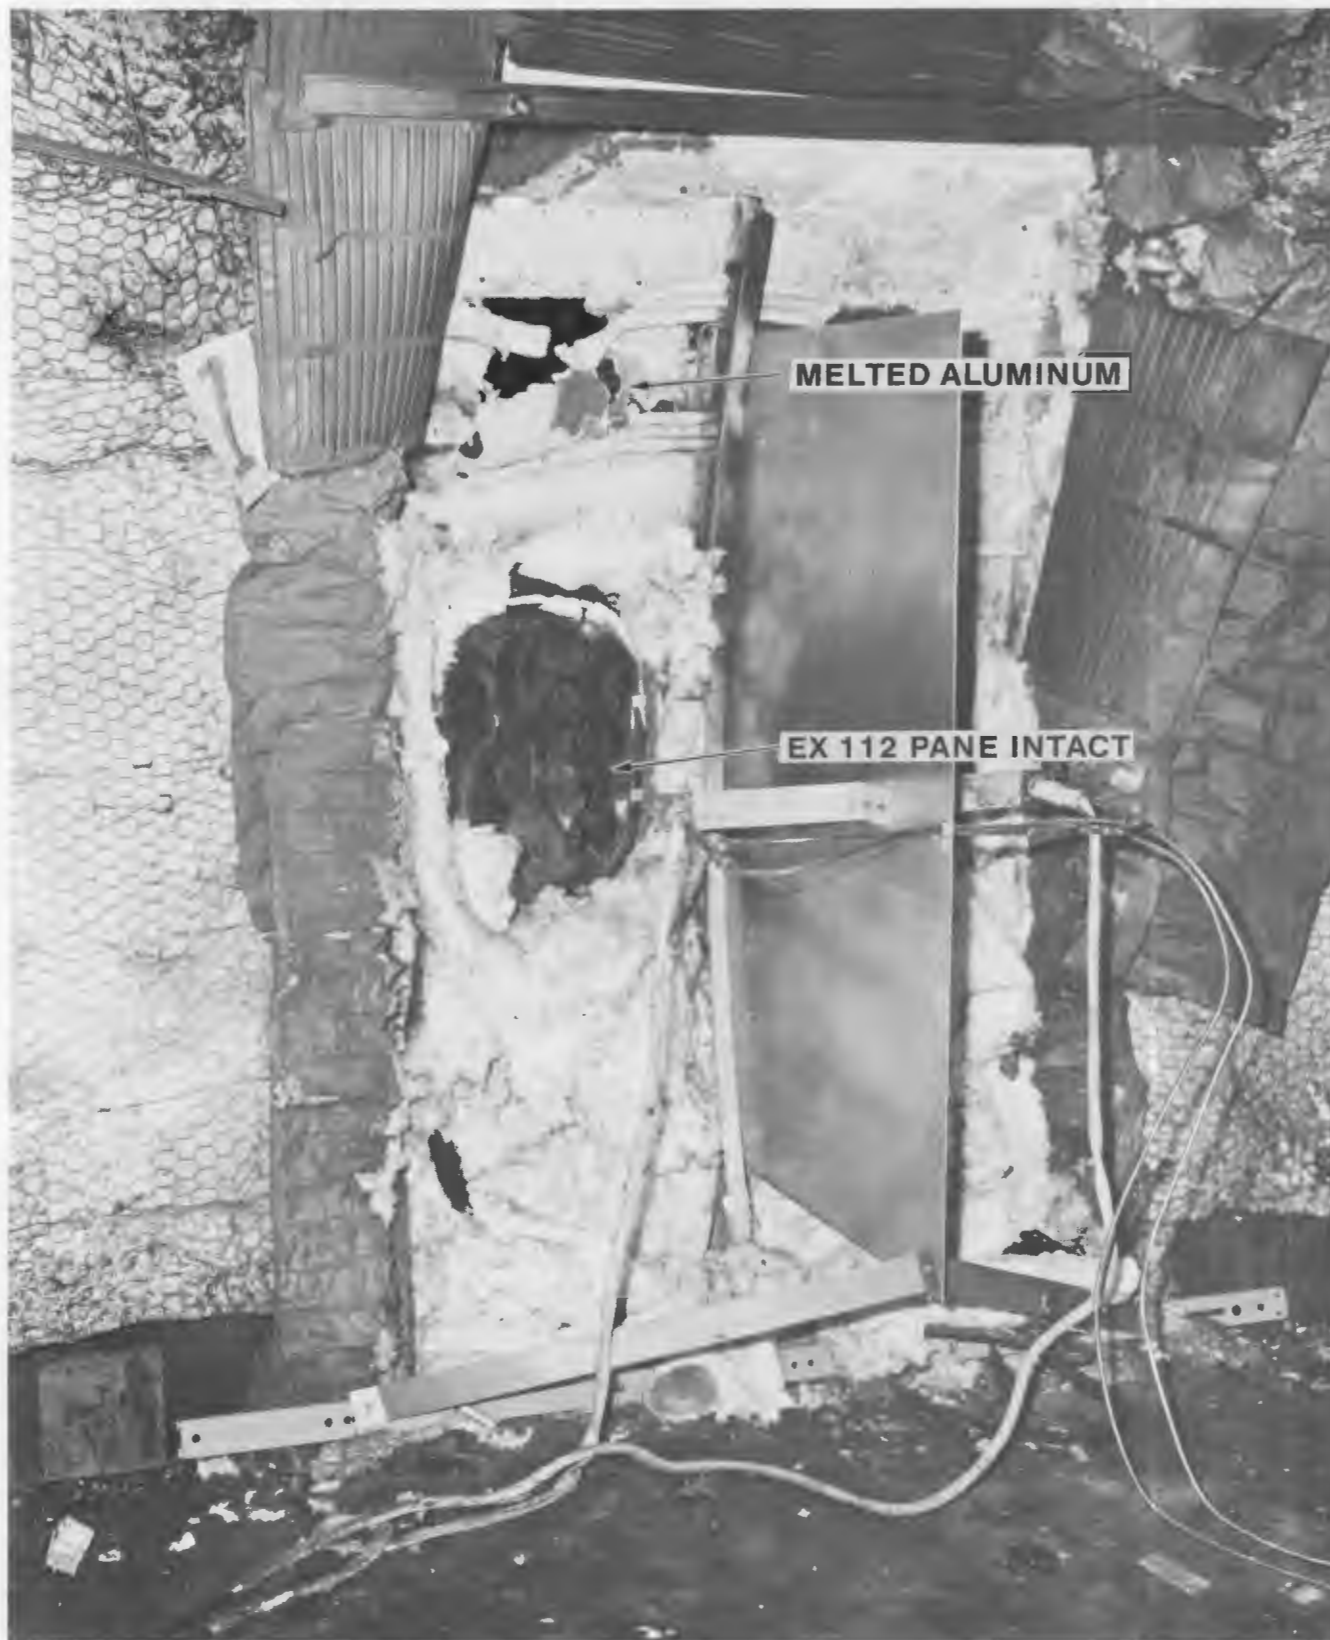
FIGURE 8. FIRE DAMAGE TO THE THERMALLY IMPROVED DC-10 WINDOW SYSTEM SHOWING THE FAIL-SAFE (EX 112) PANE IN PLACE (TEST 1)

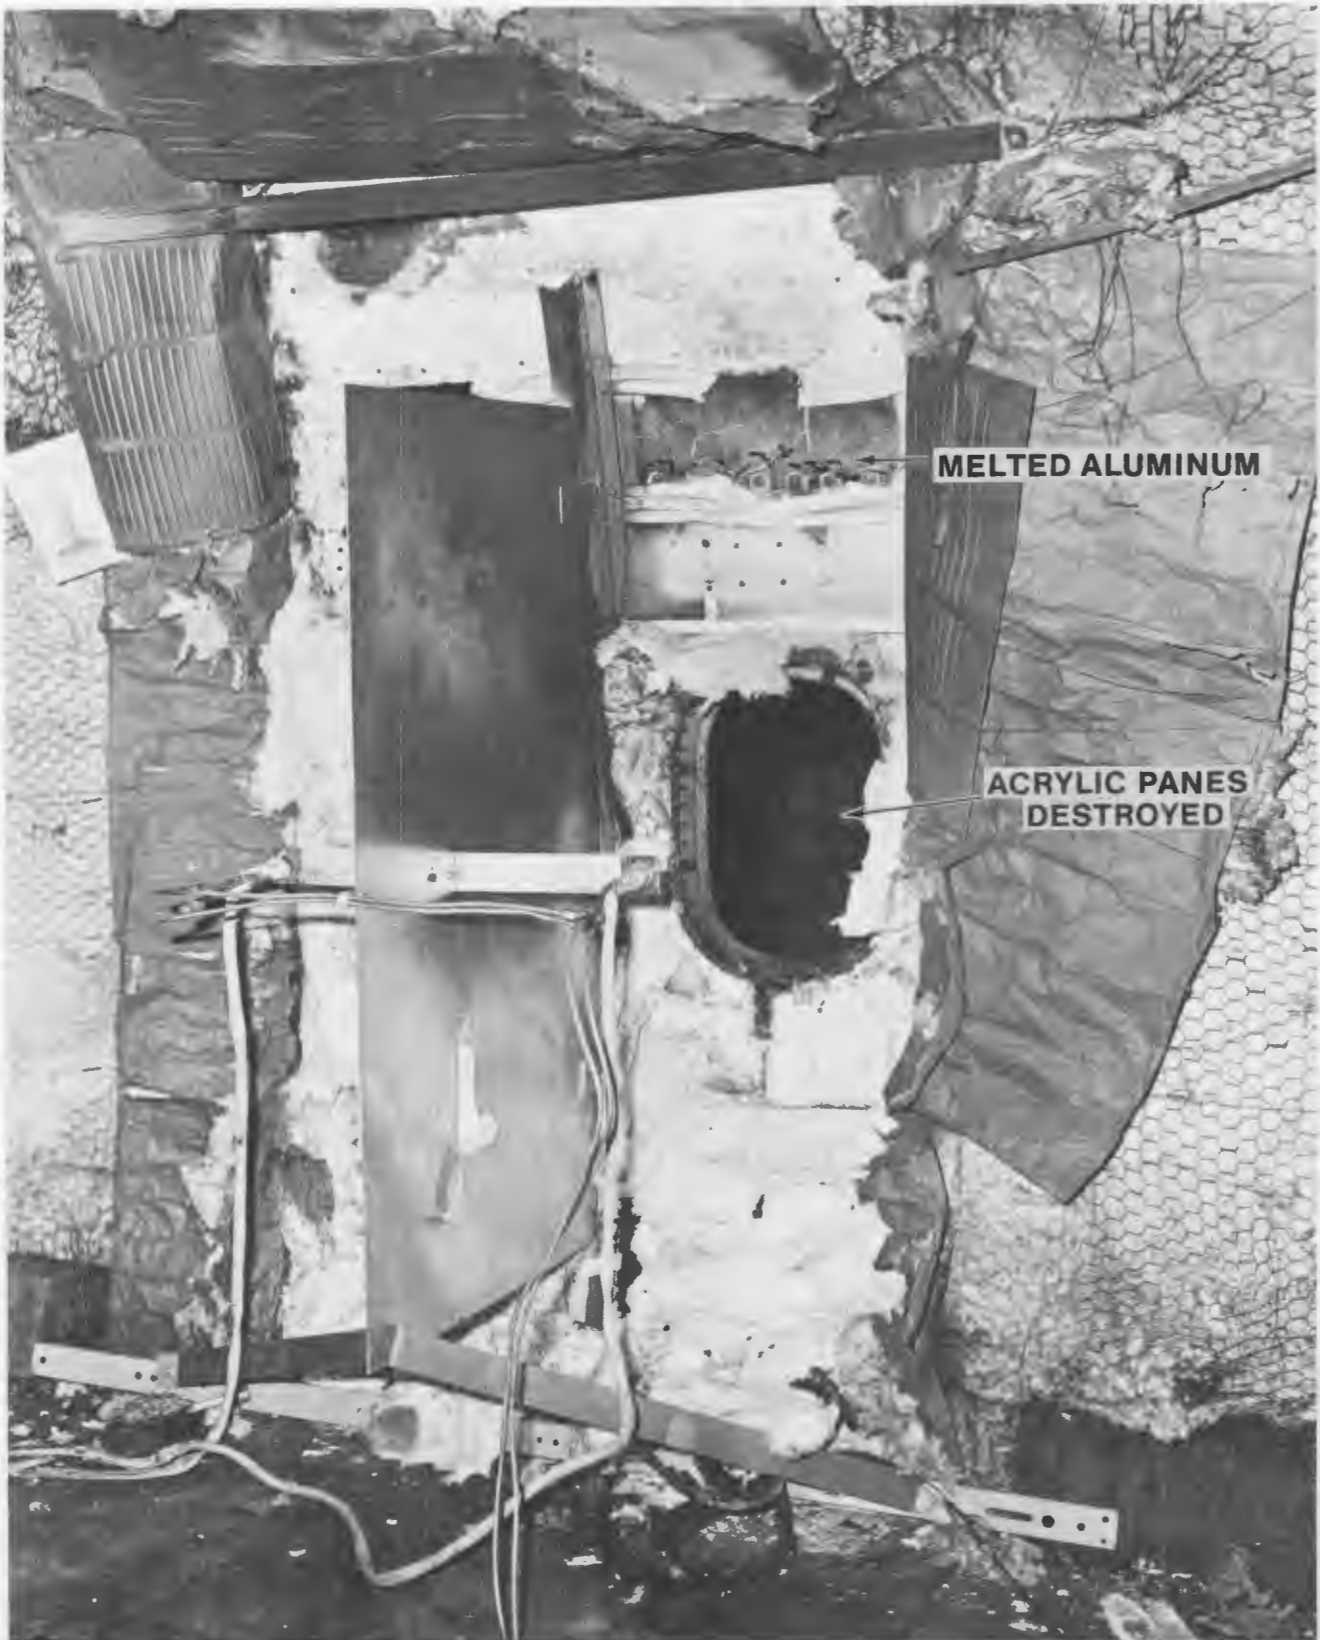
FIGURE 9. FIRE DAMAGE TO THE STANDARD DC-10 WINDOW SYSTEM SHOWING THE COMPLETE DESTRUCTION OF THE ACRYLIC WINDOW PANES (TEST 1)

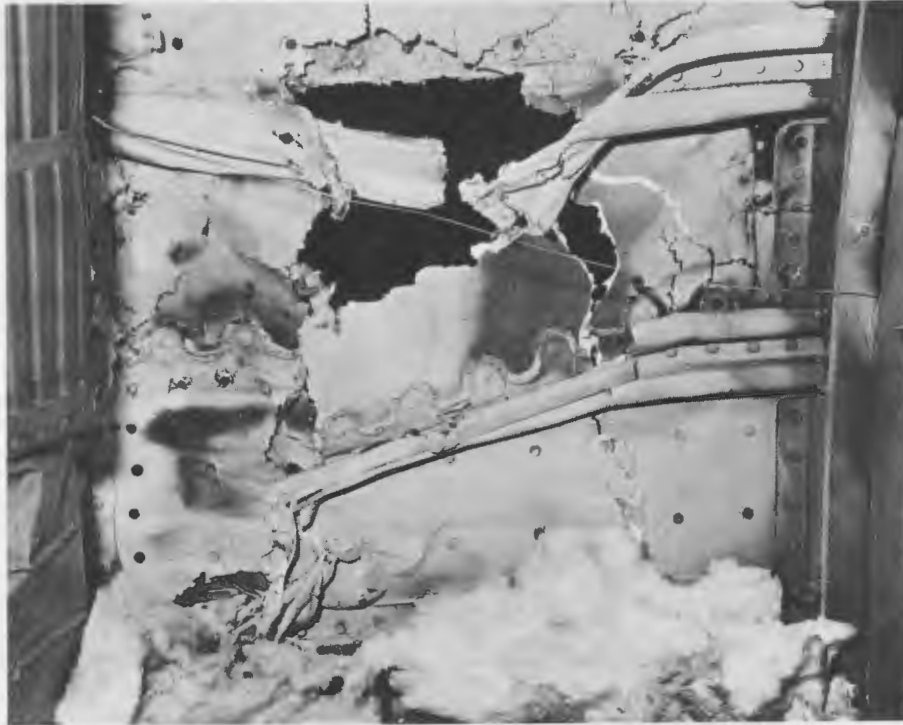
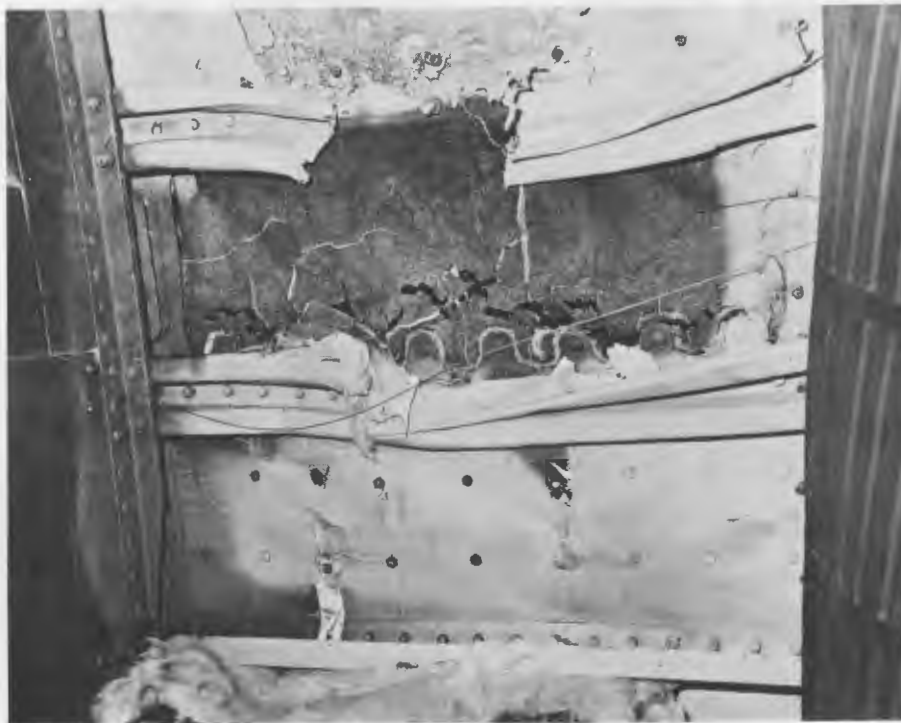
(a) Thermally Improved (EX 112) Window System

(b) Standard Acrylic Window System

FIGURE 10. ALUMINUM SKIN FAILURE (MELTING) MODES ABOVE THE AIRCRAFT WINDOWS

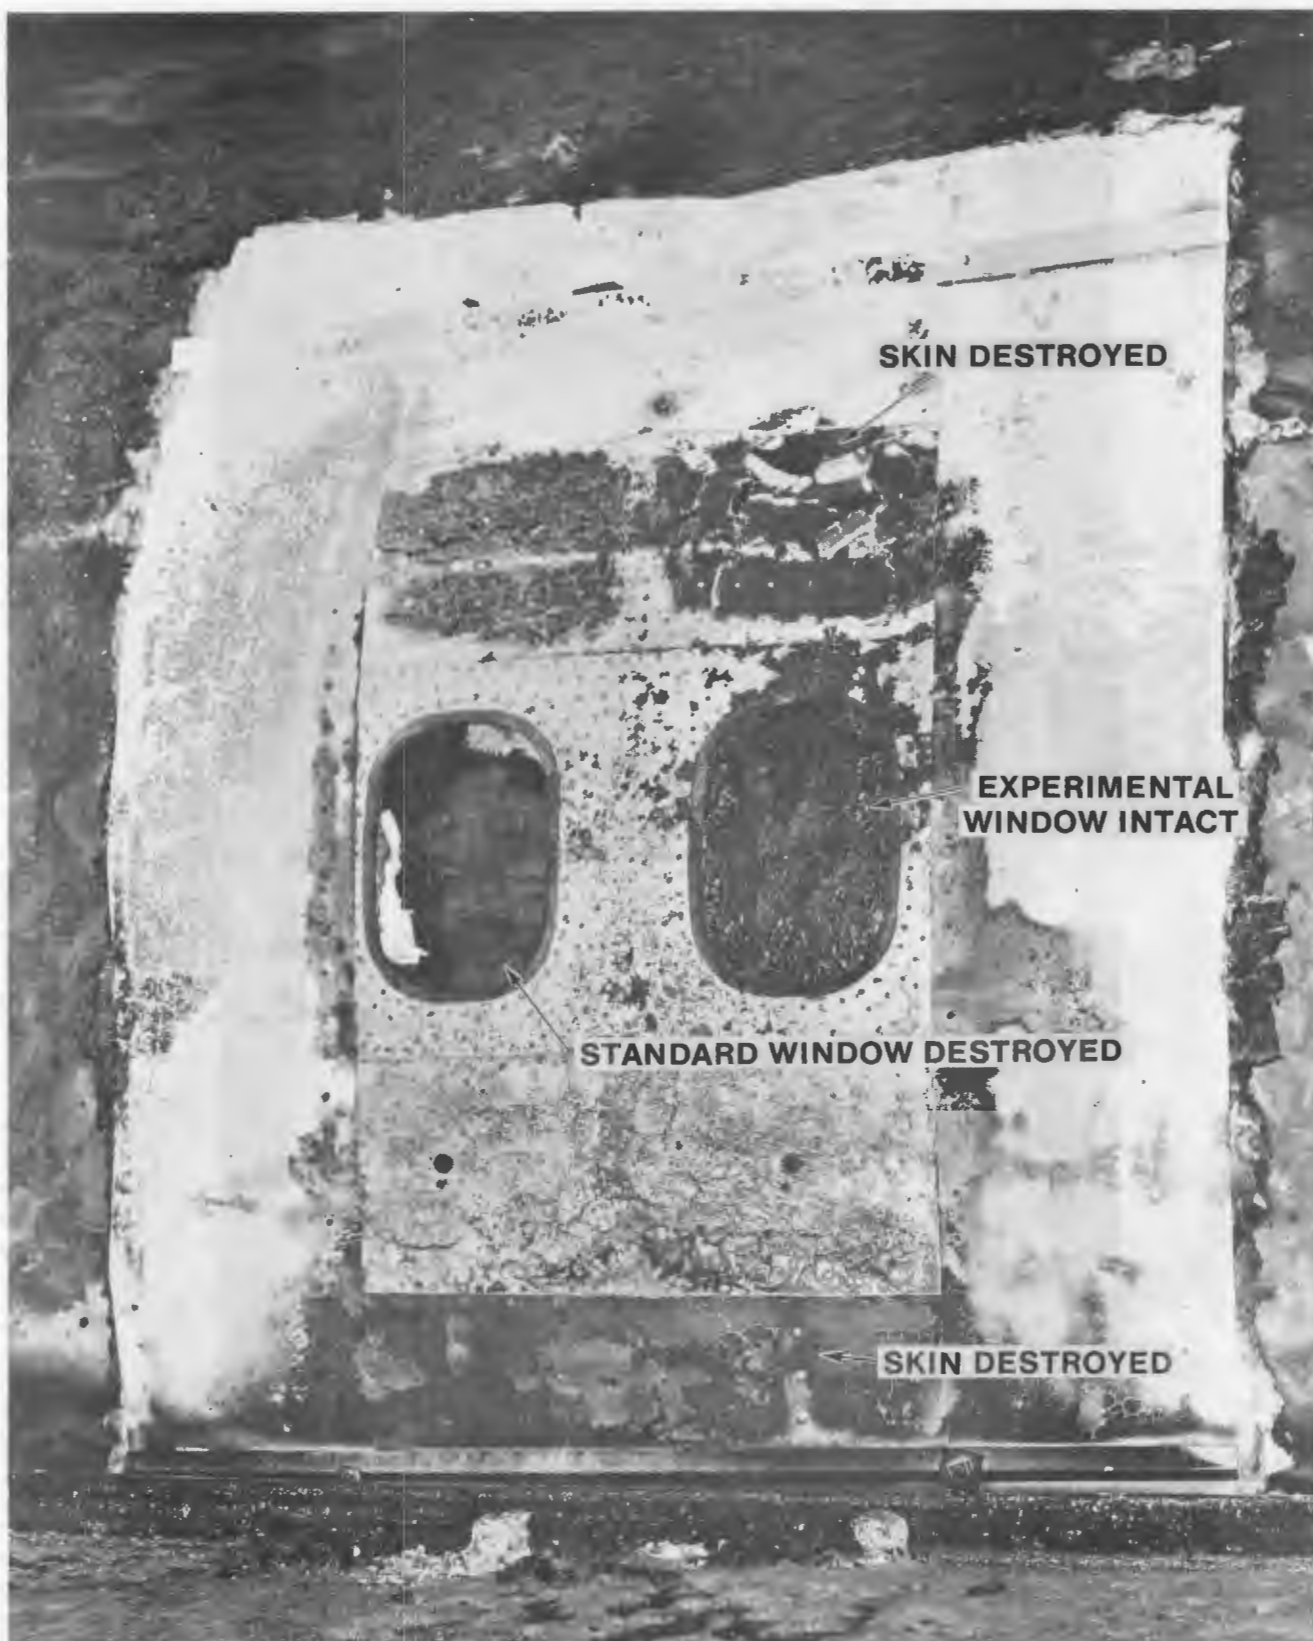
RESULTS: The temperature rise of the DC-10 fuselage segment during fire exposure in test 1 is indicated by the profiles presented in figure 7 for the aluminum skin and belt areas. These data show that the aluminum skin above the windows started to melt in 64 seconds (1.07 minutes) which was confirmed by an analysis of the photographic coverage. However, the skin below the windows and belt area did not reach the incipient melting temperature for aluminum of 900° F until 198 seconds (3.3 minutes) after fuel ignition. The fire damage to the skin above the improved (EX 112) window system is shown in figure 8 and above the acrylic window in figure 9. A more detailed interior view of the failure mode of the fuselage skin in these areas is presented in figure 10. An overall exterior view of the fire damage sustained by the DC-10 fuselage segment is presented in figure 11.

FIGURE 11. EXTERNAL FIRE DAMAGE TO THE DC-10 WINDOW SYSTEMS (TEST 1)

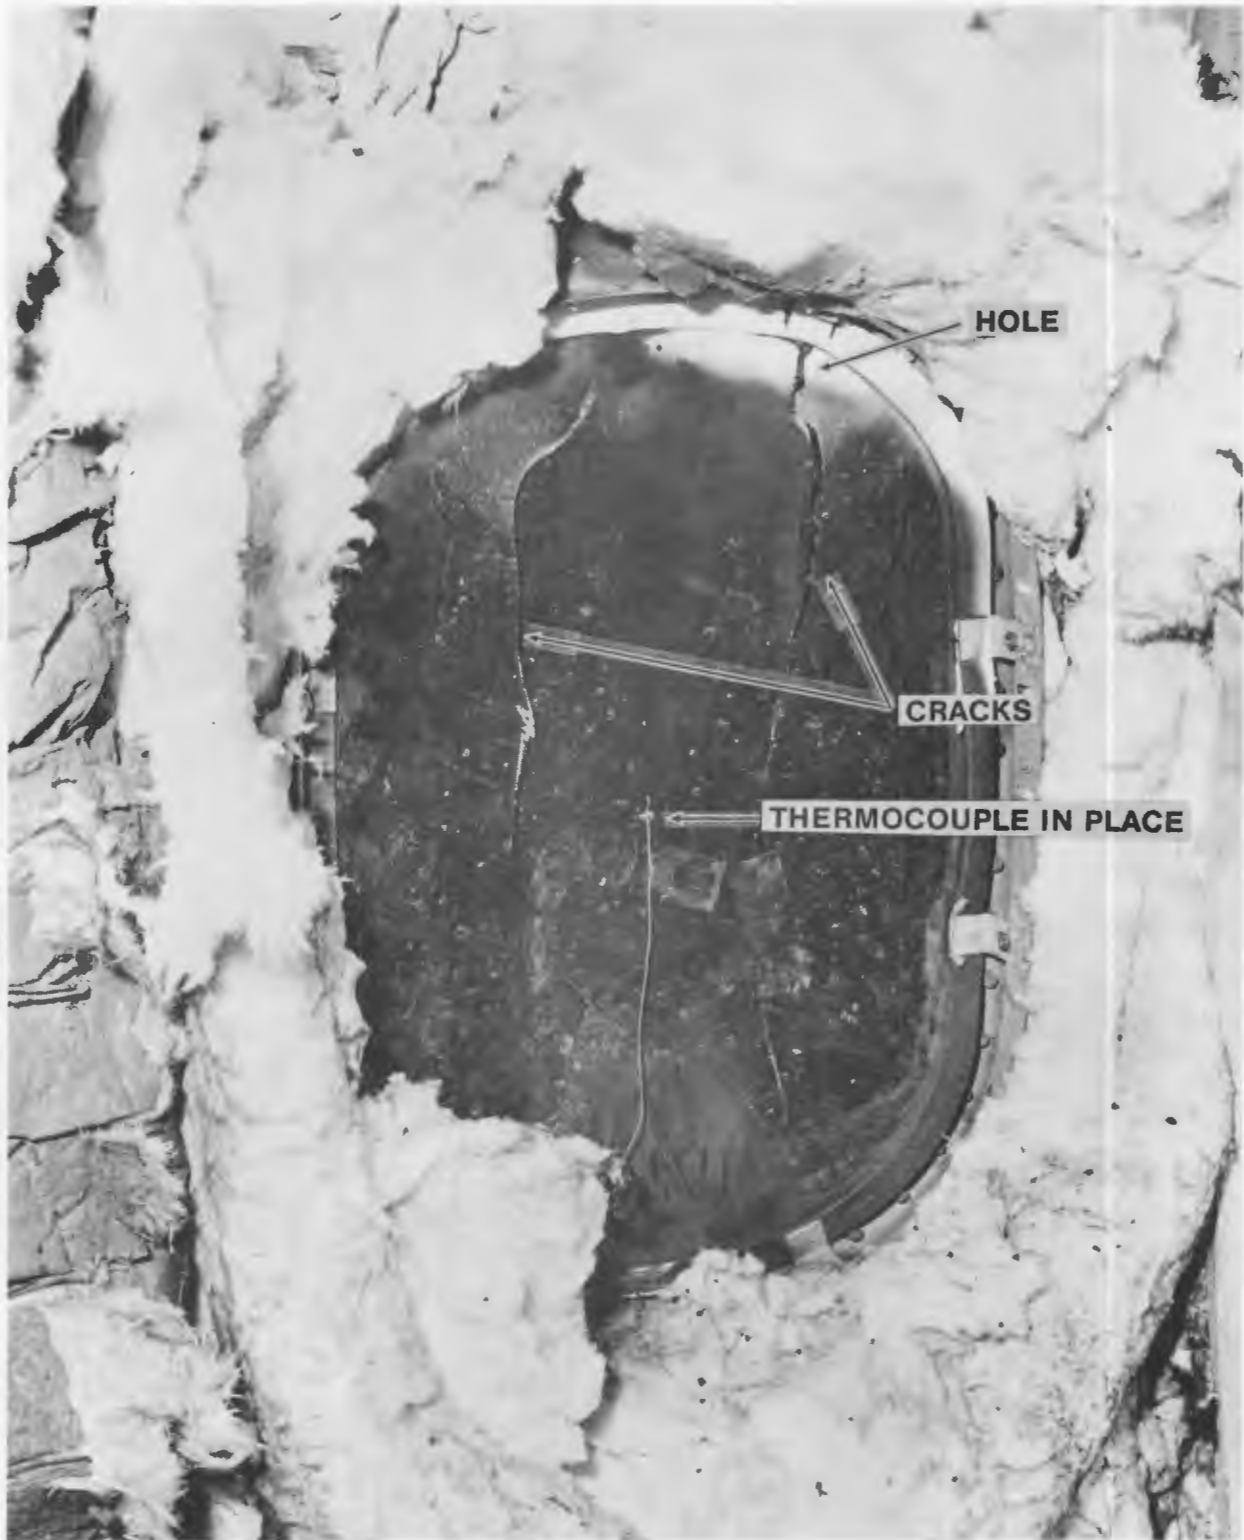
FIGURE 14. CLOSE-UP VIEW OF THE FIRE DAMAGE TO THE FAIL-SAFE (EX 112) WINDOW PANE (TEST 1)

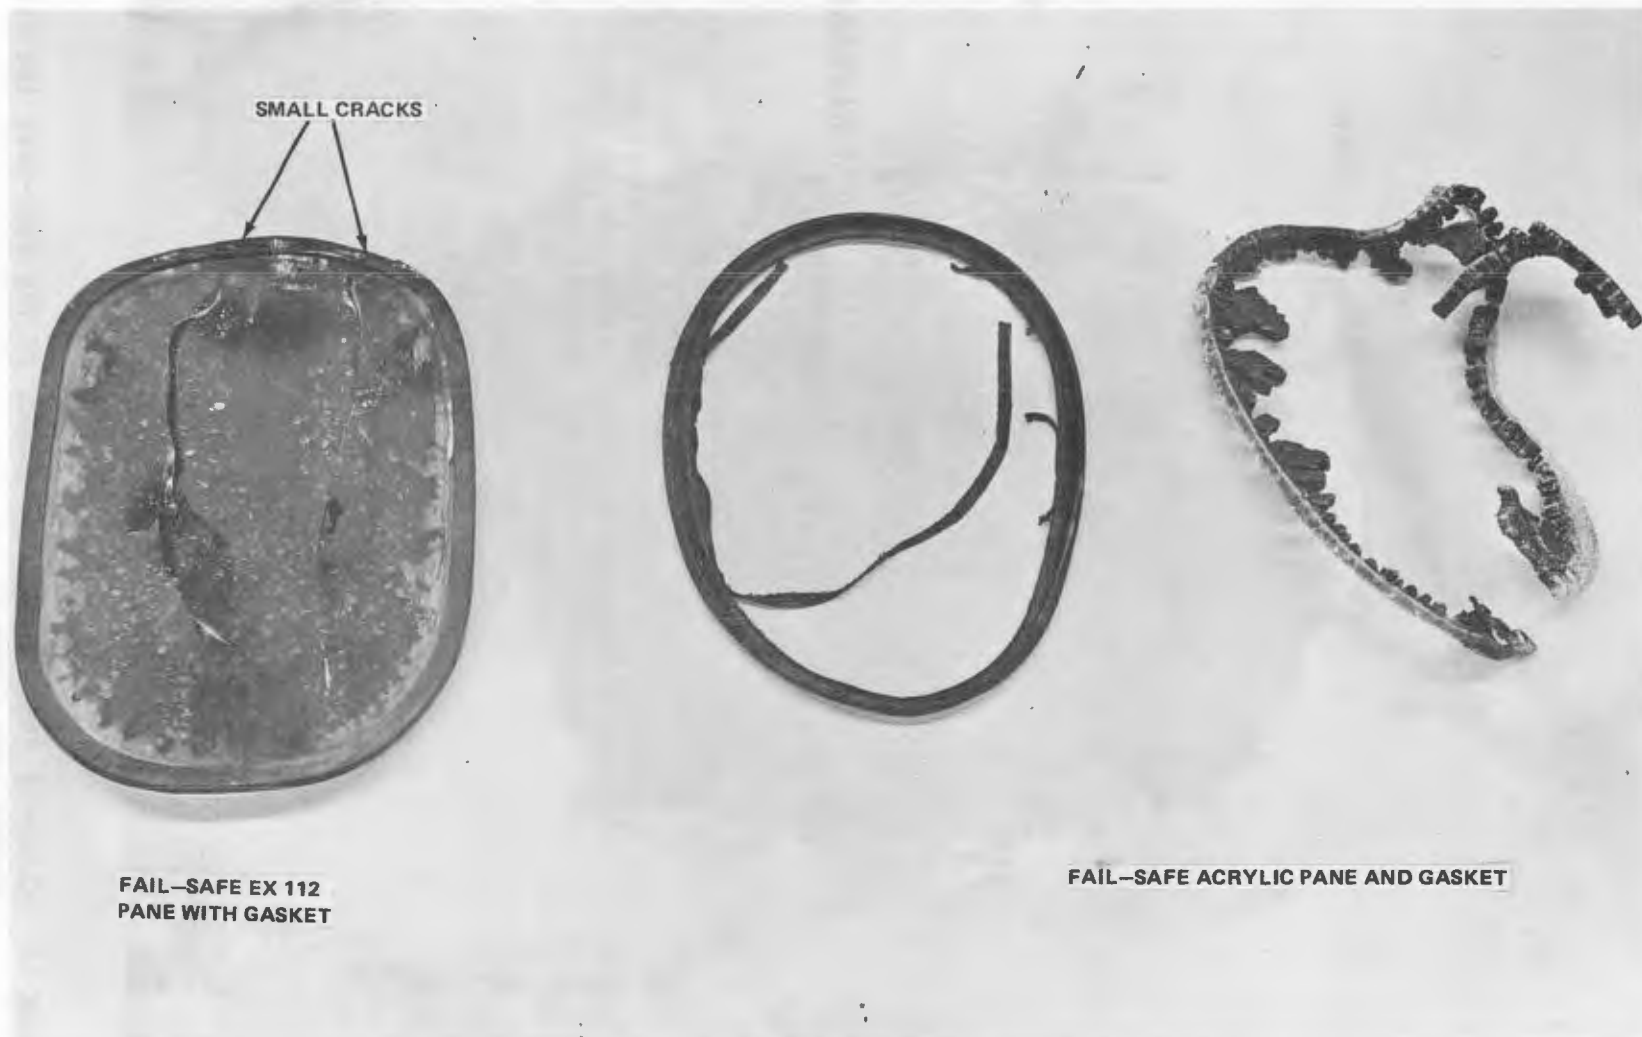
The temperature data obtained from the thermocouples embedded in the pressure and fail-safe window panes for both the experimental (EX 112) and standard (acrylic) window systems are presented in figure 13. The profiles numbered 3 and 7 show that the temperature rise of the pressure panes on the experimental and standard window systems reached 900° F in 144 seconds (2.4 minutes) and 152 seconds (2.5 minutes), respectively. The temperature profiles obtained for the experimental (EX 112) and standard acrylic fail-safe panes show that the EX 112 pane reached approximately 314° F in 199 seconds (3.3 minutes) and that the temperature data for the acrylic pane was lost. Additional data superimposed on the time temperature profiles in figure 13 show that the first visual flame penetration through the standard acrylic window system occurred in 146 seconds (2.4 minutes) after fuel ignition. While only very minor flame intrusion was observed through several small cracks in the EX 112 fail-safe pane (figure 14) after 225 seconds (3.75 minutes), which was the duration time of the test. The condition of the standard acrylic and experimental EX 112 fail-safe panes with their respective silicone rubber gaskets are shown in figure 15.

A detailed examination of the condition of the silicone gasket after it was removed from the window frame revealed it had retained a large part of its structural integrity and flexibility (figure 15). The thermal resistivity demonstrated by the gasket under severe fire exposure is noteworthy and its survival is attributable in part, to the thermal resistance of the EX 112 fail-safe pane, the relatively high specific heat of aluminum and the mass of metal comprising the belt system.

FIGURE 15. FIRE DAMAGE SUSTAINED BY THE IMPROVED EX 112 FAIL-SAFE PANE AND THE STRETCHED ACRYLIC PANE (TEST 1)

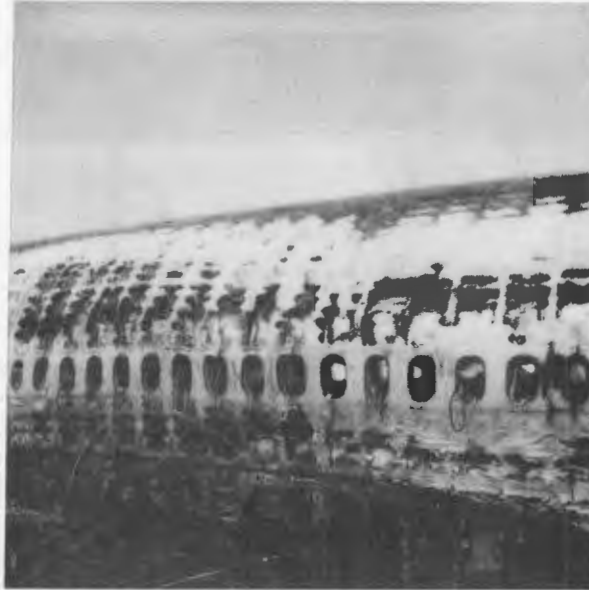
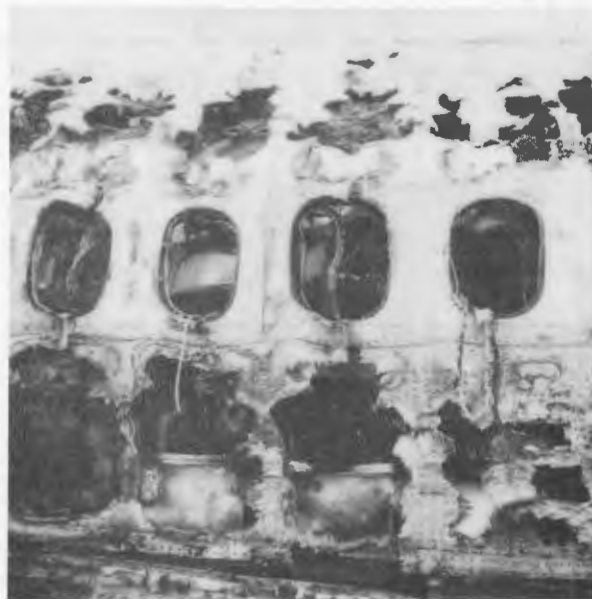
The higher heat resistance of the belt system over the fuselage skin is evident in the photographs presented in figure 17 of the Continental Airlines DC 10-10 accident on March 1, 1978 at the Los Angeles International Airport. This failure mode, in general, was consistent with that observed in the first and subsequent tests conducted in the C-133 fire test bed.

(a) General View of the Fuselage Damage

(b) Detailed View of the Belt System Area

FIGURE 17. FAILURE MODES OF THE CONTINENTAL AIRLINES DC-10 AIRCRAFT  
FUSELAGE SKIN AND WINDOW BELT SYSTEM

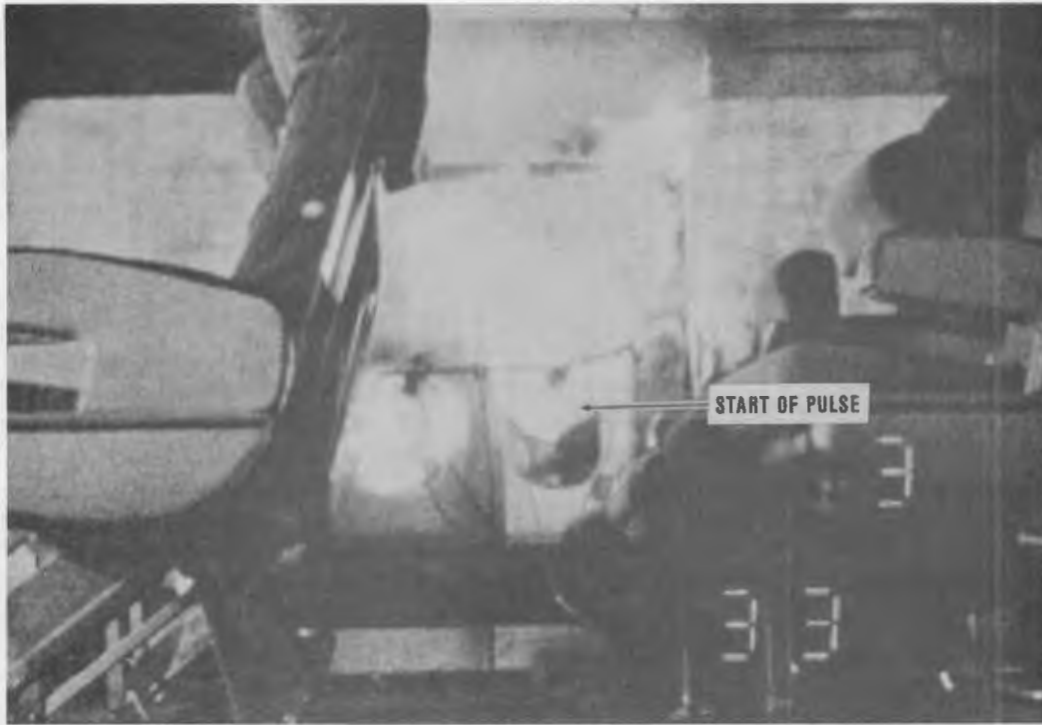
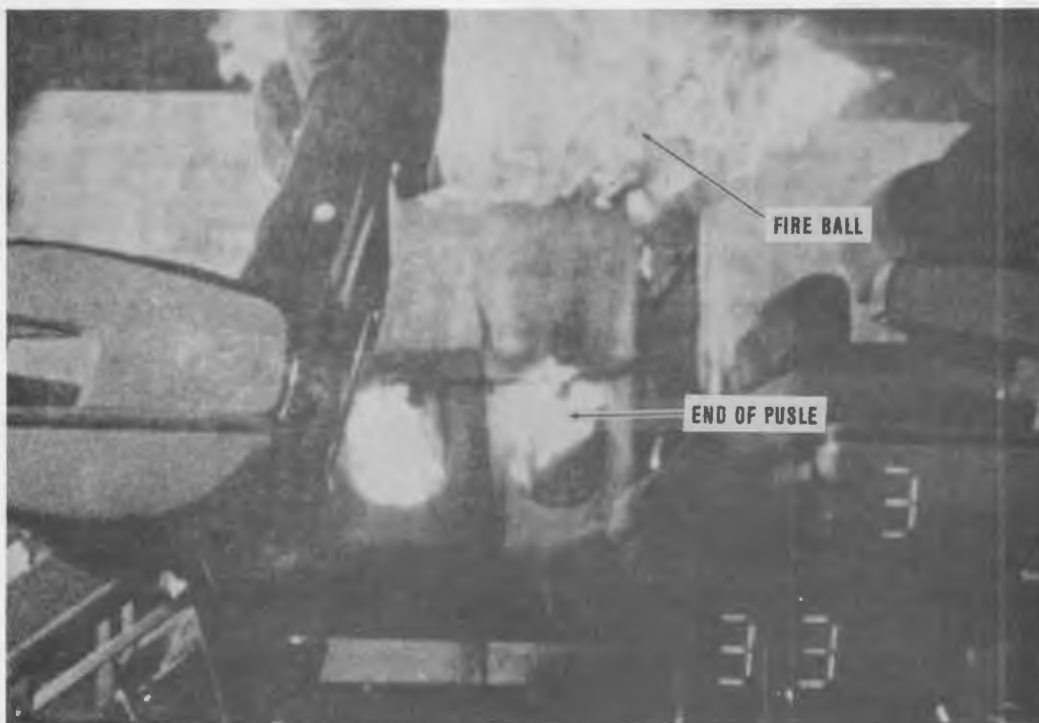
Concurrently with the failure of the acrylic window system, the external fire plume penetrated into the cabin interior. The series of photographs presented in figure 18 show the flame plume pulsating at approximately one second intervals through the window opening after the destruction of the acrylic window panes. This condition continued for the duration of the test and would pose a severe threat to passenger survival during egress from an aircraft and serve as an ignition source for the interior cabin furnishings.

FIGURE 18. PHOTOGRAPHIC SEQUENCE SHOWING FLAME PULSATION THROUGH THE ACRYLIC WINDOW OPENING

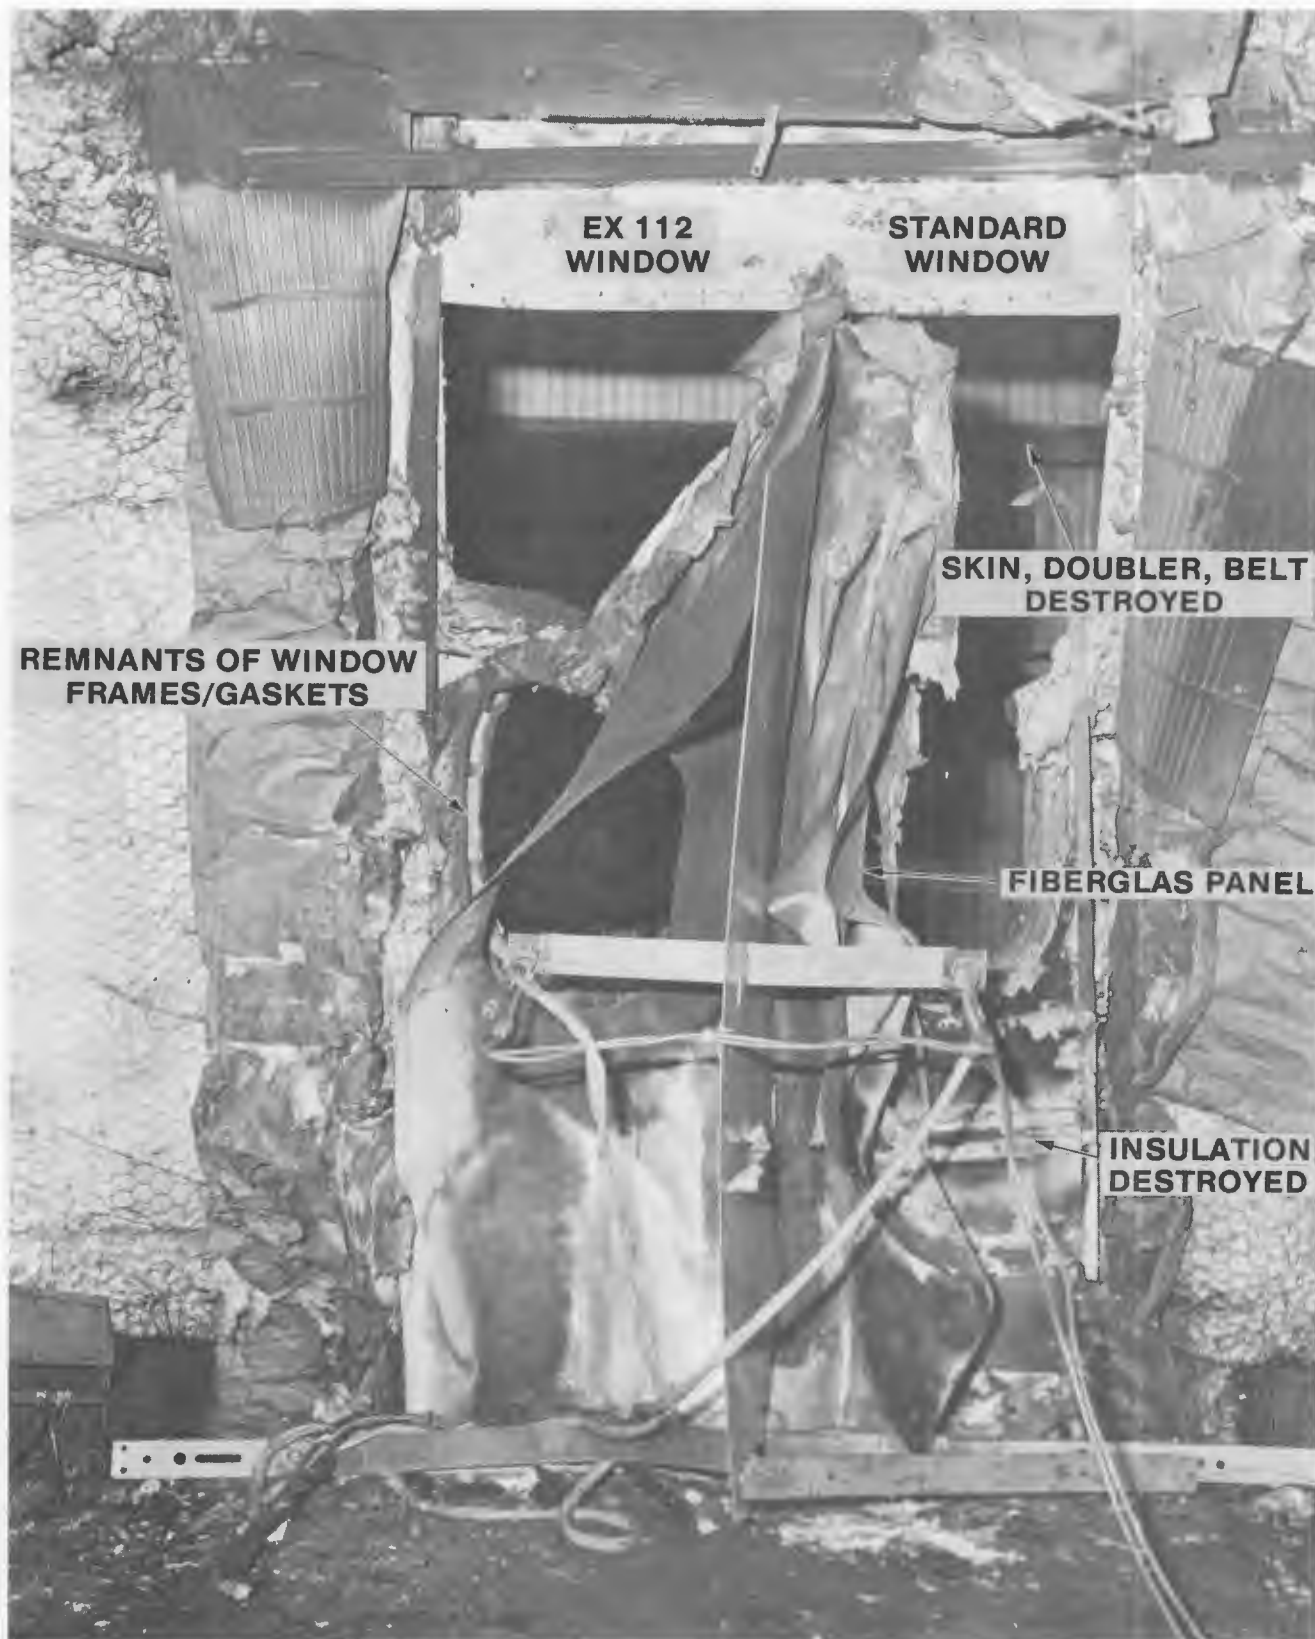
The visual fire damage to the aluminum fuselage structure around the thermally improved and standard window configuration is shown in figure 24. A more detailed interior view of the fire damage to the improved EX 112 window system is presented in figure 25. Figure 24 shows a portion (approximately 25 percent) of the silicone rubber gasket still mounted in position in the window opening around the thermally improved window system. From these photographs it is evident that the integrity of any window system comprising a pressure and fail-safe pane mounted in a rubber gasket is dependent heavily upon maintaining the structural and thermal integrity of the belt and window framing material.

FIGURE 24. FIRE DAMAGE TO THE STANDARD (ACRYLIC) AND IMPROVED (EXIT 112) WINDOWS (TEST 2)

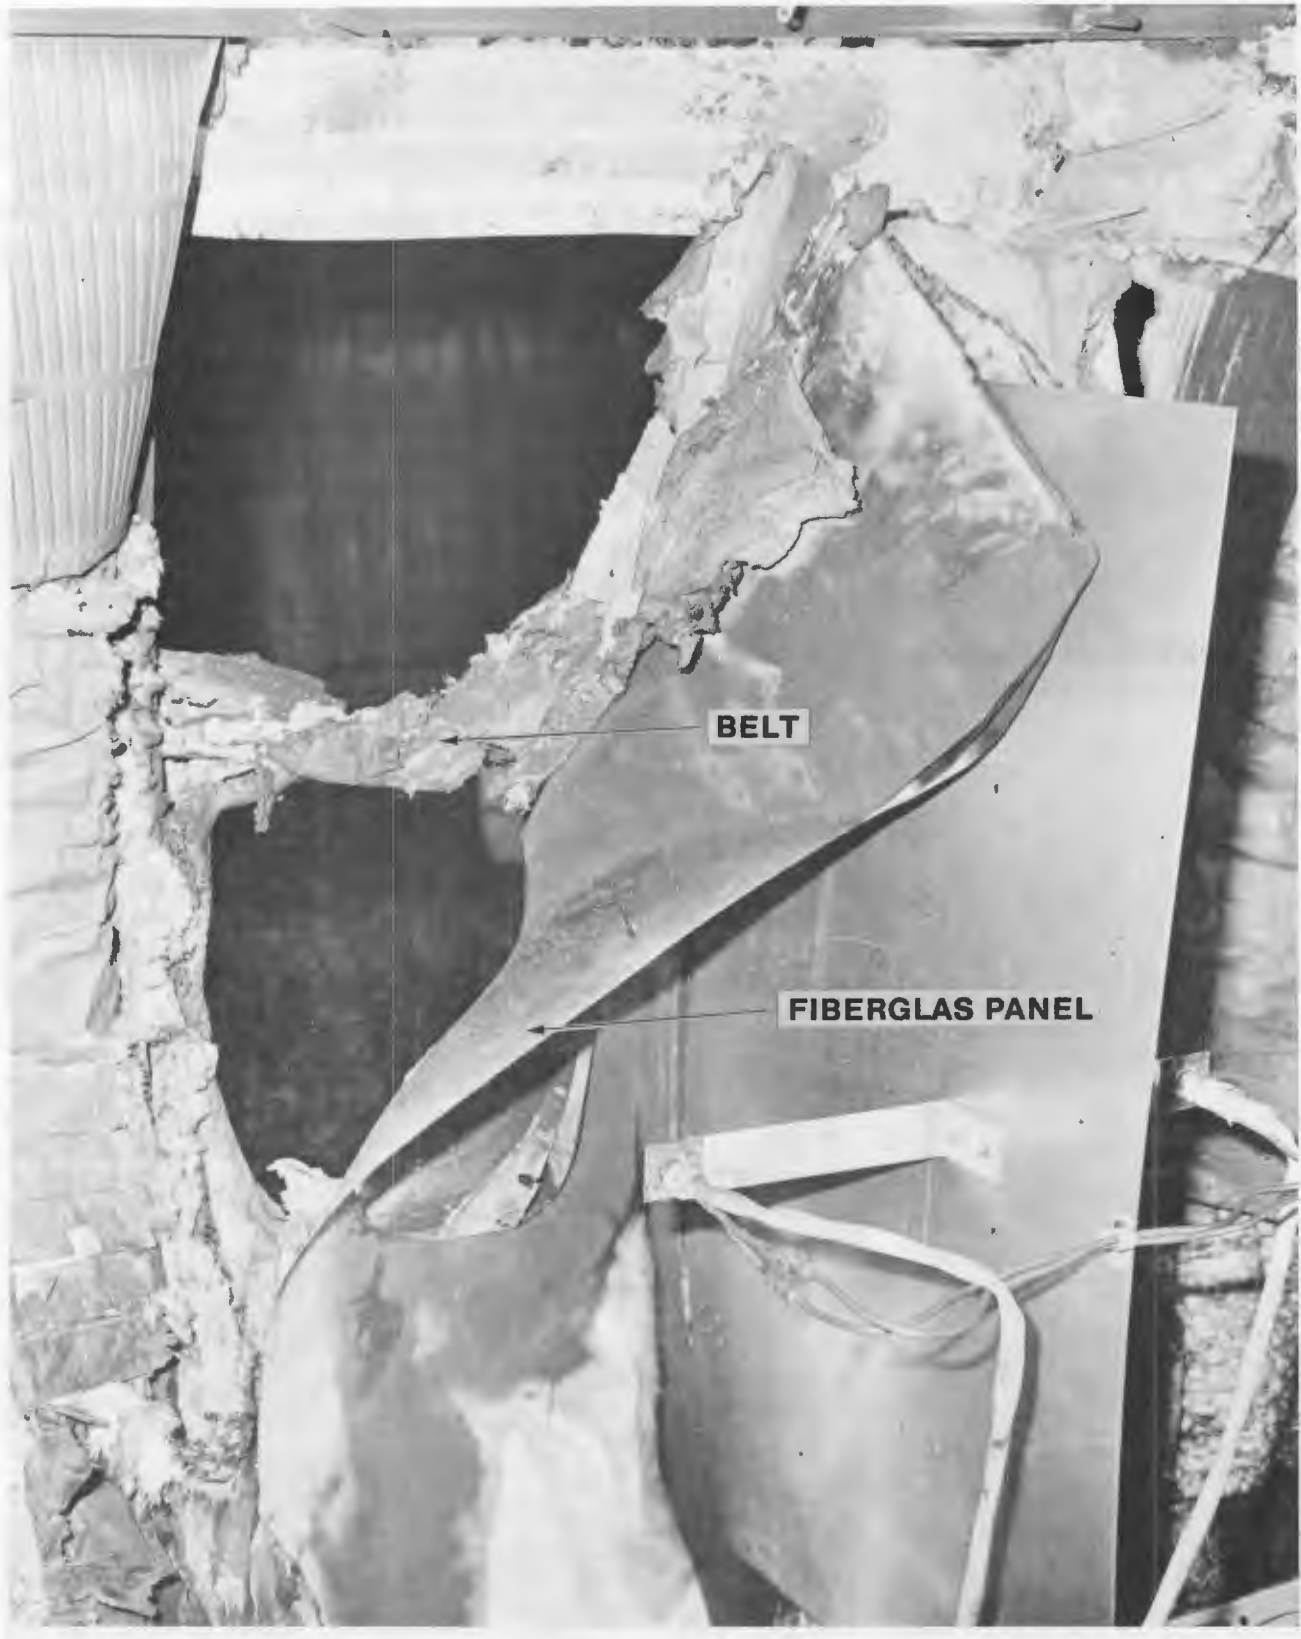
FIGURE 25. CLOSE-UP VIEW OF THE FIRE DAMAGE TO THE IMPROVED (EX 112) WINDOW SYSTEM (TEST 2)
