Publication No. FHWA-RD-93-109 July 1994

Testing of Small and Large Sign Support Systems FOIL Test Number: 92F022

Federal Highway Administration

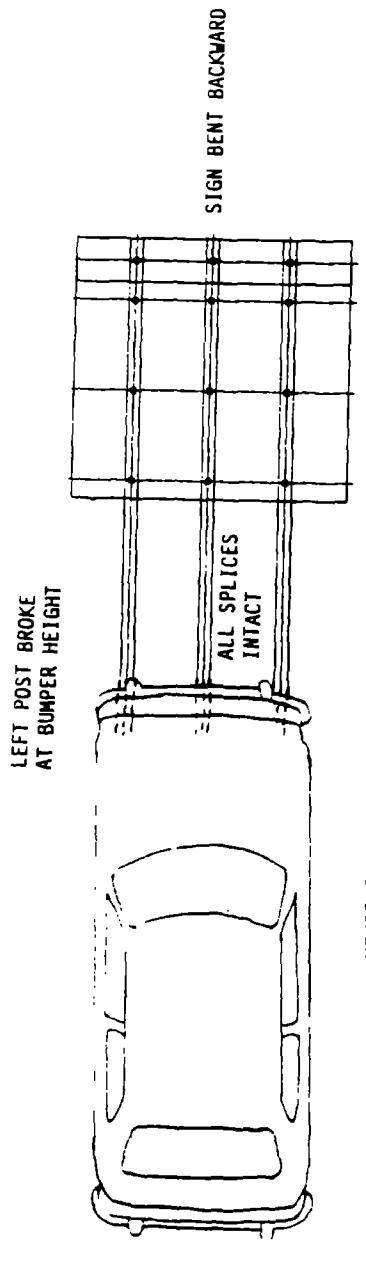
The bumper made contact with all three sign posts and began to collapse. The u-channel legs began to bow away from the vehicle and wrap around the front end of the vehicle. The vehicle continued forward; pushing the u-channel legs through the weak soil. The required force to break the six grade-2 splice bolts or flatten the u-channel was higher than the resisting force of the weak soil therefore the weak soil gave way before the bolts and the vehicle forced the u-channel to plow through the sand. Once the u-channel had pushed through the sand as far as possible the flattening or breakaway force required still could not be obtained because to much energy was consumed plowing through the weak soil. The splice bolts did not break, however the left post did break approximately 15 in (381.0 mm) above ground. The post 0.054 s into the crash event. Two posts bent backwards but never flattened or broke. The u-channel legs pushed through the sand approximately 2.7 ft (0.8 m). The u-channel began pushing through the weak soil upon impact and continued to push through the weak until the vehicle had come to a stop 0.834 s after impact. The sign system remained in the weak soil leaning back 60 degrees. The vehicle came to rest on the broken post's stub and the other two leaning posts. The u-channel was later pulled from the ground and a bend in each u-channel post was recorded 12 in (304.8 mm) below the ground line.

VEHICLE ROLLED UP SIGN

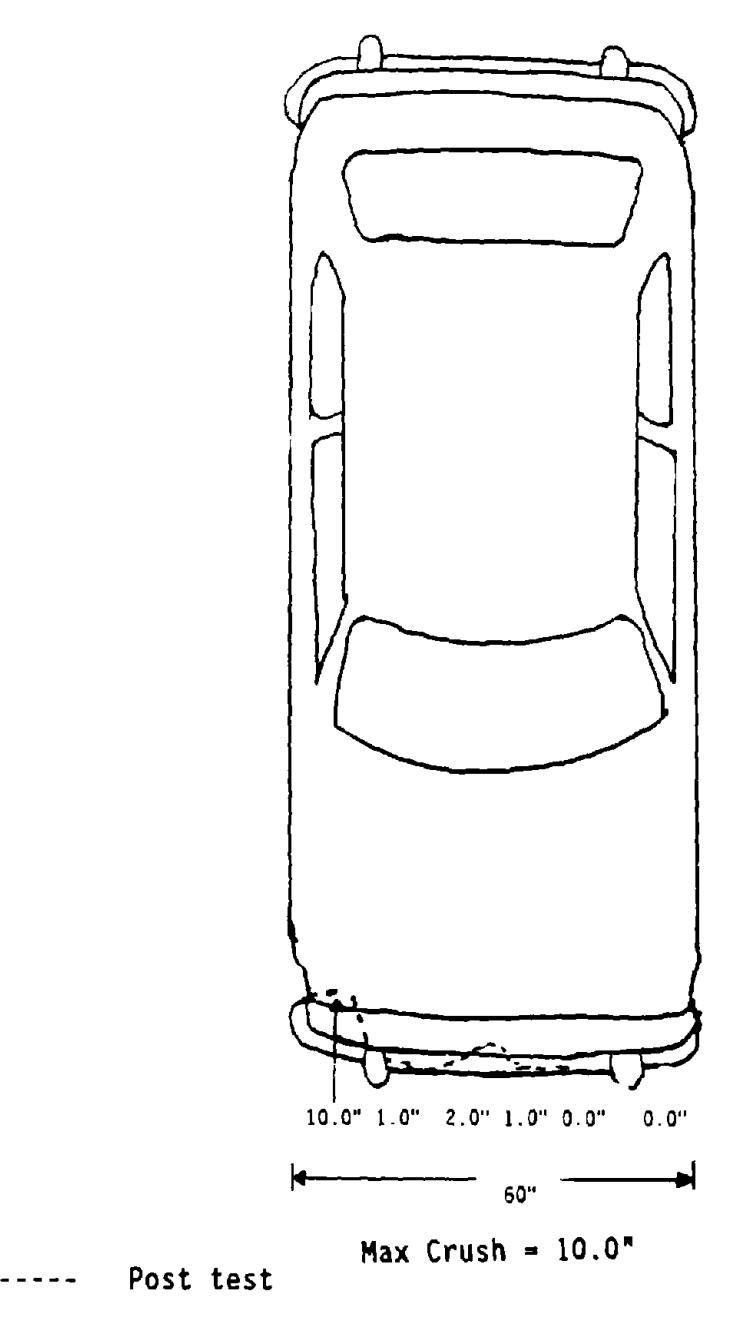
Figure 13. Sketch of vehicle crush, test 92F022.

Damage to the vehicle consisted of damage to the bumper and grill. The right side of the vehicle sustained the maximum crush due to the superficial plastic parts which were damaged. The center of the bumper sustained a 4-in (101.6-mm) dent. The occupant compartment was intact after the test.
