# **Improvement of Railroad Roller Bearing Test Procedures and Development of Roller Bearing Diagnostic Techniques**

## **Volume II - Diagnostics**

1. Report No. FRA/ORD-81/28,II		2. Government Accession No.		3. Recipient's Catalog No. <b>P883 107953</b>	
4. Title and Subtitle IMPROVEMENT OF RAILROAD ROLLER BEARING TEST PROCEDURES AND DEVELOPMENT OF ROLLER BEARING DIAGNOSTIC TECHNIQUES (Volume II - Diagnostics)				5. Report Date April 1982

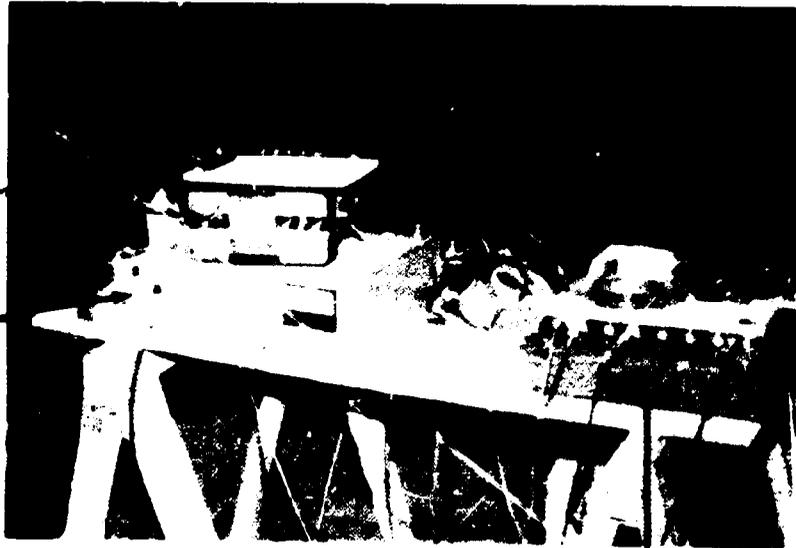
BEARING TURNING FIXTURE

ULTRASONIC CRACK DETECTOR

VIBRATION  
ENVELOPE DETECTOR

DATA TAPE RECORDER

To evaluate the high frequency vibration technique for internal surface defect detection in a manner suitable for rip track use, a device was built which rotated the cup on the axle. This device (which is shown in Figure 14) was used to test 90 bearings on wheelsets that had been removed from service at the Southern Railway Coster Wheel Shop in Knoxville, Tennessee. This evaluation was done at the Southern's wheel shop instead of an actual rip track because of the large number of available roller bearing wheelsets and because the bearings were to be removed and inspected as normal routine. Thus, a convenient and natural unbiased

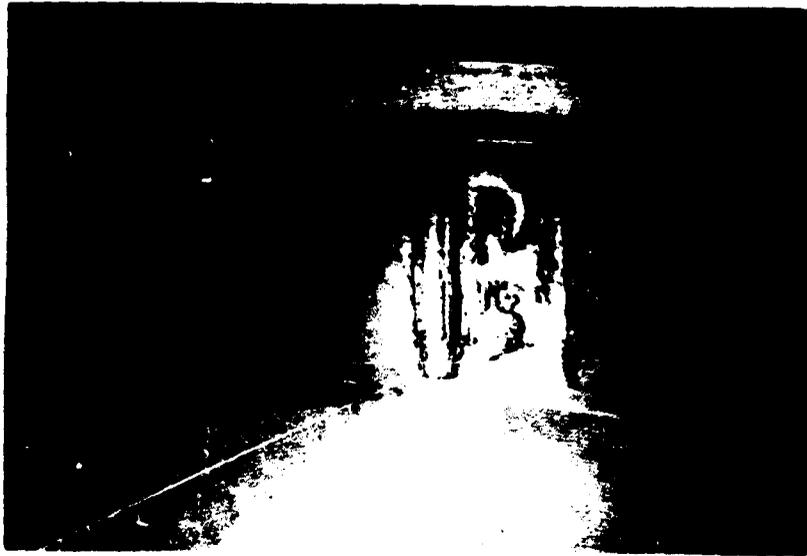
FIGURE 20. BEARING 104 WATER -ETCHED CUP (NO DAMAGE  
PROGRESSION FROM 100-HOUR TEST)

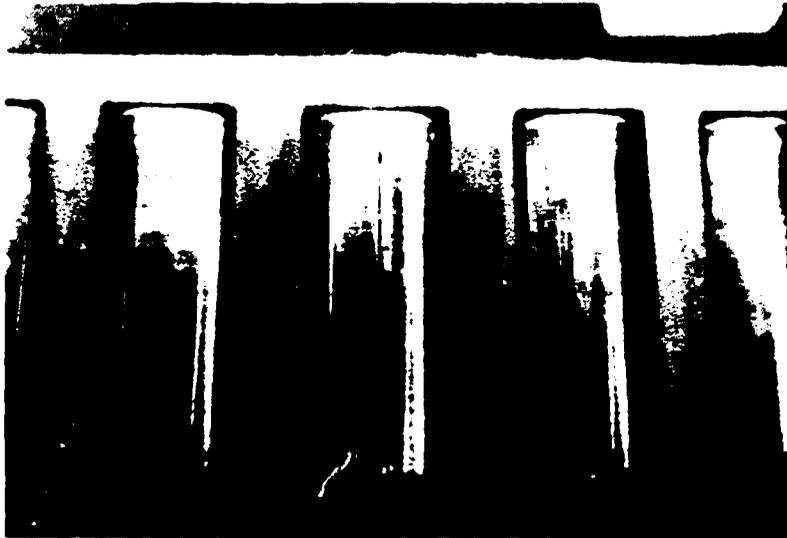
FIGURE 24. BEARING 110, SPLIT ROLLER (NO SIGNIFICANT PROGRESSION)

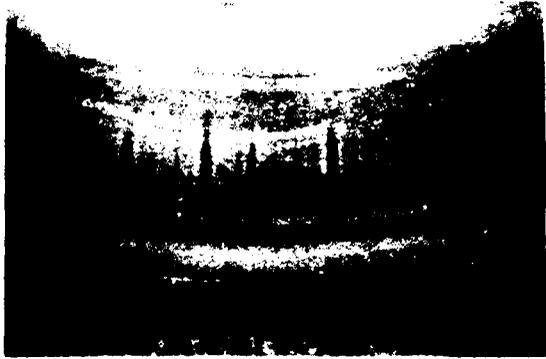
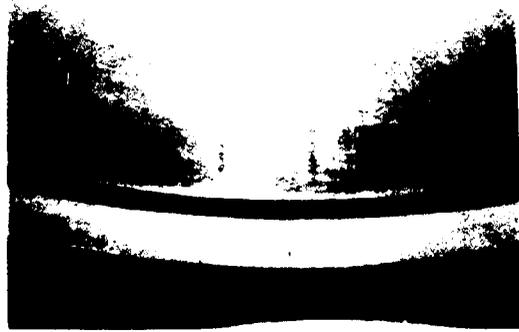
112B BRINELLED

112 BRINELLED

109 WATER-ETCHED

Generally water-etch damage and light brinell damage did not induce further damage during test, as shown in Figure 25. Spalled rollers did not show significant damage progression during test,

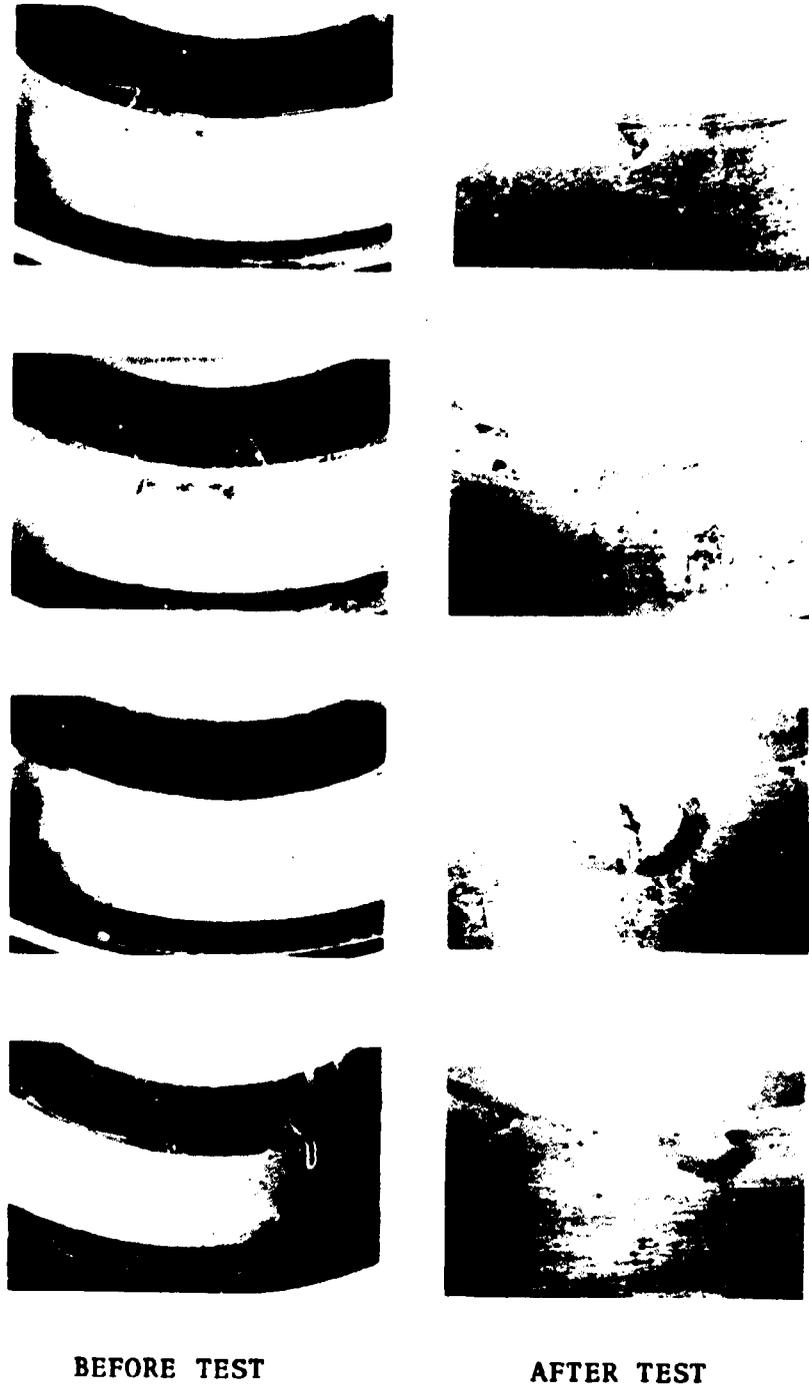
FIGURE 26. PROGRESSION OF RACE SPALLS DURING EQUIVALENT OF 5,000 MILES AT 65 MPH UNDER 26,000 LB. LOAD (BEARING NO. 113)
