# **Summary of DPM Winterization Test Activities**

Lawrence P. Silva

Transportation Systems Center Cambridge MA 02142

January 1982 Final Report

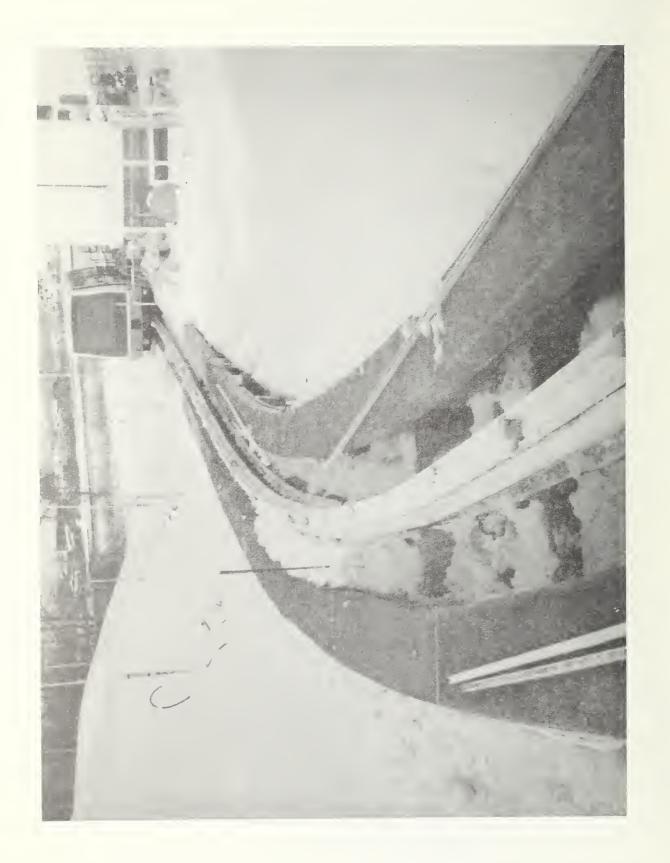
Guideway-surface heating is provided over the entire length of the 250-foot extension, as well as in a 30-foot test surface west of Station 3. Controls, which allow adjustment of heat up to 90 watts/ft<sup>2</sup>, are located in Station 3. Power and signal rails are located along a steel I-beam positioned between the nearly 2-foot-wide concrete running surfaces. Each power, signal, and ground rail is equipped with two 1-ohm/ft resistive heating wires.

These are connected in such a manner that various heating levels can be maintained concurrently. A central time-on/-off control is located in Station 3, and power-on/-off control boxes are located along the guideway, each controlling approximately 500 linear feet of guideway-rail heating.

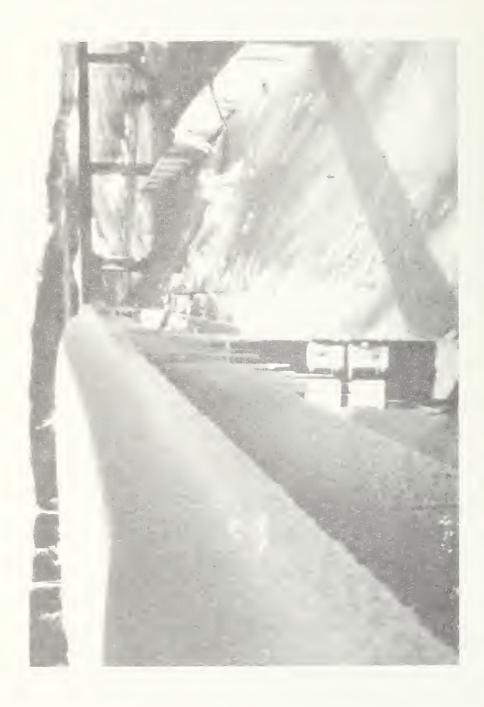
FIGURE 2-3. UMI MONORAIL SYSTEM AT MZG

The MZG system, located in Apple Valley, Minnesota, was used by UMI for the 2-year test program. The monorail (Figure 2-3) is a revenue-service system which was designed, manufactured, and constructed for daily operations. Because the facility was under construction at the start of the test program, only a portion of the entire system was available for testing. A 1000-foot section of guideway was made available for testing and operation; it included over 500 feet of the main guideway, the main guideway/maintenancespur switch, and the spur from the main guideway to the entrance of the maintenance building. In addition, the maintenance building, transfer beam, outside storage facilities, and the weather measurement/recording instruments were all available for both winters.

The top of the guideway, a welded box beam fabricated of COR-TEN plates, tubes, and surface is 40 inches wide. The primary traction surface extends 4 inches outside the beam walls to provide a sheltered overhang for the inverted power and control rails that are mounted two to a side.

The guideway is supported on at-grade concrete foundations and on COR-TEN columns in the elevated sections. At selected support points, the guideway is free to slide horizontally in either one (tangent sections) or all (curve sections) directions. At the remaining supports, the guideway is fixed by clamps (atgrade) or welds (above-grade).

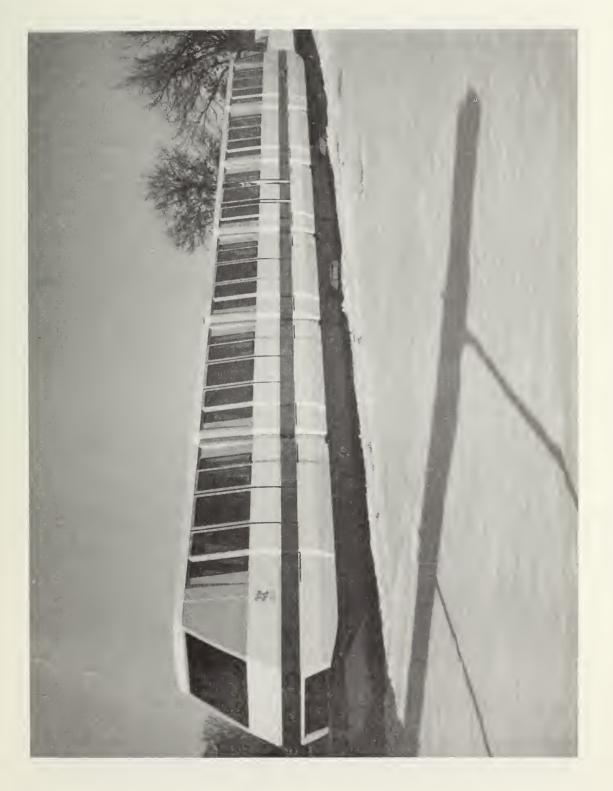
FIGURE 2-4. UNIMOBIL TOURISTER TRAIN

The vehicles are steered by the support bogies which are guided by mechanisms attached to each bogie. These mechanisms consist of hard-tired, vertical-axis guidewheels that are mounted in sets of two to engage guidance surfaces located on either side of the guideway. Each set is arranged so that one guidance wheel leads and the other trails the bogie support wheels. All of the guidewheels are spring-held against the guidance surfaces; these wheels are contained by housings that are pivot-connected to frames attached to the bogie structure and have limited travel in the horizontal direction.

The trains used during the 1979-80 winter are each designated by numbers (1, 2, and 3). Train 1 was available in its entirety

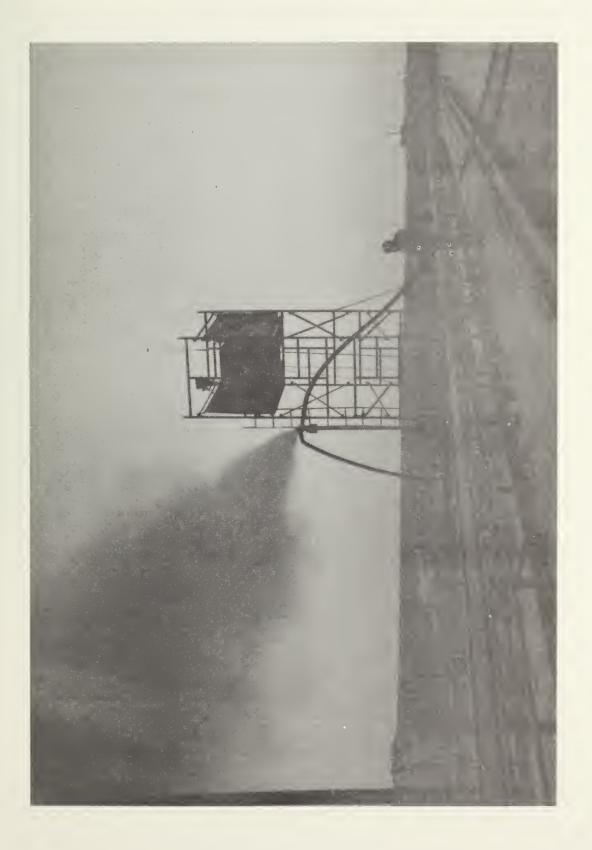
FIGURE 2-5. SNOWMAKING FACILITIES

To supplement the naturally-occurring snowfall events, artificial snowmaking equipment was utilized at the test sites to augment the number and severity of test conditions. The snowmaking facilities, shown in Figure 2-5, consisted of an air compressor, water pump, snow towers and guns, air and water hosing, and miscellaneous valves and gauges. A pre-chiller was used at several sites to decrease water temperature prior to the mixing of water with compressed air. Strict procedures were followed to insure proper operation of the snowmaking system to prevent freeze-up of lines and valves and to create a range of snow qualities from dry to wet snow, ice, and freezing rain.

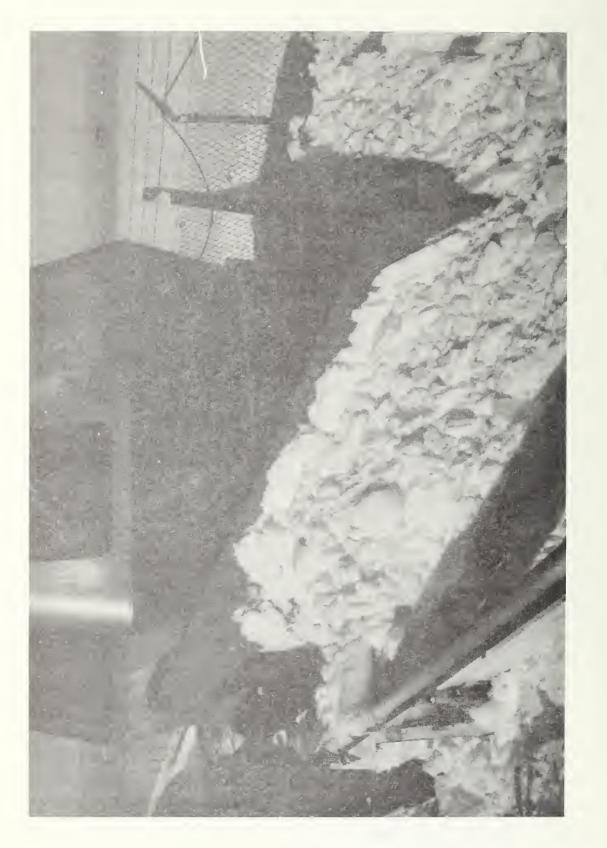
In an effort to develop winter protection-methods which would de-emphasize heating as a "panacea" for winter operation of AGT systems, the contractors successfully developed mechanical snowremoval methods. The Otis system, which utilizes a channel guideway configuration, is the most vulnerable to accumulations of snow along the guideway. During the program, Otis experimented with snow removal via vehicle-mounted shrouds and a massive V-shaped plow, shown in Figure 5-1. Adopting a philosophy of periodic circulation of vehicles with shrouds as the primary method of keeping the guideway clear, Otis recorded the performance of the shroud and observed the circulation times required for this operating mode. Based on a severe 2-in/hr snowfall, circulated vehicles had only 1 inch of snow to plow with each pass (30-minute intervals). After several passes, snow builds up along the sides of the guideway, presenting a potential problem to the proper operation of the power and signal rails and the emergency-braking For this reason, a closed-guideway arrangement has strips. serious drawbacks, and adoption of an open-sidewall arrangement must be considered for this method to be plausible. Taking into account the situation where a large accumulation of snow precedes the commencement of removal activities, Otis developed and tested a large V-shaped plow which was mounted to the front of the vehicle. More than enough thrust was available from the LIM propulsion system to plow in excess of 2 feet of snow. Assuming that the guideway would have sidewalls, the plow was designed to lift the snow over the guideway to the street below. Problems were encountered with the power-collection system during these test runs, as snow compacted along the collector assembly and rails causing interruption to power and signal pickup. Modifications to the plow reduced the amount of snow which circumvented the plow blade, but for deployment, reliable operation of the plow will require either relocating the collector assembly toward the rear end of the vehicle or utilizing a self-propelled vehicle for this function.

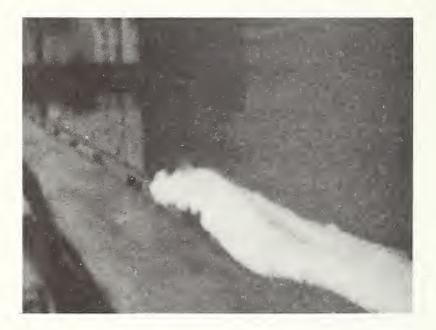
FIGURE 6-1. NEW WESTINGHOUSE DOOR-TRACK DESIGN

Westinghouse's C-100 vehicle was used for the vehicle performance tests which included cold soak, cold start-up, and longitudinal and lateral guidance tests. The test vehicle's door-track configurations were varied in order to evaluate and compare their relative performance. For one set of doors the sill was changed to include more drain holes, similar to that of the Atlanta-type vehicles. Teflon  $\stackrel{\text{(N)}}{\longrightarrow}$  coating was provided on one half of this door track and electrical heating was provided on both the old and modified door tracks. Testing revealed that the new door-track design (Figure 6-1) allowed maximum area for snow and water to be drained or pushed away as doors opened. The Teflon coating of sills did not result in any appreciable difference in door performance and although heating proved successful for removing ice and snow in the door tracks, not enough data

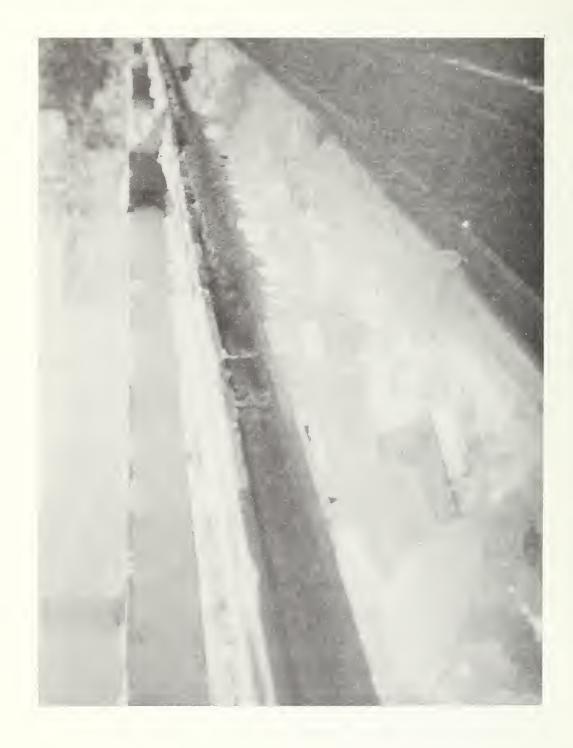
FIGURE 7-1. ICE ACCUMULATIONS ON UNHEATED POWER RAILS

Observations were made of the power-rail-heating system's performance during the test program and it was found that no

power-distribution-related shutdowns occurred due to winter precipitation. The installation of a resistance heater wire in the power rail and the routing of the wire through power-rail joints and expansion joints provided some potential problems which need to be solved prior to the installation of heaters in a DPM system. The wire insulation needs to be thin to allow sufficient heat transfer characteristics but is susceptible to shorts and insulation faults that might occur because of thermal expansion and contraction of the rails.

Otis concluded that power-rail heating is essential to assure complete reliability of the power distribution system. Based on the experiments conducted, a power level of 8 to 10 watts/ft is sufficient for reliable system operations. If this level of heating is initiated at the onset of precipitation or frost, only 15 to 20 minutes of operation is required to warm the rails and ensure reliable system operations. Anticipation of inclement conditions was an important objective since successful prediction and activation of the heating system some time ahead of precipitation will virtually eliminate service interruptions or delays.

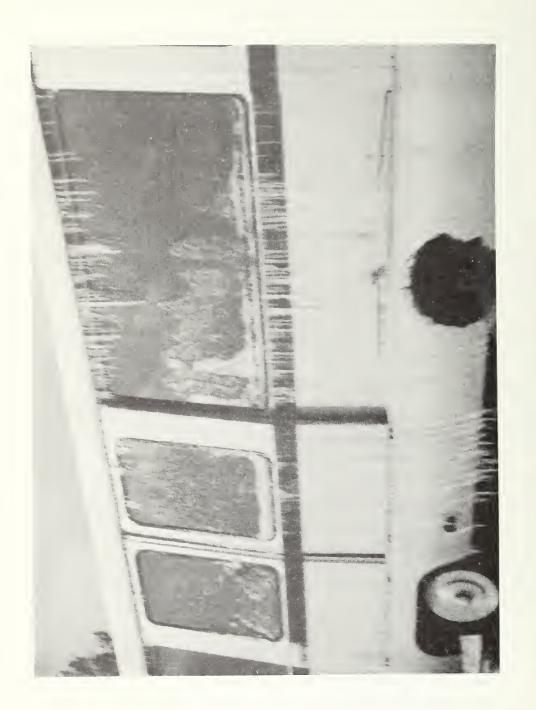
FIGURE 8-1. WESTINGHOUSE VEHICLE AFTER OVERNIGHT STORAGE ON UNPROTECTED SIDING

Overnight storage of vehicles on an unprotected siding (Figure 8-1) was considered a possible trouble spot so tests were conducted by Westinghouse to determine if freeze-up would occur and, if so, what measures should be taken to get the vehicles in service. A parking area was designated on the test-track spur. Thermostatically-controlled heaters were installed beneath the axles of the parked vehicles. The objective of this test was to determine whether radiant heaters in the parking area reduce the possibility of brake-shoe/-drum freeze-up overnight in cold weather. During the winter testing of 1979-80 it was determined that vehicle-storage-area heaters are not needed at temperatures down to 0°F. Although there was no evidence to support the need for parking-area heaters, the WTD radiant heater system was demonstrated to keep the bogie temperatures above freezing. Tests with sub-zero temperatures, however, would be necessary to draw conclusions about the necessity of such heaters under those conditions.
