Downtown People Mover (DPM) Winterization Test Demonstration: UMI

**Donald P. Sullivan
James Zaenger**

**Universal Mobility, Inc.
2040 East 4800 South
Salt Lake City UT 84117**

**January 1982
Final Report**

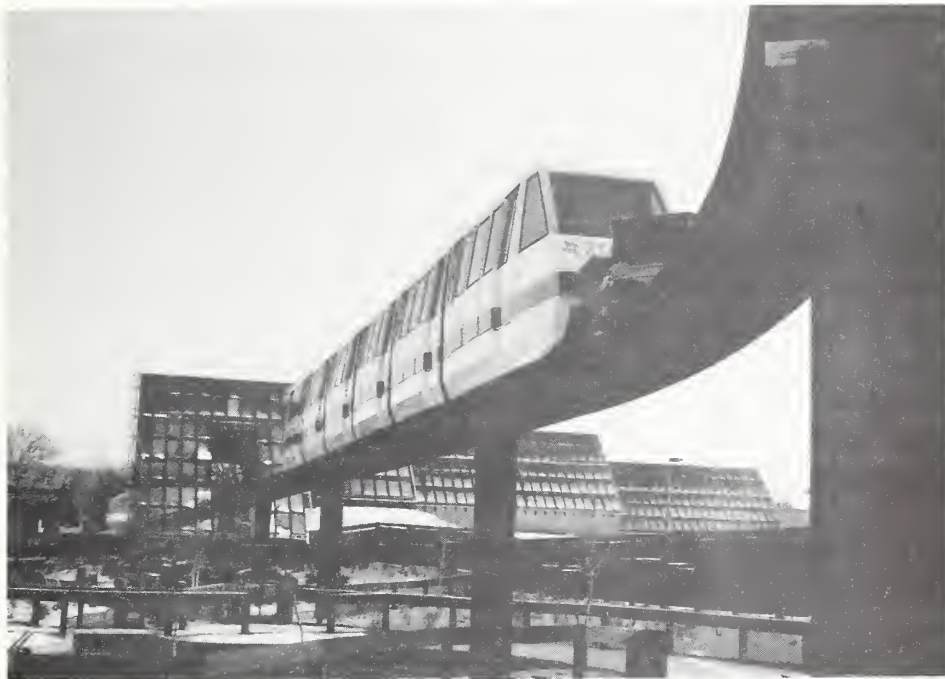
FIGURE 2. TRAIN NO. 3 WITH SNOW MODULE READY FOR USE

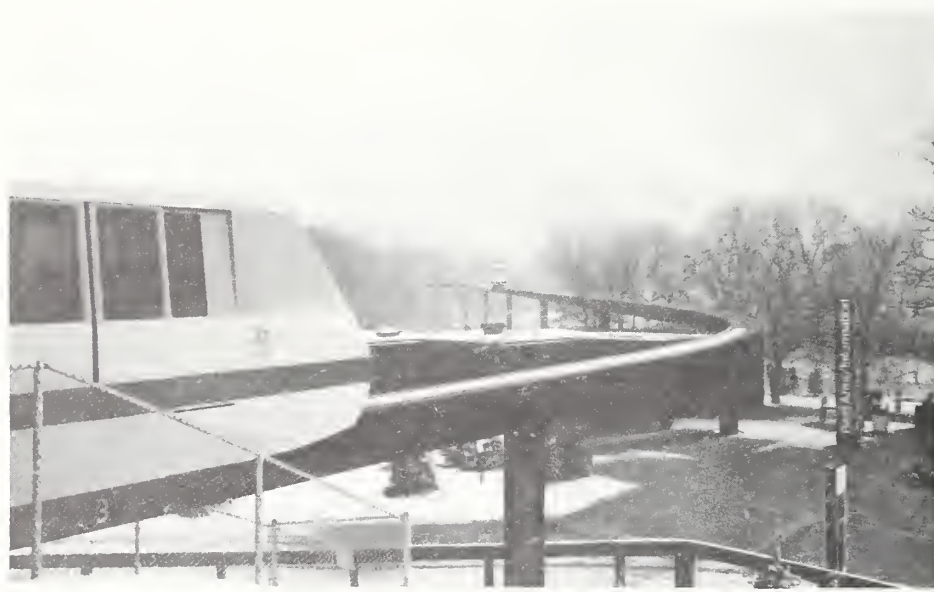
FIGURE 3. AUTOMATIC SPACING OF TWO TRAINS
APPROACHING THE MAIN STATION

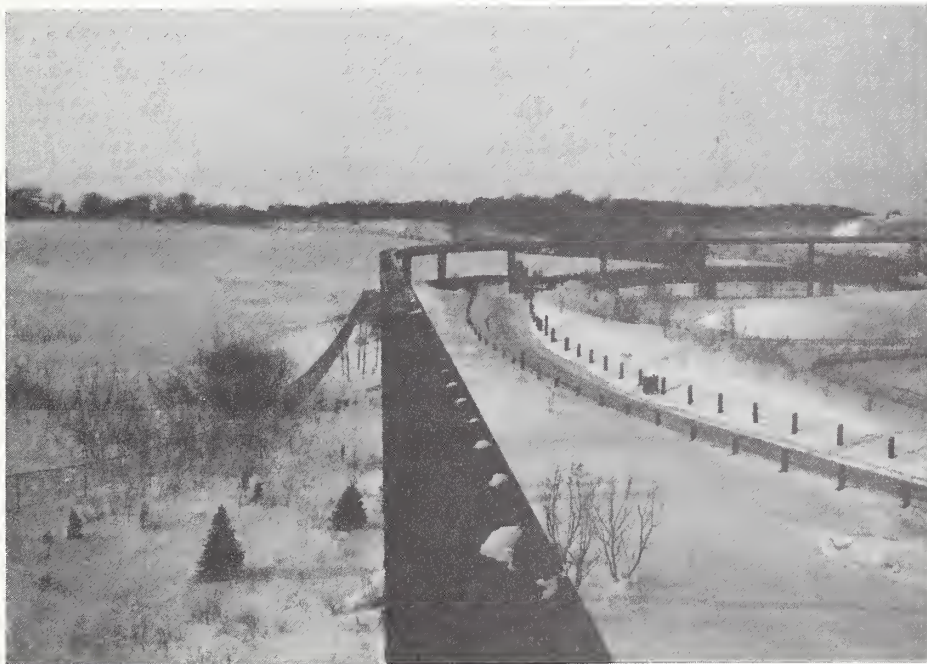
FIGURE 5. WIND FREQUENTLY CLEARS SNOW FROM GUIDEWAY

The CGC functions in two related, but distinct, ways. The first is that by being cold and free of any geometric features which can trap snow or rain, surface accumulations are comparable to, or usually less than, amounts that would collect on open ground as shown on Figure 5. The small snow deposits result from power and control rail brackets which alter the guideway's airfoil characteristics with the wind.

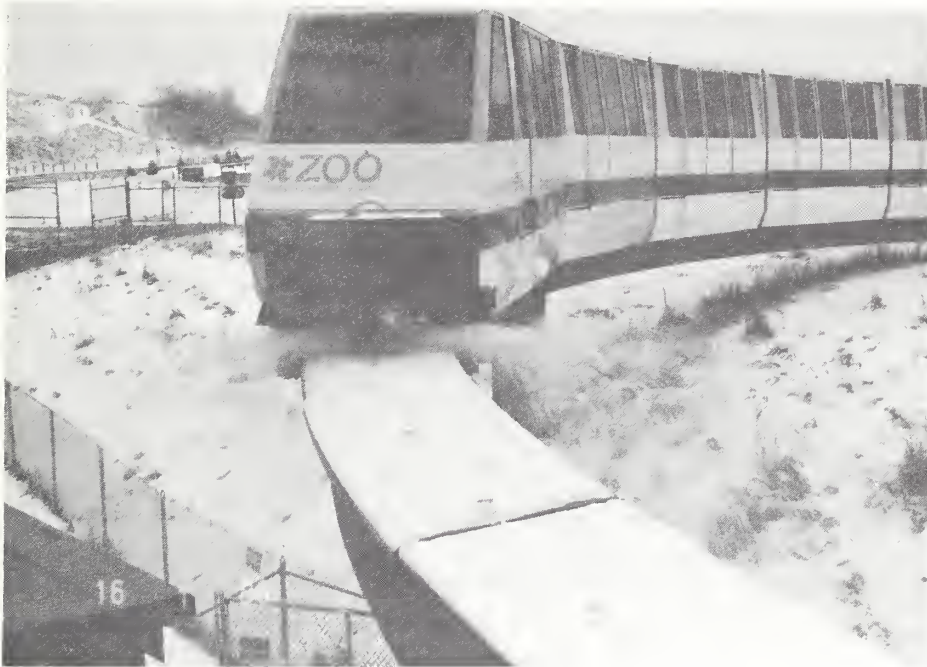
FIGURE 6. PLOW BLADE ELEVATED FOR BRUSH (ONLY) SNOW REMOVAL

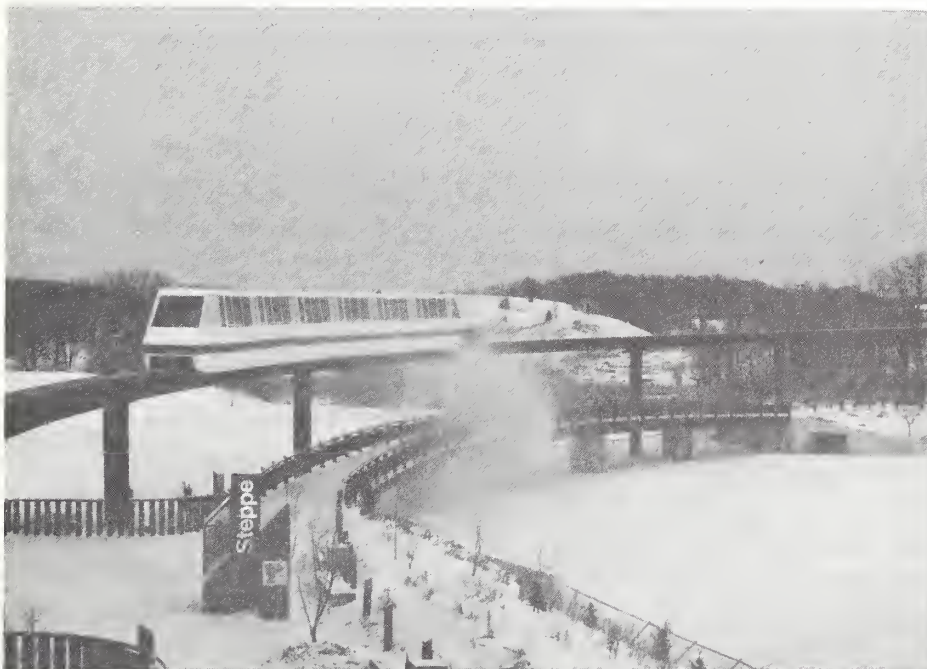
FIGURE 7. CLEAR GUIDEWAY AFTER SINGLE BRUSHING OF OVERNIGHT SNOWFALL

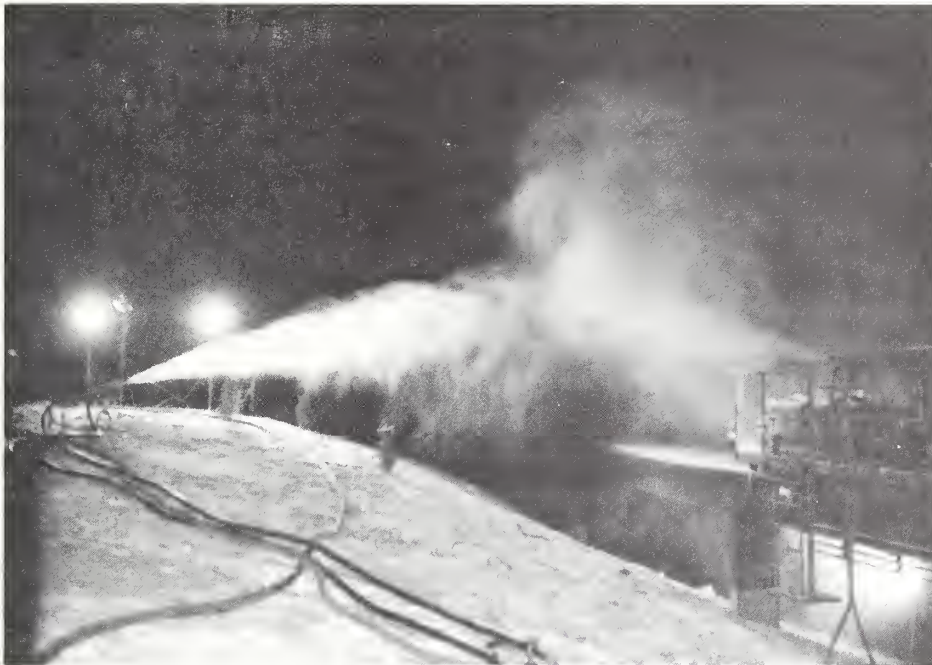
FIGURE 10. INITIAL STAGES OF LIGHT DENSITY SNOW
PRODUCED BY THREE SNOW GUNS

Figure 10 and 11 are representative of the normal sequencing for producing artificial snow or ice accumulations. At about 8:00 to 10:00 p.m., snowmaking activities were initiated. The average snow accumulation rate was in the range of two inches per hour; the maximum depth usually occurred after 8 to 12 hours -- usually about sunrise. This allowed the actual tests or demonstrations to be performed entirely, or in part, during daylight hours. For recording and observation purposes, the early morning tests were desirable during the 1978-79 Winter Program; they were absolutely necessary throughout the 1979-80 Program when MZG required the guideway every day for revenue service between 10:00 a.m. and 4:00 p.m.

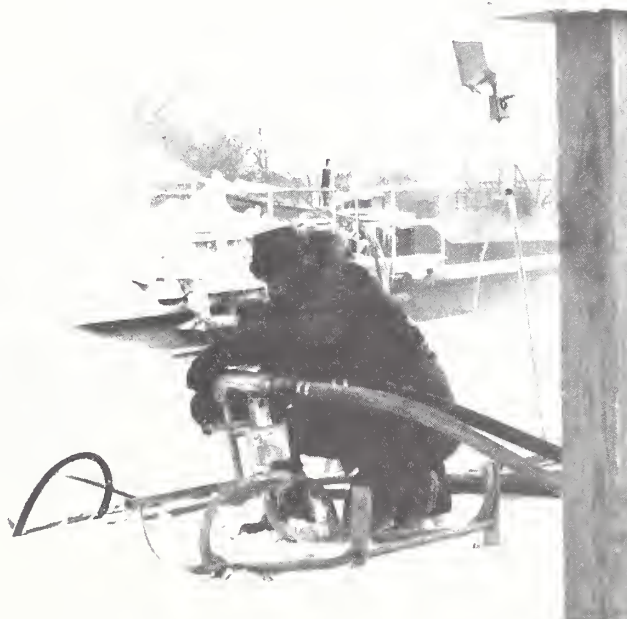
FIGURE 11. READY FOR A TEST AFTER MAKING SNOW ALL NIGHT

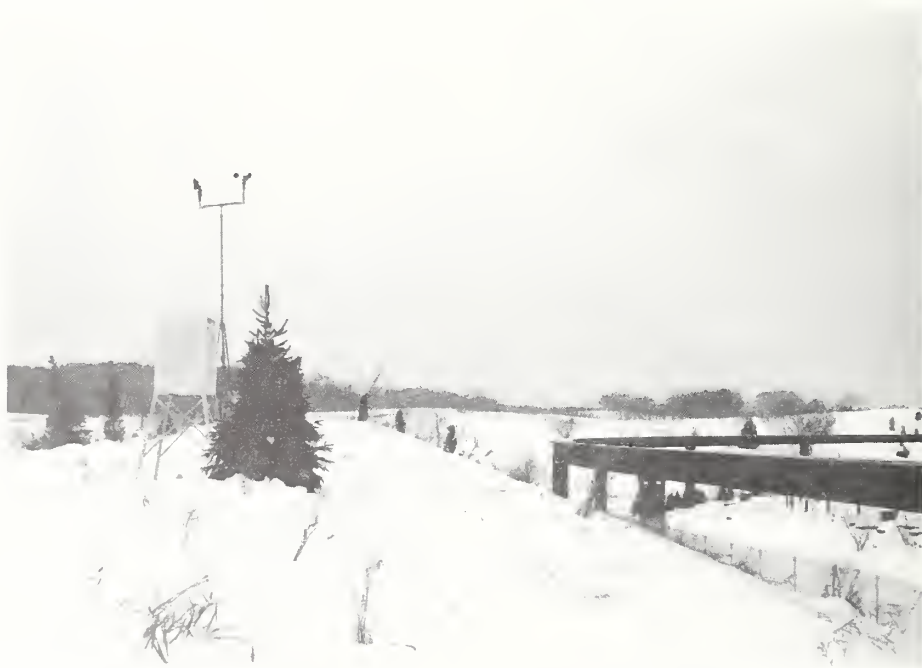
FIGURE 12. VIEW OF ON-SITE WEATHER STATION ADJACENT TO PRIMARY TEST AREA

The on-site weather station was located approximately 40 feet southerly of the MZG main guideway on a ridge at the average elevation of the entire guideway. This location was convenient to the primary (main guideway) test area as well as the guideway switch, transfer beam and maintenance building. The instrumentation and associated recording devices were installed in accordance with the applicable National Weather Service Bulletins. Figure 12 shows the on-site weather station as viewed from the easterly side.

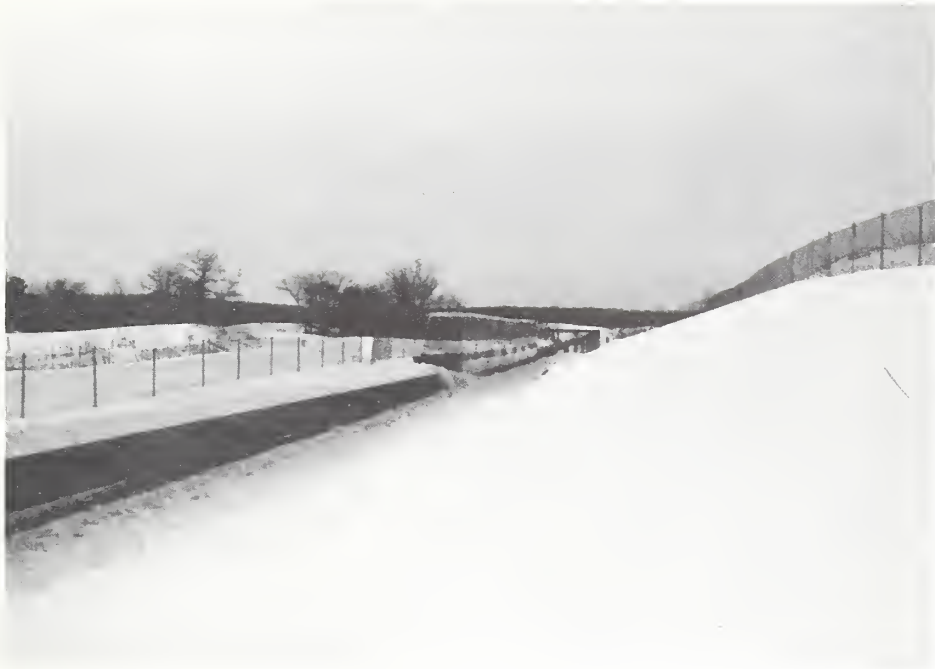
FIGURE 15. REMOVING SNOW, OVER 20 INCHES DEEP, THAT HAD BEEN PLACED BY A SNOWTHROWER

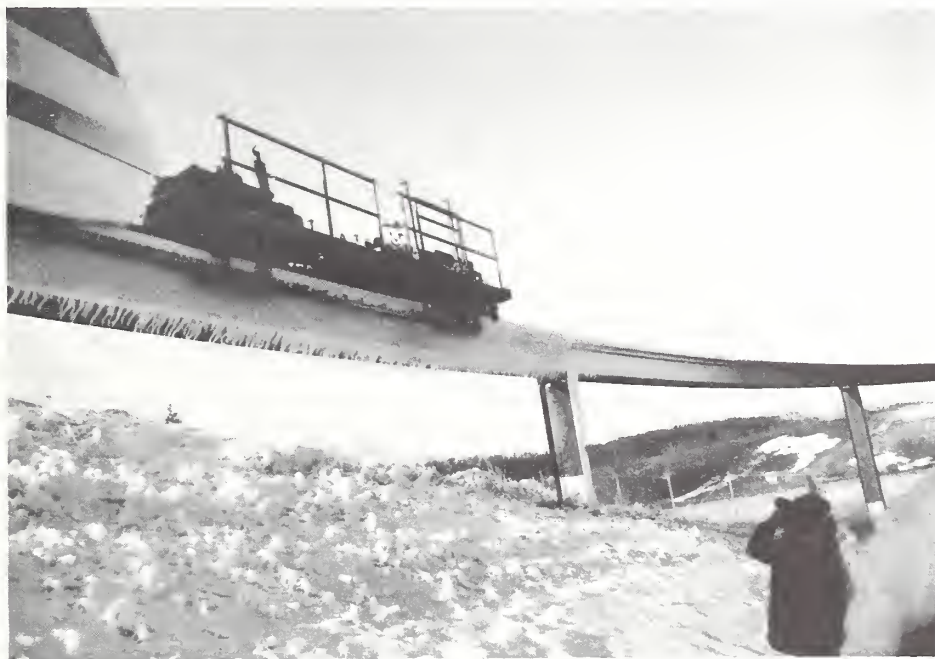
FIGURE 16. RUNNING OVER A GUIDEWAY SECTION WITH SIMULATED BLIZZARD RESULTS

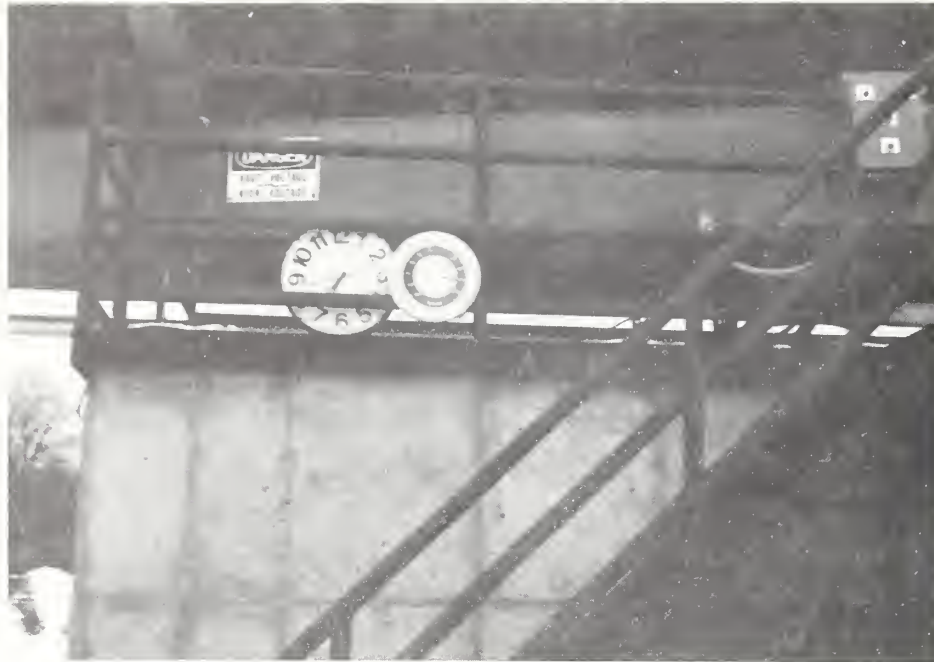
FIGURE 17. THERMOMETER INDICATING -23°F DURING EXTREME COLD GUIDEWAY SWITCH OPERABILITY TESTS

Supplemental temperature data was accumulated during the Demonstration Periods for specific tests; this supplementary data was often recorded using the manual meteorological instruments. An example of such a measure is a large face thermometer which was photographed during the low temperature guideway switch performance tests. An example of a supplementary temperature record is shown as Figure 17 on page 3-8.

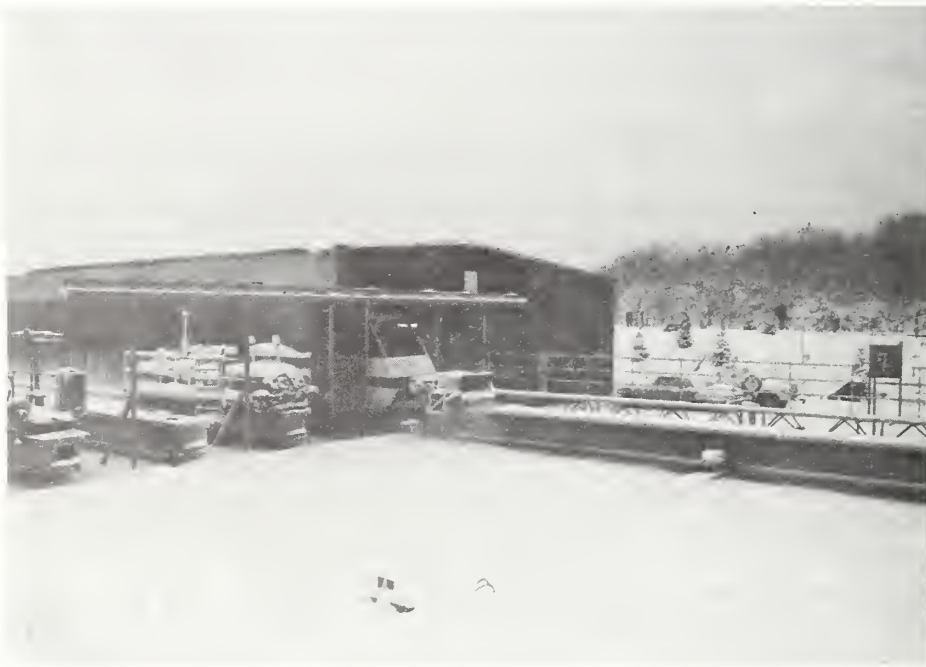
FIGURE 18. TRAIN EXITING MAINTENANCE BUILDING WHILE REMOVING SNOW FROM THE TRANSFER BEAM

Maintenance Transfer Beam -- Any DPM System will require routine, and probably curative, maintenance and servicing of vehicles in its operating fleet. It is reasonable to expect some transfer medium will be necessary to position vehicles or trains to access the appropriate maintenance building stalls for the required level of service. While there are a number of methods which can be used for positioning the vehicles, UMI selected the transfer beam, shown as Figure 18, as the least costly, most compact and simple device for effecting these maneuvers.

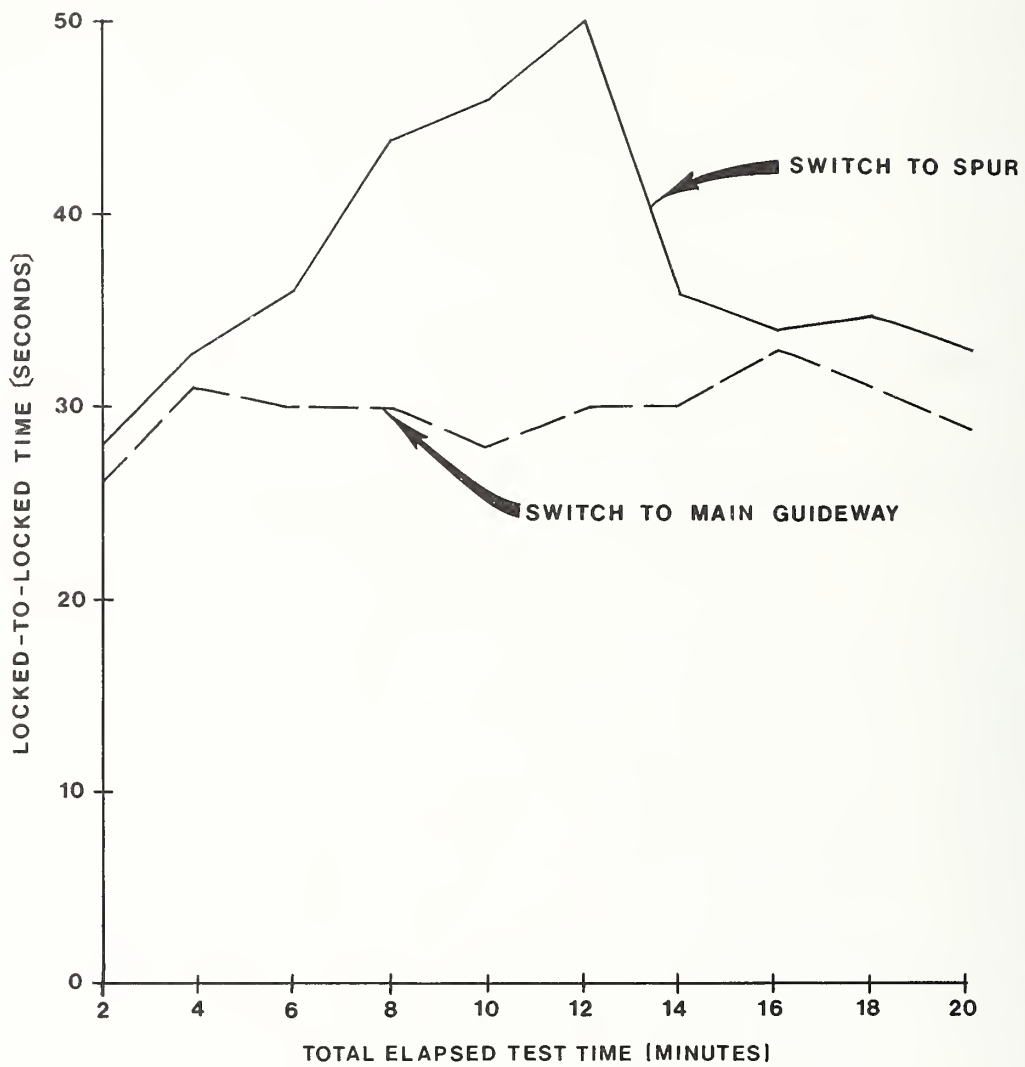
FIGURE 21. GUIDEWAY SWITCH TEST PERFORMED AT -23°F

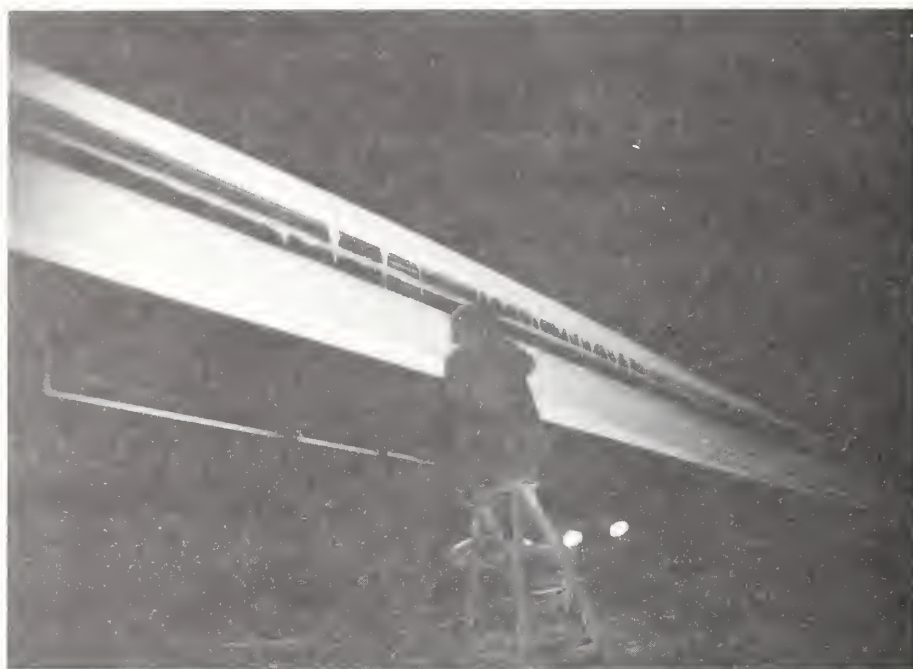
FIGURE 24. INSPECTING CLEAR INVERTED POWER RAILS AND GUIDANCE/AUXILIARY TRACTION SURFACE OF HEATED SECTION, WHILE SNOW AND ICE REMAINS ON SIDE-MOUNTED SECTION TO THE RIGHT

Figure 24 graphically depicts the results of blizzard conditions created on April 6, 1979. These conditions rendered the conventional side-mounted power rails inoperable within 15 minutes of the start of the demonstration while the UMI rails remain clear of any adverse accumulations. It should also be noted that the warmth provided by the auxiliary traction surface heating tapes was sufficient to melt the snow visible above this surface so that it fell to the ground after 20 minutes of heating.

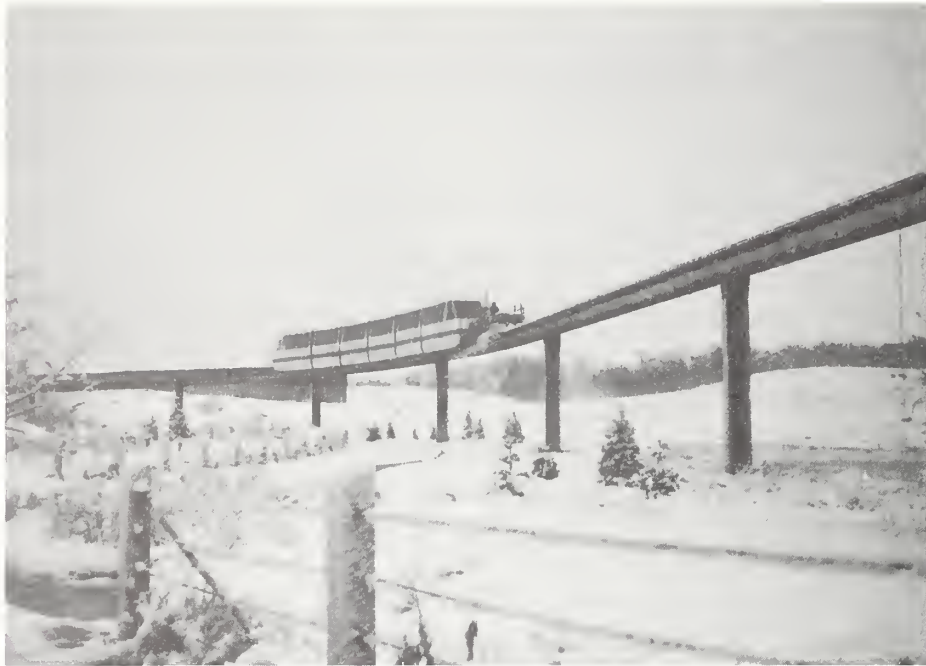
FIGURE 29. SNOW REMOVAL USING INTERIM MAINTENANCE
SUPPORT VEHICLE CAPABILITIES
