REPORT NO. CG-D-8-77

FIELD TESTS OF IN-SERVICE MODIFICATIONS TO  
IMPROVE PERFORMANCE OF AN ICEBREAKER  
MAIN DIESEL ENGINE

AUGUST 1977

FINAL REPORT

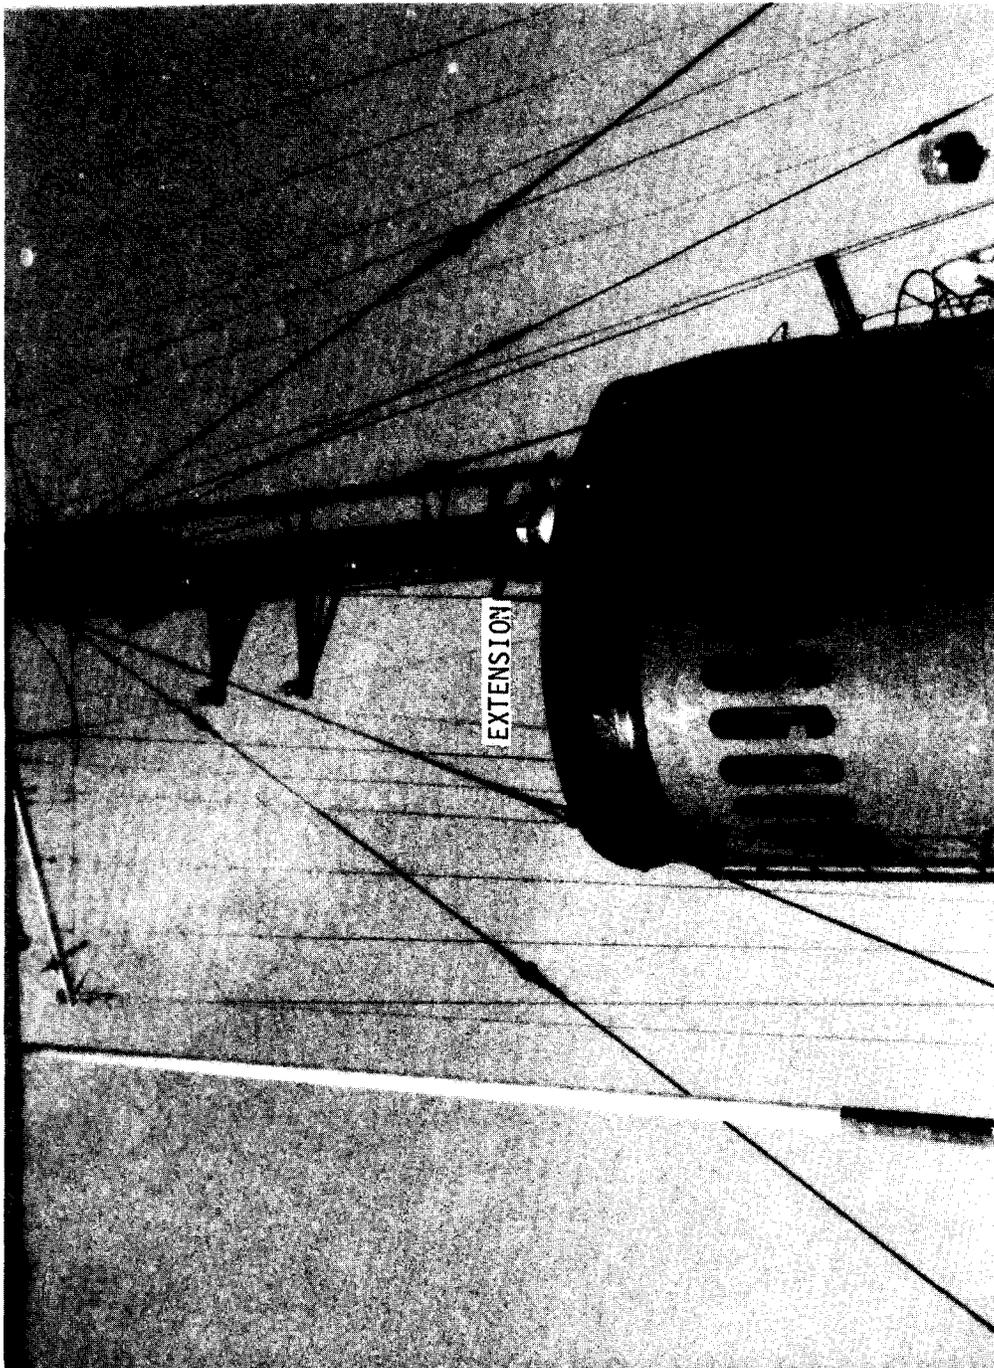
FIGURE 4. OPACITY METER - EXTENSION

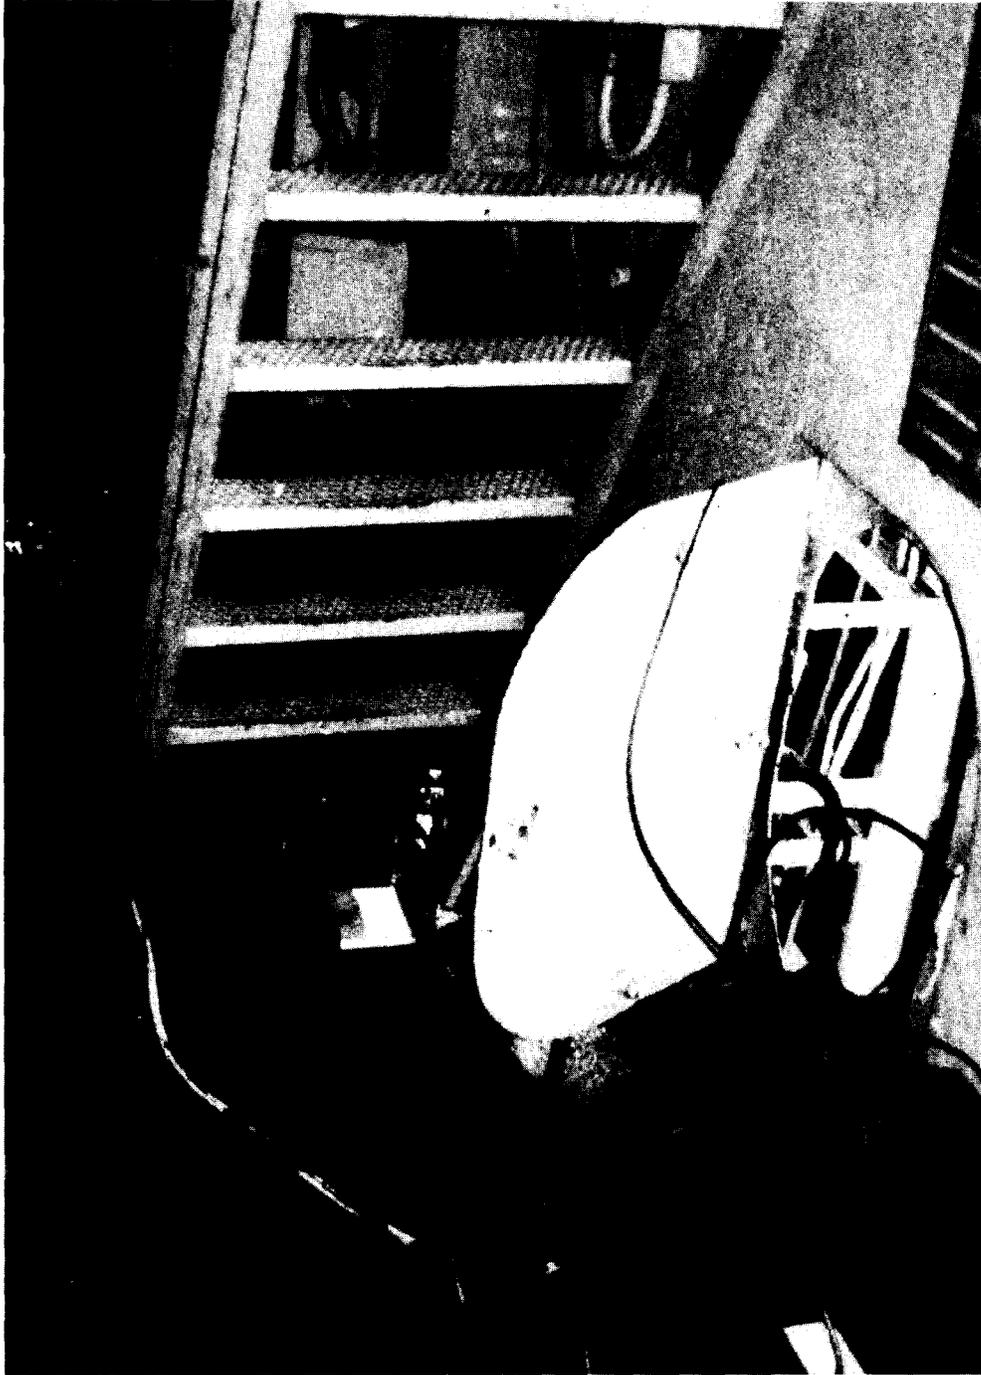
FIGURE 5. SMOKE METER CONTROLS

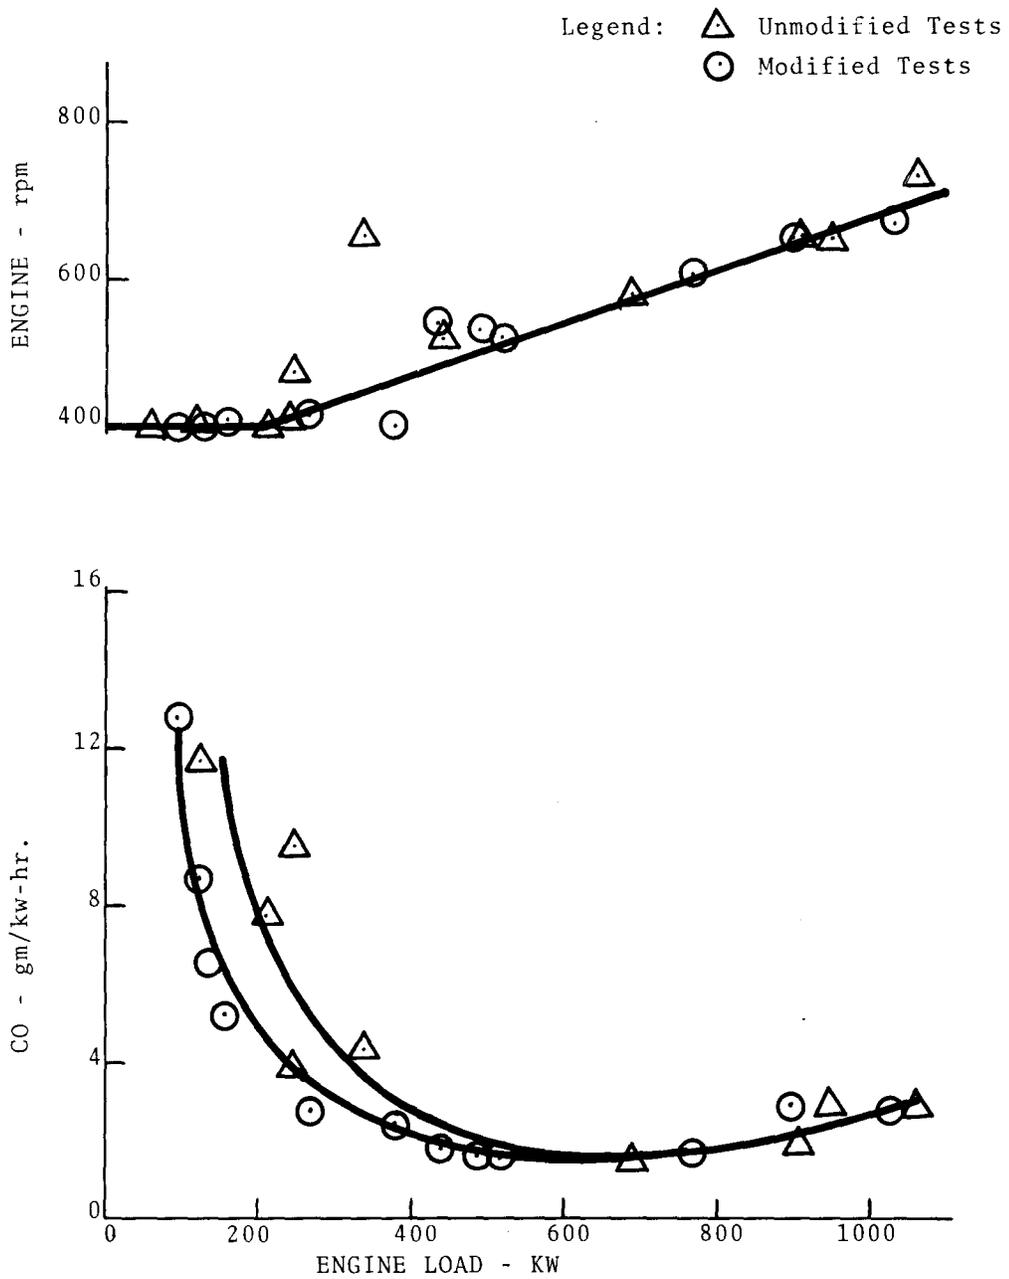
FIGURE 7. DIESEL ENGINE CARBON MONOXIDE EMISSIONS - USCG MACKINAW (WAGB-83)

The modified engine shows a significant reduction of CO at the lower engine loads and speeds, Figure 7. This reduction is due to the better atomization of the fuel oil with the pintle nozzle and the faster rate of injection at the beginning of injection, particularly at low engine speeds. The reduction in CO at no load, idle speed was from 3610 to 2050 grams per hour.

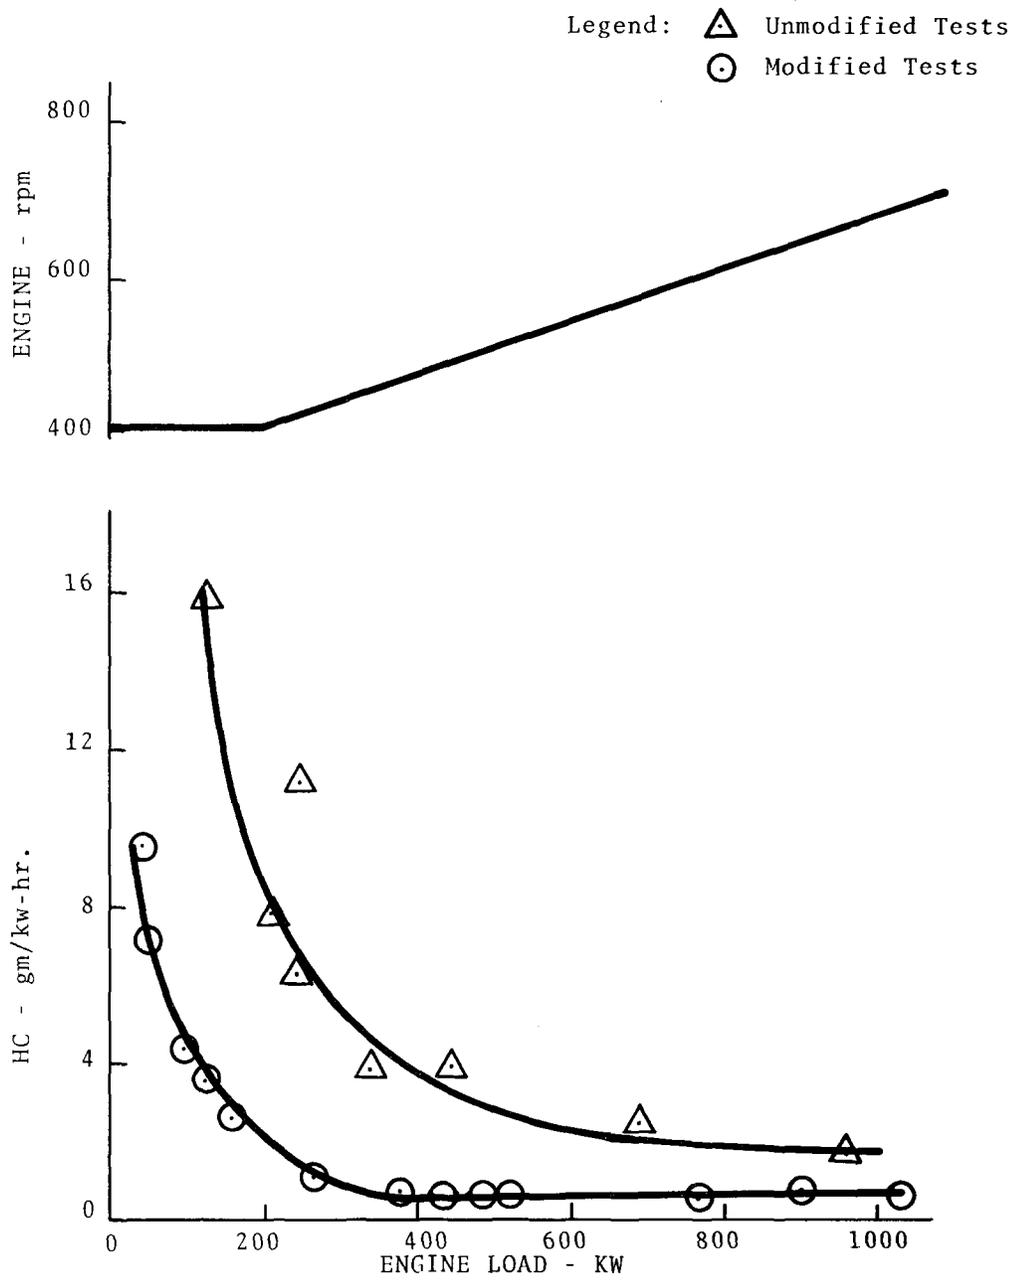
FIGURE 8. DIESEL ENGINE HYDROCARBON EMISSIONS - USCG MACKINAW (WAGB-83)

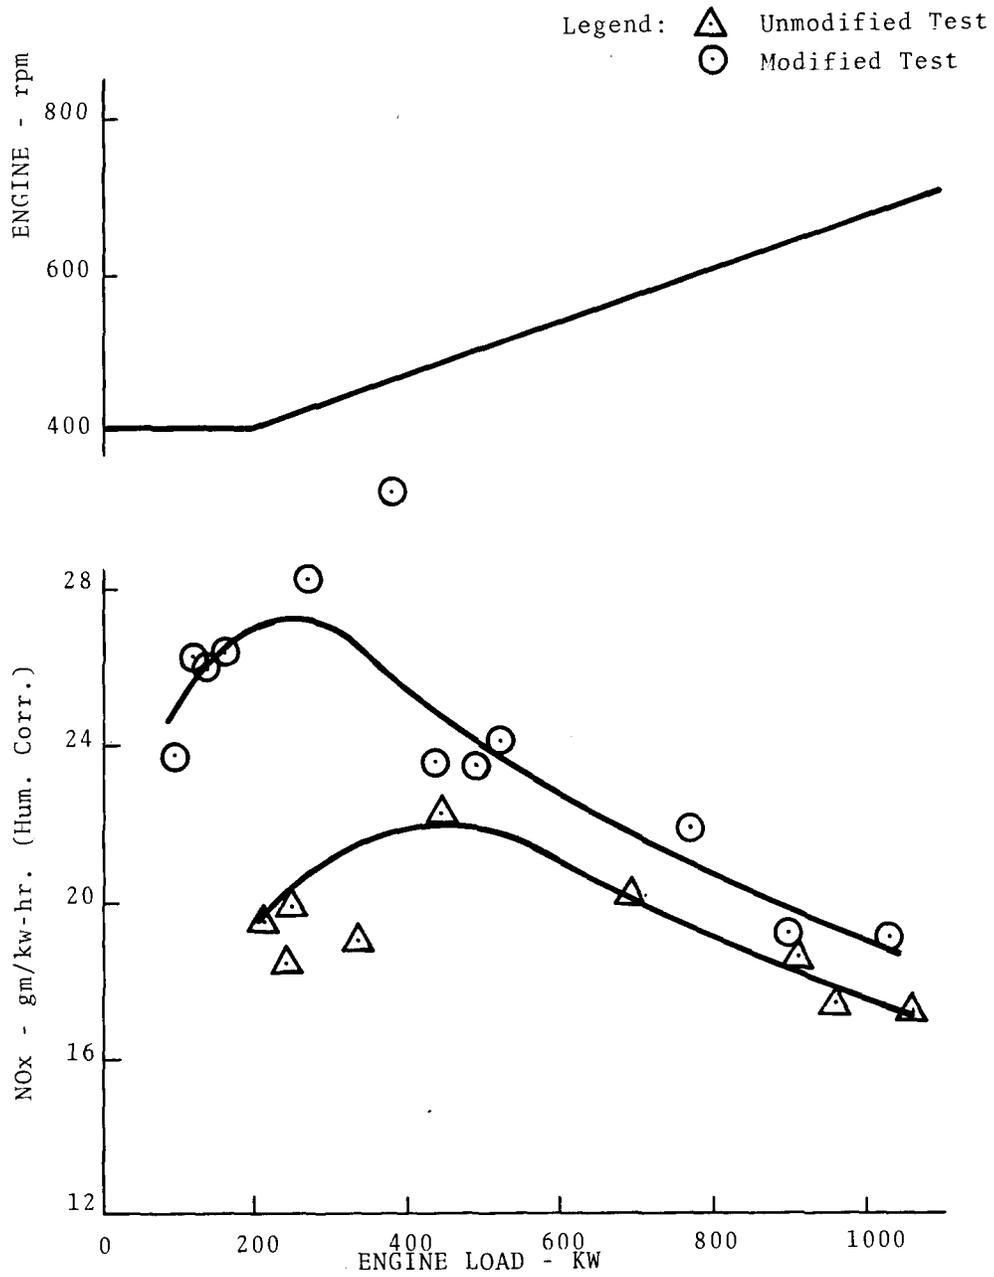
FIGURE 9. DIESEL ENGINE NITROGEN OXIDE EMISSIONS - USCG MACKINAW (WAGB-83)

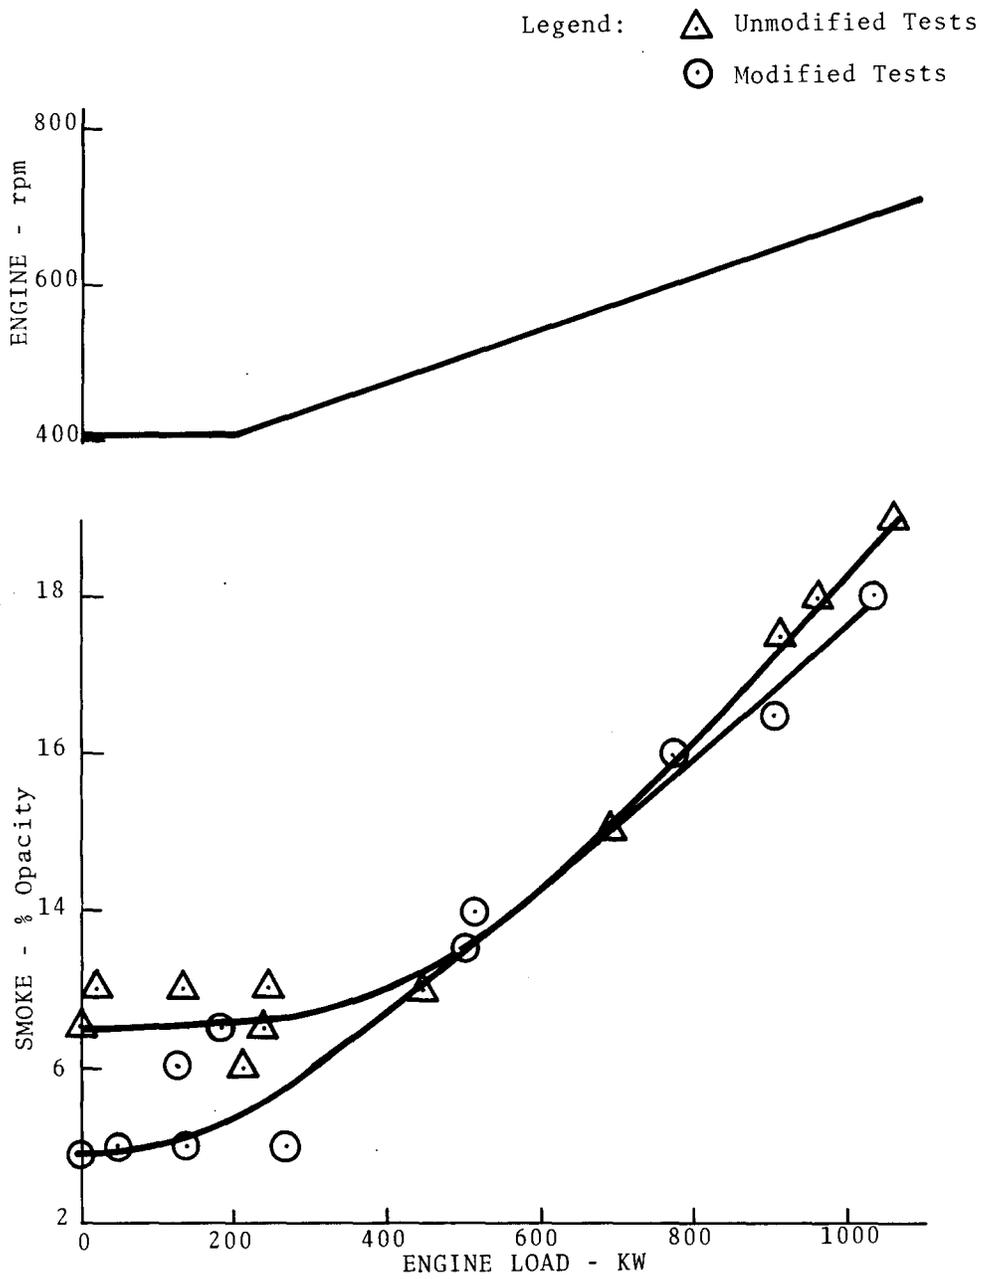
FIGURE 10. DIESEL ENGINE SMOKE EMISSIONS USCG MACKINAW (WAGB-83)

The exhaust smoke measurement during the test are shown in Appendix D. The smoke numbers on the computer printout sheets are % opacity. Figure 10 is a comparative plot of the smoke versus kilowatts recorded by USPHS smoke meter during the four test runs. The in-line meter results were not reliable because of thermal distortions. The idle and light load is about one-half with the modified engine, while no significant difference was noted above 400 kw load. It should be pointed out that under some circumstances the measuring arrangements allowed smoke from other engine stacks to pass through the opacity rings. The stack was 16 inches in diameter while the opacity ring was 30 inches in diameter. Therefore, the smoke reading may be lower than recorded. It is doubtful that the smoke readings will exceed 10% opacity, except following load changes and overloaded conditions. The ideal condition for collecting smoke data would be all engines stopped except the test unit. (However, this ideal condition would not be representative of actual ship operation.) Laboratory tests gave full torque, variable speed smoke readings of less than 7% opacity.

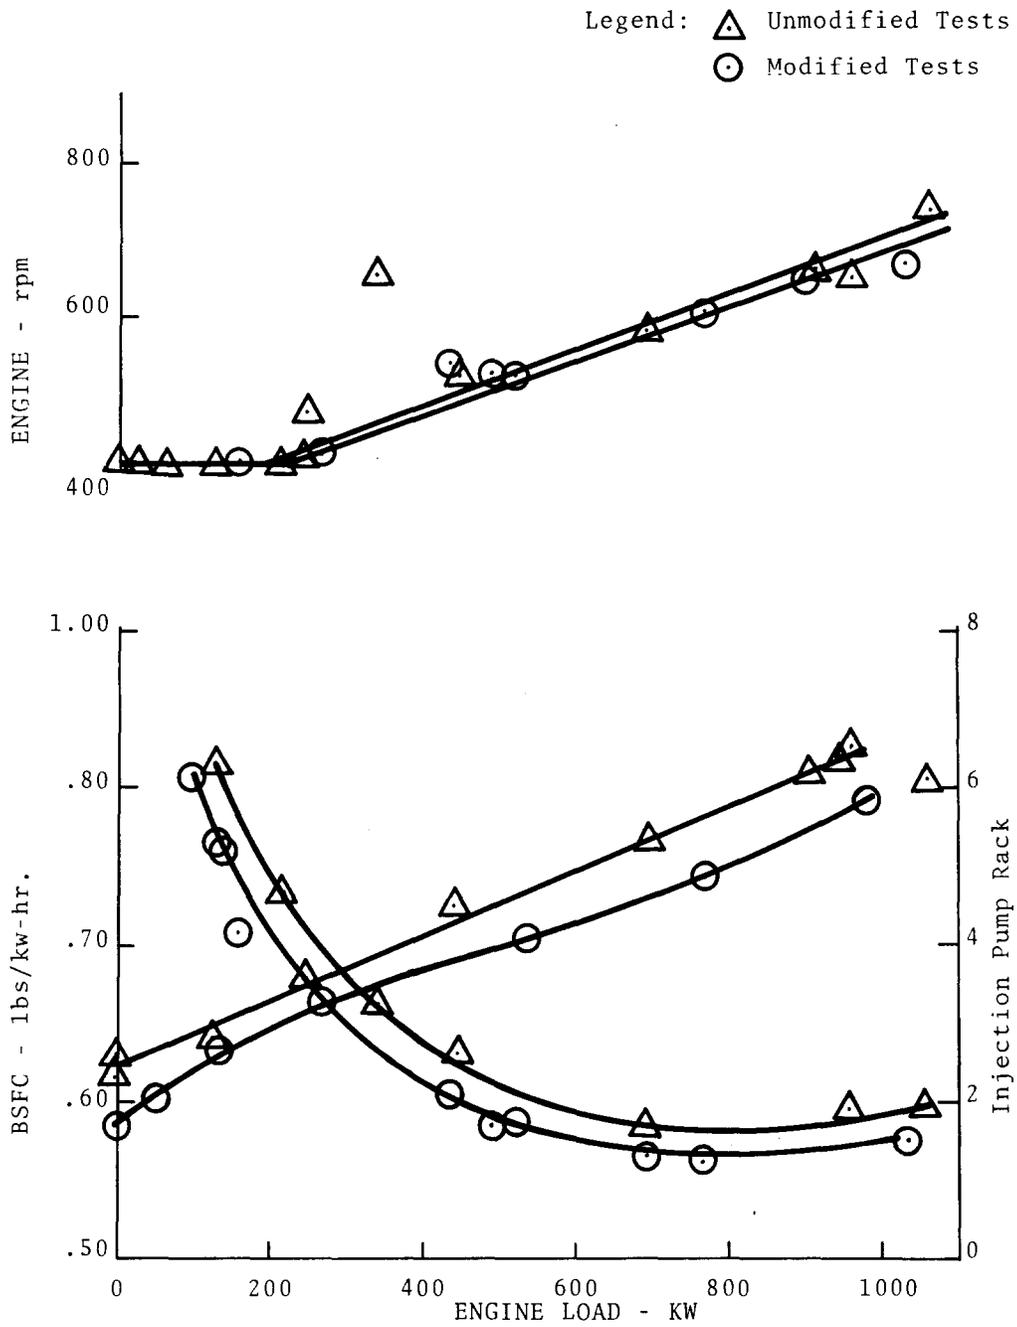
FIGURE 11. DIESEL ENGINE FUEL CONSUMPTION - USCG MACKINAW (WAGB-83)

The test results gave an improvement in fuel consumption of 1 to 3 percent with the modified engine as shown in Figure 11. These results are as expected considering the increase in the NO<sub>x</sub> gaseous emissions. Part of the improvement may be due to the late injection timing of the unmodified engine mentioned previously. The laboratory simulated engine (constant speed, variable load) tests gave fuel consumption improvements of less than 1% when all adjustments and settings were as required.

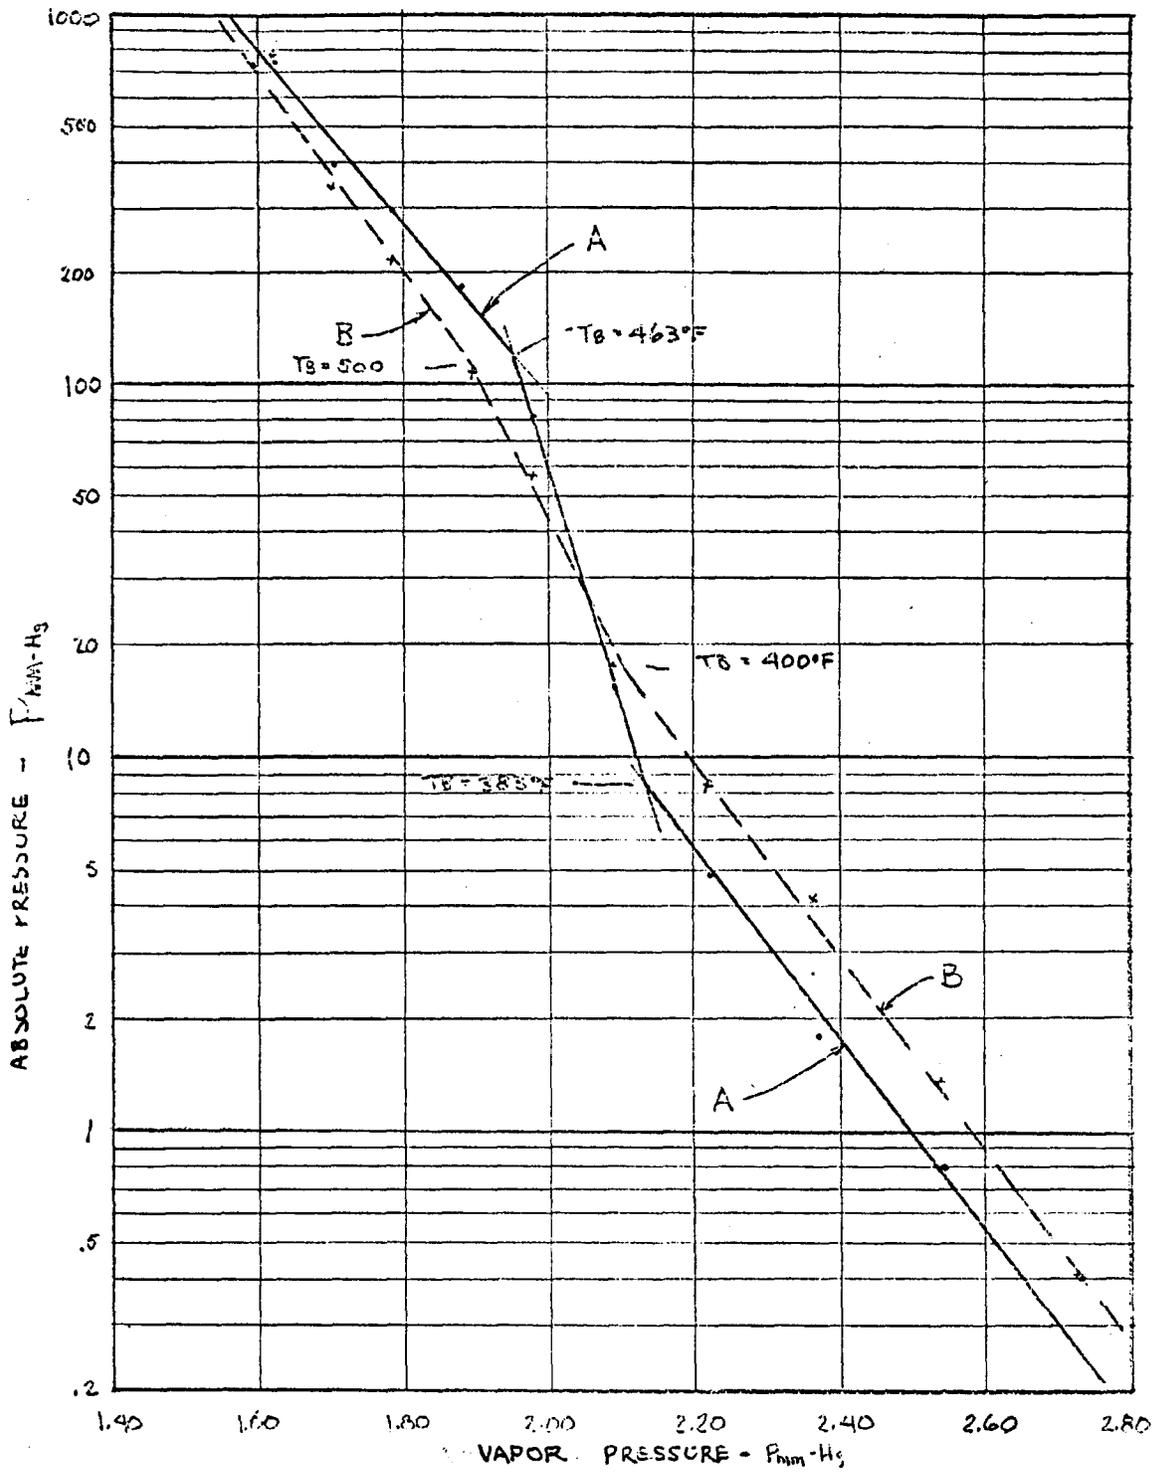
FIGURE 3.

VAPOR PRESSURE CHART  
ISOTENSIC METHOD

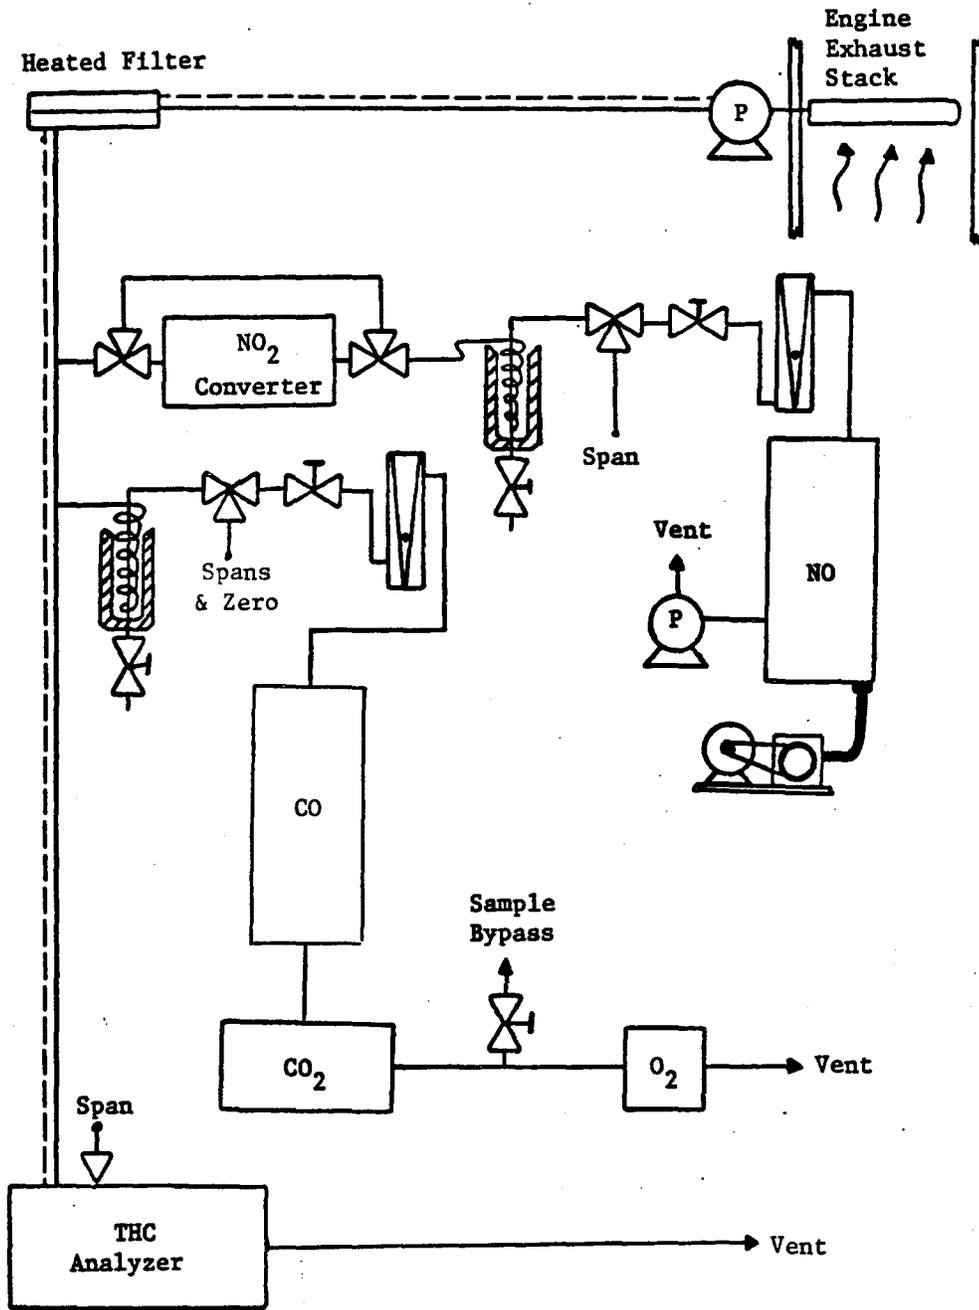
FIGURE B-1 MACKINAW EXHAUST ANALYSIS SYSTEM

The third sample leg contained the oxides of nitrogen analyzer. The hot sample was first passed through the NO<sub>2</sub> converter (when in the NO<sub>x</sub> mode) to convert all the NO<sub>2</sub> to NO. Then the sample was dried using another ice bath-refrigeration coil and transported to the NO analyzer.

Each analyzer was connected to a strip chart recorder in order to provide a permanent record of all the emission data collected.
