UMTA-MA-06-0025-82-2
DOT-TSC-UMTA-82-4

Station Platform-Railcar Threshold Gap Study

Veterans Administration Rehabilitation
Engineering Center (VAREC)
252 7th Avenue
New York NY 10001

March 1982
Final Report

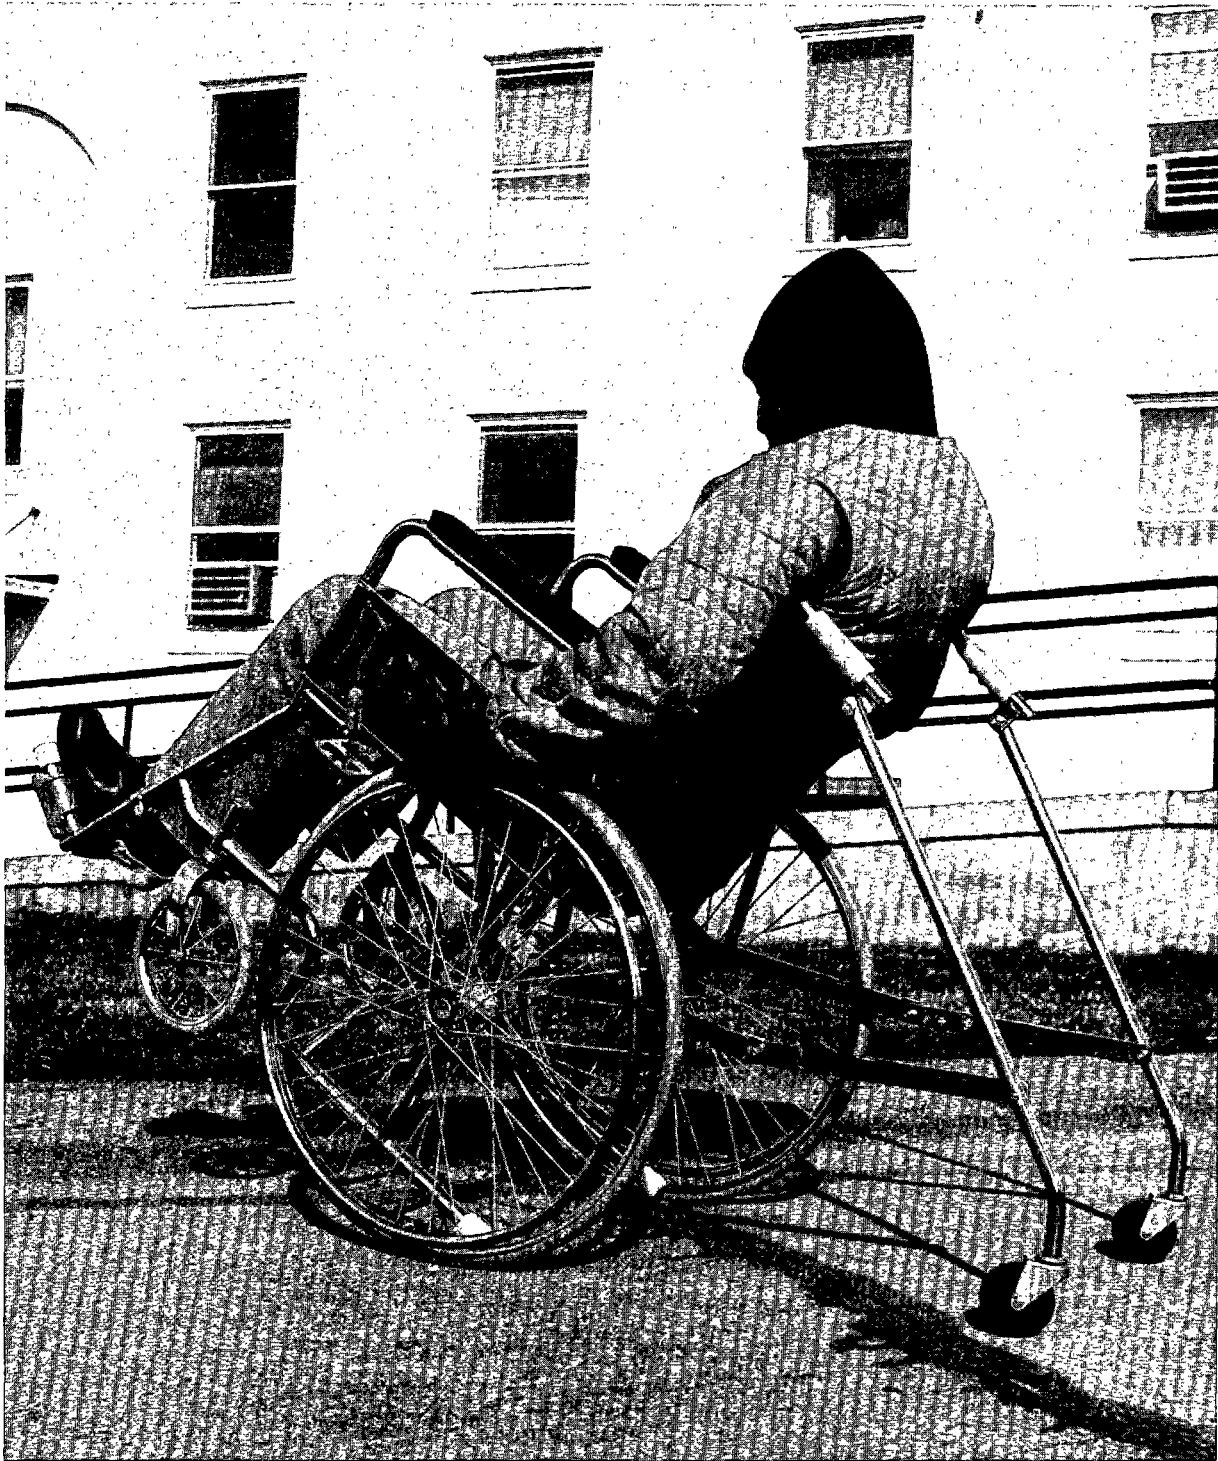
Figure 9 Aztec, dropback dolly, curb-climbing device

FIGURE 9 AZTEC, DROPBACK DOLLY CURB-CLIMBING DEVICE

curb-climbing devices for both manual and powered wheelchairs is shown in Figures 9-14. These devices present the current "state-of-the-art" of curb-climbing devices, some of which might be useful to overcome obstacles found in rapid rail transit.

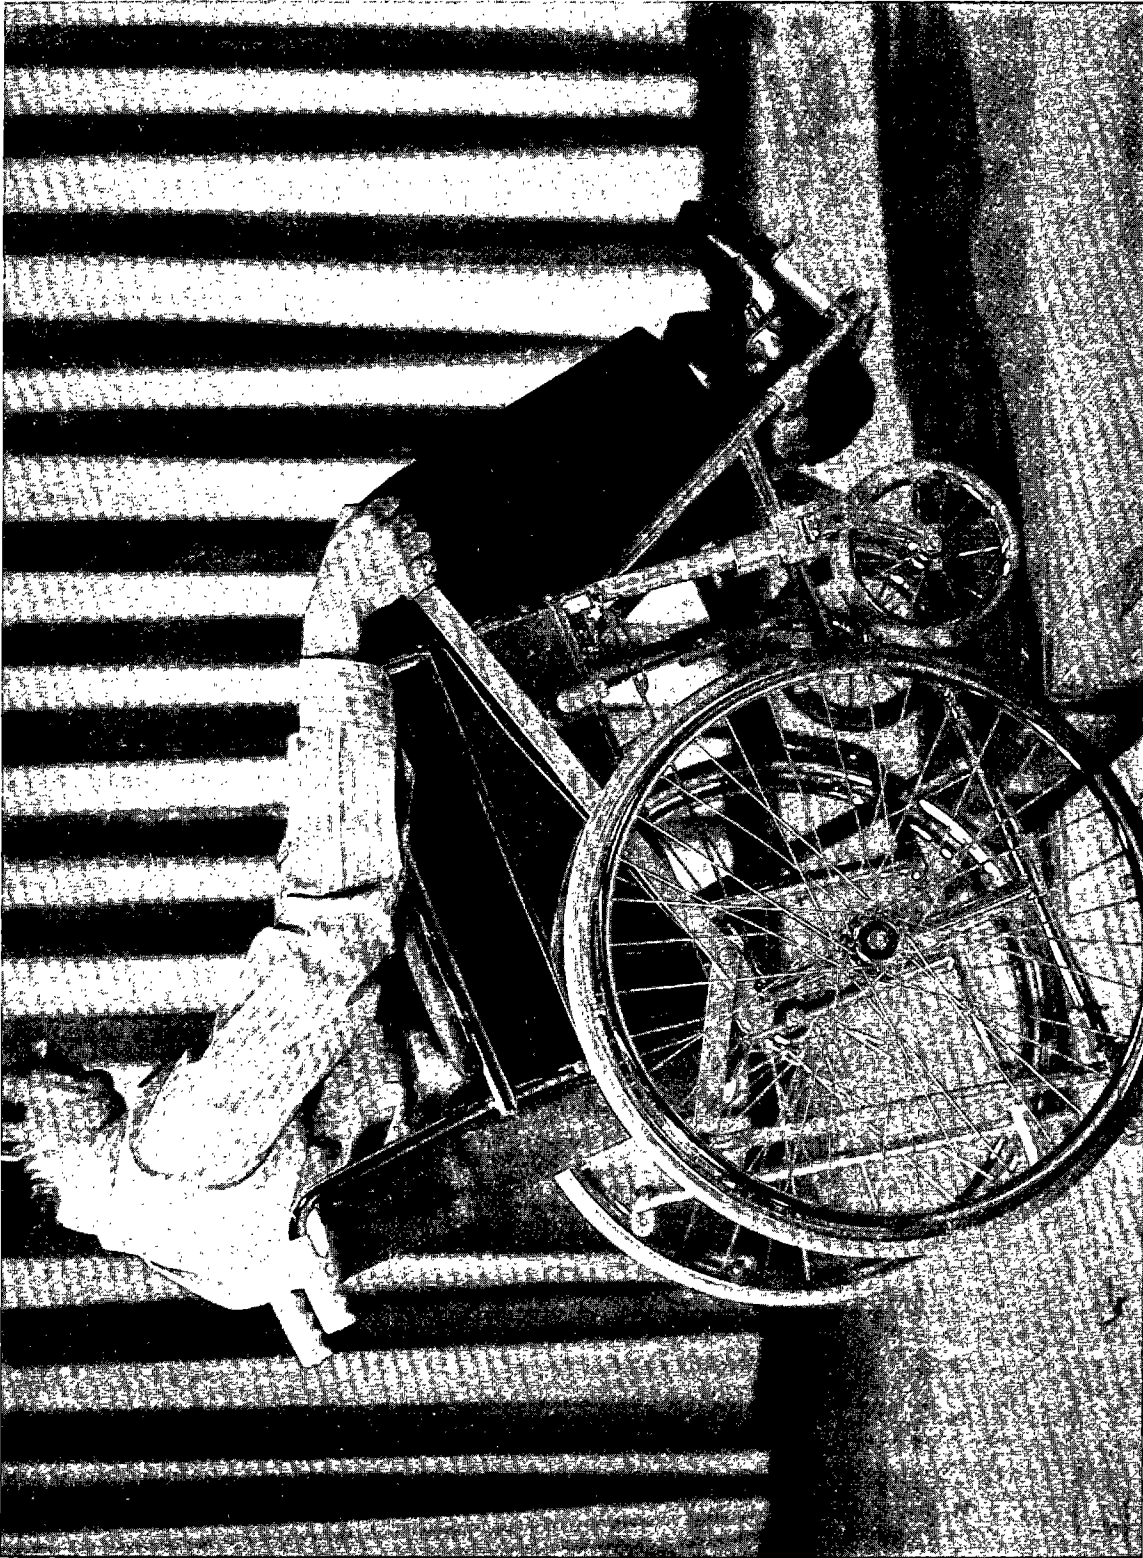
Figure 13 Locke curb-climbing device

FIGURE 13 LOCKE CURB-CLIMBING DEVICE
