## GENERAL VEHICLE TEST INSTRUMENTATION EVALUATION

Prepared by  
Transportation Systems Center

MARCH 1977

FINAL REPORT

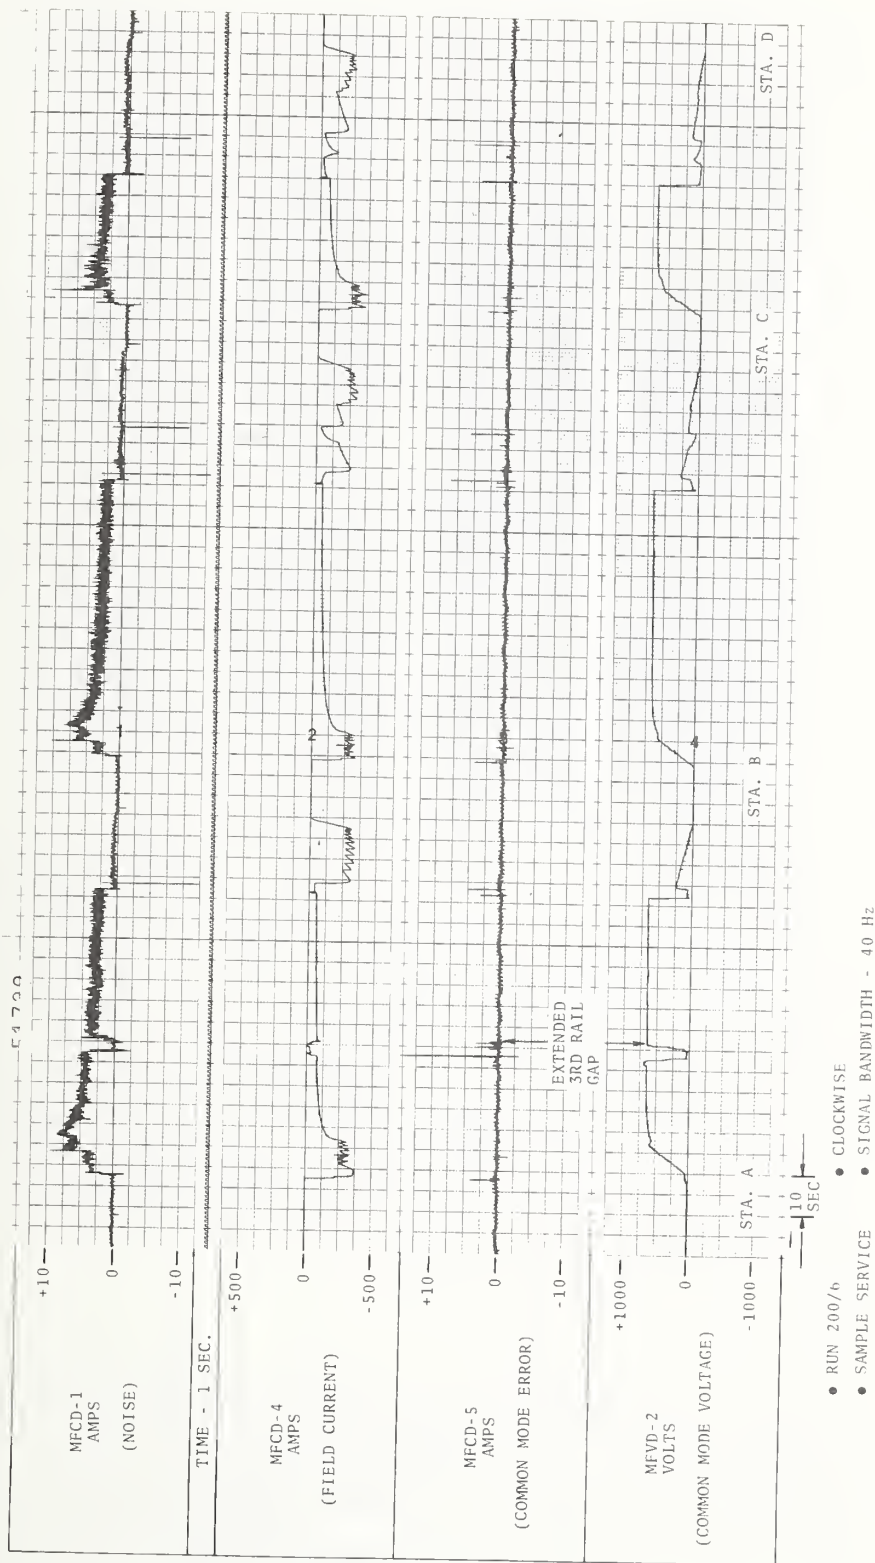
FIGURE 3-1. CURRENT SHUNT AND VOLTAGE NOISE SIGNAL CHART RECORD

Figure 3-1 is a chart record of the beginning of run 200/6, a sample service run to test the current shunt and voltage measurement systems. The field current is shown on channel 2 while noise data is shown on channels 1 and 3. As described in Appendix C, the isolation amplifier input of channel 1 had both leads connected to ground but a malfunction of another unit

did not allow the 20-foot cable to be properly installed for this test. Output signal shifts up to 1.5 percent FS on this zero signal channel are believed to be caused by pickup in the coiled input cable. On future tests, the cable would be properly installed and pickup would be reduced. These output shifts are not evident on the MFCD-5 signal which had both input leads attached to the 600-vdc line. This cable was properly installed.

MFCD-5 had both isolation amplifier leads connected to the same shunt terminal in the field circuit. On the low frequency chart record in Figure 3-1, it is seen that as the field voltage changes, short duration transients were evident on the shunt signal. These transients do not significantly degrade the system performance.

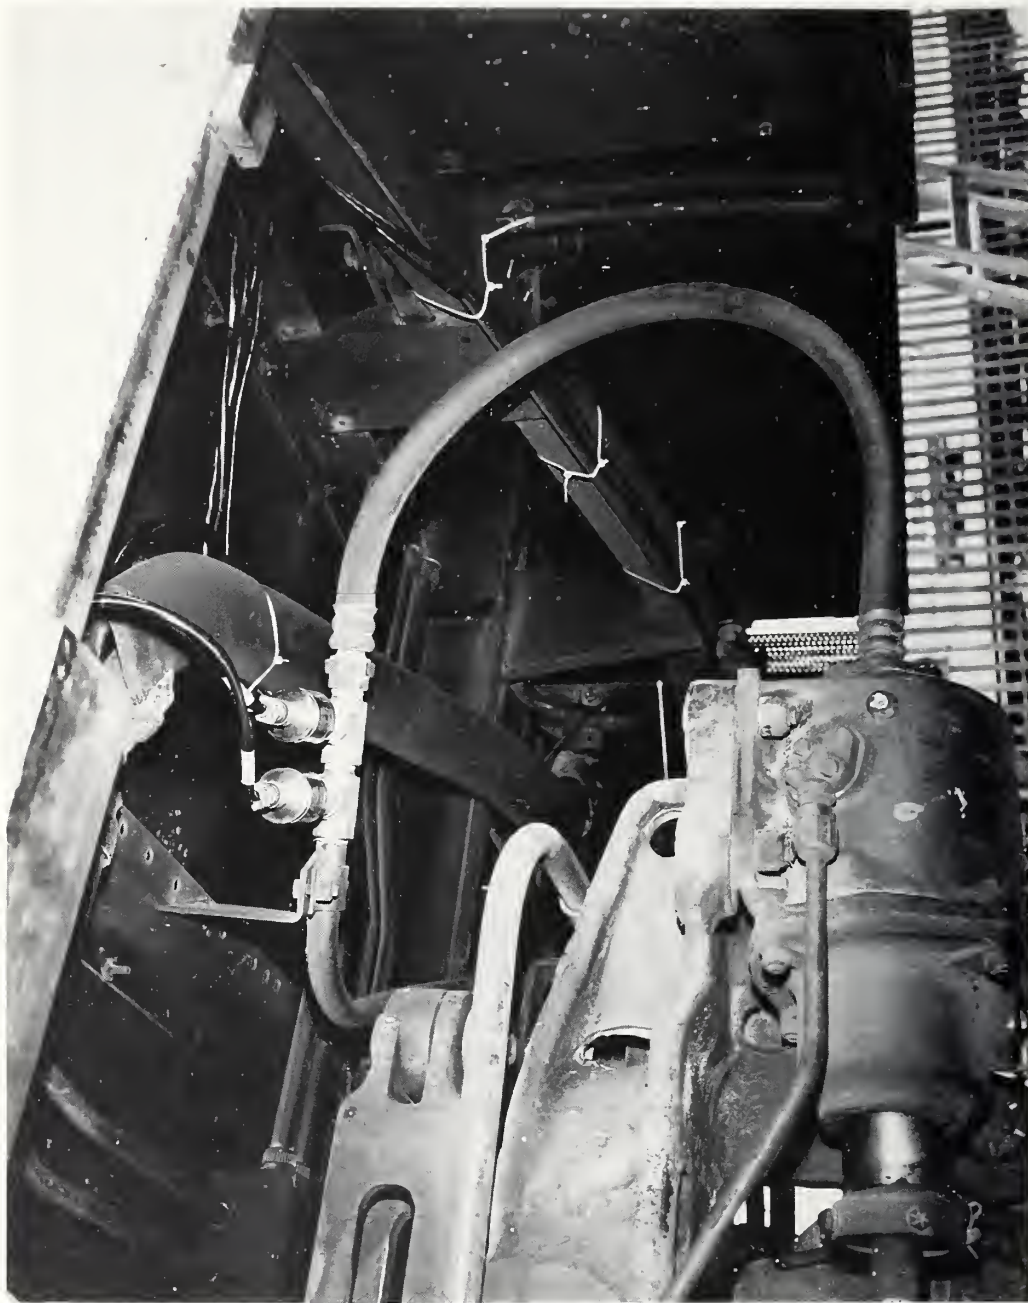
FIGURE D-2. BRAKE PRESSURE SENSOR TEST INSTALLATION, NO. 1 TRUCK

Two pressure sensors were mounted in series with the brake cylinder air on the number one truck. Under ideal conditions, the sensors output signals would be identical. Figure D-2 shows the sensor installation.
