REPORT NO. UMTA-MA-06-0041-80-1

LORAN-C RFI MEASURED
IN LOS ANGELES, CALIFORNIA

OCTOBER 1980
FINAL REPORT

U.S. DEPARTMENT OF TRANSPORTATION
URBAN MASS TRANSPORTATION ADMINISTRATION
Office of Technology Development and Deployment
Office of Bus and Paratransit Technology
Washington DC 20590

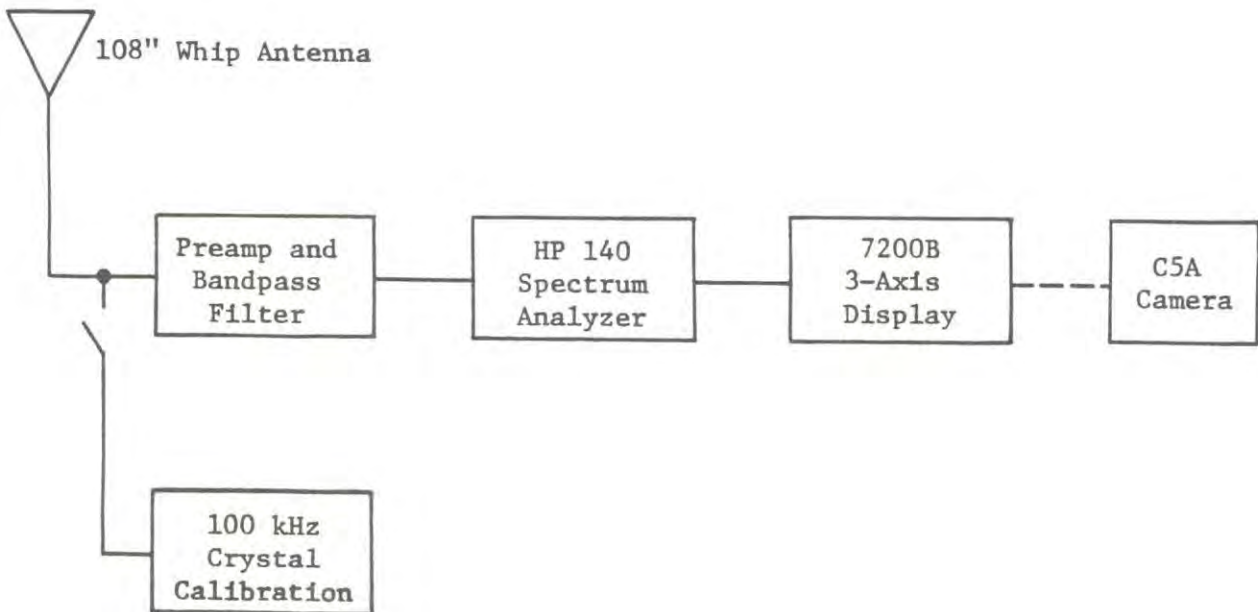
FIGURE 2-1. BLOCK DIAGRAM OF NOISE AND RFI MEASUREMENT SYSTEM

The instrumentation used to acquire data presented in this report is described in Figure 2-1. A standard 108 inch long whip antenna was employed to sense signals and noise. A low noise preamplifier was used to achieve a signal detection capability roughly equivalent to the RF sensitivity of a Loran-C receiver. An RF bandpass filter was employed in the preamplifier to prevent intermodulation product generation in the amplifier and subsequent stages from nearby radio stations and nearby radio broadband noise sources during the Phase I measurements. However, most of the data taken during Phase II were taken without the RF filter. A Hewlett-Packard Series 140 Spectrum Analyzer was employed as a scanning receiver to drive an EMTEL Model 7200B 3-Axis Display. The 3-axis display provided a moving real-time visual representation of signals and noise received by the scanning receiver.

The instrumentation was installed in an Econoline van for mobility and convenience in noise and signal measurements. The van was driven along streets representative of conditions encountered by urban and suburban area vehicles and to some locations previously identified as problem areas for Loran-C reception. Both mobile and fixed location measurements were made as necessary to define a particular noise or signal situation.
