REPORT NO. DOT-TSC-OST-76-5

## SOUND ATTENUATION KIT FOR DIESEL-POWERED BUSES

James C. Berry  
David L. Overgard

Rohr Industries, Inc.  
Chula Vista CA 92012

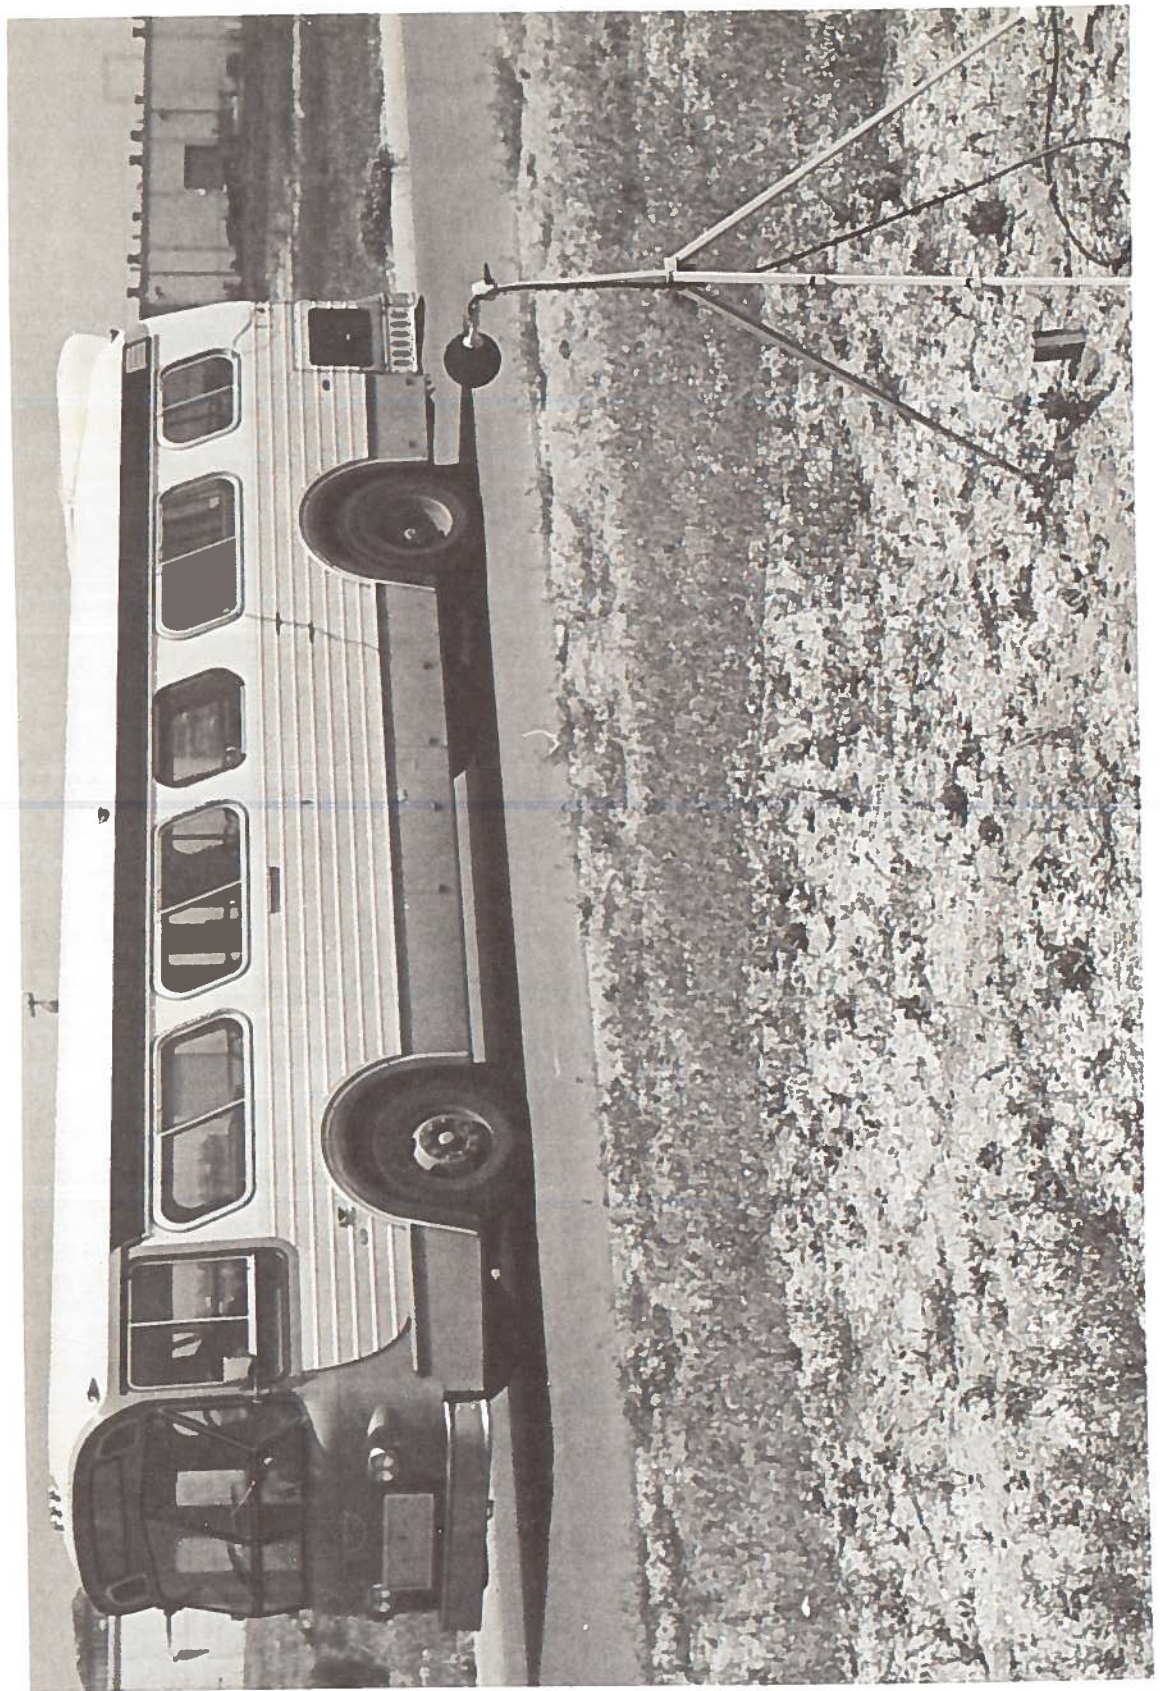
Figure 3.1-1. Acoustic Test Site

The Quay Street test site is ideal for acoustic testing because of the even temperatures and the normally low-speed wind conditions. The road surface is smooth asphalt, 35 feet wide with a 9-inch high concrete curb at the eastern edge. There are no sidewalks and the surrounding ground is flat, hard-packed and with sparse, short vegetation and free of any large reflecting surfaces. The road surface was marked with the microphone point and the end zone boundaries. Two microphone locations were established, one at each side of the road and 50 feet from the centerline of the vehicle path.
