REPORT NO. FRA/ORD-79/55

THE MEASUREMENT OF LOCOMOTIVE NOISE AT EXISTING RAILROAD TEST SITES

P.J. Remington
M.N. AlakeI
J.W. Ernest
N.R. Dixon
BOLT BERANEK AND NEWMAN INC.
50 Moulton Street
Cambridge MA 02138

FINAL REPORT

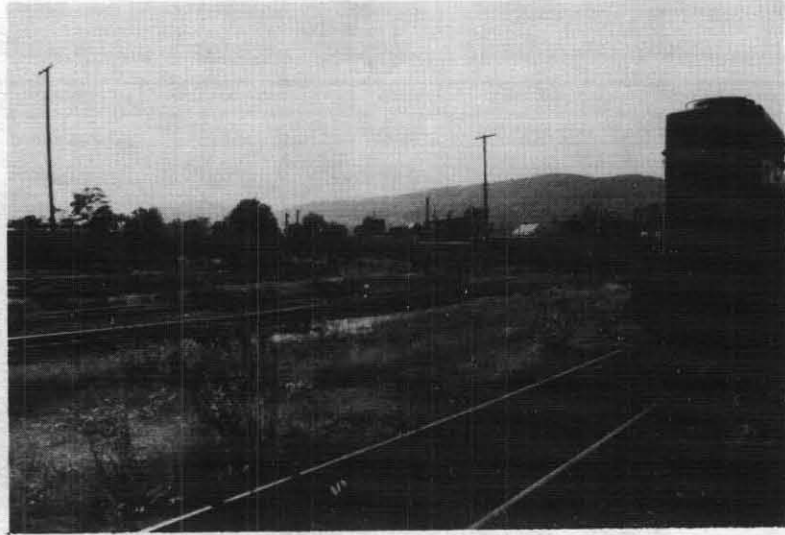
FIG. 5. (Continued)

(c) Looking Southwest, the Test Locomotive is to the Right and the Microphones are to the Left

few piles (approximately 2 ft high) of railroad rails which can be seen in Fig. 5d around the 100 ft microphone. The site conformed easily with the requirements of the EPA standards.

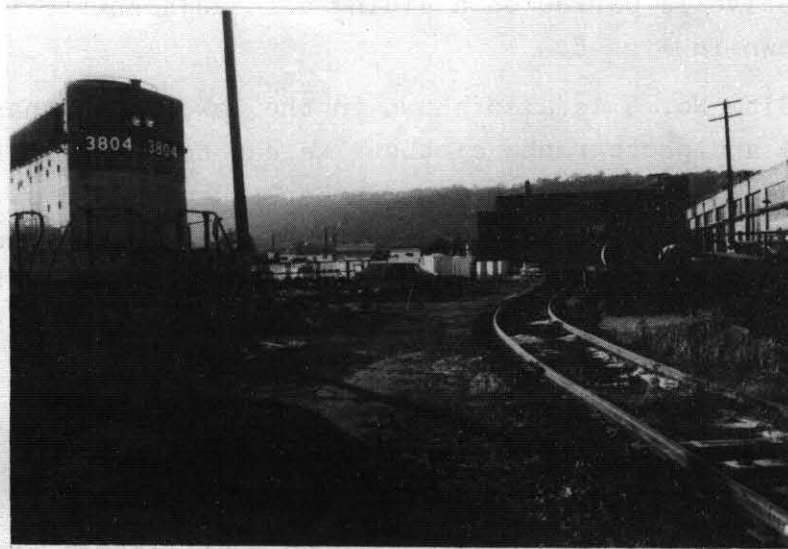
FIG. 6. TEST SITE NO. 3

(b) Looking West, the Test Locomotive is on the Left and the Microphone Array Stretches to the Right

Site No. 3 is shown at the upper left hand corner of Fig. 1. Because of space restriction, the most distant microphone was only 150 ft from the centerline of the locomotive rather than the desired 200 ft. Figure 6 contains a number of photographs of the site. It is clearly a cluttered area. Note especially that the 100-ft microphone is only some 40 ft in front of a freight car used for semi-permanent storage.

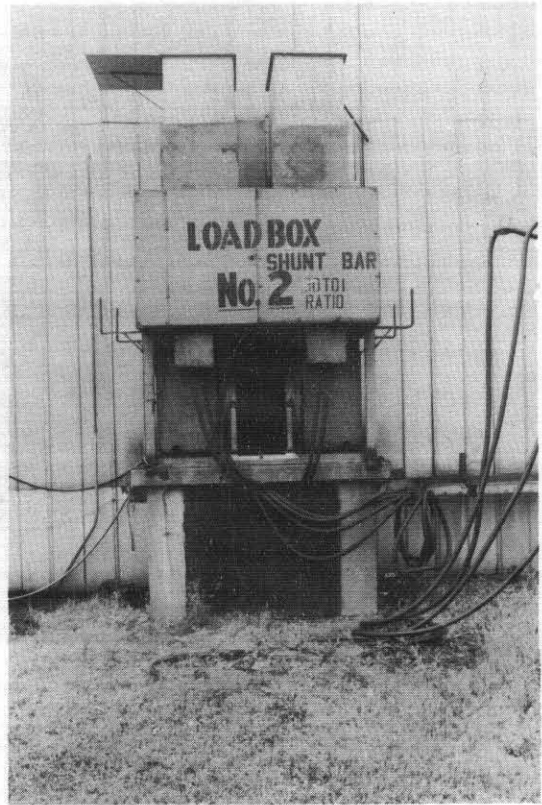
(a) Looking South at the Load Cell

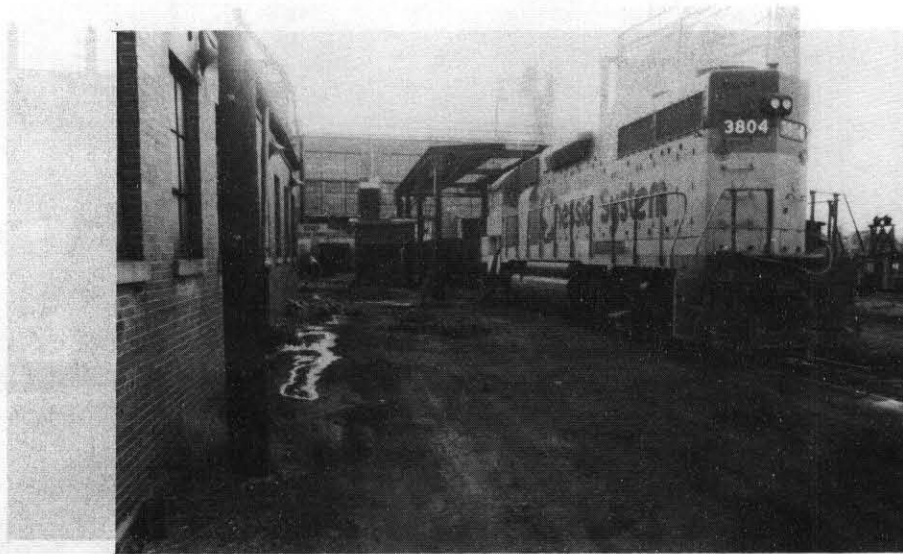
FIG. 13. TEST SITE NO. 7 - HUNTINGTON, WEST VIRGINIA

(b) Looking West, the Load Cell Can Be Seen to the Left and Forward of the Test Locomotive.

Site No. 7 was located at the locomotive repair facility in Huntington, West Virginia. Figure 12 shows a map of the test area, and photographs can be found in Fig. 13. It was not possible to locate a 200 ft microphone at this site because such a microphone would have had to be placed in the mainline right of way. The site is somewhat cluttered, as shown in Fig. 13; but as Fig. 13c and d show, there is a clear line-of-sight to the microphone.

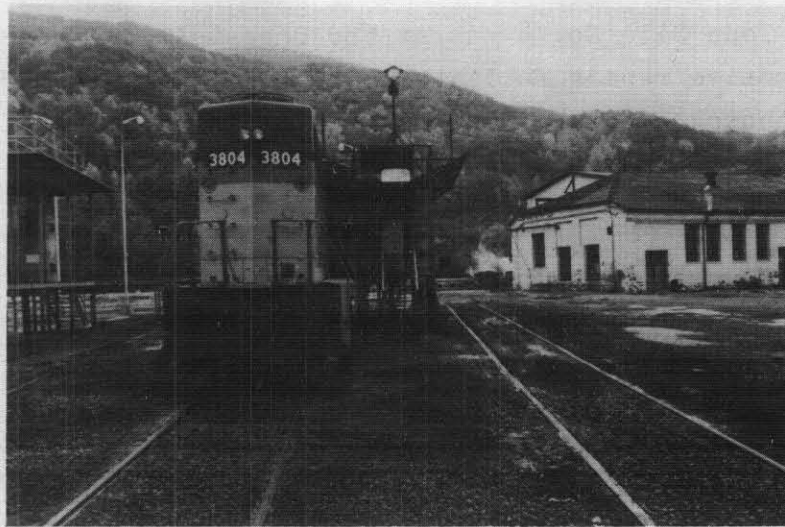
FIG. 15. SITE NO. 8 — CLIFTON FORGE, VIRGINIA

(a) Looking South at the Test Locomotive; the Test Load Cell is on the Right, the Microphones are out of the Picture to the Left; a Second Load Cell *not* used in the Testing Can Be Seen to the Left.

Test Site No. 8 was at the Chessie's Clifton Forge, Virginia locomotive repair facility. Figure 14 shows a map of the area, and photographs are found in Fig. 15. This site is about as close to a conforming site as one will find anywhere in the railroad industry. The only reflecting objects within the area specified in the EPA standards (Fig. 3) are the two load cell structures. The load cell between the test locomotive and the microphones was not used in the tests. Of course, even with the microphone being shielded from the load cell by the locomotive, one would expect some contamination of the locomotive noise by the load cell noise.

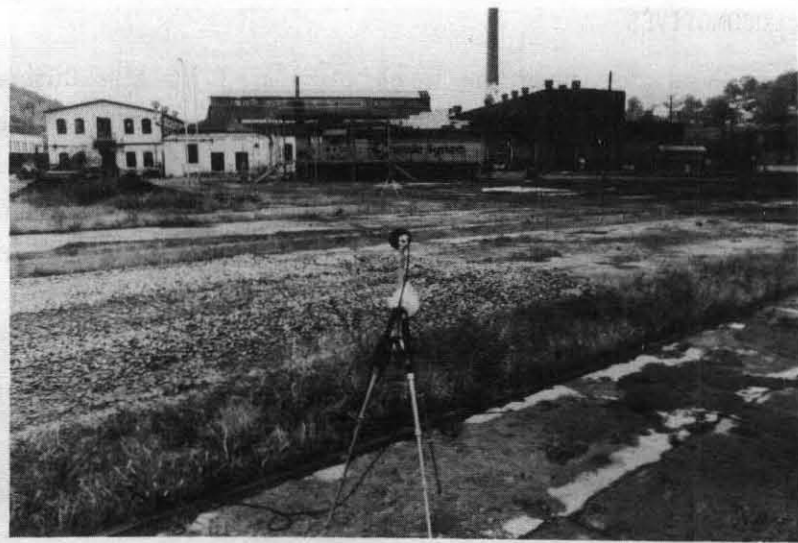
FIG. 15. (Continued)

(d) Looking West at the Test Locomotive from the 100 Ft Microphone

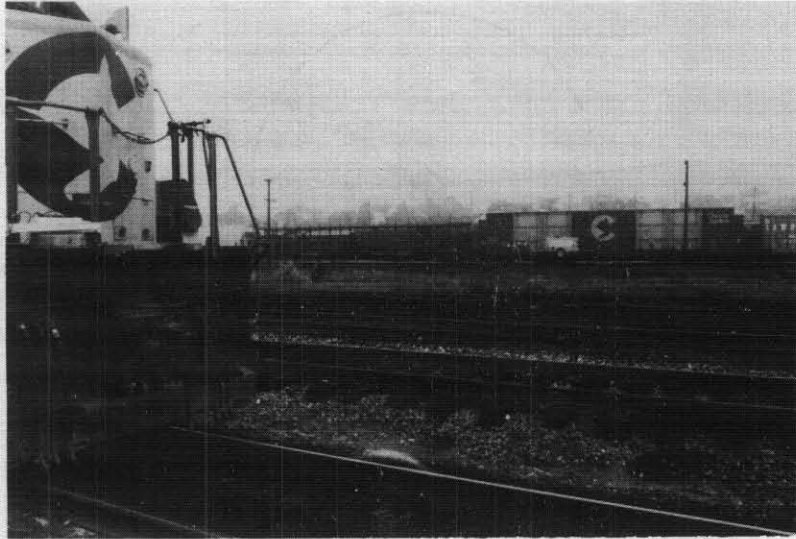
FIG. 17. (Continued)

(b) Looking Northwest at the Microphones

In addition to the stationary load cell test sites, a site for making passby measurements was also selected. The passby site was located at the Cumberland, Maryland locomotive repair facility. A test track of good quality rail used for dynamic load testing of locomotives was selected for the passby tests. A portion of that track is visible in Fig. 1. A map of the site and photographs are found in Figs. 16 and 17, respectively. The site was cleared of freight cars as shown in Fig. 16 so as to conform with the site requirements in the EPA standards. However, a parking lot south of the test track could not be cleared of automobiles and light trucks (see Fig. 17a). These vehicles were sufficiently low compared to the locomotive that their effect on the locomotive noise measured at the microphones located on the other side of the locomotive was negligible.

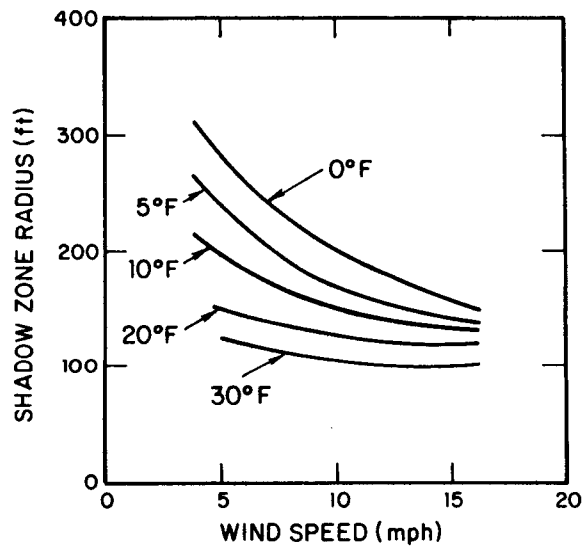
FIG. 30. RADIUS OF THE SHADOW ZONE IN THE UPWIND DIRECTION [7].
 (The Source is Assumed to be 15 Ft High and the Receiver 4 Ft High. The Temperatures Shown are the Decreases in Temperature Going from Ground Level to 6 Ft. The Wind Speed is the Value at 6 Ft and the Calculation Assumes Zero Wind Speed 3 In. Above the Ground.)

a source height of 15 ft (typical locomotive exhaust stack) and a receiver height of 4 ft (typical microphone height), we have calculated the radius of the shadow zone for the receiver upwind from the source. Figure 30 illustrates the results of those calculations assuming that temperature decreases with height above the ground (a typical daytime condition). The wind speeds in the figure are the speeds at 6 ft above the ground* assuming zero wind speed at 3 in. above the ground, and the temperatures in the figure are the decreases in temperature from ground level to 6 ft above the ground. When the receiver is located at distances less than the shadow zone radius from the source, there is nominally no attenuation [4]. Once the microphone is in the shadow zone, the attenuation due to diffraction increases with distance to nominally 20 dB at a source-receiver distance of two shadow zone radii. Thereafter, further increases in the source-receiver separation have little effect on the attenuation due to diffraction.
