REPORT NO. FRA/ORD-79/52

MEASUREMENT AND DIAGNOSIS  
OF THE NOISE FROM A  
GENERAL ELECTRIC C36-7  
DIESEL ELECTRIC LOCOMOTIVE

P. J. Remington  
M. N. Alake1  
N. R. Dixon

DECEMBER 1979  
FINAL REPORT

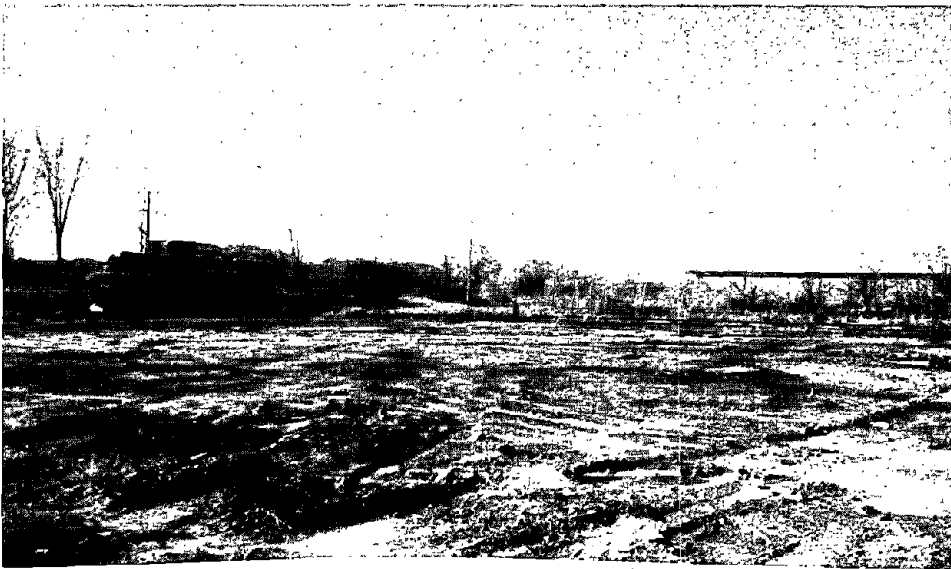
FIG. 3. TEST SITE.

(b) Looking Southwest; the Test Locomotive is on the Left.

The site for both stationary and pass-by tests was one specially prepared by General Electric to conform to the requirements in the EPA Railroad Noise Emission Standard [1]. Figures 3a and 3b show views of the site and Fig. 4 shows a plan with the load cell building and the seven wayside microphone locations on the north side of the track.\*

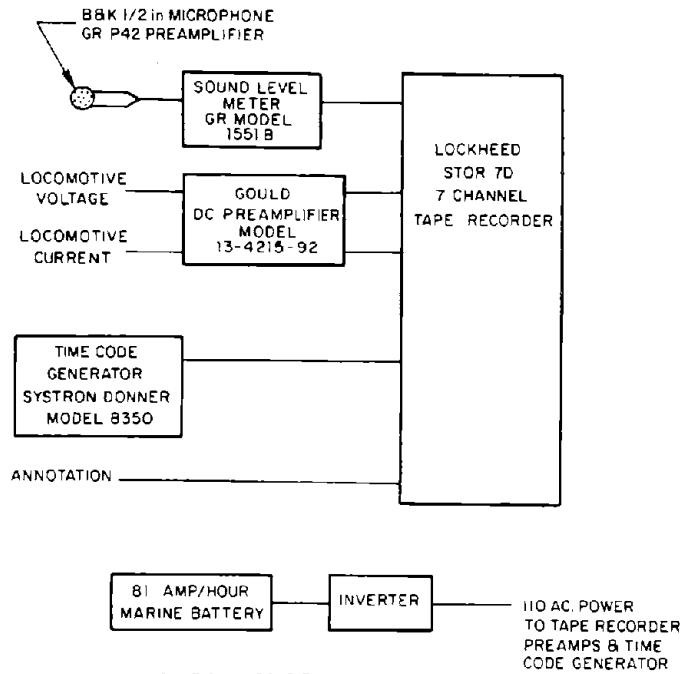
FIG. 5. ON-BOARD INSTRUMENTATION SYSTEM.

unchanged for all except the diagnostic tests where no on-board recordings were made. The system shown for recording locomotive output-current and voltage (power) was eliminated during the course of the testing because of repeated failure of the dc pre-amplifiers. Fortunately, the locomotive had an on-board system that provided a voltage proportional to output power. This was monitored and recorded on a strip-chart recorder. The on-board microphone was located at a position approximately 1 ft to the left of the engineer's left ear. The time-code generator was used so that wayside and on-board tape recorders could be synchronized, if necessary, during data reduction.

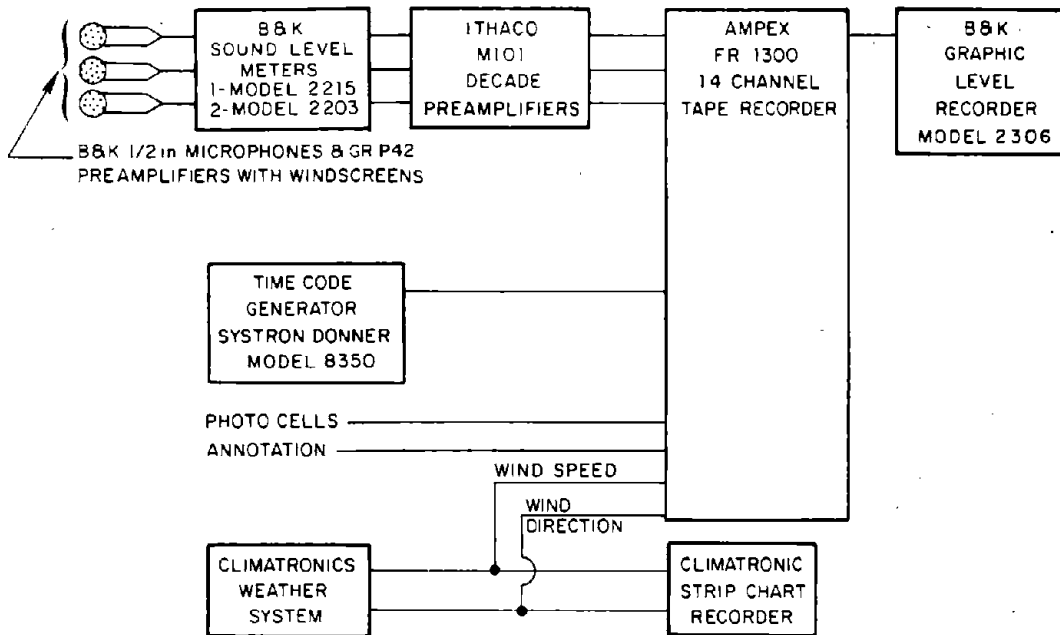
The wayside instrumentation system changed slightly depending on the particular test being performed. Figure 6 shows the recording system for the pass-by tests. The heart of the system

FIG. 6. WAYSIDE INSTRUMENTATION FOR PASS-BY TESTS.

is a 14-channel FM tape recorder operating at 30 ips intermediate band (0-10 KHz frequency response). Three microphones at locations 3, 6, and 7 in Fig. 4 were used at the wayside. To minimize the shielding effects of the locomotive hood, the microphones were placed at gradually increasing heights as they approached the locomotives. Figure 7 shows the configuration of the microphone array. Six photocells were placed at 20 ft intervals at the wayside to obtain locomotive position and speed. An automotive

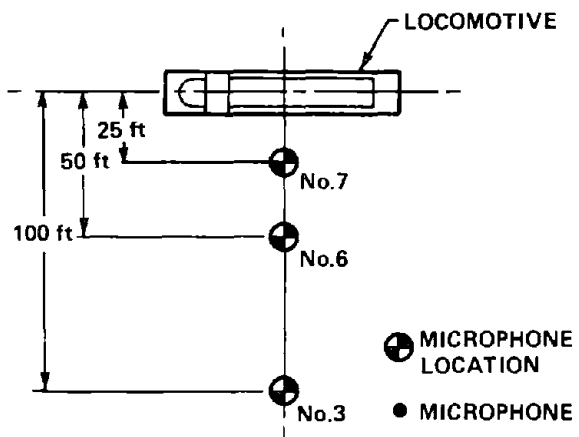
(a) PLAN VIEW

(b) SIDE VIEW

FIG. 10. SHIELDING TEST MICROPHONE LOCATIONS.

in Fig. 10. The locomotive noise was measured with the locomotive in normal operating condition. During the diagnostic tests, additional shielding measurements were carried out with the locomotive placed in a configuration first to enhance exhaust-noise, and then to enhance radiator cooling fan noise. Section 4.2.3 describes the locomotive configuration for these tests.

The overall A-weighted sound levels, measured at each of the 8 microphone positions of Fig. 10 for the locomotive in normal operating condition, are shown in Fig. 17. The positions of the boxes to the right of the locomotive, in the figure, correspond to the microphone positions in Fig. 10. The number in each box is the overall A-weighted sound level measured at the corresponding microphone position. Data are presented for the locomotive at idle, throttle 8, loaded and throttle 8, unloaded. No data from the AAR smoke test procedure throttle-wipes are shown for reasons previously given. Similar data are presented in Figs. 18 and 19 for the locomotive configurations in which radiator cooling fan and exhaust noise are enhanced, respectively.

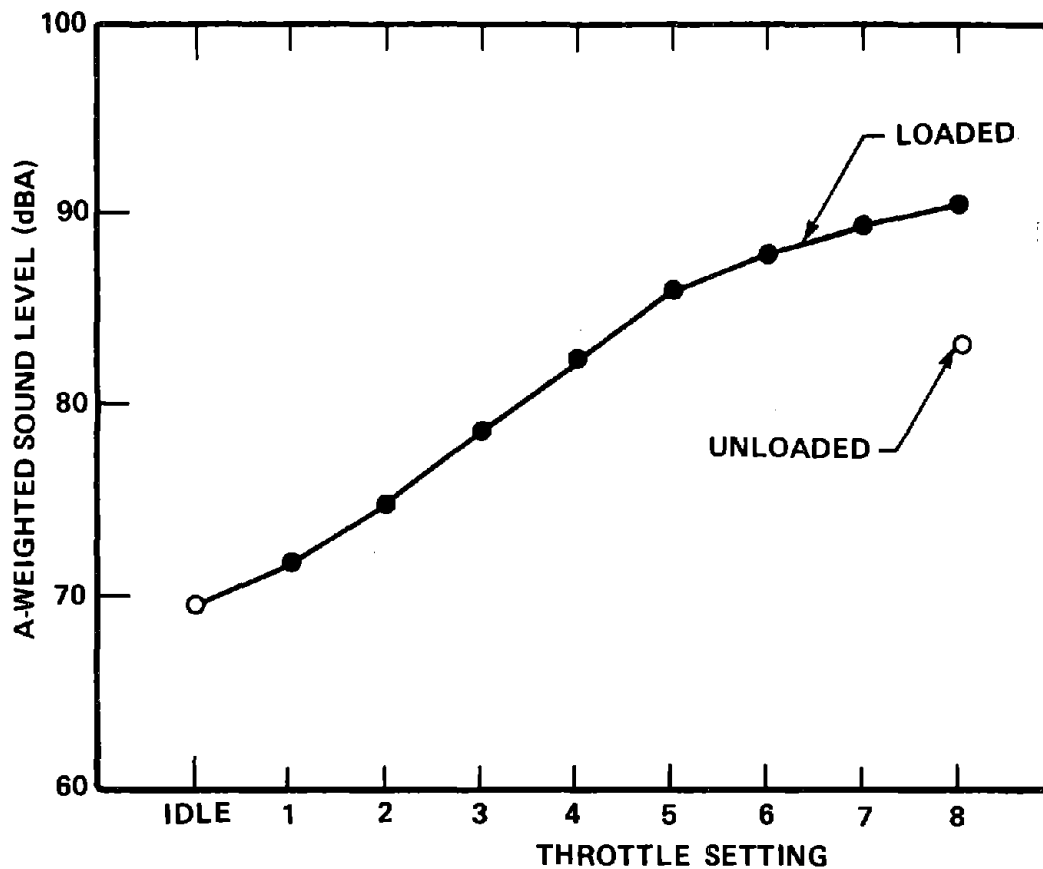
The change in noise level at the 100 ft microphone (location No. 3 in Fig. 9) with throttle settings is shown in Fig. 13 for the locomotive loaded by the load cell. In-cab levels are shown in Fig. 14 for windows open and closed. When the AAR smoke test procedure was run, the noise levels obtained were essentially the same as the steady state levels in Fig. 13 and 14; i.e., during each throttle change the noise changed smoothly without "overshoot" to the steady state level of the final throttle setting as shown in Fig. 15. Consequently, no throttle wipe test results are presented in this report.

FIG. 13. SOUND LEVEL AT 100 FT MICROPHONE (LOCATION NO. 3) VS THROTTLE SETTING WITH LOCOMOTIVE LOADED BY LOAD CELL.

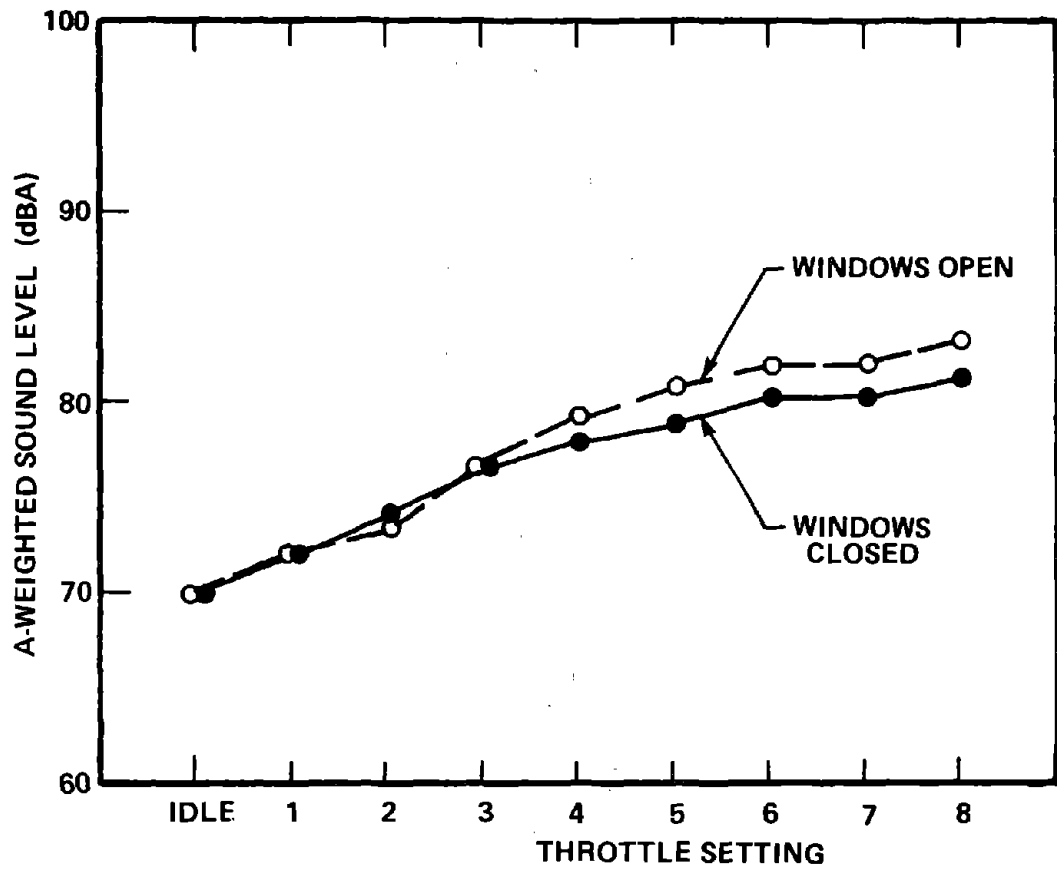
FIG. 14. IN-CAB NOISE LEVELS VS THROTTLE SETTING WITH LOCOMOTIVE LOADED BY LOAD CELL.

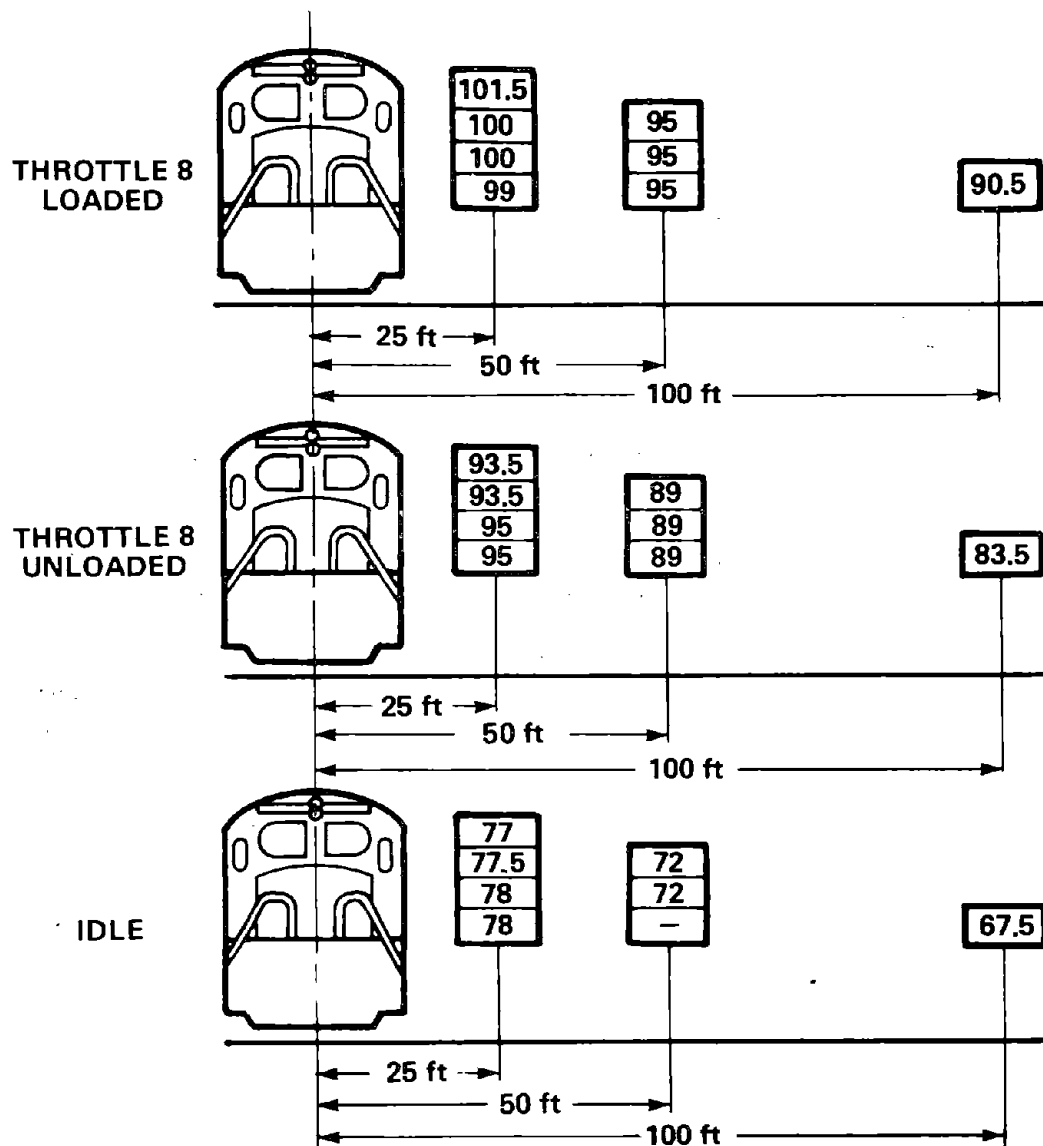
FIG. 17. A-WEIGHTED SOUND LEVELS DURING SHIELDING TESTS WITH LOCOMOTIVE IN NORMAL OPERATING CONDITION.

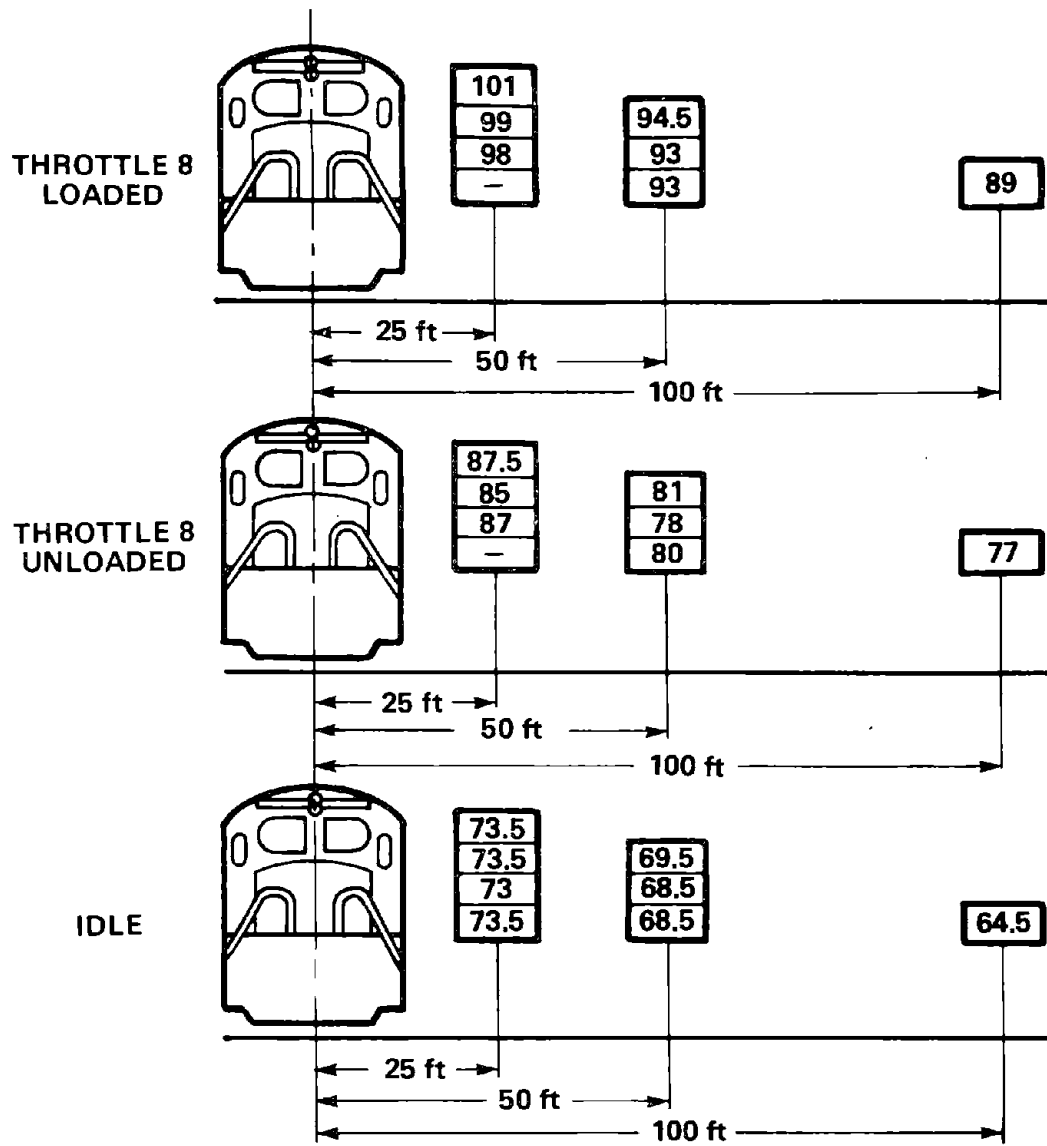
FIG. 19. A-WEIGHTED SOUND LEVELS DURING SHIELDING TESTS WITH LOCOMOTIVE IN CONFIGURATION WITH ALL SOURCES, *EXCEPT EXHAUST FULLY QUIETED*.

At the 25 ft microphone, however, there is a noticeable change in noise level with microphone height for certain locomotive configurations and operating conditions. For the locomotive operating fully loaded in throttle 8 and in normal operating condition (Fig. 17) or configured to enhance exhaust noises (Fig. 19), the noise level increases with height. At idle or throttle 8, unloaded, the effect is absent or at least less prominent. Since in these latter two throttle and load settings exhaust noise is significantly reduced, the 2.5 to 3 dBA increase in noise level with height, when operating fully loaded at throttle 8, appears to be due to a decrease in the shielding of exhaust noise by the locomotive hood at the higher microphones.

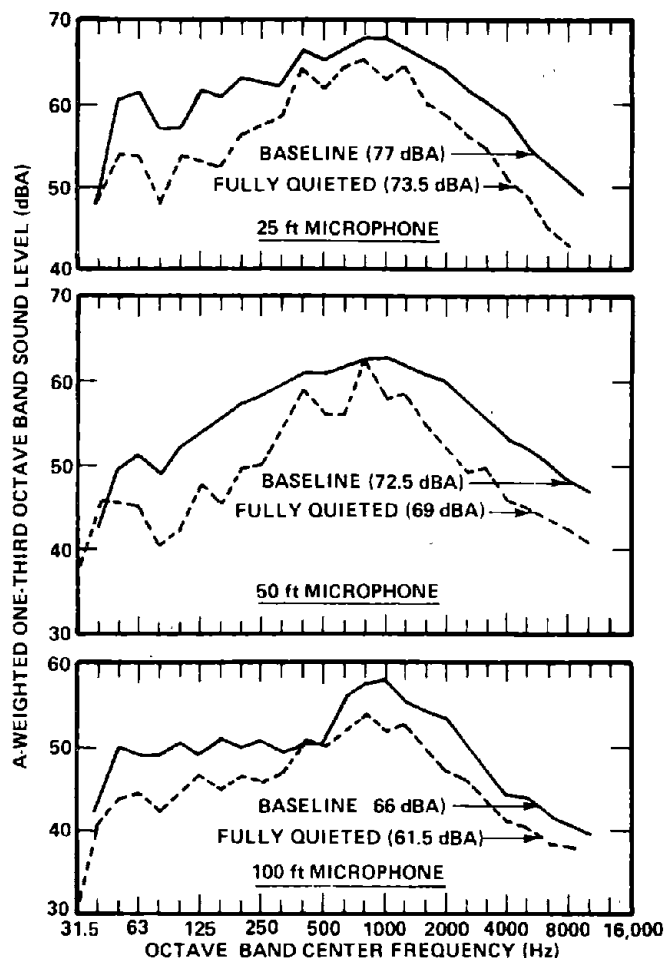
FIG. 33. COMPARISON OF FULLY QUIETED NOISE LEVELS AT IDLE WITH BASELINE NOISE LEVELS.

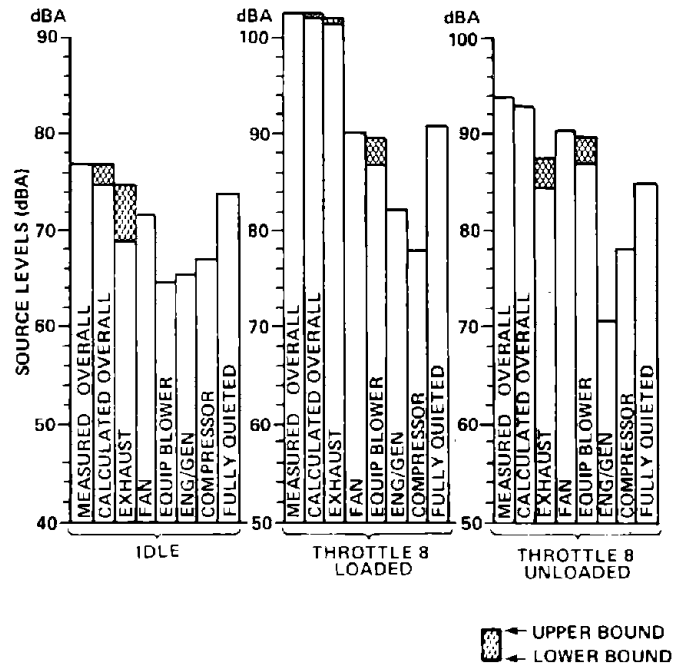
FIG. 34. UPPER AND LOWER BOUND SOURCE LEVELS AT 25 FT.

FIG. 35. UPPER AND LOWER BOUND SOURCE LEVELS AT 50 FT.

FIG. 36. UPPER AND LOWER BOUND SOURCE LEVELS AT 100 FT.

negligible. For illustrative purposes, Fig. 25 shows the structureborne source spectra for throttle 8, loaded. For throttle 8 operation, all but the engine/generator air-compressor source spectra have been obtained from cover and expose measurements by subtracting the fully quieted spectra from the spectra measured with a given treatment removed. As the discussion earlier pointed out, these spectra represent a lower bound on the source strengths. The upper bound has been omitted from these figures so as to avoid further complicating an already involved display. Both upper and lower bounds are given in the bar charts of Figs. 34 through 36.
