REPORT NO. FRA-OR&D-75-57

BRUSH TESTING FOR THE
TLRV POWER COLLECTION SYSTEM

APRIL 1975
INTERIM REPORT

Prepared for
U.S. DEPARTMENT OF TRANSPORTATION
FEDERAL RAILROAD ADMINISTRATION
Office of Research and Development
Washington DC 20590

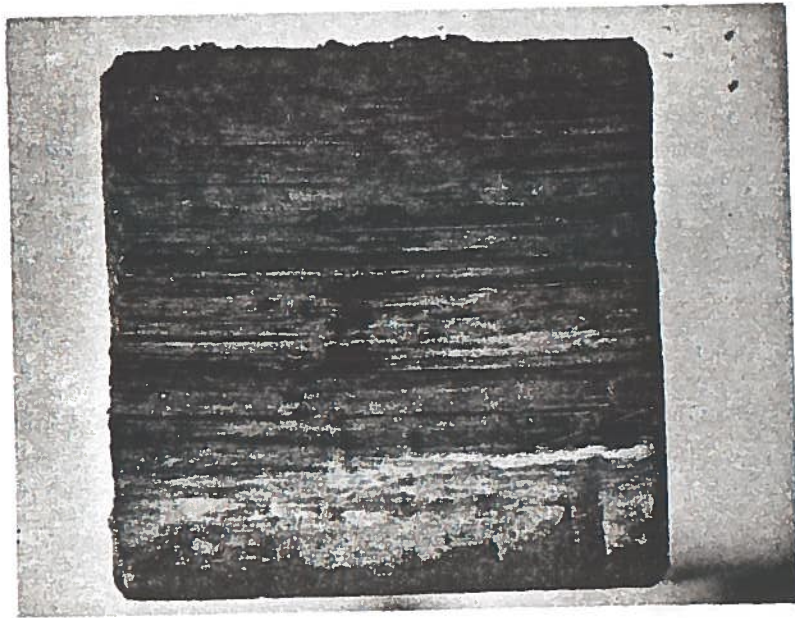
Figure 8. (a) Smearing of Metal on Sliding Surface of Ringsdorf M130
(b) Metal Migration on Side of Brush Material Ringsdorf, M130

1. Ringsdorf M132, a metal/graphite brush, exuded metal (probably Babbit) when the brush became heated. Figure 8 shows the small balls of metal that migrated to a non-sliding surface and the melted metal that smeared on the sliding surface. Buildup within the aluminum brush holders caused the brushes to bind, so that constant brush pressure could not be maintained.
2. Ringsdorf 507, a carbon/graphite brush, caused excessive copper picking of the wheel along with excessive chatter and clinging. Tests were abandoned to prevent damage to the wheel.
3. Carbone 845 chipped during wear-in, as shown in Figure 9. This material was judged too fragile for the application.
