DOT-VNTSC-FAA-04-04

FogEye UV Sensor System Evaluation: Phase II Report

Final Report
December 2003

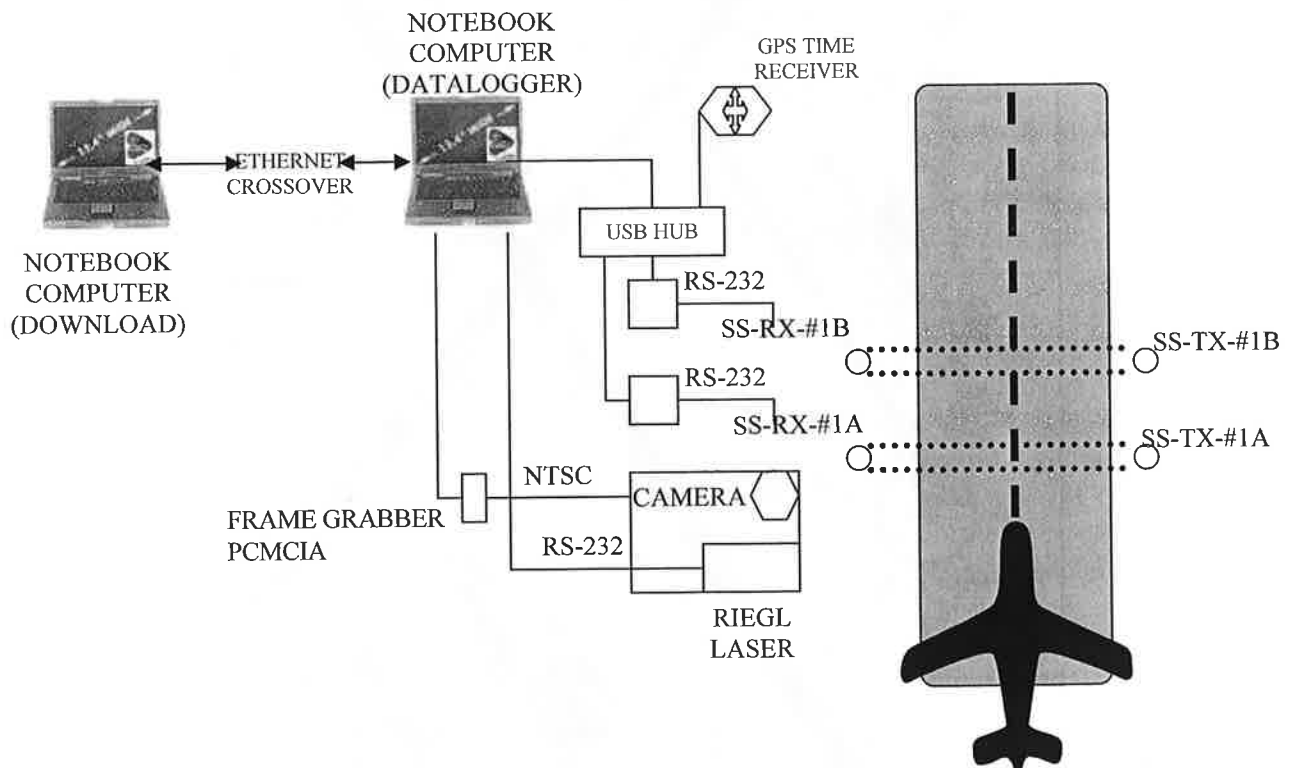
FIGURE 2

There are 2 FogEye pairs, 1 Laser, 1 Video Camera and a Laptop Computer located at each taxiway. The interconnections for the entire system are shown below in Figure 2. A schematic of the taxiway T is depicted in Figure 3.

FOGEYE DATA ACQUISITION SENSOR NETWORK ARCHITECTURE

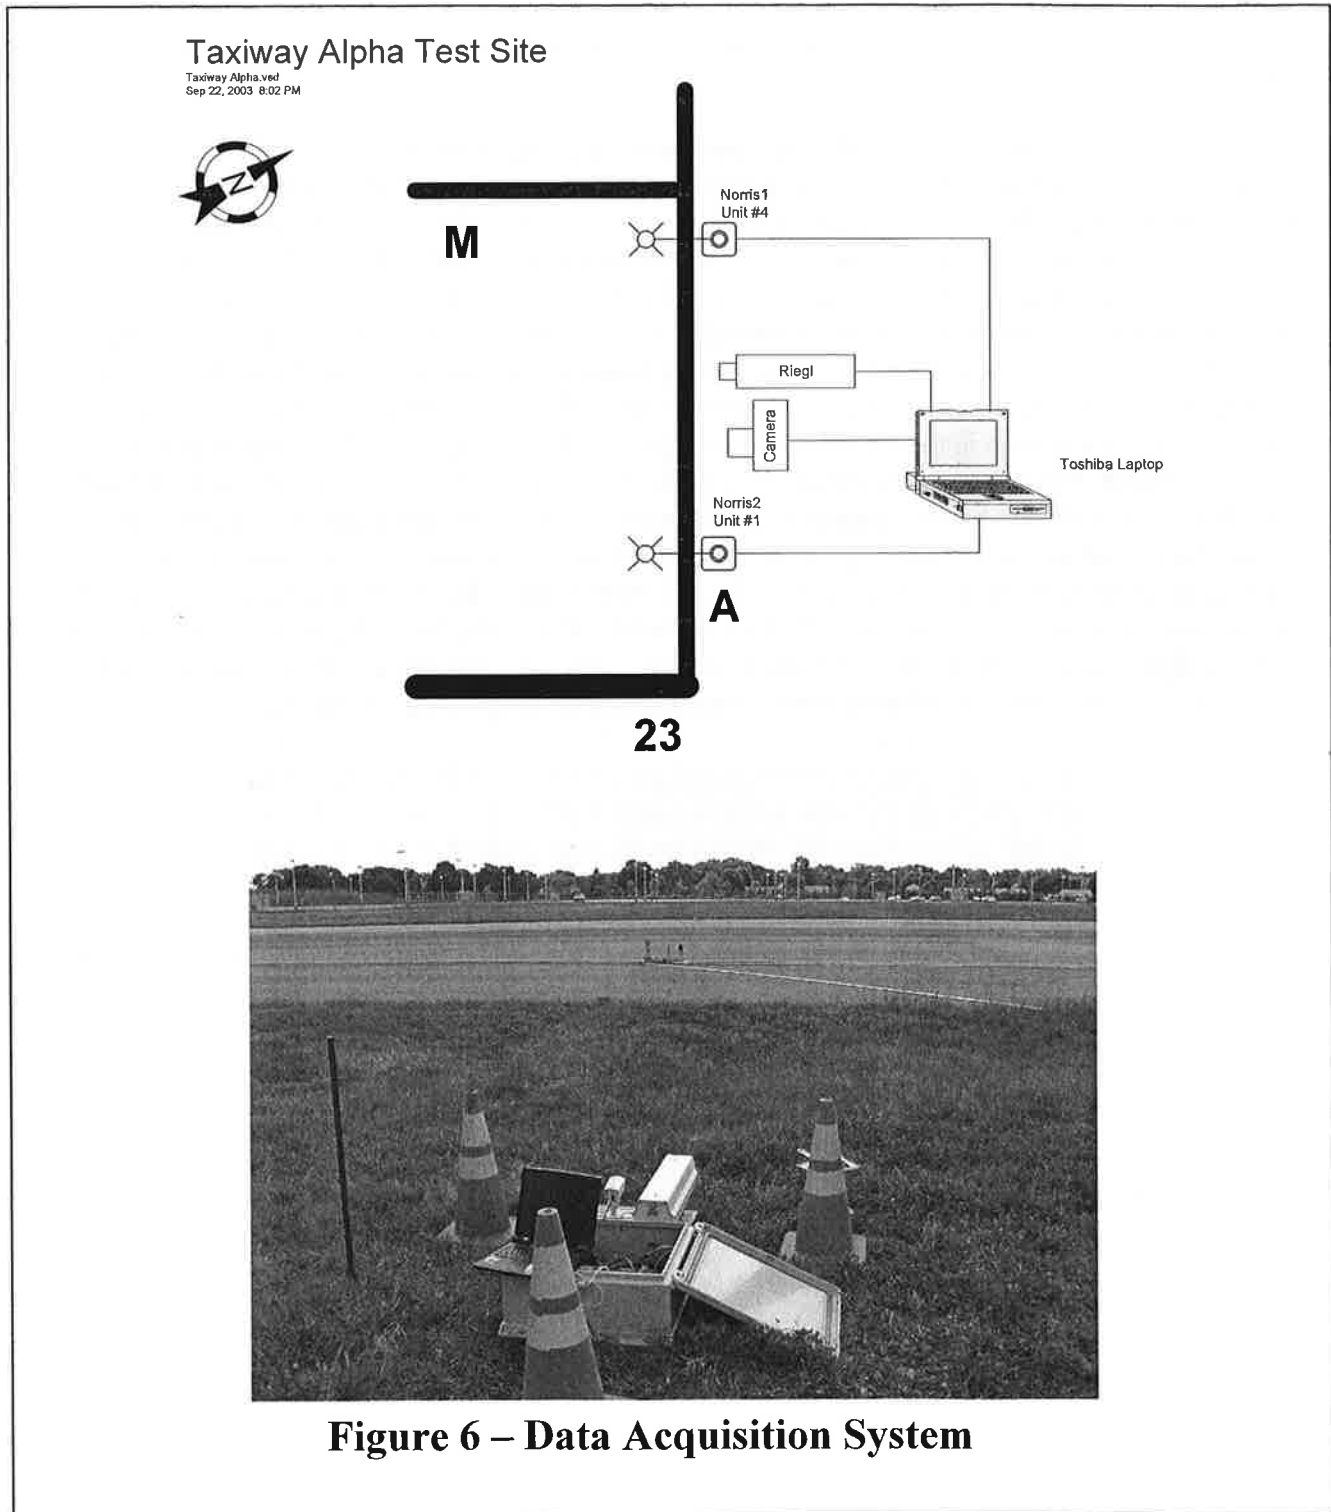
Two Riegl laser range finders were used to independently detect aircraft in the region monitored by the FogEye sensor pairs. A height suitable for both GA and airline aircraft was selected. The Volpe data acquisition system is designed to accept serial messages and apply time tag. The clock synchronization signals are sent out by the Volpe data acquisition system to the FogEye sensors. The DAS is shown below in Figure 6.
