Intermodal Surface Transportation Efficiency Act Section 6015 Study: Assessment of Border Crossings and Transportation Corridors for North American Trade (Northeast)

An Assessment of the Adequacy of U.S-Canadian Infrastructure to Accommodate the Trade through Eastern Border Crossings
Appendix:
Descriptive Profiles of Maine Frontier

An Assessment of the Adequacy of U.S-Canadian Infrastructure to Accommodate the Trade through Eastern Border Crossings

Appendix:
Descriptive Profiles
of Maine Frontier

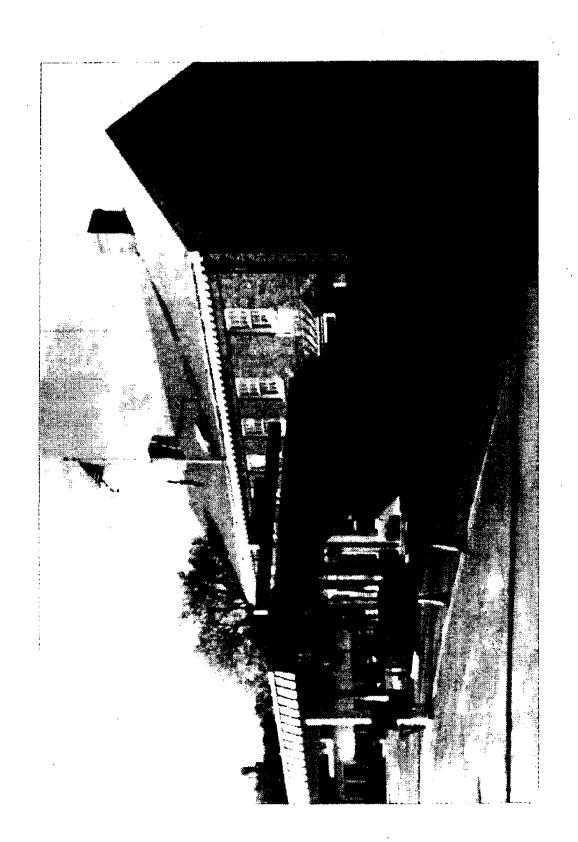
The U.S. Custom facilities at the Ferry Point station have not experienced any significant renovations in recent years. The operation is smaller than its counterpart in Canada. The design of this compound, implemented 60 years ago, is inadequate and thus creates a primary impediment to the flow of traffic. The two truck bays built for secondary inspection in 1936 were not designed for the large commercial vehicles presently entering the compound. Not only is the current warehouse too small for the inspection of most commercial vehicles, those for which an inspection is necessary, must maneuver significantly to back into docks. Between the need for commercial traffic to take a 90 degree turn into a very limited space, and the difficult maneuvering required for inspections, it is not unusual for traffic to come to a standstill when a few commercial vehicles enter at the same time. A backup of 4 to 5 automobiles will impede the flow of commercial vehicles into the compound.

Calais, Ferry Point: Administration building and approach to primary inspection lanes

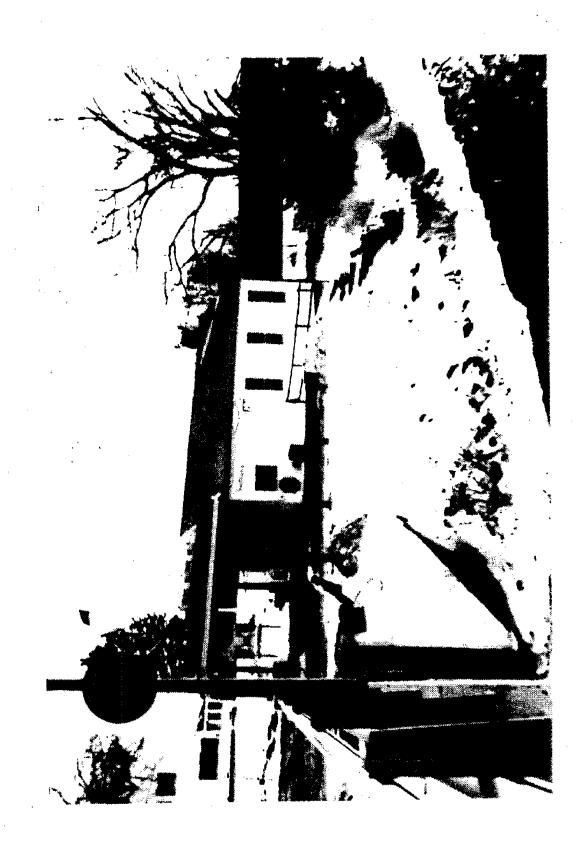
Calais, Milltown: U.S. Customs administration building and primary inspection

Calais, Milltown: Rear view of U.S. Customs building, primary inspection, and bridge to Canada

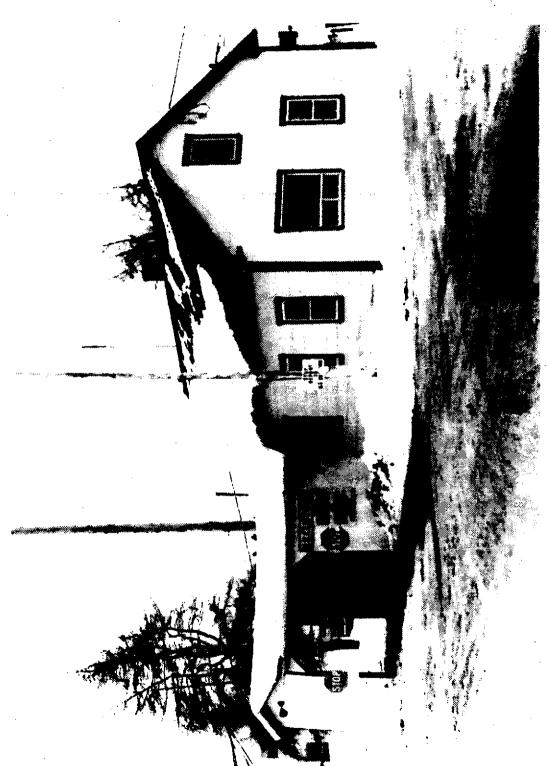
St. Pamphile: Administration building
