Safety of High Speed Magnetic Levitation Transportation Systems

MAGNETIC FIELD TESTING OF THE TR07 MAGLEV VEHICLE AND SYSTEM VOLUME II - APPENDICES

Final Report
April 1992

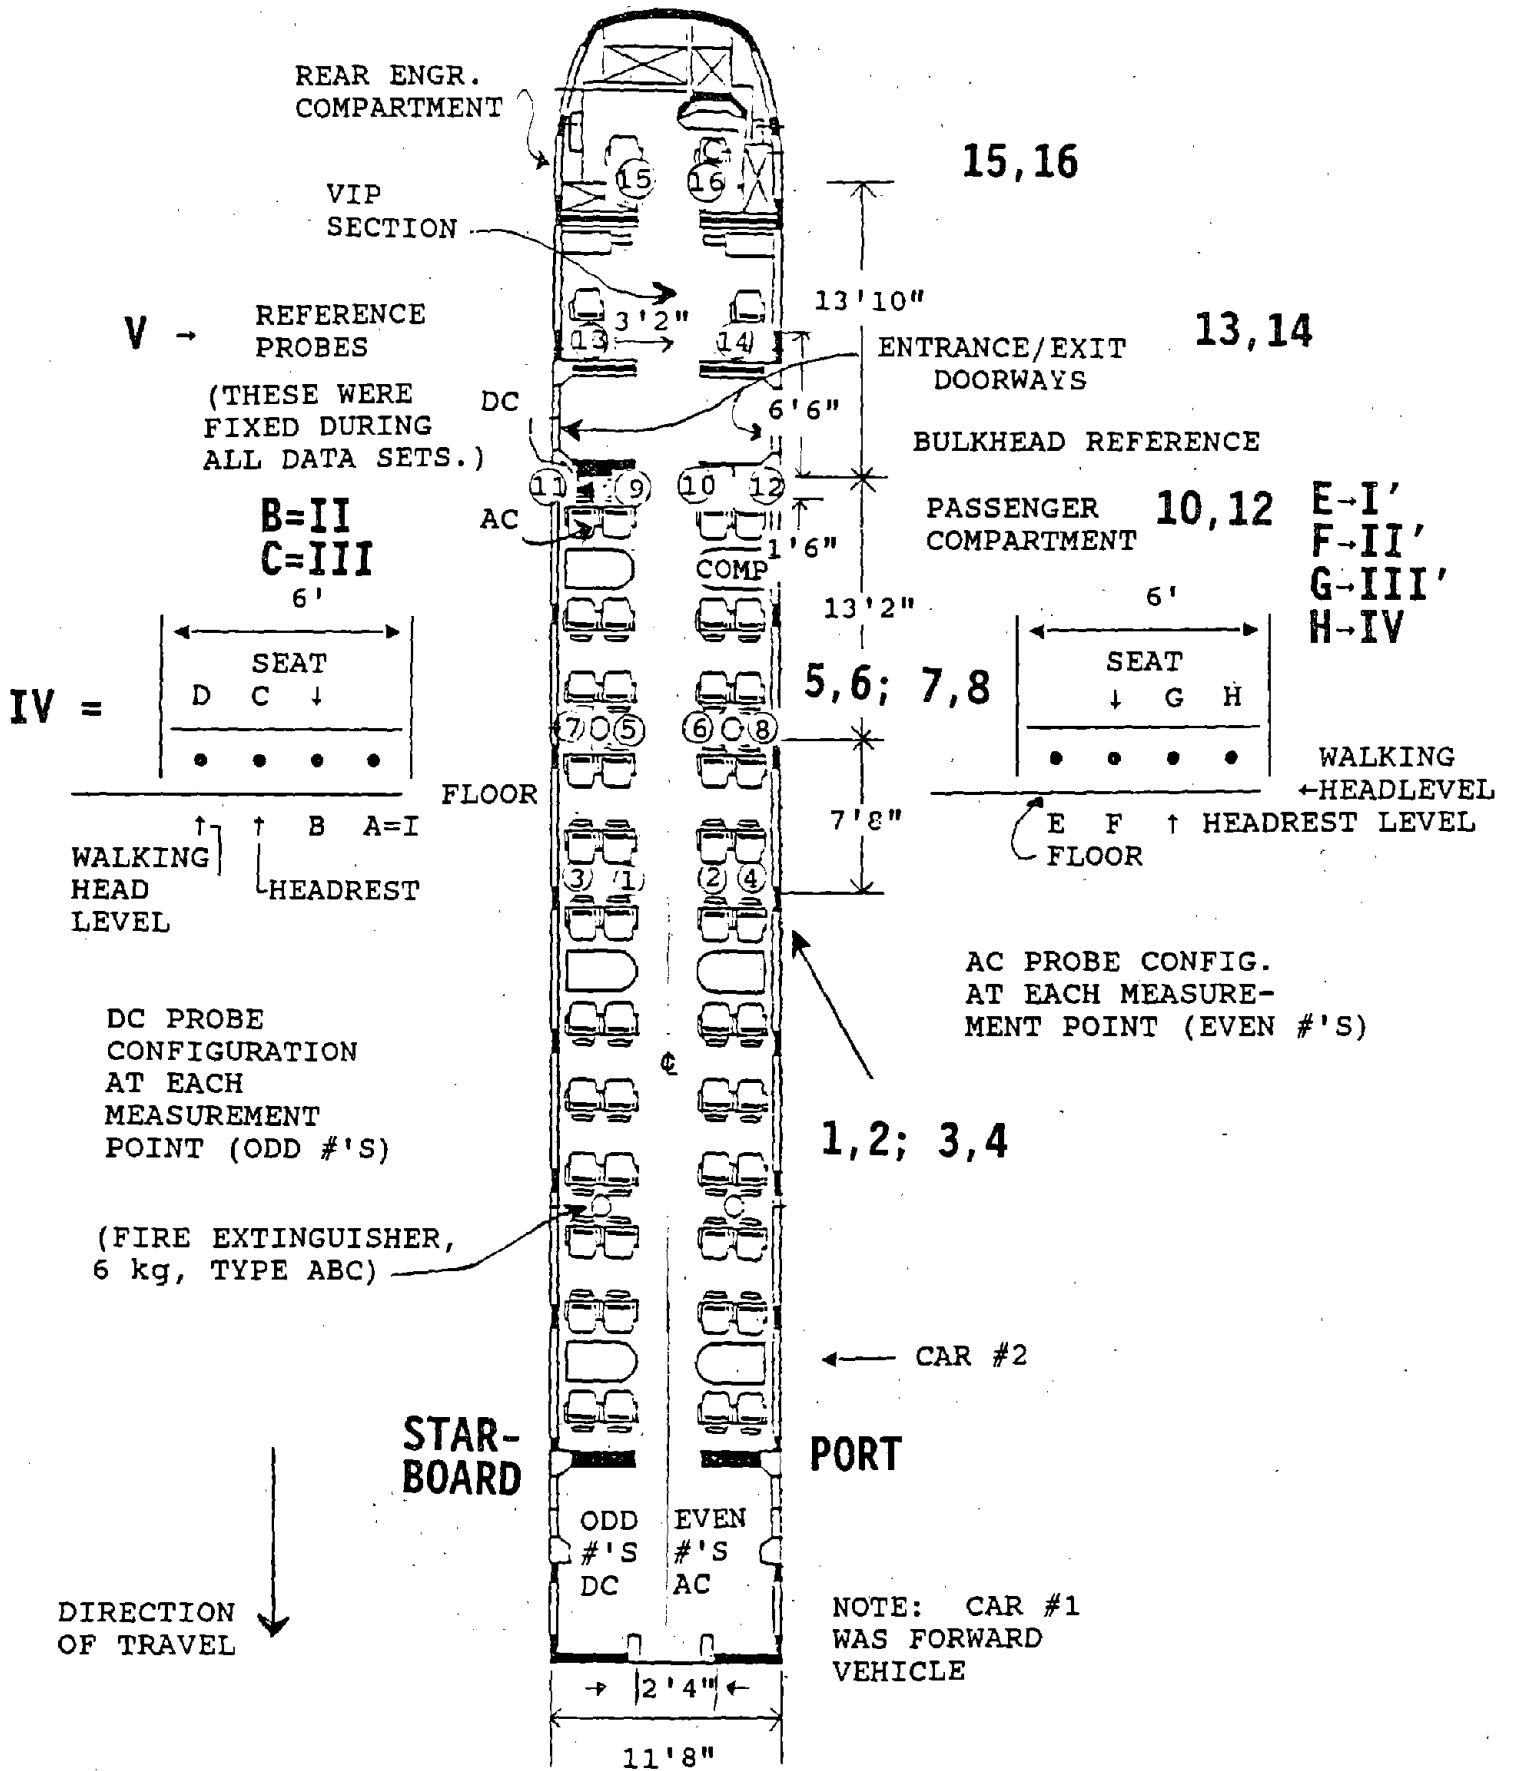
ON-VEHICLE MEASUREMENT POINTS (AUG. 7, '90)

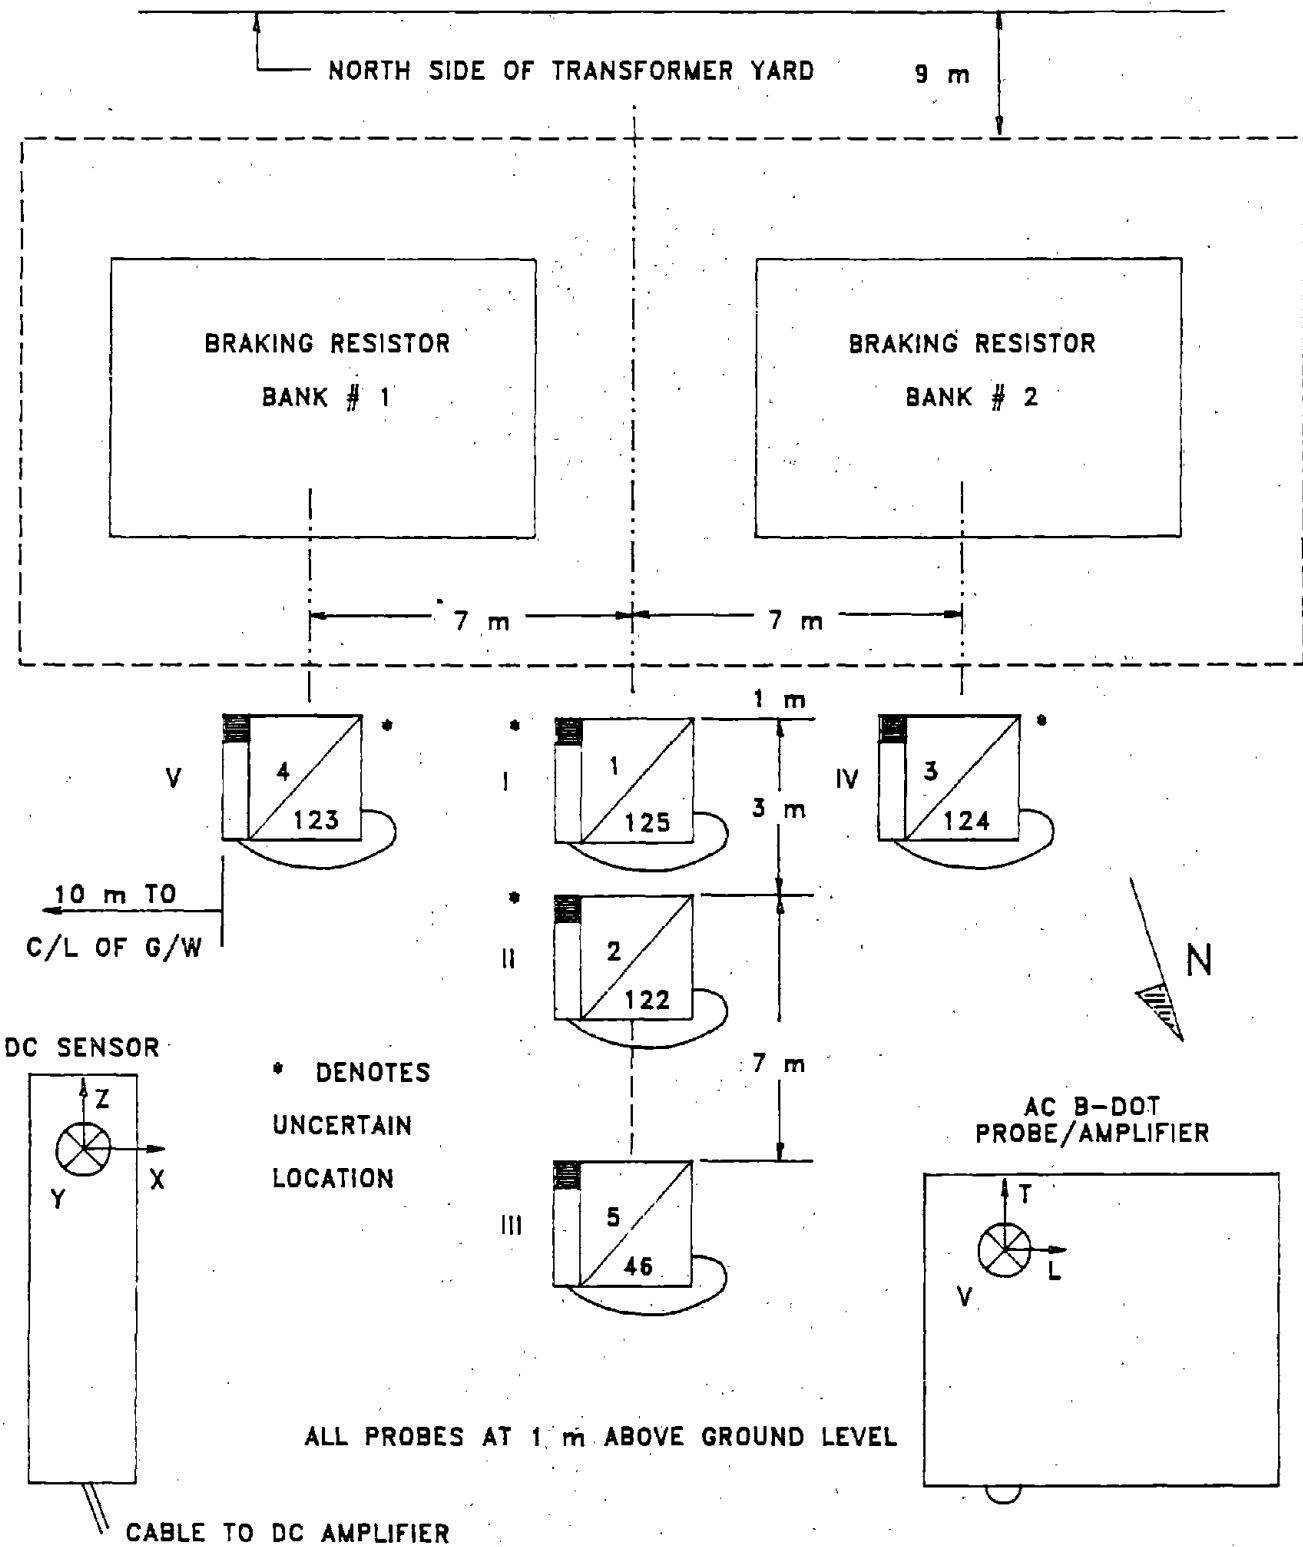
SETUP 23: BRAKING RESISTOR BANK
