UMTA-MA-06-0120-83-4
DOT-TSC-UMTA-83-55

Air Conditioning Modifications to AMG Buses

Prepared by:
Transportation Systems Center

December 1983
Final Report

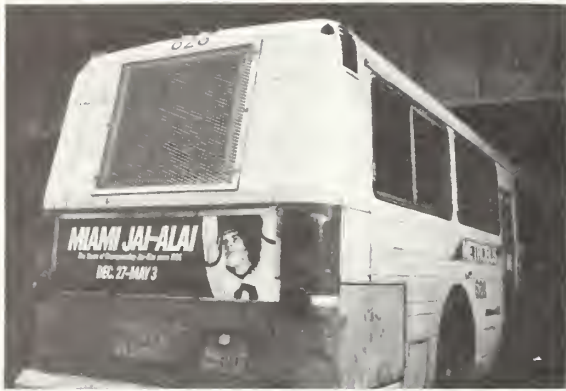
FIG. 1. MIAMI MOD. #1
RELOCATED O.E.M. CONDENSER

5.1.1 General - Miami's structural A/C modifications consisted of removing the rear window, inside rear wall and rear panel, and then cutting or detaching elements of the body skin, roof, hand rails, light fixtures and roof bow. The O.E.M. condenser was moved to the upper rear section of the bus behind an aluminum grill (Figure 1).

5.1.2 Mod. #1 - Miami mounted the condenser on a hinge to allow it to swing out for cleaning. A sheet metal duct, which houses the single condenser fan, was installed directly behind the condenser and protective grill. Intake air is drawn into the duct from an opening cut in the roof of the bus (Figure 2) and then forced through the condenser. The interior rear wall of the bus was replaced with sheet metal and covered with rugging to provide a finished look (Figure 3).

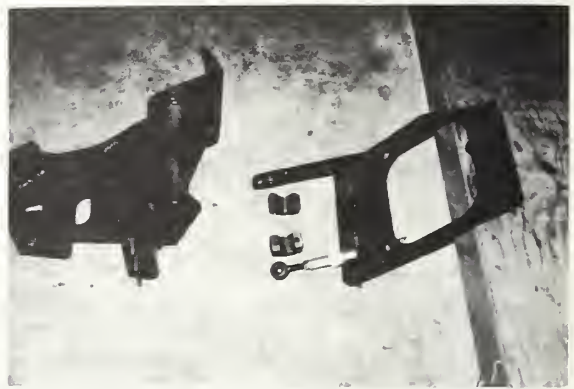
FIG. 4. MIAMI MOD. #1 & (FINAL)
RTS MOUNTING BASE COMPONENTS

Miami Mod. #1 mechanical air conditioning modifications consisted primarily of discarding the original compressor mounting base and the belt tensioning cylinder. The O.E.M. Trane compressor was mounted on a new (RTS) base (Figure 4) which was bolted to the V730 transmission housing. The base also provided a belt tensioning pivot mounting location for the additional alternator required to power the condenser fan (Figure 5).

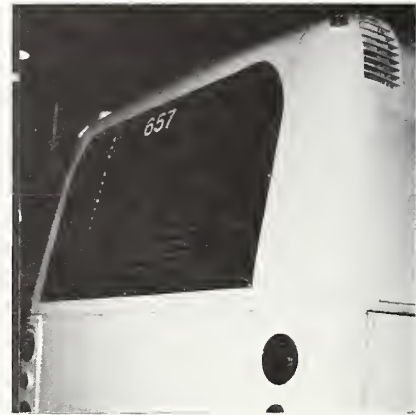
FIG. 8. MIAMI MOD. (FINAL)
FIBERGLASS LOUVER PANEL

Miami's Mod. (Final) requires the same body changes as for Mod. #1. The original condenser is located in the same position as in Mod. #1, but a louvered panel (Figure 8) was used in place of the Mod. #1 aluminum grill (Figure 1). However, a major refinement is that the condenser is bolted and fixed in place. The swing-out condenser design employed in Mod #1 for cleaning purposes proved to be unnecessary because the new location of the condenser provides, essentially, for self-cleaning by the flow of rain water. Also, since the intake air duct opening is at the roof level of the bus, intake air is cleaner than in the original design and the condenser, therefore, requires less cleaning.

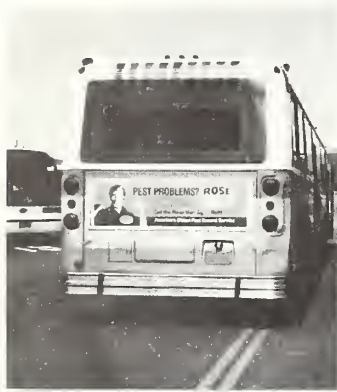
FIG. 12. L.A. MOD. #1
AIR INTAKE LOUVERS IN BODY SKIN

5.2.2 Mod. #1 - L.A. used the "New-Look" condenser with two 14" diameter condenser fans and motors mounted horizontally and in line with the face of the condenser (Figure 11). Intake air is drawn through louvers located in the body skin above the condenser. The condenser is protected with a removeable, expanded-aluminum grill (Figure 12). The interior rear wall was framed with wood and angle iron and covered with white melamine plastic laminate (Figure 13). A shroud, similar to that installed in the Miami modifications, was placed in front of the radiator.

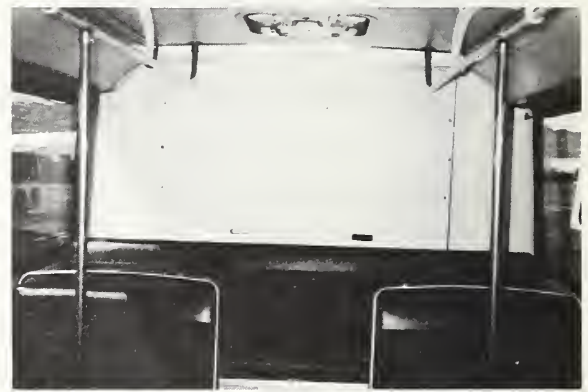
FIG. 13. L.A. MOD. #1 WHITE PLASTIC
LAMINATE INTERIOR REAR PARTITION

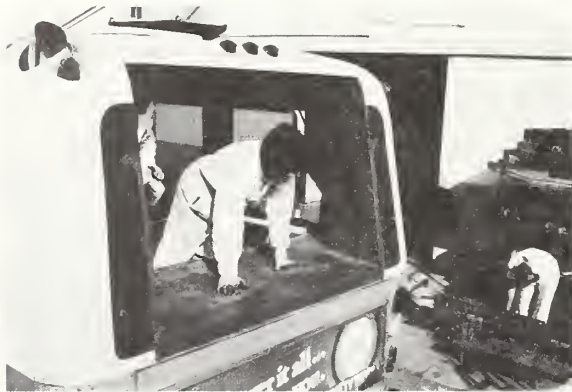
FIG. 17. L.A. MOD. (FINAL) FINISHED OPENING FOR A/C ASSEMBLY

5.2.4 Mod. (Final) - Structural A/C design for this modification, as in Mods. #1 and #2, consisted of removing the rear window, rear panel, and inside rear partition and then cutting the body sheet-metal skin. In Mod. #1 and #2, this sheet metal was retained for air intake louvers which became part of the bus body (Figure 12). Mod. (Final) departed from this approach, a clearance opening being cut (Figure 17) to receive a pre-assembled plenum chamber (Figure 18) which houses the "New Look" condenser, two 18" diameter fans, fan shroud and fan motors. This welded, watertight, steel assembly was designed and built by SCRTD shops and was welded into place in the finished opening in the back of the bus (Figure 19).

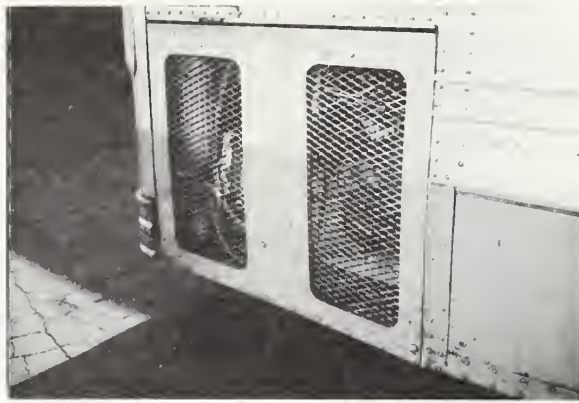
FIG. 21. L.A. MOD. (FINAL)
MODIFIED COMPRESSOR COMPARTMENT ACCESS DOOR

The engine compartment access door was modified by cutting two openings for better air circulation (Figure 21) to assist in reducing engine compartment temperatures.

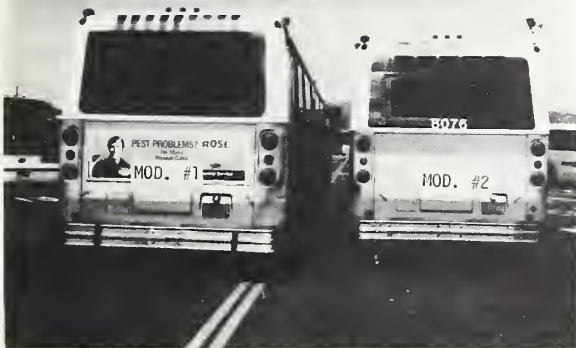
VIEW OF LOUVERS IN BUS BODY
