Report No. UMTA-MA-06-0025-75-7

STATE-OF-THE-ART CAR ENGINEERING TESTS AT DEPARTMENT OF TRANSPORTATION HIGH SPEED GROUND TEST CENTER FINAL TEST REPORT

VOLUME VII. POST-REPAIR TESTS

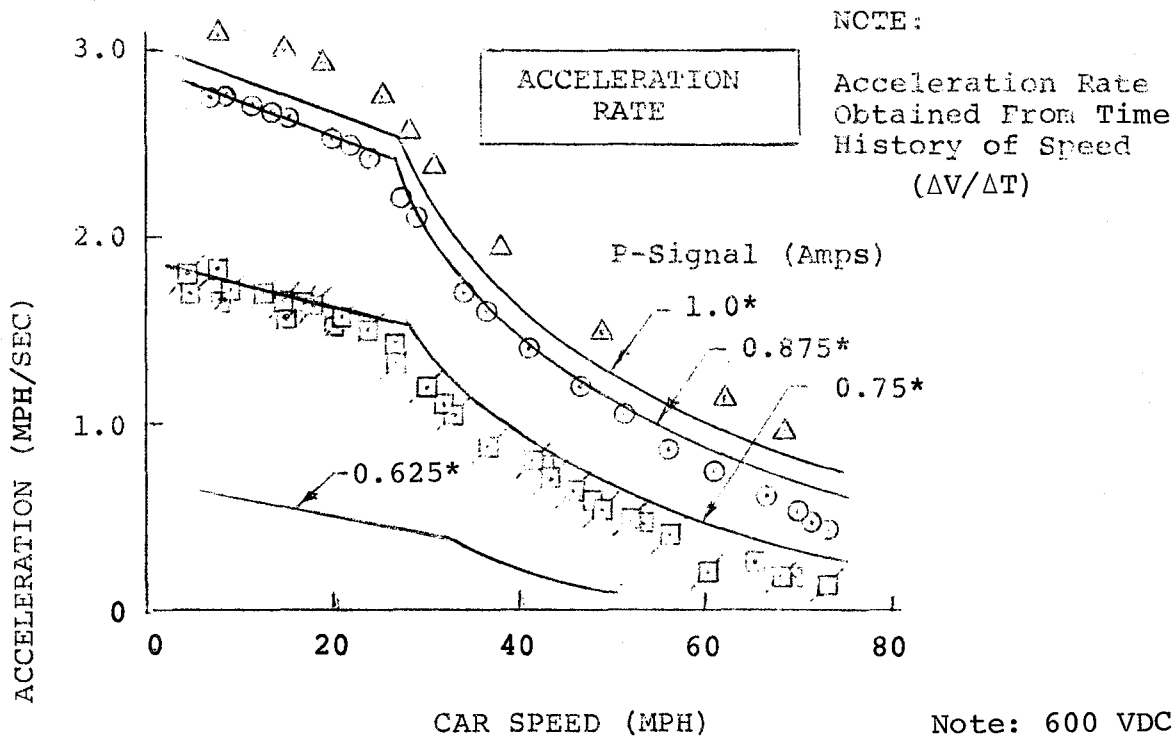
Figure 3-1. Acceleration Control Characteristics

Figure 3-1 presents the acceleration control characteristics from the original SOAC tests and the repaired SOAC tests for 105,000-lb cars in one and two car train configurations. Acceptable data was obtained for the repaired SOAC at Master Controller inputs of 0.875 amp and 0.75 amp; however, in attempting to obtain full service acceleration with a "P" signal of 1.0 amp, the track voltage dropped below the nominal 600 volts due to the limited capacity of the trackside electric generator. The estimated data for a "P" signal of 1.0 amp was obtained by applying the change in acceleration rate between the "P" signal of 0.75 amp and 0.857 amp.

In Figure 3-1, the calculated acceleration vs car speed data as plotted for "P" signal = 1.0 amp from the repaired SOAC tests shows higher accelerations for the same car speeds than the original data. This is undoubtedly due to the uncertainty of assumptions involved. This discrepancy is not reflected in the control linearity plot of acceleration vs controller input; since the calculated data is still within the $\pm 10\%$ full scale tolerance band.

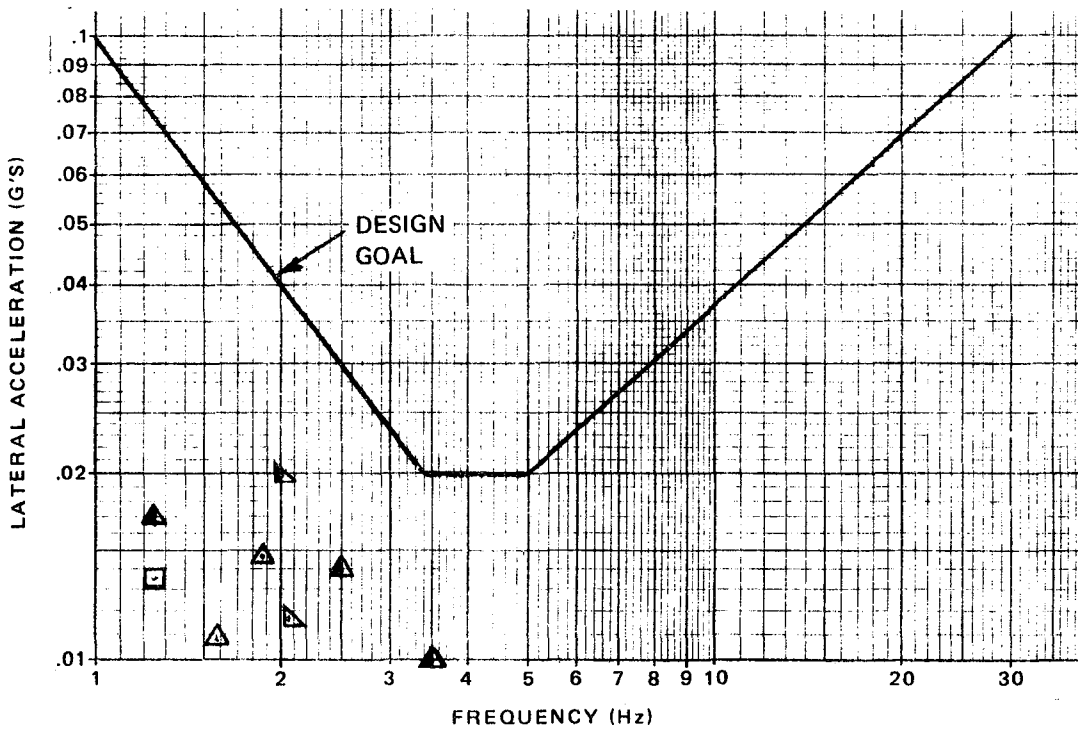
Figure 6-11. Comparison of High-Density Car Ride Quality and Goals

Comparison of the retest data to the SOAC ride quality goals is shown in Figure 6-11. As noted in the previous discussion, most of the levels are below the original test data levels. As mentioned the level of the second order bending mode at 15 Hz is strongly dependent upon speed and this might account for the difference between the retest and original test data levels.

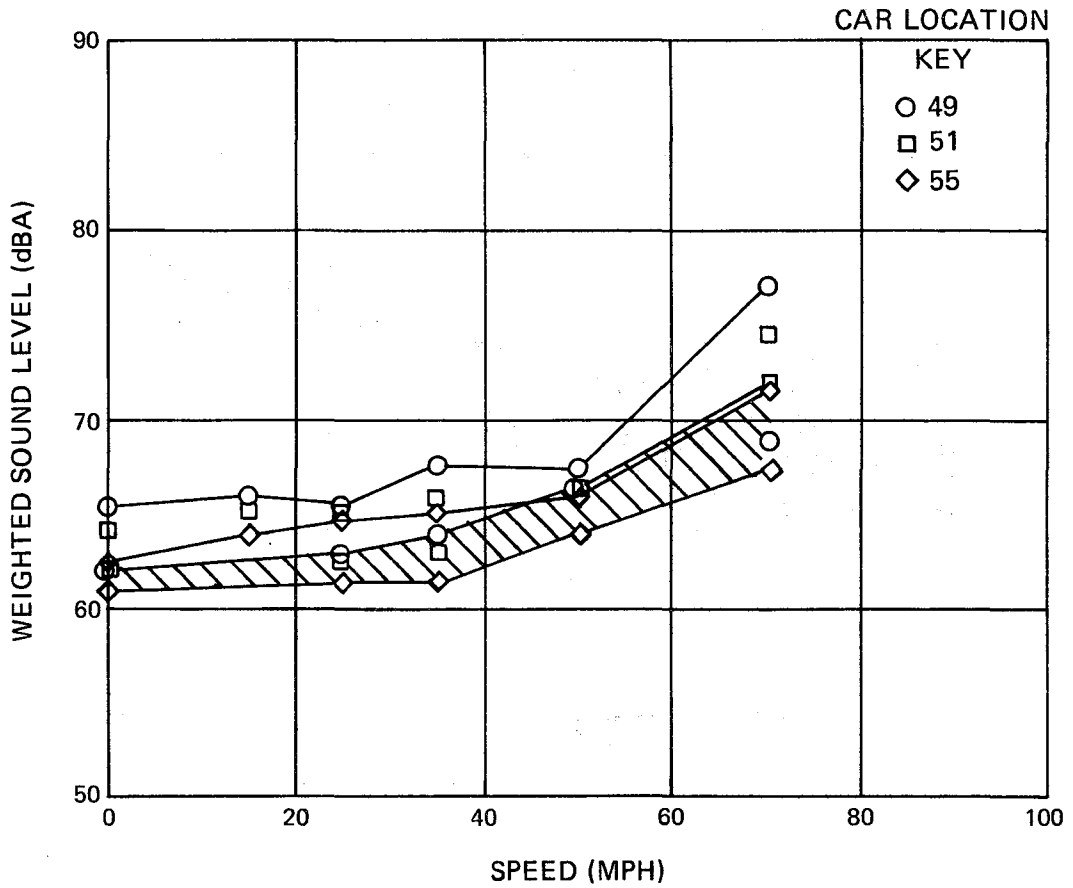
Figure 7-4. Comparison of Interior Noise Levels of SOAC No. 2 Car Before and After Repair

The plot of weighted sound levels versus car speed as shown in Figure 7-4 compares the post-repair test results with those obtained from the original tests. Figure 7-5

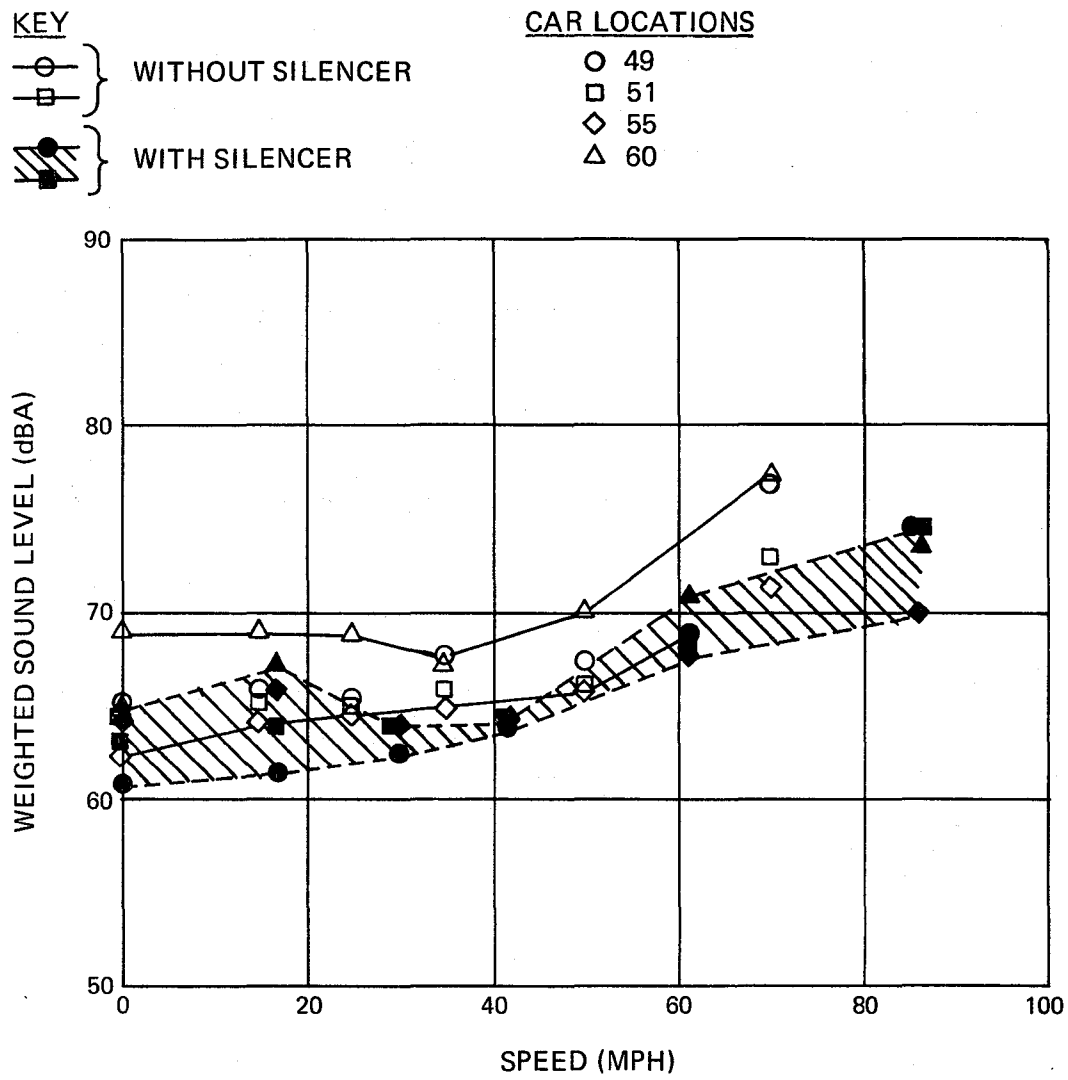
Figure 7-5. Comparison of Interior Noise Levels Before and After Silencer Installation

presents the sound levels with and without the air conditioning duct silencer installation, as obtained during the post-repair testing.

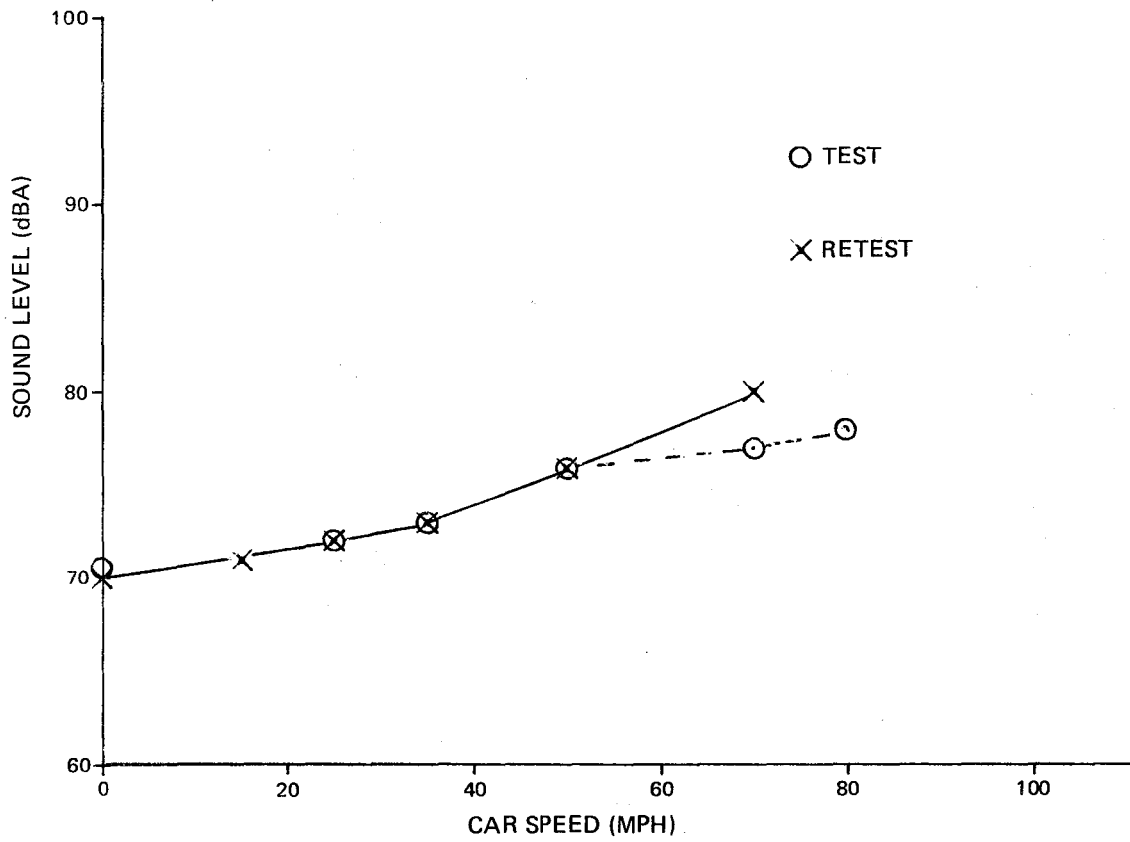
Figure 8-2. Comparison of Wayside Noise Levels Measured 50 Feet from Track for Post-
Repair and Original Tests

The test data from the original test program showed a sound level of 70 dBA for the No. 2 car at rest, and equipped with steel wheels. The data for the same car equipped with resilient wheels at rest was slightly lower. The difference was attributed, at least in part, to wind and weather and the fact that the microphone was positioned slightly beyond the prescribed 50-foot

distance. Therefore, the test data for the resilient wheels were normalized to pass through 70 dBA at zero mph. In keeping with this precedent, the post-repair test data were also normalized in the same manner.
