OPTICAL AUTOMATIC CAR IDENTIFICATION (OACI)
FIELD TEST PROGRAM

TRANSPORTATION SYSTEMS CENTER

MAY 1976

FINAL REPORT

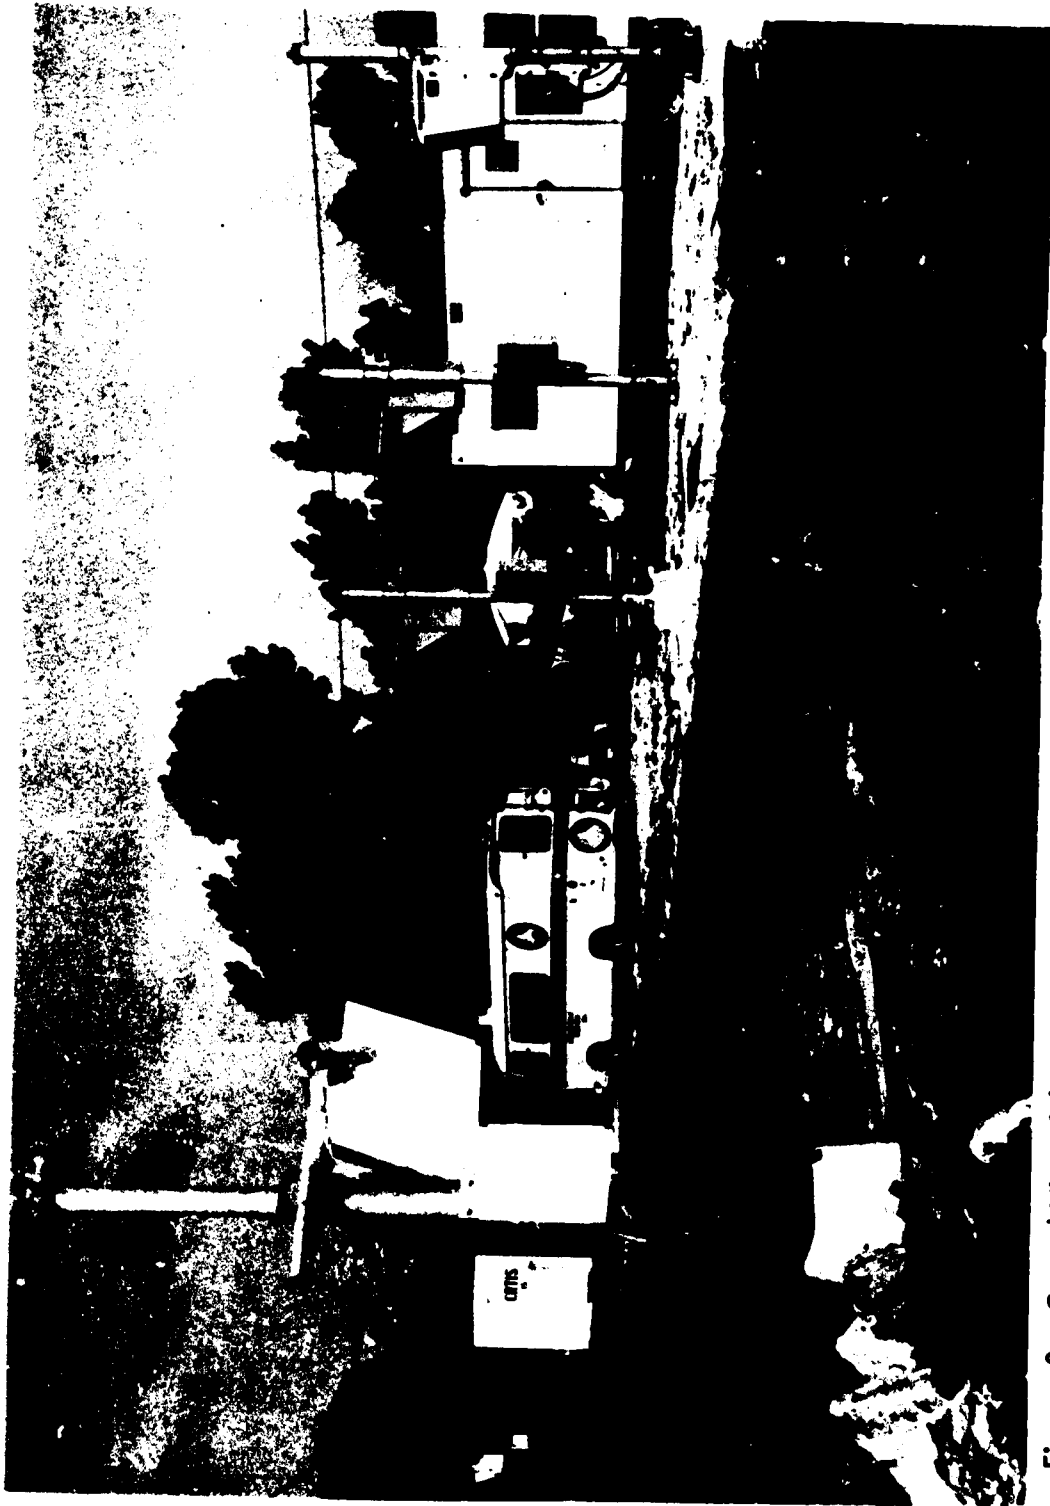
Figure 3. General View of the OACI Chicago Test Site. In the Foreground is Scanner #2. On the Other Side of the Track from Left to Right, Scanners #1, 5, 4 and 3. The TSC Van (Left) and the OACI Instrumented Trailer (Right) are Also in View.

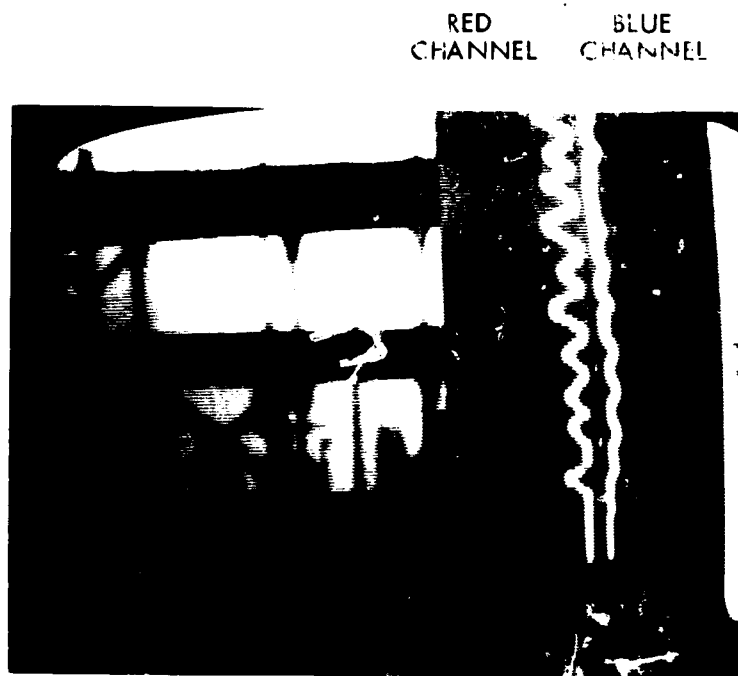
Figure 28. TV Image Corresponding to Car # 1097 (Train # 12, Side # 2). The Analog Signal is Recorded from Scanner # 3 (Track Side # 1). The Cause of Non-Read was Identified as Rusted Background Which Affected the Front Surface of the Labels.
