JRC2012-74087

CRIPPLING TEST OF A BUDD PIONEER PASSENGER CAR

Volpe National Transportation Systems Center
US Department of Transportation
Cambridge, MA 02142

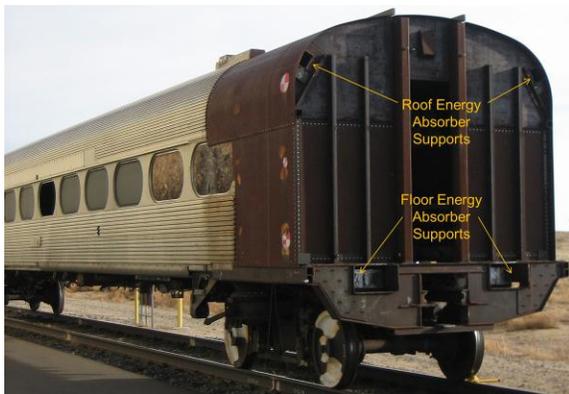
In order to access the energy-absorber supports, the end frames were removed from both ends of both Pioneer cars. Additionally, the energy-absorbing components were removed. Figure 2 shows the end of Pioneer car 248 with its end frame removed. The four energy-absorber support locations are indicated in this figure.

Figure 2. Pioneer 248 with End frame Removed

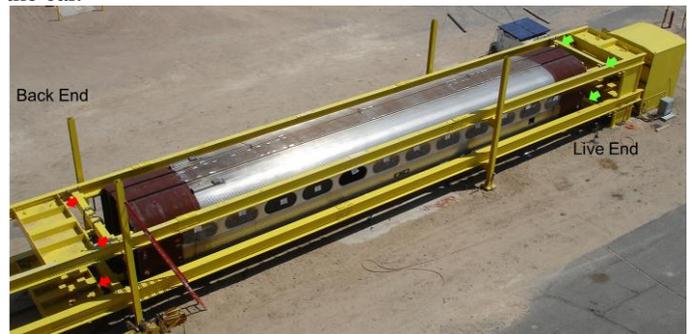
The frame used to restrain the car during both crippling tests is made up of four longitudinal beams: two at the roof-level and two at the floor-level. The four beams are supported by a series of vertical beams and span the length of the car. The two longitudinal beams at a given height are attached to one another by a lateral support at each end of the car. The live end of the frame is attached to the ground, but the back end is free to move longitudinally. Based upon the load path through the car and into the frame, the four longitudinal beams will stretch in response to loads being transmitted into them by the car. The test frame, with Car 244 installed within it, is shown in Figure 3. Three of the loading locations on the live end are indicated in this figure, as are three reaction locations on the back end of the car.

Figure 3. Crippling Test Frame with Car 244

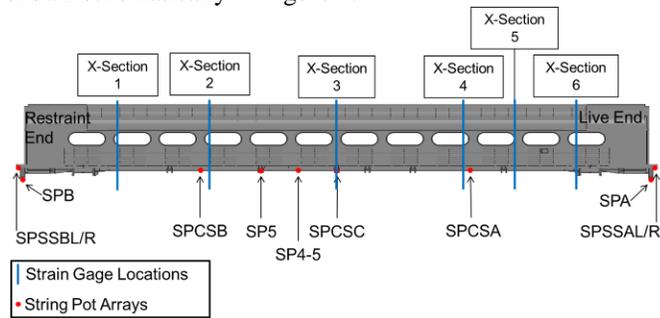
Strain gages were installed at six cross-sections of car 244 during the crippling test. Arrays of vertical, lateral, and longitudinal string potentiometers were installed at 11 locations on the underframe of the car. As explained in Reference 8, the use of this string pot arrangement permitted the measurements at each point to be resolved into displacements in each of the three directions. The string pot and strain gage locations are shown schematically in Figure 4.

Figure 4. Strain Gage and String Pot Locations in Fully-Instrumented Crippling Test

Strain gages were installed on car 244 on the members shown in Figure 6 at cross-sections 1 through 5 as shown in Figure 4. The bottom flange of the center sill buckled at approximately cross-section 5. While the center sill experienced buckling in the upper web at a different location, the lower flange buckle was very close to several strain gages. This buckle and two strain gages installed on the center sill are shown in Figure 20. The lower flange of the center sill features an additional plate welded to its top surface toward the live end of the car that terminates at this cross-section. In this photograph the live end of the car is to the left hand side.

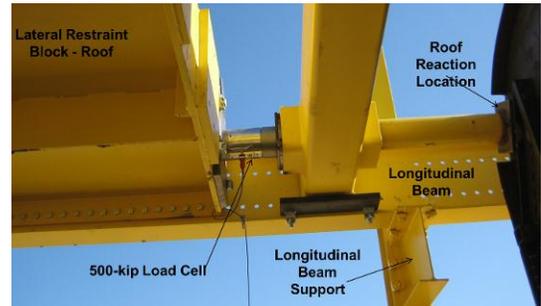
Eight load cells were used to measure the individual loads being placed on the car as well as to examine the load path through the structure of the car. A load cell with a capacity of 1,000,000 pounds was placed between each floor energy-absorber support and the test frame on both the live and back ends of the car. A 500,000-pound capacity load cell was installed between each roof energy-absorber support and the test frame. Figure 5 shows the restraint arrangement at the roof-level at the back end of the car. The car is at the right side in this photograph, the load cell in the center, and the lateral component of the test frame at the left side.

Figure 5. Roof Reaction Location at Back End of Car, Crippling Test

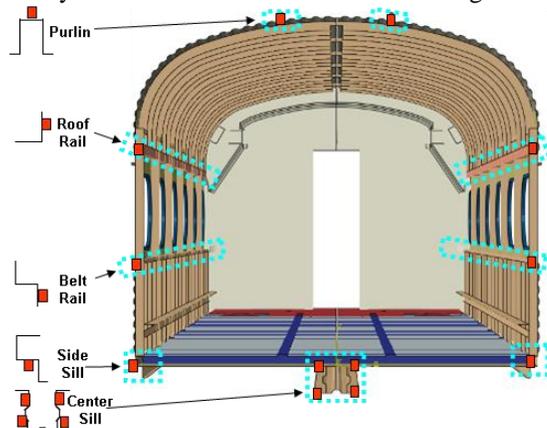
Uniaxial strain gages were used to instrument the car at six cross-sections. At sections one through five, gages were applied to the center sill, side sills, belt rails, roof rails, and purlins. At location six, strain gages were only used on the side sill and belt rail. Figure 6 shows a cross-section of the car taken from the FE model. The members that were instrumented with strain gages are indicated in this figure. The placement of the strain gages on the cross-section of each member is indicated by the sketches on the left side of this figure.

Figure 6. Cross-section of Pioneer 244 Showing Strain Gages in Crippling Test

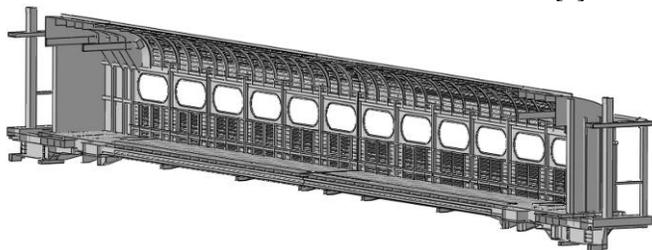
A half-symmetric (full length, half width) FE model was used to simulate the 800,000 pound buff strength test. This model is shown in Figure 7. This FE model had been derived from previous Budd Pioneer FE models used to simulate a series of dynamic impact tests [7]. The results of this model were in sufficient agreement with the results of the 800,000 pound line-of-draft test for the model to be considered validated [8].

Figure 7. Half-symmetric FE Model Used in 800-kip Buff Strength Analysis

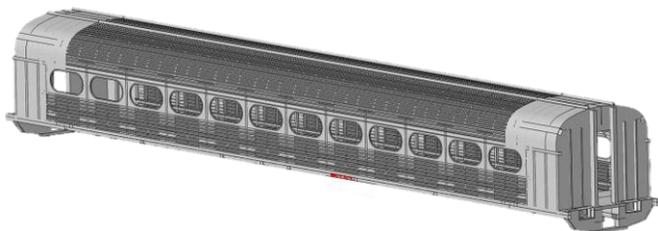
This validated model was used as the starting point to create the crippling model. Because the endframes and CEM components were removed from both Pioneer cars to permit loading along the collision load path in the crippling tests, these structures were removed from the crippling FE model as well. Additionally, because the lateral-vertical symmetry used in the 800-kip model could suppress a lateral buckling mode in the crippling model, the existing structure was mirrored to create a full-car model. The crippling analysis model is shown in Figure 8.

Figure 8. FE Model Used in Crippling Analysis

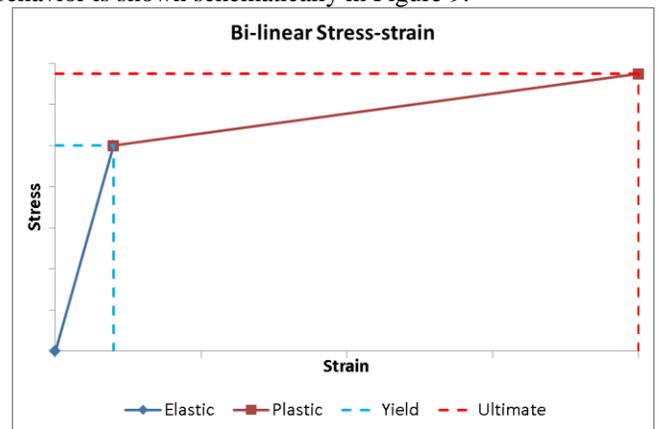
This car includes several different types of steel in its structure. A simple bi-linear material representation was used for most strength properties defined in the FE model. The first portion of the material property definition represents the elastic response of the material up to its yield strength. The second portion of the material property definition represents the plastic behavior of the material between its yield strength/strain and its ultimate strength/strain. No attempt was made to include fracture or material softening in this model. Bi-linear material behavior is shown schematically in Figure 9.

Figure 9. Schematic of Bi-linear Representation of Material Strength Property

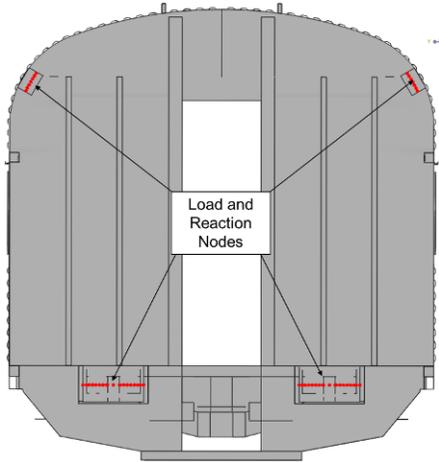
Four energy-absorber supports on the live end of the car were used as loading locations. The corresponding locations on the back end were used to restrain the car in the longitudinal direction. Load was introduced into the FE model by prescribing a 2 inch/second displacement on a row of nodes at the center of each floor- and roof-level energy absorber support. At the rear (reaction) end of the car, a similar row of nodes at each energy-absorber location was prevented from moving in the longitudinal location. Applying the boundary condition to a single row of nodes allowed each location to pivot in response to the applied or reacted load. These locations are indicated on the FE model in Figure 10.

Figure 10. Load and Reaction Locations on FE Model

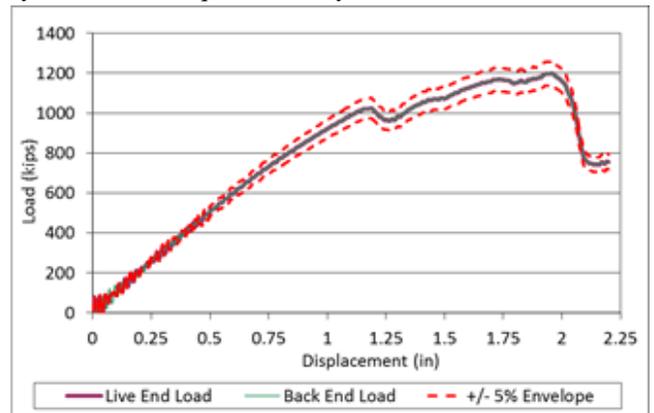
The four loads applied to the live end were added together and plotted against the displacement of the live end. The four loads at the back end were also summed and plotted against the displacement of the live end. A +/- 5% envelope on the live-end force was plotted alongside the two load-displacement characteristics in Figure 11. This figure shows that the applied load and the reaction load are in close agreement. The model may be considered quasi-static by the first ETF criterion.

Figure 11. Live End Load and Back End Loads for Crippling Analysis

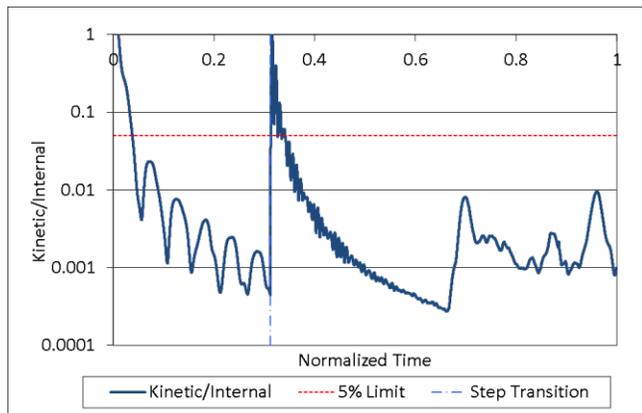
The energy ratio for the crippling simulation is plotted in Figure 12. The simulation consisted of two steps: a gravity step and a compression load step. The transition between the two steps is indicated by a dashed vertical line in this figure. The energy ratio is plotted on a logarithmic scale as this quantity varied by several orders of magnitude over the course of the simulation.

Figure 12. Ratio of Kinetic Energy to Internal Energy for Crippling Simulation

Figure 12 shows that the ratio of kinetic energy to internal energy was well below 5% for nearly the entire length of the simulation. Based upon this criterion, the crippling analysis can be considered quasi-static.

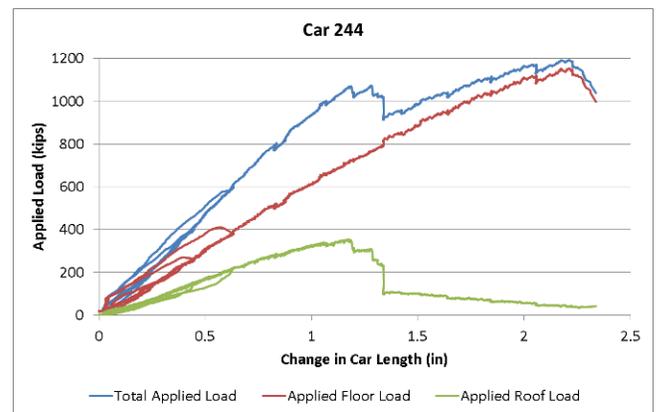
Figure 13 contains a plot of the applied load versus the change in car length for car 244 during its crippling test. This figure includes a plot of the sum of the two floor-level live-end load cells, a plot of the sum of the two roof-level live-end load cells, and a plot of the sum of the four live-end load cells.

Figure 13. Applied Loads, Car 244 Crippling Test

As seen in the Figure 13, the roof structure carries a smaller load than the floor and buckles at a lower load. Once the roof has buckled the applied roof load quickly drops. The floor structure continues to carry load once the roof has buckled. When crippling is reached, nearly the entire load is entering the car structure through the floor-level energy-absorber supports.

Figure 14 contains a plot of the applied load versus change in car length for the FE analysis of the crippling test. Similar to Figure 13, this figure includes plots of the applied floor load, the applied roof load, and the total applied load. The horizontal axis represents the change in car length as calculated by the FE model. This is the same measurement as was used in Figure 13.

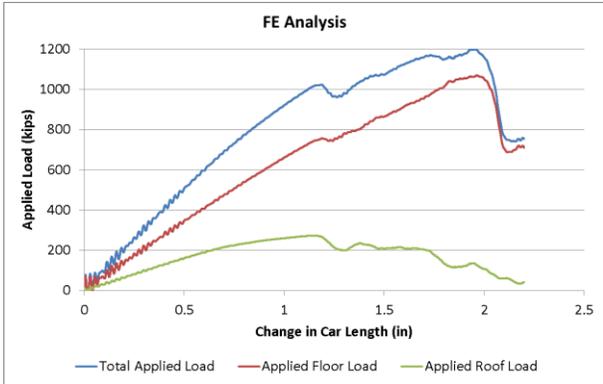
Figure 14. Applied Loads, FE Analysis

The load-versus-displacement behavior calculated by the FE model is similar to the measurements made during the test. In the FE model as well as the test, the roof's load-displacement curve has a lower slope than that for the floor, as well as a lower buckling load. The roof structure in the FE model buckles at a lower load than the roof structure in the test car. In the FE model, the roof undergoes more gradual buckling behavior than was experienced during the test, resulting in a less-abrupt drop in roof load.

The floor structure in the FE model behaves similarly to the floor structure in the test. At the time of crippling, the majority of the load supported by the car body is entering through the floor structure. However, in the FE model the roof is carrying more load than the roof in the test of car 244.

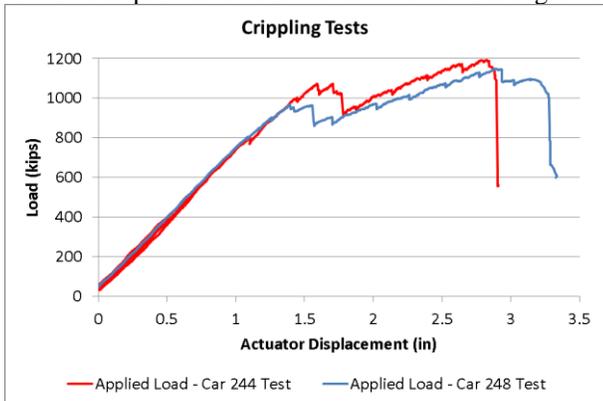
Because car 248 was tested in a limited-instrumentation "shakedown" test, displacement measurements were not made at the back end of the car. While displacement measurements were made at each hydraulic actuator on the live end, the stroke length of each actuator is a measurement of the compression of the car plus stretching of the test frame. Because car 244 was tested in the same frame, the live end actuator displacements from the two tests can be compared directly to one another. The total applied load in both test cars is plotted against the live end actuator displacements for cars 244 and 248 in Figure 15.

Figure 15. Load versus Actuator Displacement for Tests

Cars 244 and 248 experienced similar modes of deformation throughout the test. Both of the cars initially deformed in an approximately linear manner with increasing load. In both tests the roof buckled at a load of approximately 1-million pounds. Car 248's roof buckled at slightly less than 1-million pounds, and car 244's at slightly more. Following this buckling, the load continued to climb as the underframe continued to carry load. Crippling was reached when the center sill and side sills failed in buckling.

the corresponding drop in load the total load resumed its rise as the load carried by the underframe increased. The load-displacement characteristics from both cars possess similar slopes following the roof's buckling, as seen in Figure 15. Finally, the ultimate load for each car was reached when the center and side sills failed by buckling.

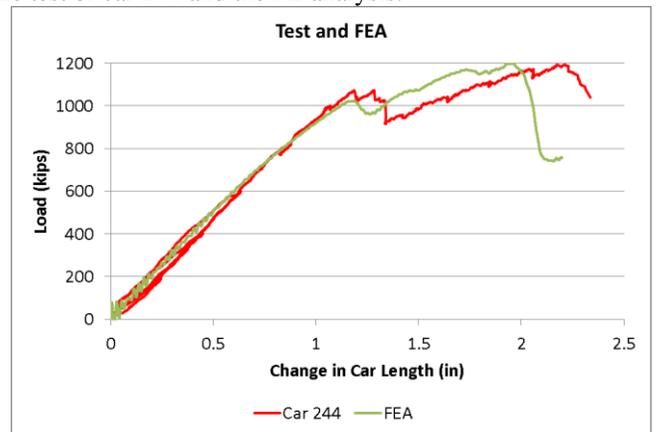
Because the FE model was fixed at its back end but the test car was restrained by a stiff but deformable frame, the live end displacement in the FE model is not the same as the live end displacement in the test. In the fully-instrumented test of car 244, the longitudinal displacement of each reaction location on the rear end of the car was measured. The shortening of the car itself was calculated by subtracting the rear end displacement from the live end displacement. Because of the limited instrumentation installed on car 248, the rear end displacement was not measured and car shortening cannot be determined. The load versus change in car length is plotted in Figure 16 for the test of car 244 and the FE analysis.

Figure 16. Load vs. Change in Car Length for Car 244 and FEA

The crippling behaviors observed in both tests and calculated by the FE model are largely the same. Car 248 reached a crippling load of 1.15 million pounds. Car 244 and the FE model both reached crippling loads of more than 1.19 million pounds.

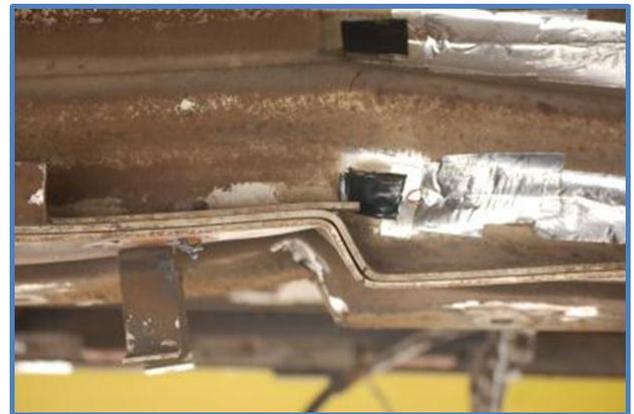
Figure 20. Buckle in Lower Flange, Center Sill of Car 244

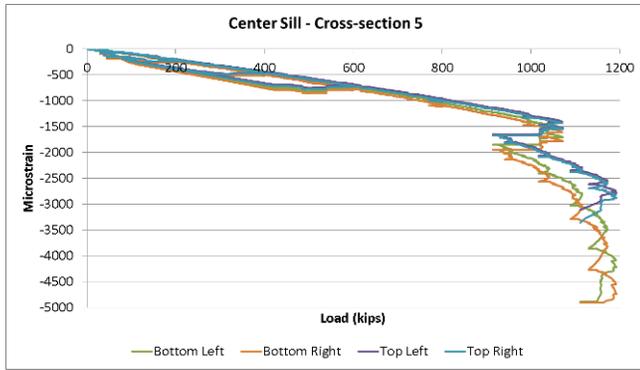
Each center sill cross-section that was instrumented with strain gages included an upper and a lower gage on each side, for a total of four gages. Because the buckle in the lower flange in car 244 was roughly the same shape across the entire width of the center sill both the lower left and lower right gages recorded very similar behavior. The strain measured by each of the four gages is plotted against the total applied load in Figure 21.

Figure 21. Strain vs. Load for Center Sill of Car 244 at Buckled Lower Flange

The strains measured in the center sill are roughly linear with respect to the applied load up to a load of approximately 1-million pounds. This load correlates with the approximate load at which the roof of the car buckled. Beyond 1-million pounds the lower strain gages experience a more rapid change in strain for a given change in load than the two upper strain gages. The strain gages used in the crippling test of Car 244 had a measurement capacity of +/- 3,000 microstrain.

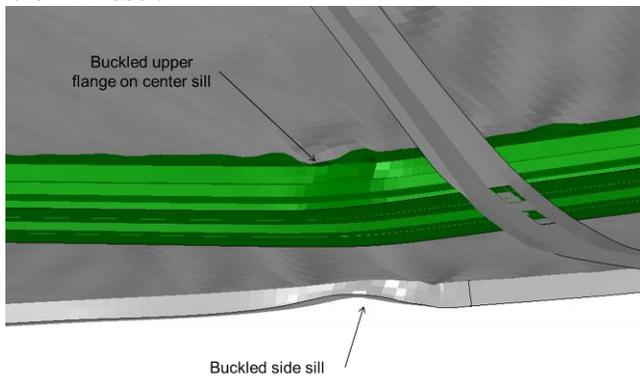
In the FE model, the center sill buckled closer to the center of the car (see Figure 17). The center sill in the FE model experienced a buckling of the upper flanges and webs. Figure 22 shows a close-up view of the buckled center sill and side sill in the FE model.

Figure 22. Buckled Center Sill in FE Model

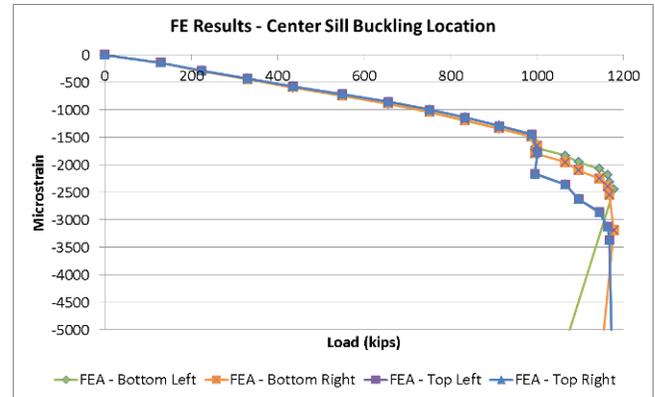
Field data were collected in the vicinity of the buckle during the crippling analysis. Figure 23 plots the strains in the center sill at the buckling location. The four data series shown in this figure are for elements in locations that correspond to the approximate placement of strain gages on the cross-section of car 244's center sill.

Figure 23. Strain vs. Load for Center Sill of FE Model at Buckled Location

The strain behavior in the FE model in the vicinity of the center sill's buckle is similar to the behavior seen in car 244. The four gages register approximately the same strain for a given load up to approximately 1-million pounds. Because the center sill in the model buckles at the top, the two calculated locations closer to the top indicate a faster rate of change of strain per change in applied load than the two locations at the bottom.
