Trespass Prevention Research Study – West Palm Beach, FL

1. AGENCY USE ONLY (Leave blank)		2. REPORT DATE March 2014		3. REPORT TYPE AND DATES COVERED Technical Report
4. TITLE AND SUBTITLE Trespass Prevention Research Study – West Palm Beach, FL			5. FUNDING NUMBERS RR97A3-HMC53

6. AUTHOR(S) Marco daSilva and Tashi Ngamdung			RR97A4-JT336 RR97A5-LLA42, MLA42	
7. PERFORMING ORGANIZATION NAME(S) AND ADDRESS(ES) U.S. Department of Transportation Research and Innovative Technology Administration John A. Volpe National Transportation Systems Center 55 Broadway Cambridge, MA 02142			8. PERFORMING ORGANIZATION REPORT NUMBER DOT-VNTSC-FRA-14-02

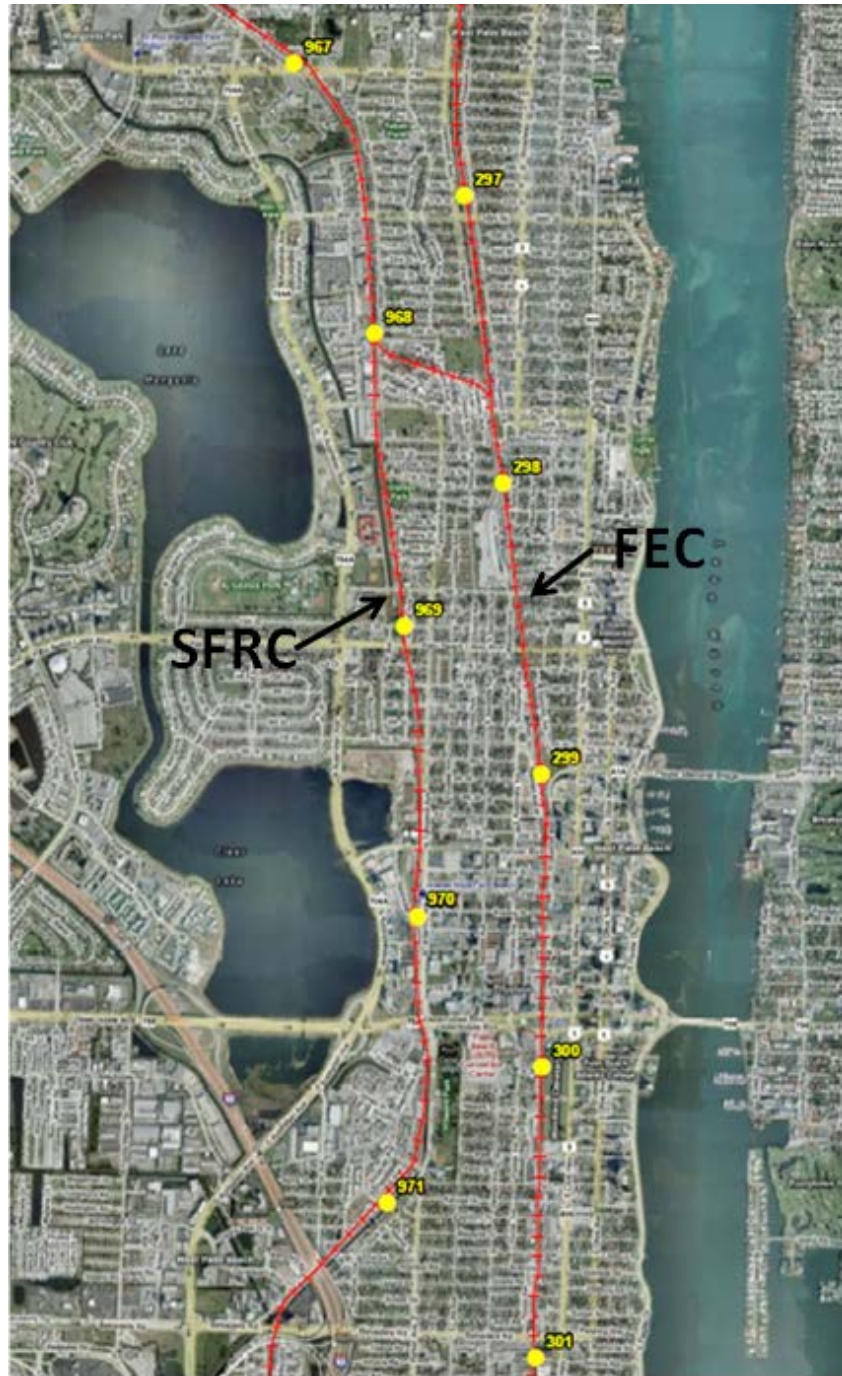
Figure 2. Trespass Prevention Research Study Area in West Palm Beach, FL

Figure 2 shows a map of the two rail lines within the study area. The boundaries of the study area are defined by milepost locations on both lines, with the SFRC study area bounded by mileposts 966-973 and FEC by mileposts 296-301. The SFRC study area is specifically bounded by 45th Street on the north end and Summit Boulevard on the south end.

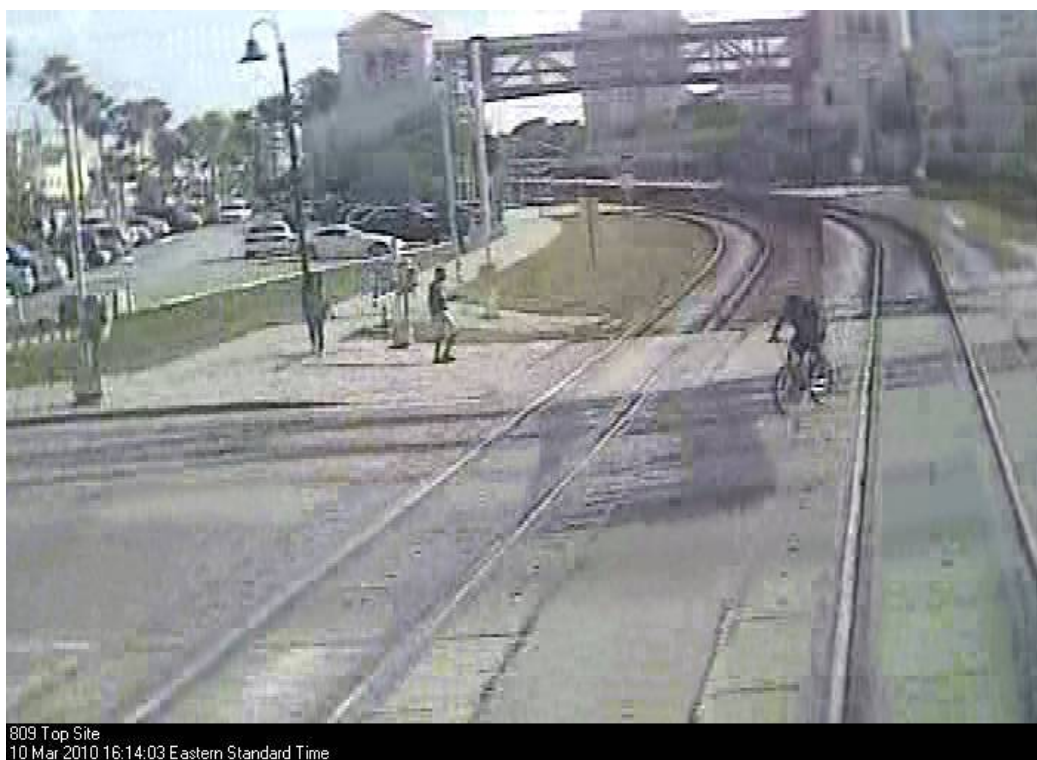
Figure 5. Grade Crossing Trespass Event

A trespass event was defined as an event involving a person or cyclist on the railroad ROW identified through analysis of the video data. Trespass events were further classified into two subtypes: at grade crossings and on the ROW. Trespassing at a grade crossing was defined as occupying the crossing while the grade crossing gates were in the down position, which follows the same definition of a trespasser at a gated crossing as defined by FRA [5]. As already mentioned, the SFRTA line in the study area is double-tracked and all crossings are equipped with four-quadrant and pedestrian gates. Figure 5 shows an example of this type of trespassing event involving, in this case, a pedestrian and a cyclist violating the down gates at the Banyan Boulevard crossing after the train has passed (this view is from the rear cab-car). The other trespass type, trespassing on the ROW, was used to capture all non-grade crossing trespassing. Figure 6 shows an example of this type of event involving two trespassers on the ROW.

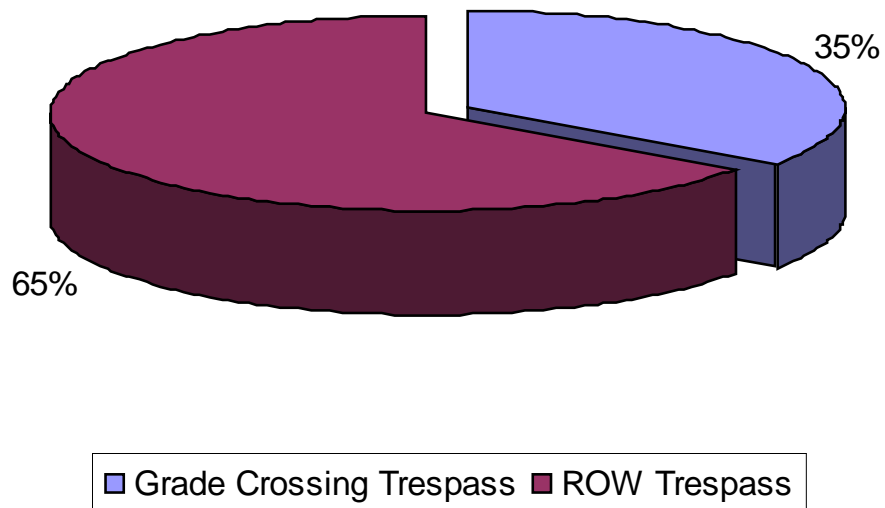
Figure 7. Trespass Event Location, SFRTA Locomotive Video Data

A total of 176 trespass events involving 230 trespassers were identified through the review of the set of 613 trips. This averaged out to 0.3 trespass events per trip, or one trespass event every 3.5 trips. The overall probability of a trespass event during any given trip was almost 29 percent. A total of 60 of the 176 events involved trespassing at a crossing either before or after a train while the gates were in the down position. The remaining 116 events involved trespassers along the ROW at non-crossing locations. Figure 7 shows the distribution of each type of trespass event.

As shown in Table 3, most of the grade crossing trespass events involved pedestrians or cyclists violating the gates after the train. As already mentioned, the SFRTA line is double-track throughout the study area. A significant risk of a second train approaching from the opposite

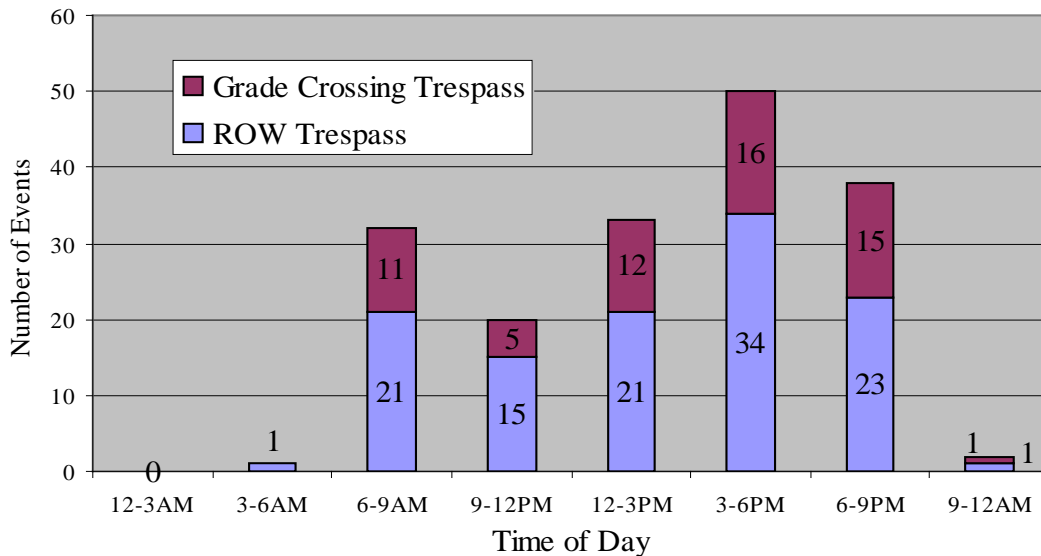
Figure 8. Trespass Events by Time of Day

Figure 8 shows the breakdown of trespass events by time of day. Overall, approximately 70 percent of the trespass events occurred after 12 p.m. The data also reveals that the highest number of trespass events on the SFRTA line within the study area occurred during the 3 p.m. to 6 p.m. time period, regardless of event type. It should also be noted that of the 50 daily weekday trips by the SFRTA line, a total of 22 trips pass through the study area in the morning hours and 28 in the afternoon and evening hours.

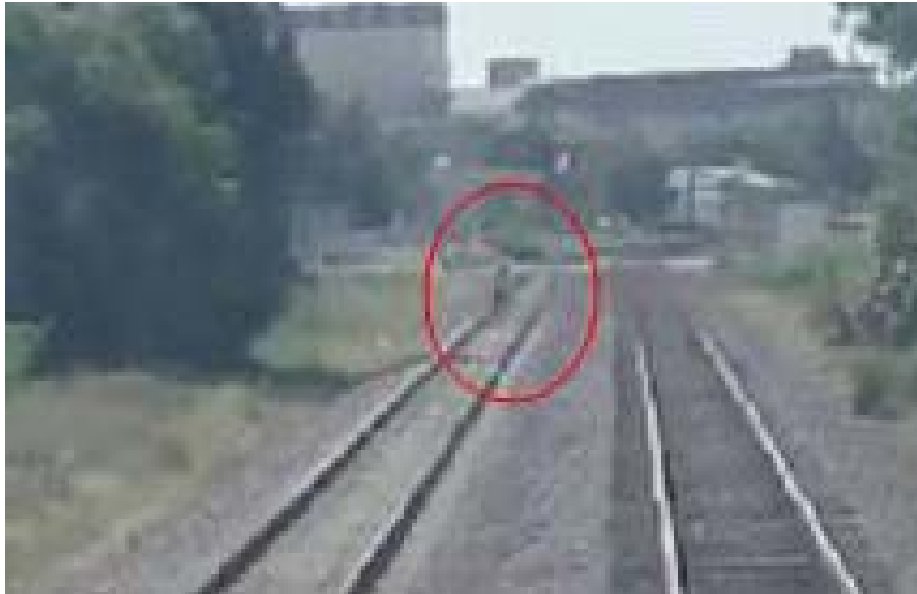
Figure 11. Trespasser Crossing Tracks on North Approach to 7th Street Crossing (SFRTA)

During the first visit to the study area in October 2009, the research team was provided with an opportunity to ride in the locomotive during an SFRTA Tri-Rail trip through the study area. The research team noted two separate trespass events during that single trip. Figure 11 shows a trespass event involving a female trespasser crossing the tracks ahead of the oncoming train on the ROW between Palm Beach Lakes Boulevard and 7th Street.

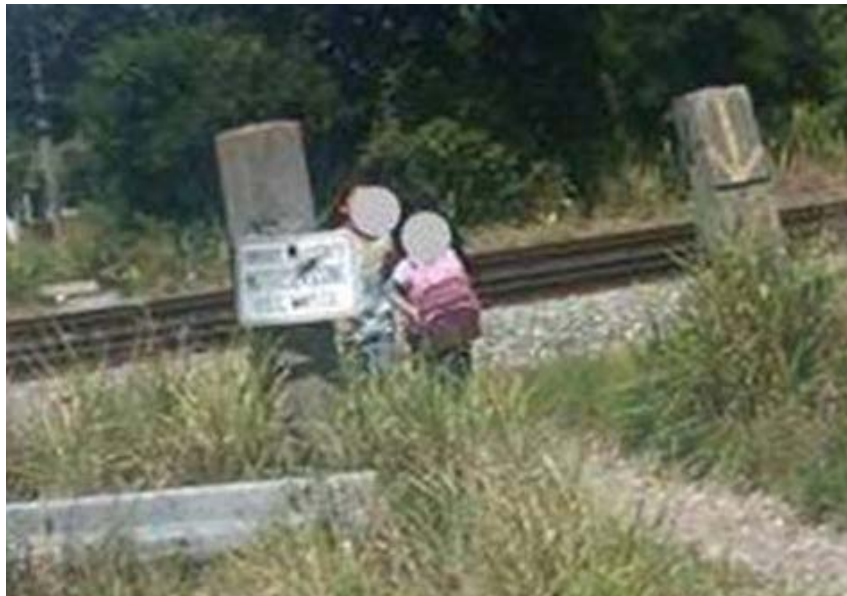
Figure 13. FEC ROW Trespass Event Example

The research team performed multiple site visits to known trouble spots all along the ROW within the study area and catalogued a total of 32 locations where there was evidence of trespass (observed trespassing, worn paths, and breaks in fencing). The research team observed many instances towards the northern part of the study area involving children with backpacks trespassing across the FEC tracks. Figure 13 shows an example of such an event observed by the research team during a site visit in April 2010. During that same visit at that same location, the research team observed 15 trespassers in less than 30 minutes. Most of the trespassers were children or teenagers crossing the tracks. Following these field observations, the research team engaged in discussions with the Palm Beach County School District to ascertain the underlying cause of this issue. The team concluded that this particular location and the predominance of children and teenage trespassers may have had to do with the catchment area of the local schools (the geographic area from which students are eligible to attend a local school) and substantial distance between grade crossings in that area.

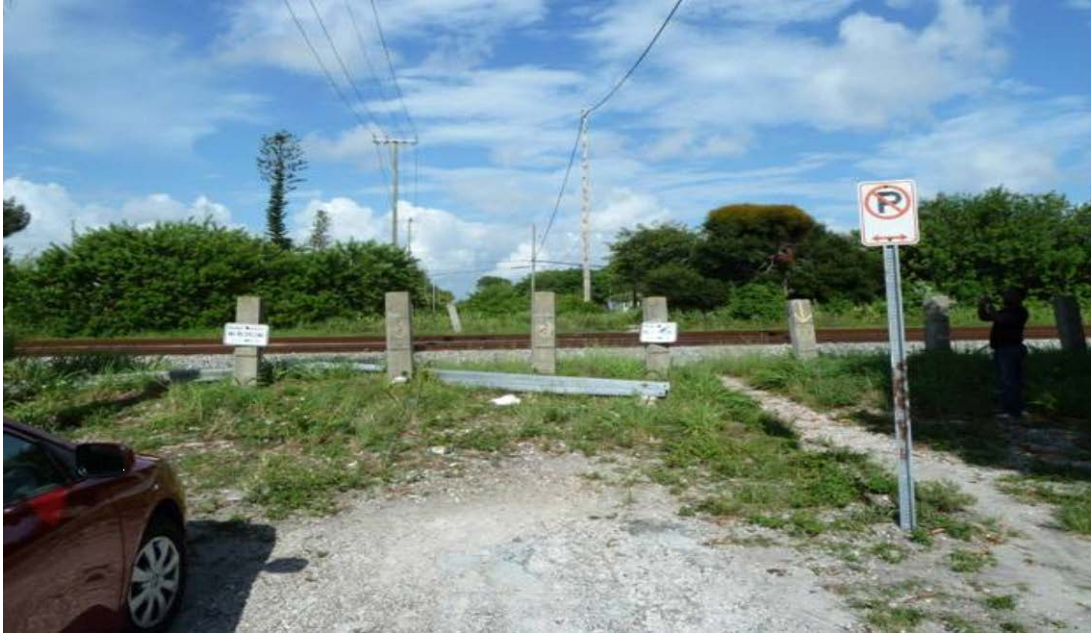
Figure 15. 43rd Street Dead End Abutting FEC ROW

16) Picture ID	244 - 252
17) Comments	The worn out trespassing route connect the 43 rd street that is separated by the tracks. One side of the track looks like dead end street and the other side is open area. The dead end side is barricaded with guard rails however the rails are torn down. During our site visit, we saw a man in his late 40 with his fishing rod cross the track.

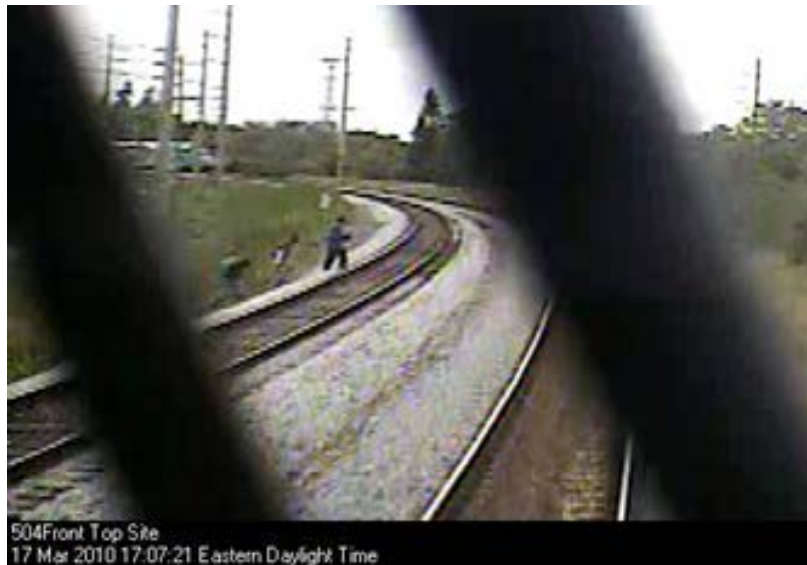
Figure 23. Trespass event on SFRC ROW between 45th and 36th Streets

As of December 2013, several strategies had been implemented or were in the process of being implemented at each of the top seven locations along the SFRC. The installation of a fence at the location bounded by 45th and 36th Streets is one example of an implemented recommendation at one of the high-risk locations. Figure 23 shows an event captured by the locomotive video at that location involving three trespassers and two trains, one of which is seen near the top left of the picture as it approaches. One of the recommended strategies for that location was the installation of a fence to the east of the ROW. The fence was installed by FDOT in September 2012, as shown in Figure 24.

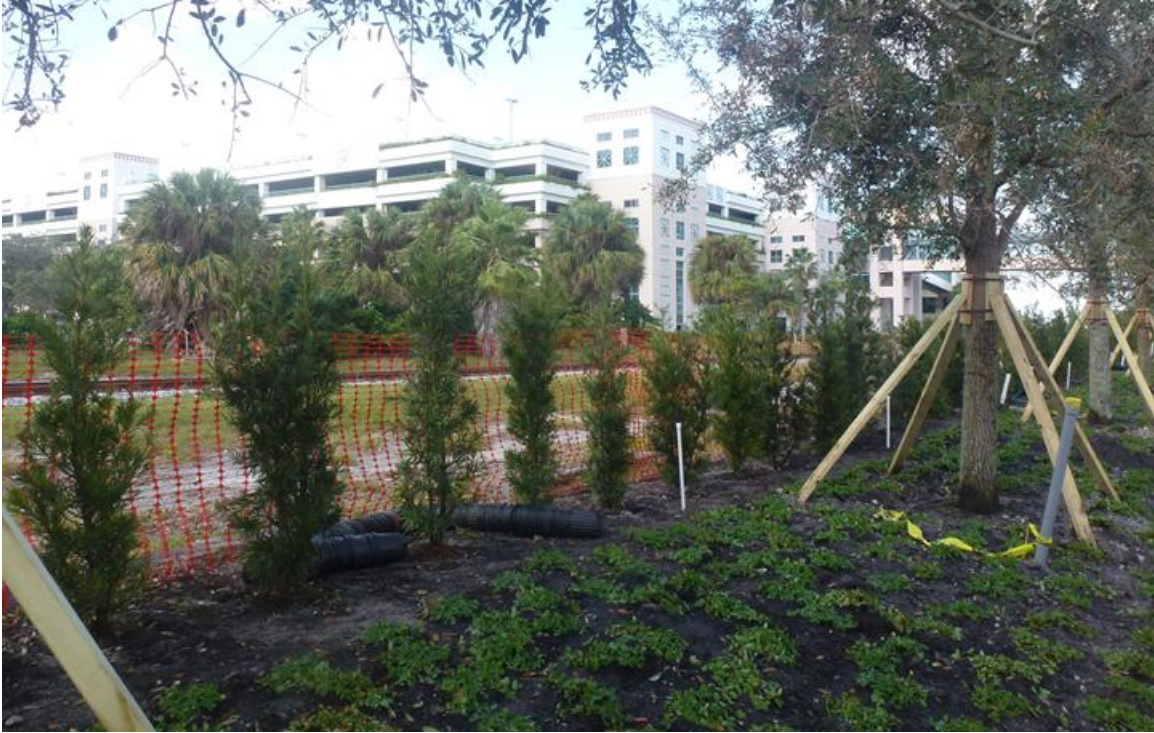
Figure 25. Landscaping bordering FEC ROW along Quadrille Boulevard (January 2013)

- Boys & Girls Club fencing installed by club
- Fencing at park bordering Boys & Girls Club repaired by city
- Beautification project by city of Quadrille Boulevard area bordering ROW (landscaping and fencing), as shown in Figure 25

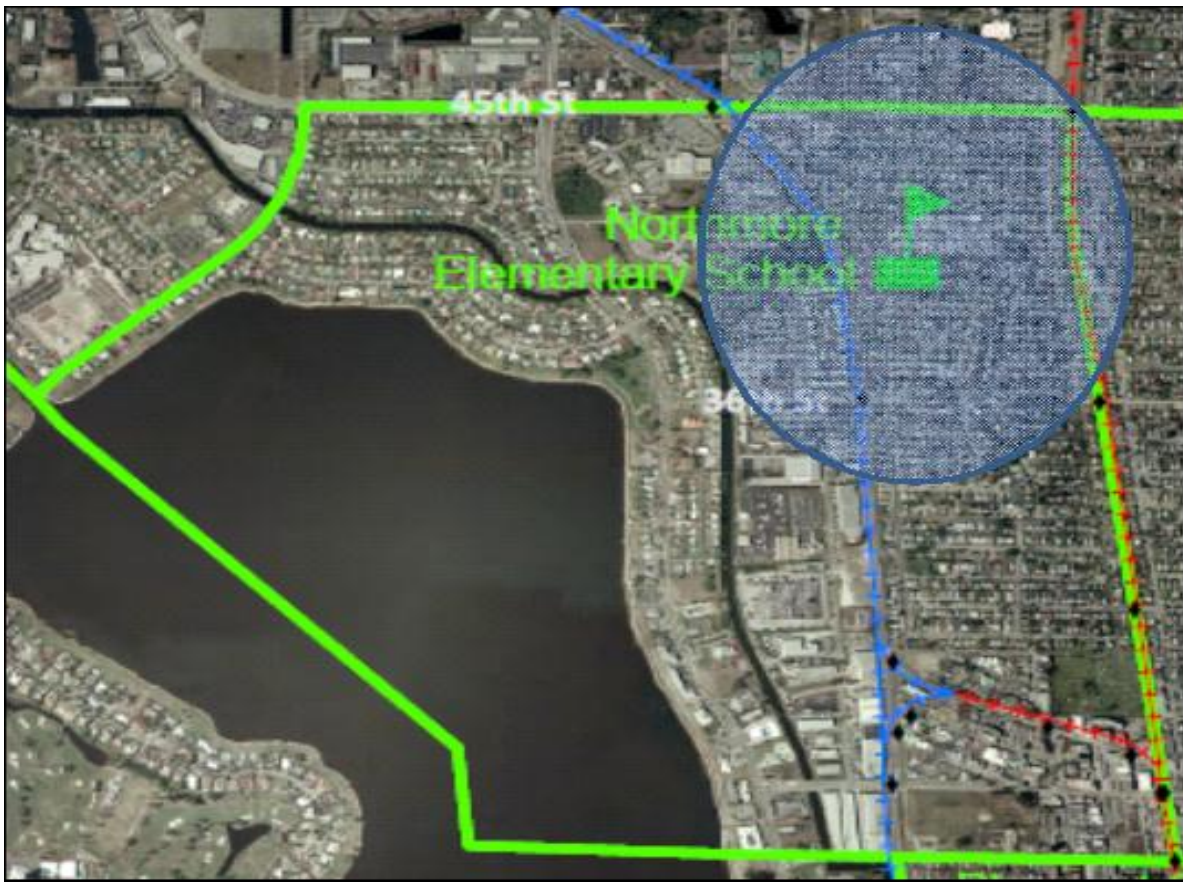
Figure C-6. Northmore Elementary School Attendance and Walk Rule Boundaries

Additionally, even if using a conservative $\frac{1}{3}$ mile estimate of distance traveled with the 10-minute walk rule, a substantial portion of the residential area to the opposite side of the ROW is within walking distance of the school, the area contained within the blue circle in Figure C-6. As shown by the data analysis, this school is a causal factor for the trespass problem noted at or near the northeast corner of the housing development on the west side of the ROW just north of 36th Street. As shown later in this report, most trespass events on the SFRC ROW (the blue line in Figure C-6) near the school involve young trespassers crossing the tracks. Interestingly, the school boundary follows the FEC ROW outlined by the red line to the right of the school in Figure C-6, and therefore theoretically decreasing the exposure to students walking to and from school since their school is on the same side of the ROW.

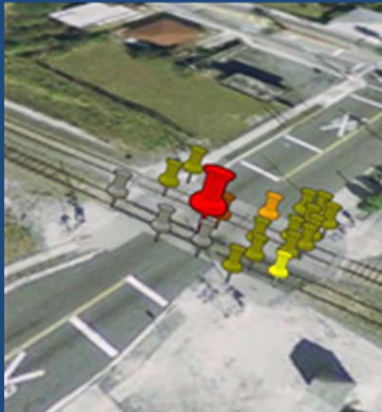
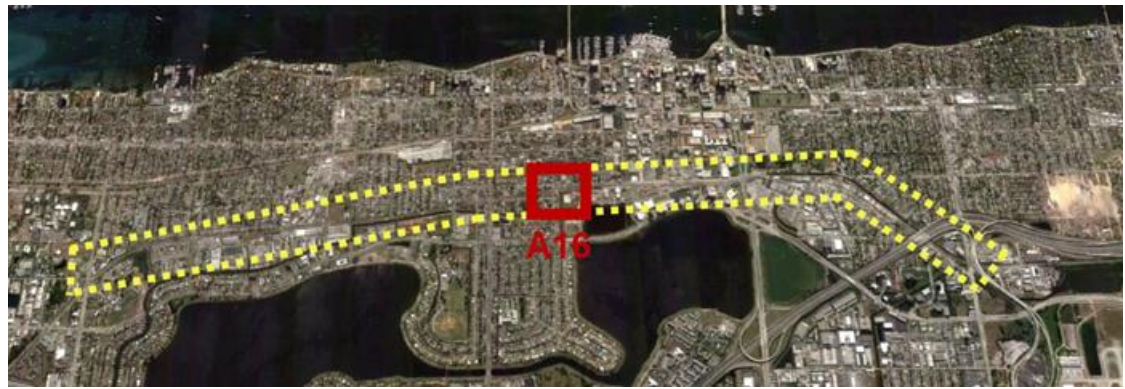
Location ID: A16
Description: 7th Street Grade Crossing

Trespass History:
1 fatality (12/04/07)
1 suicide (09/22/05)
1 attempted suicide (03/24/06)
Tri-Rail locomotive video - 14 trespass events (03/05/10-07/05/10)
3 trespass events noted via Veolia reports (04/07/10-04/19/10)

Most events involve pedestrians violating the pedestrian gates at the crossing.

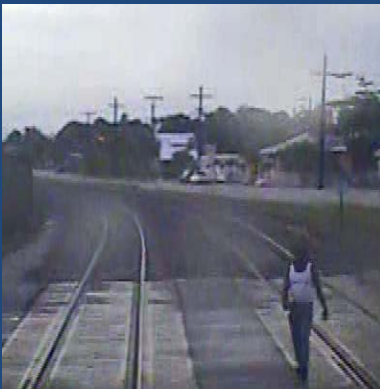
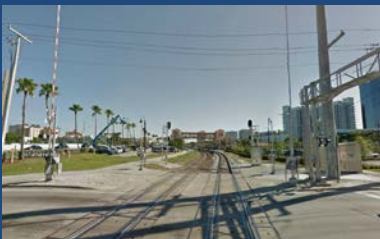
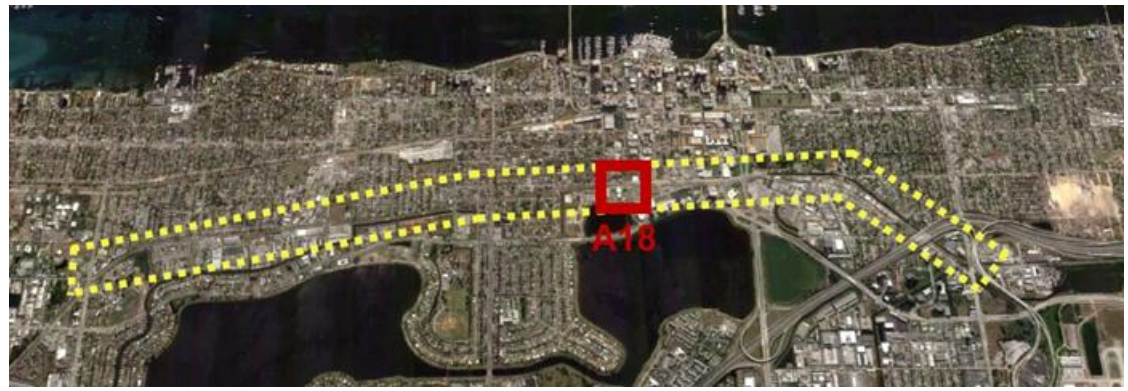
Trespass History:
1 fatality (07/17/05)
16 trespass events recorded via
Tri-Rail locomotive video
(03/05/10-07/05/10)

Most events involve pedestrians violating the pedestrian gates at the crossing.

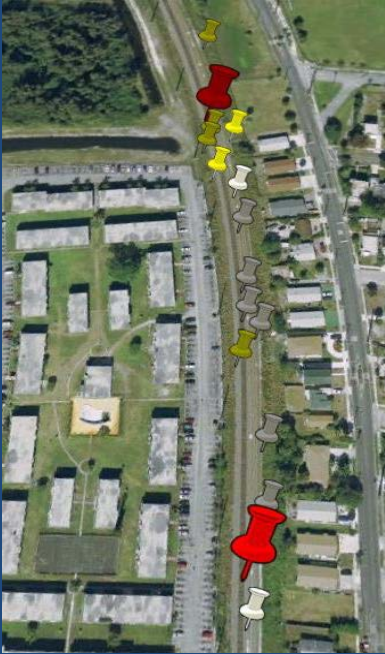
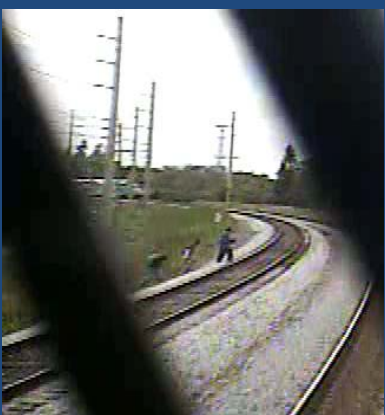
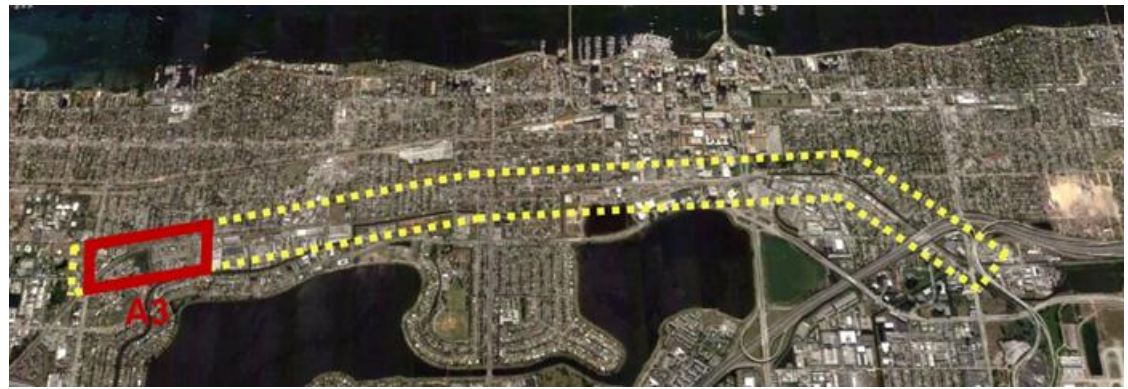
2 fatalities (02/07/08, 04/21/08)

14 trespass events recorded via Tri-Rail locomotive video (03/05/10-07/05/10)

8 trespass events noted via Veolia reports (04/07/10-04/19/10)

Most events involve young trespassers crossing the ROW near the northeast corner of the Sunset Place Apartments on the west side of the ROW.

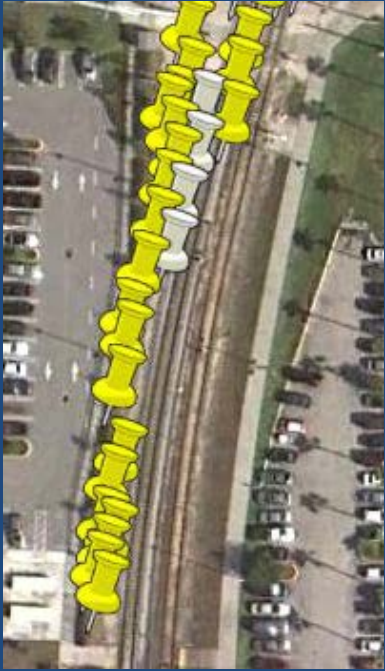
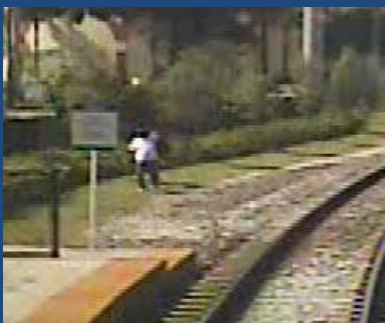
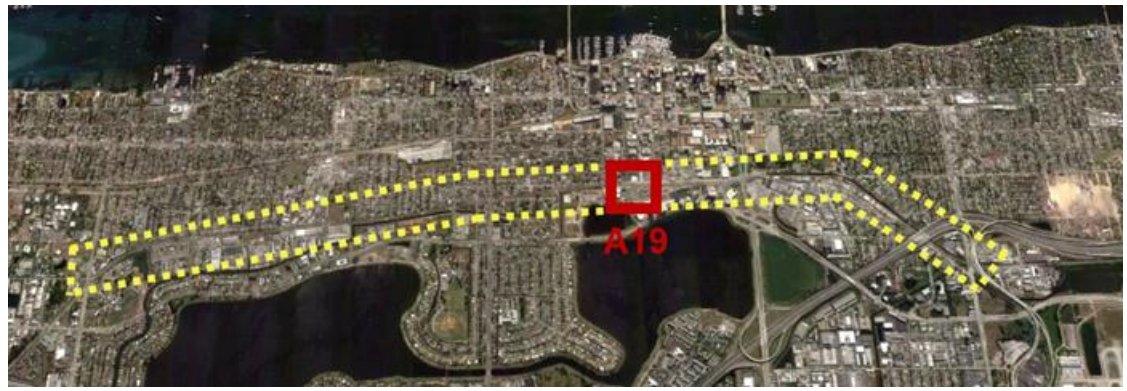
- 1 attempted suicide (11/24/09) – reported by Tri-Rail at the WPB station but exact location within property unknown
- 22 trespass events recorded via Tri-Rail locomotive video (03/05/10-07/05/10)
- 4 trespass events noted via Veolia reports (04/07/10-04/19/10)

Most events involve rail system users walking to and from west side station platform from Banyan Boulevard. A small number (3 out of 22) locomotive video trespass events involved trespassers crossing the tracks in the section between the end of the inter-track fence and Banyan Boulevard.

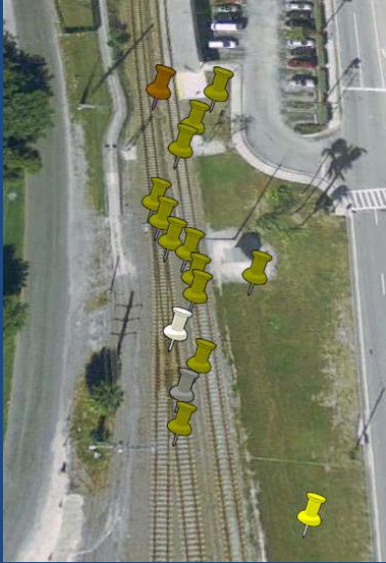
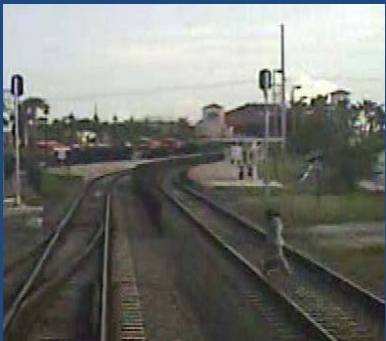
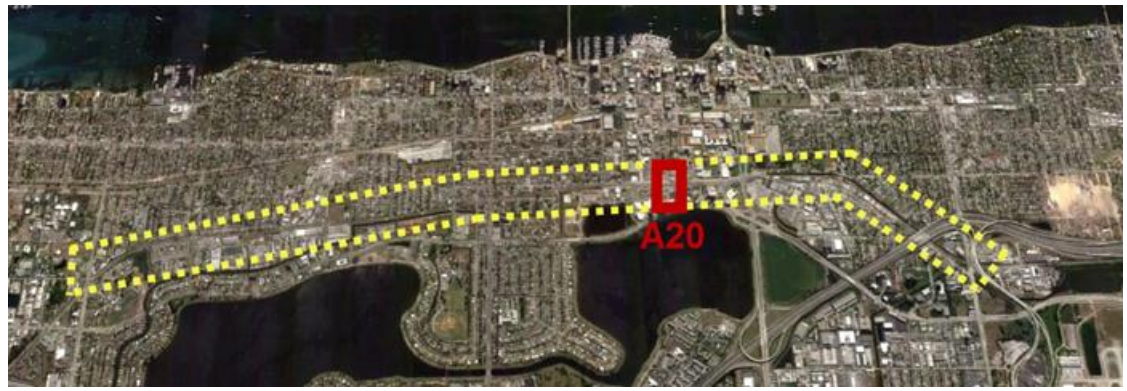
Location ID: A20
Description: Mockingbird CP

- 13 trespass events recorded via Tri-Rail locomotive video (03/05/10-07/05/10)
- 2 trespass events noted via Veolia reports (04/07/10-04/19/10)

Most events involve rail and/or bus system users walking between west side of the ROW and east side station platform or Tamarind Avenue. Many trespassers are students at the Alexander W Dreyfoos Jr School on Tamarind Avenue.

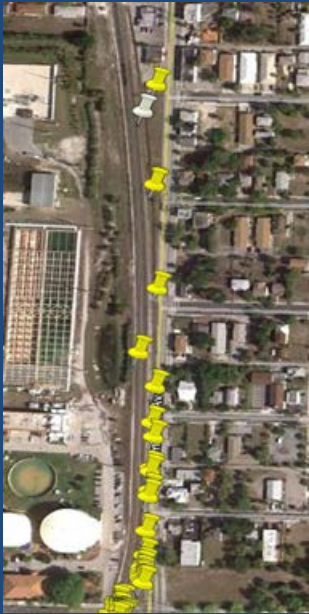
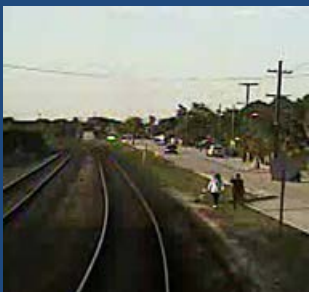
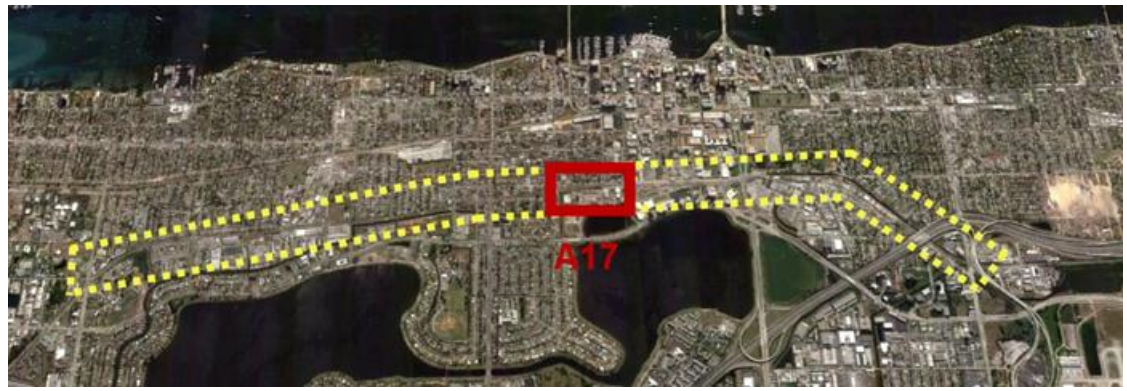
21 trespass events recorded via Tri-Rail locomotive video (03/05/10-07/05/10)

1 trespass event noted via Veolia reports (04/07/10-04/19/10)

Most events involve trespassers walking along the east side of the ROW parallel to Tamarind Avenue. A substantial number of trespassers walking southbound to Banyan Boulevard cross the tracks before they reach the grade crossing.
