## Effect of an Active Another Train Coming Warning System on Pedestrian Behavior at a Highway-Rail Grade Crossing

1. AGENCY USE ONLY (Leave blank)	2. REPORT DATE April 2014	3. REPORT TYPE AND DATES COVERED Technical Report April 2012 – September 2013
----------------------------------	------------------------------	---

7. PERFORMING ORGANIZATION NAME(S) AND ADDRESS(ES) U.S. Department of Transportation Research and Innovative Technology Administration John A. Volpe National Transportation Systems Center 55 Broadway Cambridge, MA 02142	8. PERFORMING ORGANIZATION REPORT NUMBER DOT-VNTSC-FRA-13-06
--	---

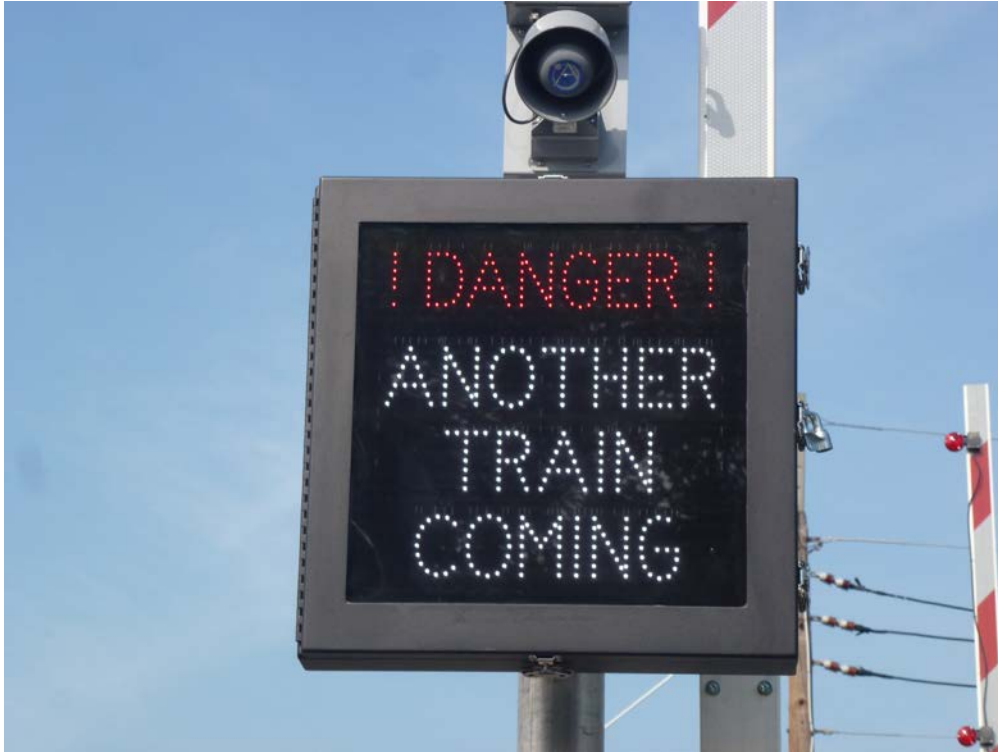
**Figure 1. Another Train Coming Warning Sign and Auditory Alert Speaker**

The sign chosen by NJ Transit Rail for the current study is the same type presently in use at near-station crossings along the Union Pacific West Line in the Chicago area [6]. The system, which is depicted in Figure 8, flashes the word “Danger” in red and displays “Another Train Coming” below it in bright, white Light Emitting Diode (LED) lights. Above the sign is mounted a speaker, which is also depicted at the top of Figure 8, which repeats the phrase “Danger, another train coming” in a male voice for the duration of the activation.

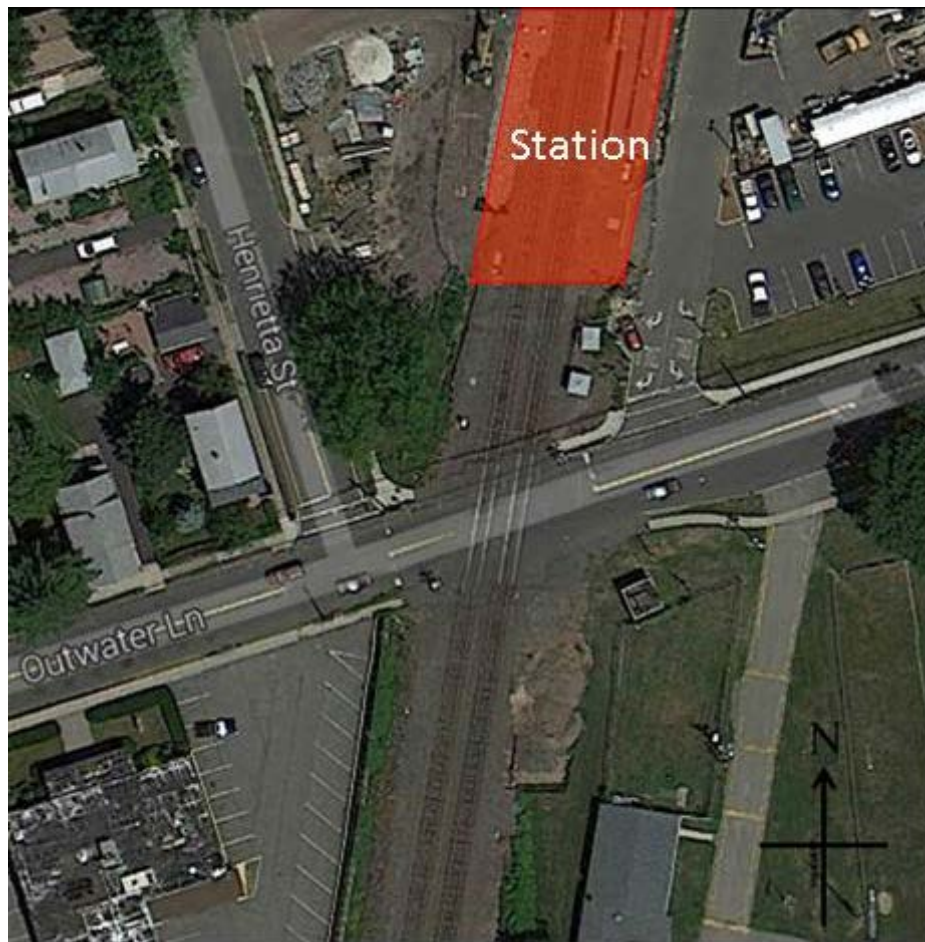
**Figure 2. Outwater Lane Grade Crossing in Garfield, NJ**

NJ Transit Rail selected a grade crossing along the Bergen County Line at Outwater Lane (grade crossing ID# 263413V) located in Garfield, NJ, to pilot test the second train signage safety enhancement. The crossing, shown in Figure 2, is adjacent to the NJ Transit Plauderville Train Station, which is located at the top of this depiction.

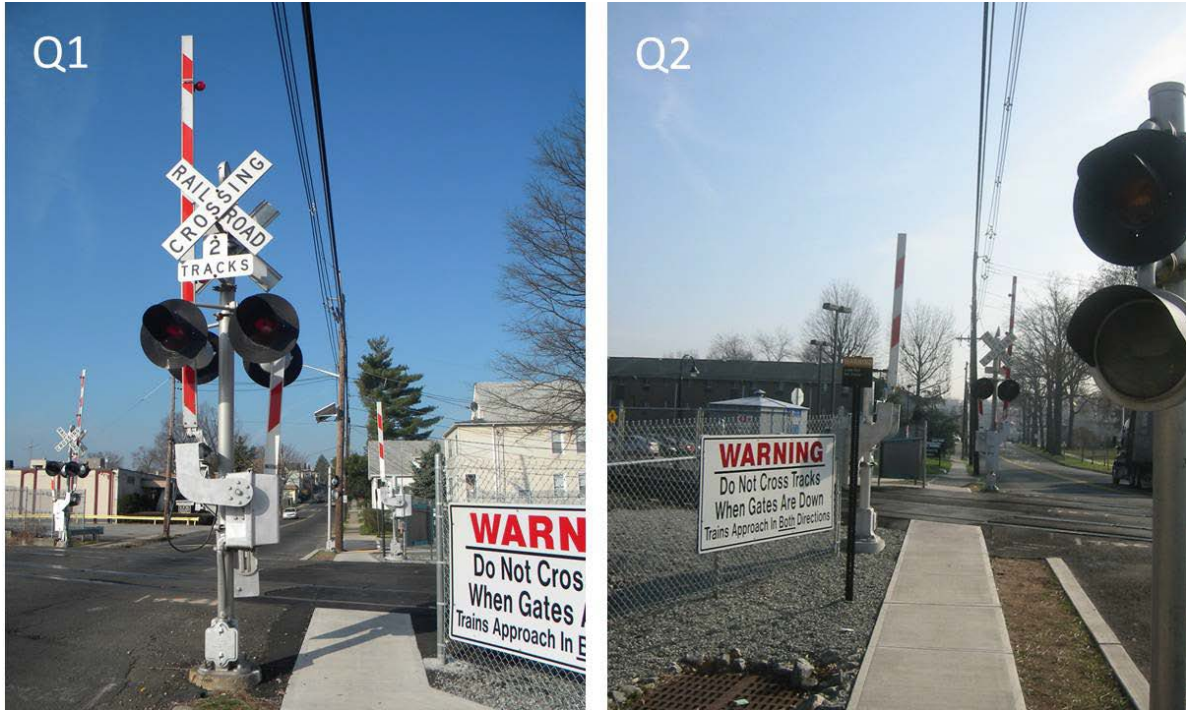
Quadrant 1 (Q1) and Quadrant 2 (Q2) had similar safety enhancements in place at the start of the data collection. As seen in Figure 4, both Q1 and Q2 had train activated pedestrian gate signage warning pedestrians of potential train activity. Both also had fencing to prevent pedestrians from travelling to the outside of the gate.

**Figure 4. Quadrant 1 (left) and Quadrant 2 (right) Safety Enhancements at the Start of the Study**

When the pedestrian gate is in the horizontal position (fully descended), it borders a fence and blocks pedestrians from walking around the gate and outer boundary of the sidewalk. In Quadrant 3 (Q3), there were train activated pedestrian gates; however, this quadrant lacked the channelization and signage that was found in Q1 and Q2. The pedestrian gates in Q3 are depicted in Figure 5.

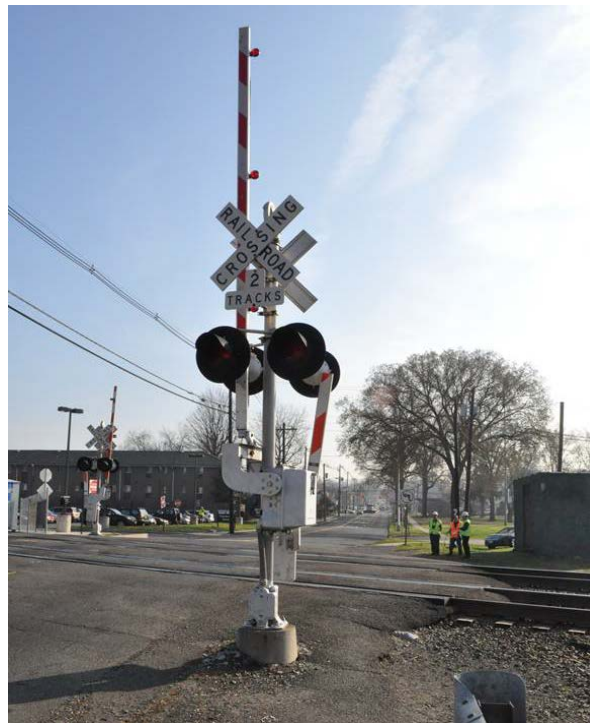
**Figure 5. Quadrant 3 Safety Enhancements at the Start of the Study**

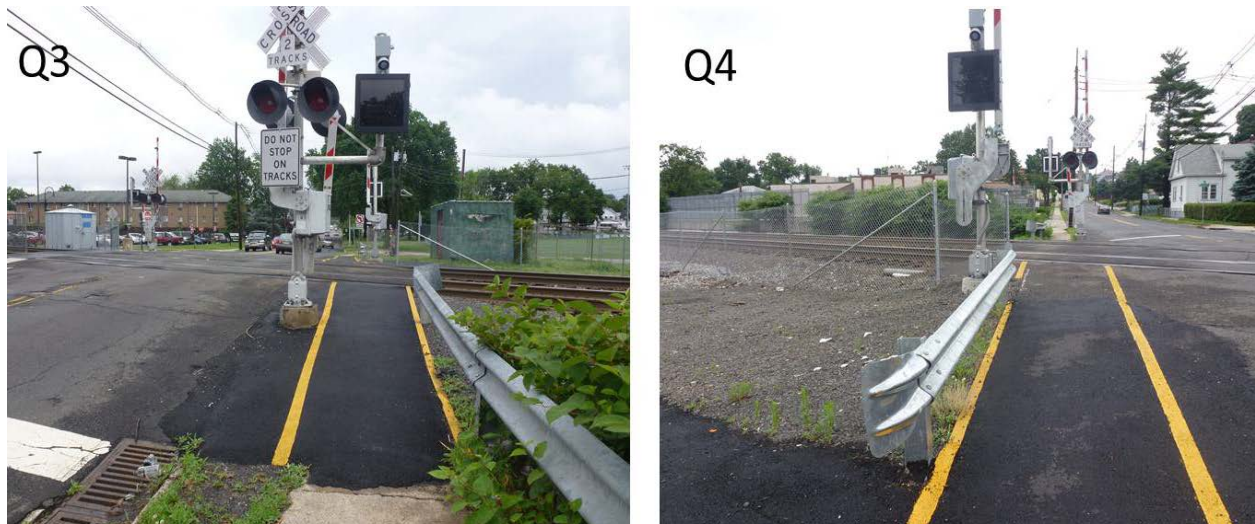
Enhancements were made to both Q3 and Q4 after data collection began for this study. In August 2012, train activated pedestrian gates were added to Q4, and channelizing guard rails were added to both Q3 and Q4. These guard rails were intended to deter pedestrians from travelling around the pedestrian gates (to the outside) once the gates had descended. The extended guard rail in Q3 and the new pedestrian gate and guard rail are depicted in Figure 7.

**Figure 7. Added Safety Enhancements in Quadrant 3 (left) and Quadrant 4 (right) in August 2012**

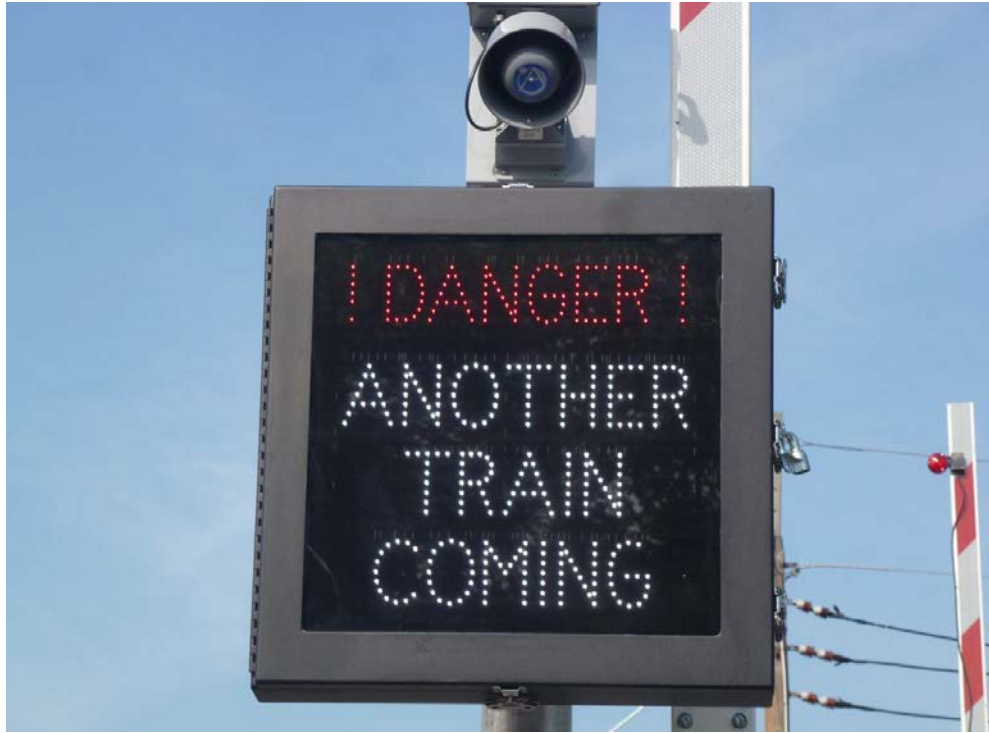
**Figure 8. Another Train Coming Signage and Auditory Speaker**

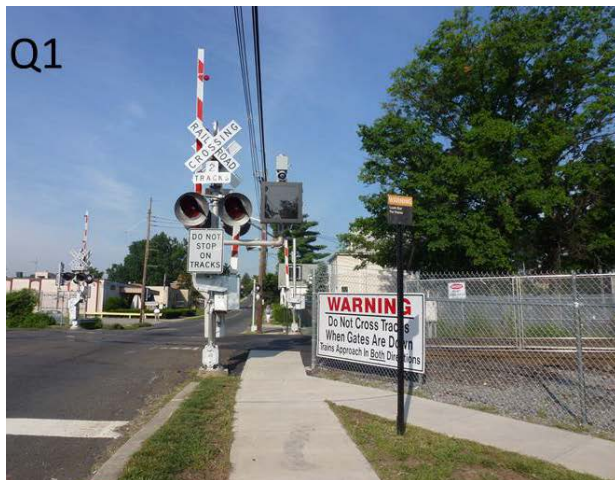
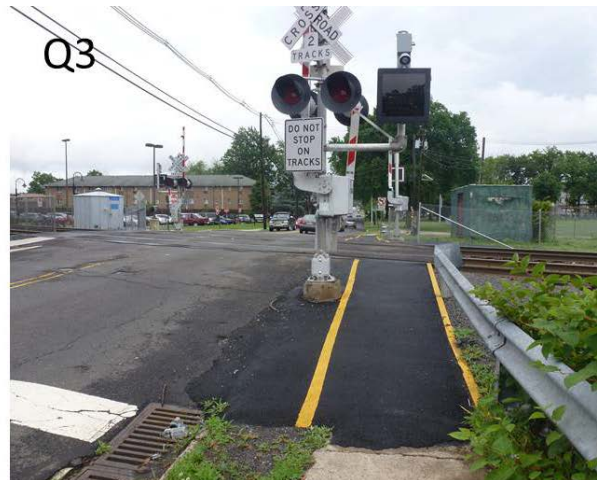
The systems were mounted at the crossing in one of two ways. In Q1 and Q3, the sign and speaker were mounted on an arm sticking out from the gate pole, onto which were mounted both the street and sidewalk gates. As seen in Figure 9, the signage in Q1 (left) and Q3 (right) was positioned directly above the pedestrian walkway.

**Figure 9. Another Train Coming Signage Placement in Q1 and Q3**

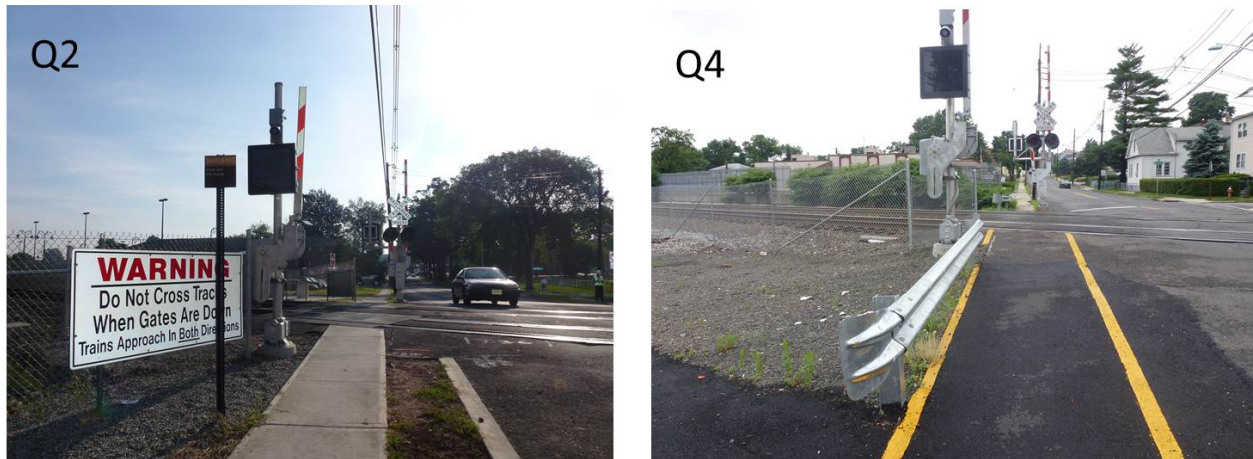
Placement of the signage in Q2 and Q4 was slightly different. In each of these quadrants, the sign and speaker were mounted directly to the gate post without any arm extending the signage away from the post. In these quadrants, the signage was not directly above the pedestrian walkway, but instead to the left of the walkway, as depicted in Figure 10.

**Figure 10. Another Train Coming Signage Placement in Q2 and Q4**

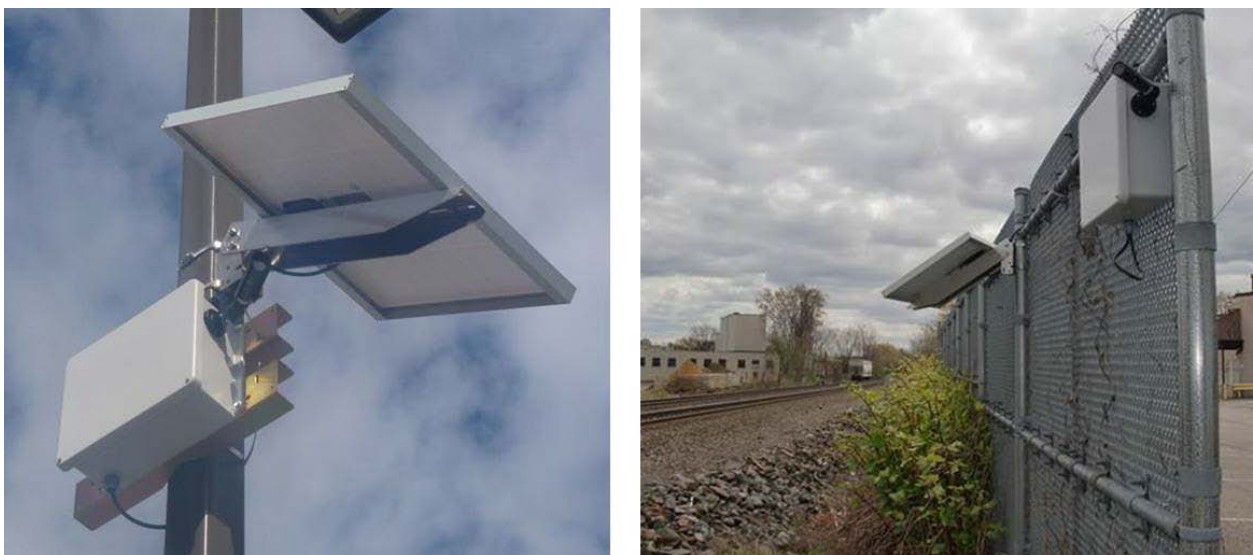
The data collection equipment consisted of two small video cameras connected to a digital video recorder and solar panel. Figure 11 shows the two systems, each consisting of a solar panel, camera, and box which housed the digital video recorder.

**Figure 11. Solar Panel, Camera, and Box Housing the Digital Video Recorder**

One of the two cameras was mounted to a pole located near Q1 (the pole-mounted setup is shown in the left half of Figure 11). The view from this camera captured pedestrian movements in all four quadrants; however, pedestrians approaching Q4 could not be seen. A sample of the view from the camera is provided in Figure 13.

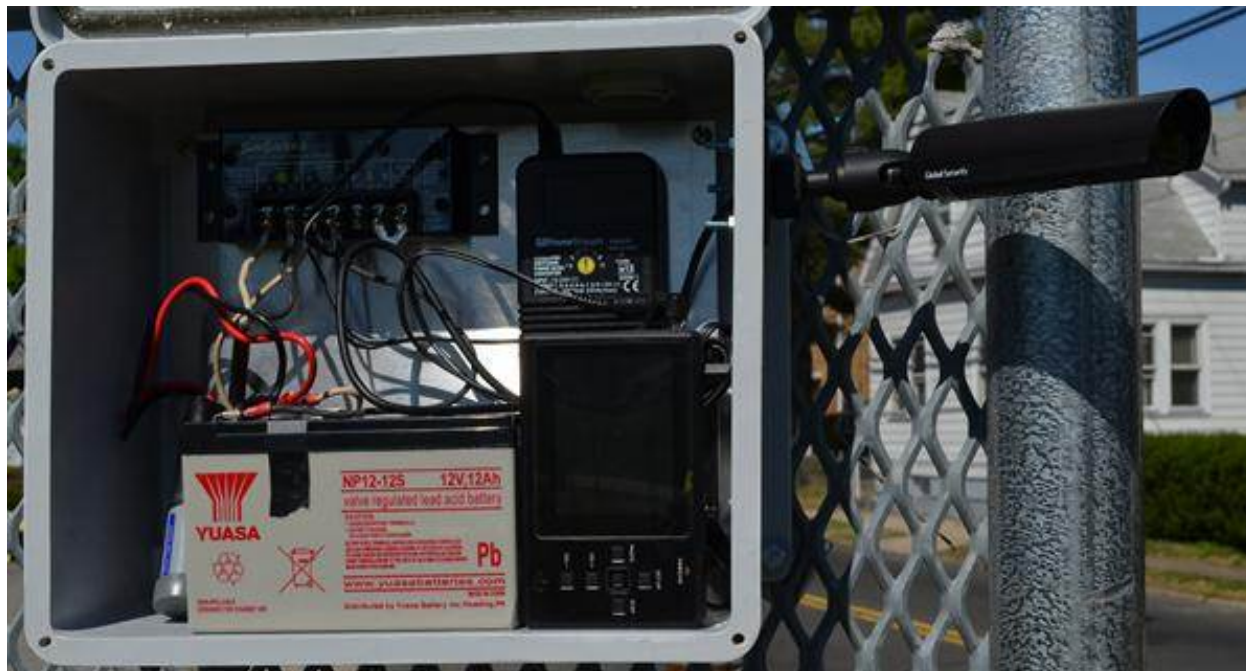
Inside each box was a digital video recorder that was able to record and store videos of the crossing. The digital video recorder was fully powered by the solar panel and is shown in Figure 12.

**Figure 12. Digital Video Recorder**

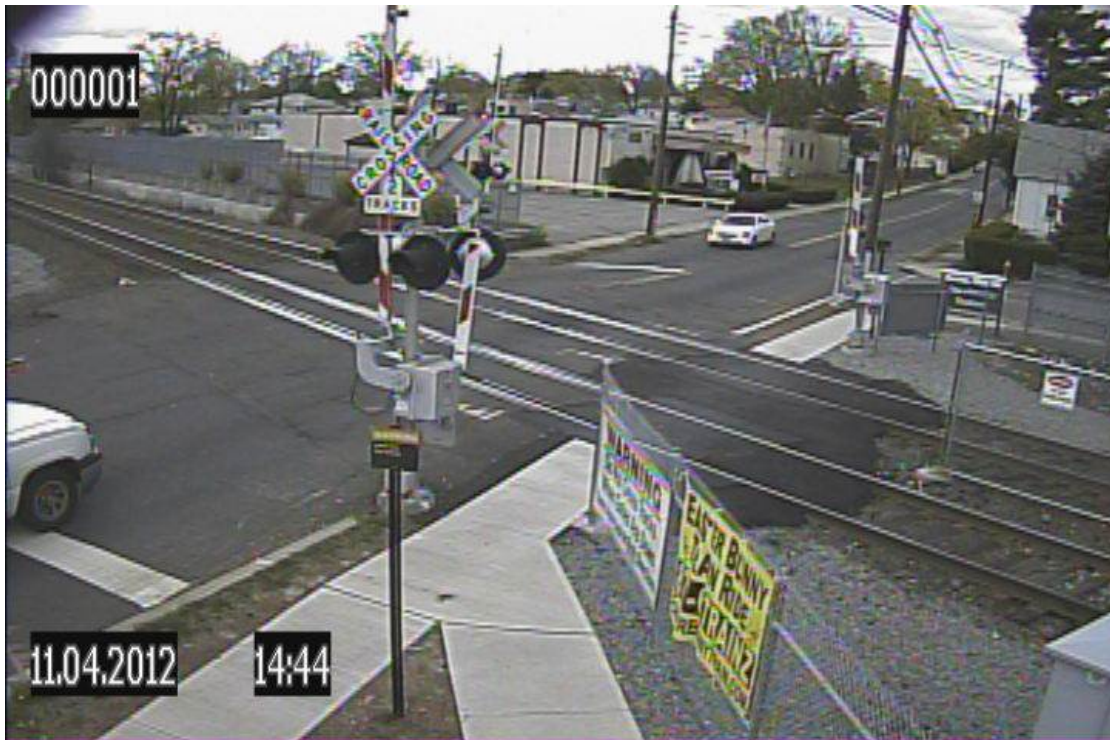
Figure 13. View from Pole Mounted Camera in Q1

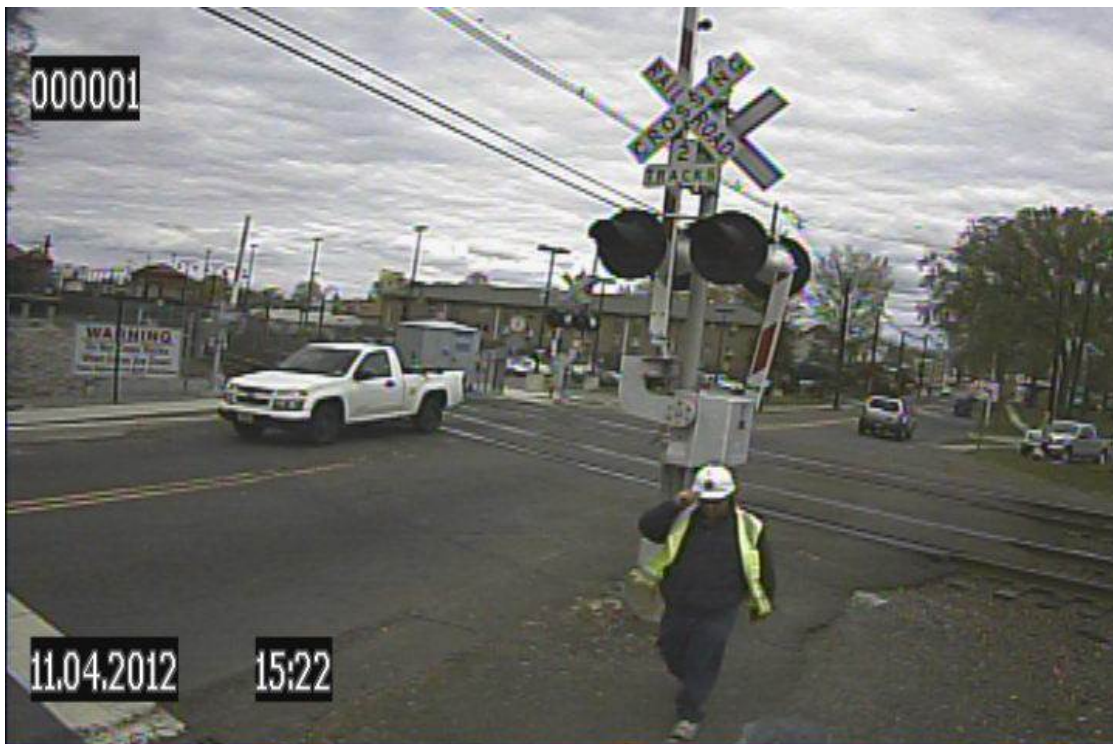
A second camera was mounted on the fence near Q3. This camera was connected to the same type of digital video recorder and solar panel as the pole-mounted camera. This camera was also capable of capturing pedestrian movements in all four quadrants; however, the vantage point was closer to the ground. Figure 14 provides a sample view from the fence mounted camera.

Figure 14. View from Fence Mounted Camera in Q3

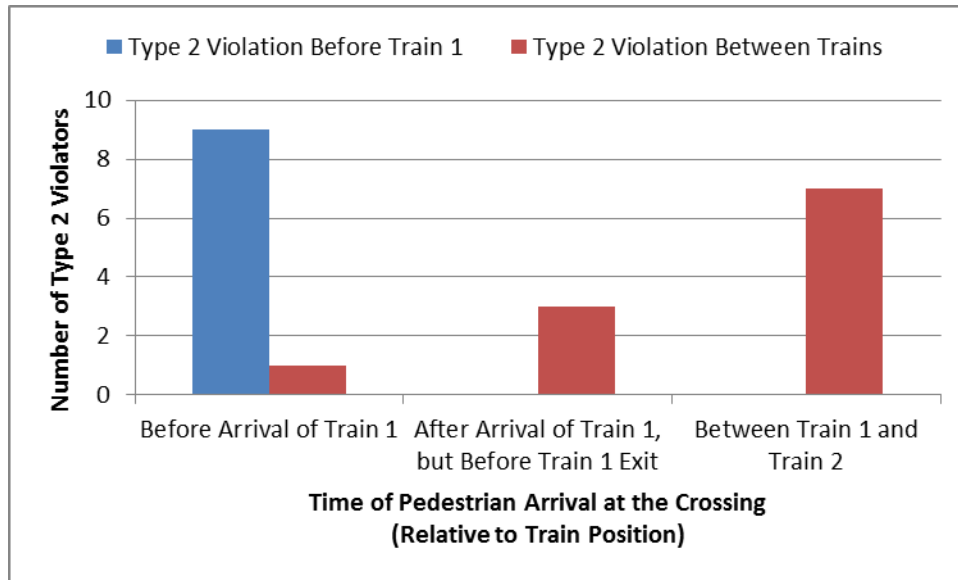
**Figure 16. Number of Post-Installation Type 2 Violators by Arrival Time of the Pedestrian at the Crossing**

In Figure 16, those pedestrians in the post-installation period who arrived at the crossing prior to the arrival of Train 1 and went on to violate by going under the gates were most likely to violate before the first train arrived (as opposed to waiting to violate between or after both trains). This was not the case for the pre-installation condition where none of the eight violators who arrived prior to the arrival of Train 1 decided to violate before the first train had arrived.

Almost half (45 percent) of the individuals who violated between trains had arrived at the crossing prior to the arrival of the first train. Pedestrian arrivals prior to Train 1 were slightly higher in the post-installation condition (11 [52 percent] after installation compared with 8 [38 percent] before installation). Pedestrians, both before and after installation of the signage, may have had the opportunity to violate prior to the arrival of the first train, but many (and *all* of those in the pre-signage condition) waited until after the first train to violate. Figure 16 provides a more detailed look at the arrival patterns for *only the post-installation* condition by grouping the pedestrians into those who violated before Train 1 and those who violated between Train 1 and Train 2 (Note that arrival times after “Between Train 1 and Train 2” have been removed because no Type 2 violations occurred during these times.).

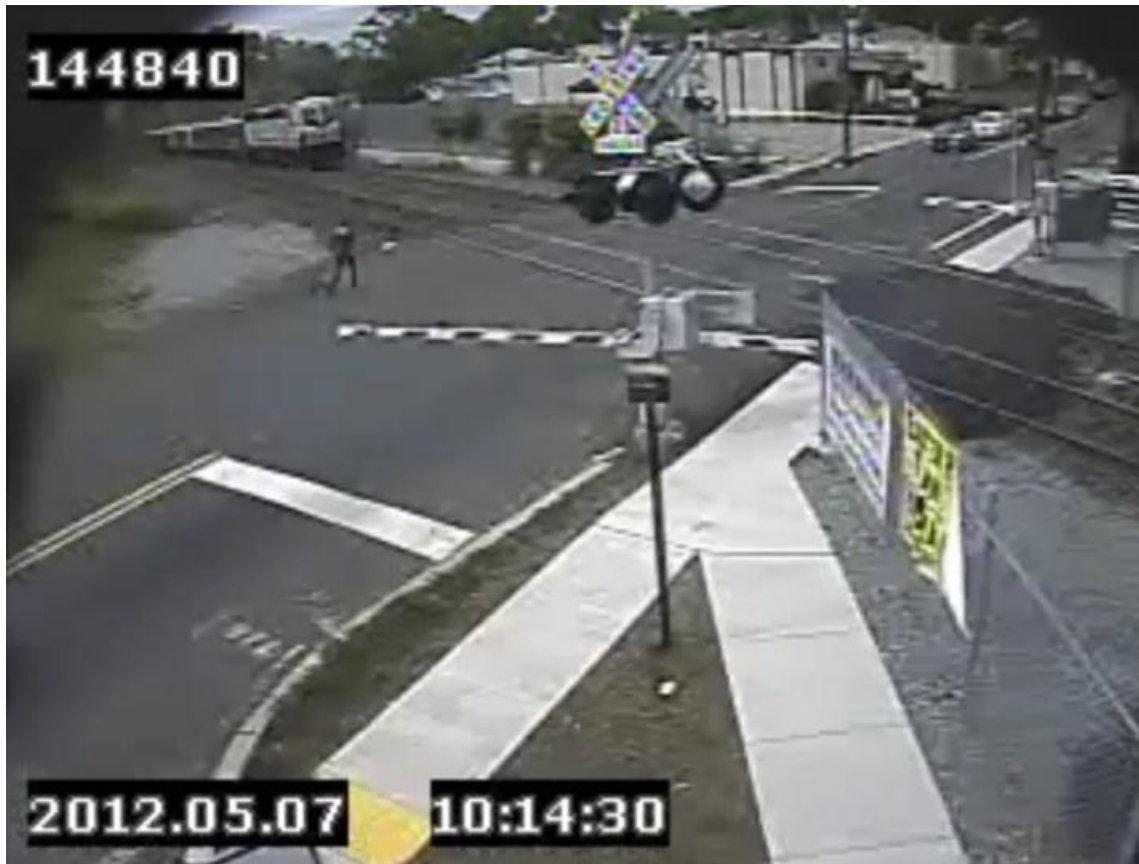
The first image below depicts a pedestrian violating the crossing in the road as a train approaches. This violation occurred prior to the installation of the second train warning system.

**Figure 17. Pedestrian Violation Prior to Second Train Warning System Installation**

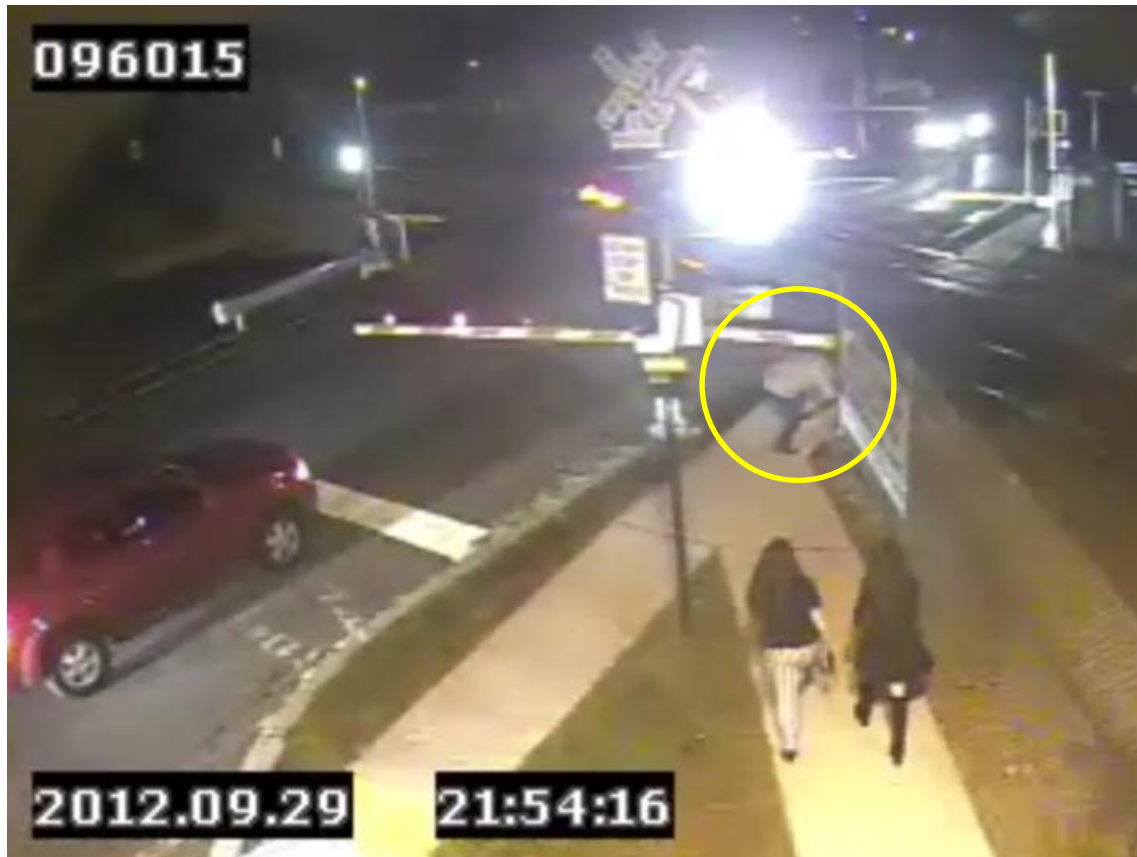
The next image depicts a pedestrian, circled in yellow, violating the crossing by traveling under the horizontal gate. Shortly after the first violation occurs, the two women depicted at the bottom of the image also violate the crossing by going underneath the horizontal gates. The bright light in the image is the glow from the second train warning sign that has been activated by the approaching trains.

**Figure 18. Pedestrian Violation after Second Train Warning System Installation**
