U.S. Department of
Transportation

Federal Railroad
Administration

Full-Scale Dynamic Testing of Locomotive Crashworthy Components

9. SPONSORING/MONITORING AGENCY NAME(S) AND ADDRESS(ES) U.S. Department of Transportation Federal Railroad Administration Office of Railroad Policy and Development Office of Research, Development, and Technology Washington, DC 20590			10. SPONSORING/MONITORING AGENCY REPORT NUMBER DOT/FRA/ORD-15/33

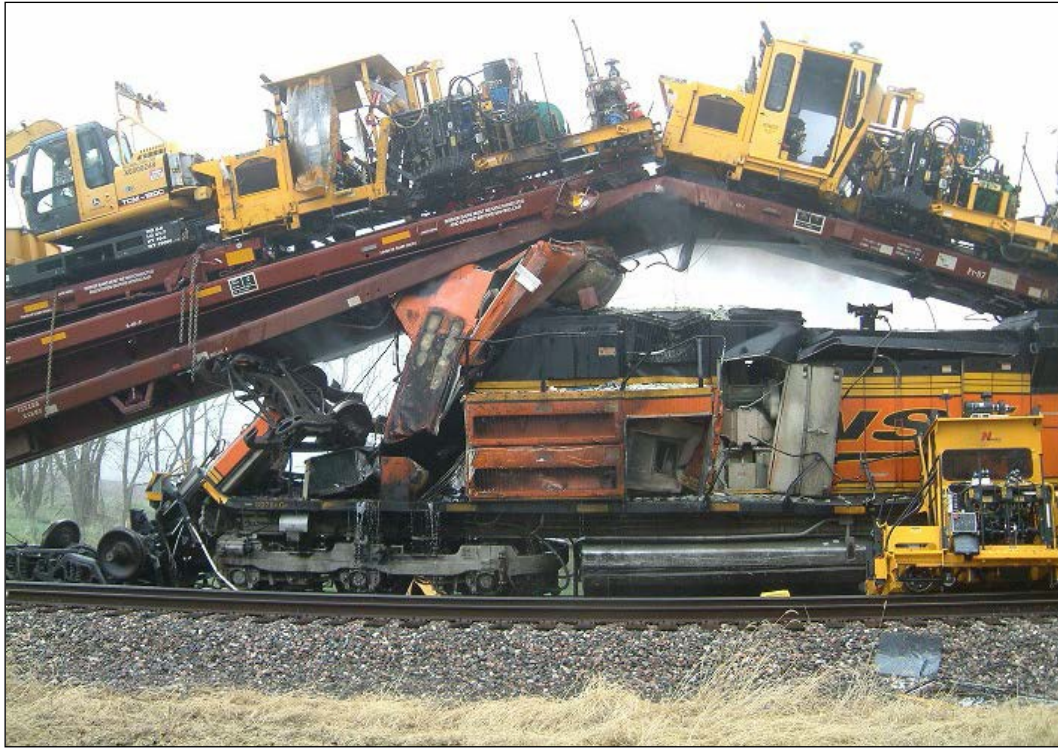
Figure 1. April 17, 2011, Collision: Red Oak, Iowa

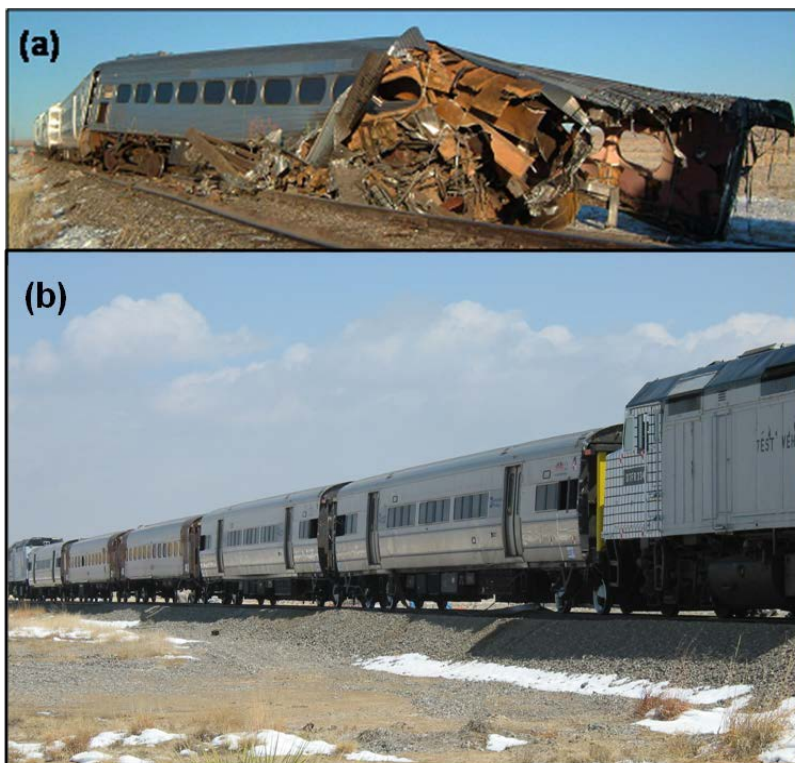
Figure 2. Comparison of Outcomes of Full-Scale Train-to-Train Collision Tests

CEM systems for passenger trains have been widely employed in Europe. In the United States, CEM systems are just now being developed. Beginning in 2000, FRA and the Volpe Center initiated a series of research programs aimed at developing a CEM system for a passenger train meant for use on the U.S. general railroad system. Those activities culminated in a full-scale collision test between a cab-car-led passenger train outfitted with a CEM system, traveling at 34 mph, and a standing, conventional locomotive-led train. This test, conducted in March 2006, clearly demonstrated the benefits of CEM design. Not only did the CEM train dissipate the energy of the collision through controlled deformation of crush zones throughout the length of the train, but the passenger train and the locomotive-led train both stayed on the track—in stark contrast to the results of a similar test of conventional equipment, in which the cab car overrode the locomotive (Figure 2).

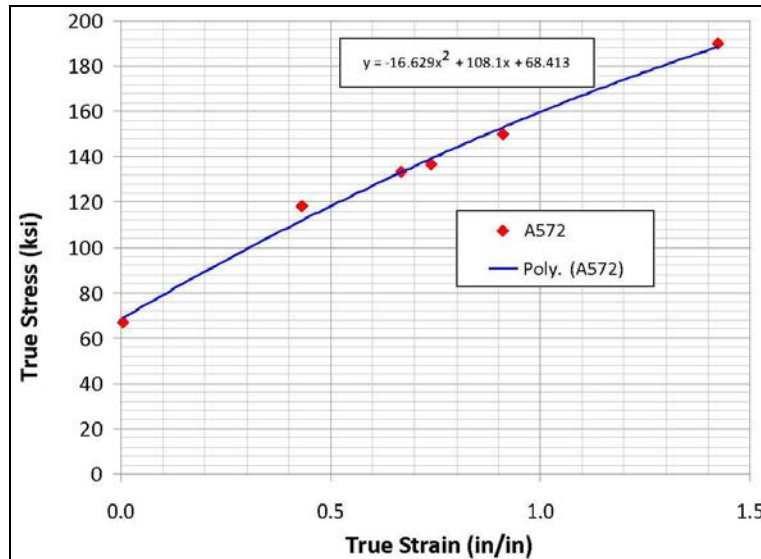
5. The final diameters of the necked sections of each test specimen were measured and used to calculate a diametral strain.
6. A polynomial fit to the six measured stress/strain values was made to determine a complete stress-strain curve. The individual data points and polynomial fit are shown in Figure 8.

Figure 8. True Stress-Strain Curve for A572-50 Fit to Measured Data

These data indicate a fracture strain in uniaxial tension of 1.42. This value was used as the basis for selecting parameters of a Bao-Wierzbicki failure model that was implemented in FEA models of tube crush.

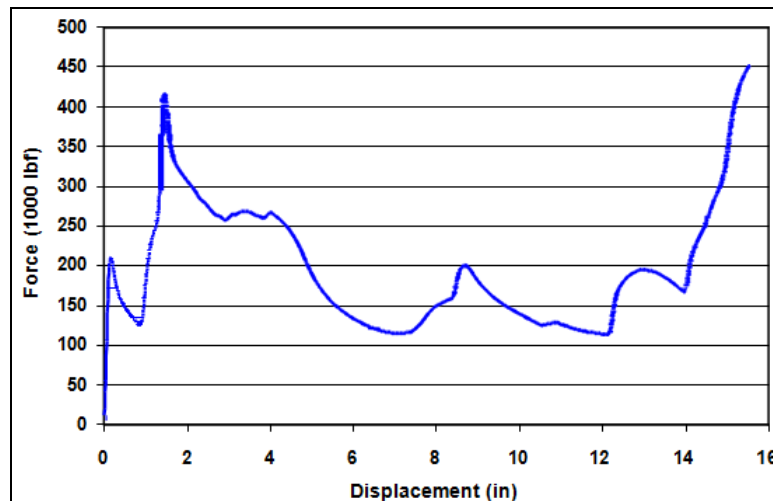
to fold, until the folds begin to consolidate at around 14 inches of crush and the load rapidly builds up again. The predicted energy absorption after 14 inches of crush is 214 ft-kips.

Figure 12. Pre-test FEA Model Predicted Force-Crush Curve

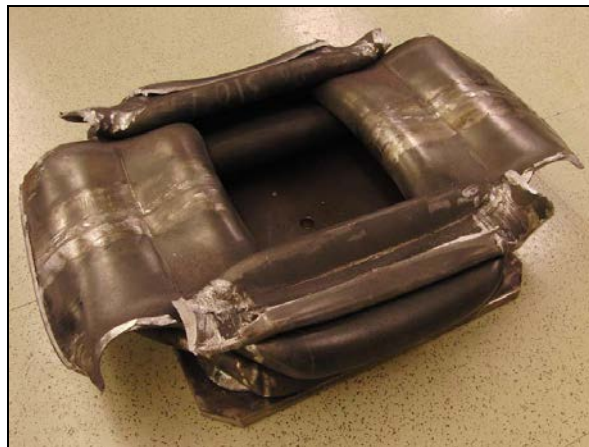
Figure 14. Post-test Photograph of First Test Article

about 1.5 inches away from each of the corners of the tube (Figure 13). The test was continued, and as the tube deformed, two opposing sides of the plate (the “front” and “back” of the specimen) began to peel away from the tube due to continued propagation of the vertical cracks. The test was stopped after 15.5 inches of crush. When the tube was completely unloaded and removed from the testing machine, the entire top plate had separated from the rest of the tube due to the propagation of a crack all the way around the slotted region of the tube. A photograph of the tube after the test (minus the separated top end) is shown in Figure 14.

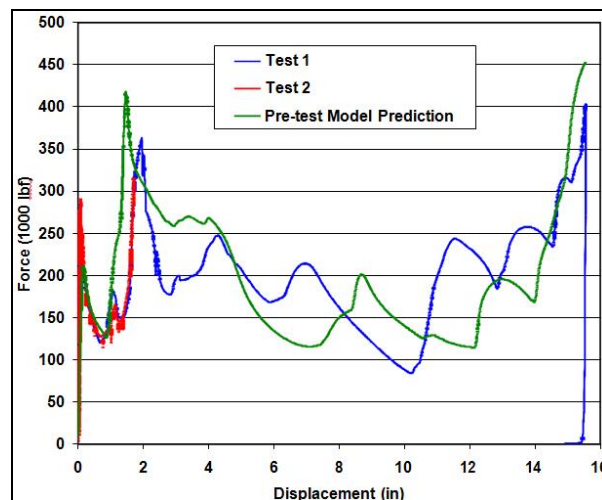
A comparison of the pre-test model prediction of force-displacement curve with test results is shown in Figure 16. The model seems to do a good job of predicting behavior early on for both tests. Once fracture initiates, the behavior in the test begins to diverge from model predictions, as one might expect. Nonetheless, the general characteristics of the curves (load magnitudes, size and shape of undulations) are similar. The measured crush energy after 14 inches of crush is 220 ft-kips for the first test, which is only about 3% more than the predicted value.

Figure 16. Comparison of Pre-test Predictions and Test Results for Force vs. Displacement

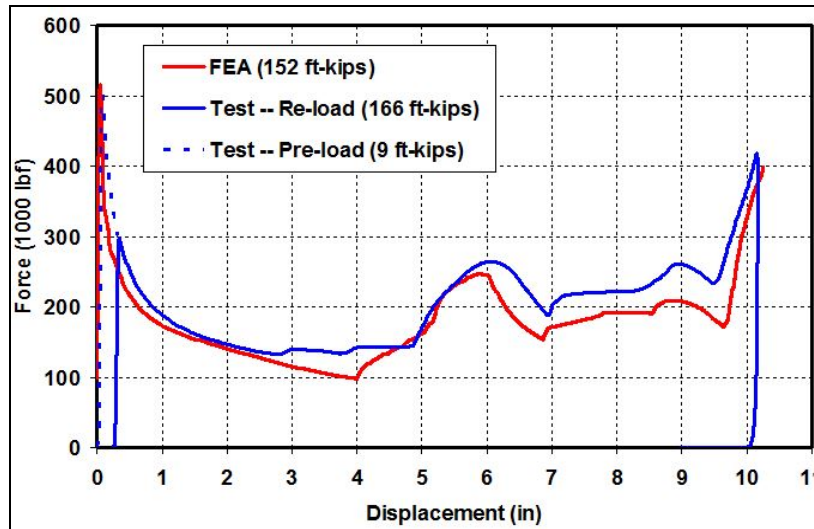
Figure 24. Comparison of FEA Predictions of Force-Displacement and Energy with Test Results for Two-Slot Tube Design

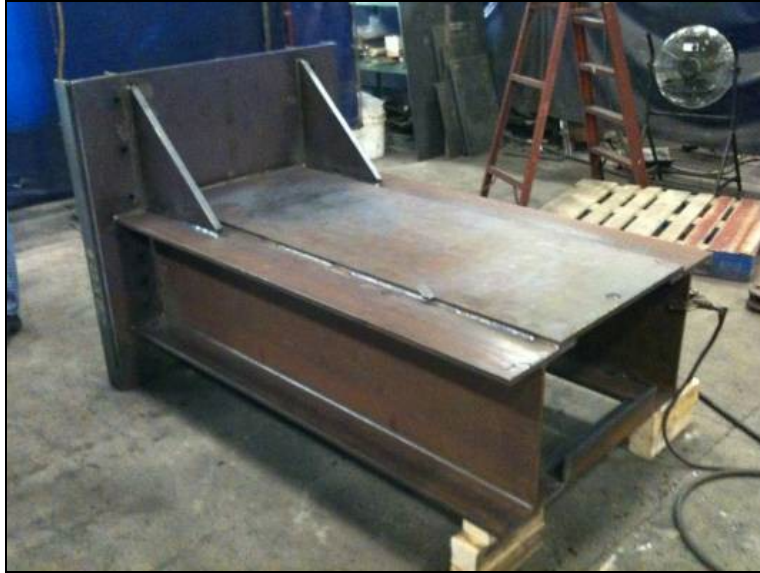
Figure 25. Support Beam Assembly Undergoing Final Welding

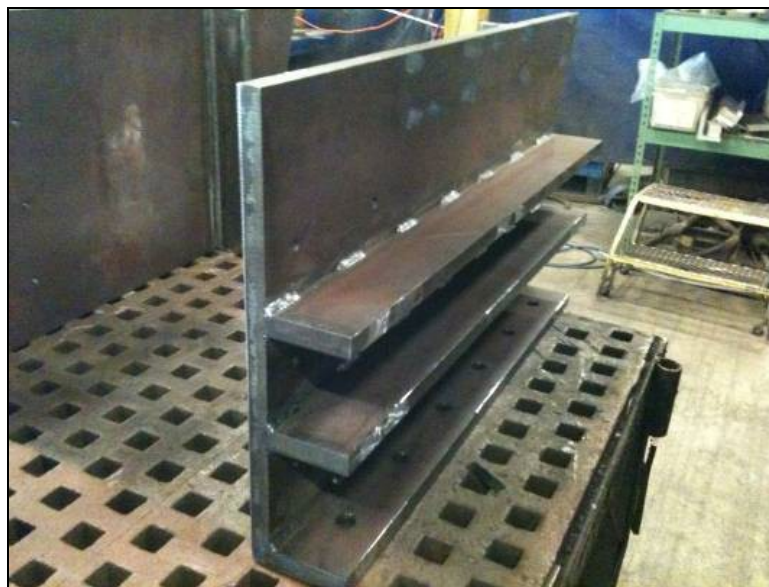
Figure 26. One of Two Side Wall Assemblies Before Final Welding

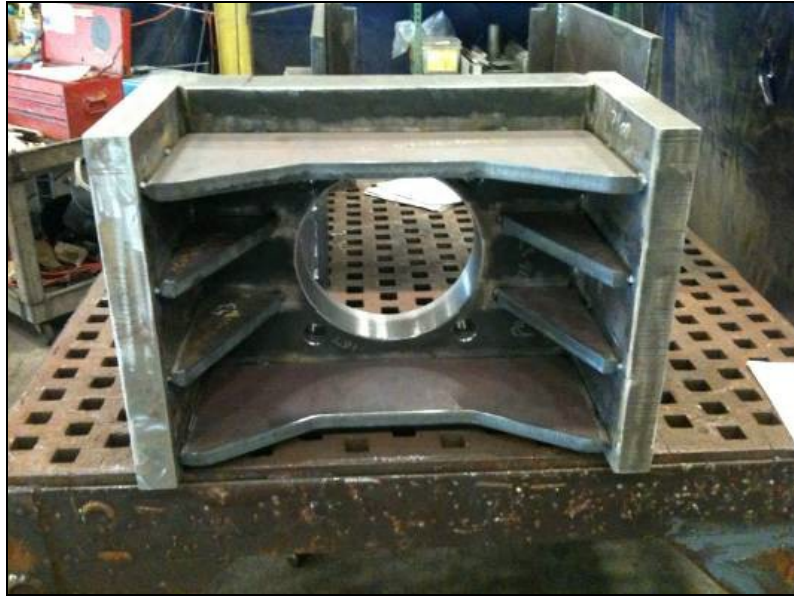
Figure 27. Sliding Lug Assembly Before Final Welding

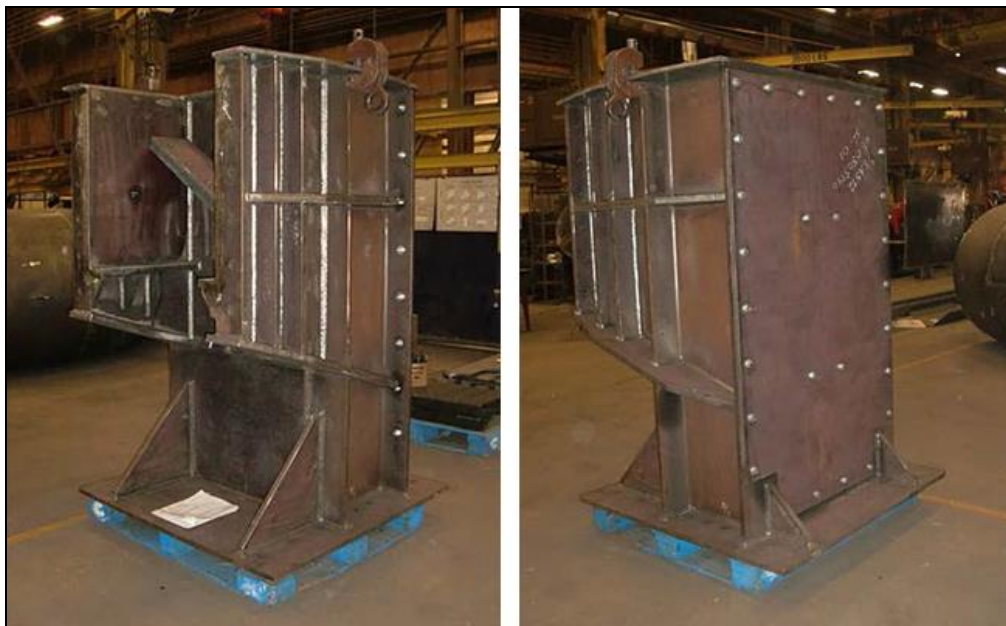
Figure 28. Photographs of the Push-Back Coupler Test Article, Minus the Sliding Lug Assembly

BEPeterson completed fabrication of all of the push-back coupler test article assemblies, except for final machining and installation of the shear bolts, in November 2011. TIAX and Volpe personnel made an inspection visit to BEPeterson shortly thereafter. A number of key dimensions were measured and found to be in tolerance. Photographs taken during that visit are shown in Figures 28 and 29.

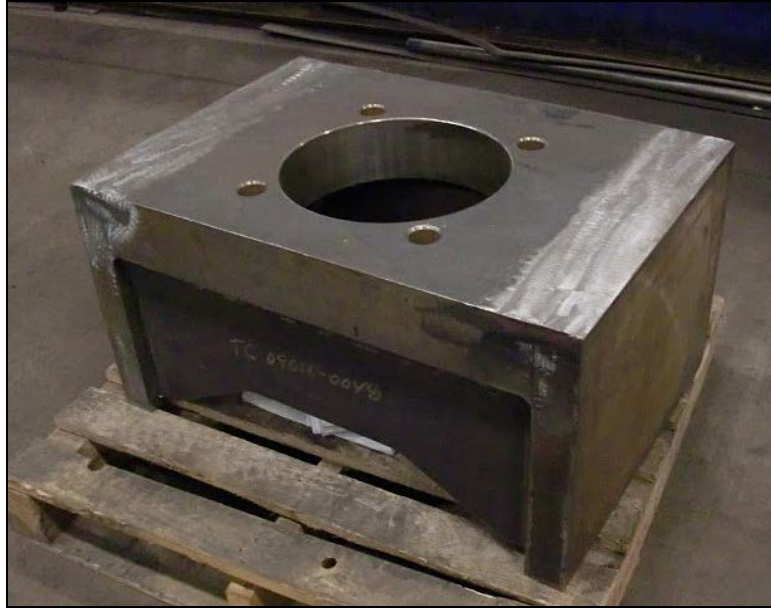
Figure 29. Photograph of the Sliding Lug Assembly Before Final Machining

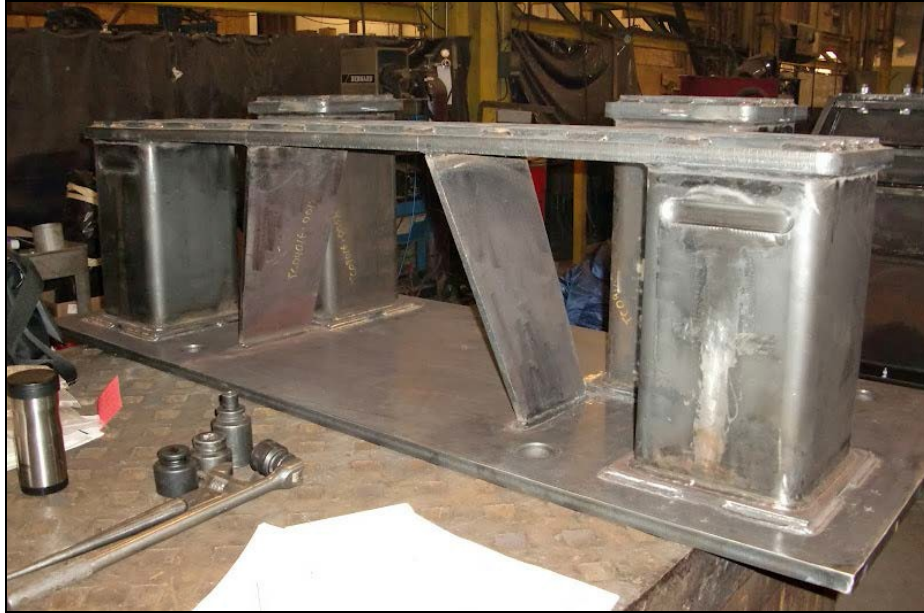
Figure 32. Photograph of Completed Deformable Anti-climber Test Article

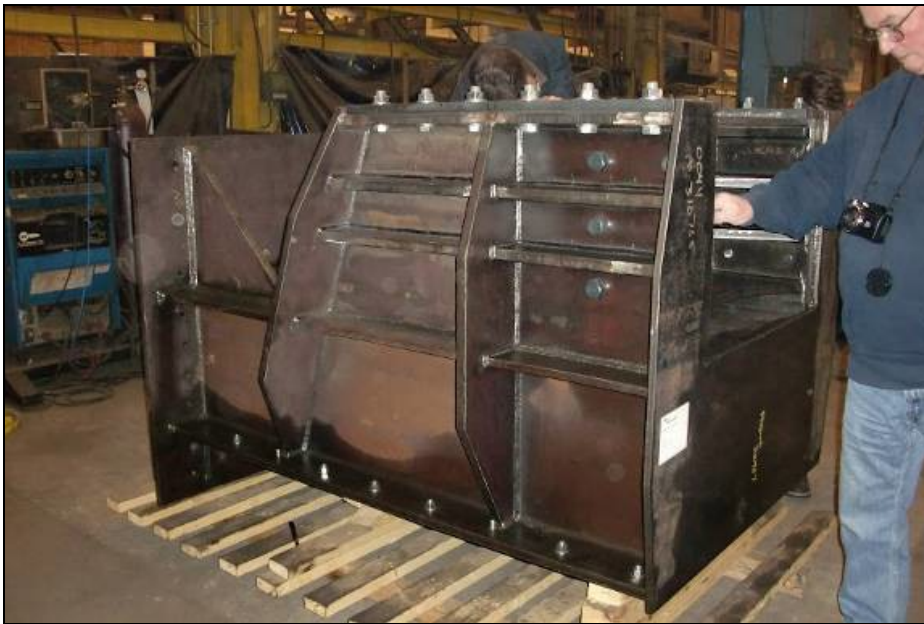
Figure 33. Photograph of Completed Push-Back Coupler Test Article (Upside Down)

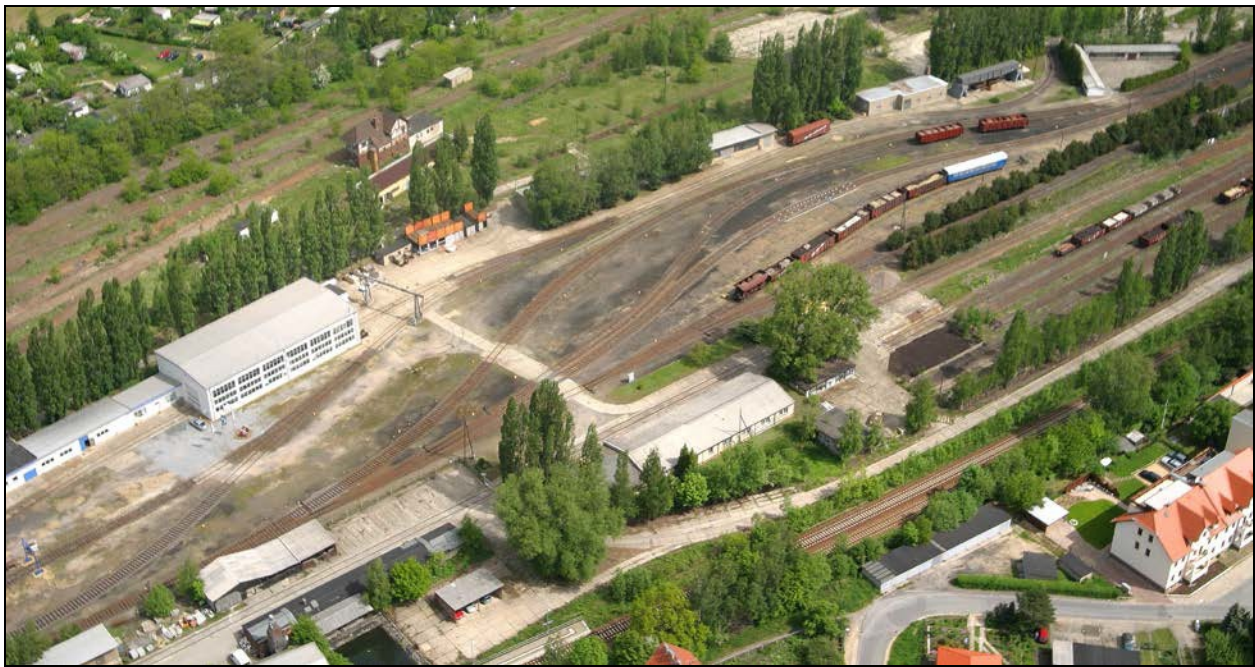
Figure 36. Görlitz Dynamic Test Facility

Dynamic testing was conducted at TÜV SÜD Rail GmbH, in Görlitz, Germany (Figure 36) under contract to TIAX's subcontractor, SGH. The Görlitz facility is an accredited test laboratory pursuant to DIN EN ISO/IEC 17025 for the tests described in this document. Furthermore, TÜV SÜD Rail GmbH is accepted for approval testing of railway vehicles by the German Federal Railway Authority (Eisenbahn-Bundesamt) and by several certified bodies throughout the European Union.

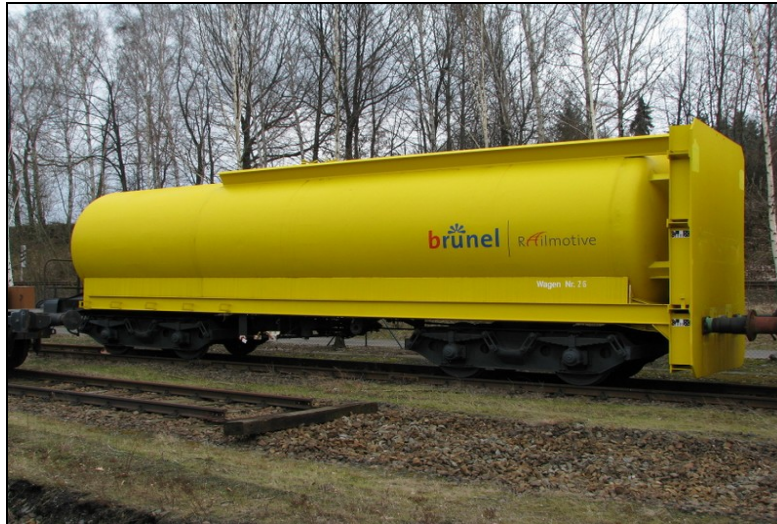
The impact energy for both tests was provided by a moving rail car (Figure 37) with mass equal to 79.8 tonnes (176,000 lbm), brought to the test collision speed by a V22 locomotive (Figure 38). The locomotive pushes the impact car to a speed just greater than the desired test speed and releases it a few hundred meters before the test wall. The condition of the front plate of the impact car depends on the test. For the push-back coupler test, the test article was mounted to the flat, forward end of the vehicle. For the deformable anti-climber test, the test article was mounted to the instrumented wall and impacted by the flat end of the vehicle.

Figure 37. 80-Tonne Impacting Rail Car Used for Both Tests

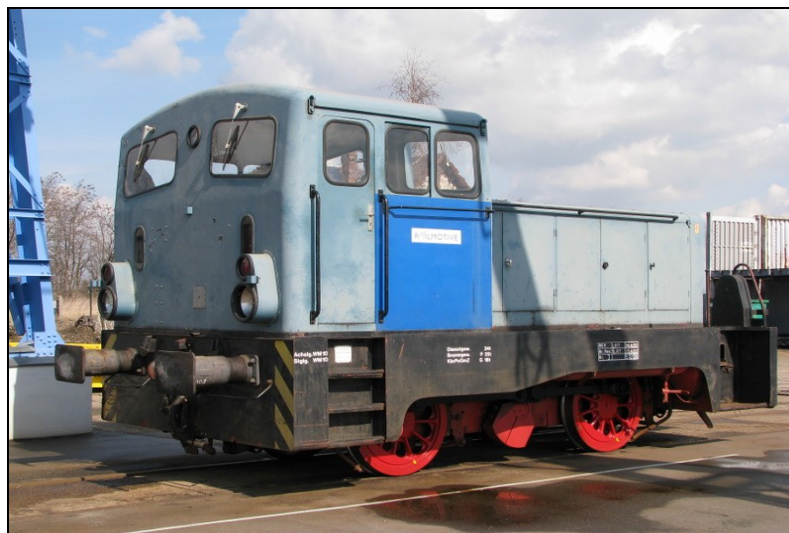
Figure 38. The Pushing Locomotive, Type V22

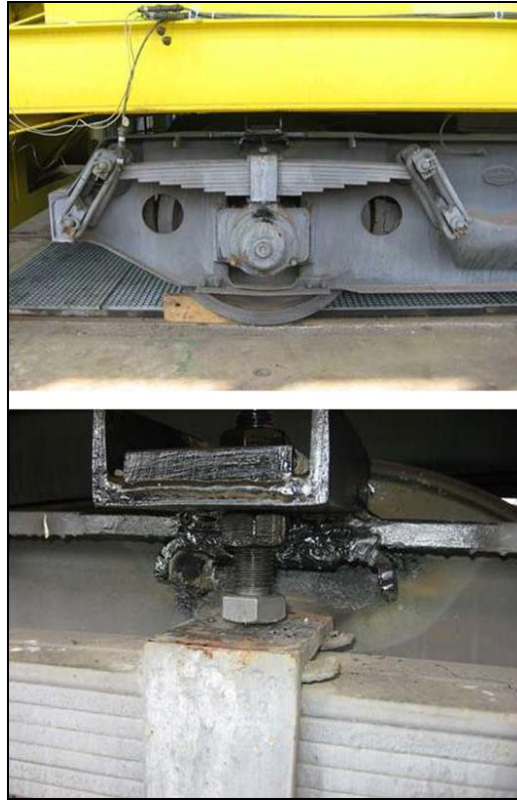
Figure 39. Photographs of One of the Bolts Used to Limit Vertical Travel of the Car Body With Respect to the Truck

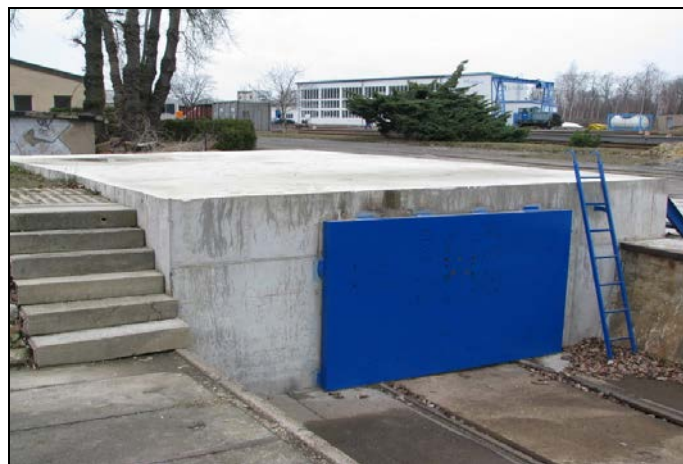
Figure 40. End Platform Plate on the Impact Wall

The impact wall consists of a thick steel plate mounted on a concrete base (Figure 40). Load cells are mounted onto the plate in a configuration that depends on the test.

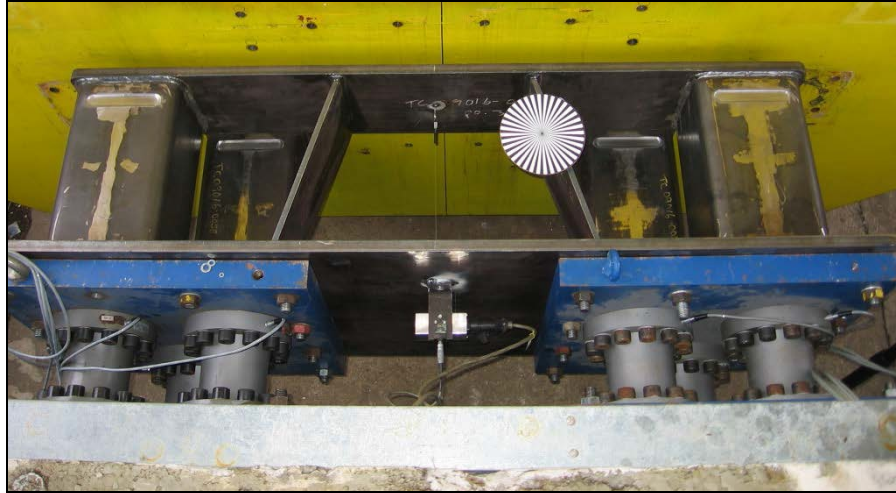
**Figure 42. Load Cell Configuration on the Impact Wall
Used for the Deformable Anti-Climber Test**

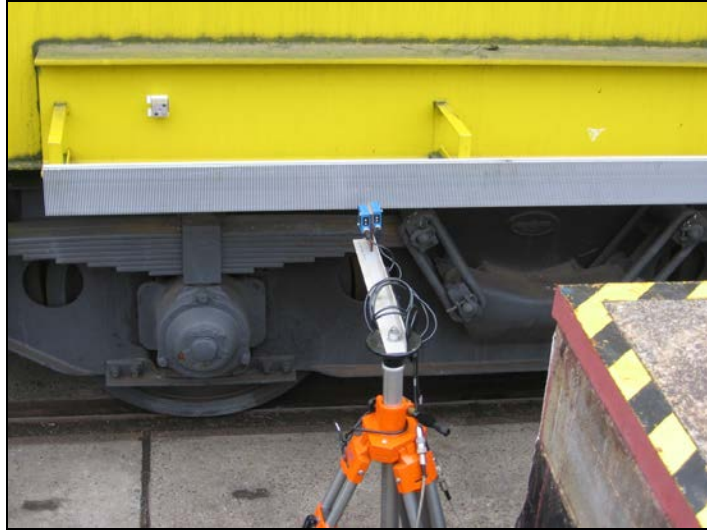
The primary displacement measurement system, used for both tests, consisted of laser sensors that read a ruled strip mounted on the side of the impacting rail car, as illustrated in Figures 43 and 44. This system has been found to be very accurate. A string potentiometer was also used to measure displacement for the push-back coupler test. (The details of this instrumentation are listed in Table 4.) The data signals were amplified through signal conditioners and recorded using an MGCplus with Quantum X amplifier modules, manufactured by HBM GmbH, and a measuring computer. After the test, the data were downloaded to a dedicated data-acquisition computer in a digital format. Data were subsequently processed using PC-based computer programs. The gradation of the laser/ruler displacement measurement system is 2.5 mm.

Figure 43. Stroke Measurement by the Laser/Ruled Strip

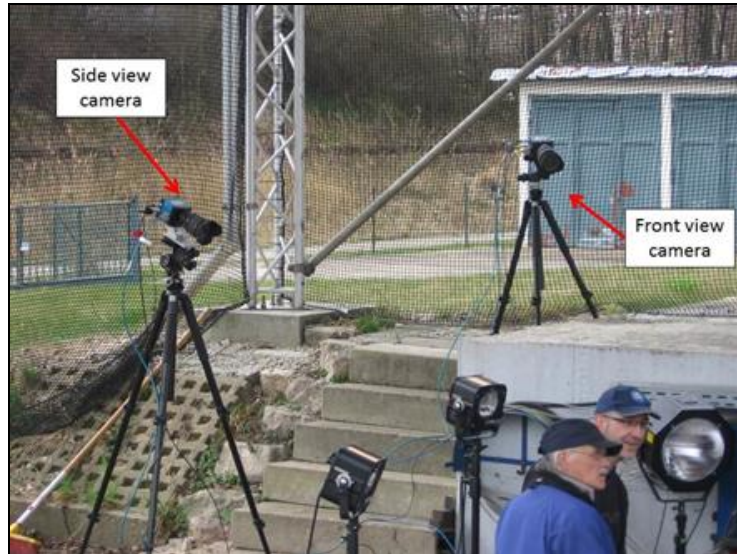
Figure 47. Locations of High-Speed Cameras for Push-Back Coupler Test

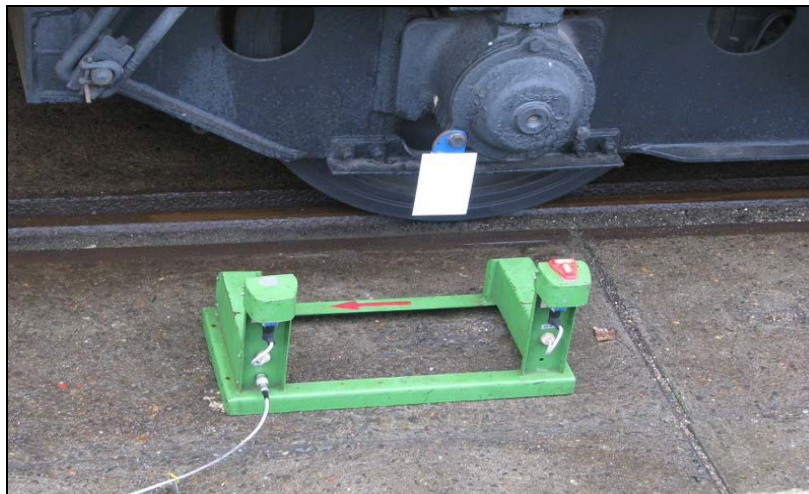
measured, scanning by means of two reflection photo sensors with 90° phase shift to identify the direction of motion and the reversal point.

Figure 49. Speed Measurement by Means of Photo Sensors

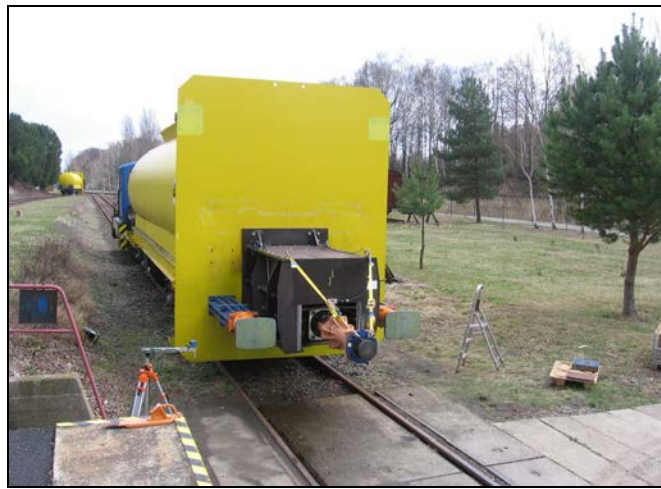
Figure 59. Photograph of the Push-Back Coupler Test Article Mounted on the Impact Car

Figure 58 shows an illustration of the test configuration for the push-back coupler test. Figure 59 shows a photograph of the test article, which is mounted to the impacting rail car and has an extension component that represents an actual coupler shank. There is a load cell mounted on the end of this extension piece (Figure 60), which impacts the end plate of the test wall load cell system within a ring that prevents lateral motion.

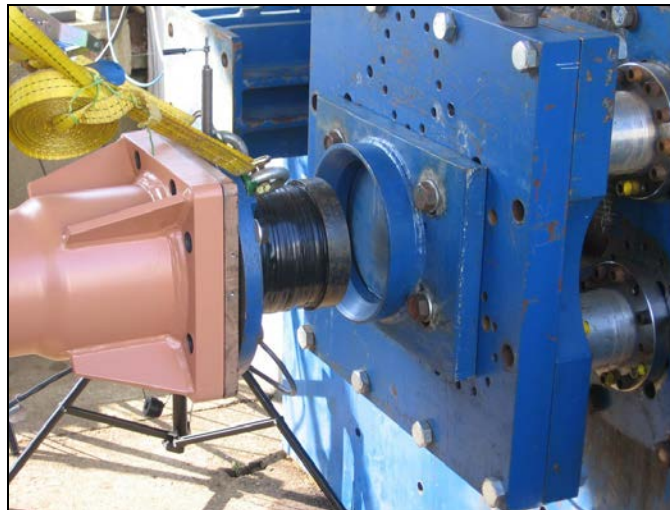
Figure 60. Photograph Showing Interaction of the Push-Back Coupler Extension Piece With Load Cell and End Plate of the Wall-Mounted Load Cell System

Two independent measurements of impact load were made for this test. Figure 64 compares measured load-displacement responses for the load cell set mounted on the instrumented wall with the single load cell mounted at the end of the coupler extension (see Figure 60). The two measures of load are generally consistent. Figure 65 shows measured raw and filtered load versus displacement, with the load in this case taken from the load cell set on the wall. In both figures, the displacement is taken from the ruled strip until a maximum displacement is reached, then taken from the string potentiometer at the coupler extension, which properly shows the rebound effect (which the ruled strip does not). Note that the data in Figure 65 have been filtered with CFC 60, because filtering with CFC 180 shows significant fluctuation in load at low displacement (Figure 66), which makes it difficult to identify the push-back trigger load.

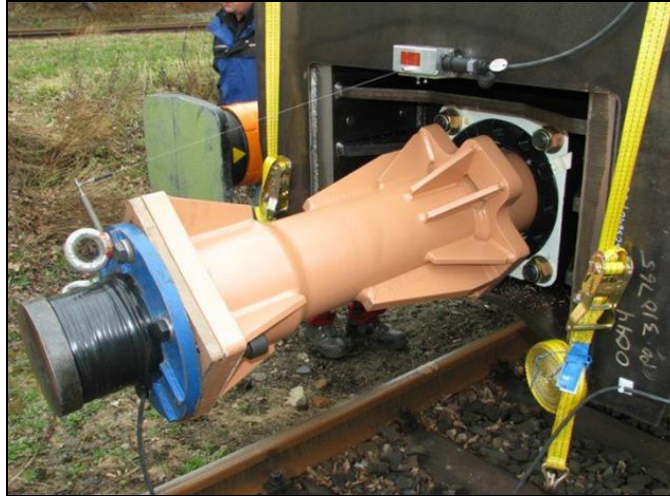
Figures 62 and 63 show the test article after the first impact. The deformation tube was essentially exhausted. Lubrication ports that extended outward about ½ inch from the coupler mounting block were partially crushed, indicating that the back plate of the coupler extension had just made contact in the first impact. This was consistent with the 18-inch stroke measured for this part of the test.

Figure 62. Push-Back Coupler Test Article After the First Impact

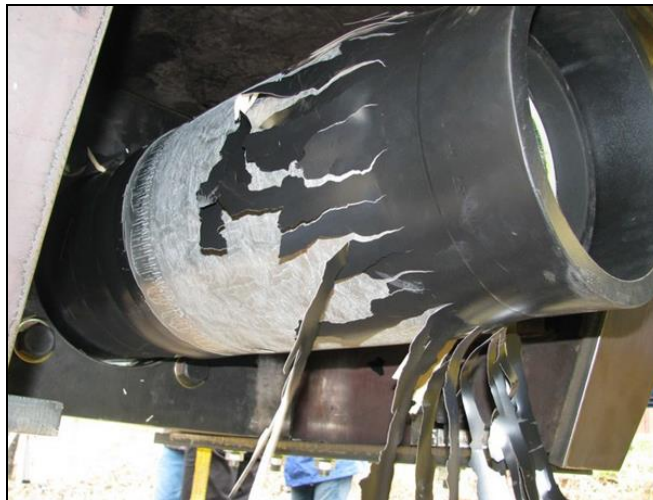
Figure 63. Push-Back Coupler Deformation Tube After the First Impact

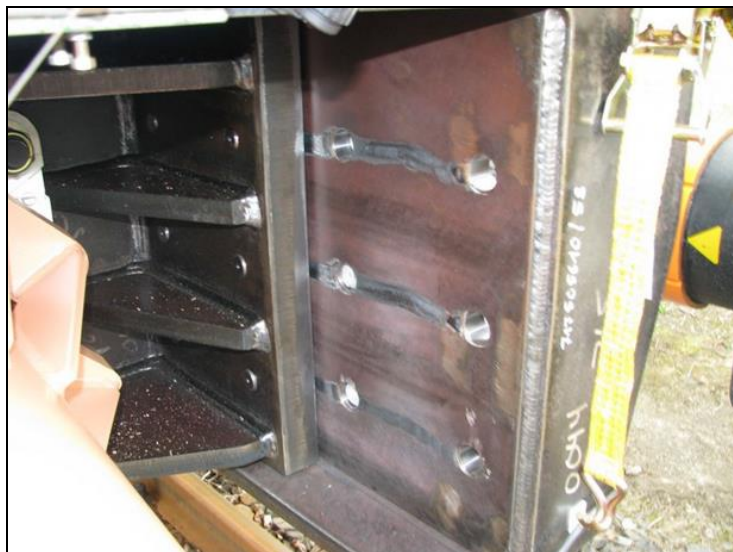
Figures 68 and 69 show the test article after the second impact. The sliding lug has been pushed back about 10 inches. The bolts did not all fail completely on a plane parallel to the direction of motion. The three bolts on the left front of the sliding lug all appear to have sheared at roughly a 45 degree angle through half of their thickness (Figure 70). There are also gouge marks on the facing surfaces of the support assembly, as shown in Figure 69, indicating that the sheared bolts scraped along the side of the support assembly as the sliding lug pushed back. In fact, it was not possible to separate the lug from the support assembly immediately after the test because of at least one protruding bolt surface. Figure 71 shows the measured load-displacement plot, in which the load is taken from the load cell set on the wall and the displacement is taken from the string pot at the coupler extension.

Figure 69. Photograph Showing Gouging Marks in the Coupler Support Assembly After the Second Impact

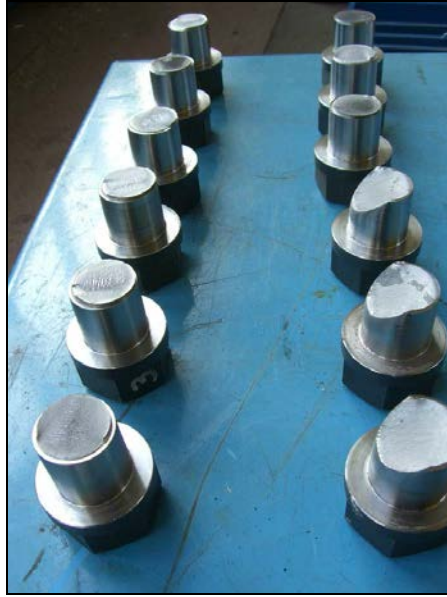
Figure 70. Photograph Showing All Twelve Failed Shear Bolt Heads

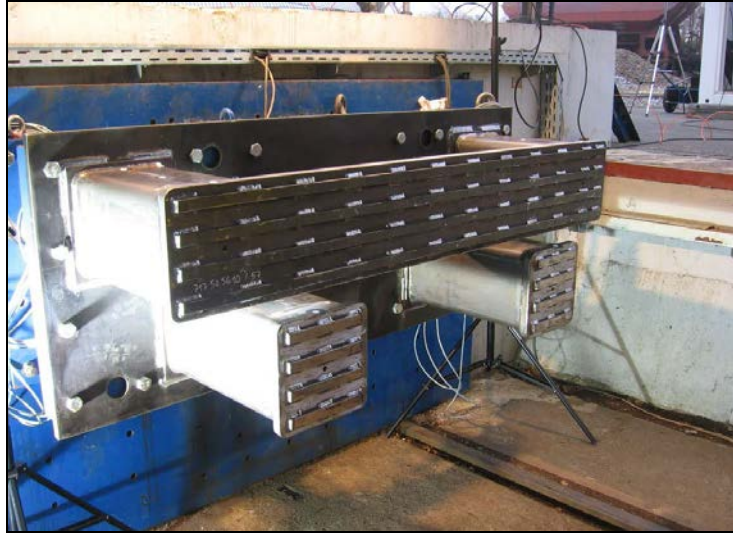
Figure 72. Photograph of the Deformable Anti-Climber Test Article Mounted on the Impact Wall Prior to Impact

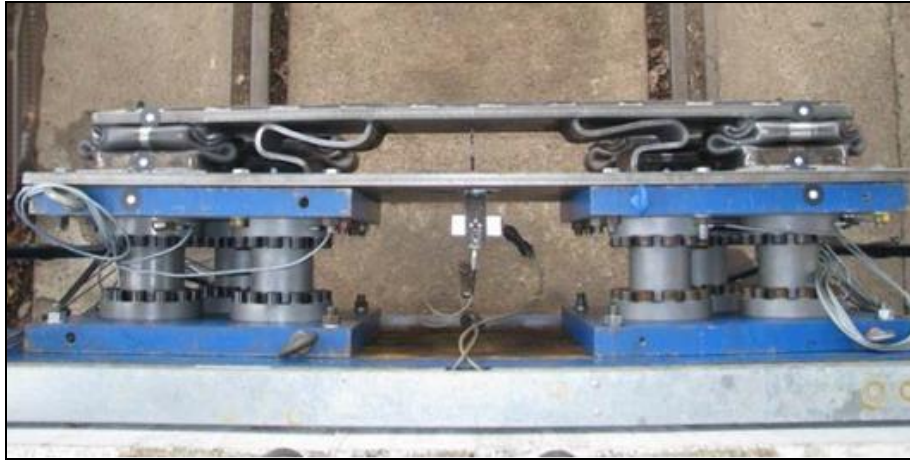
Figure 74. The Deformable Anti-Climber Test Article After Impact (Top View)

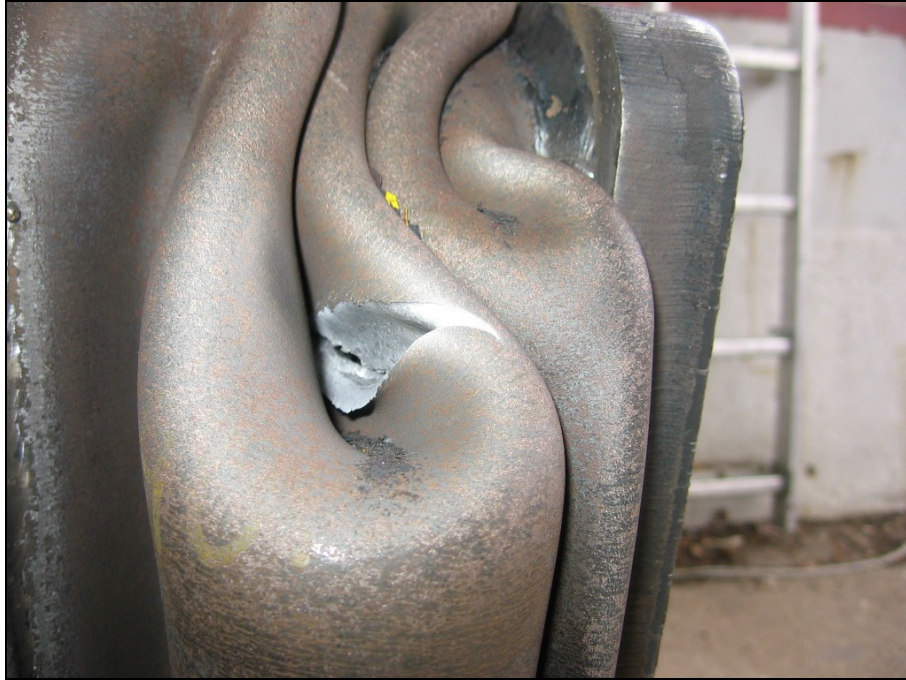
Figure 76. Photograph of a Crack in the Deformable Anti-Climber Test Article After Impact
