Road 151, Santa Fe National Forest

Observations, Considerations, and Recommendations from the Interagency Transportation Assistance Group (TAG)

September 14-16, 2015

Prepared for:
U.S. Forest Service

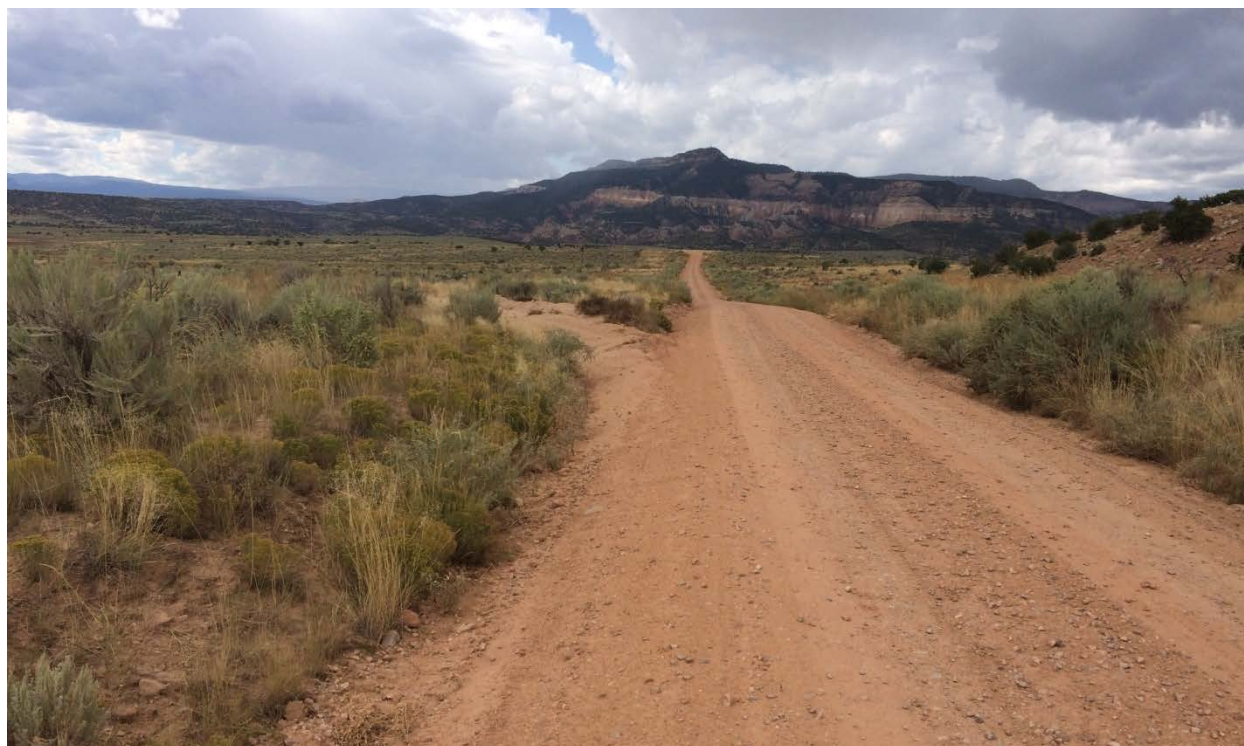
Figure 1: Relatively straight section of FR 151 between the road's start at U.S. Route 84 and the Rio Chama.

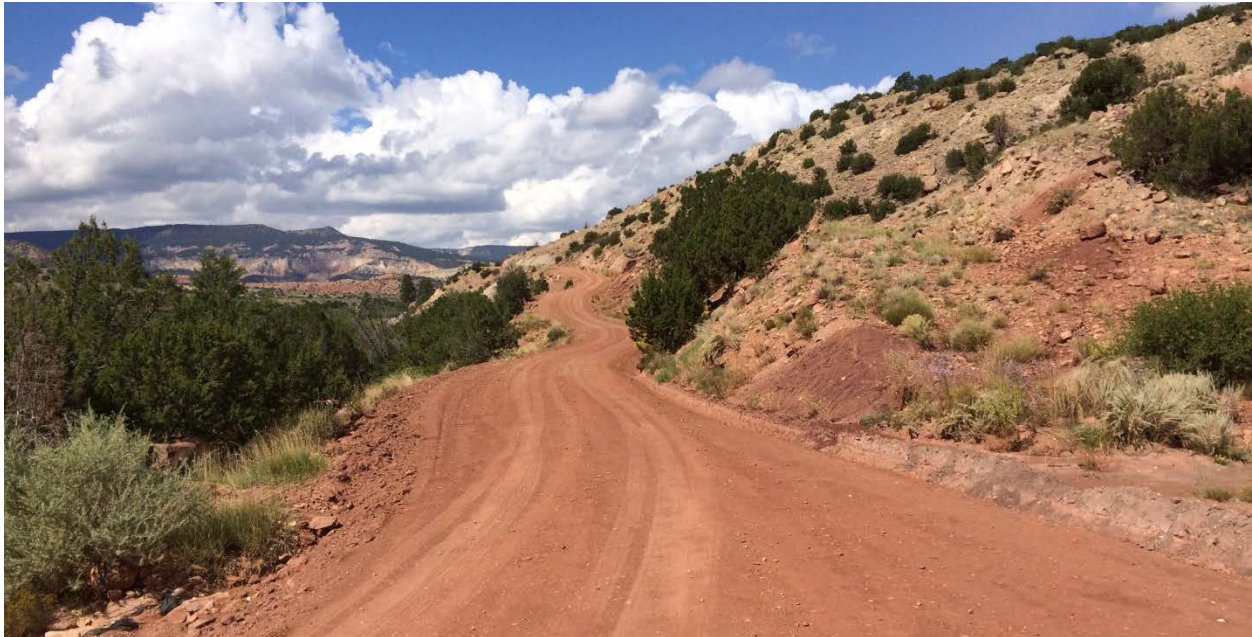
The landscape around Mile Post 6 is particularly striking, attracting road users to observe the natural beauty of the Rio Chama River from the cliffs of the adjacent canyon. However, as illustrated in Figure 3, road conditions around Mile Post 6 are particularly challenging, including narrowing road width, steep

grade changes, tight blind curves, and few areas to pull over. Many recreational visitors need to pass through this section of the road to access the sites listed below.

Figure 3: FR 151 Conditions at Mile Post 6, one of the steepest sections of the road.

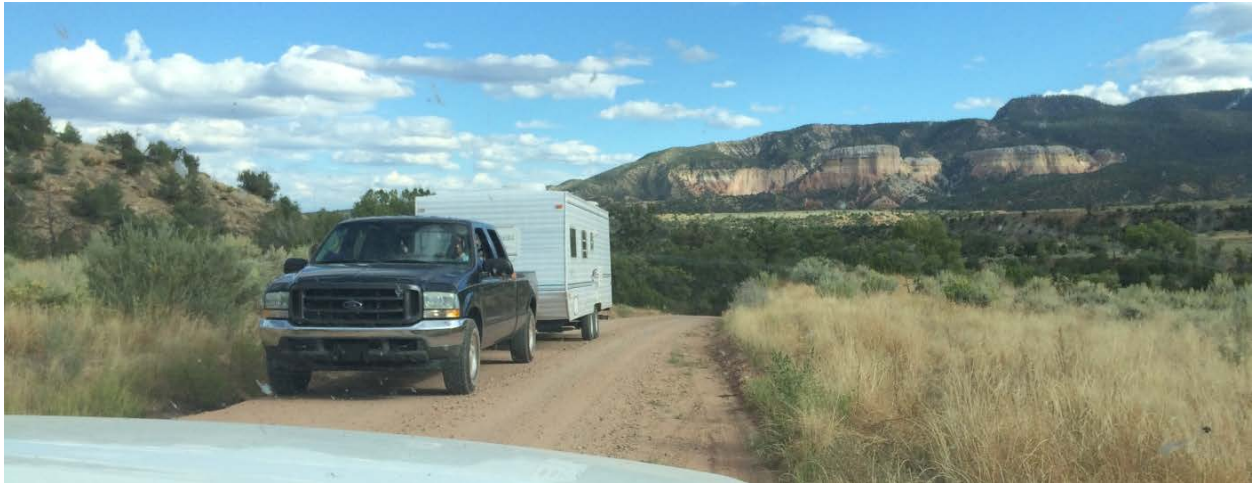
Figure 5: Sharing the road with large vehicles on FR 151

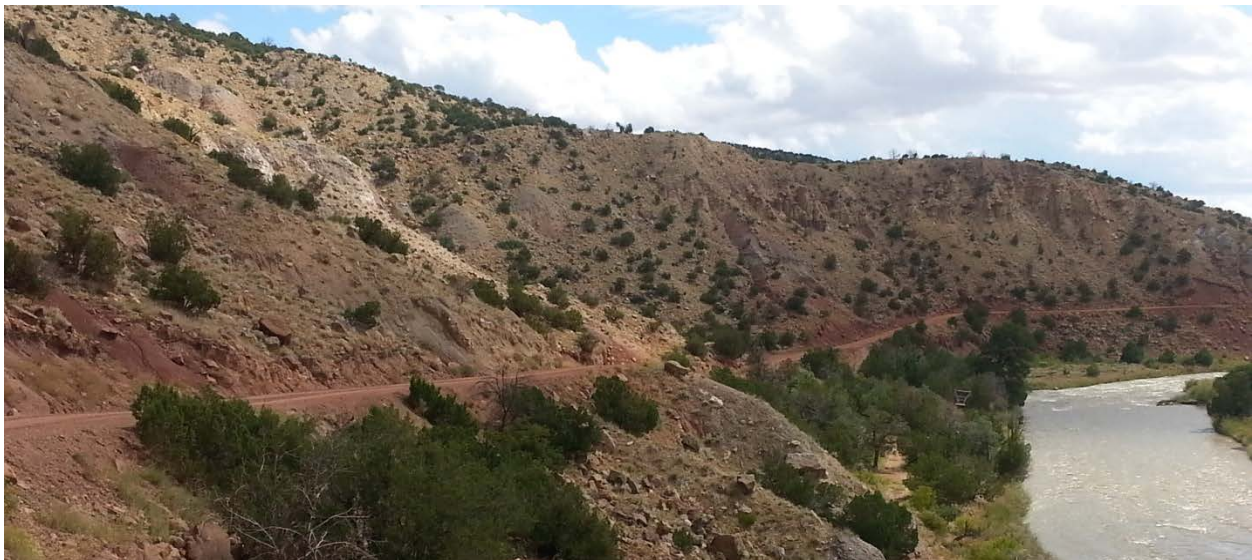
One of the more hazardous sections of the road is between Mile Post 6 and 7. This portion of the road is particularly narrow, contains tight turns (see Figure 6), abuts steep drop offs (see Figure 7) with an eroding roadbed (see Figure 8), and changes grade very quickly. During wet weather, when vehicles do not have enough momentum coming off of the tight curves on the road, they can become stuck trying to climb the hill. The issues highlighted below concerning narrow roads and blind curves are particularly relevant to this section of the road.

Figure 6: FR 151 adjacent to the cliffs near Mile Post 6

- **Advantages:** Improved safety through visibility, guardrails, or pullover areas on a potentially hazardous portion of the road. A retaining wall could reduce erosion and aggregate runoff into the Rio Chama.
- **Disadvantages:** Expensive. Although a retaining wall, in particular, can include an aesthetic treatment to reduce the visual impacts, this infrastructure addition could diminish the scenic view of the river and corridor from FR 151 as well as the overall natural character of the roadway. The conditions of the hillside, including existing archaeological sites near Mile Post 6, would have to be analyzed for potential impacts or risks.

Limited paving at key points near Mile Post 6 could help both reduce aggregate runoff into the river and improve safety and traction. The paving method could range from asphalt wearing course to the application of a high friction surface treatment (HSFT).⁵

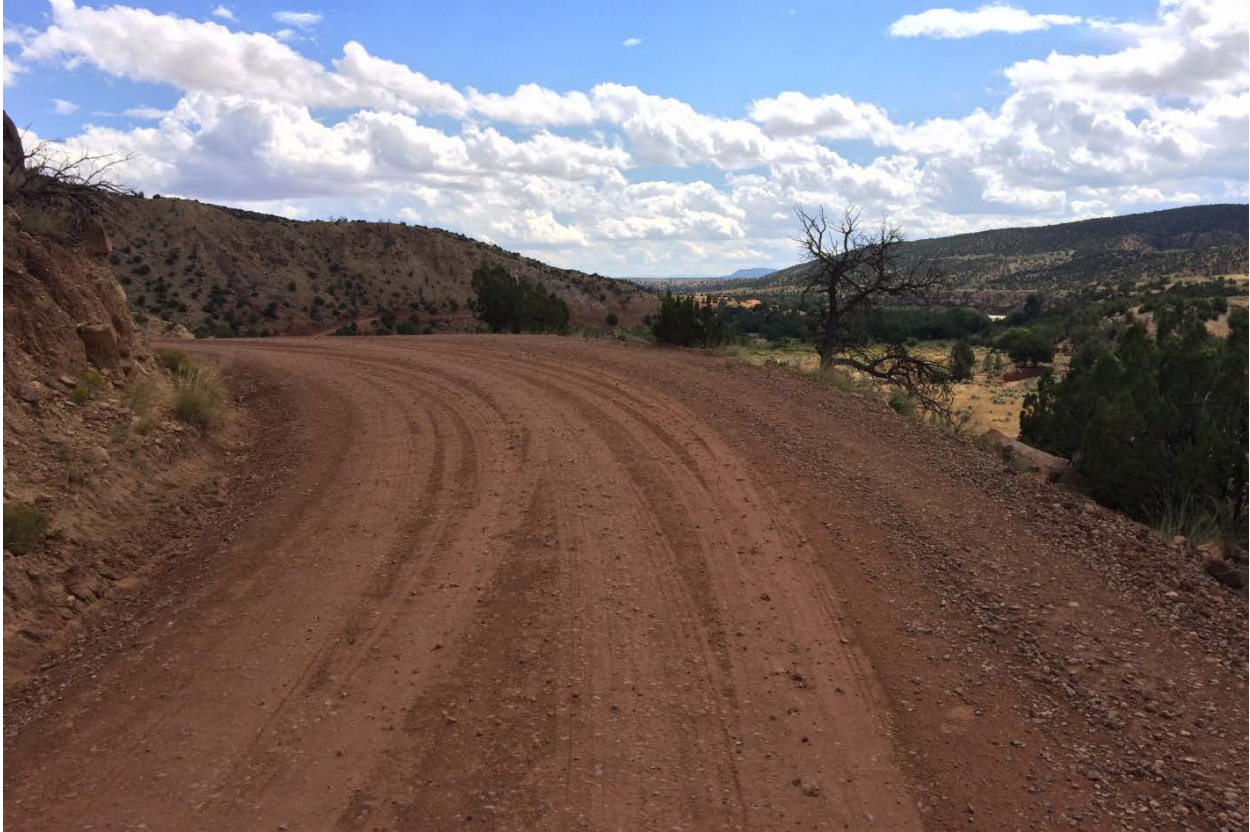
Figure 7: Limited sight distance curve near Mile Post 6

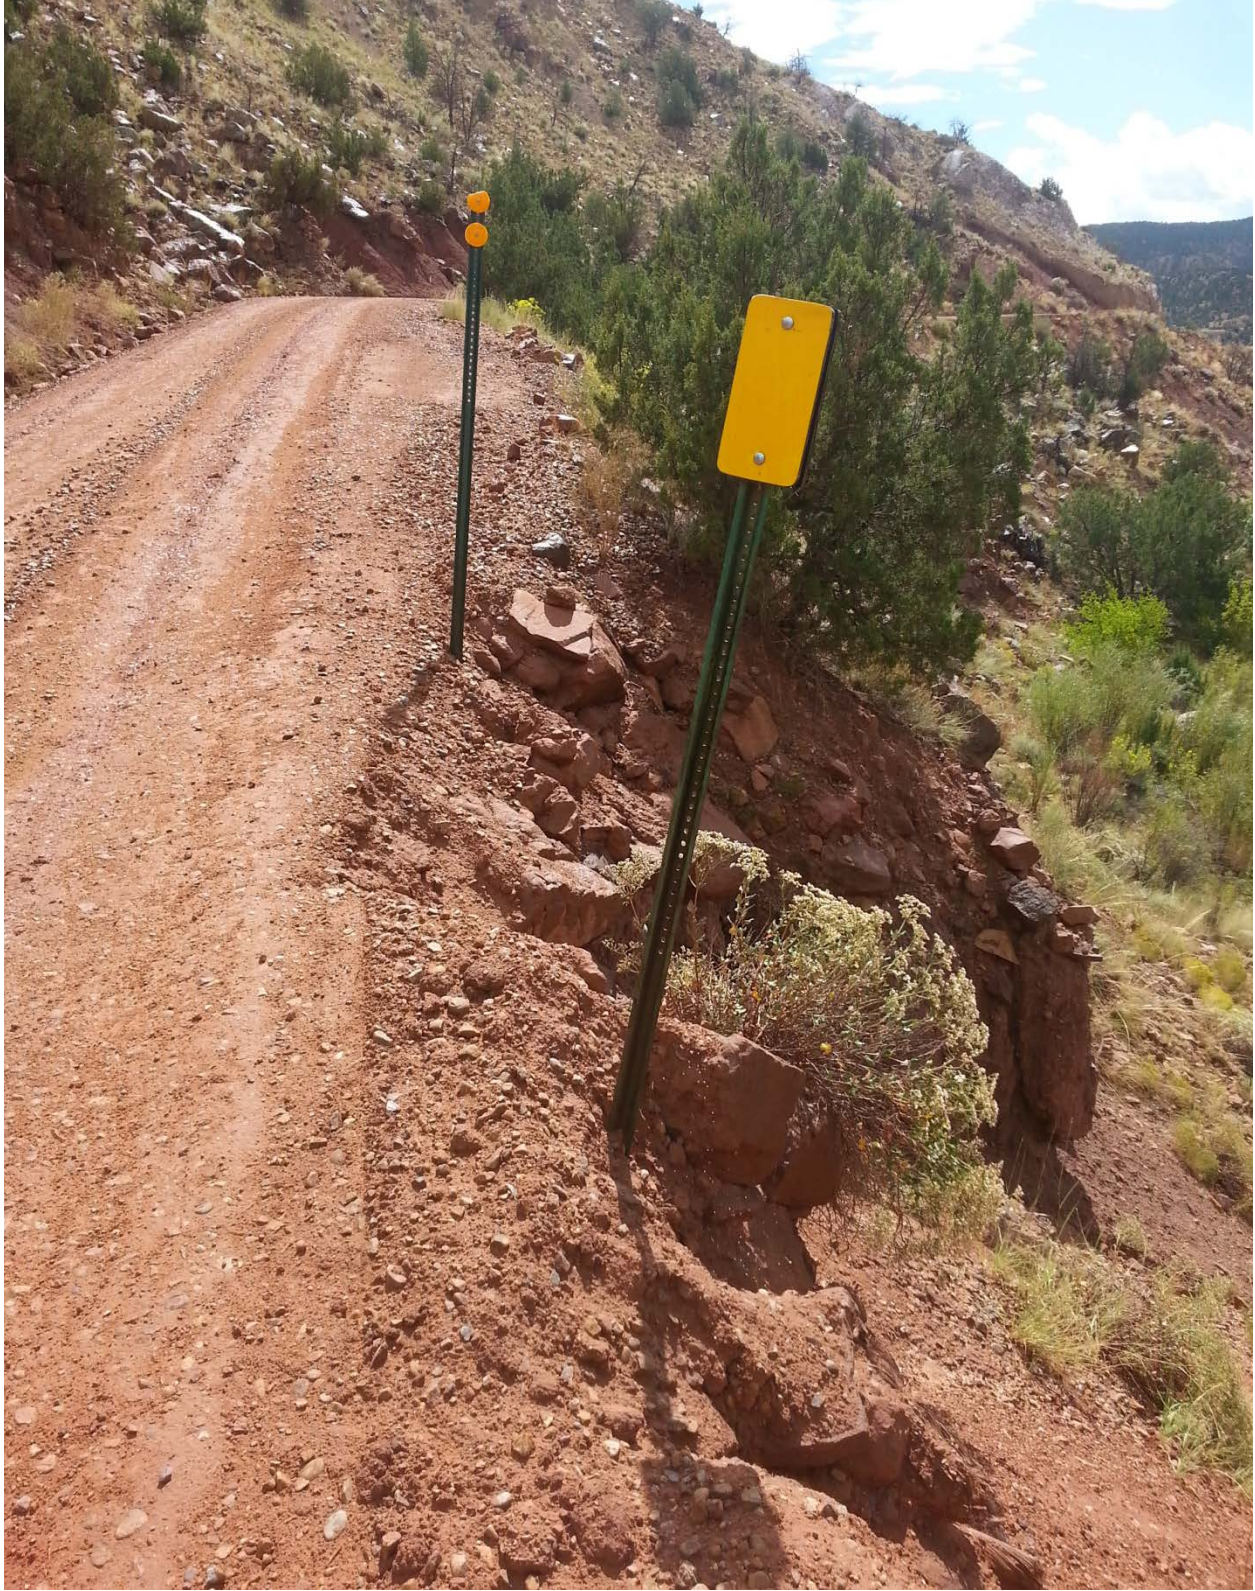
Figure 8: Existing delineators along the edge of eroding roadbed near Mile Post 6

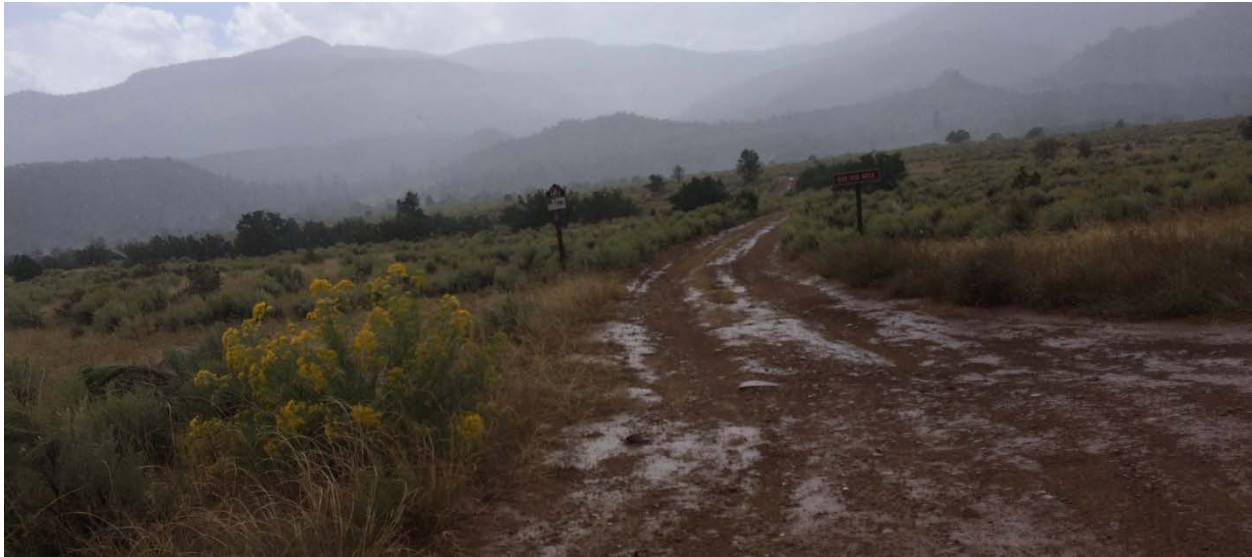
Road conditions at some of the day use sites have degraded to the point where they have become impassable. A combination of flooding and poor drainage have caused vehicles to form large tracks and divots along the access roads, forcing drivers to move off the roads onto sensitive terrain, which makes conditions worse and threatens adjacent heritage sites. Figure 9 provides an example of wet road conditions at the day use site.

Figure 9: Wet two-track road at a day use site.

The access road to Rio Chama Campground and connectors to other public day use areas and administrative sites are degraded and susceptible to flooding during storm events. Improvements to sites along the road could be prioritized. For example, the access road to the river gauging station maintained by the USACE and the U.S. Geological Survey was washed out in December 2014 according to FS staff. However, the gauging station is a less than five-minute walk from the main road so depending on how partners and the public use this site, repairs may not be necessary.

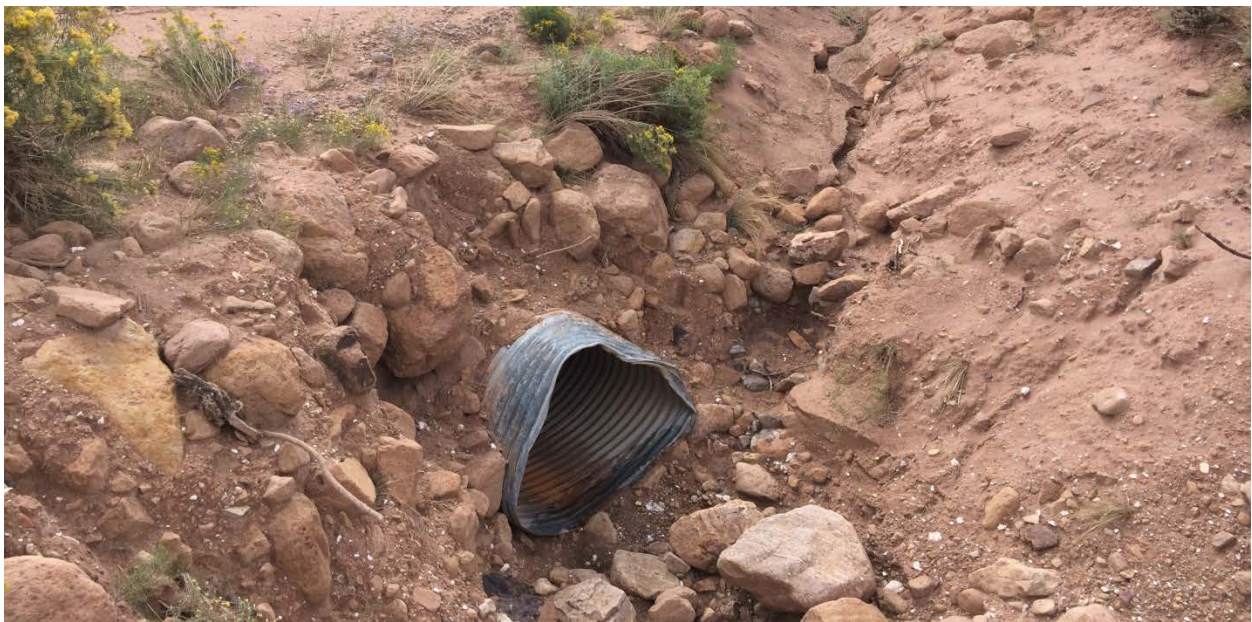
Due to the character of the terrain, heavy rains can cause flash floods along the corridor. Runoff from the adjacent arroyos, which often is diverted into the many culverts spread along the road, can bring natural debris that clogs the culverts. Figure 10 provides an example of a typical culvert along the road. Flooding is a constant concern, creating slick roadways and worsening erosion. Safety concerns are heightened at low-water crossings, which are low points along the roadway where drainage is directed over the roadway, which can create slick conditions when there is considerable clay or sediment on the roadway surface. Clogged culverts are a regular occurrence near Mile Post 4 and Mile Post 12. Issues

with low water crossings exist at Mile Post 5, as well as on the interior and access roads at the Rio Chama Campground and day use sites.

Figure 10: An example of a culvert along FR 151

- **Advantages:** Flood water could pass over the top of the road with less damage to the road surface and sediment entering the water flow. Could reduce maintenance load since there would be fewer culverts that require regular sediment removal.
- **Disadvantages:** Concrete crossings have an initially high cost. Flooding would still deposit sediment on the concrete surface, which could become a safety hazard if it is not cleared off after flood events.

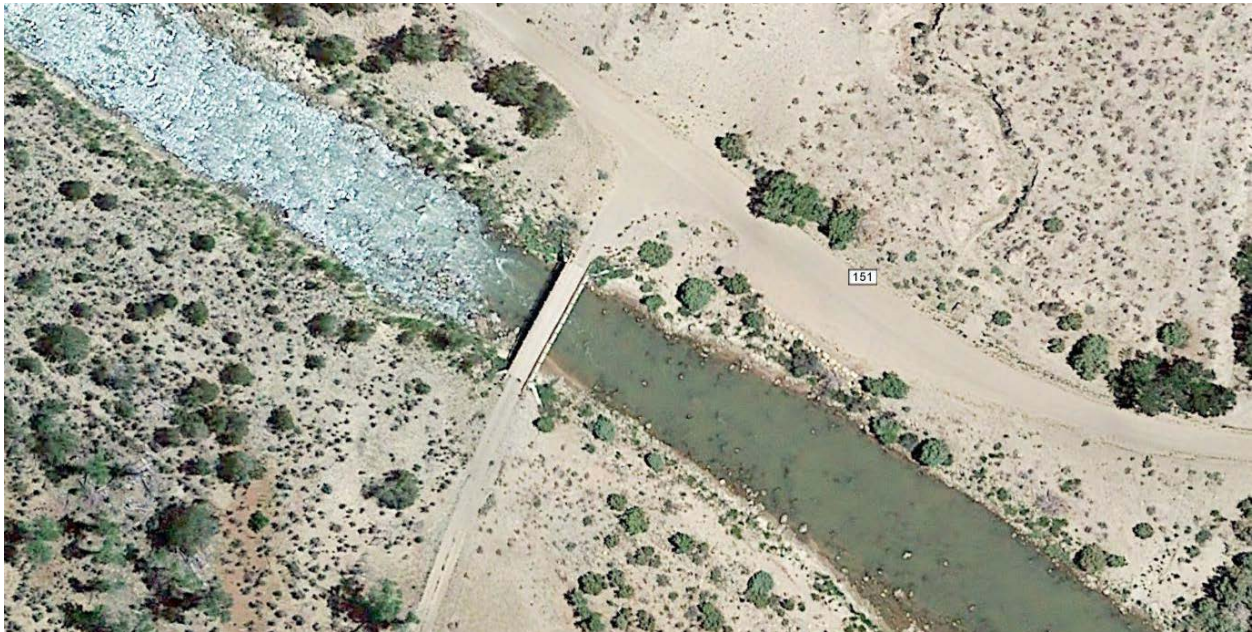
As seen in Figure 11, there appears to be space at Skull Bridge to expand the existing roadside parking by about 3,000 square feet to better accommodate horse trailers. However, monks at the Monastery reported that they did not often see equestrian users on the adjoining CDT, which is consistent with FS field staff's observation that no more than two trailers or four passenger cars are parked at one time. While the parking is not currently at capacity, expanding the roadside parking could accommodate future use as well as other users, including Land Grant users who maintain the nearby cemetery.

Figure 11: Satellite view of Skull Bridge. The small existing parking area is located on the north side of the river directly east of the bridge.

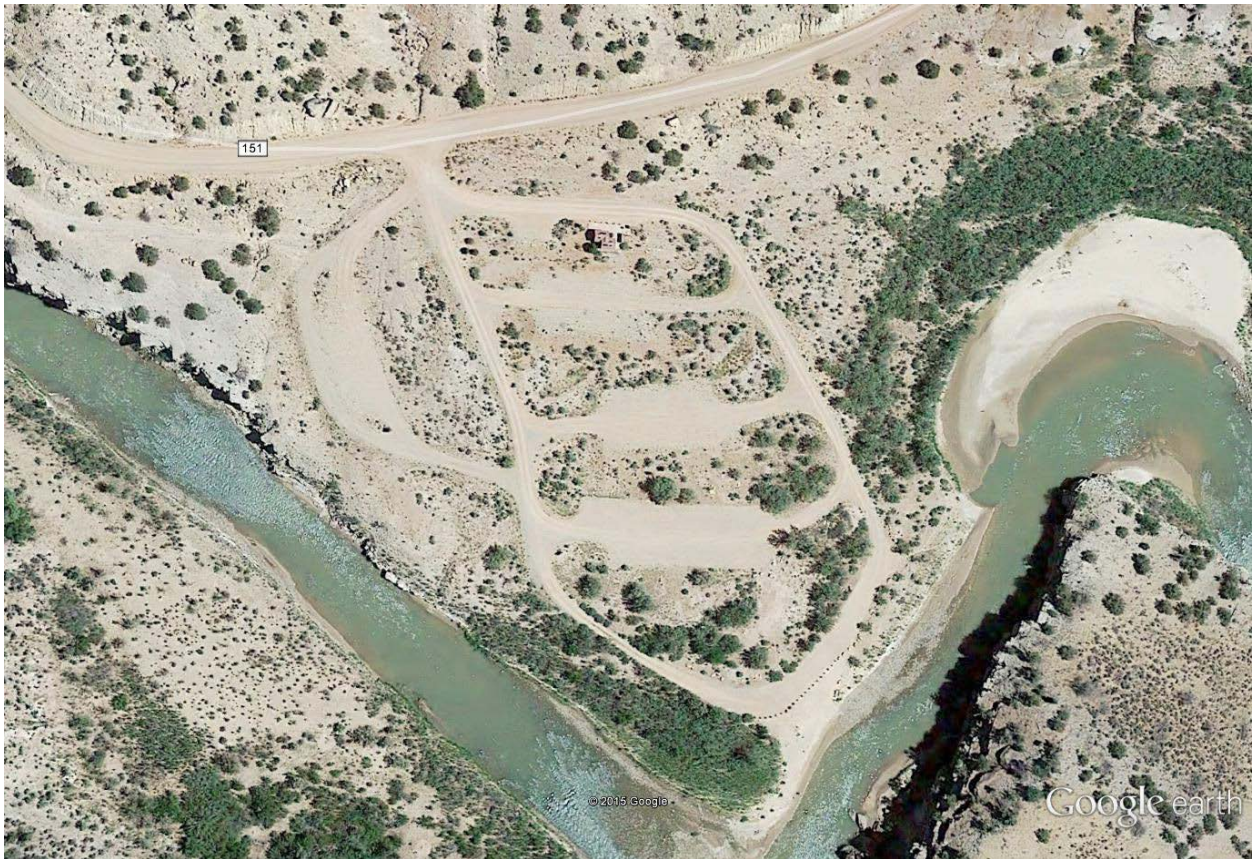
Expanding the ramps at the [Chavez Canyon put-in](#) and the [Big Eddy take-out](#) (see Figure 12) would enable additional river users to put in or take out non-motorized boats. Since additional put-ins are located on BLM land further upstream, this action should be coordinated with the BLM and other stakeholders consistent with the overall management strategy for the Rio Chama. Currently, the FS does not collect boating fees; implementing a fee system to support this maintenance and operations could be considered.

Figure 12: Ramps and parking area at Big Eddy Take-out.

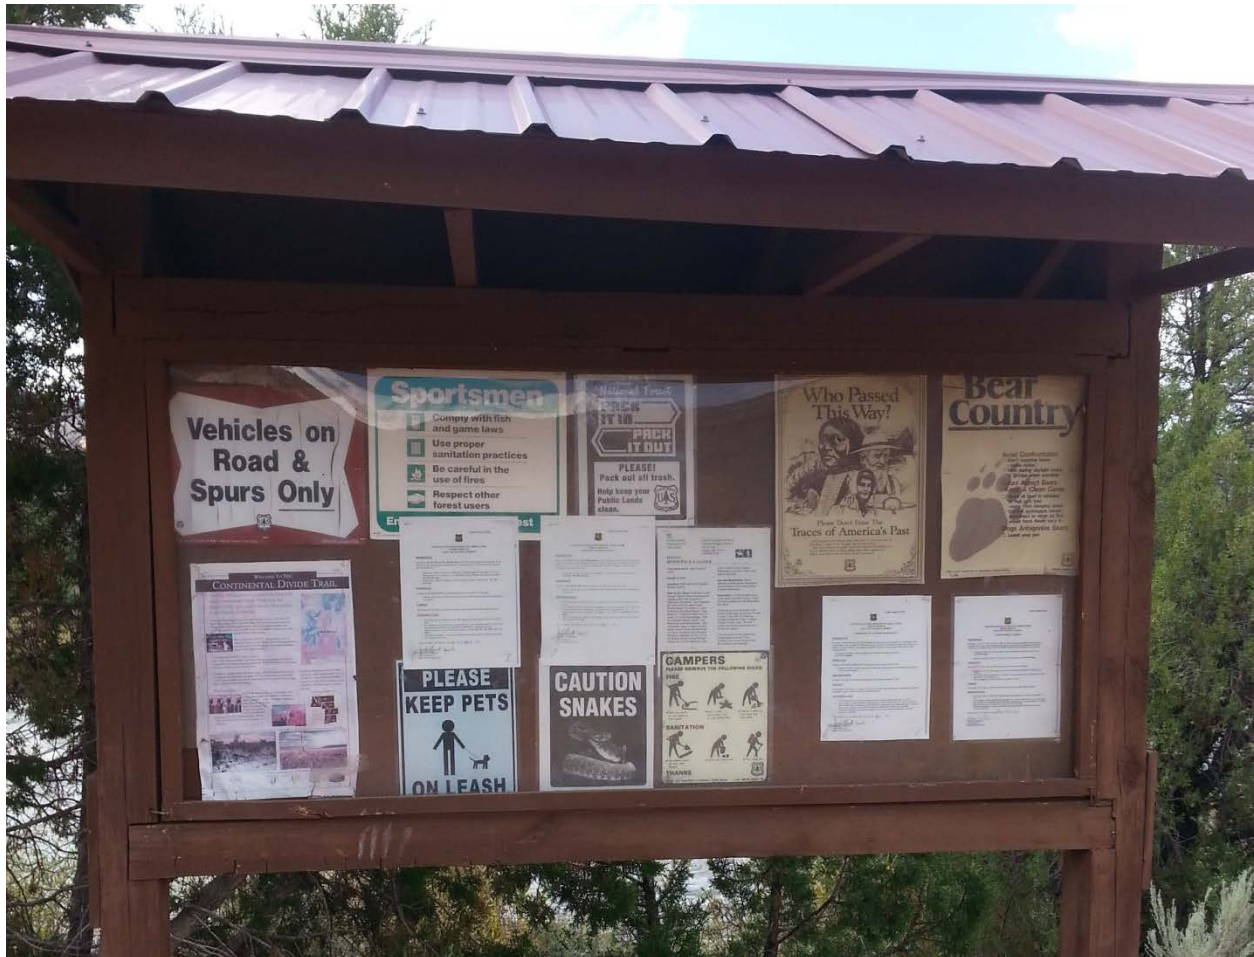
Figure 13: Information kiosk by Skull Bridge

kiosk/signboard similar to the existing one at Skull Bridge (see Figure 13) could improve safety awareness and inform visitors about recreation opportunities farther along the road.

New Kiosk at Road Entrance
