# Apache Trail, Tonto National Forest

Observations, Considerations, and Recommendations from the  
Interagency Transportation Assistance Group (TAG)

**June 15 – 17, 2015**

Prepared for:  
**U.S. Forest Service**

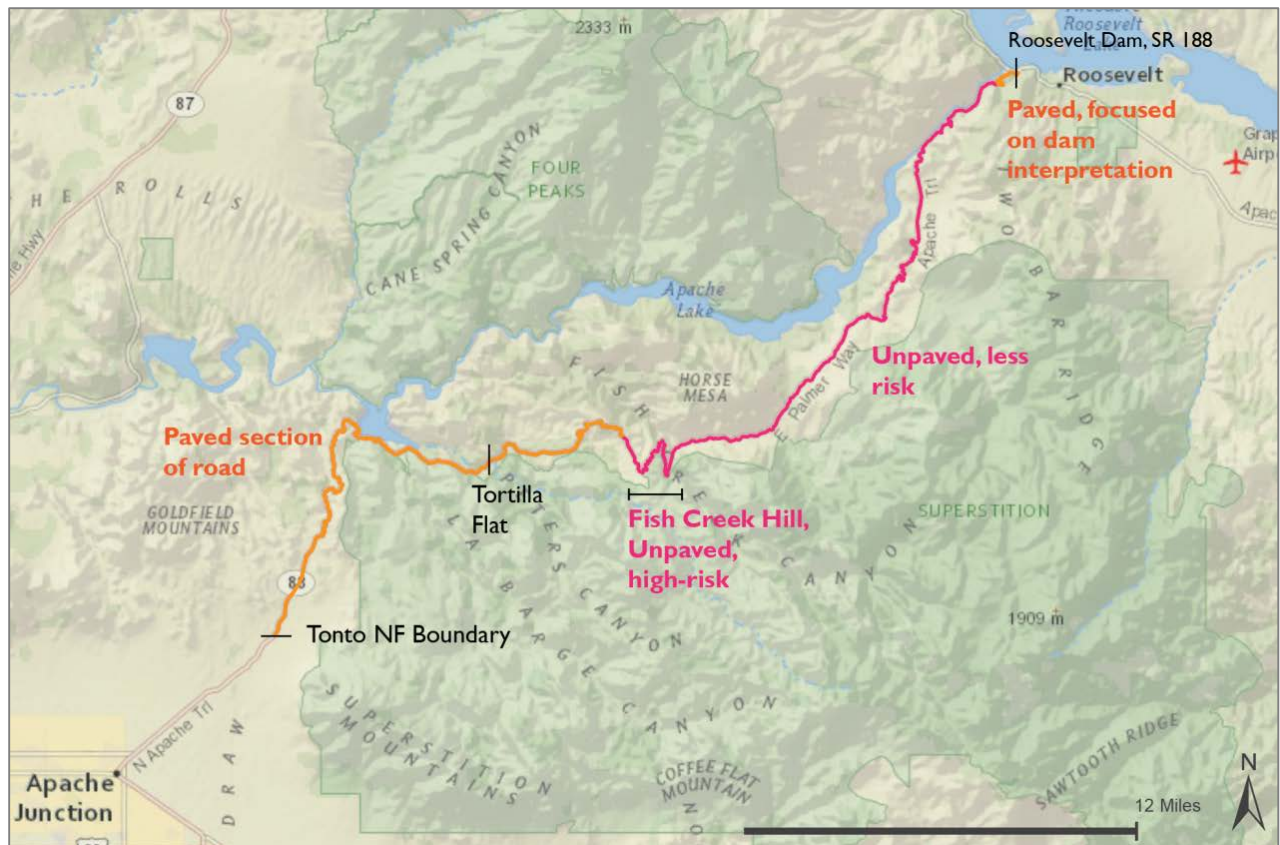
Figure 1: Map showing sections of the Apache Trail and major landmarks.

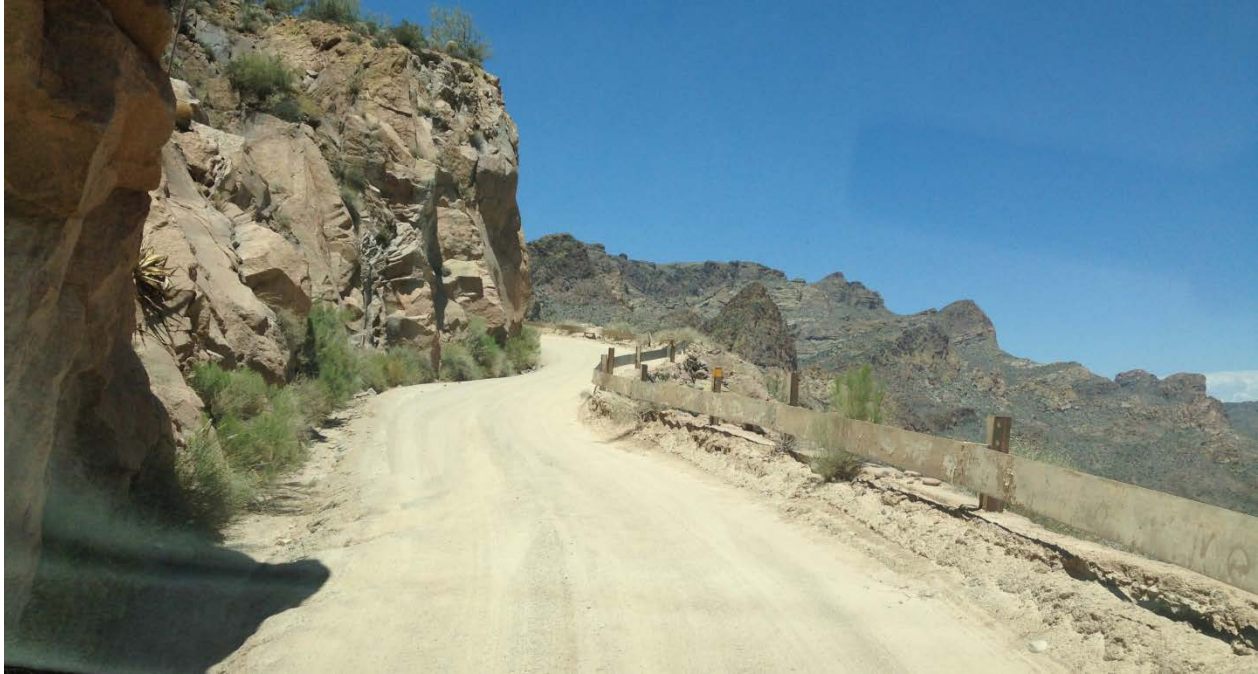
**Figure 4: Fish Creek Hill, the narrowest and steepest section of the Apache Trail.**

- **Fish Creek Hill** is the most extreme example of the hazardous geometries outlined above on the road. This steep one-mile segment along the unpaved portion of the road has an 800-foot climb/descent. It includes a number of hazardous curves and is only wide enough for one lane with few pullout areas.

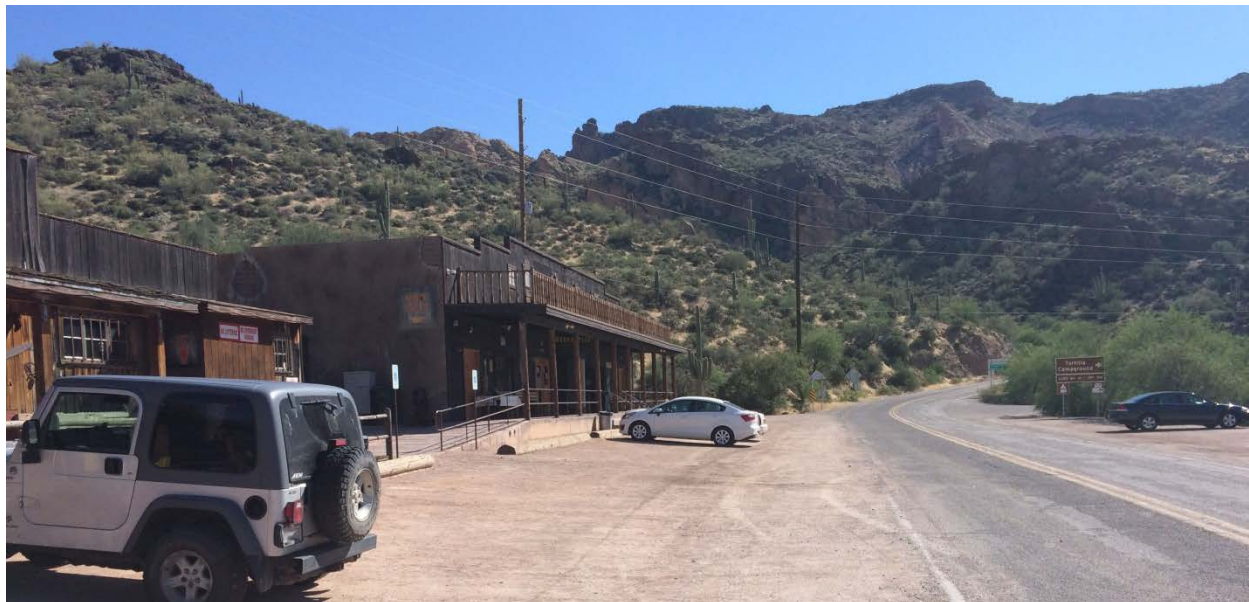
**Figure 5: Tortilla Flat, one of the main concentration of visitor-serving businesses near the transition from the paved section to the unpaved section.**

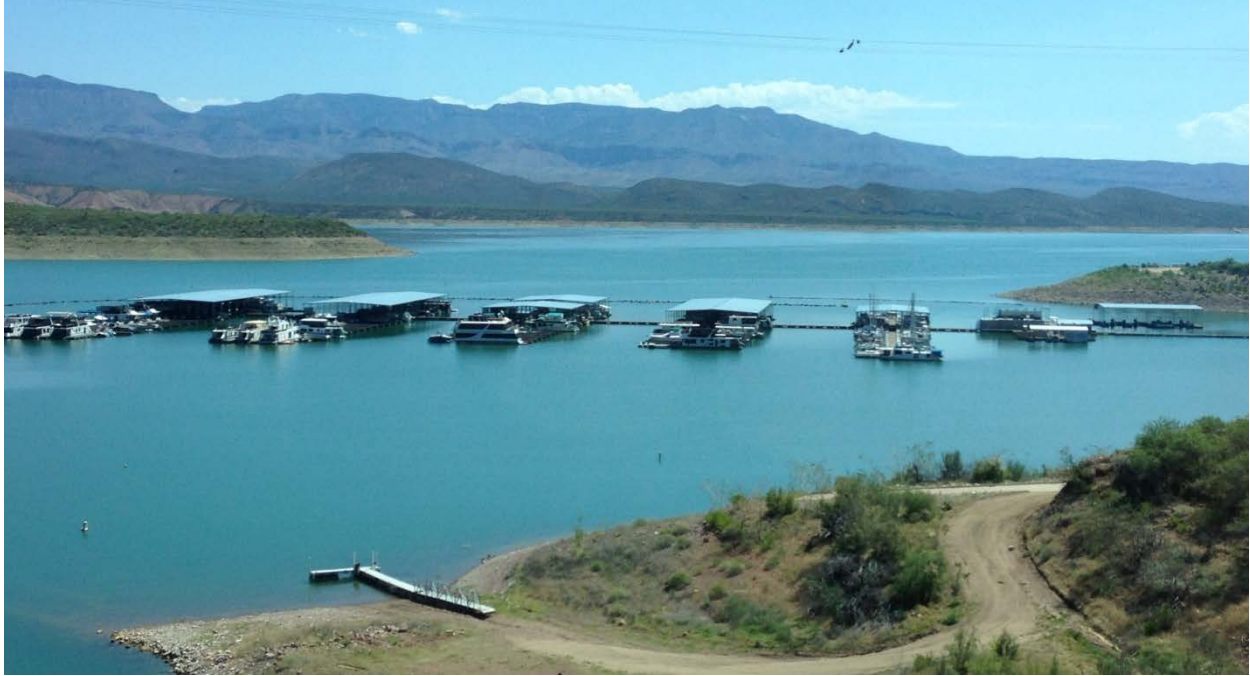
**Figure 6: Roosevelt Lake Marina. Marinas at Roosevelt Lake, Apache Lake, and Canyon Lake are important recreation destinations near and along the Apache Trail.**

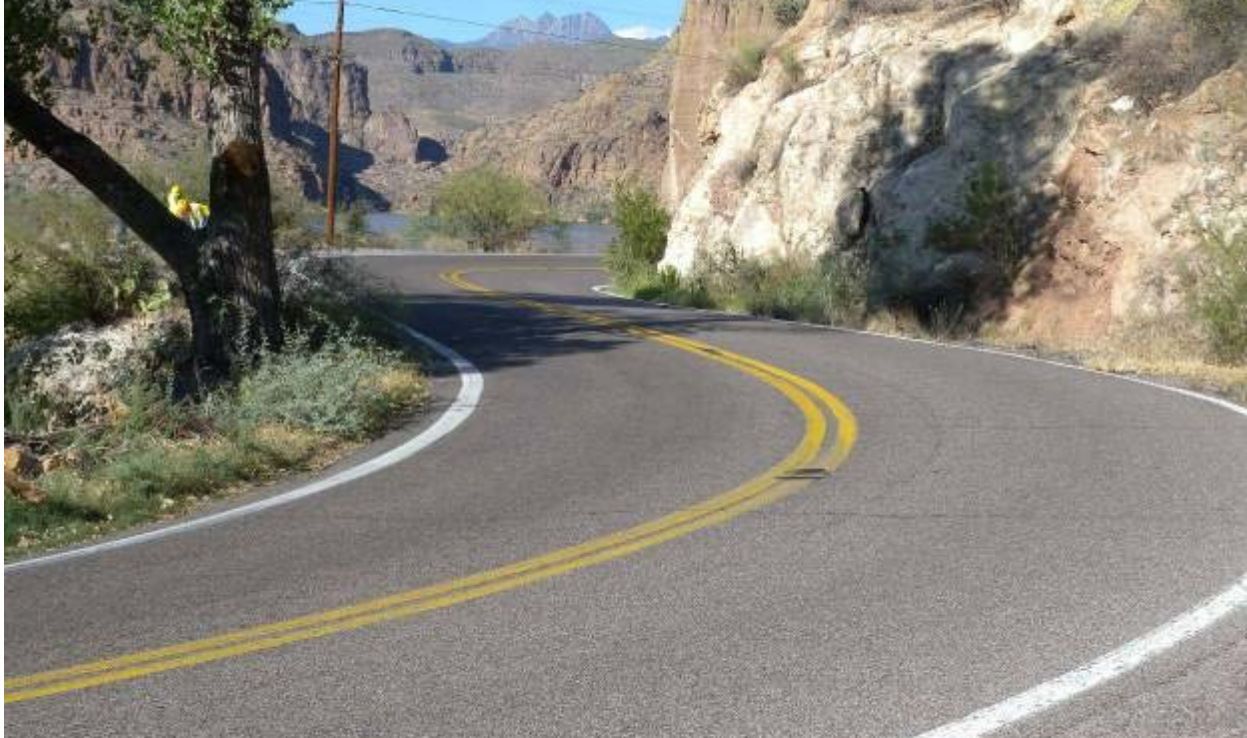
Figure 7: One of the paved hazardous curves identified in the RSA (Location #8, Source: RSA).

- **Blind and hazardous curves/geometries:** A significant number of curves along the Apache Trail have deficient curve radii and/or there is inadequate sight distance due to steep roadside cut slopes or encroaching vegetation. This includes blind curves (where drivers cannot see approaching traffic due to roadside rock faces), hairpin curves with very small radii, and decreasing radius curves (where the curve radius changes within the curve itself).

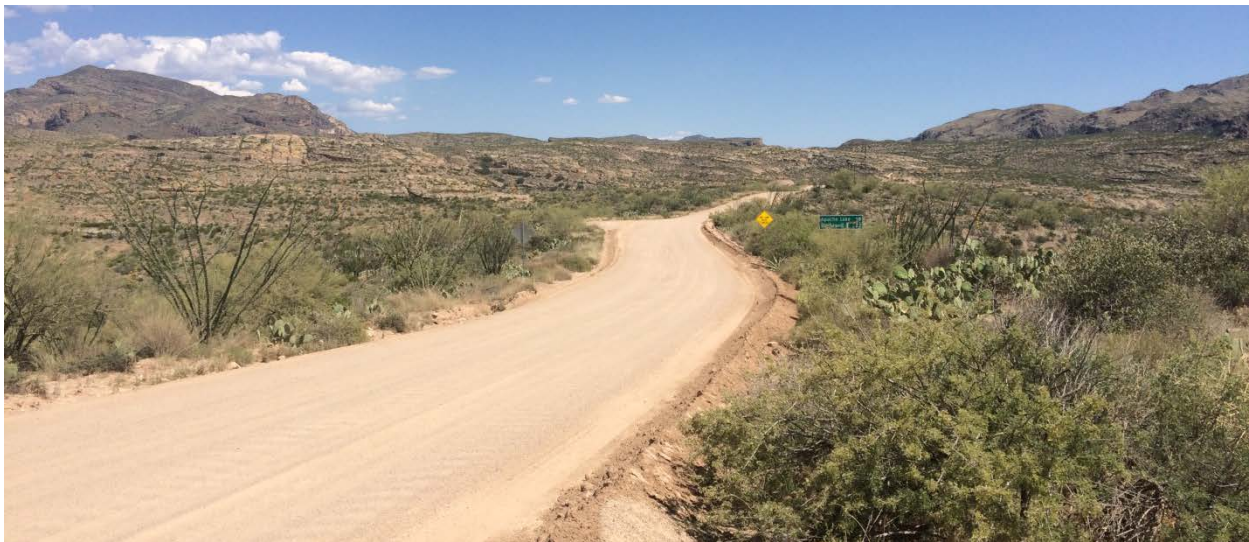
**Figure 8: A relatively flat stretch of the Apache Trail on the unpaved section.**

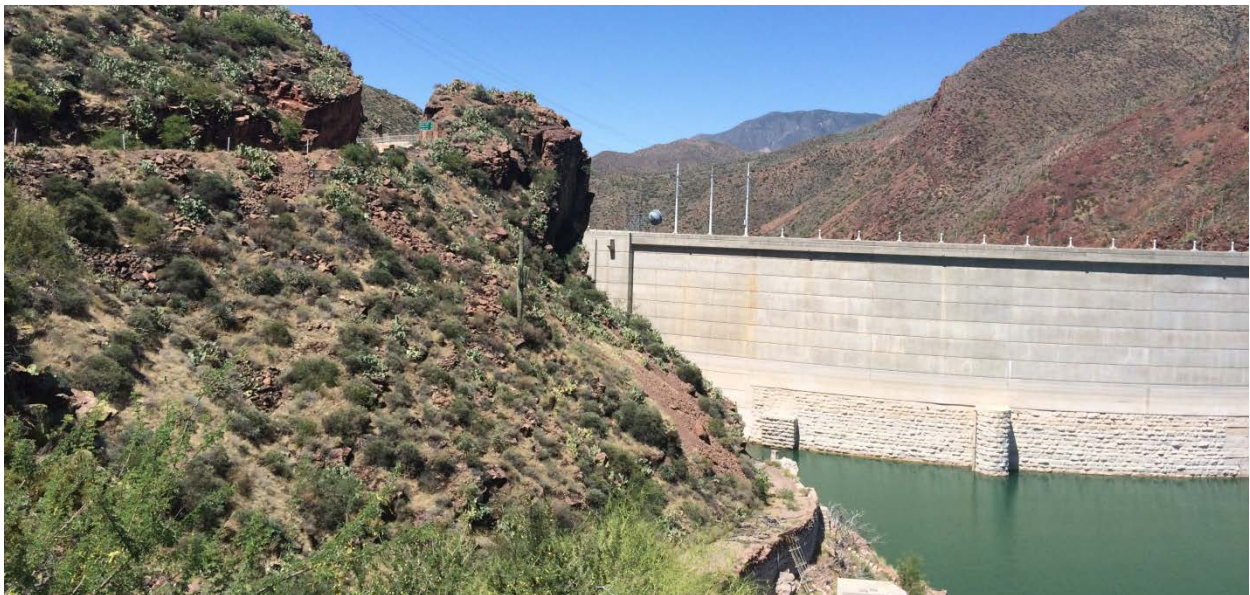
Figure 9: Roosevelt Dam, the SRP-managed dam at the northern end of the Apache Trail. The road is visible through a cut on the left.
