IMECE2016-67236

CONVENTIONAL LOCOMOTIVE COUPLING TESTS

Volpe National Transportation Systems Center
United States Department of Transportation
Cambridge, Massachusetts, USA

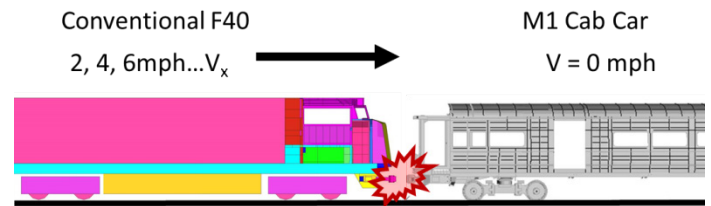
Figure 1. Schematic of coupling test initial conditions

The coupling tests were conducted repeatedly with the same conventional F40 locomotive and M1 cab car, starting at 2 mph for the first test, and increasing in increments of 2 mph, as shown schematically in Figure 1. At impact, the F40 locomotive was traveling at speed and the M1 cab car was braked. The couplers on both vehicles were open upon impact and expected to couple with each other. A total of six impact tests were conducted, with the final test conducted at a target speed of 12 mph. The vehicle weights were approximately 246 kips for the locomotive, and 73 kips for the M1 car.

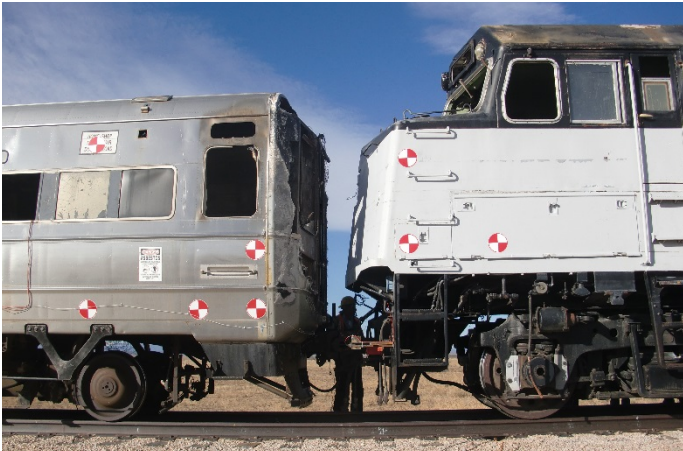
Figure 2. Pre-test photos of M1 cab car No. 9324 (left) and F40 locomotive No. 202 (right) used in the conventional coupling tests

The equipment used in the conventional coupling tests were conventional F40 locomotive No. 202 and M1 passenger cab car No. 9324, shown in the pre-test photograph of Figure 2. As can be seen in the photograph, this M1 cab car exhibits damage from a small fire. However, the structural elements of the end frame were unharmed and intact and the rest of the vehicle was undamaged.

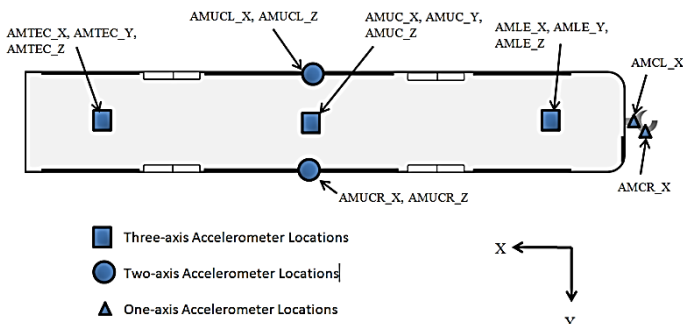
Figure 3. Schematic illustration of M1 cab car accelerometer locations

Figure 3 shows a schematic illustration of the accelerometer locations for the M1 car. Accelerometers were placed in similar locations on the F40 locomotive. The accelerometers on the carbody captured the three dimensional gross motions of the carbody – longitudinal, lateral, and vertical accelerations, as well as yaw, pitch, and roll. Seventeen accelerometer channels and eight displacement transducer channels were utilized for each vehicle, resulting in fifty total data channels.

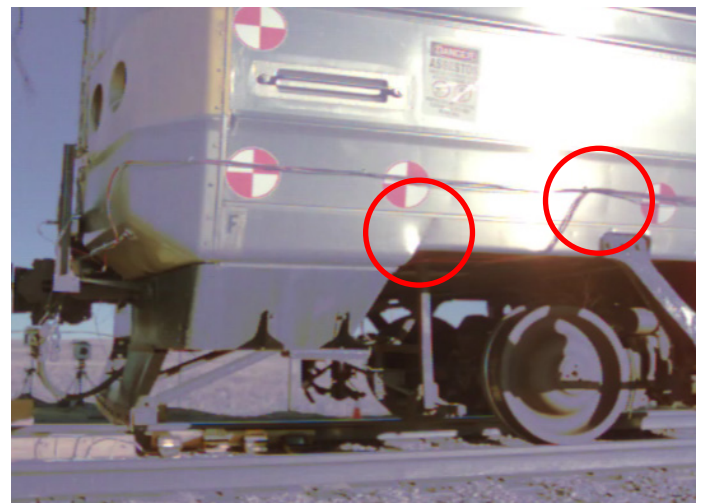
Figure 4. Dimpling of M1 shell at front left side sill truck connection after 5.7 mph impact test

The actual speed of the impact test was 5.7 mph. The vehicles coupled upon impact. Upon visual inspection, there was no apparent structural damage to the F40 locomotive. Similarly, there was no apparent structural damage to the coupler, draft gear or draft pocket of the M1 cab car. However, there was some very minor dimpling of the M1 car shell at the front left side sill truck connection to the truck, as indicated by the red circles of Figure 4.

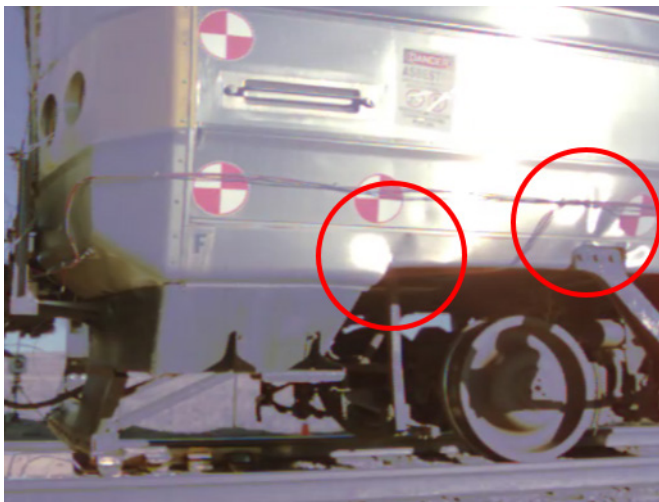
Figure 5. More pronounced dimpling of M1 shell at front left side sill truck connection after 7.9 mph impact test

Upon visual inspection, there was no apparent structural damage to the F40 locomotive. Similarly, there was no apparent structural damage to the coupler, draft gear or draft pocket of the M1 cab car. The dimpling of the M1 car shell at the front left side sill connection to the truck became more pronounced, as indicated by the red circles of Figure 5.

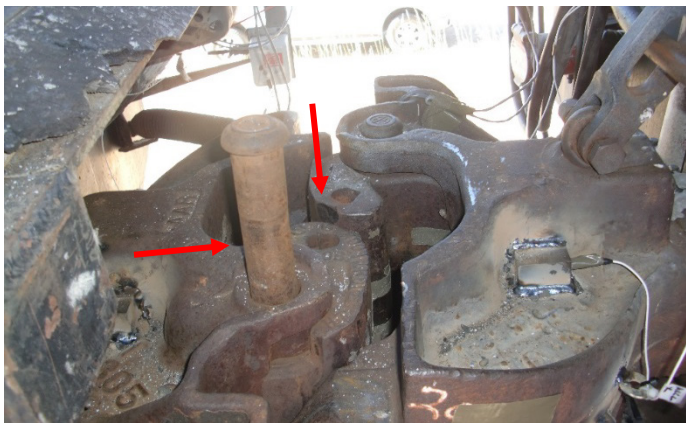
Figure 6. M1 coupler (left) hinge pin and locomotive coupler (right) knuckle damage

The actual speed of the impact test was 10.0 mph. During this test, both the locomotive coupler locking pin and the M1 coupler hinge pin came up due to vertical oscillations of both couplers as a result of the impact. This prevented the vehicles from coupling. The M1 coupler hinge pin can be seen in Figure 6.

Upon visual inspection, there was only very minor damage to the F40 locomotive. A small chip was taken out of the locomotive coupler knuckle, as indicated in Figure 6.

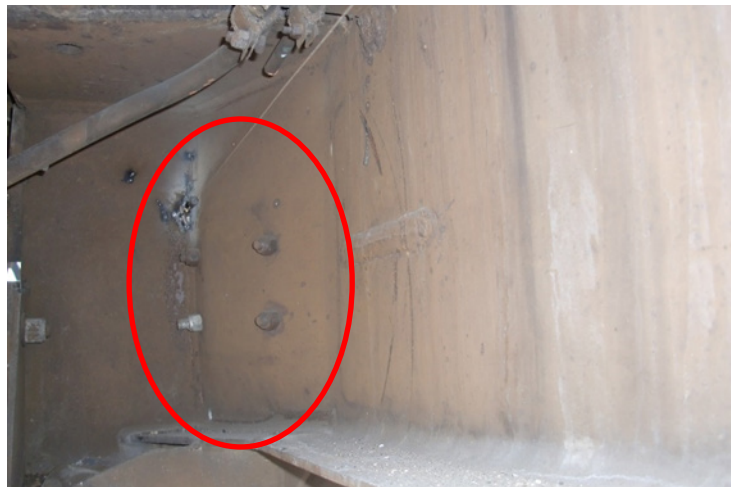
Figure 7. Bulging of M1 left draft sill due to coupler shank pushing on coupler stops inside bellmouth

In the M1 car, there was a bulge in the left draft sill at the bellmouth due to the coupler shank pushing on the coupler stops inside the bellmouth. This bulge can be seen inside the red circle in Figure 7. The coupler stops pushed in and deformed by the coupler shank can be seen in Figure 8. The left coupler stop (located on the right side in the photo) has been pushed in more and is more deformed than the right coupler stop.

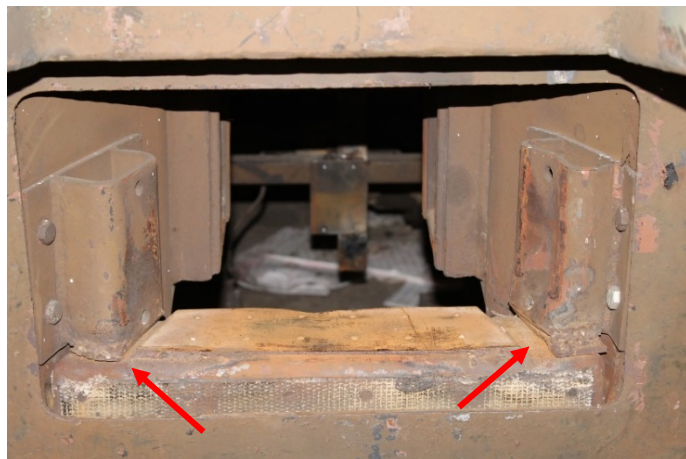
Figure 8. M1 coupler stops deformed by coupler shank

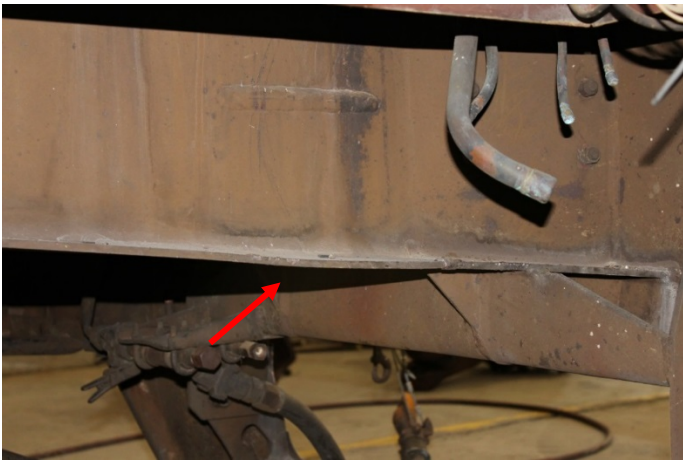
Figure 9. Deformed exterior right flange of M1 draft pocket

In the M1 car, the impact force developed in the 10 mph impact caused the exterior right flange of the draft pocket to deform, as indicated in Figure 9. The force of the impact through the draft gear also caused one of the buff plates in the draft gear to bend, as indicated in Figure 10.

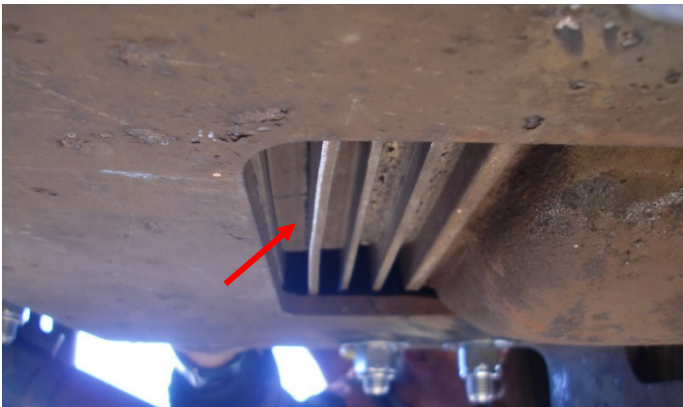
Figure 10. M1 bent buff plate in draft gear

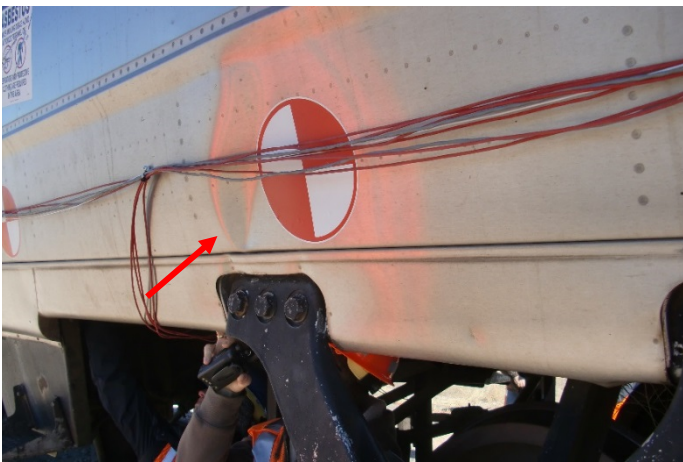
Figure 11. M1 side sill buckled at front left truck connection (exterior view)

In the M1 car, this impact caused the side sill to buckle at the front left truck connection. Figure 11 shows an exterior view of the buckle of the side sill, and Figure 12 shows in interior view of the buckled side sill at the front left truck connection. There was also some minor dimpling of the M1 shell at the side sill on the right side at the front truck connection, but the damage was more extensive on the left side.

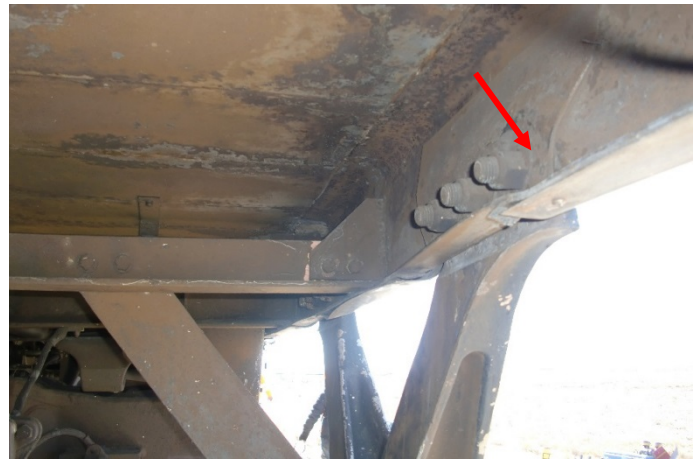
Figure 12. M1 side sill buckled at front left truck connection (interior view)

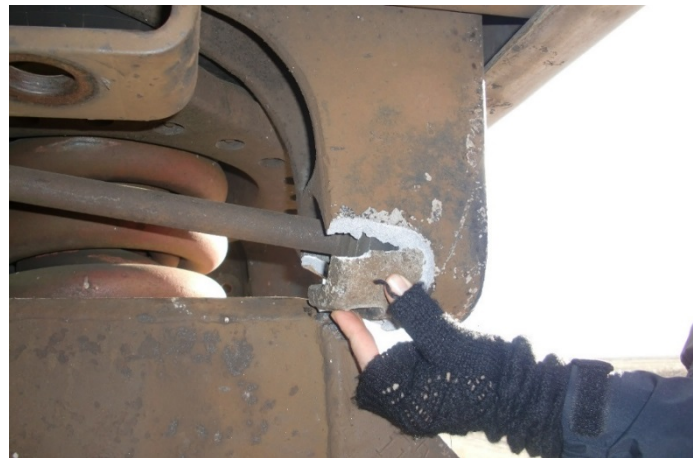
Figure 13. M1 side sill front left truck connection damage

In the M1 car, the 12 mph impact caused damage at the side sill front left truck connection, as shown in Figure 13. The impact also caused an underframe member to deform near the front left truck, as shown in Figure 14, and the front belt loop of the front truck to be severed, as shown in Figure 15.

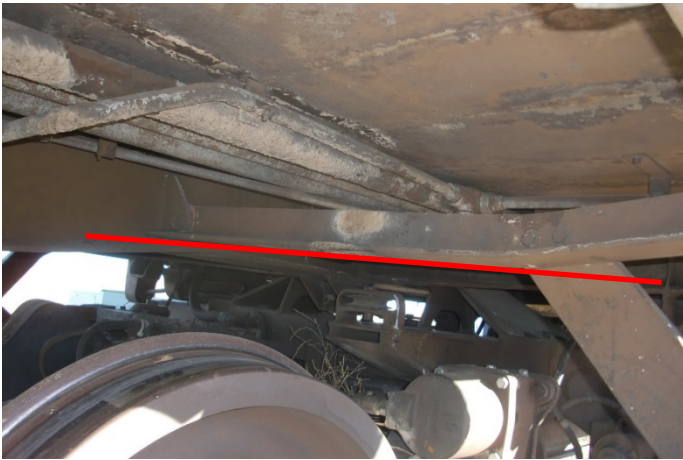
Figure 14. M1 underframe member bent near front truck connection, left side

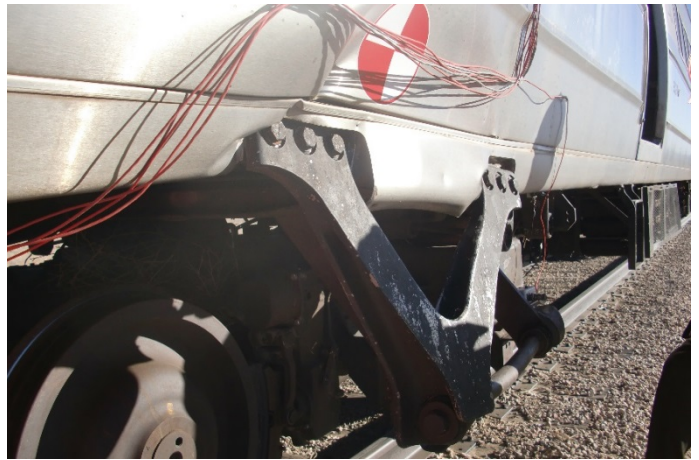
Figure 16. M1 side sill front left truck connection (exterior view)

The 12 mph impact worsened the buckle at the side sill front left truck connection, as shown in the exterior view of Figure 16 and the interior view of Figure 17, effectively crippling the M1 car. The red arrows in Figure 17 indicate cracks in the side sill. The minor dimpling that occurred in the 10 mph impact on the front right shell at the side sill connection to the front right truck worsened to buckling of the side sill at this location due to the 12 mph impact. This can be seen in the exterior view of Figure 18 and the interior view of Figure 19. The red arrows in Figure 19 indicate cracks in the side sill.

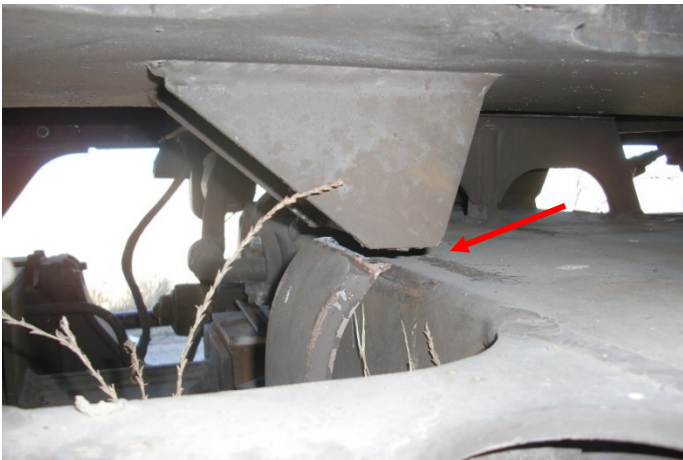
Figure 15. M1 front belt loop of front truck severed

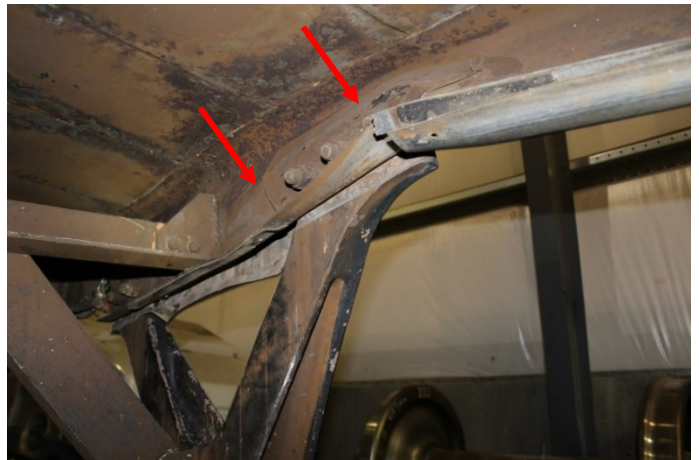
Figure 17. M1 side sill front left truck connection (interior view)

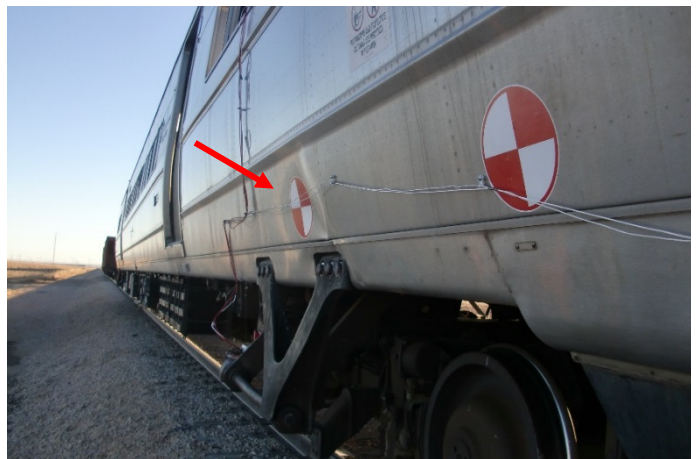
Figure 18. M1 side sill front right truck connection (exterior view)

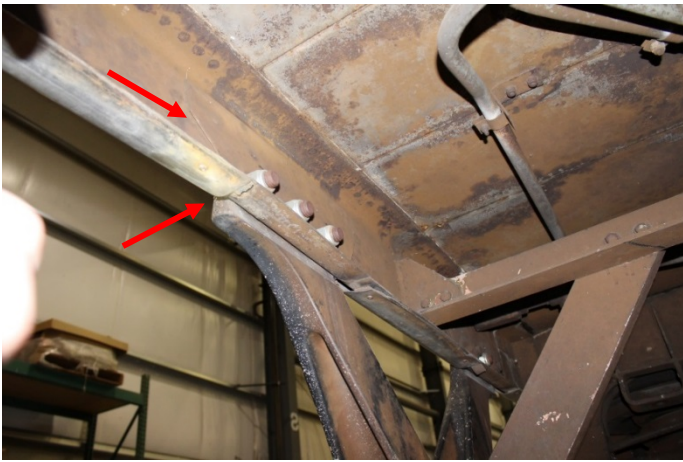
Figure 19. M1 side sill front right truck connection (interior view)

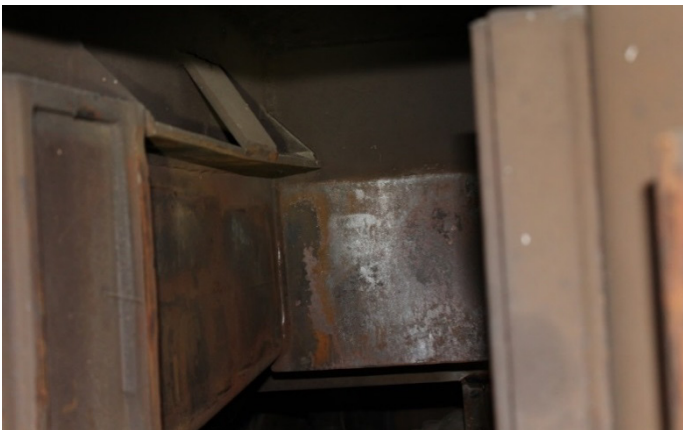
Figure 20. M1 interior draft pocket bent longitudinal member, right side

The post-test inspection of the M1 cab car draft gear and draft pocket revealed that the longitudinal members on both sides of the draft pocket were deformed, as shown in Figure 20 and Figure 21. Two of the buff plates of the M1 draft gear were also bent as a result of the six impact tests, as shown in Figure 22.

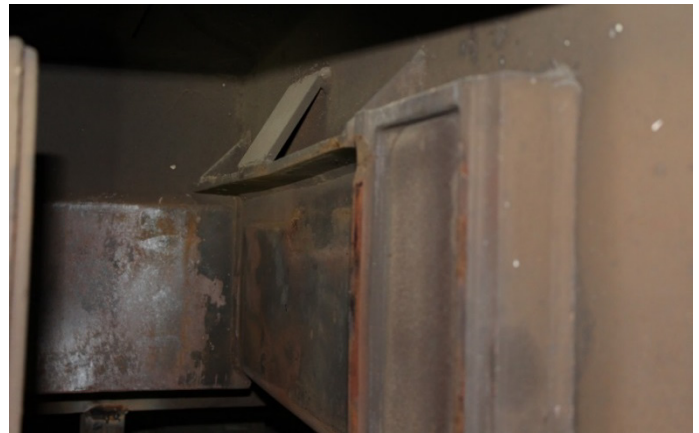
Figure 21. M1 interior draft pocket bent longitudinal member, left side

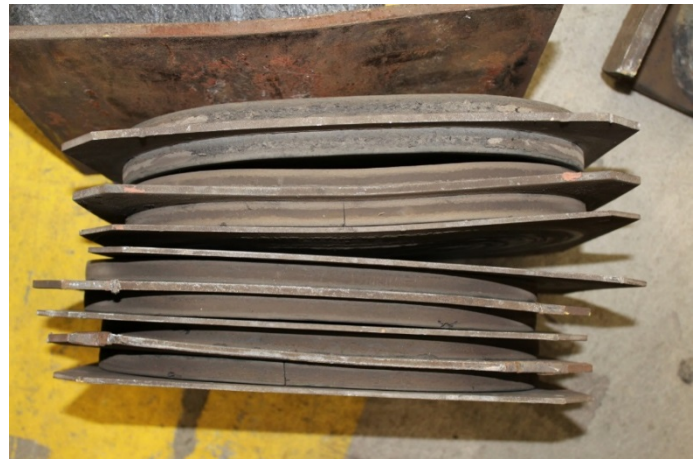
Figure 22. M1 bent buff plates

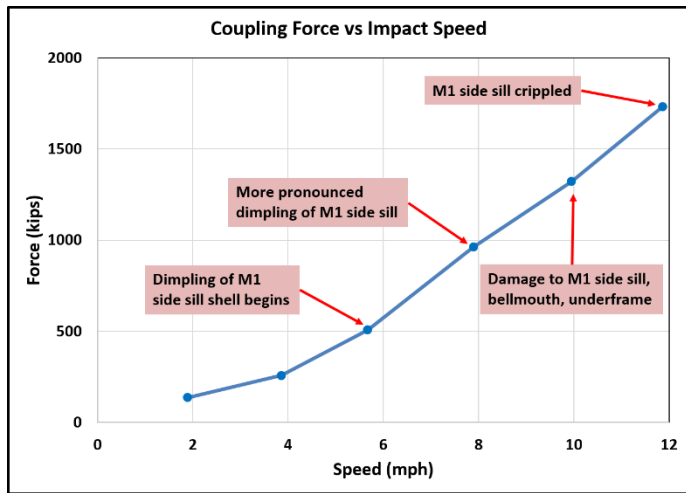
Figure 23. Coupling force as a function of impact speed

The coupling force as a function of the impact speed is plotted in Figure 23. The plot is annotated to show the

progression of damage to the M1 cab car. Again, very little damage was incurred by the locomotive through all six impact tests. As shown in the figure, no damage to the M1 occurred in the first two impact tests (1.9 mph and 3.9 mph). Dimpling of the M1 shell at the location where the side sill meets the front truck attachment occurred as a result of the 5.7 mph impact. This dimpling became more pronounced as a result of the 7.9 mph impact. The 10.0 mph impact resulted in more damage to the side sill at the front truck connection, as well as damage to the bellmouth and underframe. The 11.9 mph impact resulted in effectively crippling the side sill of the M1 cab car.

The main objective of this effort was to determine the maximum non-destructive conventional coupling speed. Figure 23 shows the measured coupling force as a function of impact speed. At 2 mph and 4 mph, no visible damage occurred to either vehicle. Between 4 mph and 6 mph, damage begins to occur. At speeds greater than 6 mph, there was visible damage. Therefore, coupling speeds should be kept under 6 mph to prevent damage. This is consistent with the Association of American Railroads' General Code of Operating Rules [11], which specifies that couplings occur "at a speed of not more than 4 mph".

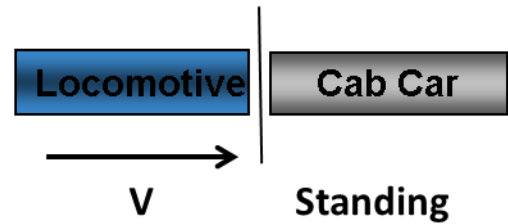
Figure 24. Schematic of one-dimensional two-degree-of-freedom lumped parameter coupling model.

A simplified, one-dimensional, two-degree of freedom, dynamic lumped-parameter model of the coupling test was developed prior to the tests, shown schematically in Figure 24. The M1 cab car is represented by a single mass, and the F40 locomotive is also represented by a single mass. The draft gears act as a spring between the two masses. The model includes the longitudinal braking force acting on the M1. The primary purpose of the model was to estimate the peak force acting between the vehicles as a function of coupling speed.

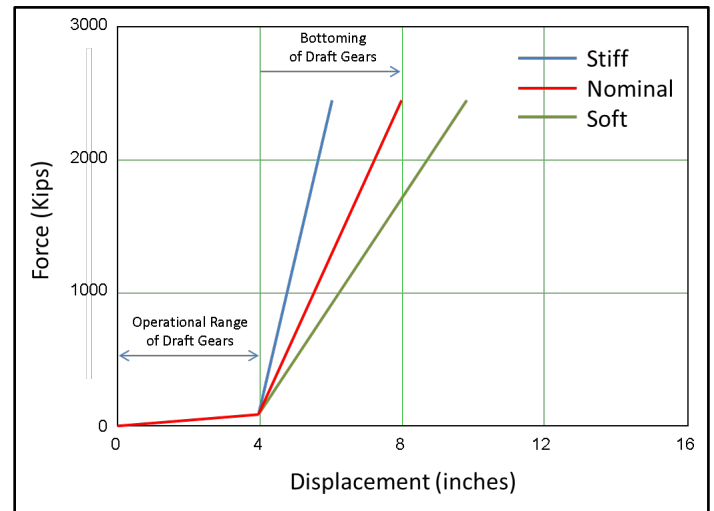
Figure 25. Input force-displacement characteristics for lumped-parameter model.

Figure 25 shows the force-displacement characteristics input into the simplified model. The characteristic is that of a relatively soft spring with a relatively hard stop. In such cases, the peak force is sensitive to the stiffness of the stop. Accordingly, a range of bottoming stiffnesses were analyzed: stiff, nominal, and soft. The bottoming stiffness is a function of both the draft gear itself and the support provided to the draft gear by the locomotive and cab car underframes.

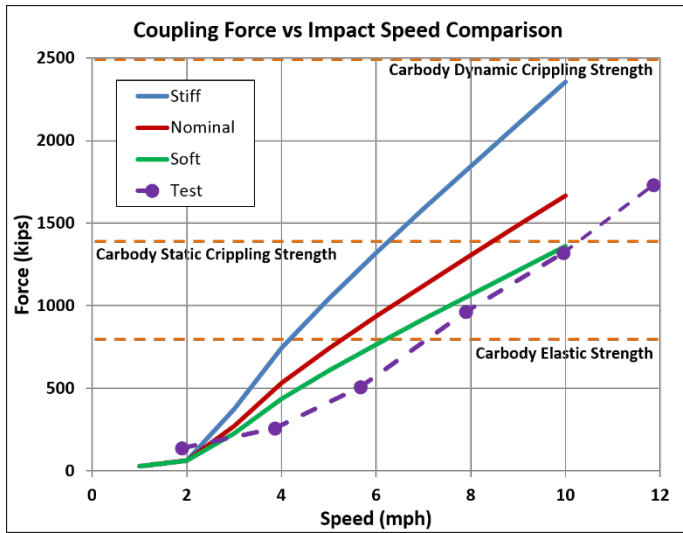
Figure 26. Peak coupling force as a function of coupling speed compared to results from lumped-parameter model

Figure 26 shows peak coupling force as a function of coupling speed, for the three bottoming stiffnesses: stiff, nominal, and soft. The graph is also annotated with the M1 car elastic strength, static crippling strength, and dynamic crippling strength [10]. Prior to the test, the coupler load was predicted to exceed the M1 cab carbody static elastic strength for coupling speeds between 4 and 7 mph. The coupler load was predicted to exceed the M1 cab carbody static crippling strength for coupling speeds between 6 and 10 mph. It was predicted that damage would occur for coupling speeds between 6 and 8 mph. This compares favorably with the test result that coupling speeds should be kept under 6 mph to prevent equipment damage.

It is important to note that the three M1 carbody strengths and the three predictions shown in Figure 26 are based on the assumption that the load path goes through the carbody alone. However, the dimpling and subsequent crippling of the M1 side sills that resulted from the impact tests indicate that the load path was through the truck attachments. This behavior could not have been captured by the simplified, one-dimensional model, since the entire M1 cab car was represented by a single mass.

The forces measured in the impact tests are also plotted with the model predictions and M1 carbody strengths in Figure 26. Despite the difference in load path, the figure shows that the results of these conventional coupling tests compares favorably with pre-test predictions of the simplified model utilizing the soft stiffness.
