DOT/FAA/AR-96/110

Evaluation of Lightweight Material Concepts for Aircraft Turbine Engine Rotor Failure Protection

July 1997

Final Report

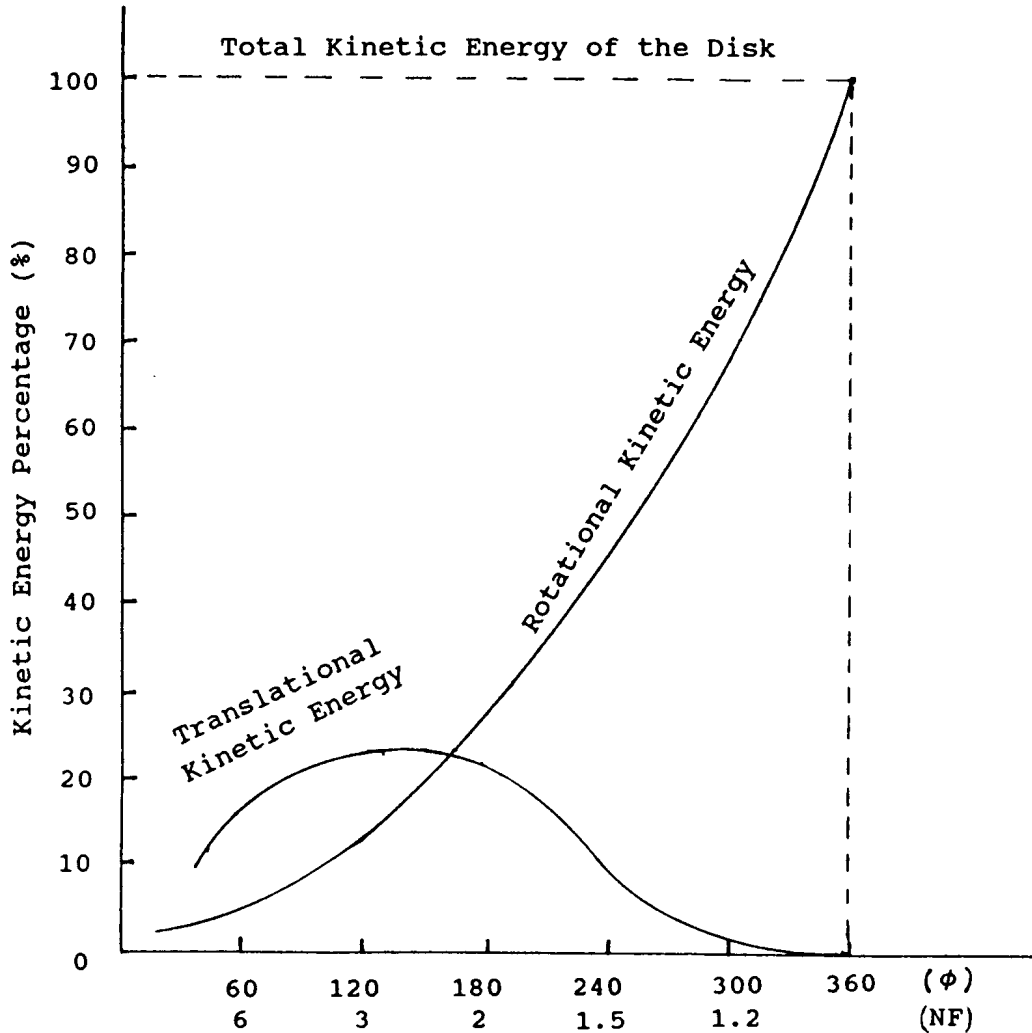
FIGURE 3. DISTRIBUTION OF TRANSLATIONAL AND ROTATIONAL KINETIC ENERGY OF ROTOR BURST FRAGMENT AS A FUNCTION OF FRAGMENT ANGLE (ϕ)

Figure 3, which comes from equations 22-25 in appendix A, shows that the maximum translational kinetic energy (KE_t) of a fragment is obtained when the fragment sector angle is equal to 133.6 degrees. The total KE_t at this angle, however, is lower than the total KE_t as the sector angle becomes smaller or the number of fragments increases. In the design of the disk failure for the containment tests, the severe translational kinetic energy produced by a 120-degree disk fragment is interesting since the difference of KE_t s between the 120 and 133.6 degrees is insignificant. At the moment of the disk failure, KE_t of a one-third fragment reaches 21% and the rotational kinetic energy (KE_r) accounts for 12.3% of the total kinetic energy (KE). However, because of the fragment energy loss due to the friction from the rubbing of the disk against the containment ring, only approximately one-half (6.1%) of the rotational kinetic energy exists. Therefore, most of the damage to engine casings or other components is caused by the translational kinetic energy of the fragments. It should also be noted from figure 3 that the translational kinetic energy decreases and reaches zero as the fragment sector angle increases and reaches 360°. At this point, the total

energy comes completely from the rotational kinetic energy. On the other hand, as the number of fragments increases, the rotational kinetic energy of a fragment decreases and becomes small. KE_r , however, becomes larger and approaches its limit of 92.6%. At this limit KE_r is very small.

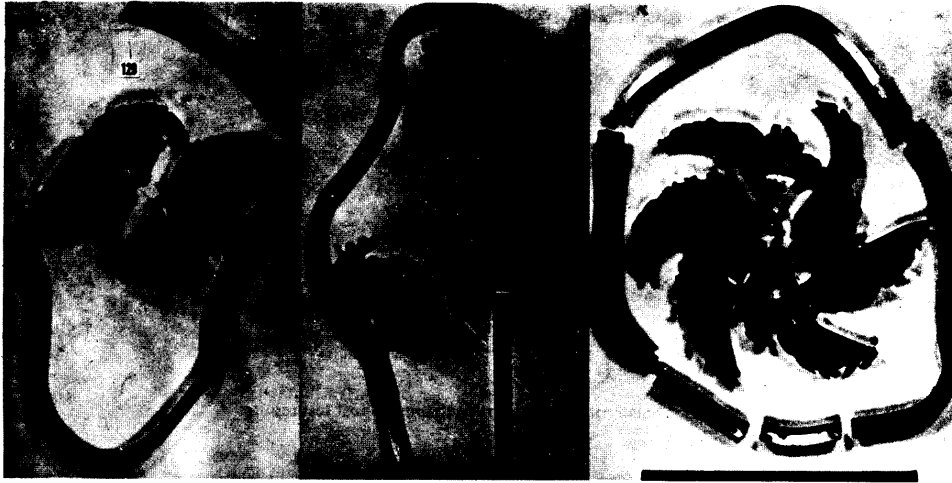
FIGURE 12. CONTAINMENT RING TENSILE FAILURE (SOURCE: SALVINO 1977)

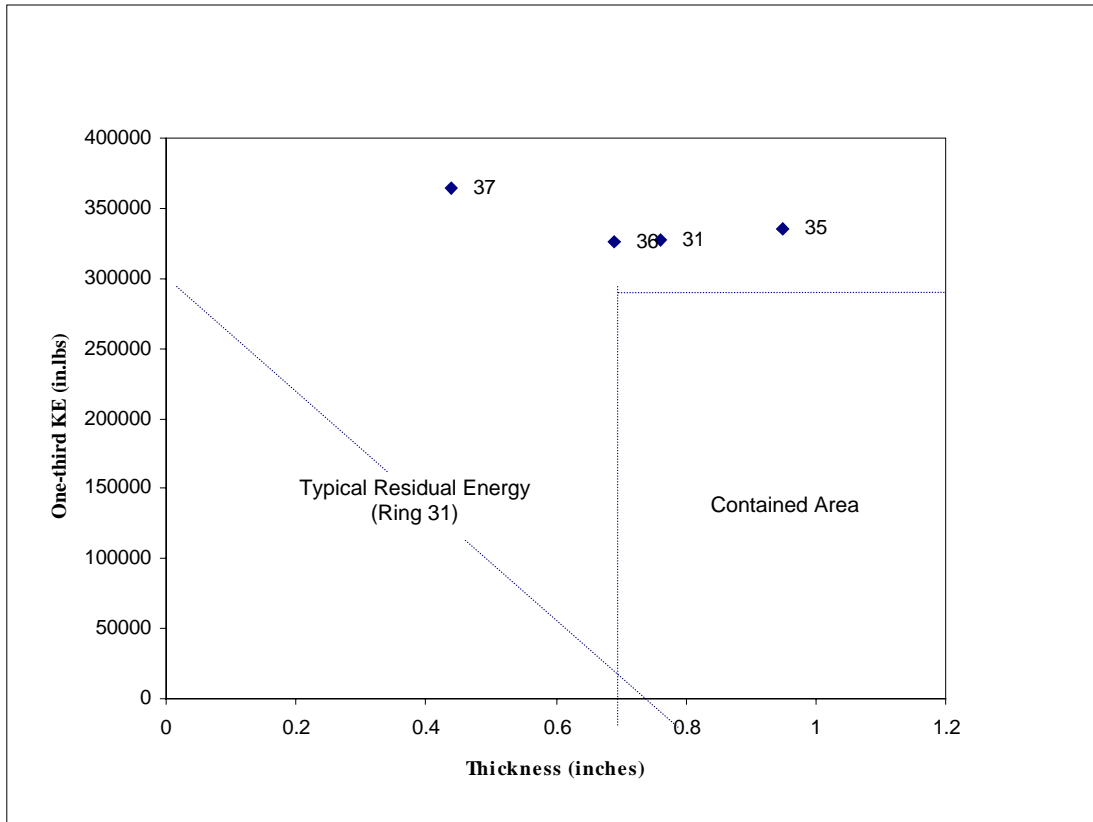
FIGURE 16. GROUP 1—FIBERGLASS-ALUMINUM

Figure 16 shows the threshold containment and a typical residual kinetic energy. The residual energy of the fragment leaving ring 31 was 13.3 kips. It was derived from the estimated penetrating duration taken from the high-speed film. Based on this approximation, the uncontained fragment was leaving ring 31 at the speed of approximately 1,690 inches per second, an equivalence of 96 miles per hour.

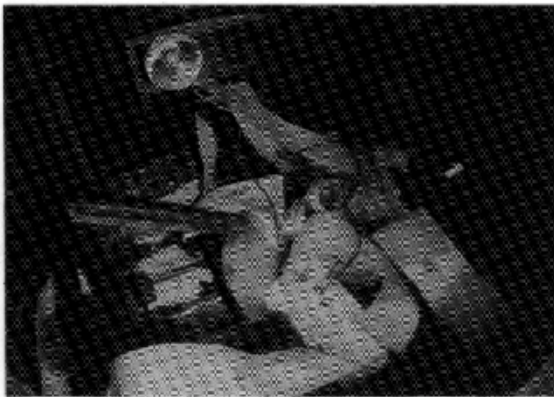
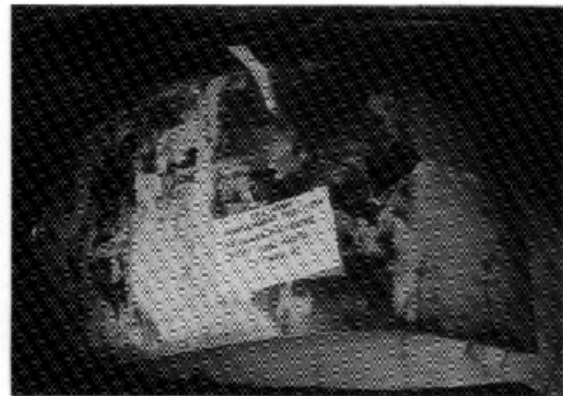
FIGURE 23. FAILURE EVENT AND POSTTEST PICTURES OF RING 28

Group 3, fiberglass impregnated with polyester resin, had five systems (rings 3, 9, 17, 24, and 28). Rings 3, 9, 17, and 24 contained all fragments. No significant damage on the outer most layers of these rings was recorded. Normalized weight and thickness of ring 3 were 47.52 lbs and 1.65 inches, ring 9 were 36.50 lbs and 1.18 inches, ring 17 were 22.00 lbs and 0.71 inch, and ring 24 were 20.86 lbs and 0.69 inch respectively. KE_w and KE_t of ring 3 were 21 kips/lb and 619 kips/in, ring 9 were 26 kips/lb and 820 kips/in, ring 17 were 49 kips/lb and 1,527 kips/in, and ring 24 were 47 kips/lb and 1,429 kips/in respectively. System 24 represented the threshold configuration. System 17, however, provided higher energy absorbed per unit weight, and it was selected for ranking. One disc fragment penetrated ring 28 and escaped. Figure 20 shows the posttest pictures of rings 3, 9, and 17. Figures 21 and 22 show the failure event of ring 3, 9, 17, and 24. Figure 23 shows the failure event and posttest pictures of ring 28. Figure 24 shows the contained area of group 3. The residual energy of the fragment leaving ring 28 at the speed of 317 inches per second or 18 miles per hour was approximately 467 in-lbs.

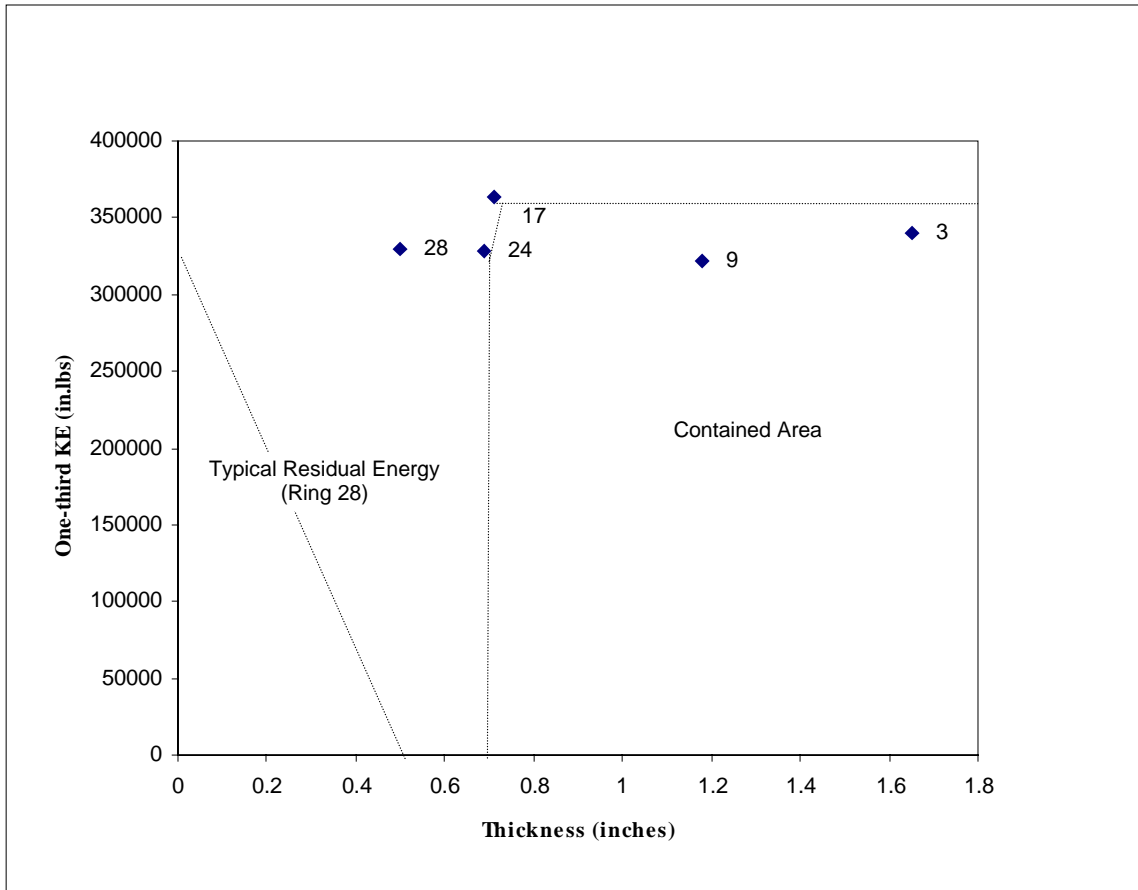
FIGURE 24. GROUP 3—FIBERGLASS-POLYESTER

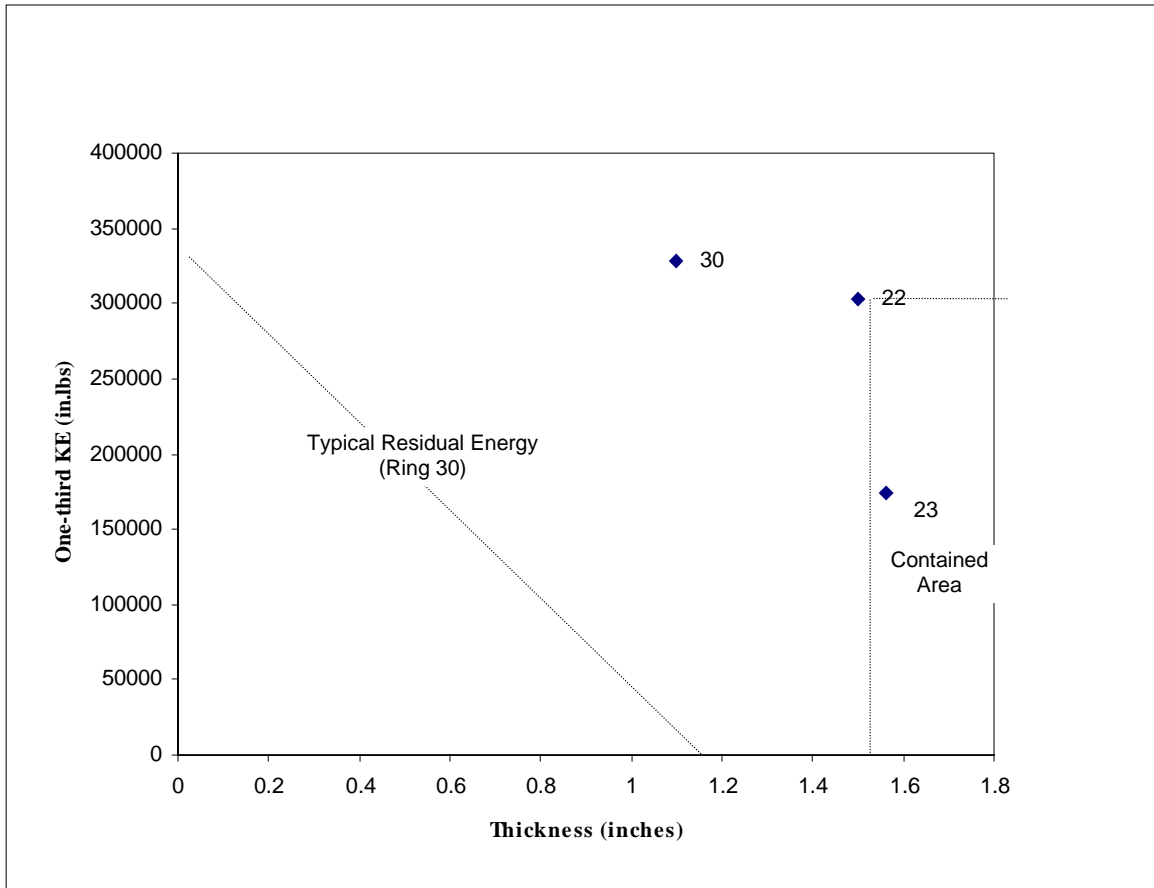
FIGURE 27. GROUP 4—DRY KEVLAR 29

Figure 27 shows the contained area of group 4. The uncontained fragment was leaving ring 30 at the speed of approximately 399 inches per second or 23 miles per hour. Its residual energy was approximately 740 in-lbs.

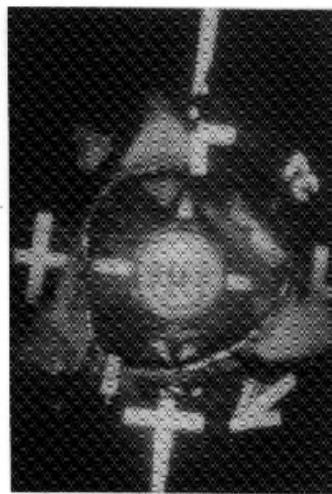
FIGURE 29. FAILURE EVENT OF RING 32

Group 5 had four aluminum lined Kevlar systems (rings 27, 29, 33, and 34) which contained all fragments. Normalized weight and thickness of ring 27 were 24.08 lbs and 1.53 inches, ring 29 were 18.26 lbs and 1.19 inches, ring 33 were 18.61 lbs and 1.16 inches, and ring 34 were 16.00 lbs and 1.02 inches respectively. KE_w and KE_t of ring 27 were 40 kips/lb and 623 kips/in, ring 29 were 50 kips/lb and 766 kips/in, ring 33 were 57 kips/lb and 910 kips/in, and ring 34 were 56 kips/lb and 883 kips/in respectively. System 33 had the threshold values. One disc fragment penetrated rings 32 and 33. Figure 28 shows the posttest picture of rings 29, 32, 33, and 34. Figures 29 and 30 show the failure event of rings 32, 33, and 34.

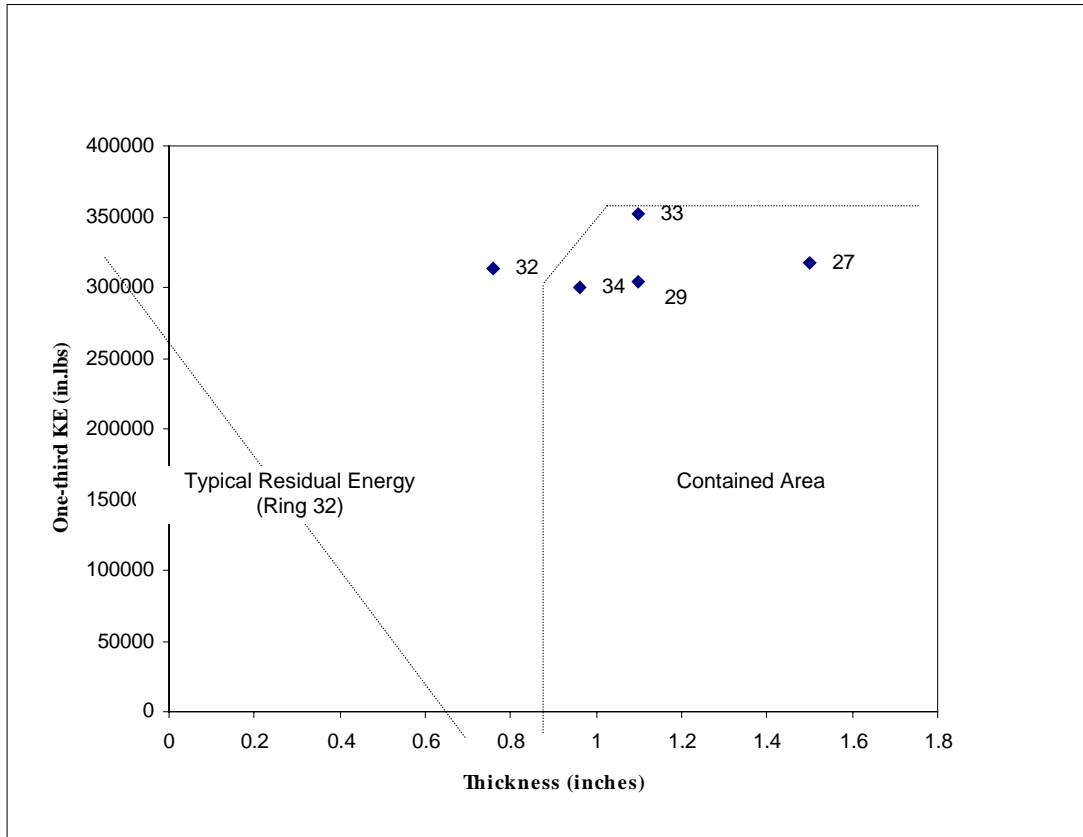
FIGURE 31. GROUP 5—DRY KEVLAR 29-ALUMINUM

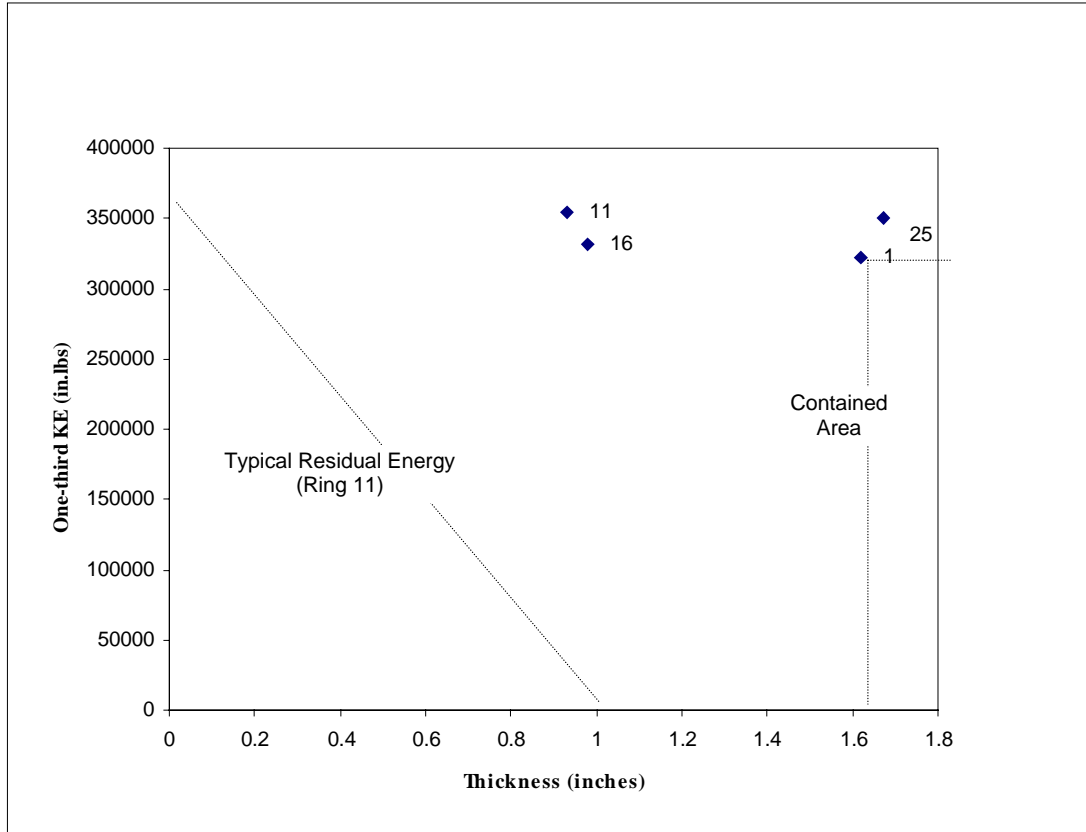
FIGURE 35. GROUP 6—KEVLAR 29-PHENOLIC

Group 6 had four Kevlar systems impregnated with phenolic resin (rings 1, 11, 16, and 25). Only ring 1 contained all rotor fragments. Normalized weight and thickness of ring 1 were 28.83 lbs and 1.62 inches. KE_w and KE_t of ring 1 were 34 kips/lb and 598 kips/in. These were the threshold values for this group. Three disc fragments penetrated and escaped ring 11. Two penetrated and escaped ring 16. One penetrated and escaped ring 25. Figure 32 shows the pictures of rings 1, 11, and 16. Figure 33 shows the failure event of rings 1 and 11. Figure 34 show the failure event of rings 16 and 25.

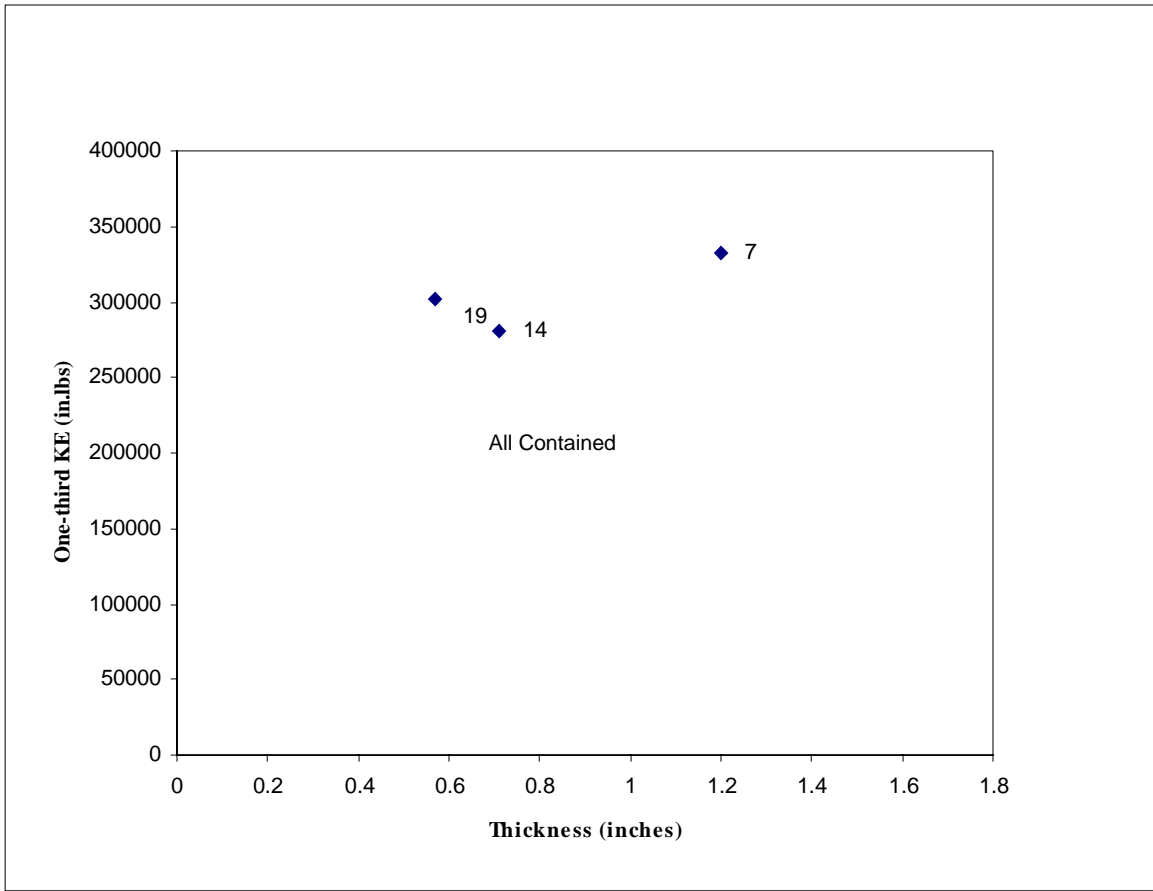
FIGURE 41. GROUP 8—STEEL-FIBERGLASS-POLYESTER

All systems (rings 7, 14, and 19) in group 8 contained all rotor fragments. Steel layer thickness of rings 7, 14, and 19 were 0.31, 0.19, and 0.12 inch respectively. Normalized weight and thickness of ring 7 were 63.90 lbs and 1.20 inches, ring 14 were 39.50 lbs and 0.71 inch, and ring 19 were 29.00 lbs and 0.57 inch respectively. KE_w and KE_t of ring 7 were 16 kips/lb and 831 kips/in, ring 14 were 21 kips/lb and 1,187 kips/in, and ring 19 were 31 kips/lb and 1,591 kips/in respectively. No system represented the threshold configuration. System 7 was, however, selected for ranking due to its higher energy absorbed per unit weight. Minimum damage was done on these systems. Figure 39 shows the posttest pictures of rings 7, 14, and 19. Figure 40 shows the failure event of ring 7 and 19. Figure 41 shows the contained area without the threshold value.

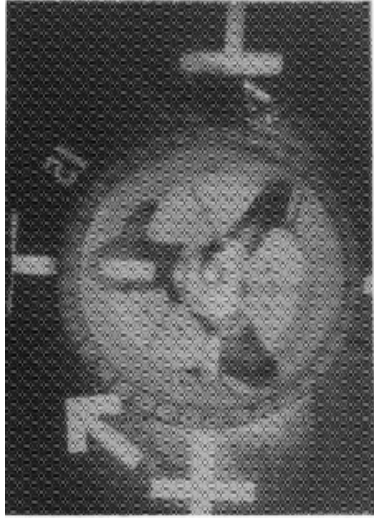
FIGURE 44. FAILURE EVENT OF RING 15

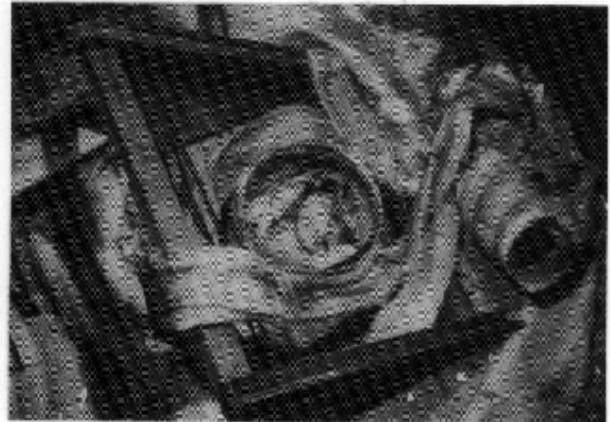
(1) FAILURE EVENT OF RING 40

(2) RING 40 BEFORE TESTING

(3) RING 40 AFTER TESTING
